The SCAPE Trust
The University of St Andrews
Queen's University Belfast
March 2010
Commissioned by Historic Scotland

The Eroding Limekilns at Boddin Point, Angus

preservation by
digital record

Historic Scotland Project Number: **53605**
NGR: NO 71340 53347

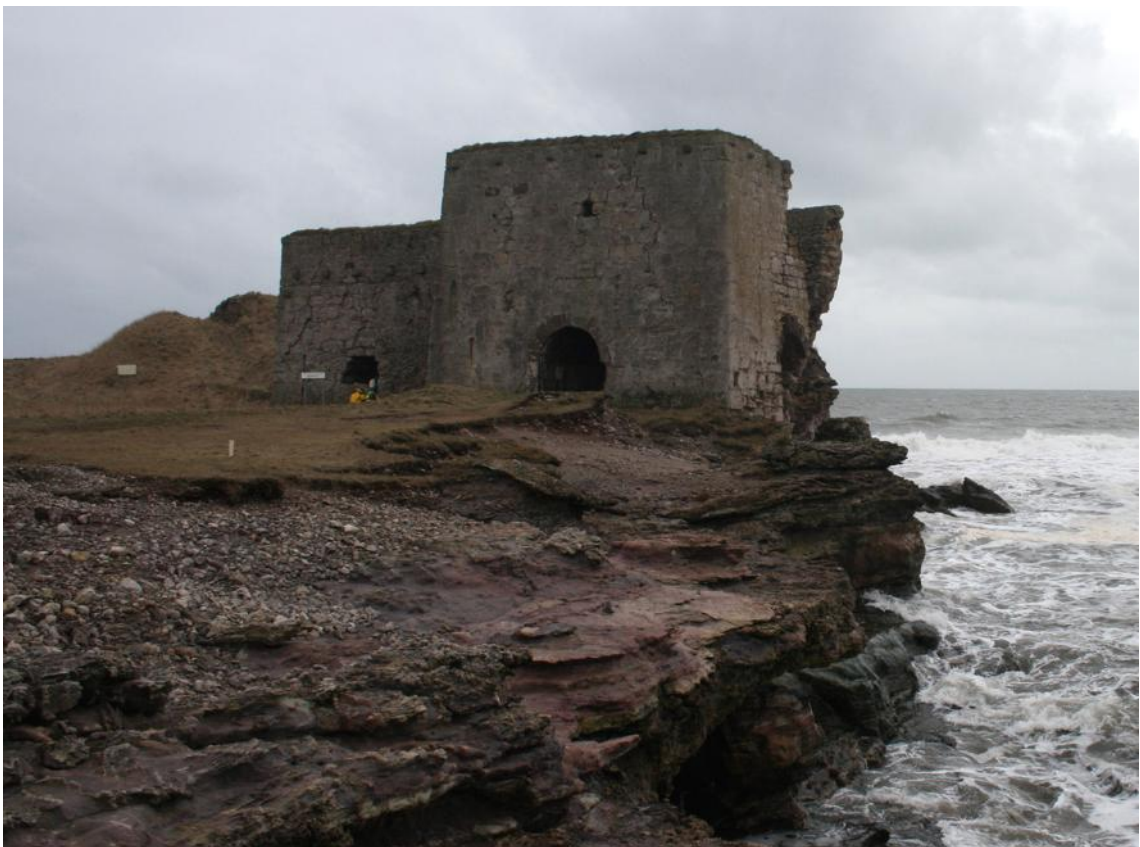
The limekilns were photographed by John Hume in 1977, at which time the structure was intact (Plate 1). In 2009, a coastal zone assessment survey of Angus was completed by The SCAPE Trust (Dawson *et al.*, 2009). This noted that parts of the limekilns had collapsed (Plate 2). The extent of the damage can be clearly seen when the 1977 image is overlain on the more recent photograph (Plate 3). The coastal zone assessment survey report carried a recommendation that the limekilns should be surveyed, as the site was under severe threat from coastal erosion.

Plate 2. Boddin limekiln photographed in 2010, showing the collapsed south western corner.

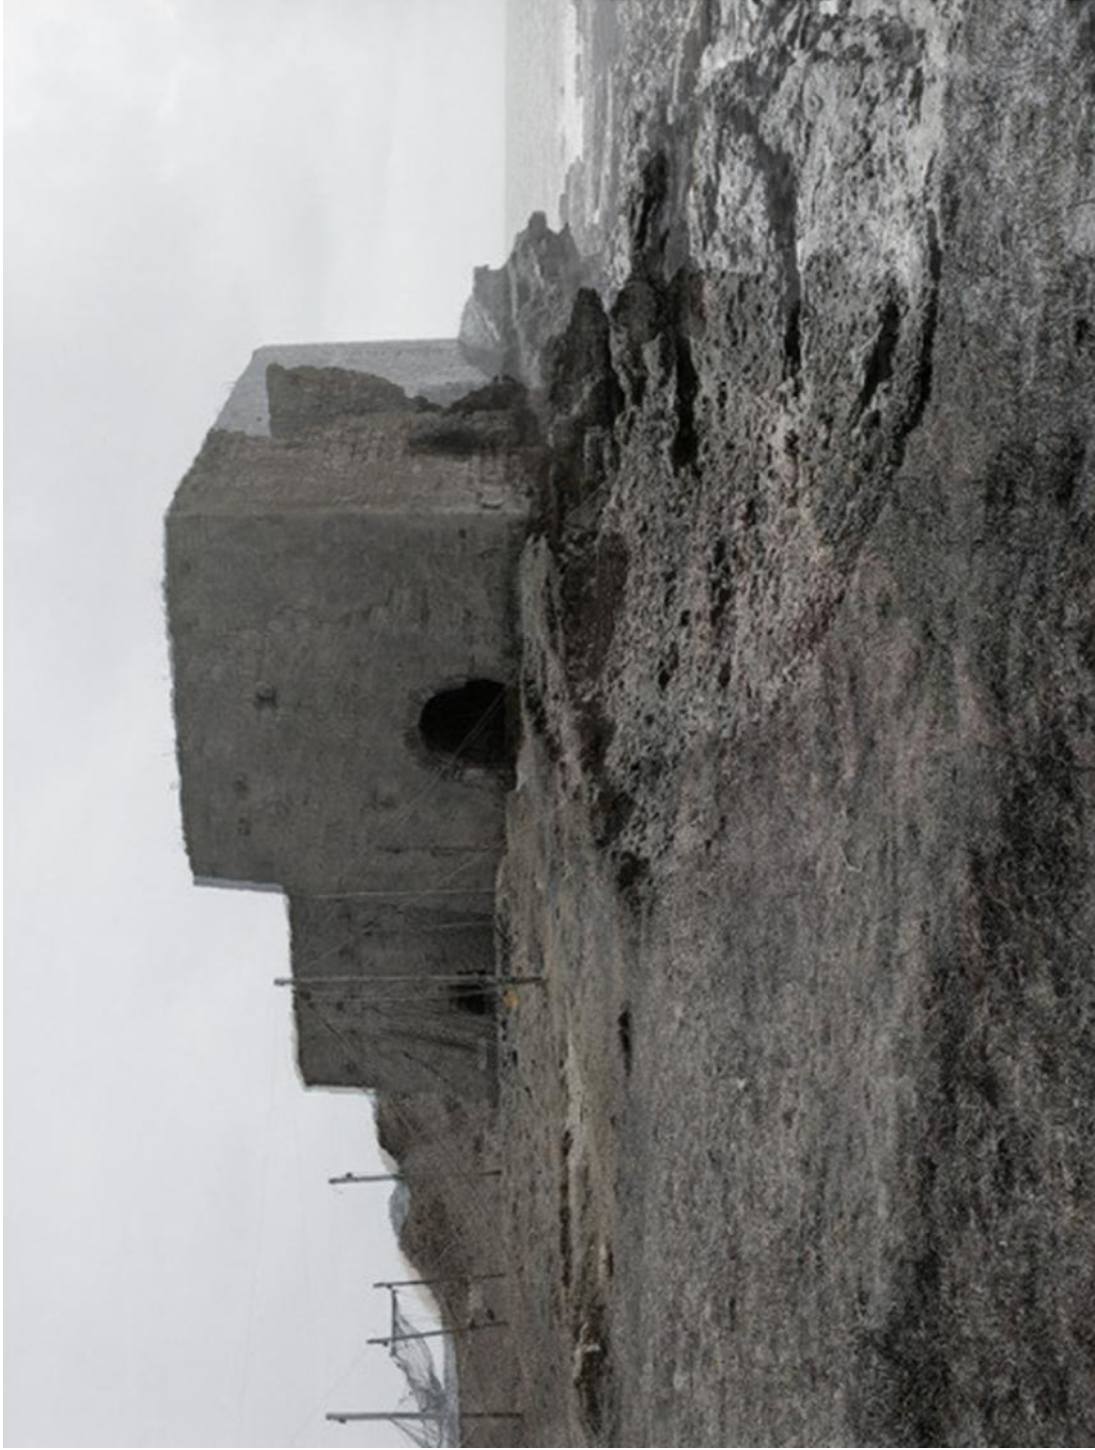
Plate 3. Images taken in 1977 and 2010 (plates 1 and 2) superimposed to show extent of damage to south western corner.

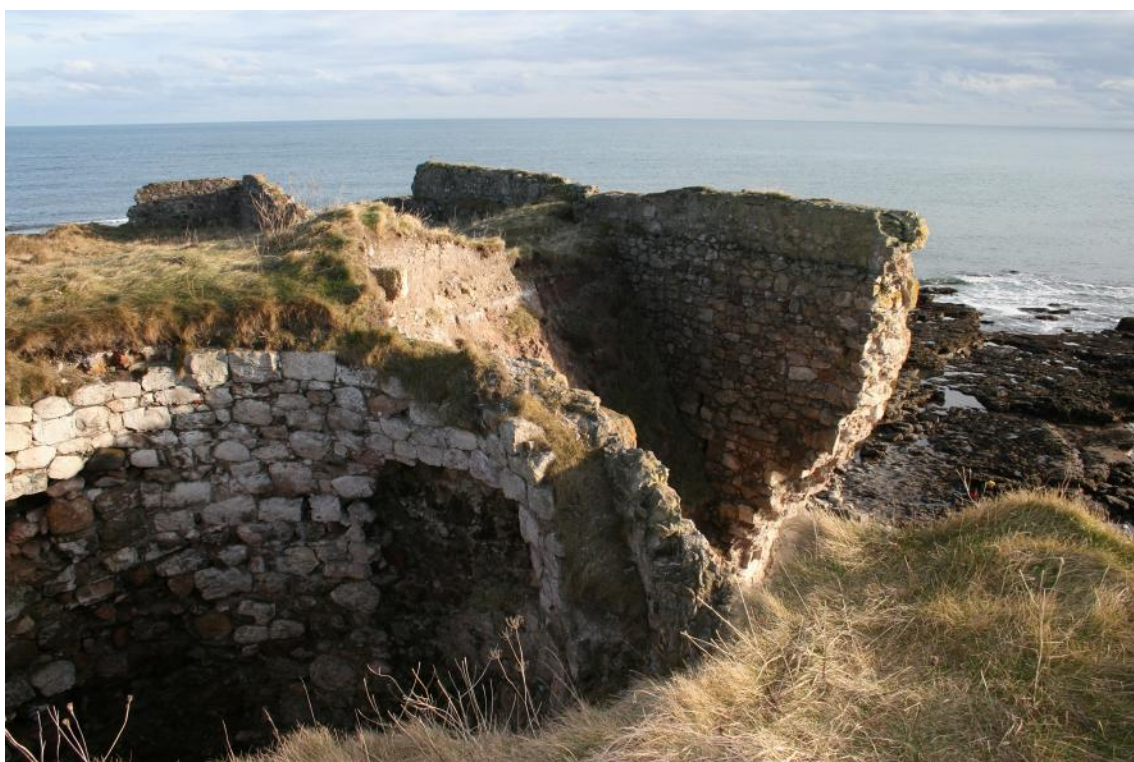
Plate 9. Inside face of the stone-lined burning chamber of the kiln 3 taken from the top of the kiln looking southwest. Also shown is the collapsed southwest corner of the main south retaining wall of the kiln block.

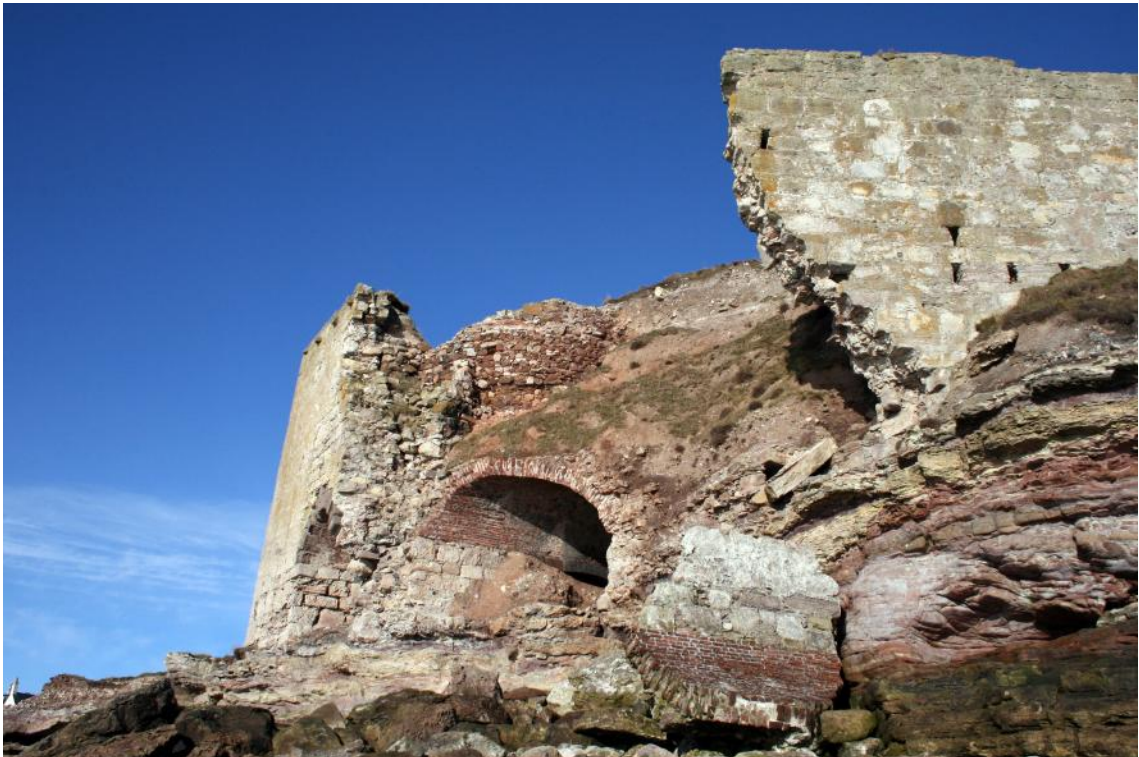
Plate 11. The internal structure of the kiln block showing the stone-lined burning chamber of kiln 3; the eroding opening of the brick vaulted interconnecting passage between kilns 2 and 3; a collapsed capstone of a stone-lined duct between the interconnecting passage and the base of the southern retaining wall; and the infill creating the bank into which the kiln structure has been built. Note the large intact fragment of archway from the eroding passageway in the foreground.

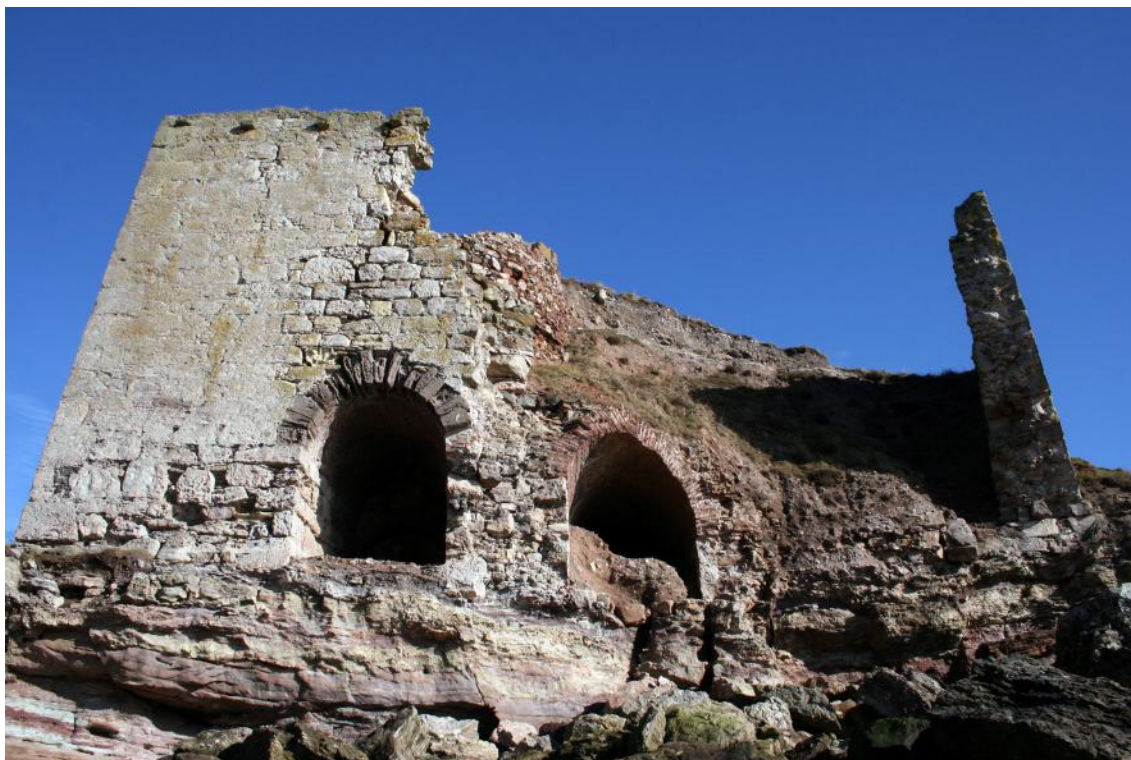
Plate 12. The surviving part of the west elevation of the limekilns showing the western stone-lined draw hole of kiln 3, with the eroding interconnecting passageway to the right. The internal structure of the burning chamber is visible above the draw hole. Note the undercut rock platform upon which this part of the kiln block is built.

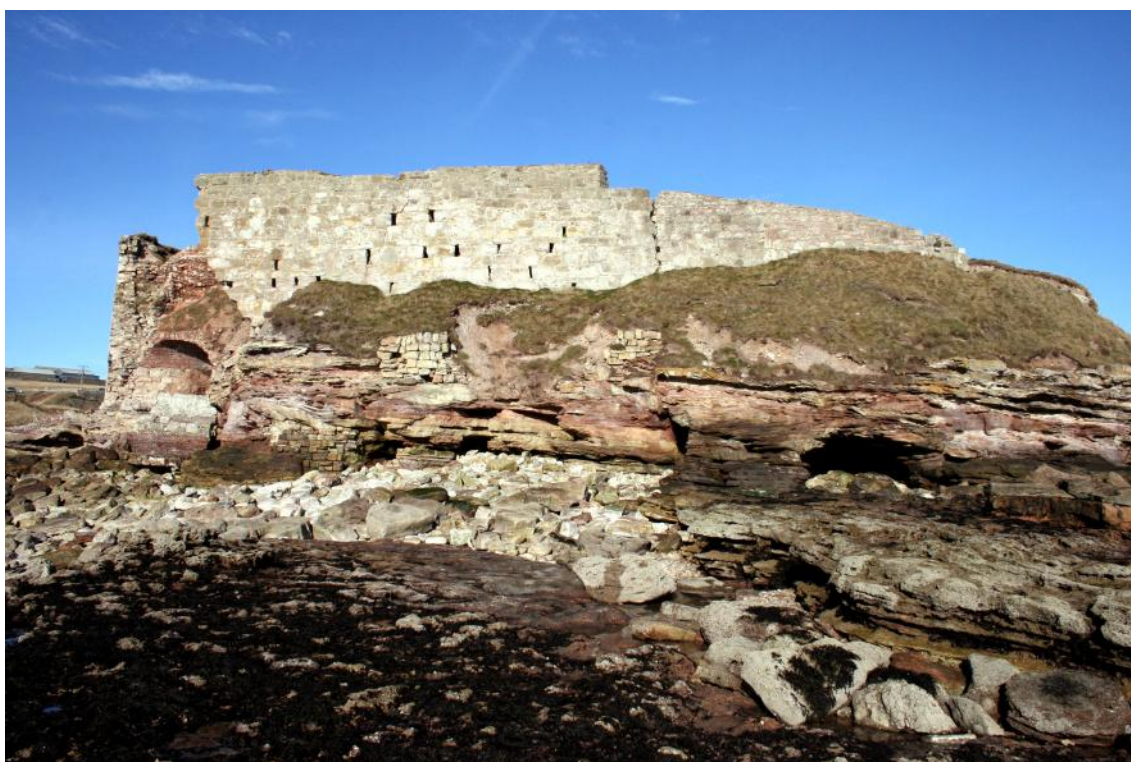
Plate 13. View of the southern elevation of Boddin limekilns, looking north. The main seaward retaining wall of the structure is pierced with drainage holes. Turf covered debris from the kilns mixed with redeposited till is piled against the outside face of the wall. Eroded cavities in the soft mudstone of the rock platform have been revetted with sandstone blocks. The eroded opening of the interconnecting passage can be seen in the left of the picture.

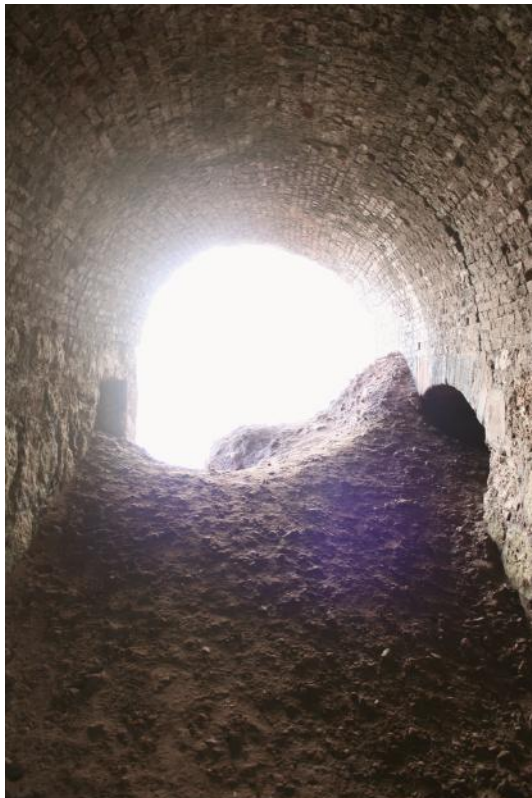
Plate 16. Looking west down the interconnecting passage towards the collapsing western entrance. The opening of the stone-lined duct is visible on the left.

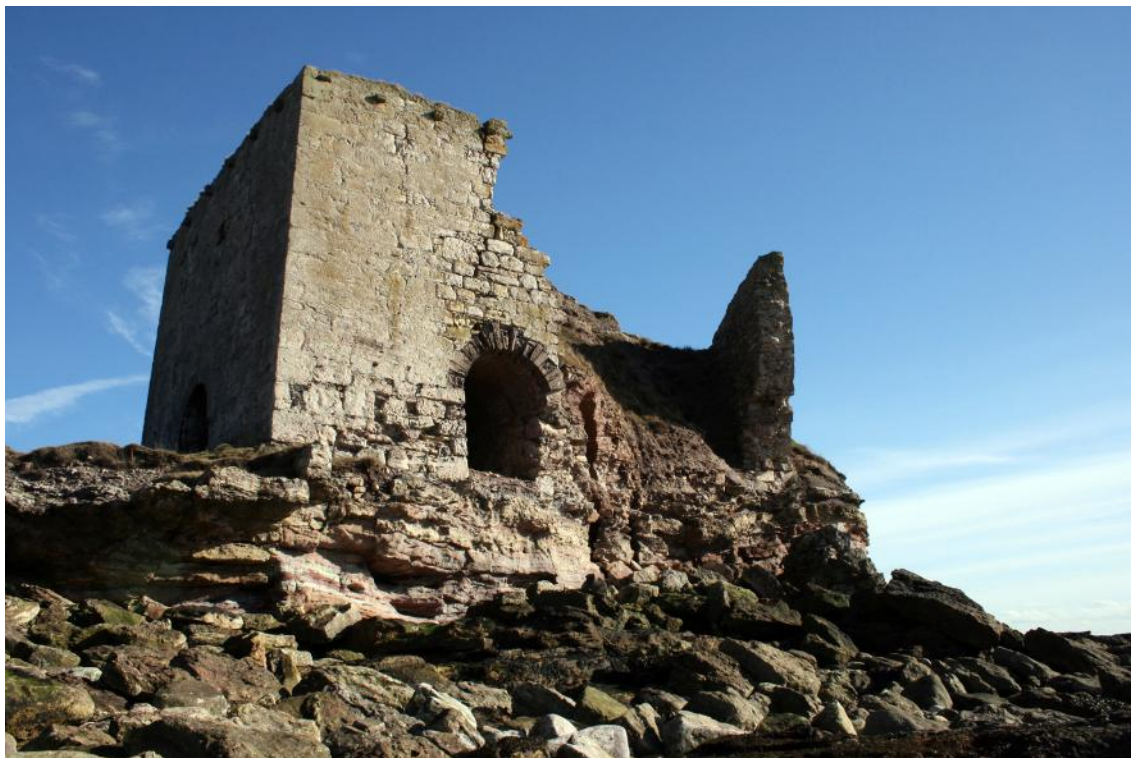
Erosion has led to the collapse of a substantial portion of the southwest quadrant of the structure. At least two thirds of the west wall and the southwest corner of the southern wall of the structure have collapsed exposing the vulnerable rubble and soil core of the monument. Internal structures such as the stone-lined burning chamber of kiln 3; a stone-lined duct (Plate 17); and the brick vaulted interconnecting tunnel are now collapsing. The bedrock platform upon which the whole of the western edge of the monument is constructed comprises a narrow band of sandstone underlain by softer mudstones and siltstones, which are being eroded by wave action leading to significant undercutting of the rock platform. The remainder of the west wall has now been undercut and further collapse of the monument is imminent (Plates 18 and 19).

Plate 18. The collapsing western side of the kiln block showing undercutting of the rock platform.

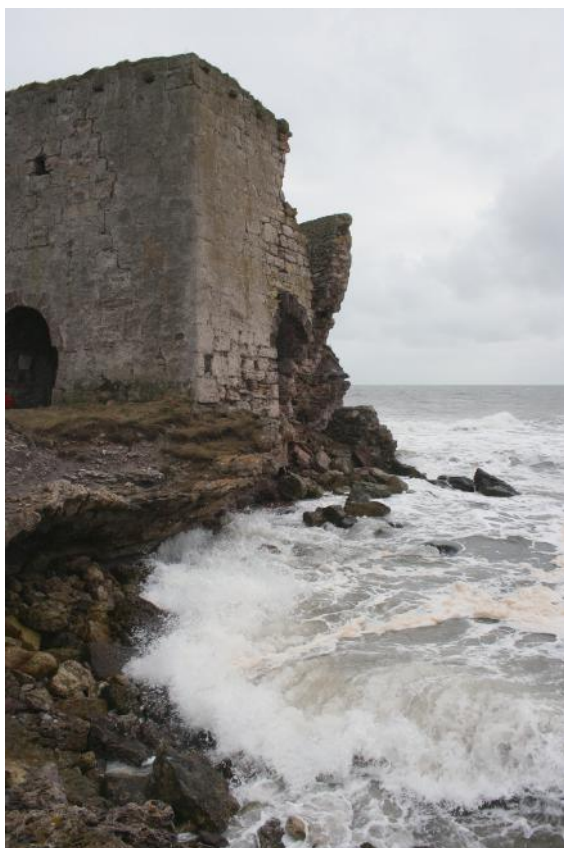
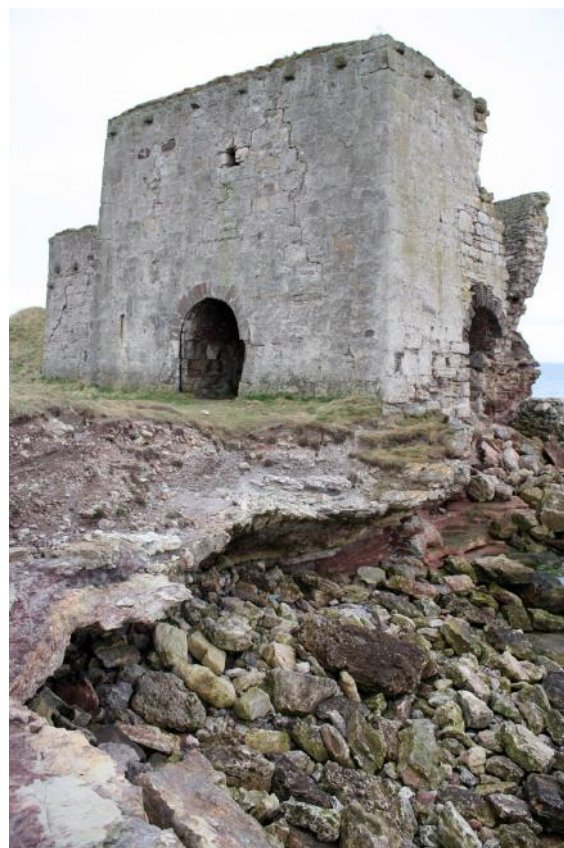
Plates 19a and 19b. Two views of the vulnerable western side of the kiln structure taken at higher and lower states of the tide, looking southeast. The rock platform underlying the remaining northwest corner of kiln 3 has been undercut and the collapse of this part of the monument could occur at any time.

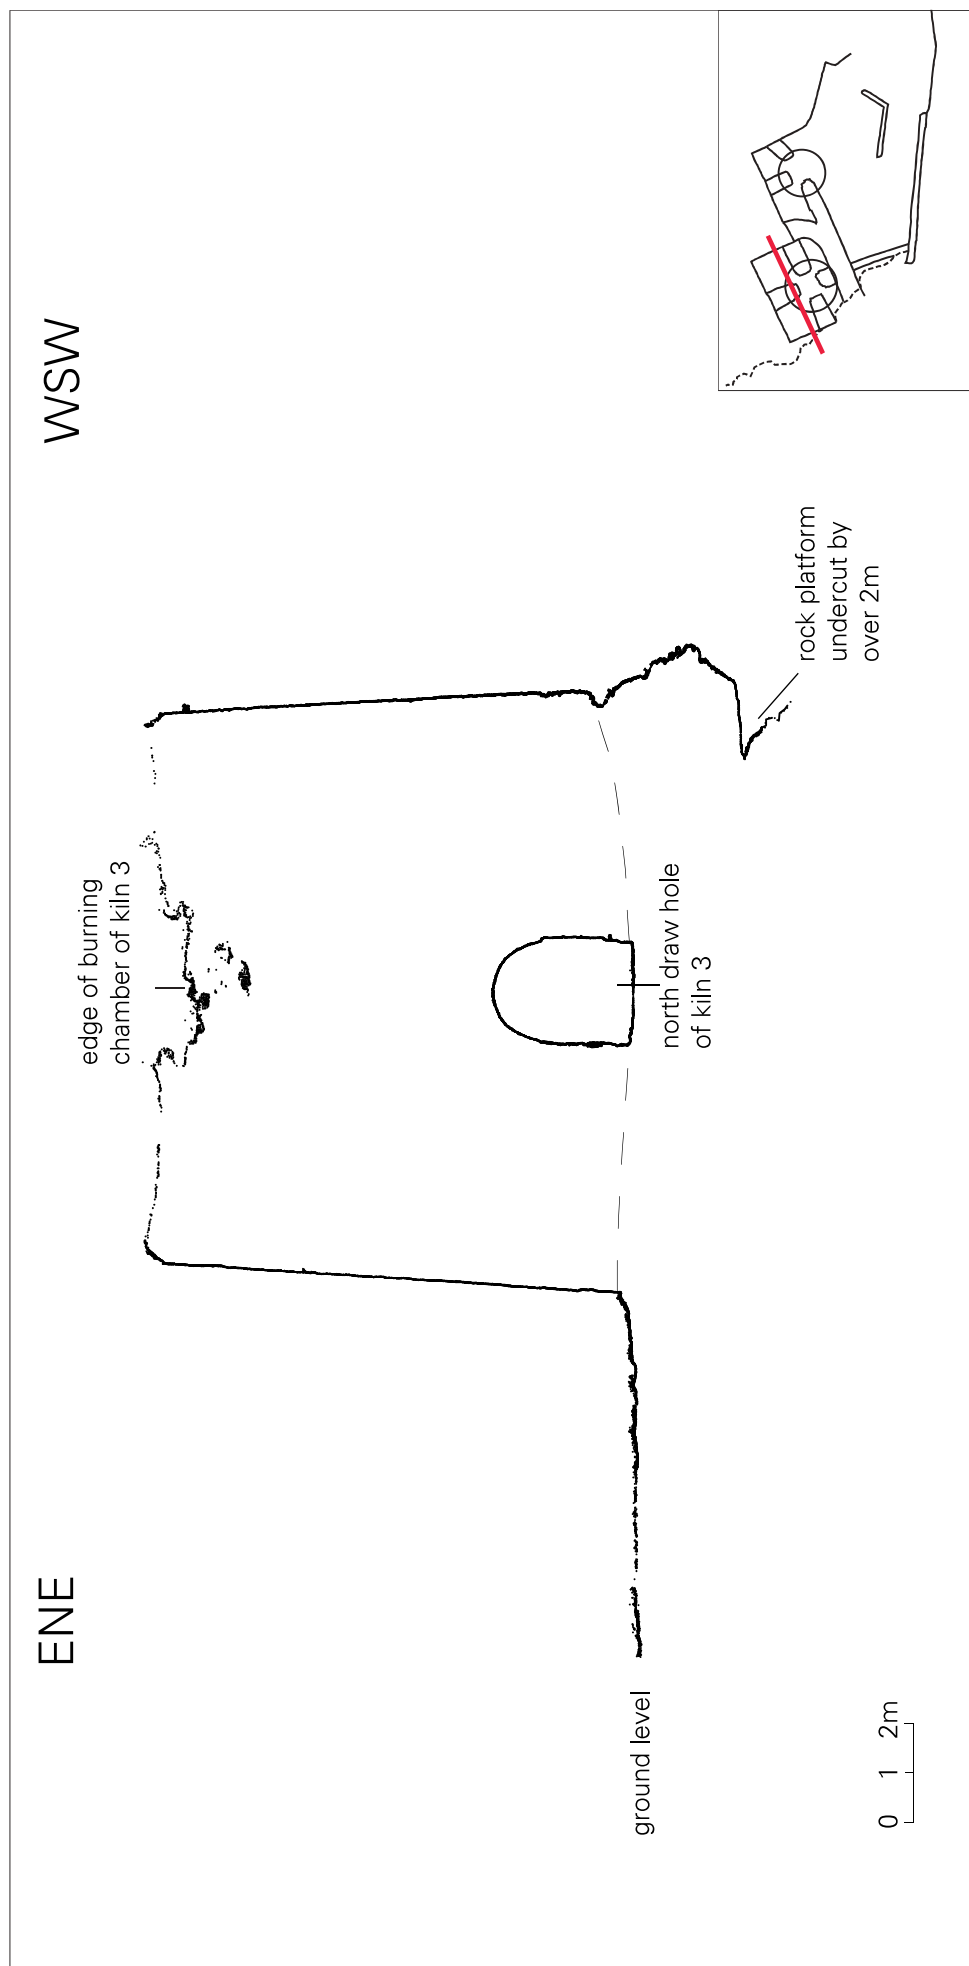
Cross section C. Raw view of east-west section through kiln 3 showing undercutting of rock platform below west wall

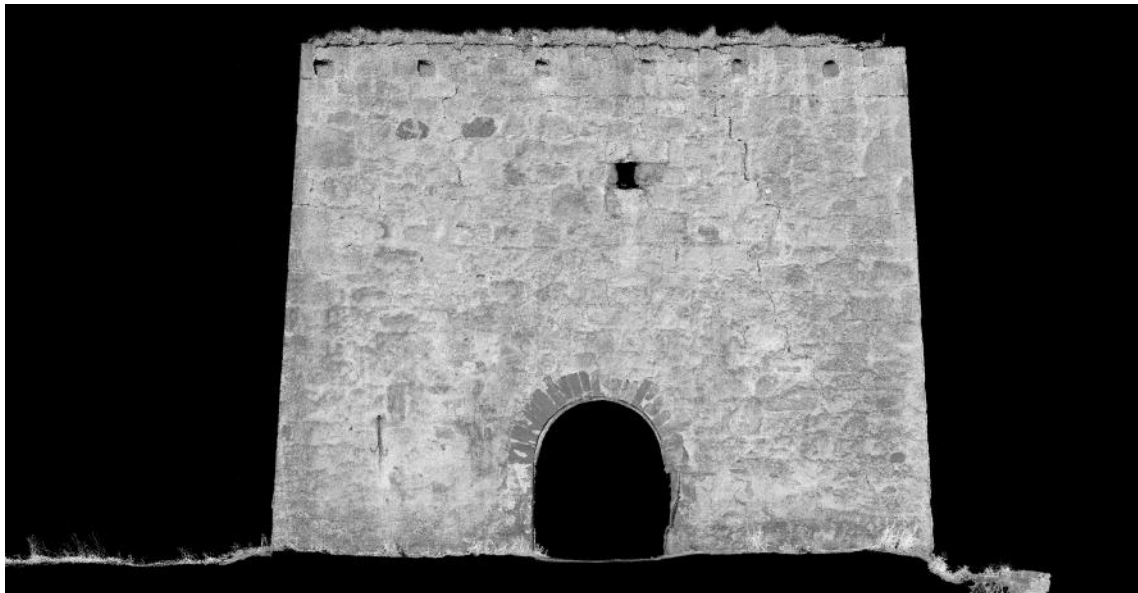
Scan 8. Detailed digital elevation of the north wall of kiln 3, showing a major crack at the northwest corner caused by undercutting of the rock platform upon which this side of the kiln is constructed.

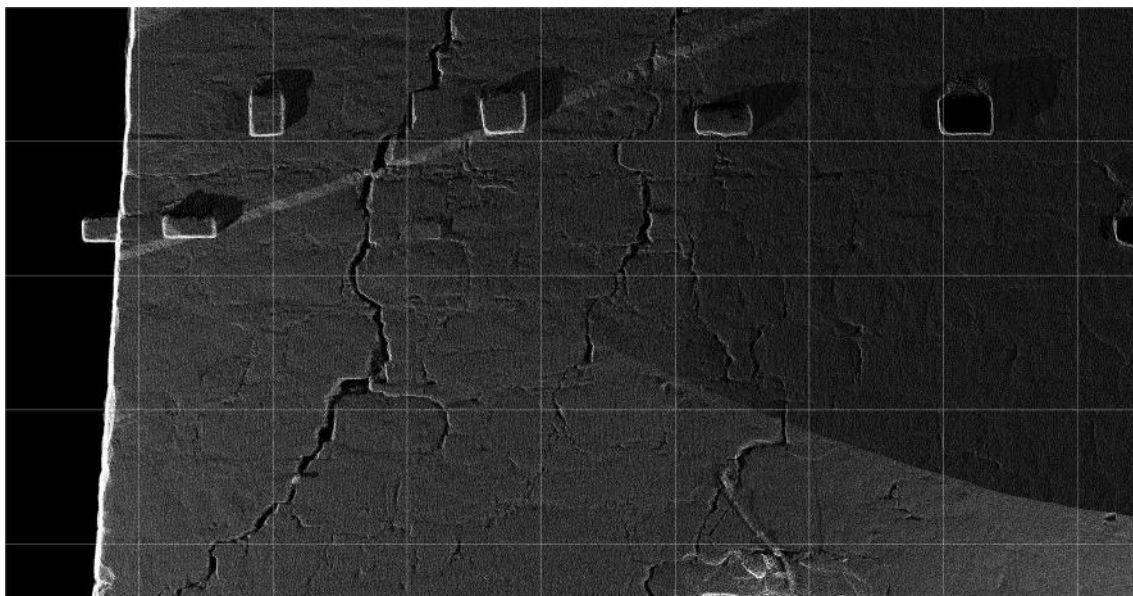
Scan 10. Detail of part of the eastern elevation of kiln 3, showing cracks within the wall.
