Archaeological surveys of *Fauna and Monreith*

Wreck recording, Kirkcudbright Bay
for the Kirkcudbright Bay Views Project
Galloway Glens
October 2019

Recording the remains of *Fauna*, Gibbhill

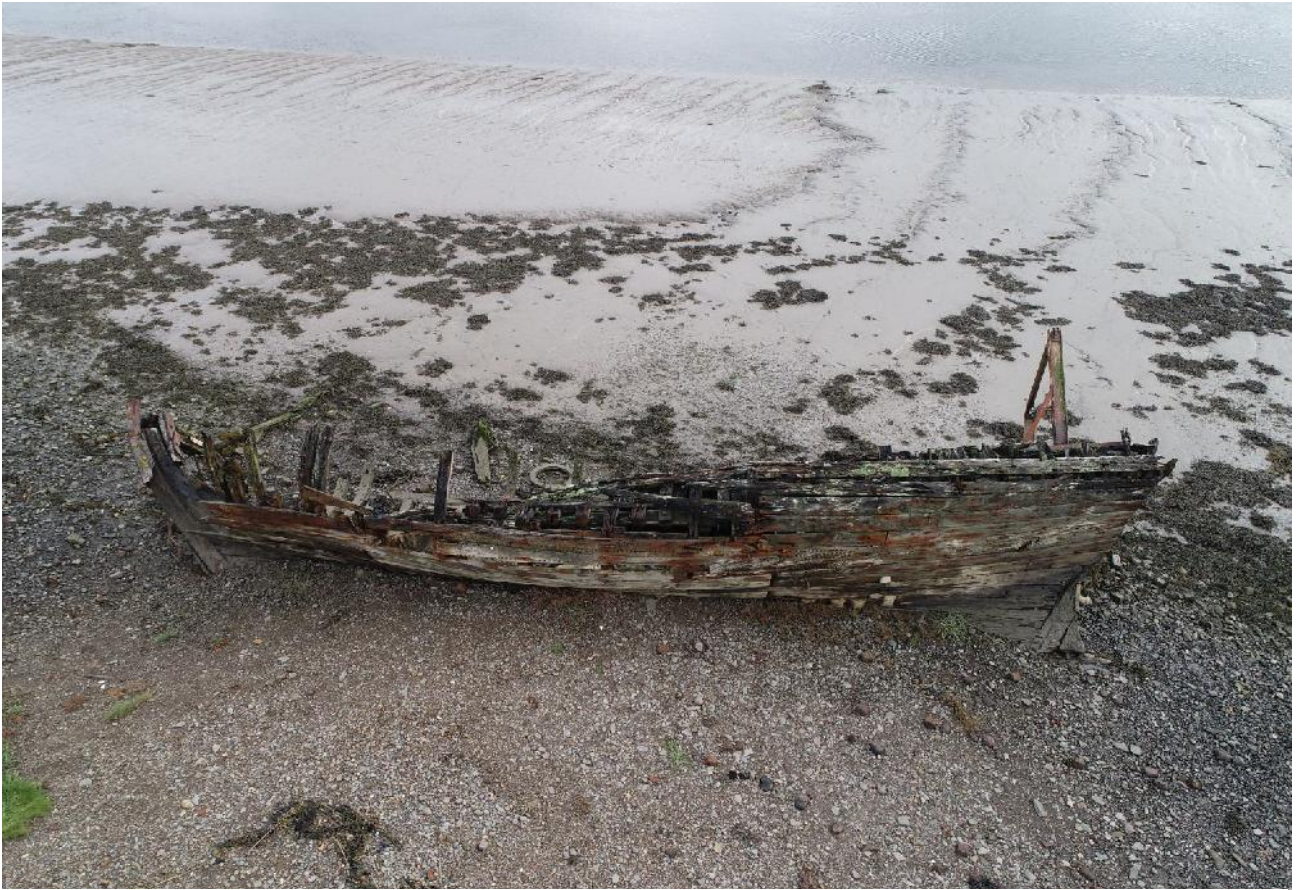
The hull lies on its starboard side, exposing the port side from the top of the keel to the level of the weather deck (figures 3 & 4).

3. Aerial view of port side

The speed of this underlines the fragility of such intertidal wooden vessels, and how rapidly and suddenly they can deteriorate once a tipping point has been reached. However, the natural processes of decay and deterioration may have been further accelerated and exacerbated by fire damage (presumably deliberate) indicated by the blackening and charring of timbers at the top of the exposed and now-collapsed port side of the hull (figure 3).

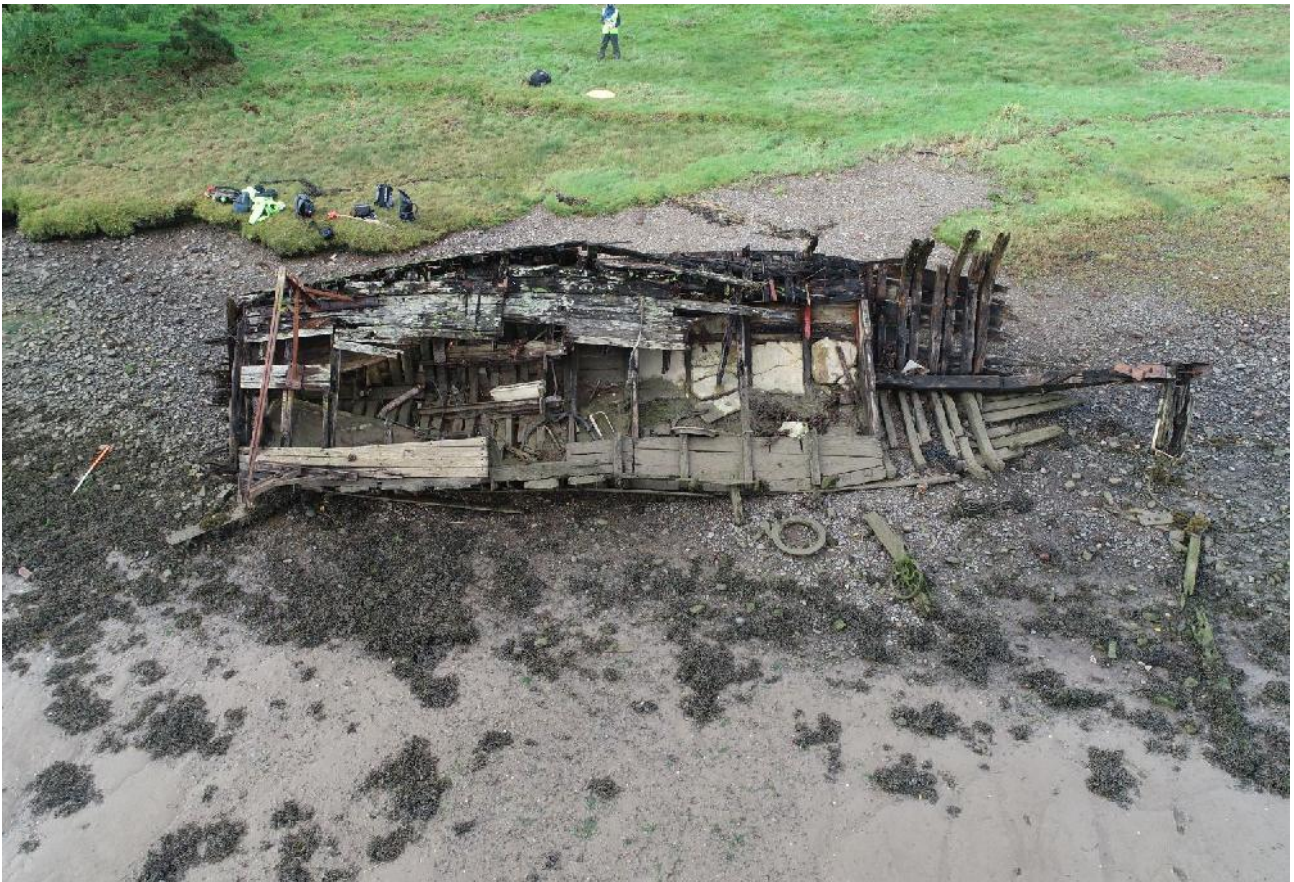
4. Aerial view of deck and interior

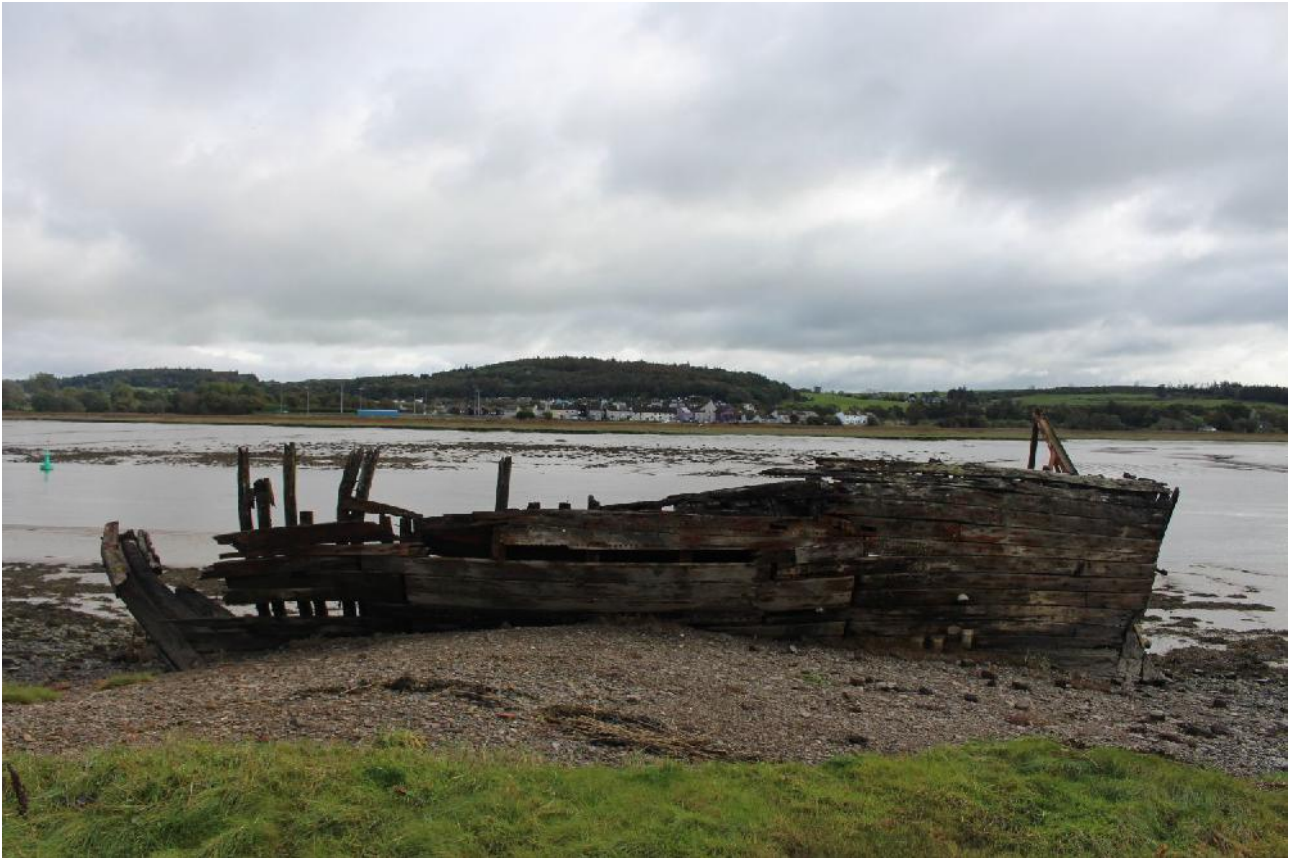
The port side bow is in poor condition, four sets of double frames survive, with some of the associated strakes up to the level of the first futtock, but the frames and all the planking around the stem post have been lost. In the midships section on the port side, the frames have failed at the joint between the first and second futtocks; the second futtocks, the framing and attached strakes have collapsed inward. The aft end of the hull is in better condition and currently mostly intact to weather deck level on both sides (figures 5 & 6).

5. General view of the port side of the hull, showing the patched strakes in the wet-well

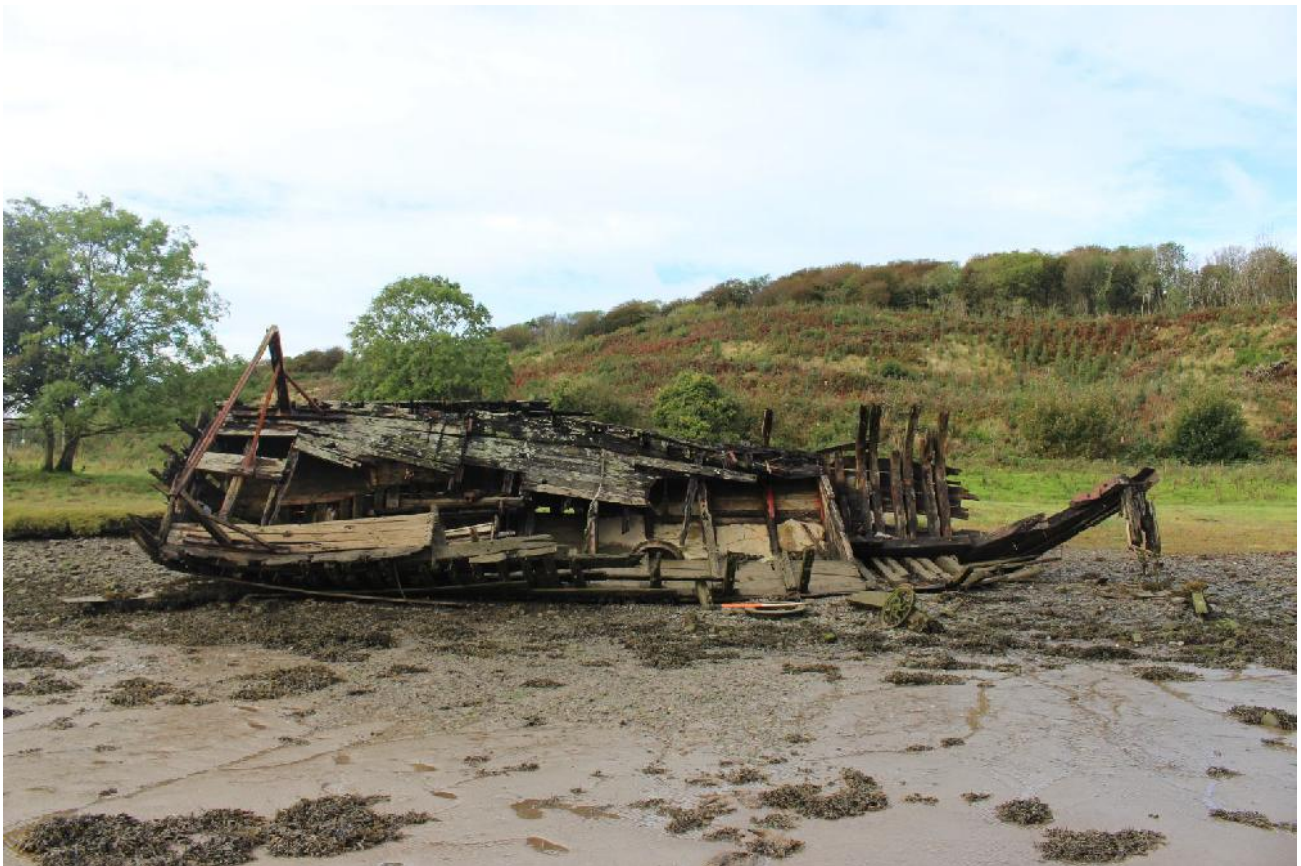
6. General view of the deck and interior

strakes. Around the wet-well, the hull survives to the orlop deck which formed the top of the wet-well compartment. Below this, it is buried in the beach sediment. At the bow the structure of the hull has largely disintegrated. Three pairs of double frames and a single frame survive attached to the keel, with some associated strakes. Neither frames nor strakes survive around the stem post, which has itself broken at a joint between two timbers, with the upper portion sagging to the starboard side (figure 6).

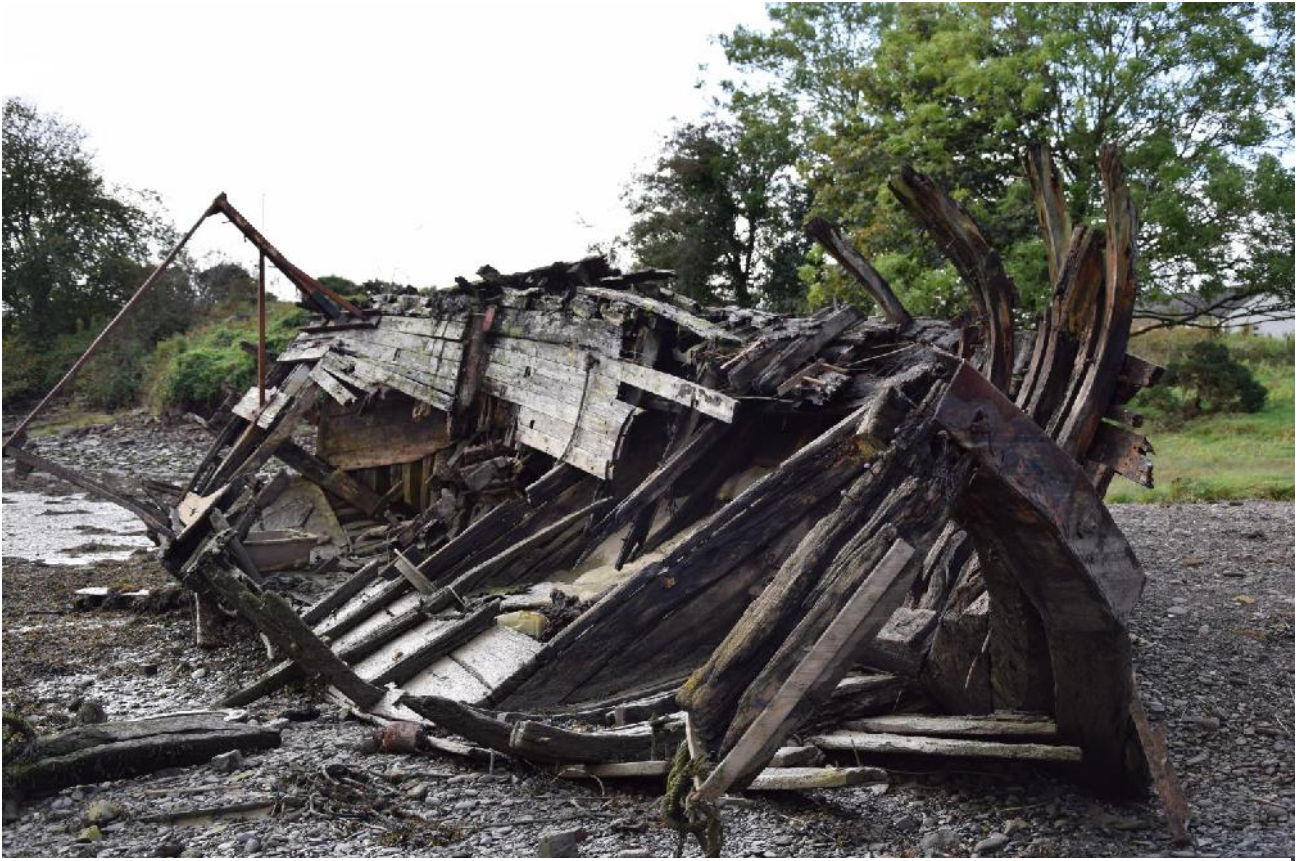
7. Bow area showing collapsed upper timber of stem post

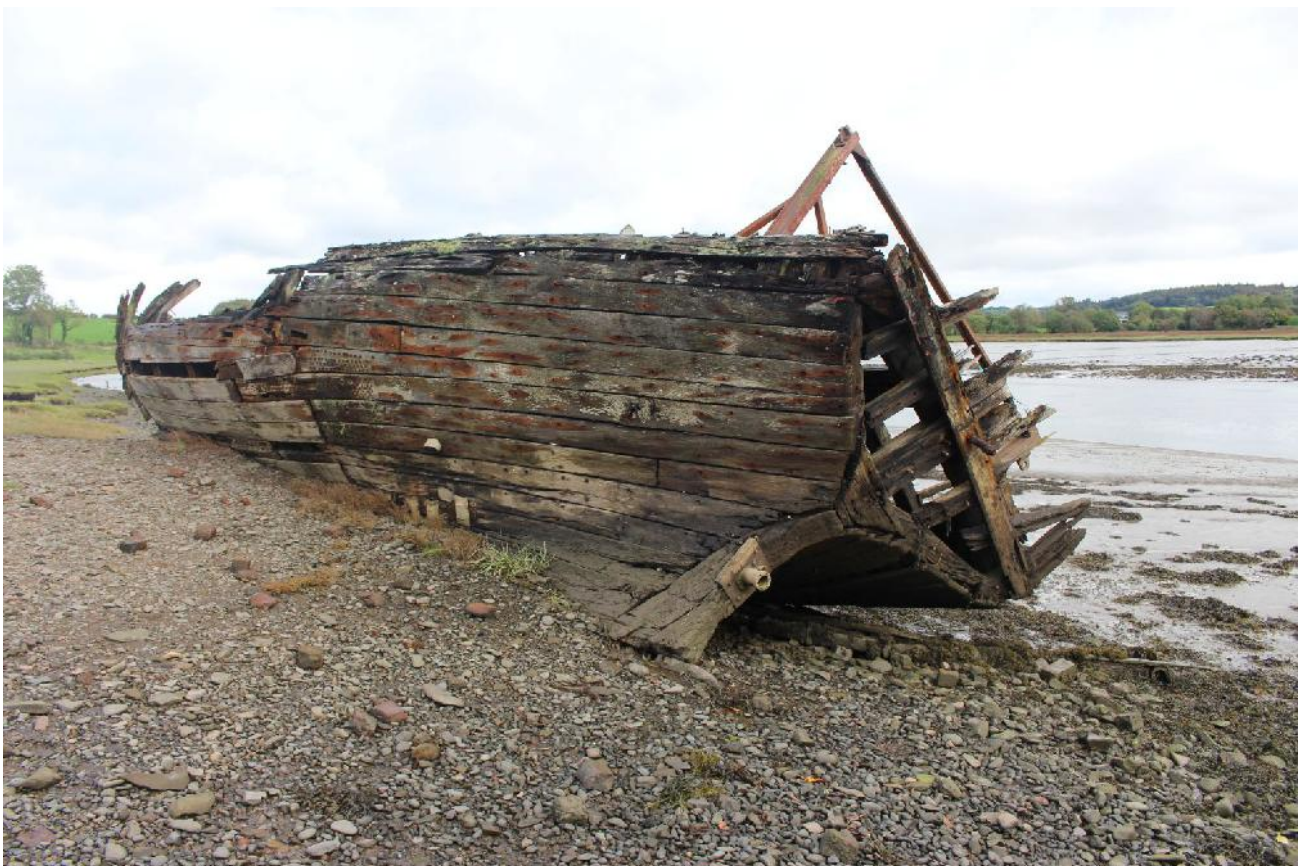
8. Stern area showing stern post, transom and trawl gantry

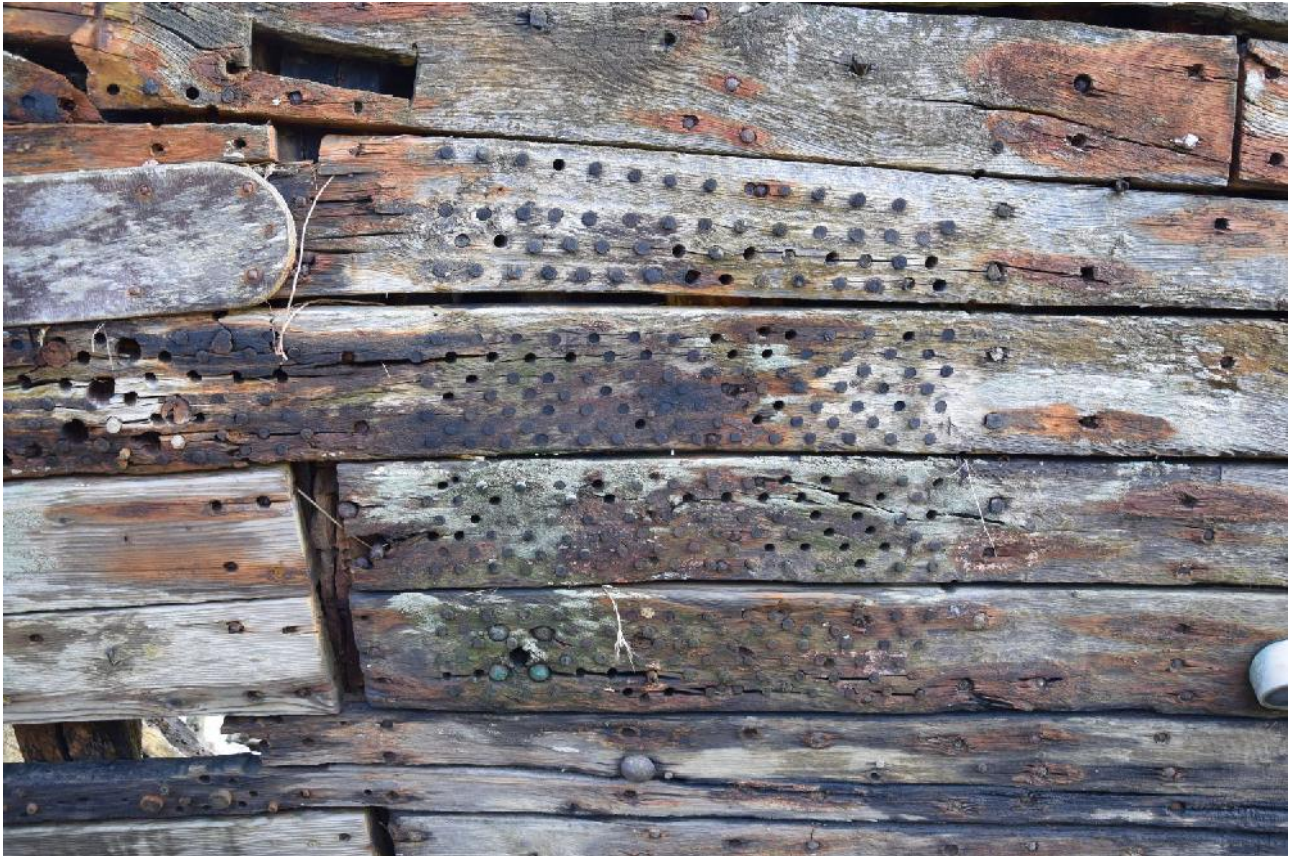
9. Detail of the holed strakes in the wet-well, and timber pegs plugging holes; replacement strakes in lower hull without holes. This repair post-dates the Fauna's time as a wet-well vessel

4.3. The concrete ballast overlays the replacement lower hull strakes on the port side (figures 9 & 19). This repair to the hull has been made without any boatbuilding competence and it is easy to believe that it dates to the same period/event as the installation of the second engine and the ballast.

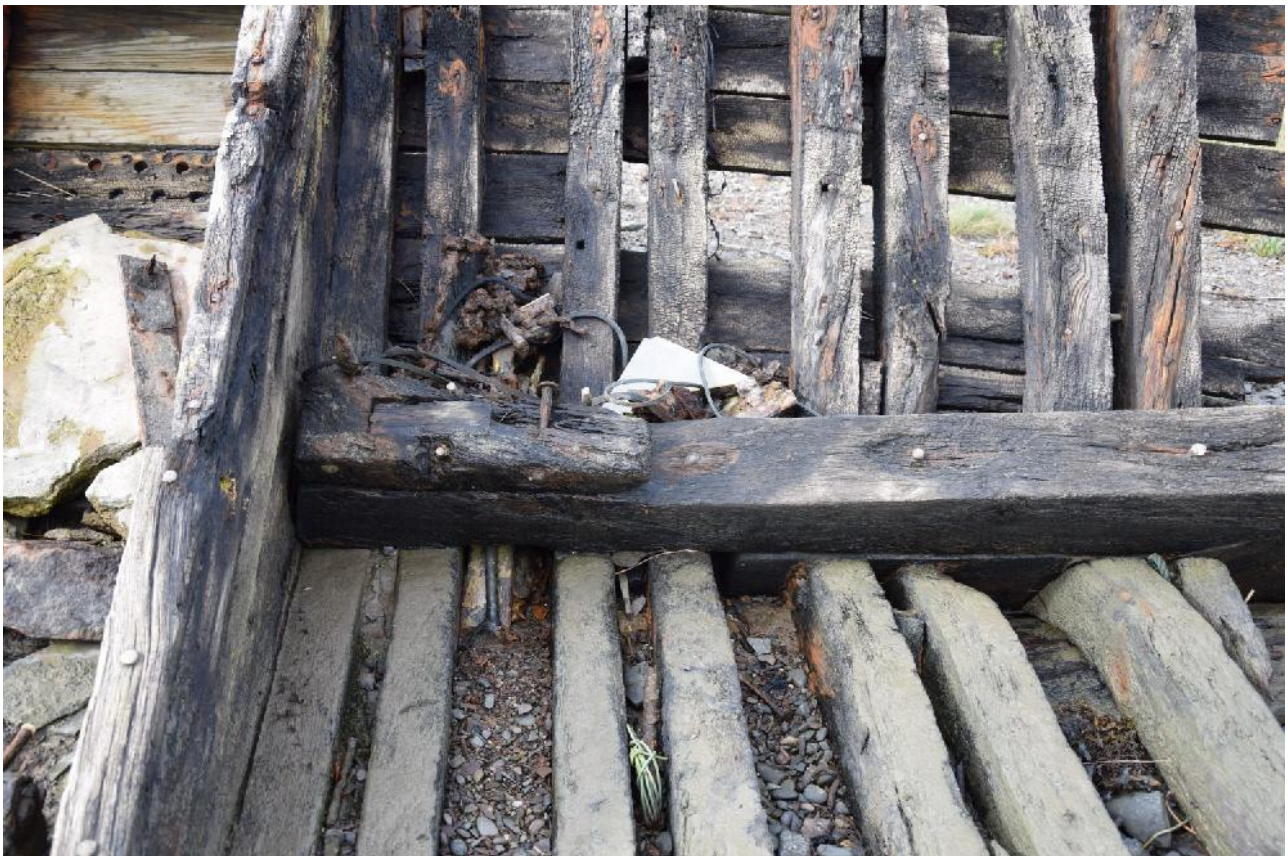
10. Mast step for a small foremast in the bow compartment, and forward bulkhead of wet-well on left with holed strakes visible

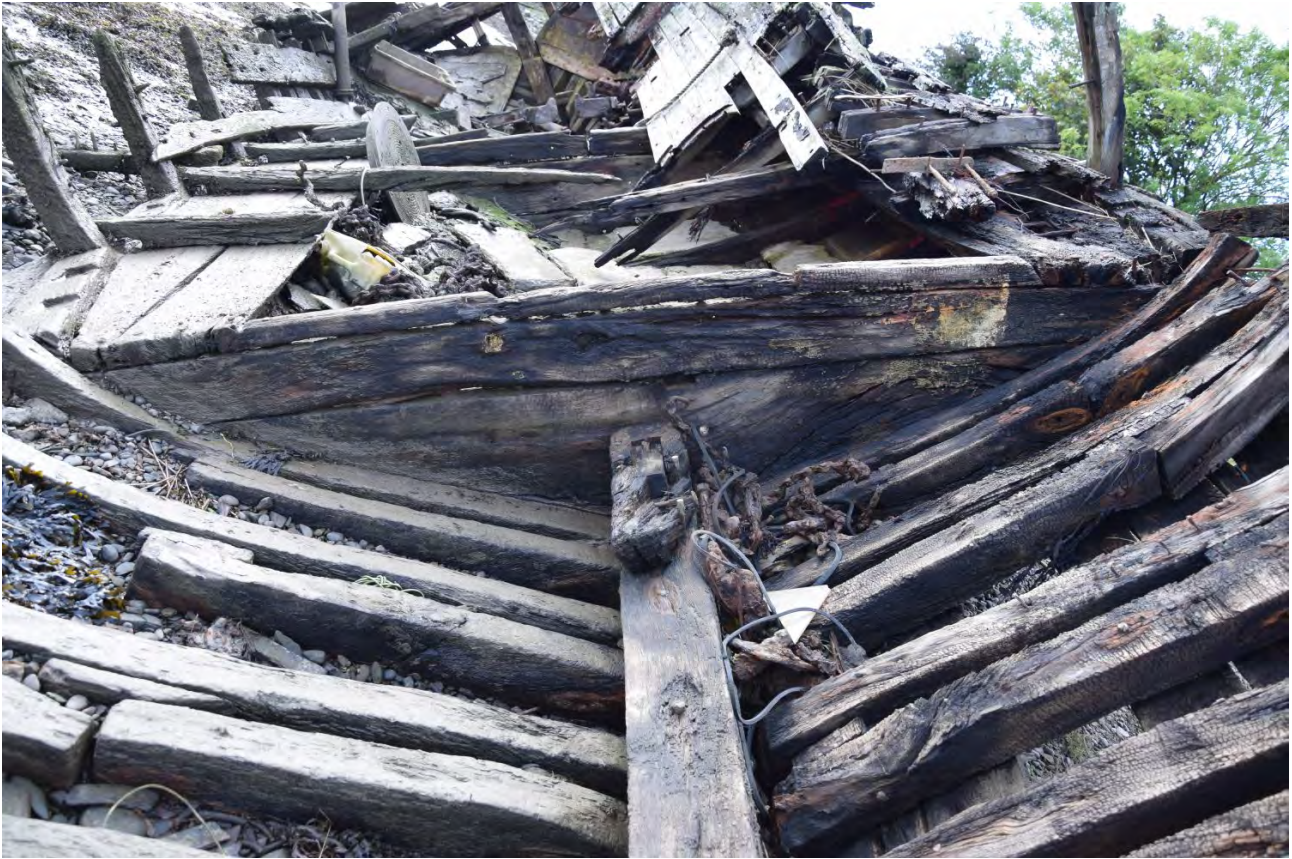
11. View along keelson across wet-well towards engine mounts

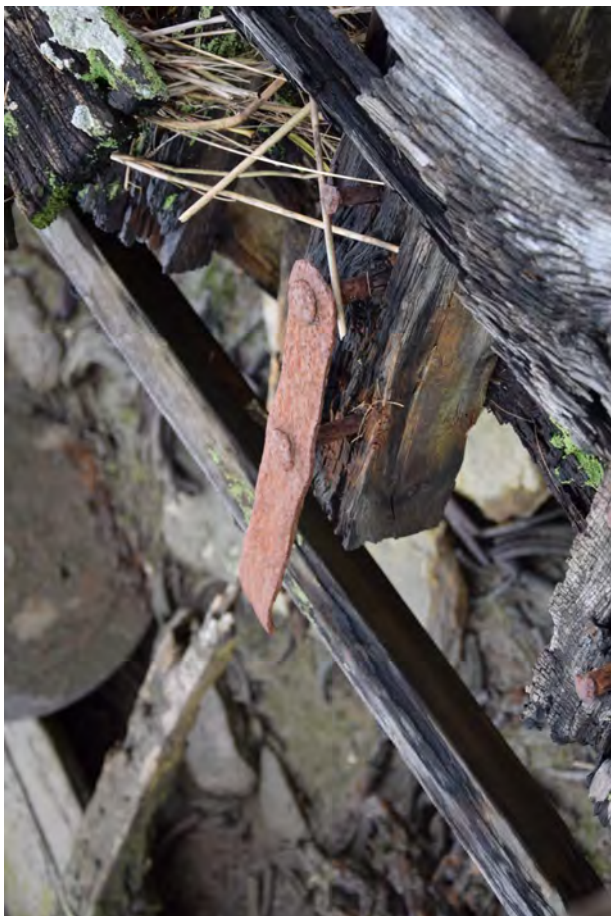
12. Chainplate attached to port bow frame

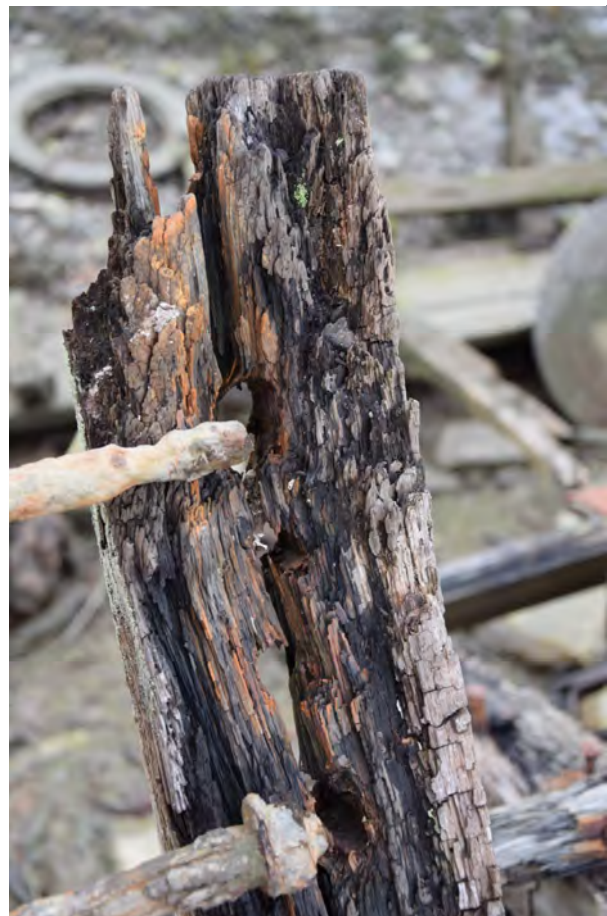
13. Bolt holes for chainplate in second port bow frame

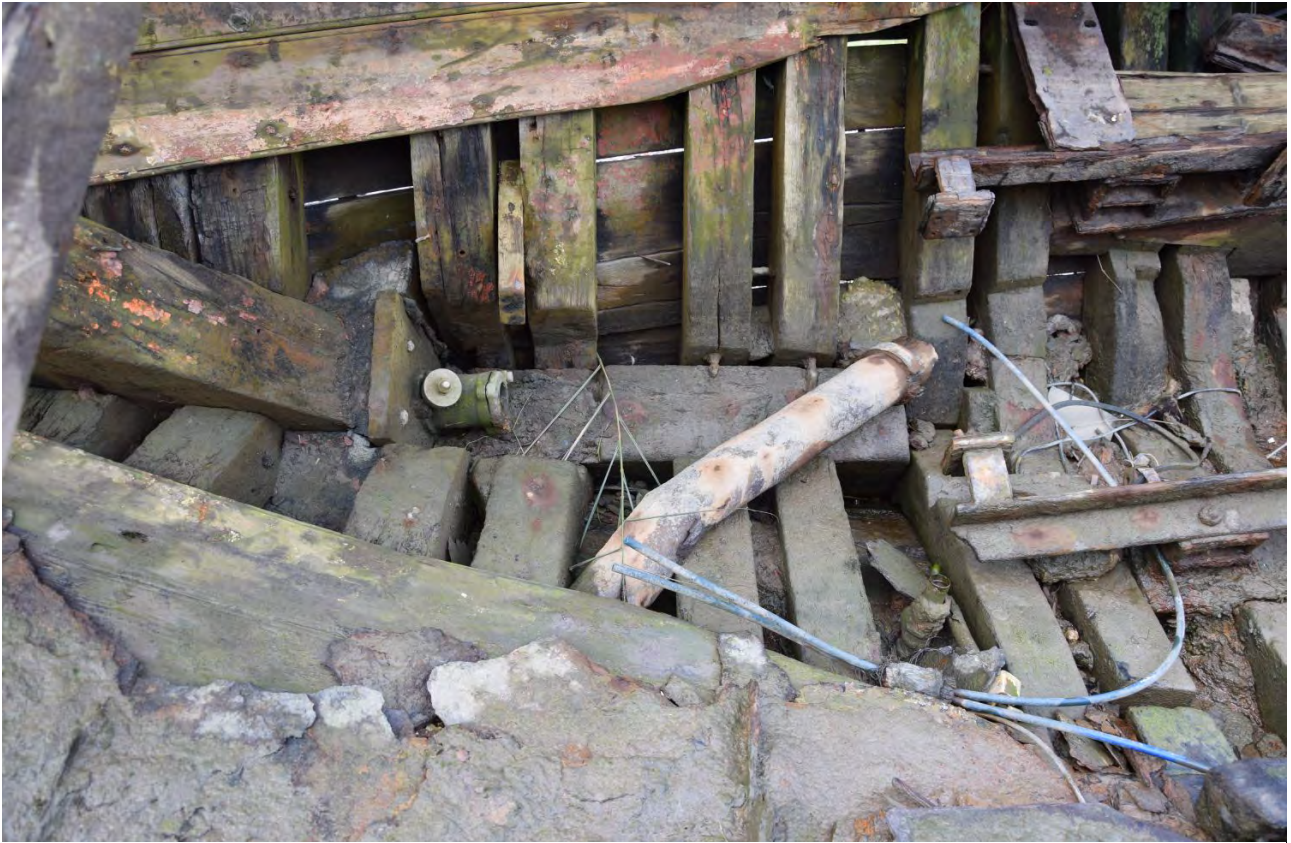
2.4. The loss of structural integrity caused by the cutting down of the floors had been compensated for by pouring concrete around the base of the sternpost and covering it with pitch (figure 14).

14. Aftermost floors cut down to accommodate engine and allow propshaft to pass through sternpost; poured concrete around base. Internal softwood timber fitted to internal face of sternpost to accommodate later stern gland associated with second engine

engine unit fitted to the four forward mounts with a separate marine gearbox mounted on the two aftermost. As was conventional in this initial installation, drive was provided to the screw via a short shaft that penetrated the stern post through a stern gland; now removed (figure 14).

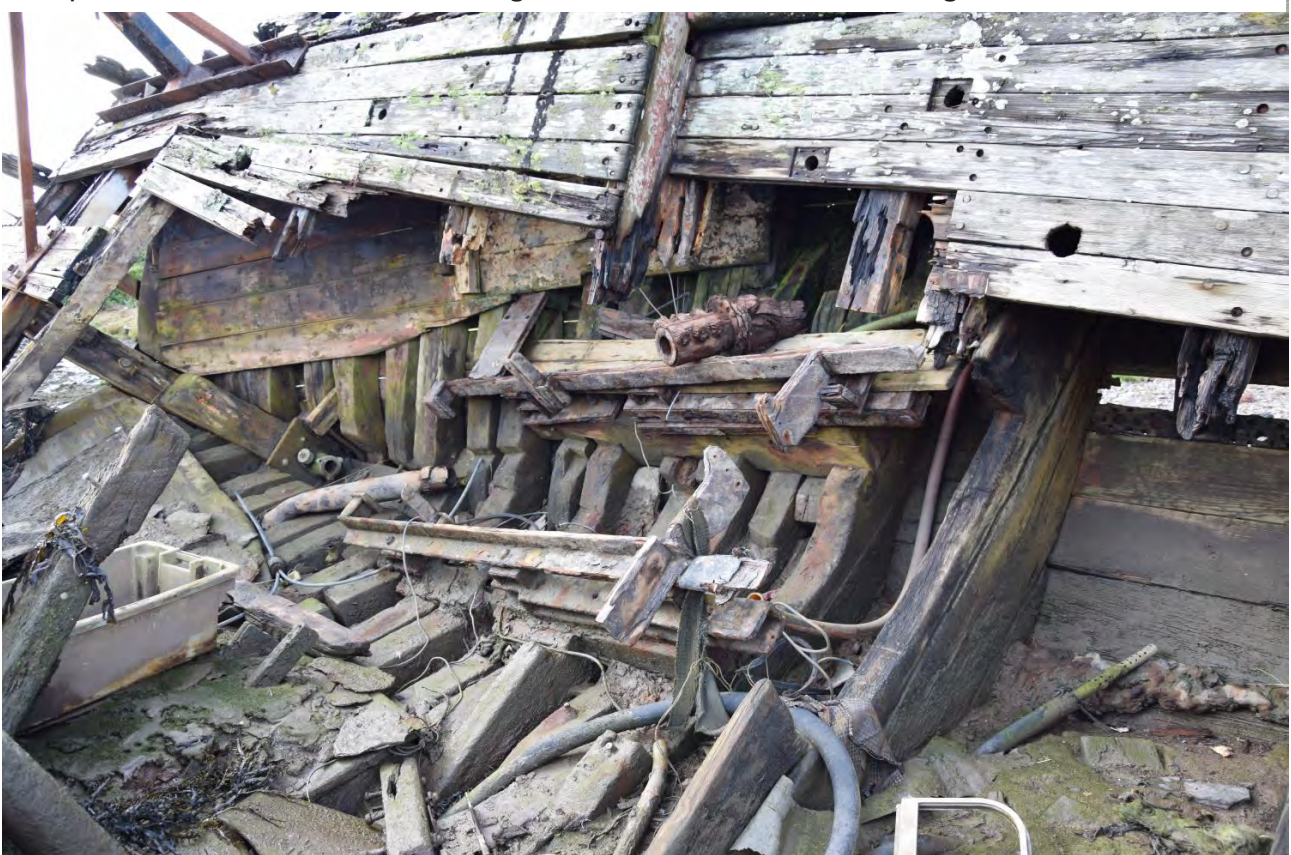
15. Aftermost two bulkheads of wet-well compartments cut down to accommodate engine. Earlier wooden engine bearers sitting on cut down floors with two pairs of steel engine mounts fitted on top and discarded Hardy Spicer joint.

3.7. The stern gland surviving on the hulk is equipment fitted after the primary engine installation, i.e. for a second engine, and replaced that of the former engine installation. This is determined by it being mounted on a large inset of softwood, that has latterly been let into the sternpost, and not directly onto the sternpost itself, as any primary installation would have been. The rebate to fit it cuts even further into the already reduced thickness of the sternpost and the streamline fillets of the initial stern gland installation. This has necessitated the fitting of an additional, internal, timber to accommodate the length of the second stern gland (figures 15, 16 & 17).

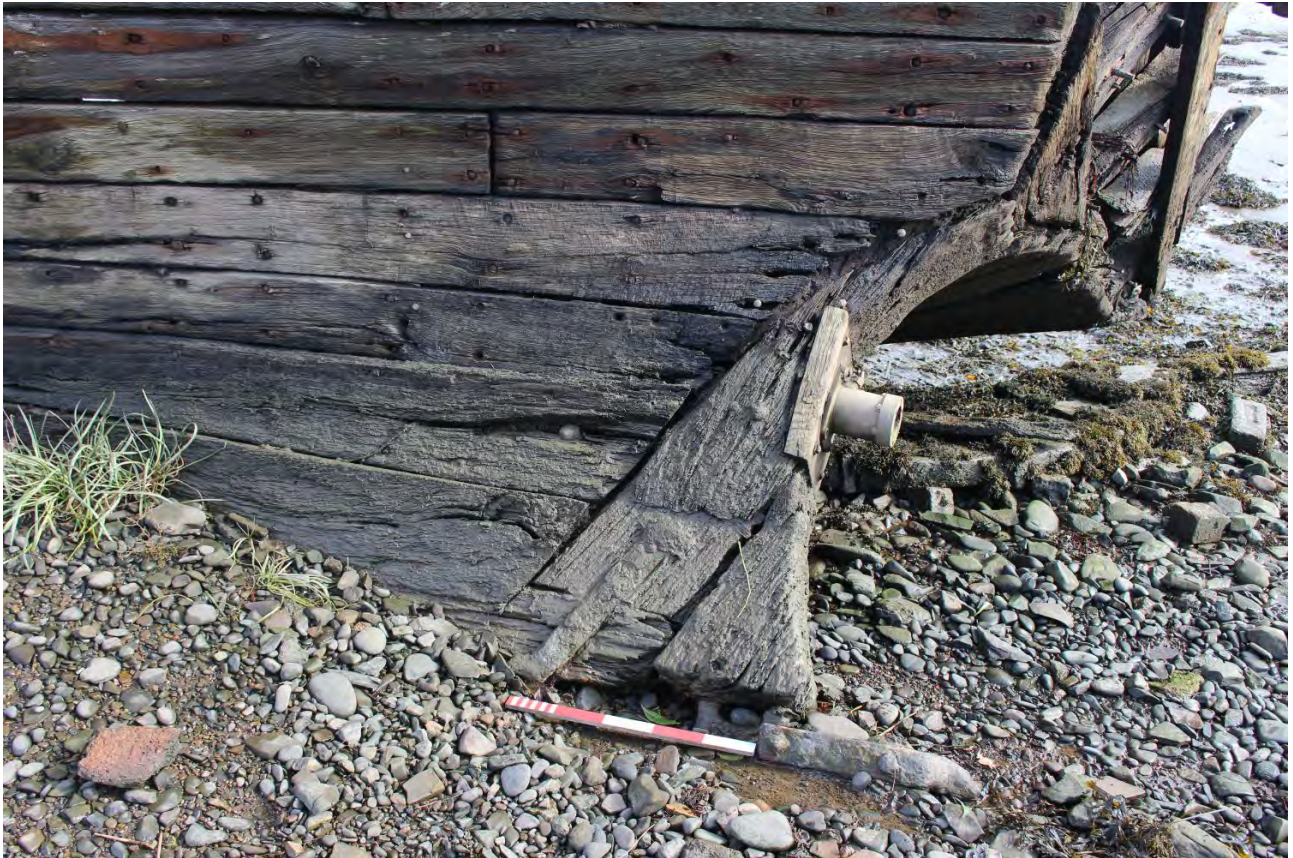
16. Cut in aft face of sternpost to accommodate screw propeller, with cheek fitted where prop-shaft cuts through, triangular extension for lower gudgeon for mounting of repositioned rudder. Stern gland mounted on softwood inset further cut into sternpost and cheeks

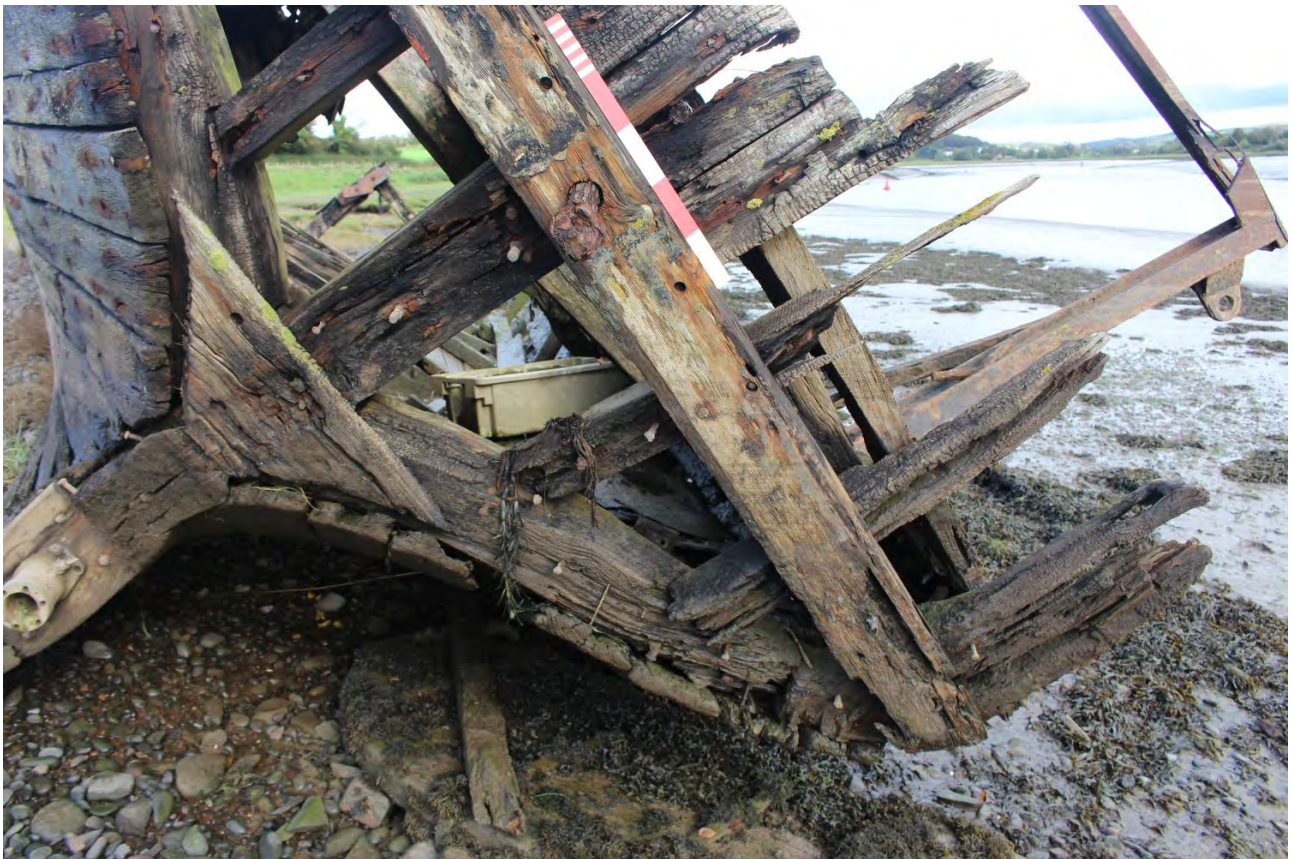
17. Transom with fallen rudder below with rehung offset setting for rudder to accommodate screw

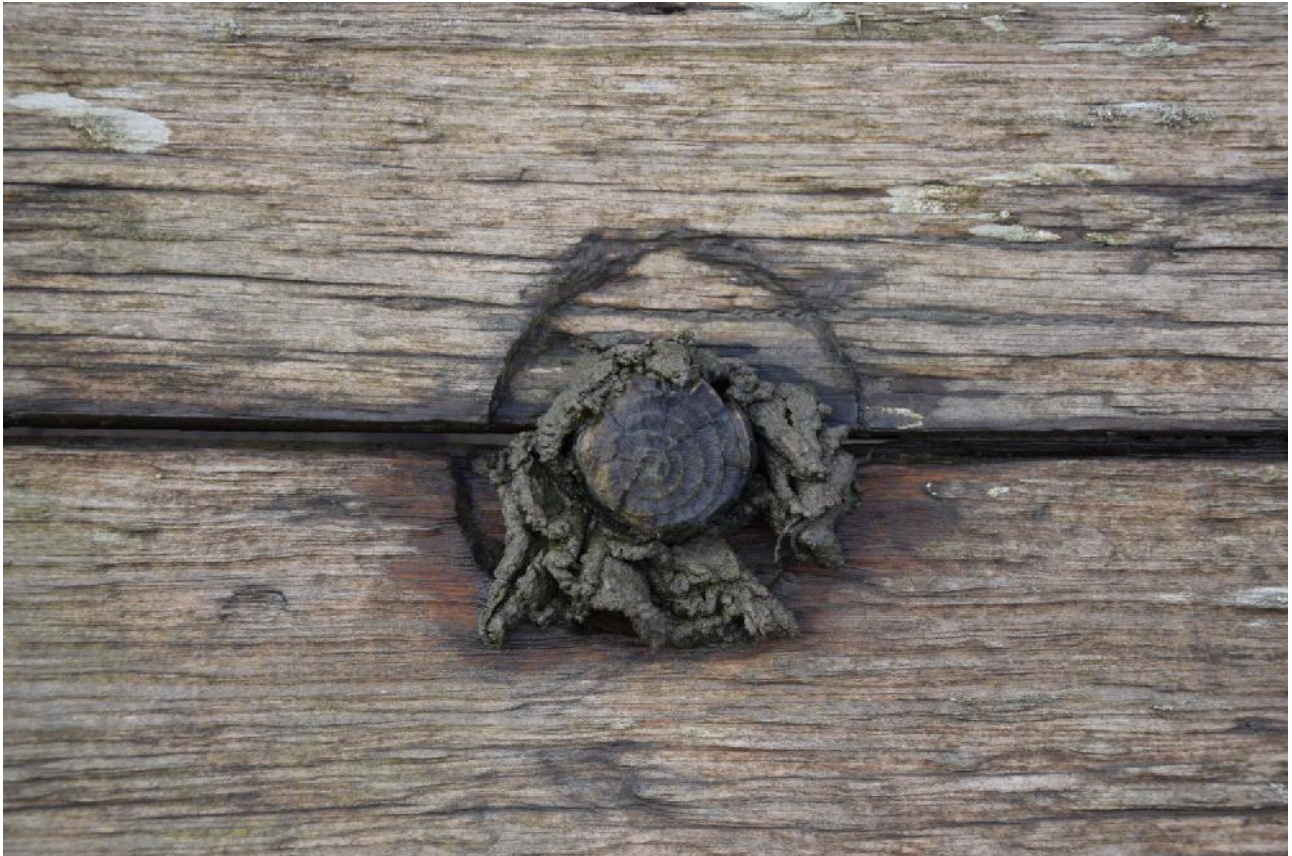
18. Fuelling hole in deck above engine

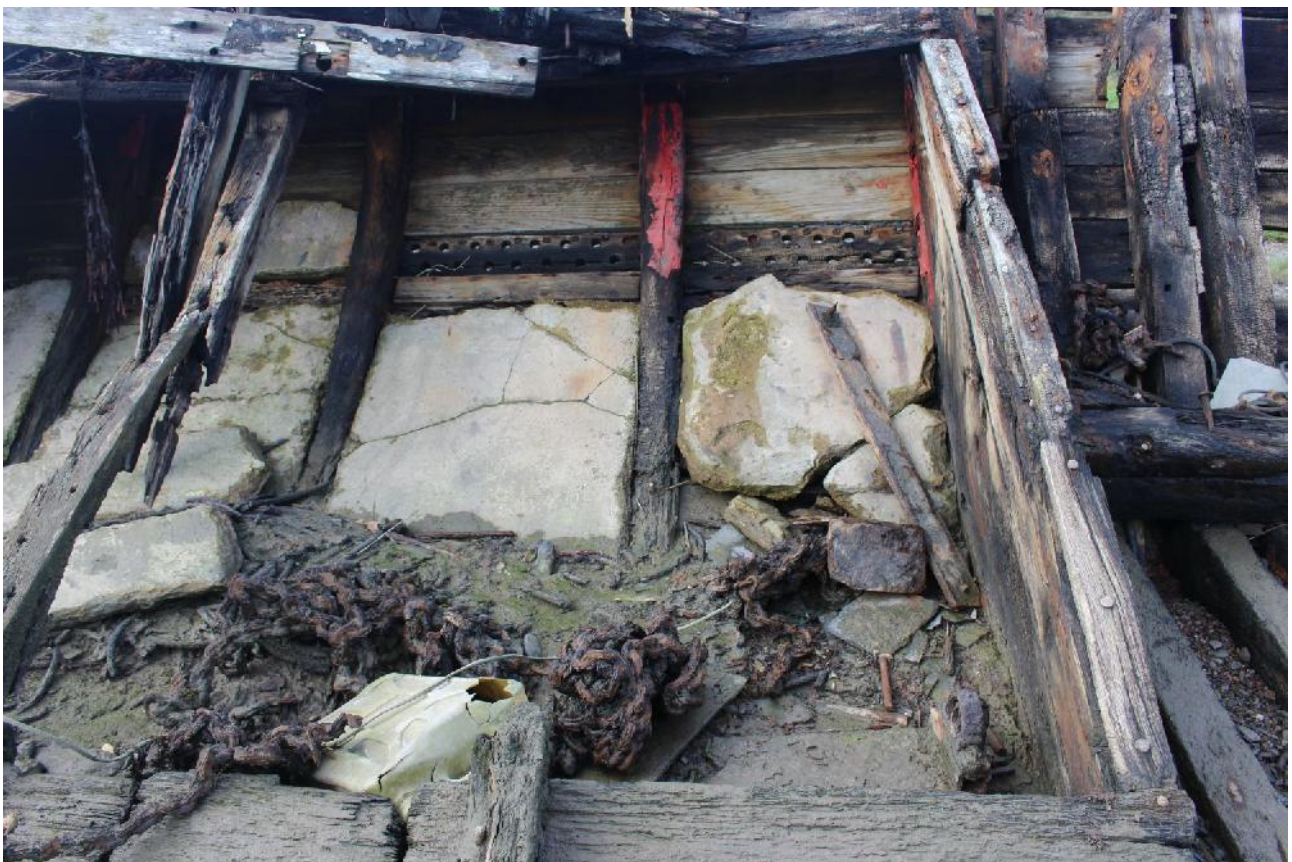
19. Concrete ballast over floors of the largest wet-well compartment, overlying the replacement strakes on the port side of the hull and likely contemporary with the installation of the later engine

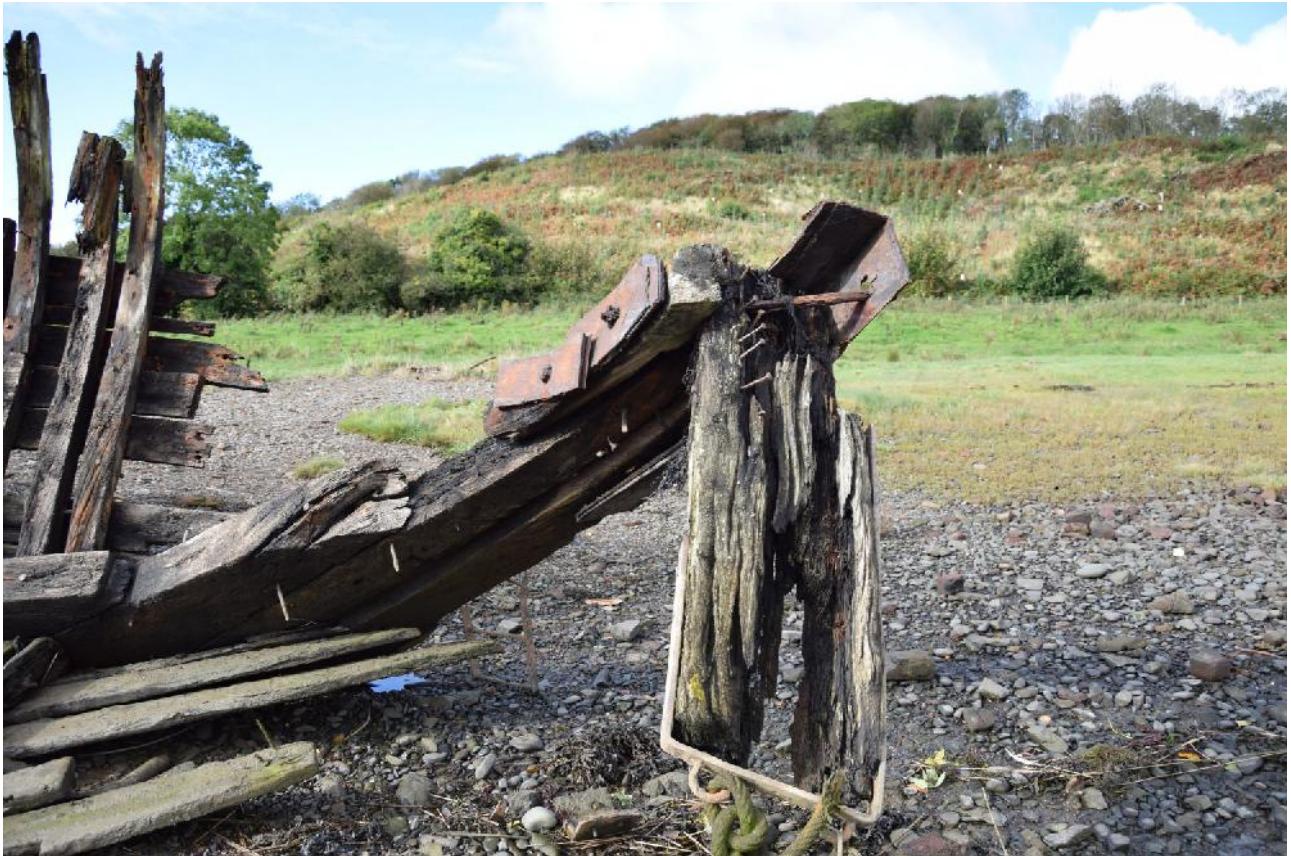
20. Stem post with collapsed upper timber and remains of steel plating

It appears that the steel sheathing of the stem, as well as providing protection against physical damage, was an unprofessional applique repair to bolster the weakened or degraded timber of the stem in the latter days of the vessel's service life. In its current state the timber of the stem has degraded to such a degree beneath the steel shrouding that little of any substance now remains (figure 20).

The second episode of major works to install a later engine was implemented with inferior skills and materials, cutting back major structural elements and using concrete not only as ballast but as a structural component of the vessel's fabric (figures 14, 16, 17 & 19). The sheathing of the stem with steel, probably as a repair for failing or degrading timber, could be contemporary to this refit (figure 20).

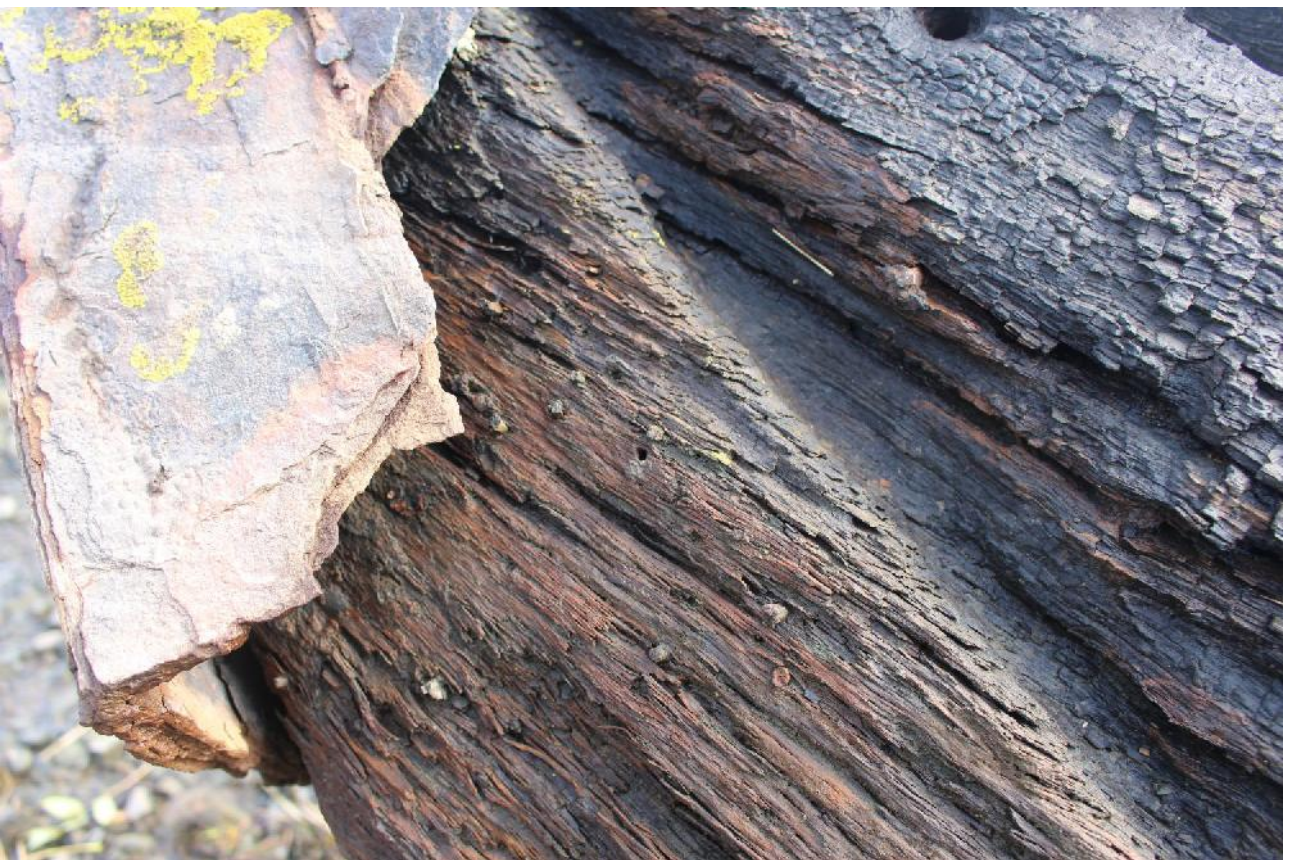
21. Detail of stem post with tiny fasteners for sheeting

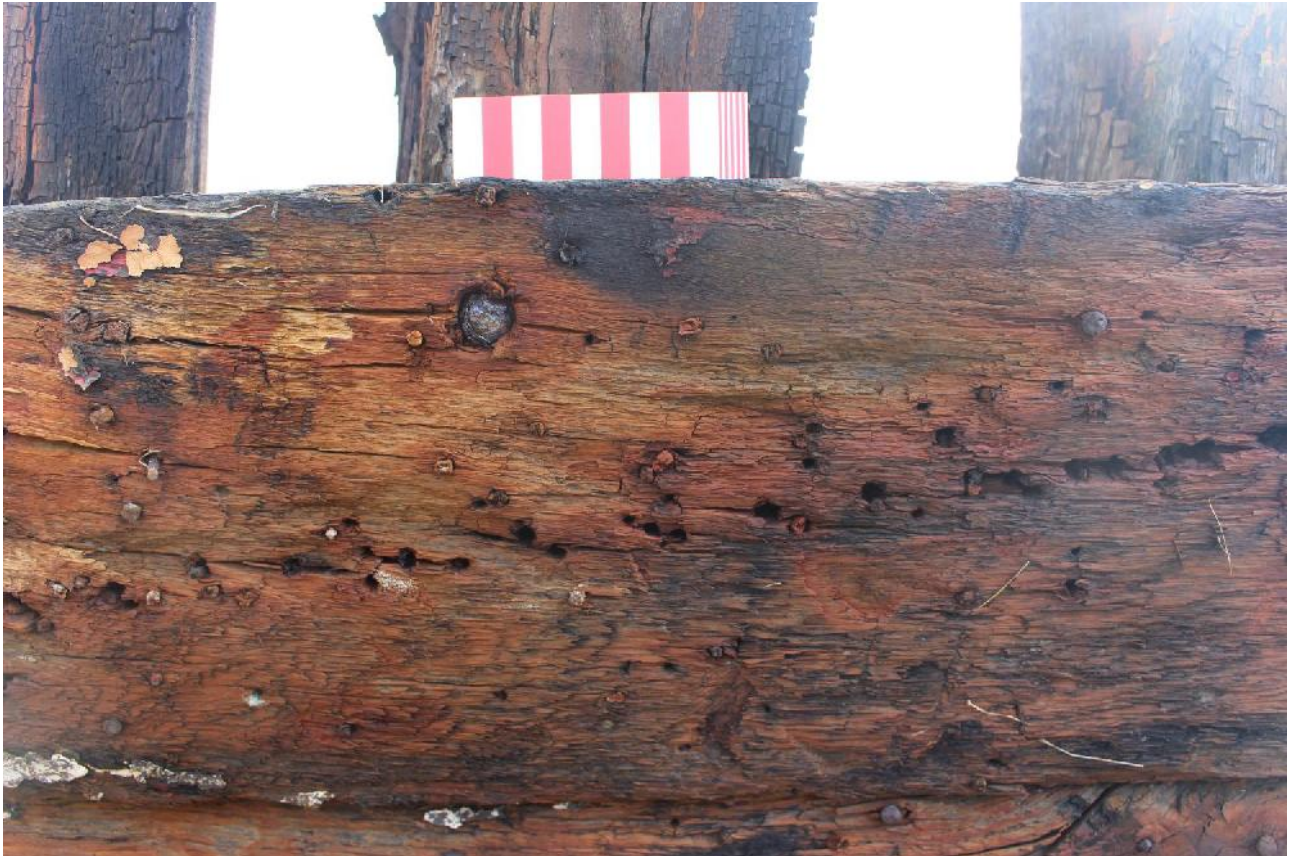
22. Iron staining and line of fasteners at waterline on port side bow
