Archaeological surveys of *Fauna and Monreith*

Wreck recording, Kirkcudbright Bay
for the Kirkcudbright Bay Views Project
Galloway Glens
October 2019

Recording the remains of *Fauna*, Gibbhill

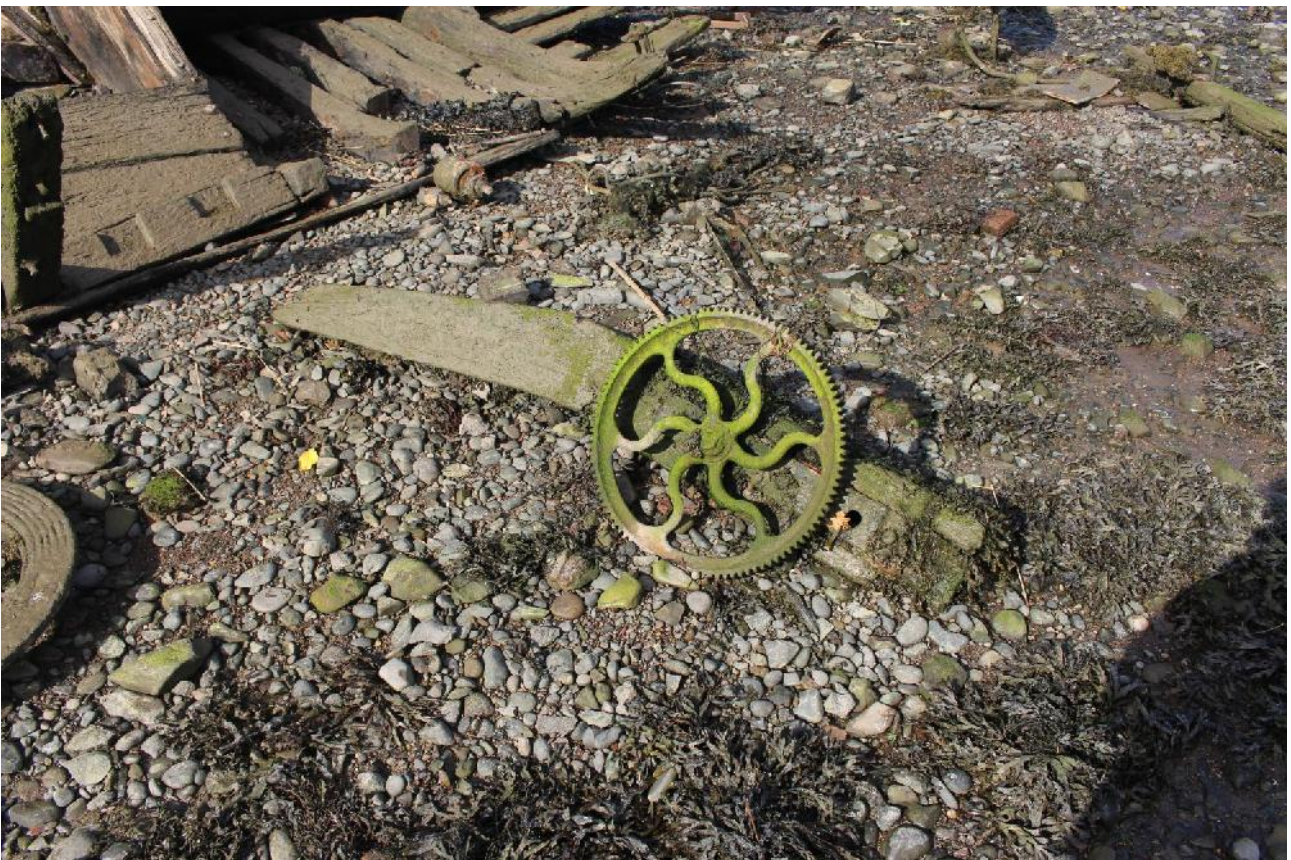
23. Collapsed samson post and windlass at bow

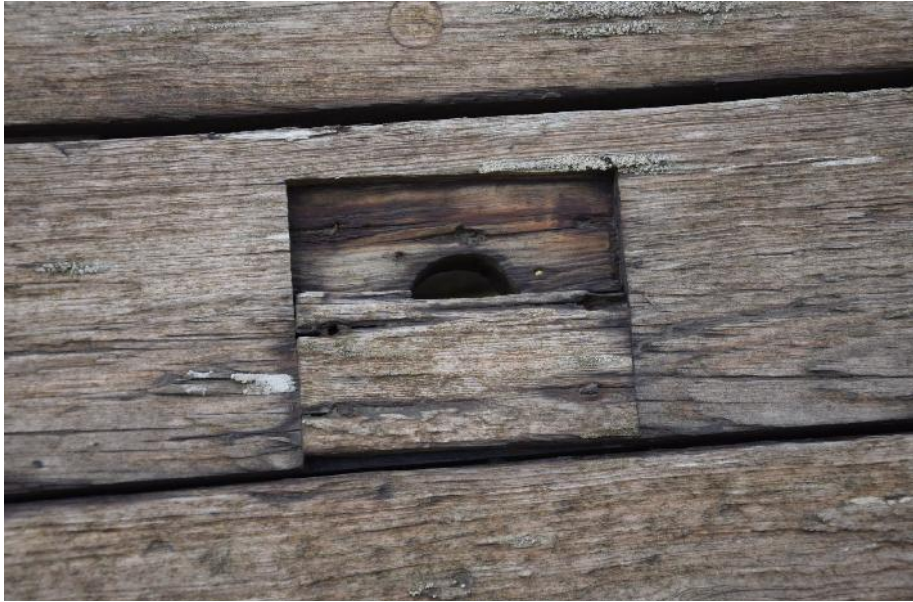
24. Patched setting in deck planking for structure / equipment

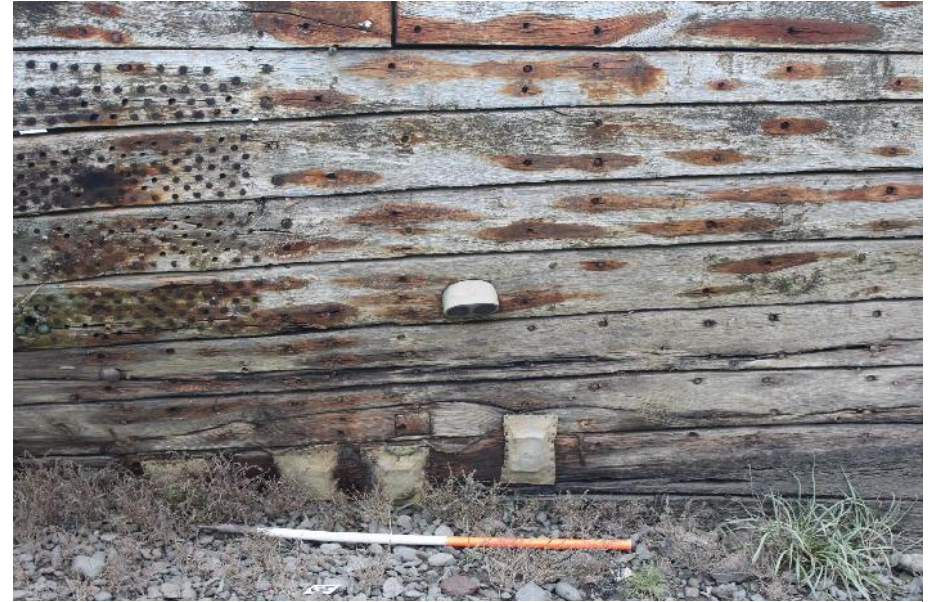
There is evidence of several phases of repairs to the hull. Rectangular and rhomboid wooden patches in the strakes on the port side near the bow have been secured to the main framing using thick timber pegs (figures 26 & 27). A rectangular wooden patch near the keel at the stern may be a similar repair, but sits close to four rectangular lead patches which appear to cover rectangular protrusions (figure 25).

25. Wooden cutout with inset patch in strakes and lead patches near keel

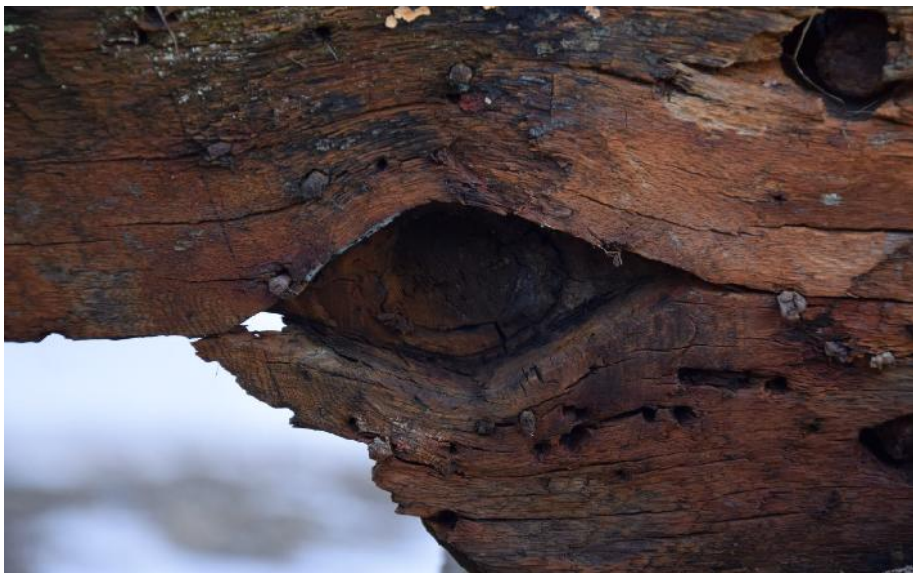
26. Rhomboid patch in strakes

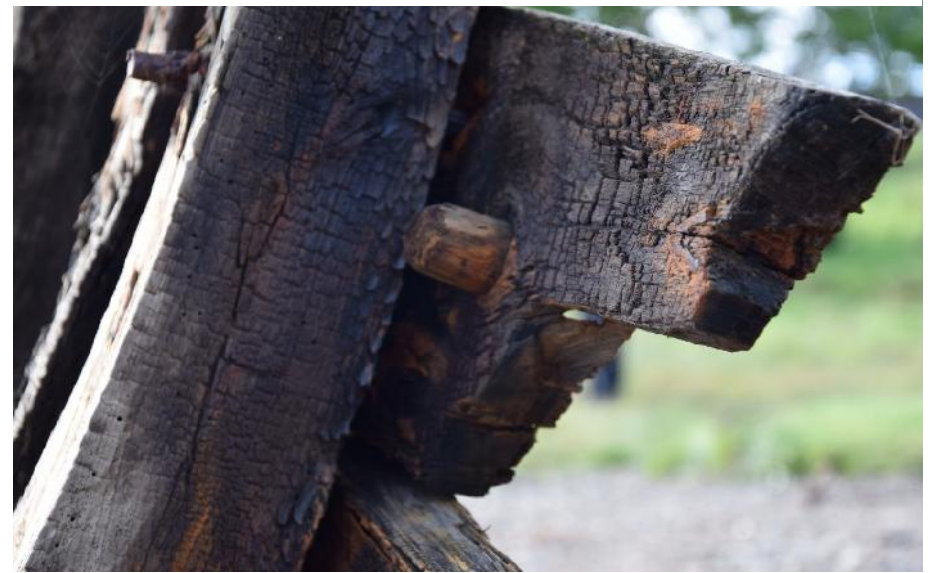
27. Interior side of patch showing wooden pin

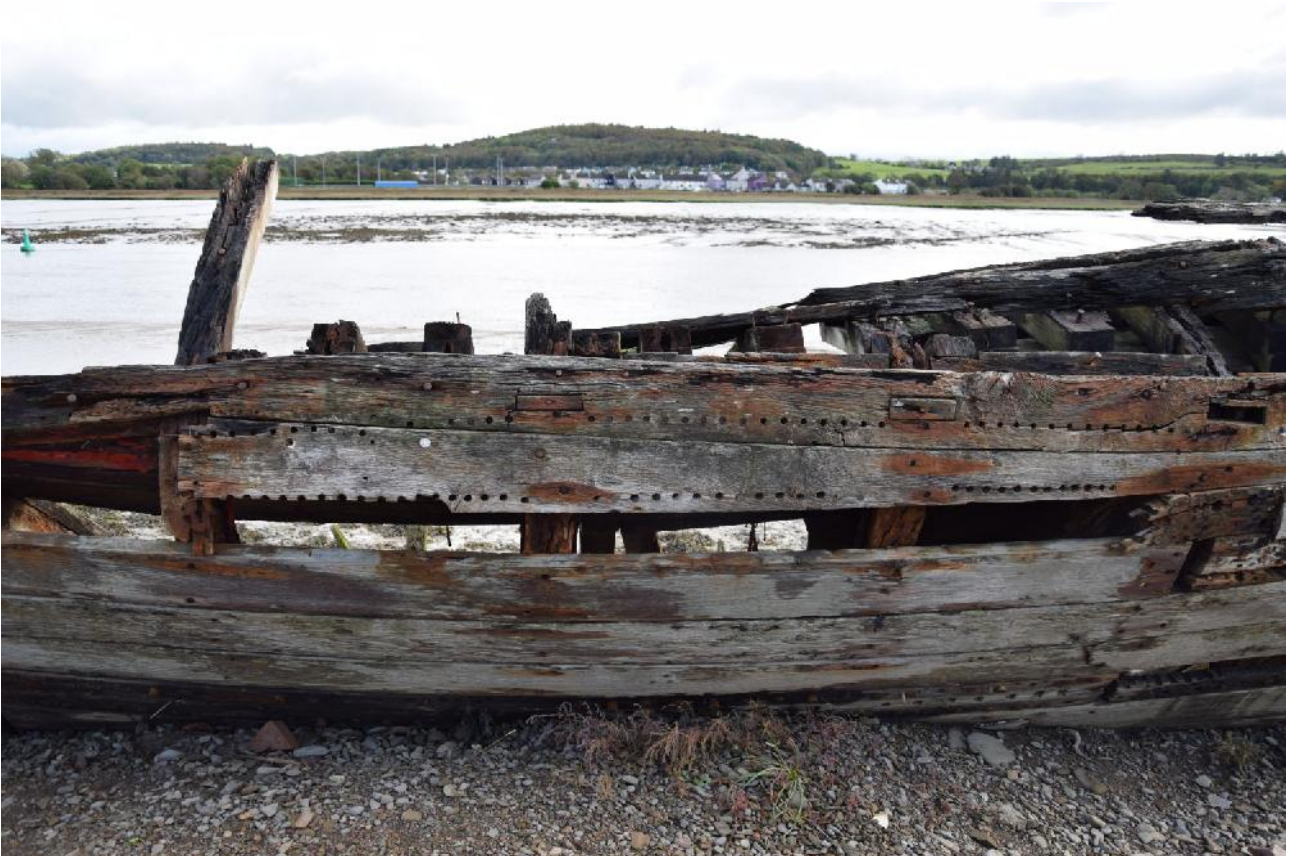
As discussed above, the replacement of some of the holed strakes on the wet-well with solid boards represents poorly executed workmanship and may be contemporary with the insertion of the second engine, post-dating the conversion of the *Fauna* from a wet-well vessel and not associated with the change in use (figures 8, 9, 19 & 28).

28. Rectangular cutouts at waterline on port side strakes on line of frames above wet-well, filled with wooden patches

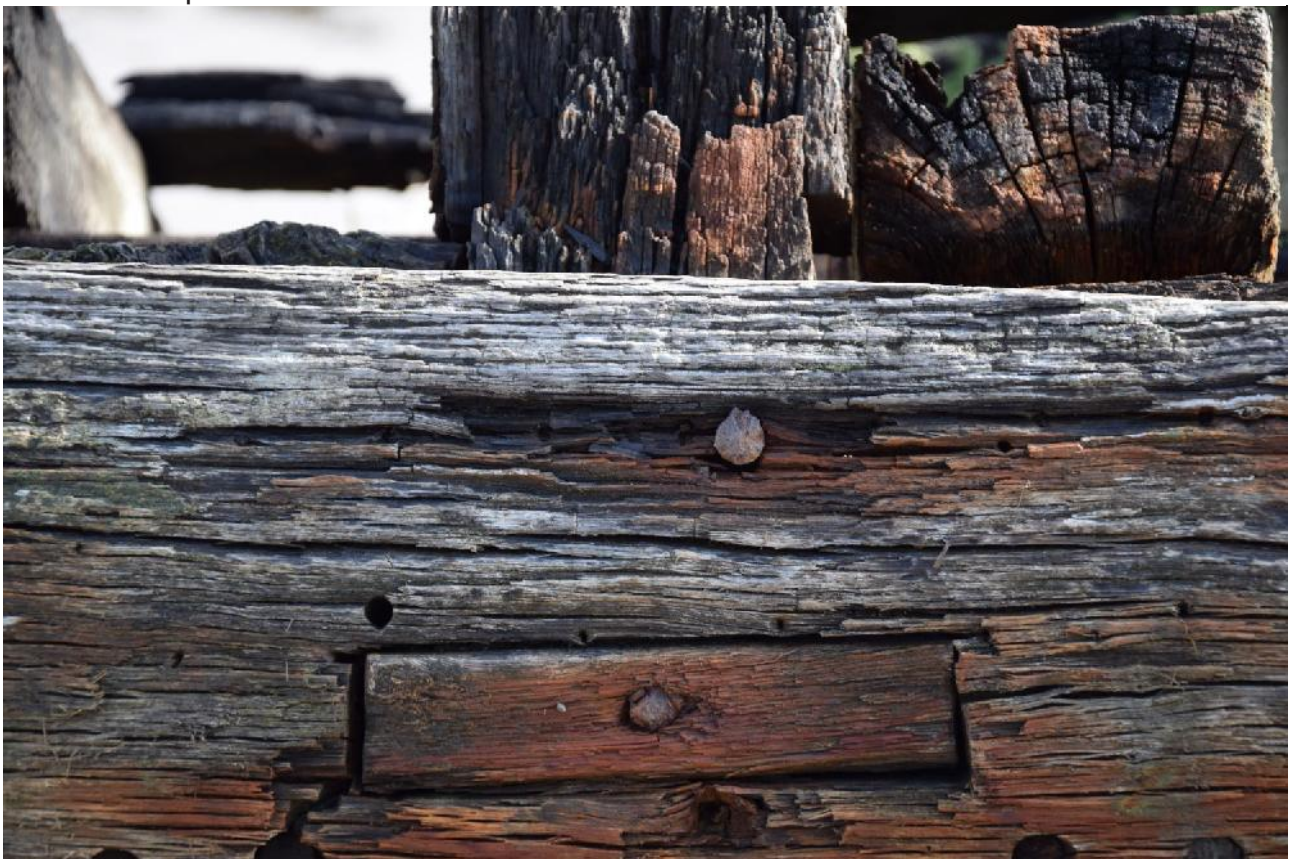
Similarly, a regular line of rectangular cutouts in the strakes runs approximately along the waterline on the lines of the widely-spaced frames in the midships section at the top of the wet-well (figure 28). Most of these have been filled with rectangular wooden patches, and it is possible that the others were originally filled in the same way (figure 29).

29. Detail of patched rectangular cutout in strake in line with frame above wet-well

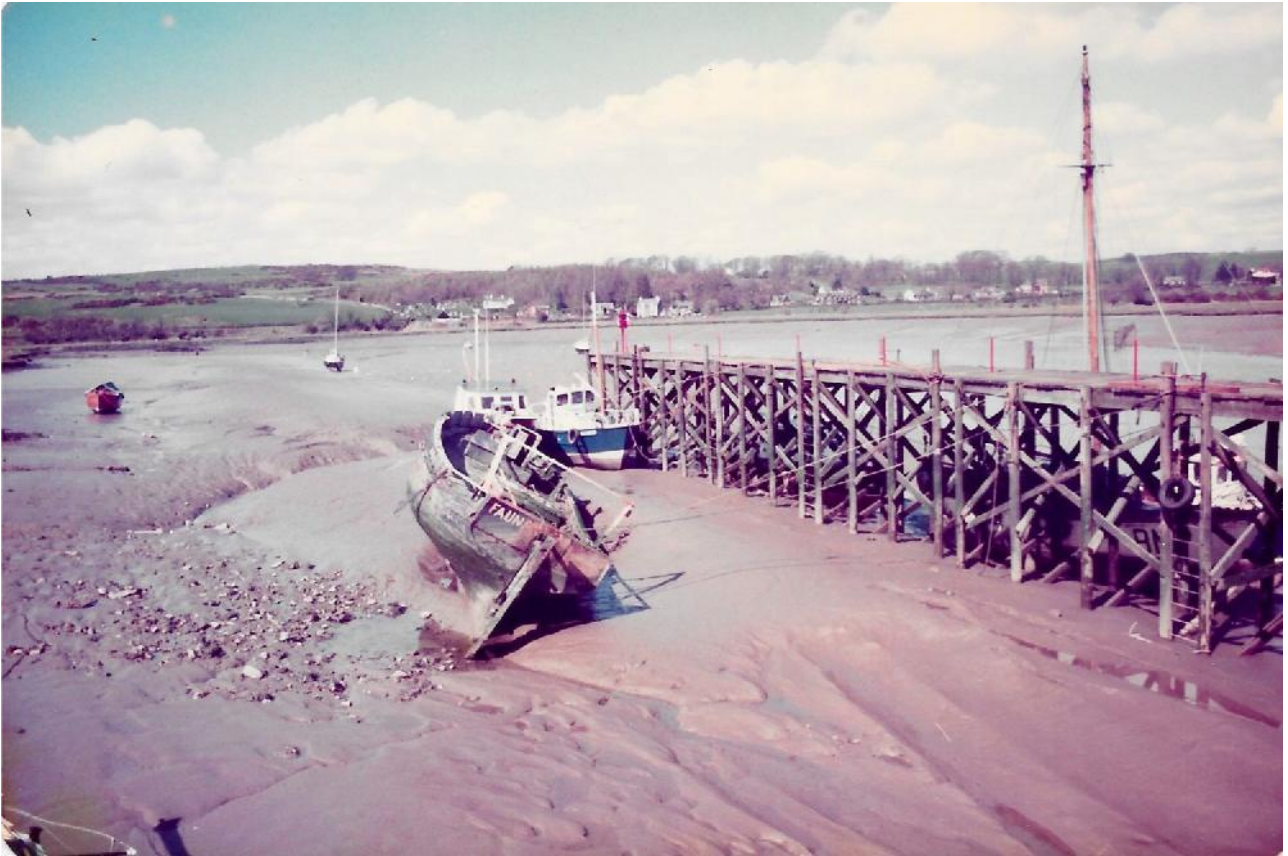
Two photos (figures 30 & 31) shared by David Collin however, appear to show the *Fauna* laid up at Kirkcudbright harbour, suggesting that even if not damaged at the quayside there as indicated by the first story, the redundant vessel was temporarily stored there prior to being finally dumped at Gibbhill.

30. 1970s photo of *Fauna* laid up at Kirkcudbright Harbour (David Collin)

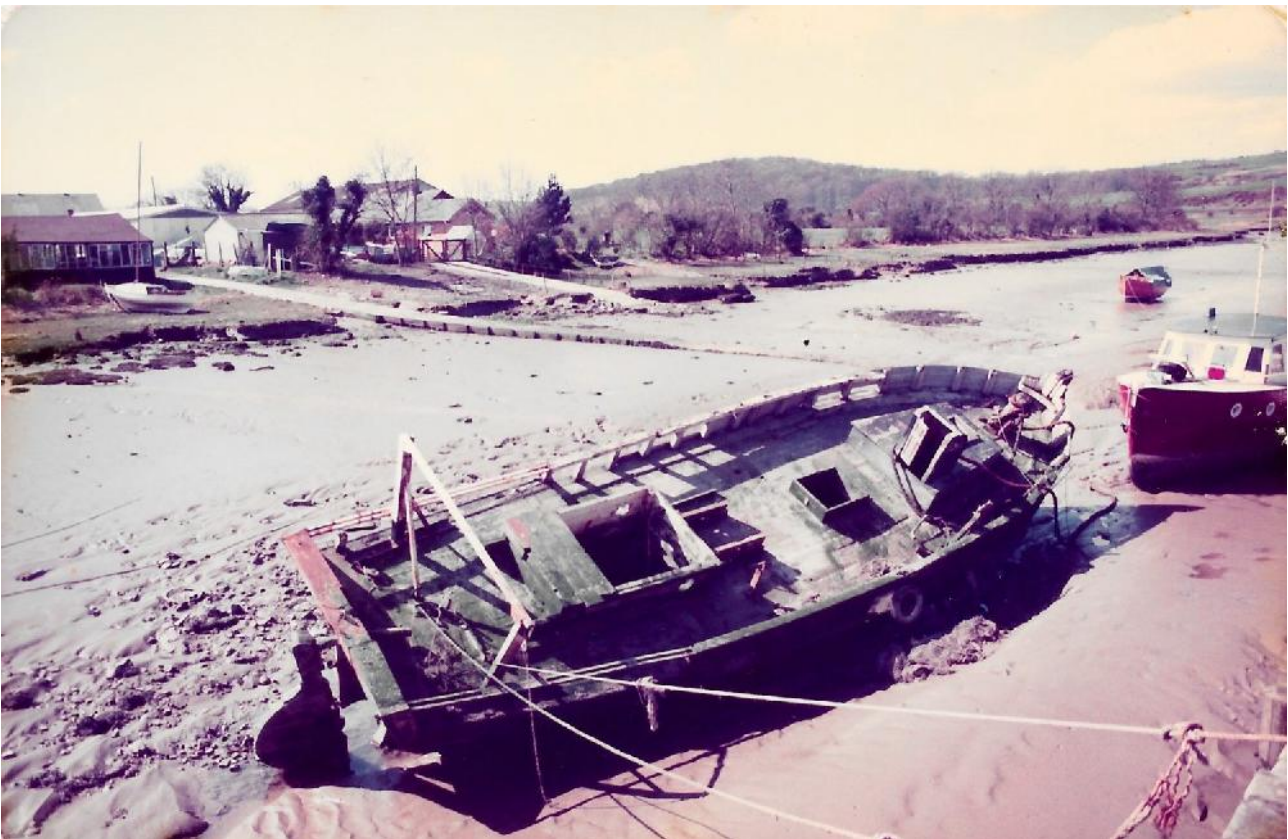
31. 1970s photo of *Fauna* laid up at Kirkcudbright Harbour. The roof of the deckhouse has been removed and no engine is visible below, the propeller has been removed (David Collin)

There is no evidence in the remaining hull structure of substantial or indifferent demolition adjacent to the engine compartment to provide easy and adequate access for its removal. Neither is any such damage visible in the historic photographic record of the hulk, including the 1970s photographs of the *Fauna* laid up at Kirkcudbright prior to its ultimate abandonment at Gibbhill (figures 30 & 31).

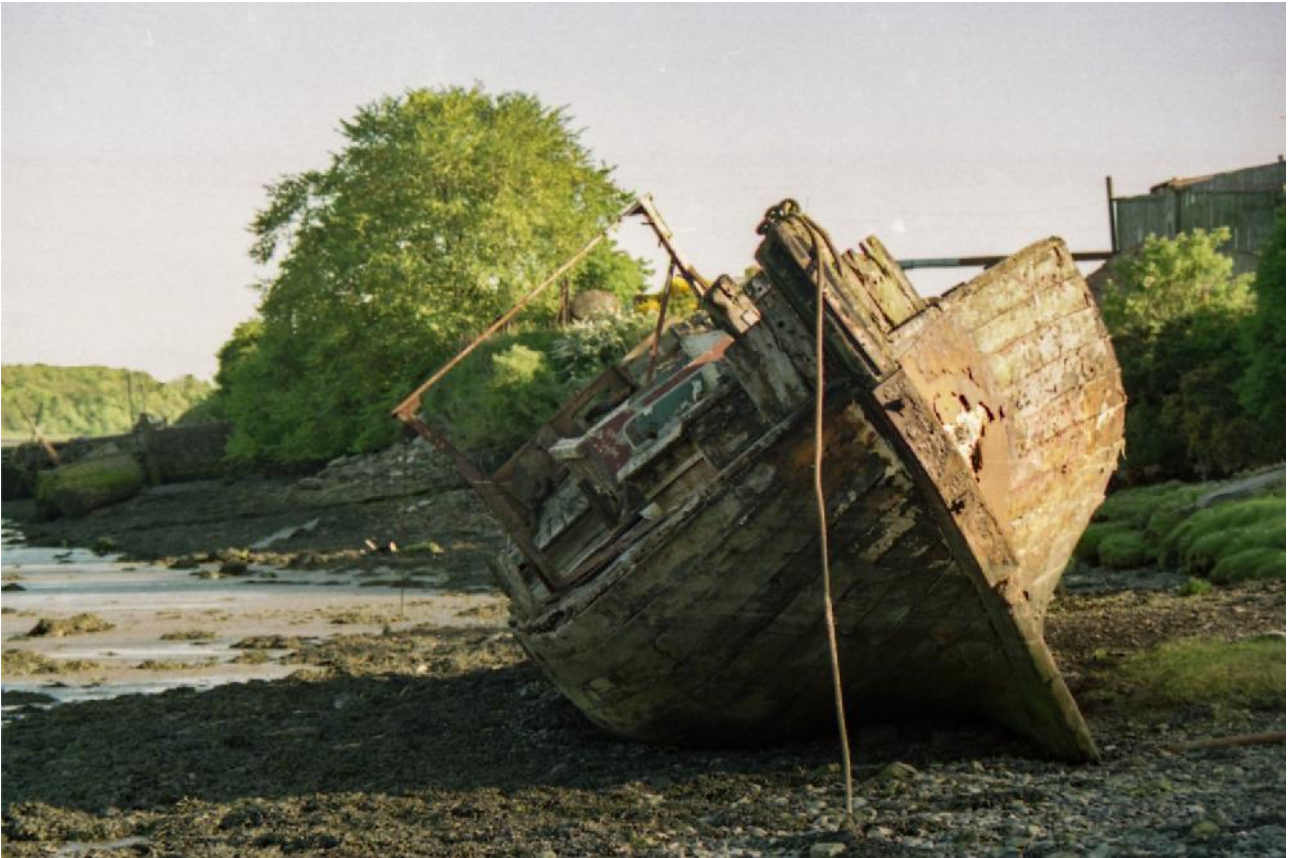
These show that the bow maintained its integrity until around 2010 and that the hull was largely intact (figures 32, 33 & 34) while several images also show traces of iron sheeting around the stem. Comparison between the 2010, 2015 and 2019 photos however (figure 34) show the steep decline in the hulk's condition, with the forward starboard side of the hull largely fallen away, detached and disintegrated. On the port side, the smaller, more widely spaced single frames in the lightly-built midships section have failed at the joint between the first and second futtocks resulting in the uppermost part of the port side of the hull, including the second futtocks and the strakes, collapsing inward. The frames are also failing lower down, at the joint between the floor timbers and the first futtocks. The bow is almost completely gone on both port and starboard side, with the stem post sagging forward, the forward frames and strakes lost (figure 34).

32. The bow end of *Fauna* intact showing metal sheeting and deck structures (Rob Steward, 1995)

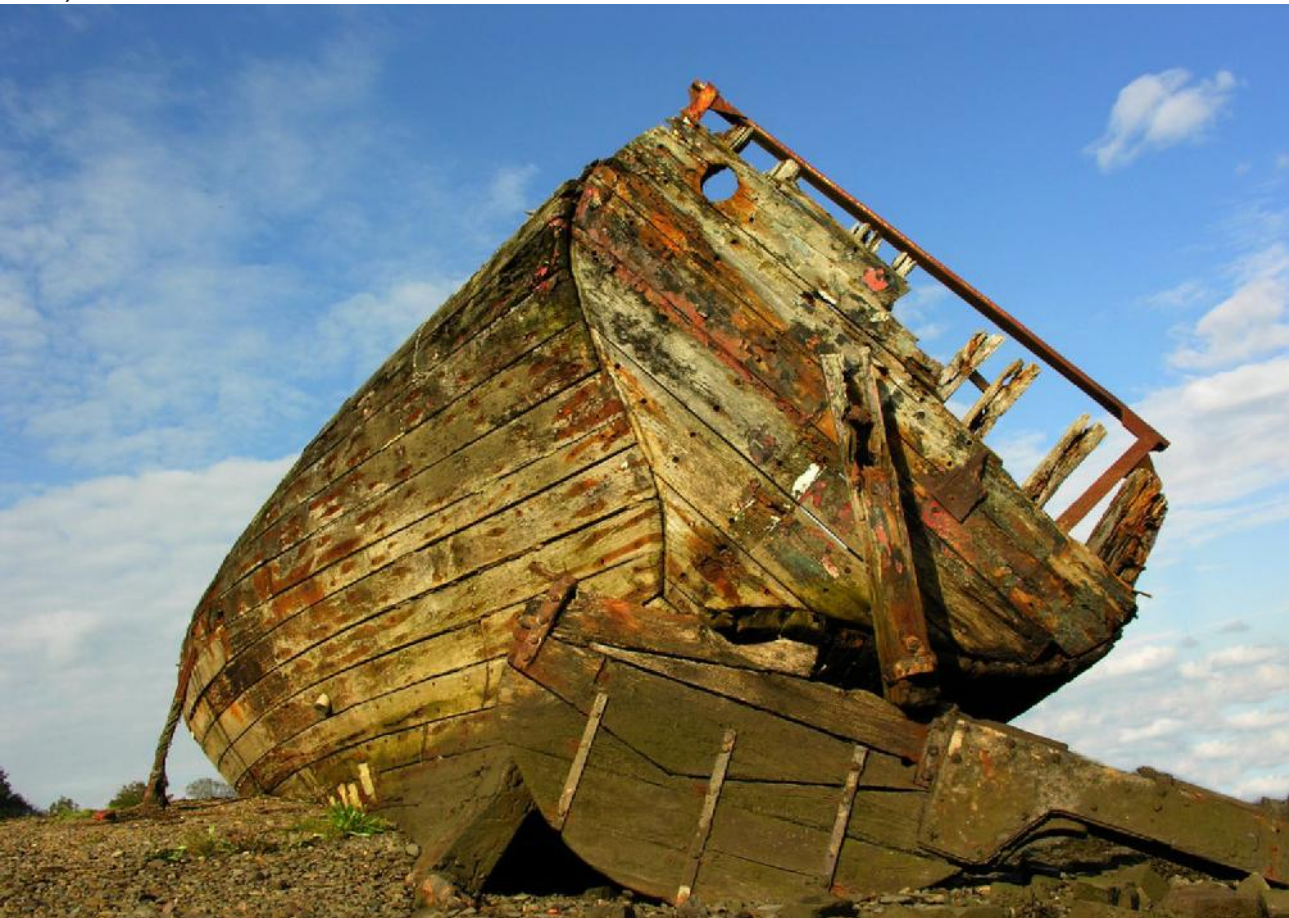
33. The stern showing the fallen rudder and plank mounted on transom to hold rudder offset to accommodate screw (Duncan McNeil, 2006)

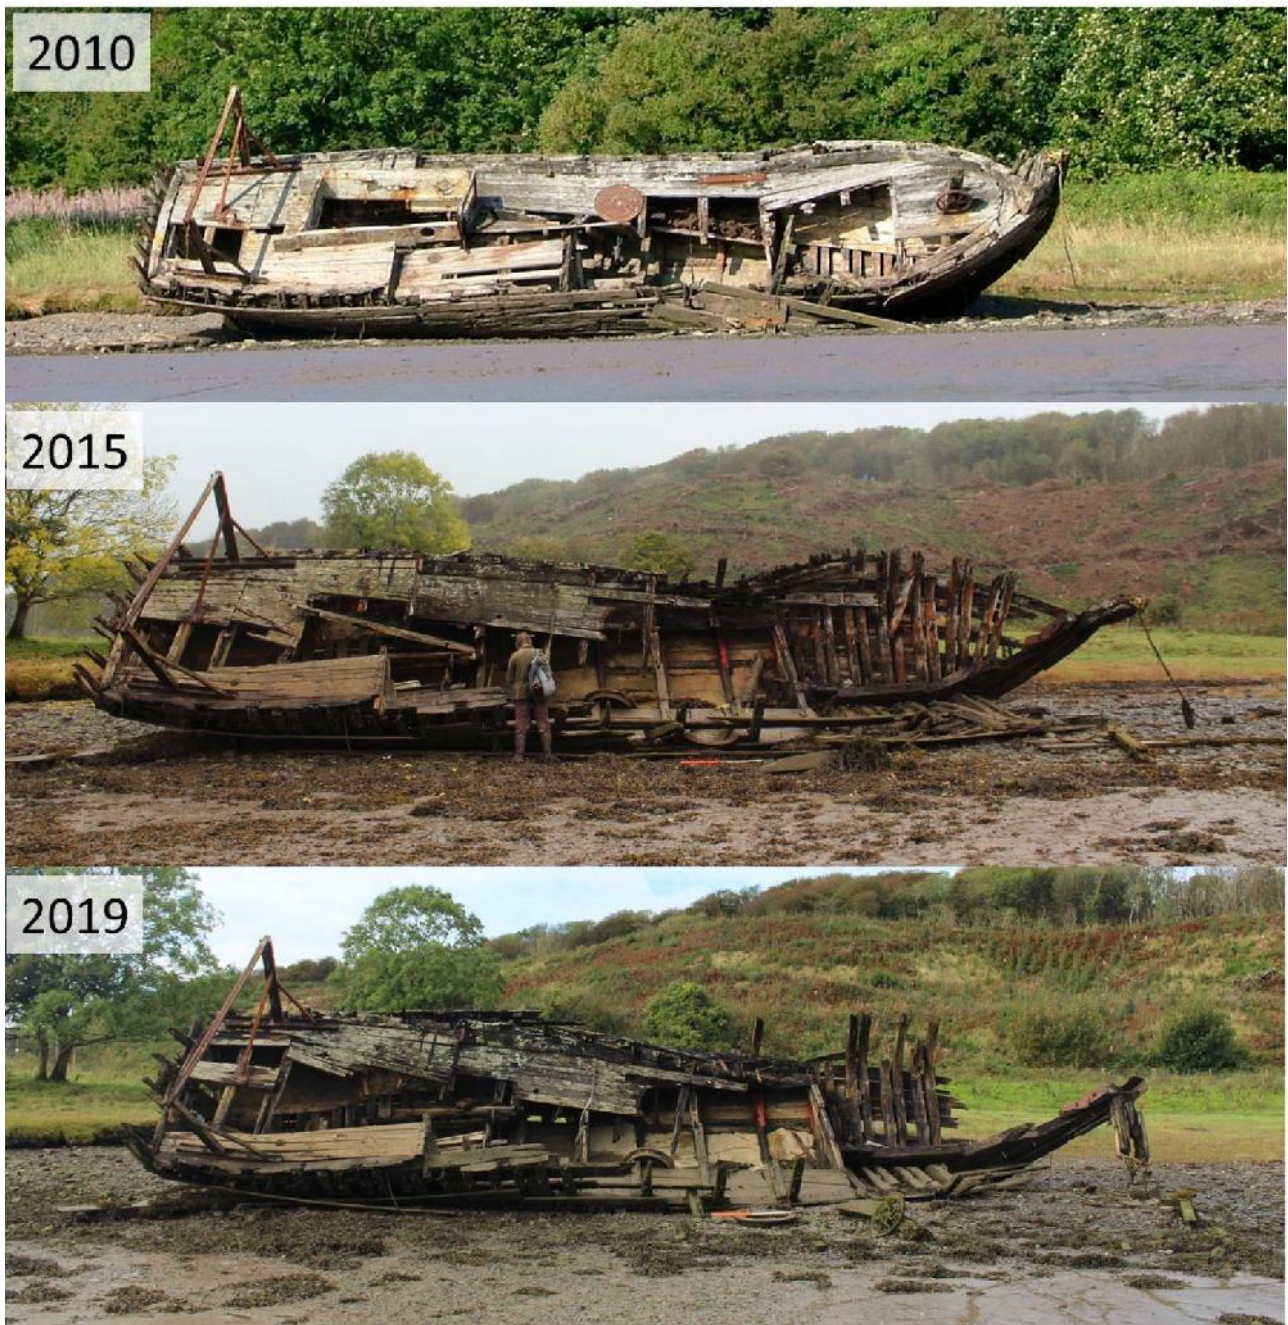
34. Photo series showing the deterioration from 2010 to 2019 (2010: David Collin, 2015 & 2019: SCAPE)

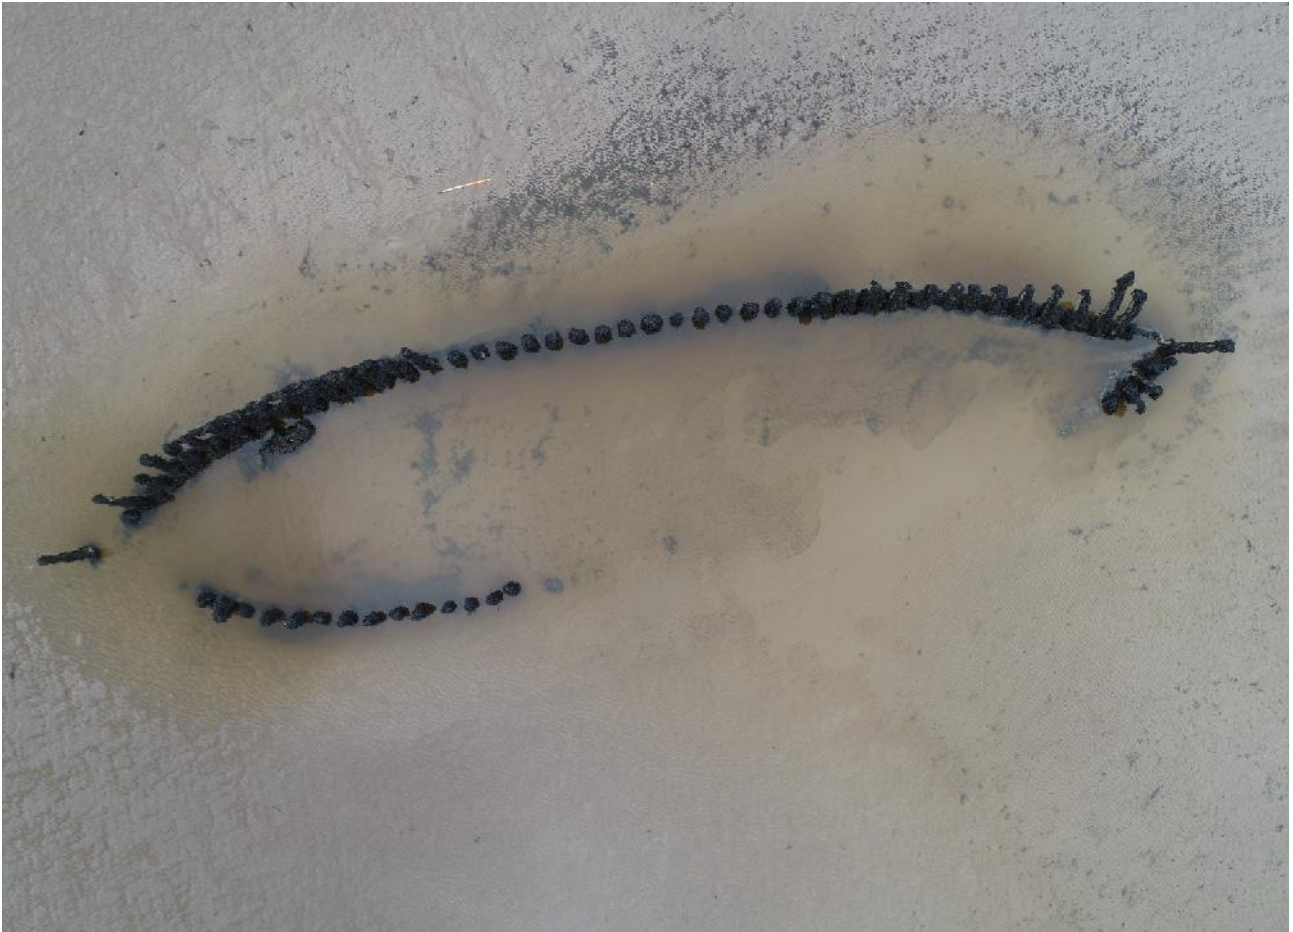
37. Drone view of *Monreith*, bow on left of image, stern to right. Red end of scale aligned approximately to north

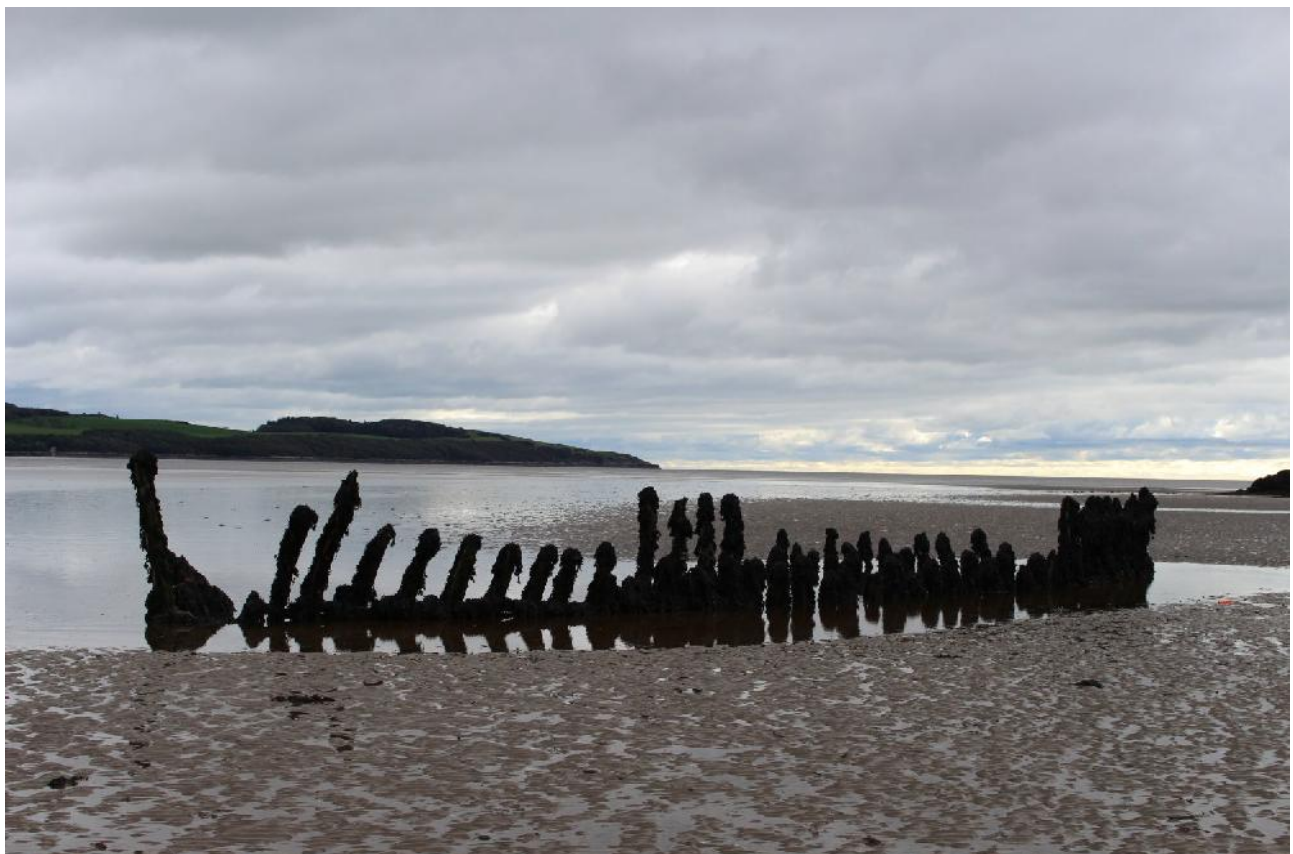
38. Stern end and starboard side of *Monreith* facing approximately south

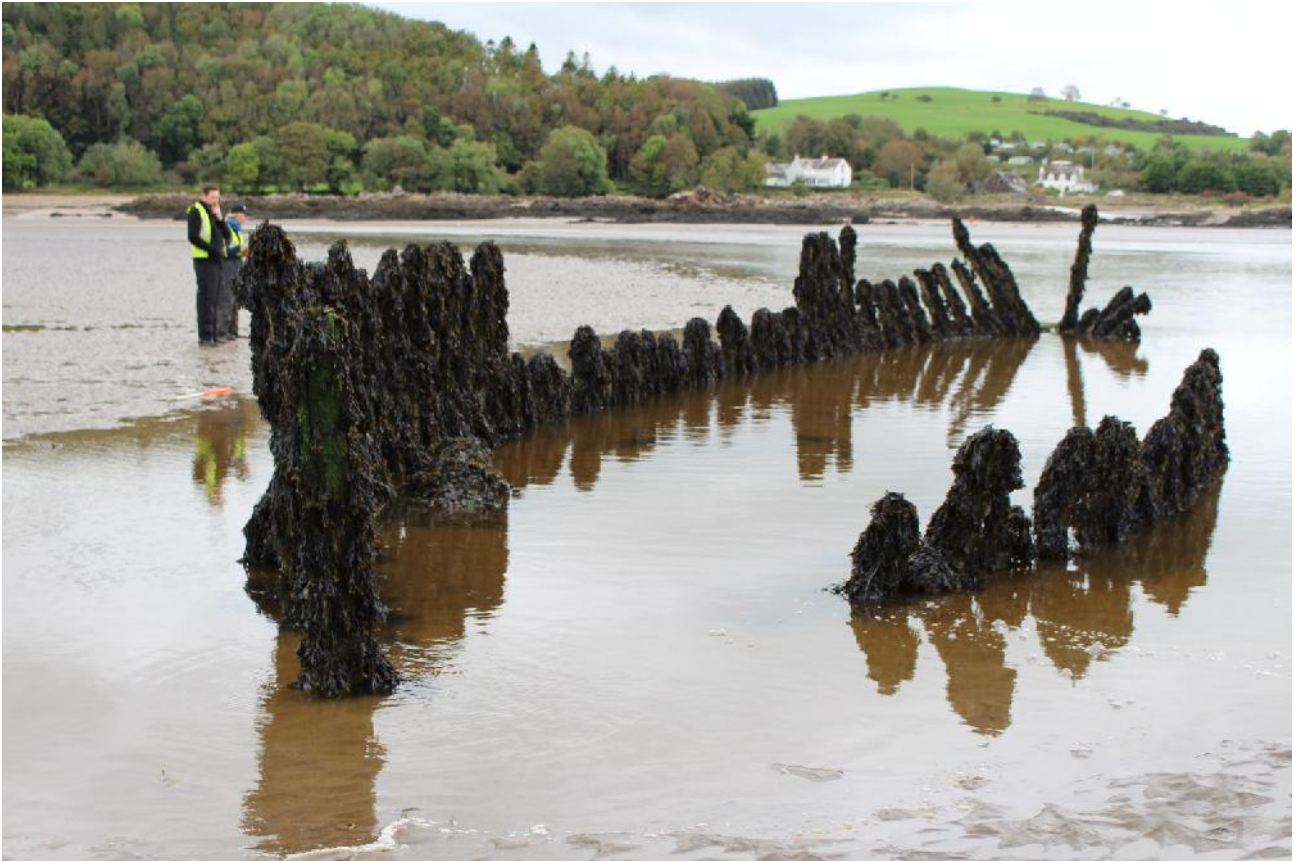
39. Bow end and port side of *Monreith* facing approximately north west

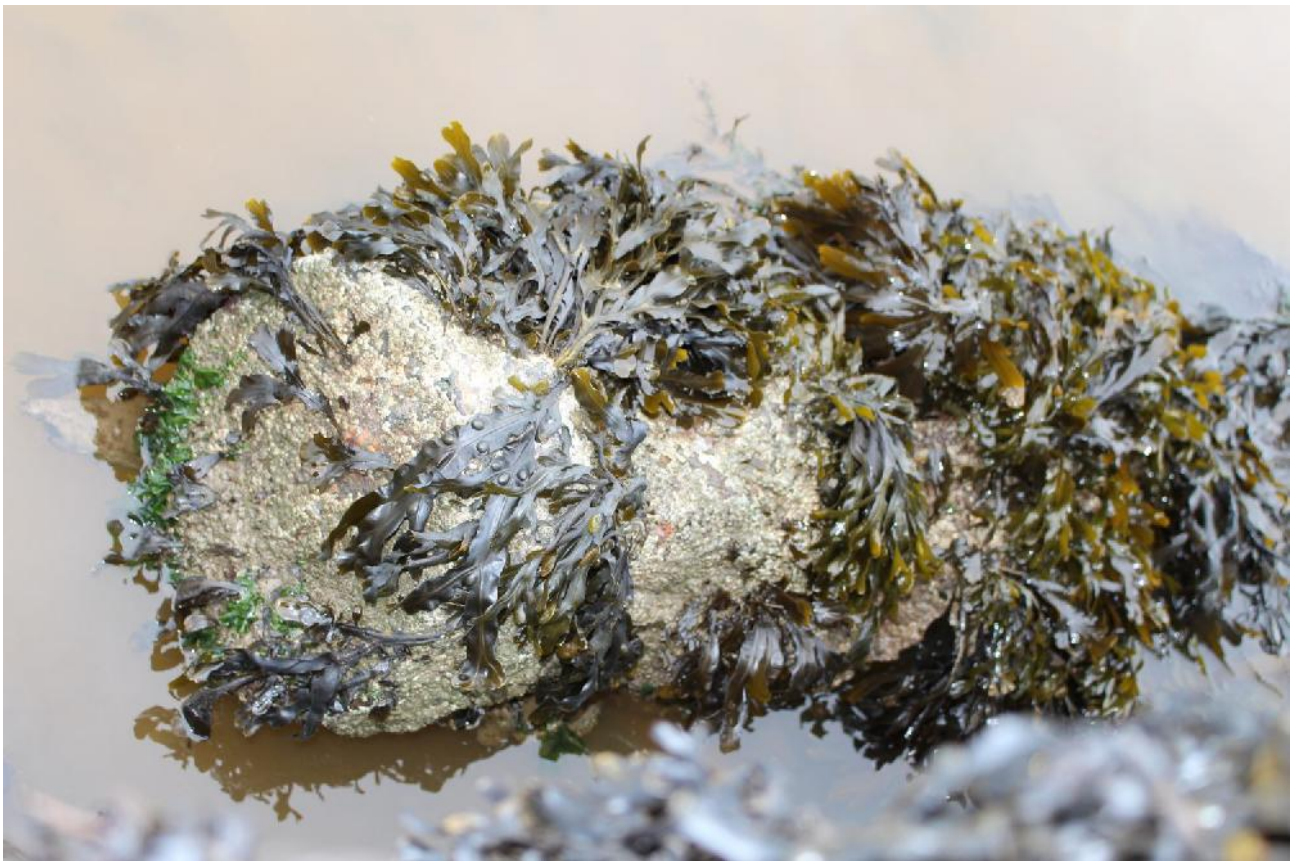
40. Detail of capstan near bow
