Report on Coastal Zone Assessment Survey:

East Lothian & Scottish Borders

**Hazel Moore
Graeme Wilson**

February - March 2006

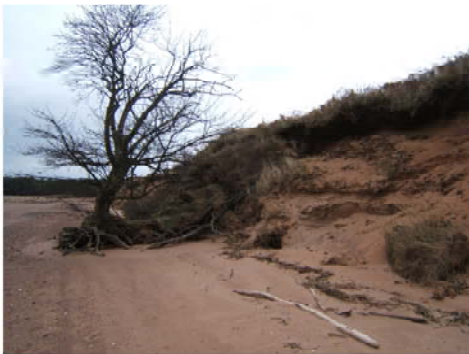
**EL36: Fish trap or
Embankment remains**

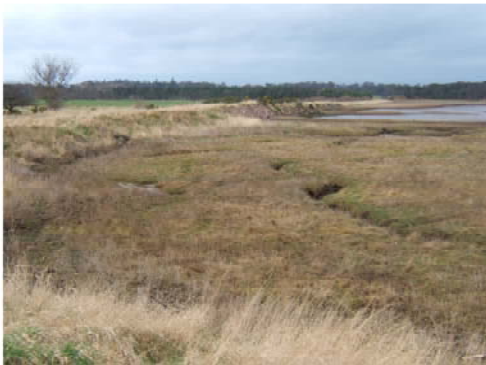
**Erosion to W of
Hedderwick Burn**

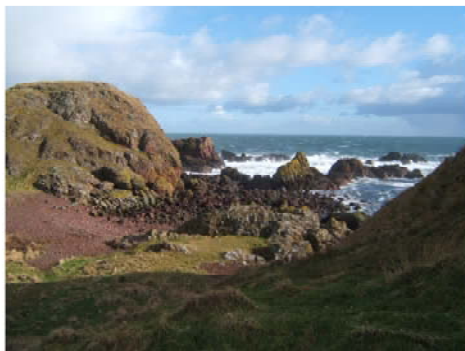
**Coastline to W of
St. Abb's Head**
