COASTAL ASSESSMENT
SURVEY:
THE FIRTH OF FORTH FROM
DUNBAR TO THE BORDER OF
FIFE

PART 2

A report for Historic Scotland

Glasgow University Archaeological Research Division

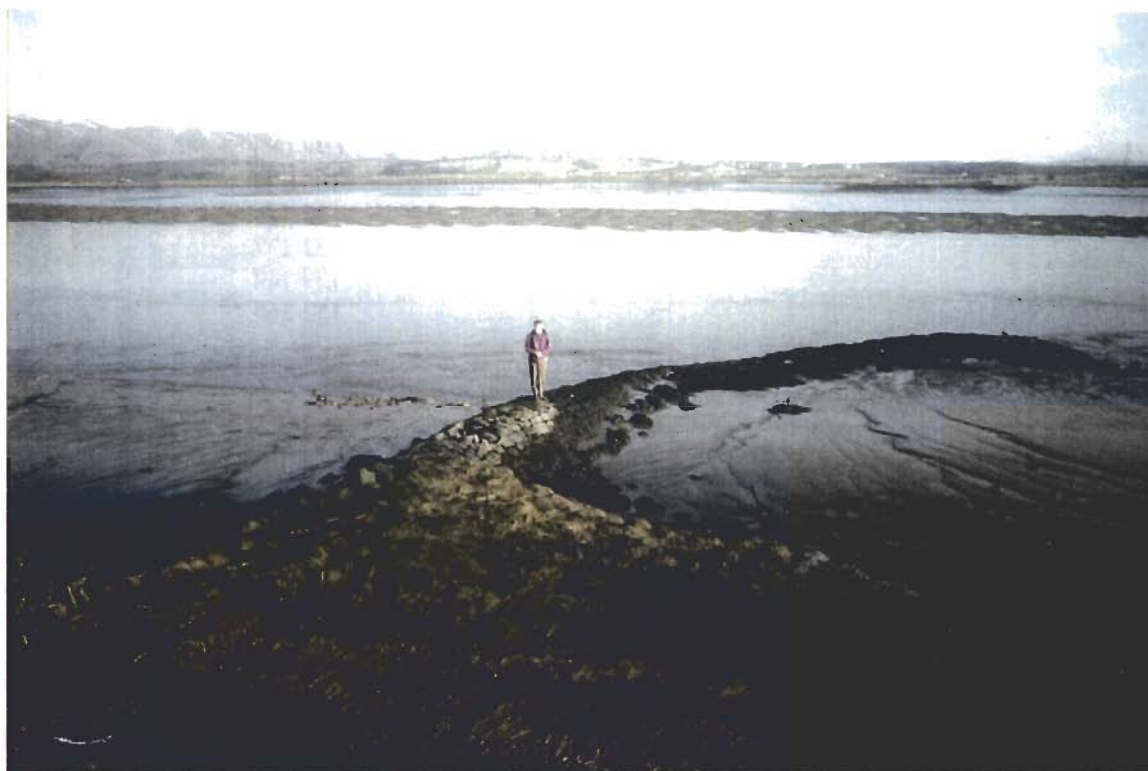
Illus 3 Pier, Dunmore Farm

NS 89 SE **NS 8900 9006**
DUNMORE HOME FARM, pier
Date visited: 22/2/96
The remains of a pier are located on the rivers edge, south of Dunmore Home Farm. A course of stones, c 1m - 2m wide, runs from the grassy tree-lined river bank through mud flats into the Forth. The remains of the pier measure c 50m long and is c 3m high at its highest point. The pier is slightly curved. It is disused and has been allowed to fall into disrepair.
Condition: Poor
Action: Survey

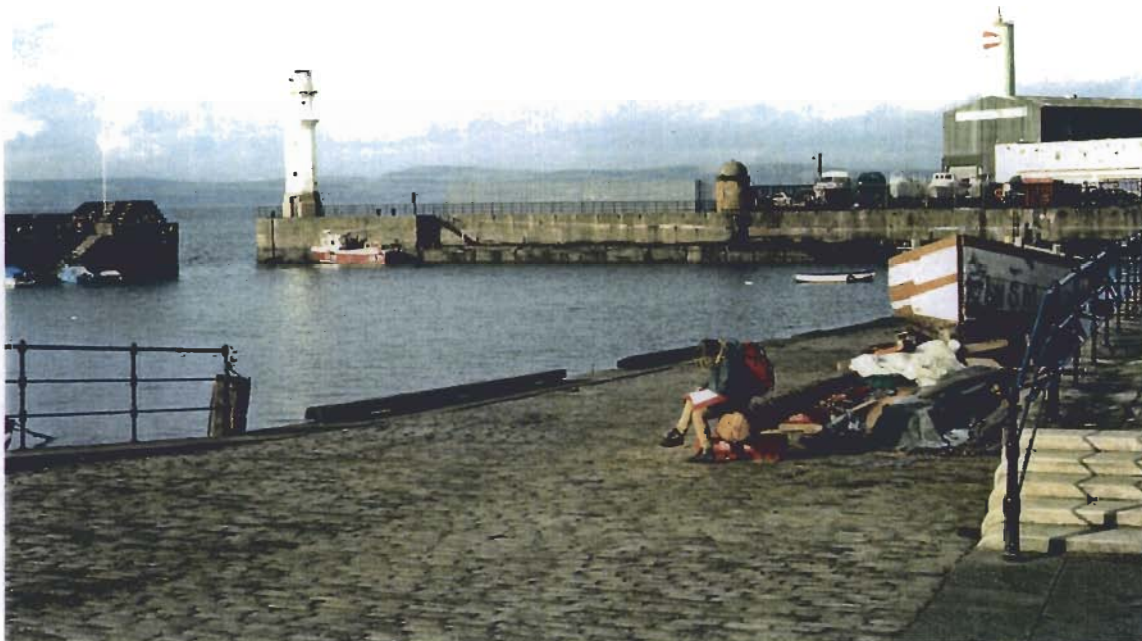
Illus 7 Newhaven Harbour and Lighthouse, NT 27 NE 76

Newhaven Harbour is a small harbour used mainly by pleasure craft. The harbour and breakwaters are well maintained, both lighthouses are upstanding and in good condition. The fishmarket is now split into two buildings, the southern half is now a Harry Ramsdens fish restaurant. The northern half appeared to be empty but may be used as a store.

Condition: Good
