EASE ARCHAEOLOGICAL CONSULTANTS

REPORT ON A COASTAL ZONE ASSESSMENT SURVEY OF ORKNEY:

AUGUST 1997

Hazel Moore Graeme Wilson

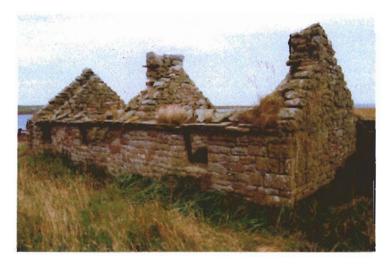
B7

Not located

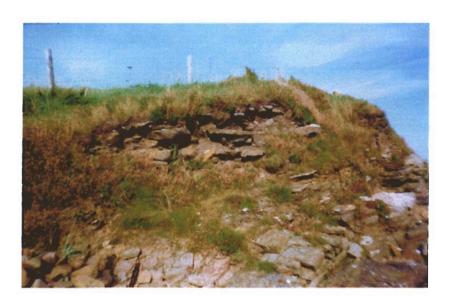
SITE B24

Fair Survey

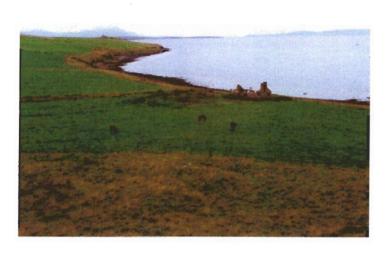
SITES SR11, SR12. TAKEN FROM BROCH SR127

Fair Monitor

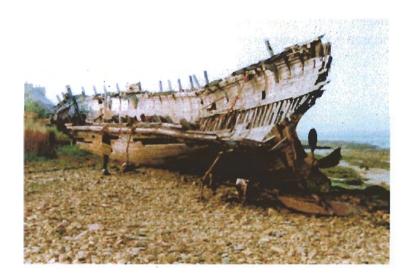
SITE SR53

The hulk of a propeller-driven wooden vessel lies partly submerged in gravel at the HWM . The base and some of the side ribs survive, in a very decayed state; the upper part of the structure has gone. The remains of internal metal fittings, together with iron nails and rivets in the vessel's timbers survive but are very corroded. The vessel is 20m long and c.9m wide. Fair
