CFA ARCHAEOLOGY LTD

Commissioned by The SCAPE Trust

The Extractive Industries of Brora Archaeological Assessment

Report No. 1138

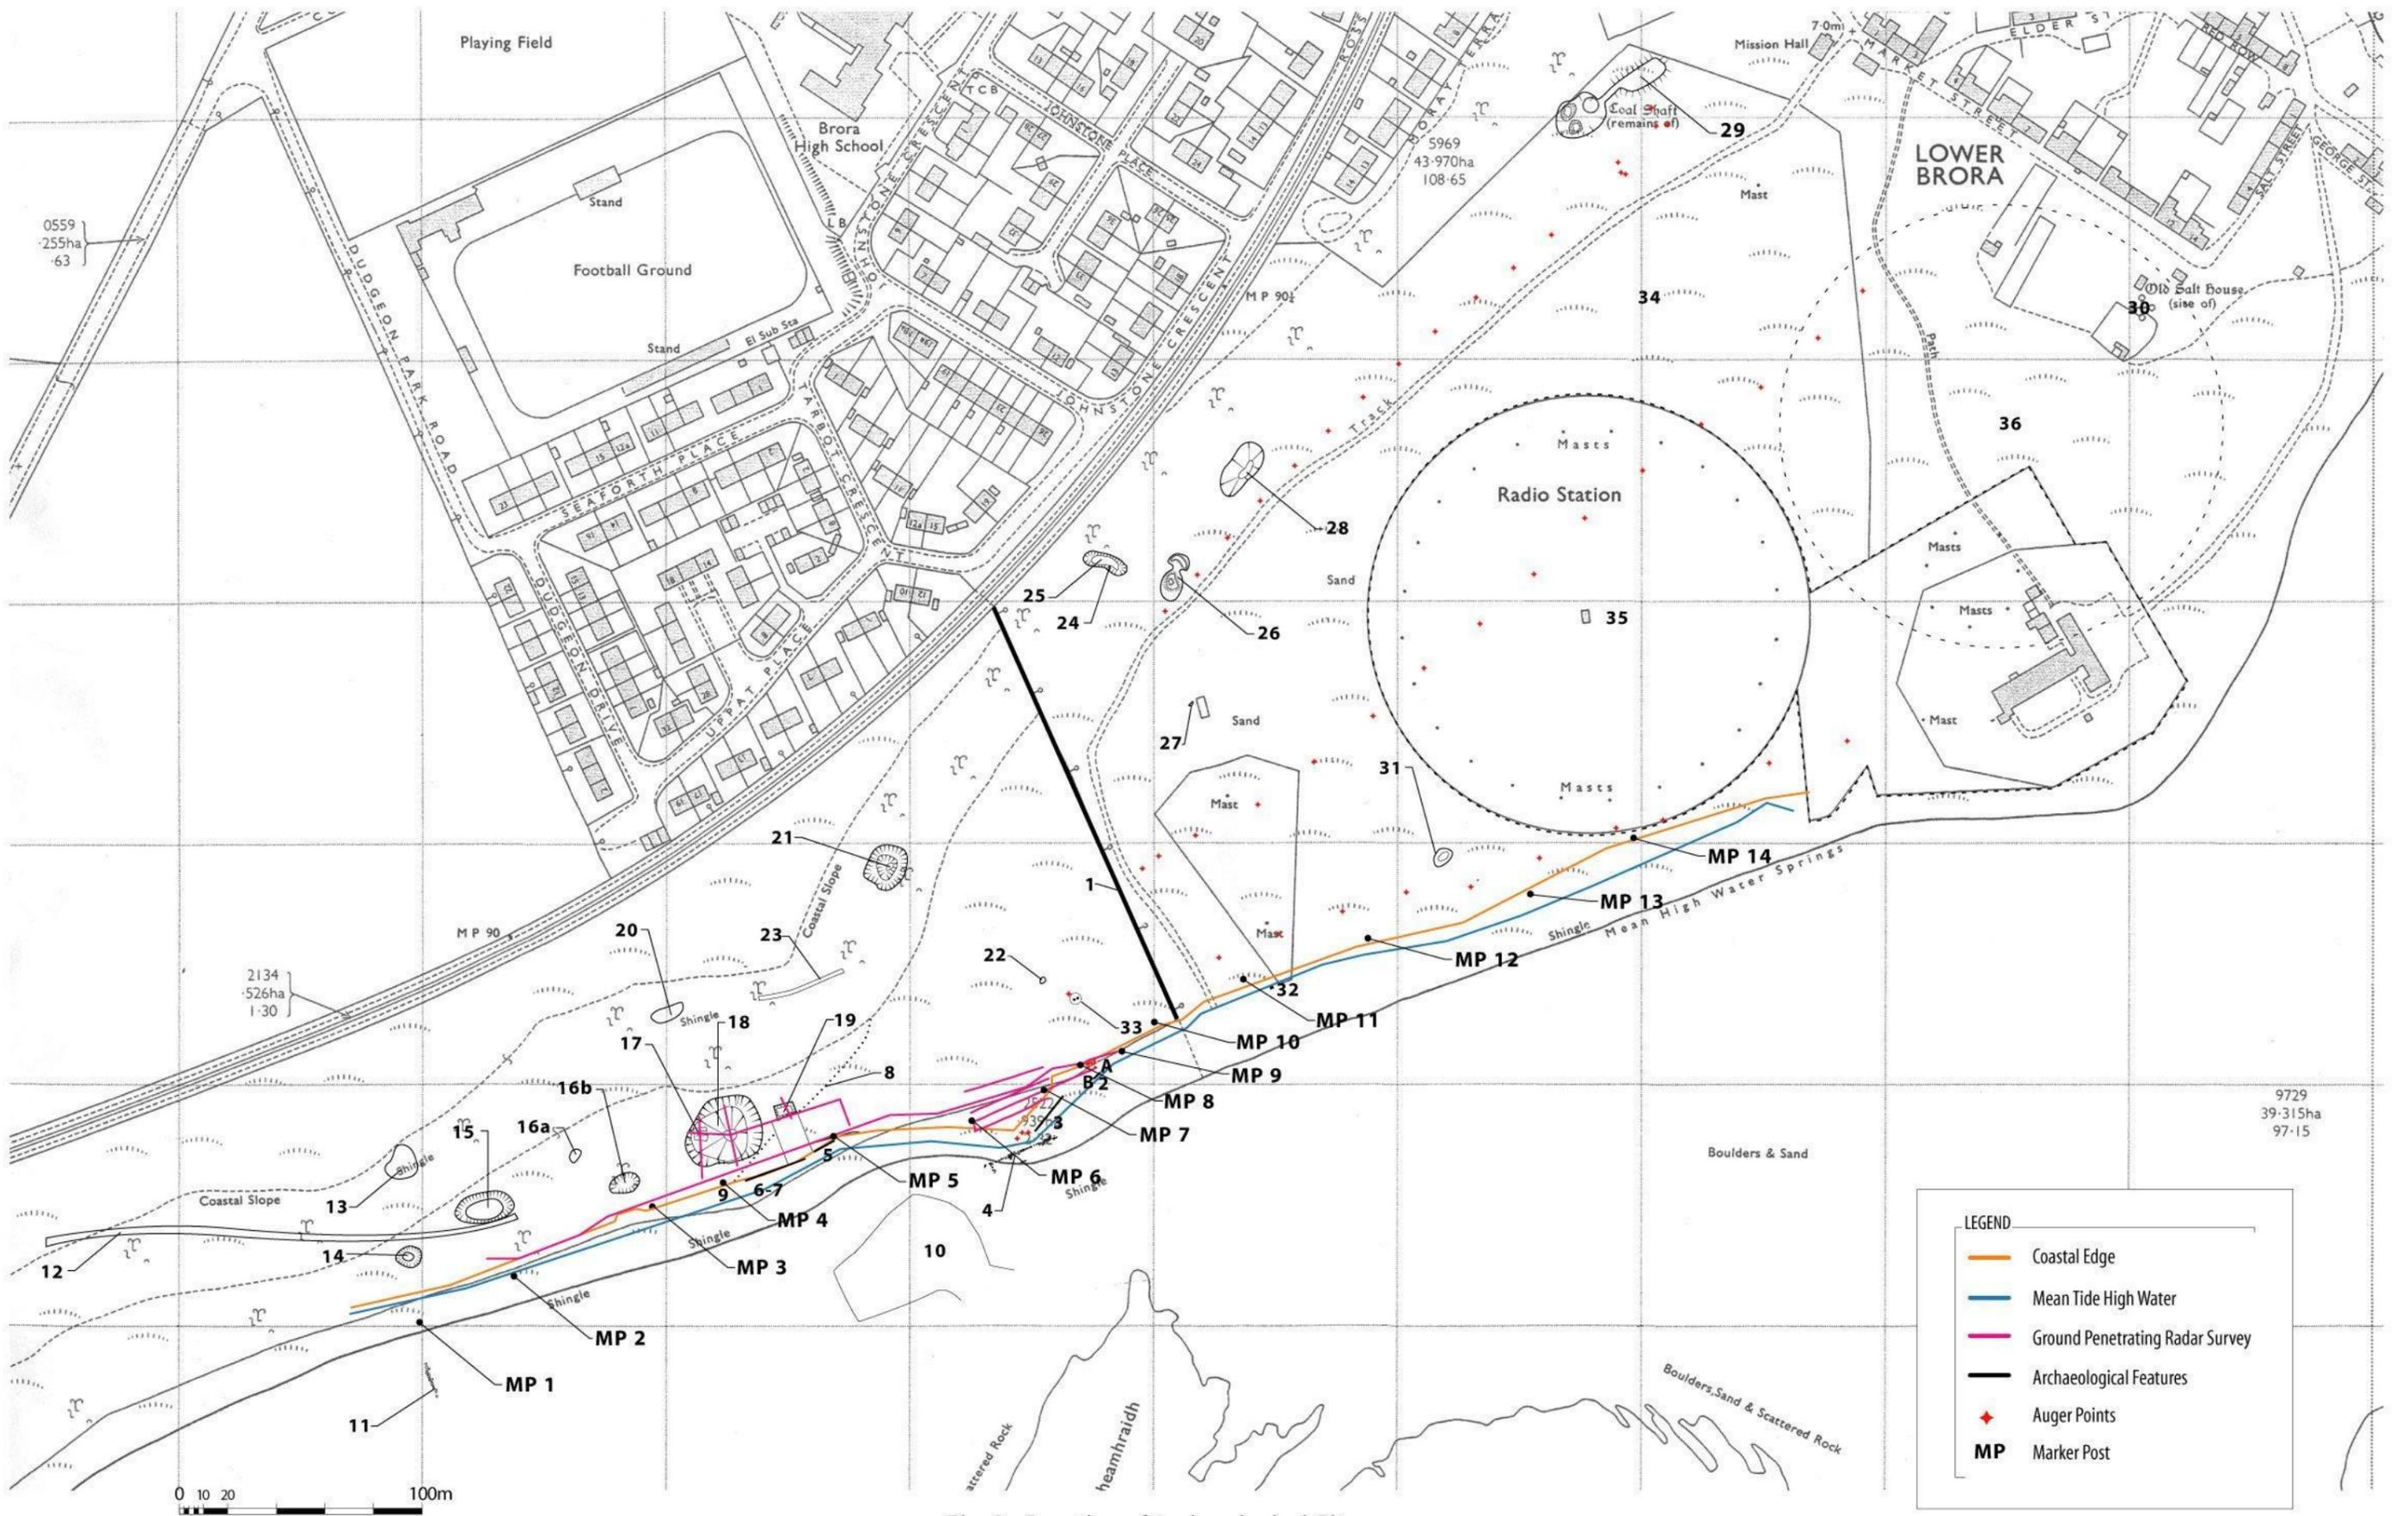
Fig. 3 - Location of Archaeological Sites

- 5.1.1 Thirty-six sites of archaeological interest were recorded during the desk-based assessment and the walkover survey of the study area (Figure 3). The site numbers are in bold in the following report and are described in full in Appendix 1. Three digit numbers in bold relate to contexts within features and a full list can be found in Appendix 2.

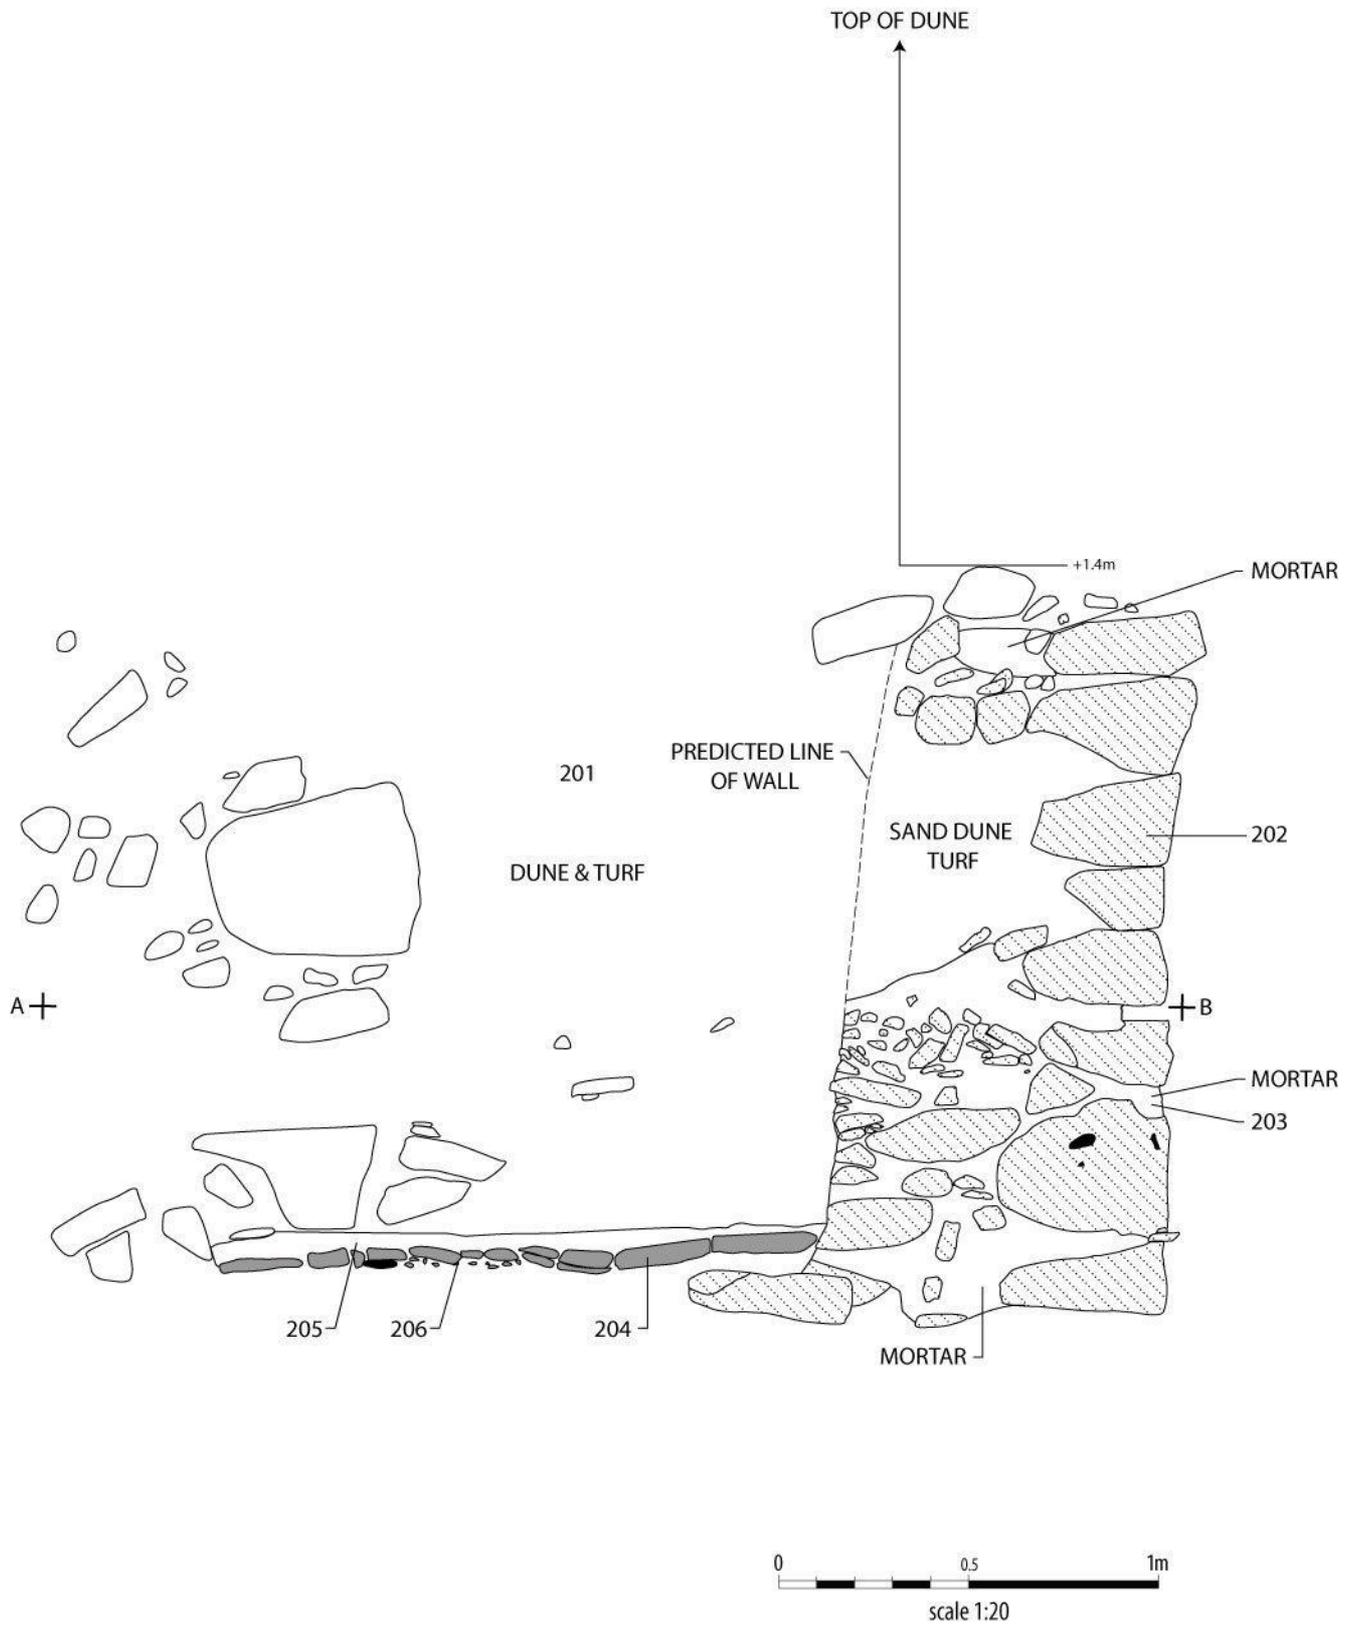
Fig. 6 - Section of building site 2 with flagged floor

- 5.8.3 The wall (202) of the possible building consisted of two faces with a rubble core. Mortar (203) was visible between the stones and also on large tumbled stones lying on the beach. Large natural blocks of stone had been used in the construction of the wall. To the west of the wall a flagged floor was visible in the section. This consisted of large flat stones which had been laid down horizontally. Smaller stones found beneath the floor were perhaps used to level the stones (206). A thin layer of dark silty material (205) was recorded

7.4.4 Sites 2 and 4 are probably the remains of saltpans recorded from historical and cartographic research. Whilst it was not possible to prove this theory during the current phase of investigation, the size of the walls remaining suggests a large building complex. It is possible that these buildings housed the salt pans themselves, although the state of erosion at these sites may prevent a conclusive answer from emerging. The auger survey over these two buildings has shown that if there are further remains of these buildings they are to be found within the large sand dune complex surrounding the sites. Stone was located during the auger survey around site 2 and interpreted as the continuation of the wall. Site 4, however, appears to be almost entirely gone, with only the back of the building surviving as a long length of wall on the beach. Further work within this area may determine what remains beneath the sand. Site 2 is more promising in relation to further work, as the building itself is visible running into the sand dune, complete with a flagged floor therefore suggesting that more lies within.

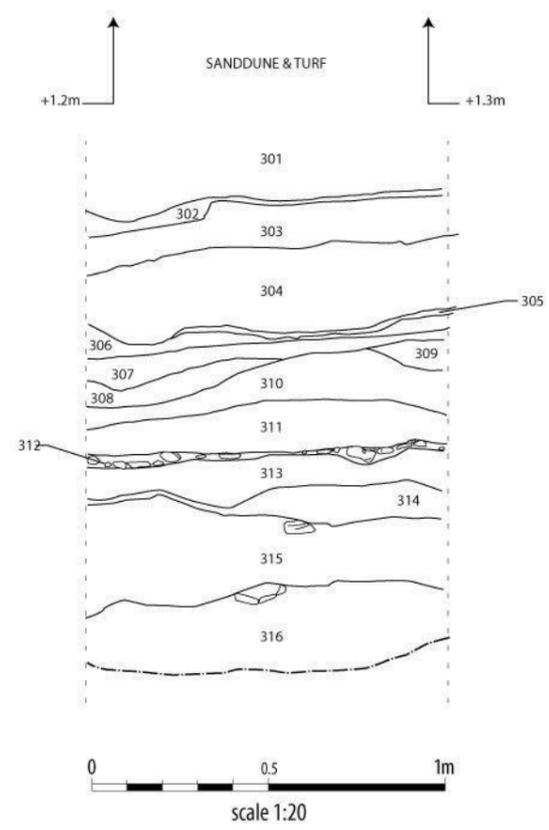
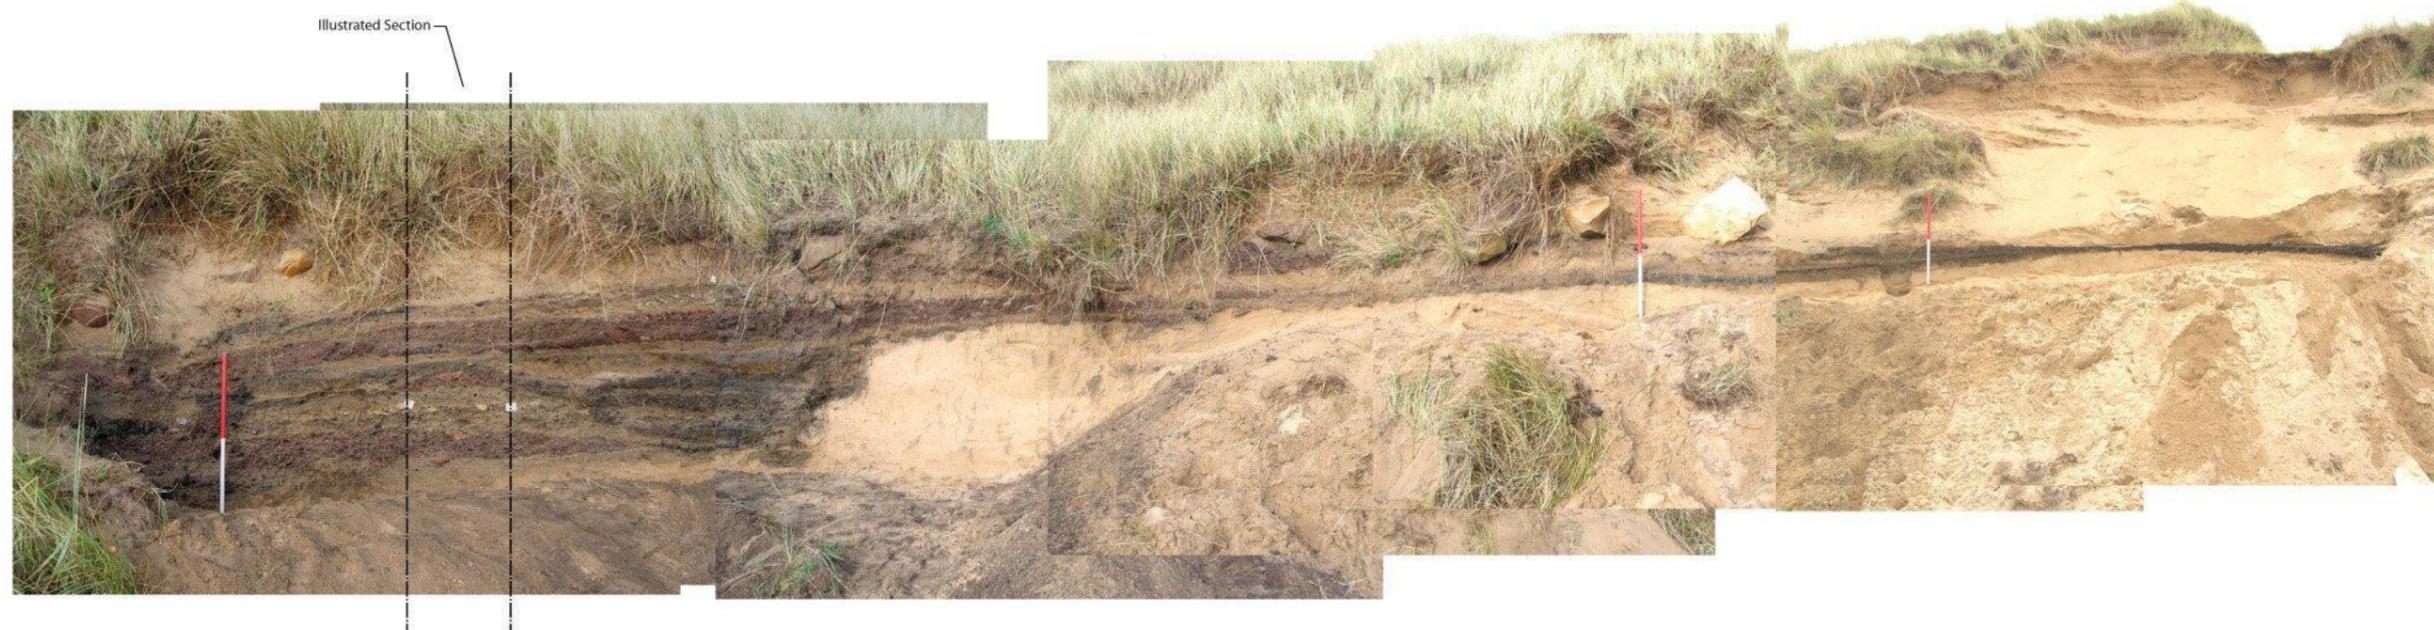
Fig. 7 - Photomontage and Section Site 3

- 5.8.5 The midden consisted of numerous layers, several of which are believed to be industrial in nature. A layer of 'dirty' natural sand (316) was recorded at the base of the midden. Above this was a layer of red and black industrial rubbish containing burnt coal, ash and shaley coal (315), measuring 0.32m thick. A sandy layer containing some flecks of shale and ash (313) was recorded above this. A layer of broken sandstone (312) was recorded lying above 313, measuring c.0.04m thick. A distinctive red layer (310), possibly burnt coal, was recorded measuring 0.2m thick. This was followed by a pocket of sand (309) at the east side of the section which contains pieces of shaley coal and ash. Another pocket of sand (308) was recorded to the west of the section and although it is not directly linked to 309, it is very similar. Above this a black layer (305) containing coal and ash, 0.02m thick was recorded. A layer of red and black material (304) containing ash, shale and burnt sandstone, 0.27m thick, was recorded lying above 305. A layer of pale clay (303), 0.14m thick with no obvious inclusions was visible above 304. A layer of burnt shale, coal and ash (302), 0.06m thick appears to comprise the top layer of the midden. This is followed by c.1.2m of sand (301) to the top of the dune.

3	Industrial Midden	NC 90464 03285 - NC 90455 03274	Layers of industrial waste eroding out of a sand dune. The layers are of uneven thickness and are made up of different materials. This probably indicates that industrial waste was dumped at different times and that some deposits were more substantial than others. The material consists of red coal ash, black shale coal, sand and shale coal, silt and sand, natural clay, burnt pieces of red sandstone and pieces of sandstone, probably chipped from larger masonry blocks. It is possible that the midden material was dumped into a pit or deflated area and it can be seen to abut the exterior wall of the building at Site 4. The visible erosion face of the midden is approximately 15m in length and approximately 1.2m in height. The inland extent of the midden is unknown as only the eroding face of the midden is visible. A possible old ground surface is visible in the section and extends from the midden in a NE direction towards the building remains at Site 2.

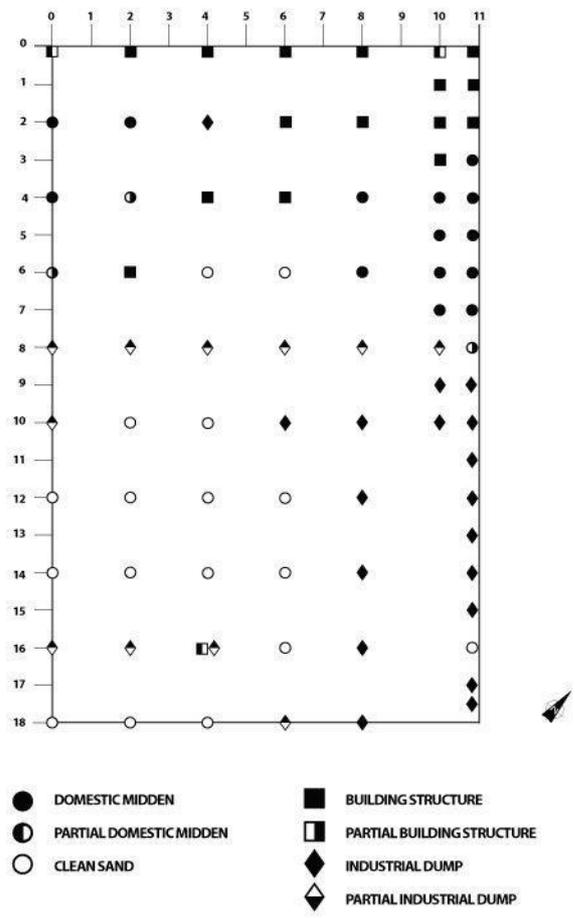
Fig. 8 - Auger Survey of Saltman's House Site 19

- 5.9.2 Figure 8 depicts the grid system used whilst augering around the 'Saltman's House' (Site 19). Augers were extracted at 1m intervals to begin with, then 2m intervals when this was found to be too time consuming. It indicates where stone, industrial midden and domestic midden were encountered. It shows that the middens visible in the coastal section directly to the south of the house continued at least up to the house. It also indicates that the midden may cover a larger area than that covered during the survey, as the full extents of the midden were not revealed. Stone was encountered along the wall of the Saltman's house and also along the projected line of the wall (Site 8) which cuts across this area. Augers were taken at three points across this line in order to rule out natural stones which gave a more accurate picture of the line of the boundary wall. They were taken at 2m intervals along the projected line of the wall.

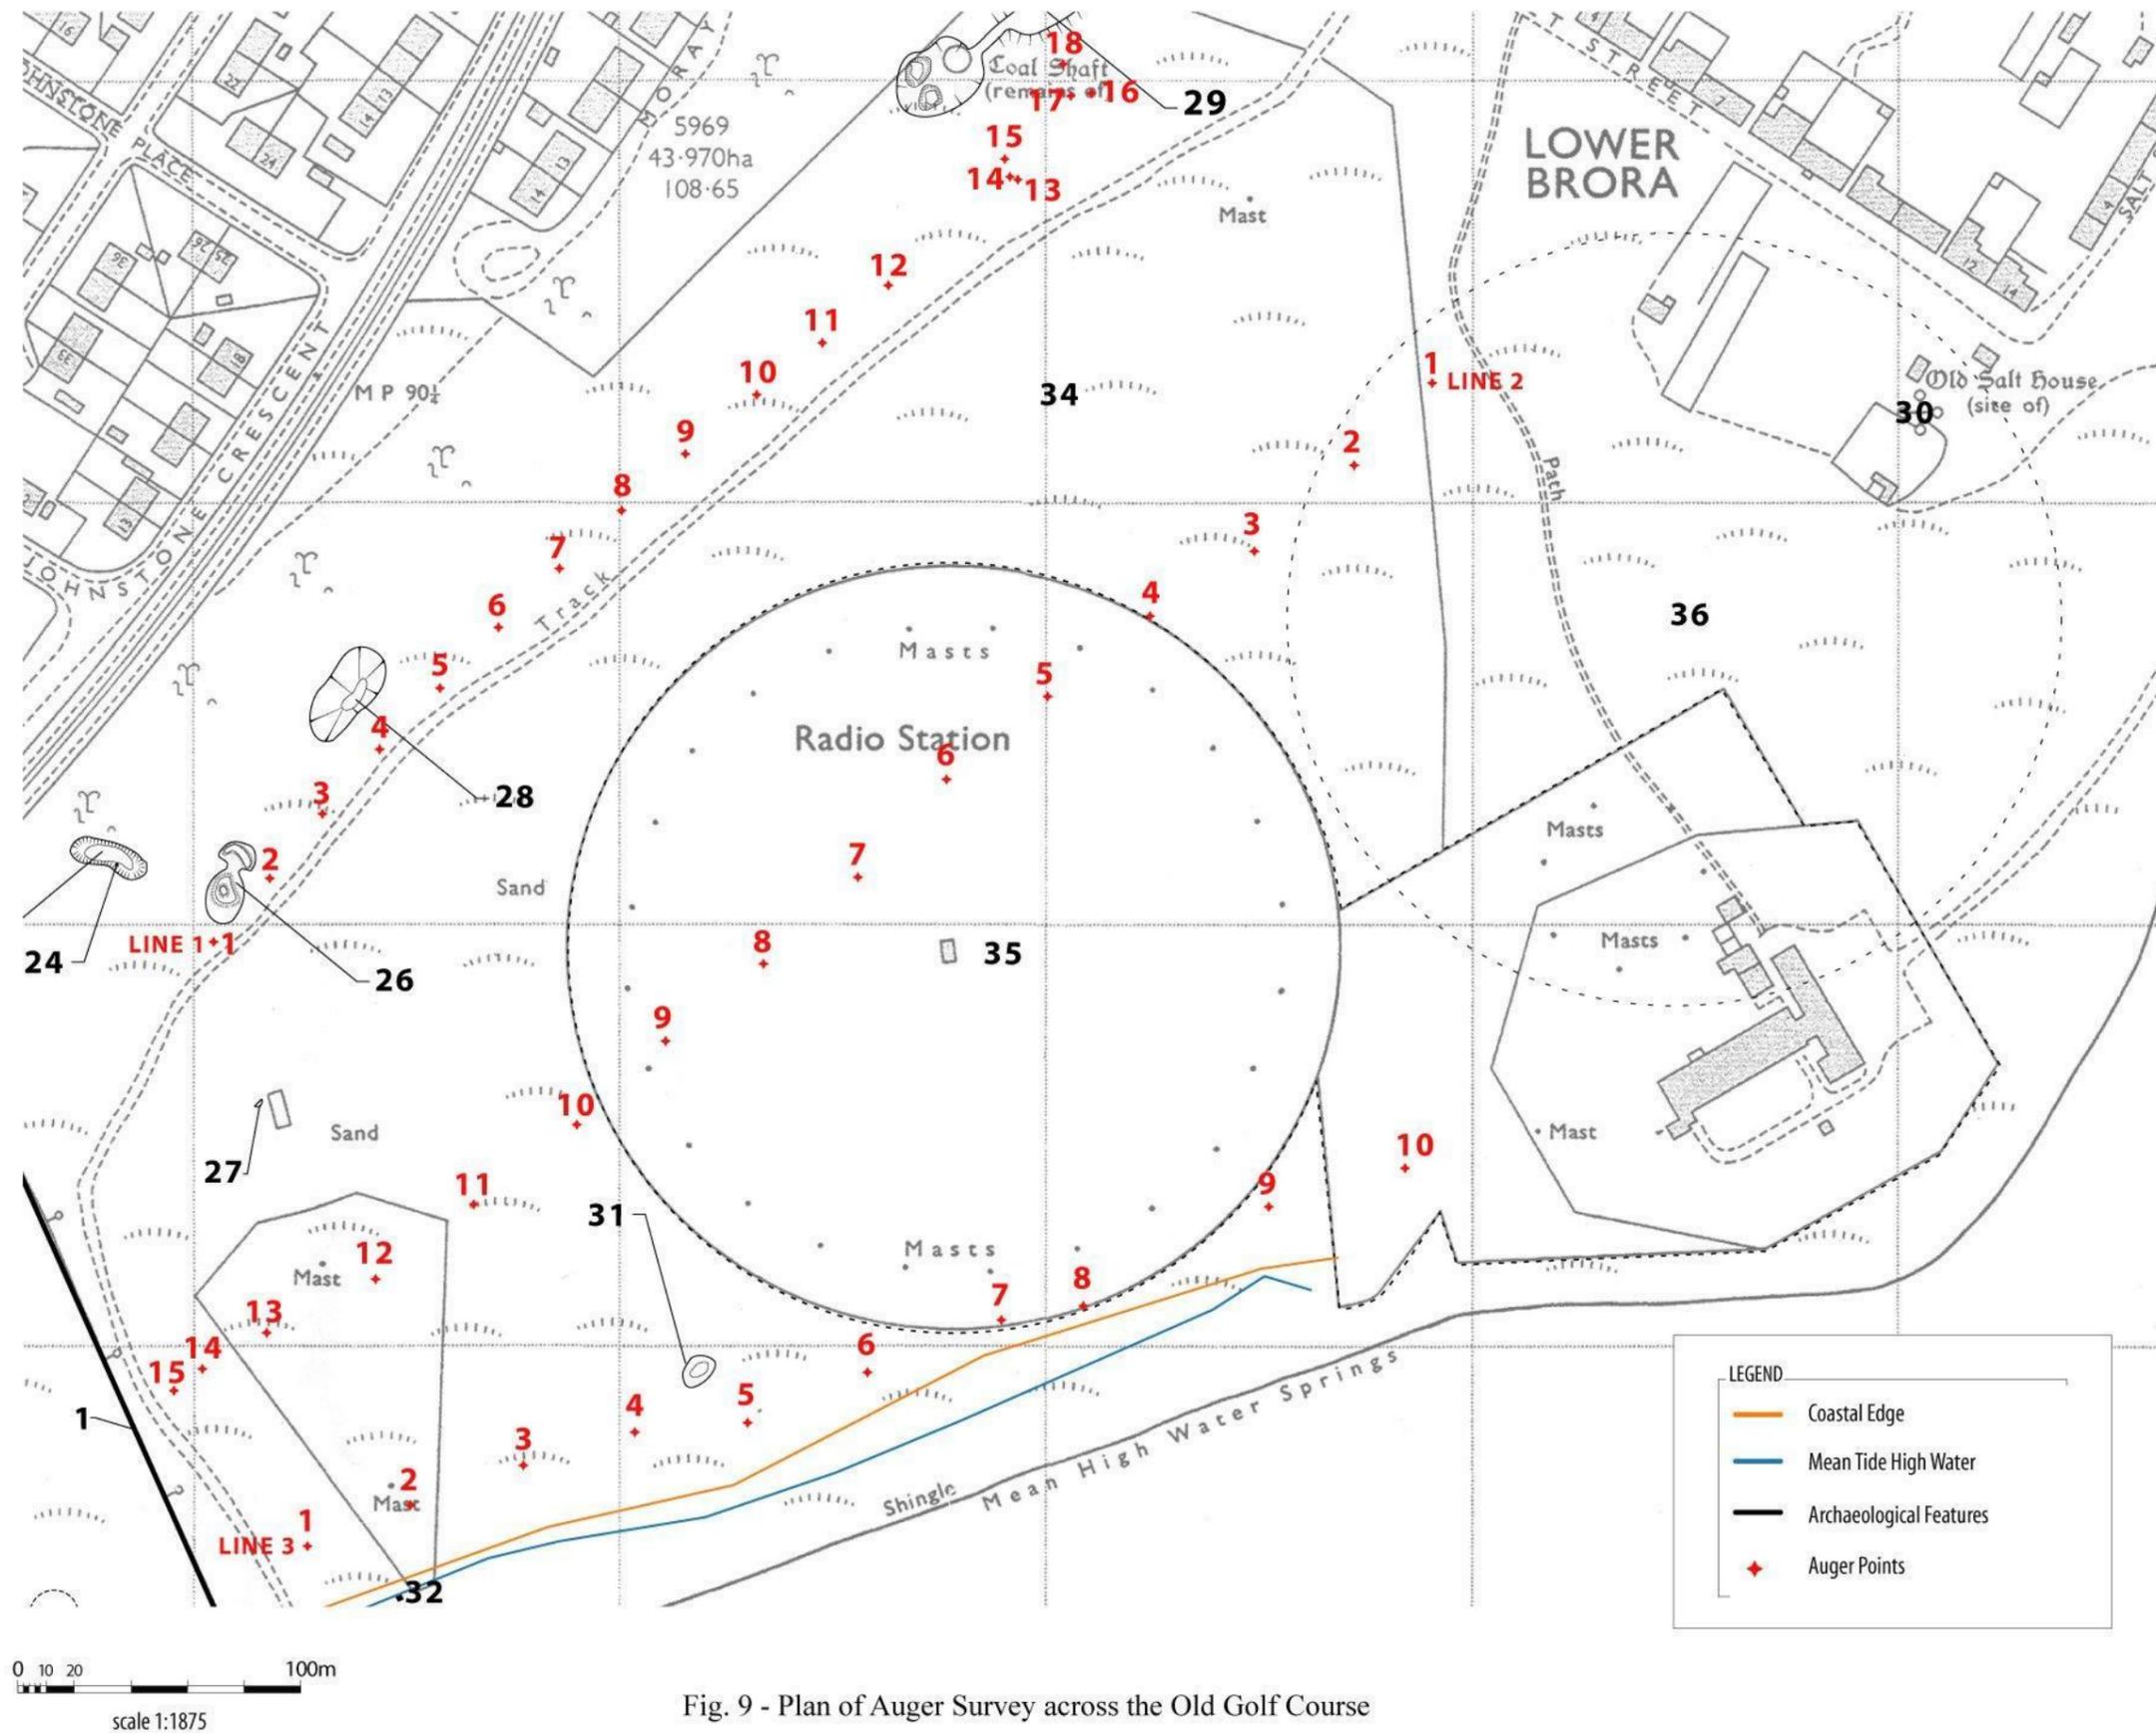
Fig. 9 - Plan of Auger Survey across the Old Golf Course

the dune complex. It was also used to assess the area of the old golf course to determine if there were industrial remains beneath the surface. The depths and nature of the deposits encountered were recorded and can be found in Appendix 8.

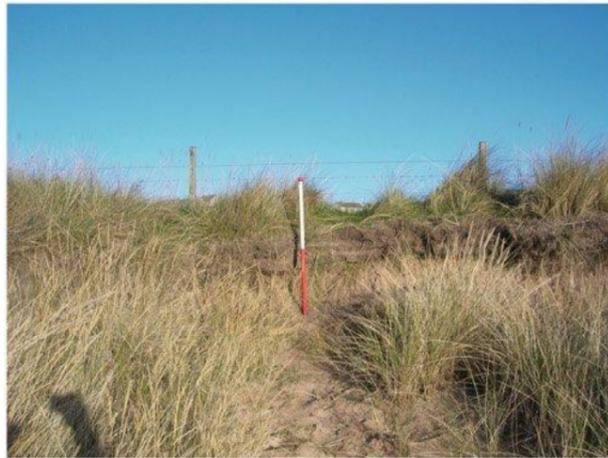
Survey Point No.	NGR	Summary description	Erosion Class
1	NC 90502 03346	Low dune cliff (1.2m) with gradual slope. Undercut below turf-line and failing. MHW (Mean High Water Mark) c. 4m. Coastal path immediately behind cliff edge.	Definitely Eroding
2	NC 90554 03332	Low dune cliff (1.5m). Vegetated slopes but failing. Slight berm at cliff base. MHW c7m. Fallen concrete block in front of cliff. Coastal path behind.	Definitely Eroding
3	NC 90525 03321	Unvegetated low edge with a gradual slope down to the beach. Cliff lost due to erosion from track down onto the beach. Low cliff rises on the S side.	Definitely Eroding

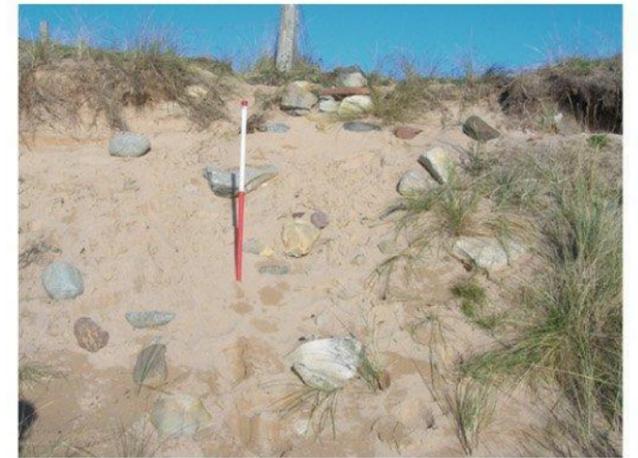
MHWM c.9m.	
4	NC 90513 03314	Cliff with c 45 angle. Boundary wall exposed in section with large sub-rounded and sub-angular boulders visible. Slope failure on N side. Vertical cliff below turf-line with recent collapse. MHWM 5m.	Definitely Eroding
5	NC 90493 03300	Low cliff with vertical face and failing slopes. MHWM 4m. On S start of higher cliff	Definitely Eroding
6	NC 90490 03291	Cliff rising to 4-5m. Exposed building wall in section. Subject to wave hammer at base where scouring is evident. MHWM 1m	Definitely Eroding
7	NC 90472 03280	Deflation feature on 7-8m high dune cliff. Not hollow but gradual 45 degree slope with vertical top. Industrial refuse from salt-pans exposed at the base of the slope. MHWM at the base. Highest point of the dune sequence.	Definitely Eroding
8	NC 90463 03267	High dune cliff, c. 5m high. Upper region is stable due to well established vegetation. The base has been eroded thus exposing industrial remains of the salt works. MHWM 1m.	Definitely Eroding

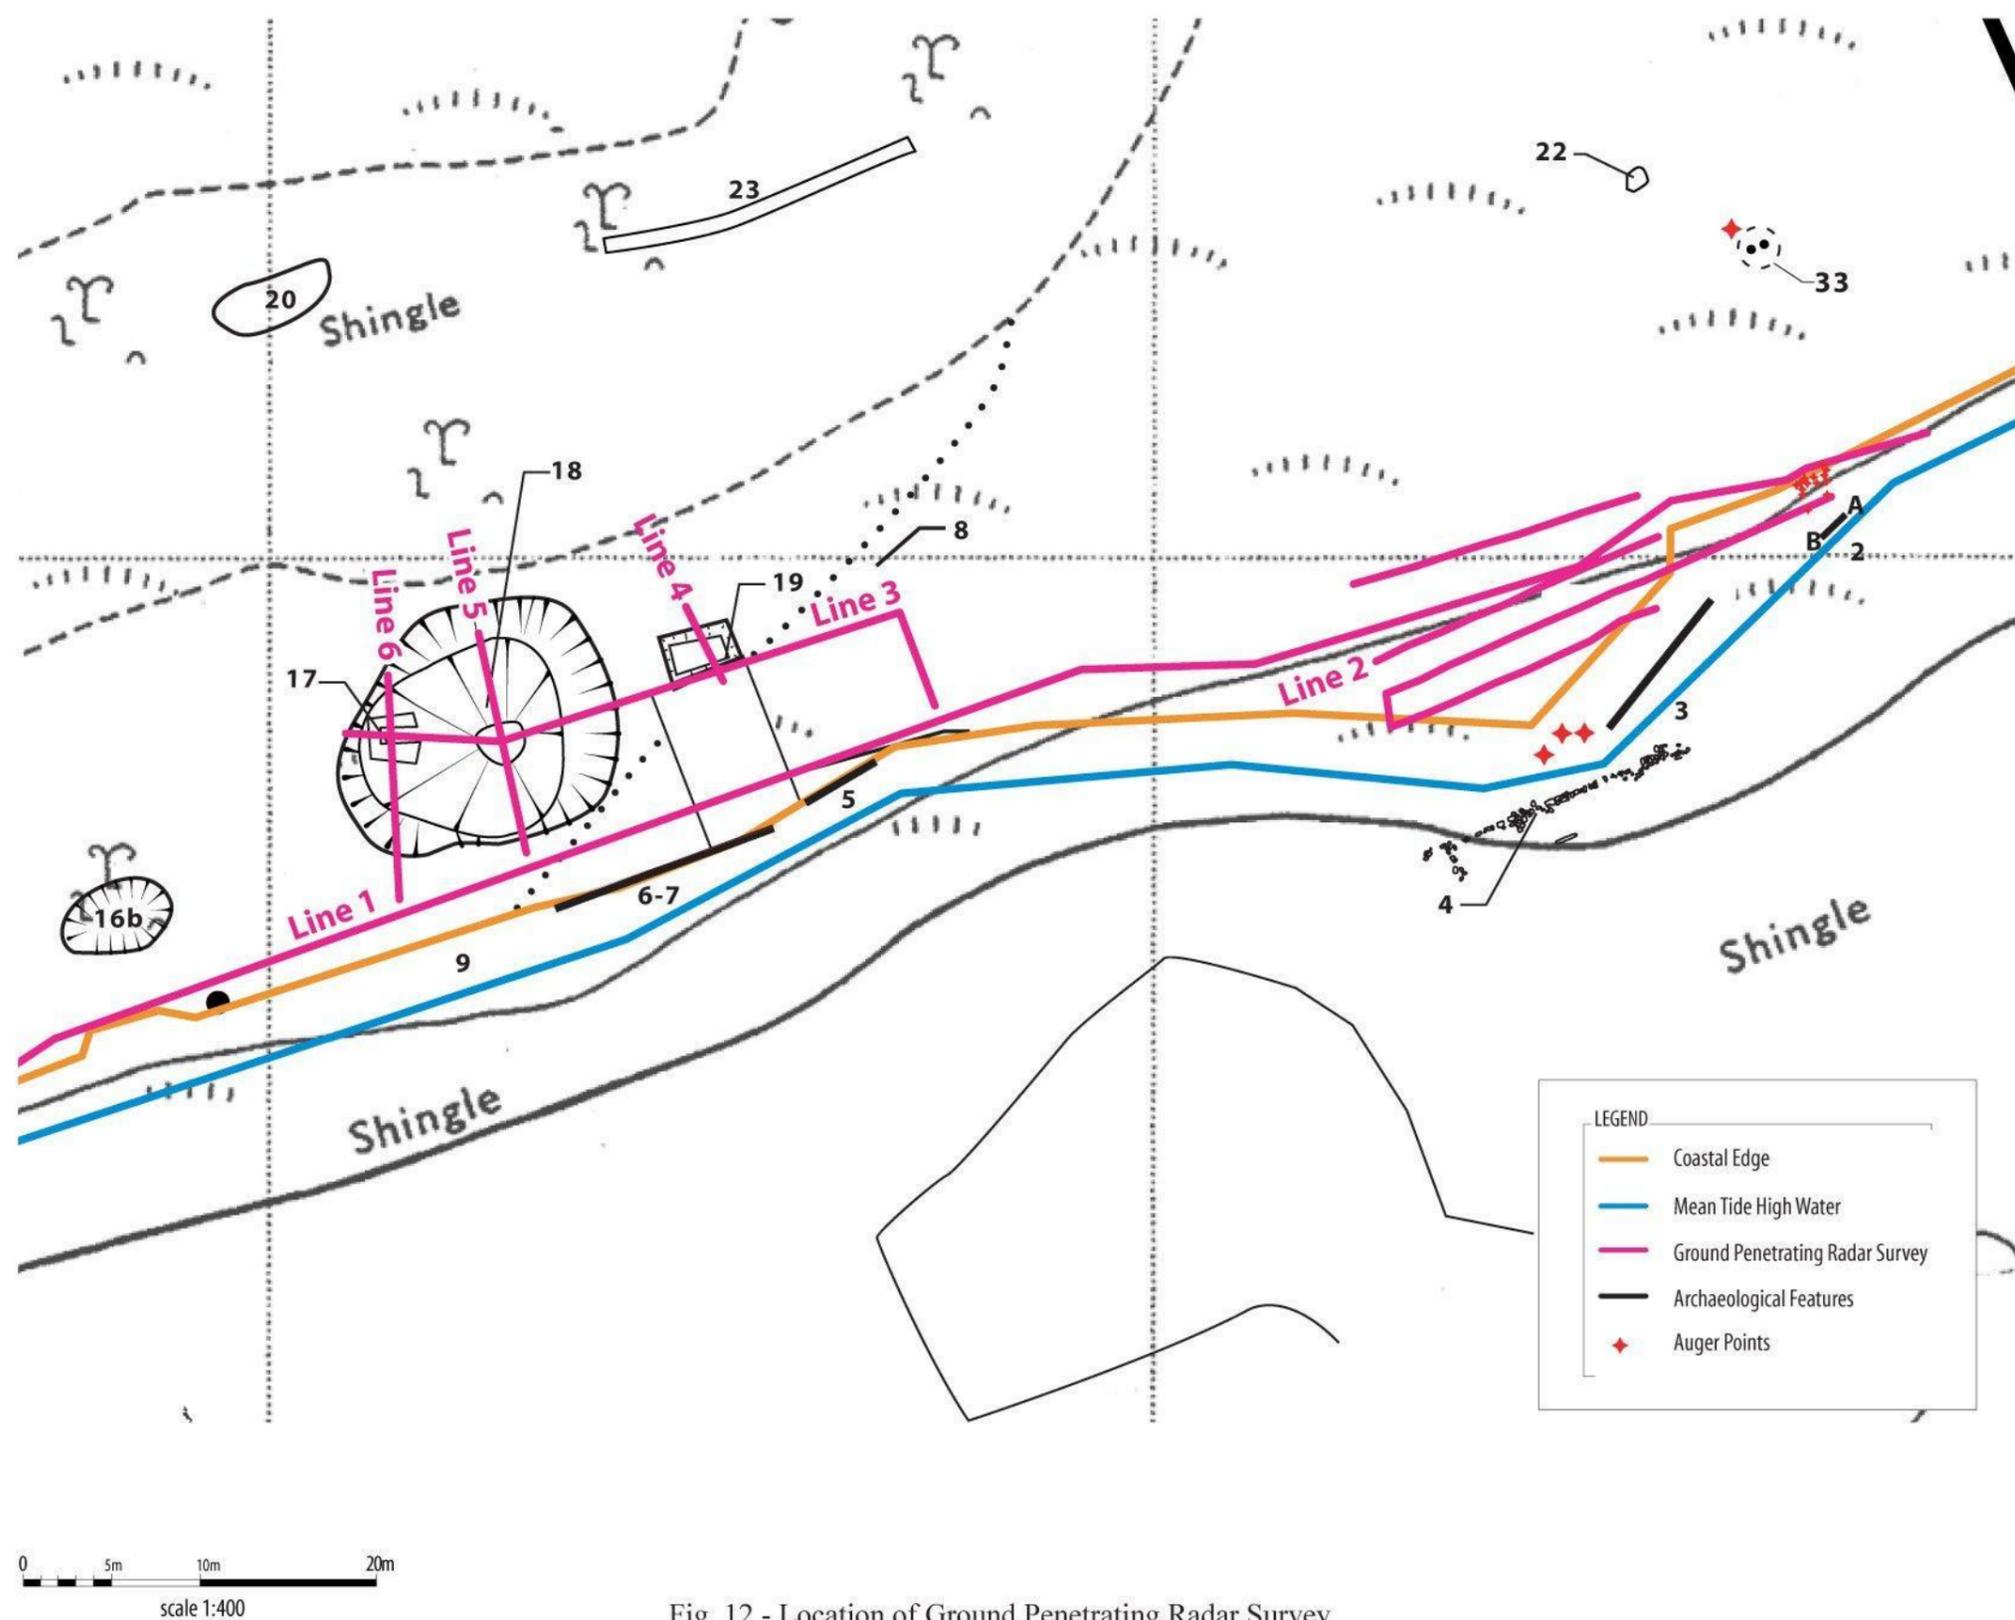
Fig. 12 - Location of Ground Penetrating Radar Survey

5.11.1 A GPR survey was carried out over the sand dune complex and an area around the Saltman's House (site **19**; Figure 12). The results of the GPR survey can be found in Appendix 7. The following information on the GPR survey was supplied by Tomi Herronen.

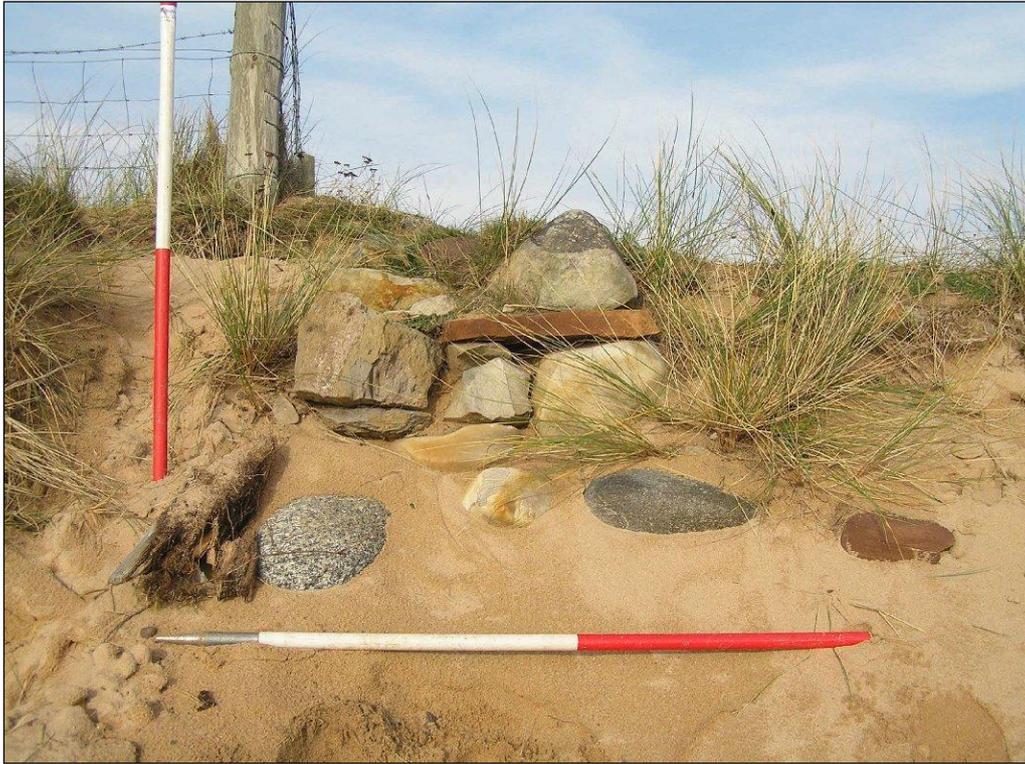
Plate 16.
Site 1 - Boundary Wall

- 5.4.1 Four walls or boundaries were identified during the desk-based assessment and field survey. Wall **1** runs approximately north to south across the study area, separating it into two parts. It is only visible on the beach where it is eroding out of the section. The line of the wall is currently marked by a modern fence line. Boundaries **8** and **9** appear to relate to the field boundary depicted on Farey's map (1812) though the corner is now missing, presumably having been eroded out of the coastal section. The 'March Stones' (**11**) depicted on Farey's map (1812) are still visible as a line of large boulders running into the sea from the coastal edge. There is no trace of this boundary running from the coast to the hinterland.

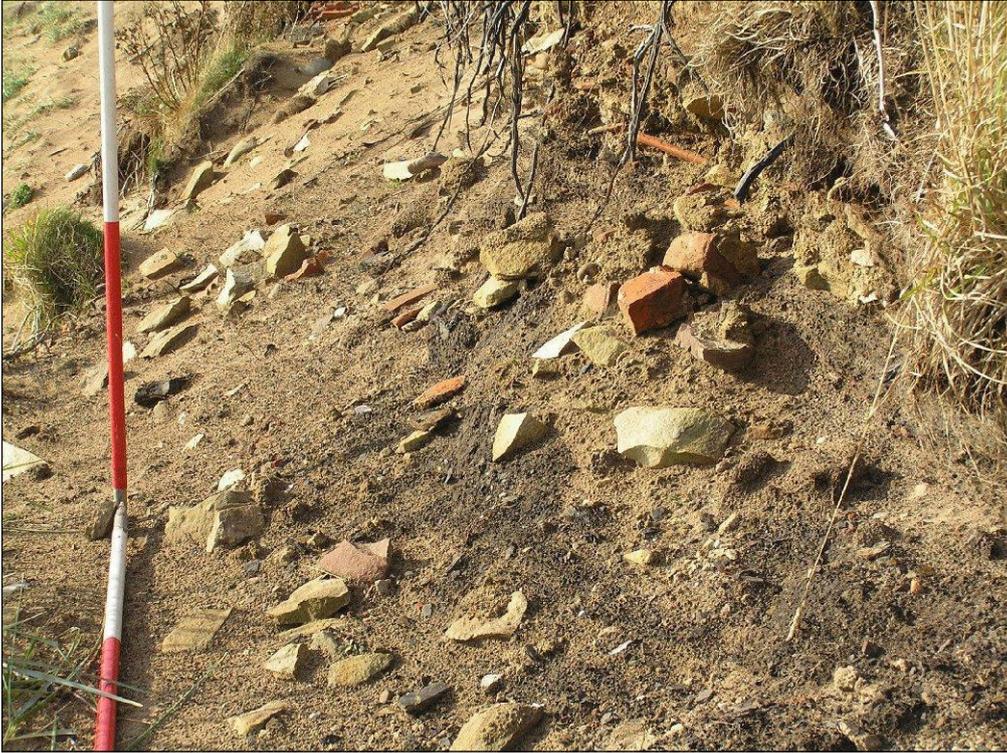
Plate 20.
Site 7 midden containing domestic refuse

7	Midden	NC 90356 03259 - NC 90329 03255	An extensive area of midden eroding out of the sandy edge of the coastline. The midden is approximately 0.7m below the surface. The sequence of layers includes a thick linear band of black ashy/shale coal below a layer of broken brick and pan-tiles. It appears that a considerable number of orange pan-tiles have been dumped, in some areas one on top of the other forming a layer of 5 or 6. This section also contains domestic waste material, including the bones from marine and domestic animals. Finds from this midden includes two glass bottle bases and a neck, possibly from a Porter bottle. Other finds include two pieces of worked flint and a sherd of sponge-ware pottery. The lateral extent of the midden is approximately 22m and it varies in thickness throughout the section. This midden may be related to the waste from the building at Site 19.
8	Wall	NC 90334 03248	The lower part of what appears to be a dry-stone wall eroding out of the sandy edge of the coastline. The stone of the wall occurs 0.1m below the surface. It is of double-skin construction with a small stone in-fill. The double skin is constructed from large blocks of roughly shaped sandstone and the fill consists of small rounded stones. Possible tools marks are visible on some of the sandstone blocks. Similar sandstone blocks can be seen on the beach below where they have probably tumbled from the erosion face. The visible portion of wall is 1.36m in length, 1.4m in width and 0.4m in height and is orientated NE/SW. This wall is depicted on a plan by John Farey in 1812. This site may be related to another section of possible wall at Site 9.
