# Coastal Zone Assessment Survey Aberdeenshire & City of Aberdeen: Cullen to Milton Ness

The SCAPE Trust and University of St Andrews  
May 2023

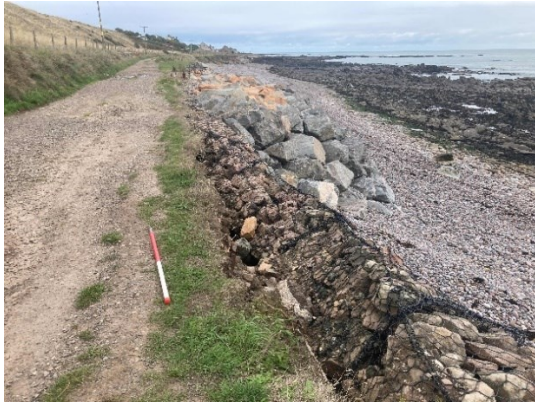
We observed several places of exacerbated erosion on either side of coastal defences installed along low-lying rocky and shingle shores especially south of Inverbervie. Good examples can be seen at Seagreens (Figure 4A) where rock armour and gabion cages have been installed along the coast, as well as all manner of ad hoc defences in front of the caravan park at Mill of Mathers. Seagreens is also experiencing erosion of the revetment wall close to the harbour (Figure 4C).

Figure 4A. Hard coastal defences in the form of rock armour and gabions. Evidence of failure of gabions, Seagreens, Aberdeenshire.

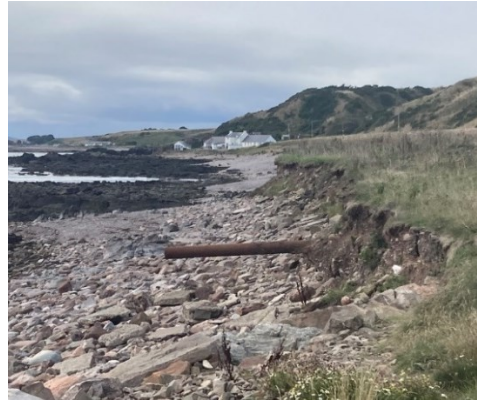
Figure 4B. Erosion of coast edge, Johnshaven, Aberdeenshire.

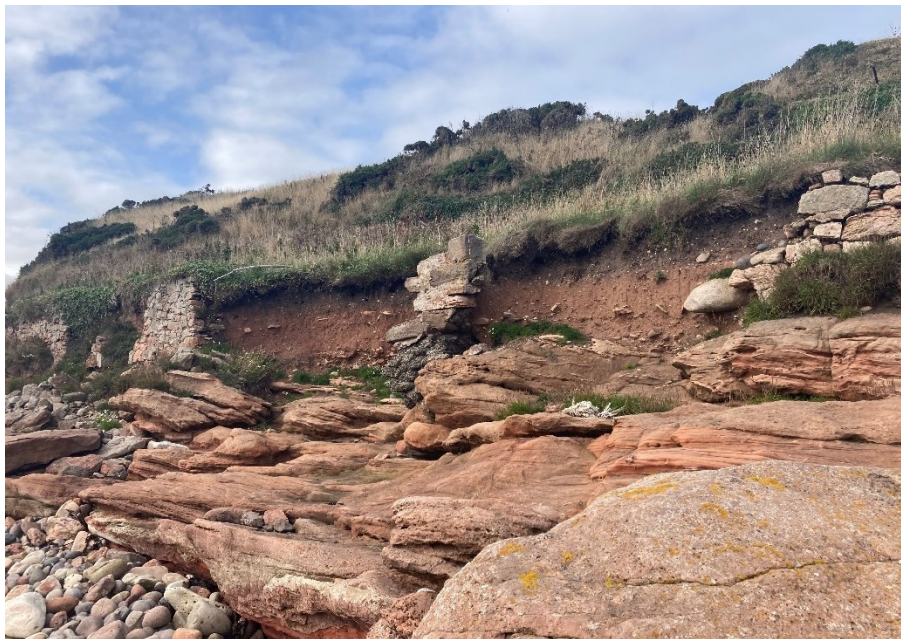
Figure 4C. Erosion of revetment wall, Seagreens, Aberdeenshire.

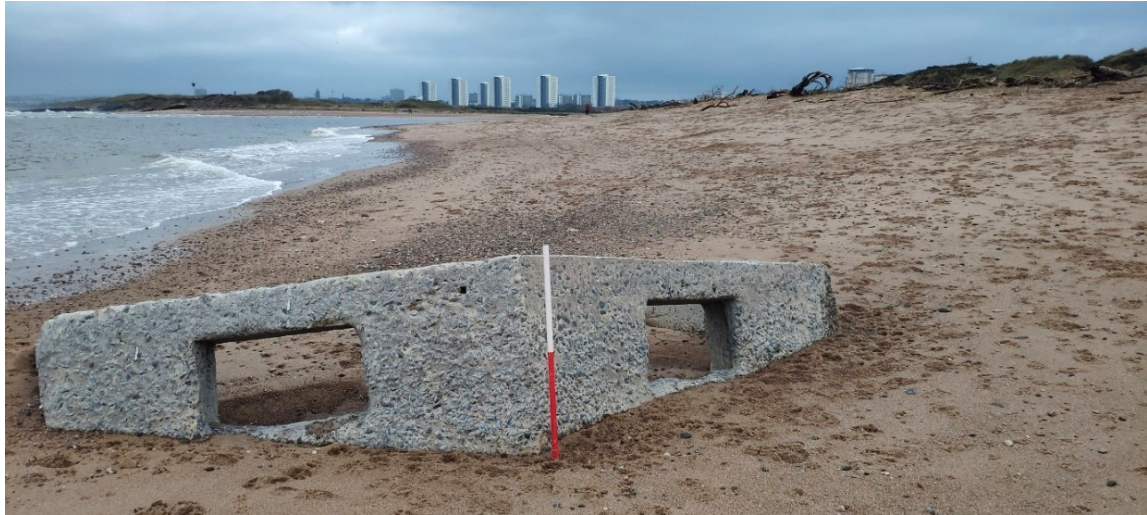
are now in the wave zone (Figure 5A and 5B). Further examples at the Burn of Mundurno, Blackdog and Milden Links, have recently rolled and slid down the faces of shifting dunes (Figures 5C and 5D).

Figure 5A. Mostly buried remains of Type 24 pillbox, Balgownie Links, City of Aberdeen (<https://scapetrust.org/sites-at-risk/site/15037> ).

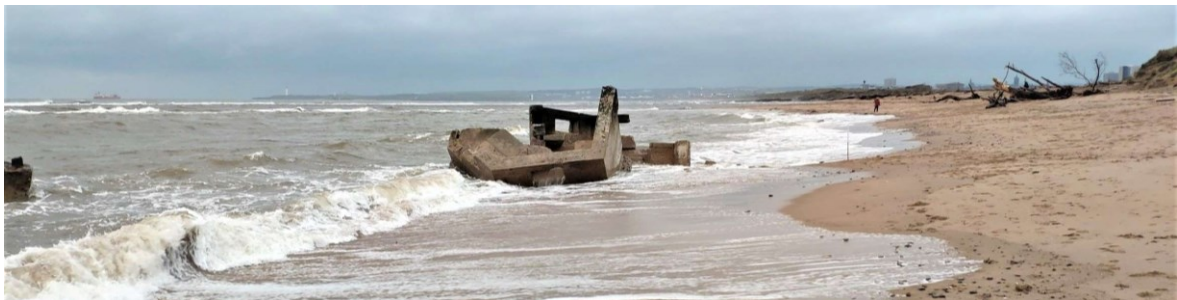
Figure 5B. Split apart pillbox in the wave zone, Balgownie Links, City of Aberdeen (<https://scapetrust.org/sites-at-risk/site/15044>).

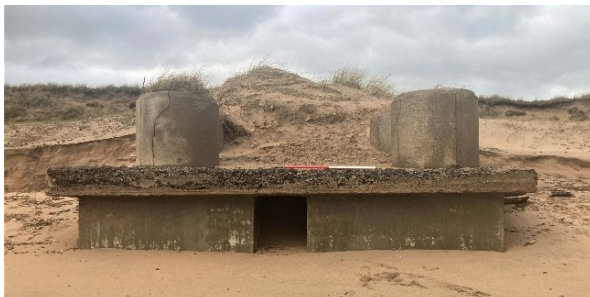
Figure 5C. Upside down pillbox, Blackdog, City of Aberdeen (<https://scapetrust.org/sites-at-risk/site/15098>).

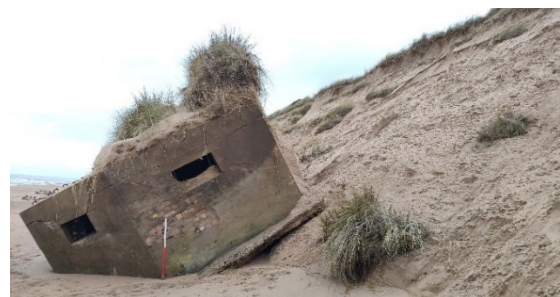
Figure 5D. Pillbox slumped down dunes, Milden Links, Aberdeenshire (<https://scapetrust.org/sites-at-risk/site/15767>).

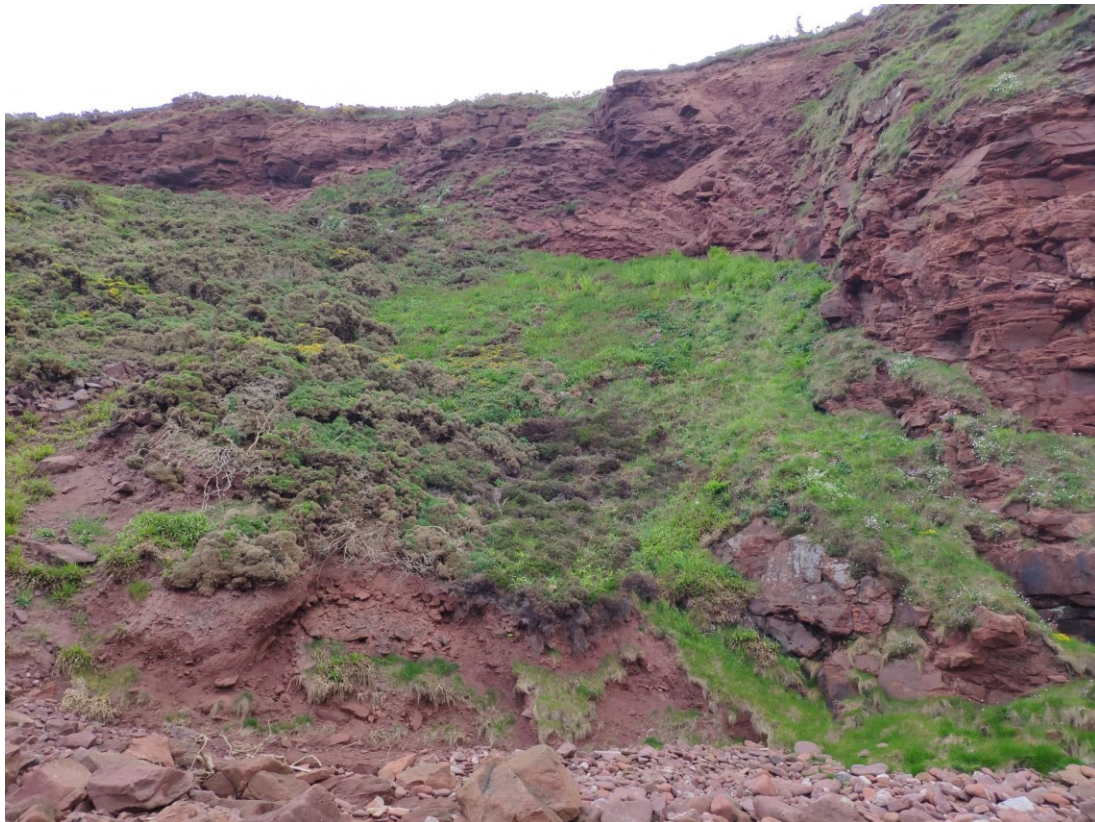
*Figure 6A. Slope failure adjacent to Pennan Harbour, Aberdeenshire.*

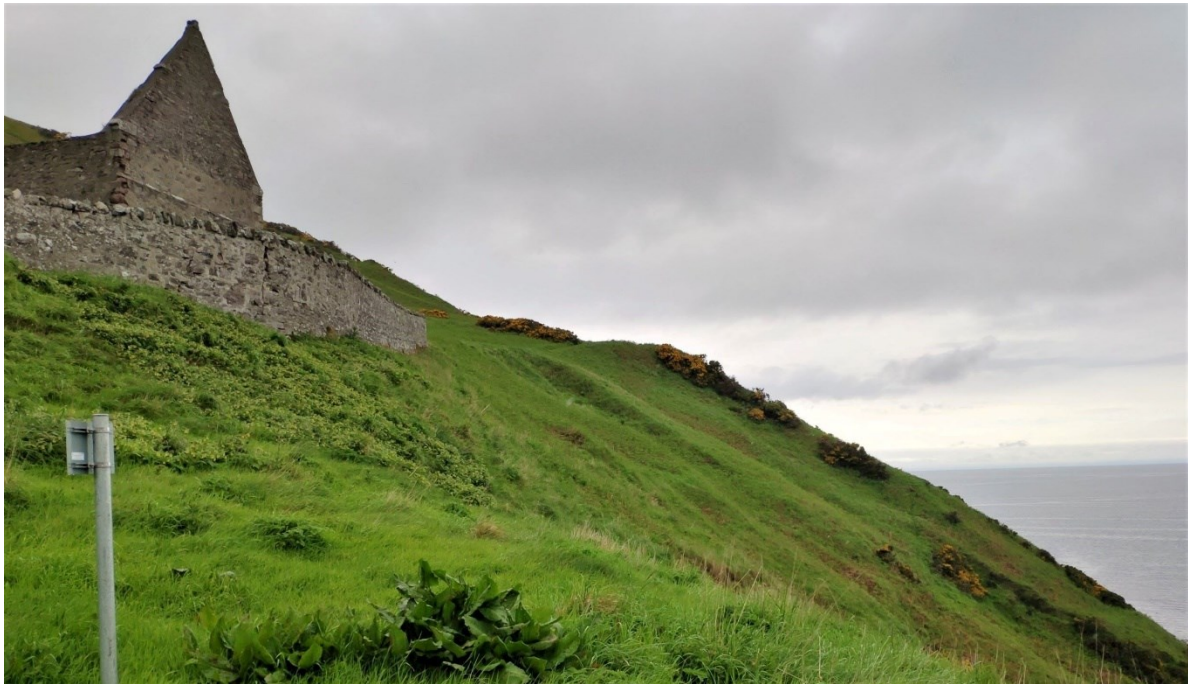
Figure 6B. St John's Church, Gardenstown, Aberdeenshire, at risk of future cliff erosion and landslip (<https://scapetrust.org/sites-at-risk/site/14562>).

Scape ID	Canmore ID	HER ID	Site Name	Site Type	Summary of vulnerability	Recommended Action
15667	290436	NJ56NE0317	Sandend	Lime kiln?	Coast edge. Erosion.	Monitor for further erosion and more structure revealed
<i>Settlement &amp; Agriculture - Buildings</i>						
14925	350364	NJ56NE0051	Red Haven	Buildings	Coast edge. Structural instability.	Monitor
15530	-	-	Gardenstown	Building	Coast edge. Erosion.	Monitor
<i>Landscapes of resource exploitation &amp; repeated human activity</i>						
14477	87194	NK02NW0032	Sands of Forvie	Lithic Working Site	Dunes, Aeolian	Monitor.
15731	-	-	Sands of Forvie	Lithic Scatter	Foreshore/ intertidal.	Regular walk along foreshore to note further material.
15734	165124	NK02NW0046	Sands of Forvie	Shell Midden	Coast edge. Slope instability.	Monitor.
15735	-	-	Sands of Forvie	Shell Midden	Dunes, Aeolian	Monitor.
<i>Religious</i>						
14562	19282	NJ76SE0002	Gardenstown, St John's Church	Burial Ground, Church	Cliff edge, landslip.	Monitor cliff.

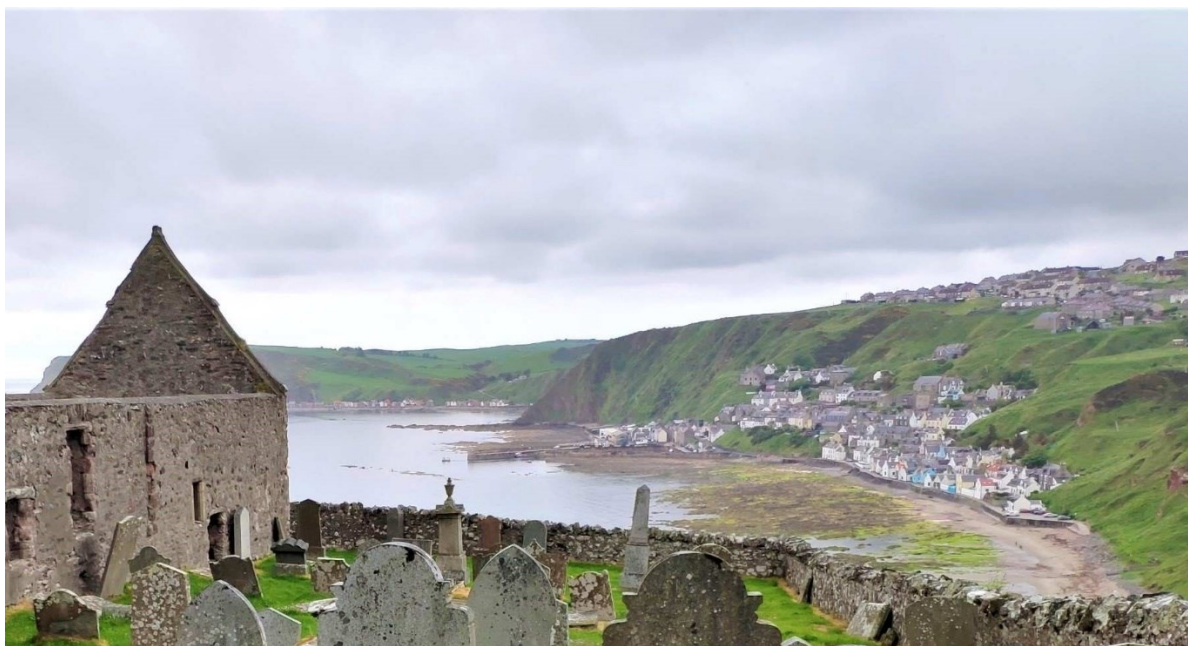
Figure 6C. View from St John's Churchyard showing the location of the villages of Gardenstown, and Crovie beyond, squeezed between sea and cliff.

Gardenstown, Crovie and Pennan were visited by SCAPE officers to assess the extent of the problem of cliff erosion and slumping in the area. Recent cliff erosion was noted close to the harbour at Pennan (Figure 6A). At Gardenstown, the boundary wall of St John's Church is at risk due to slope failure of the cliff. (Figure 6B). Communities in these former fishing villages, which occupy a thin strip of land between cliff and sea, are particularly vulnerable to the impact of both cliff failure and coastal erosion (Figure 6C).

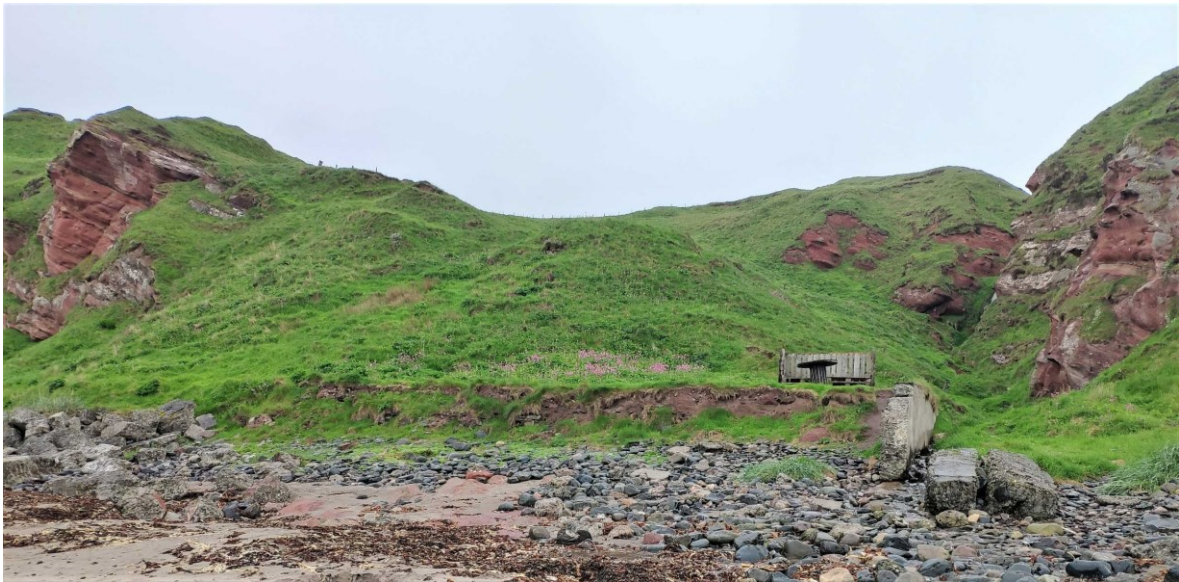
In the small bay Between St John's church and Gardenstown only a fragment of wall in the coast edge survives of a building depicted on the 2<sup>nd</sup> edition of the Ordnance Survey. A 20<sup>th</sup> century concrete sea wall to protect the building has also succumbed to erosion.

Figure 6D. All that survives of a building and concrete seawall in the bay west of Gardenstown Aberdeenshire (<https://scapetrust.org/sites-at-risk/site/15530/>)

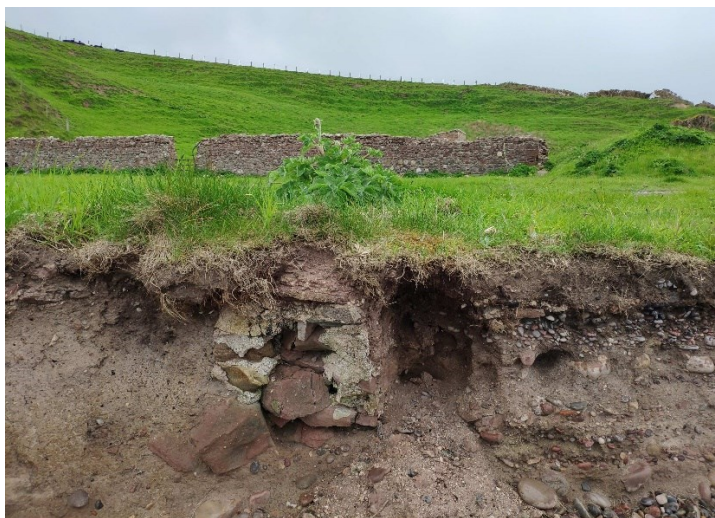
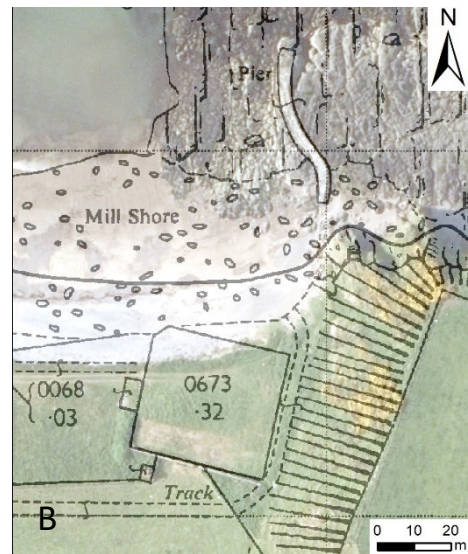
A similar example of recent erosion upon coastal buildings was encountered just west of Pennan at Mill Shore. Within the coast edge is the remains of the north wall of a large enclosure, the south wall of which is still standing (Figure 7A). Historic Ordnance Survey mapping shows that since 1969 approximately 9 metres has been lost here through coastal processes.

Figure 7A. Mortared stone wall eroding out of coast edge, Pennan Mill Bay (<https://scapetrust.org/sites-at-risk/site/15529/>); B. Comparison of modern coast edge aerial photography from 2021 (@Getmapping Plc, 2023) and National Grid 1:2500 1<sup>st</sup> Edition mapping from 1969-70 (Crown Copyright 2023, EDINA supplied service). There has been ~9m of coastal erosion in the last 50 years.

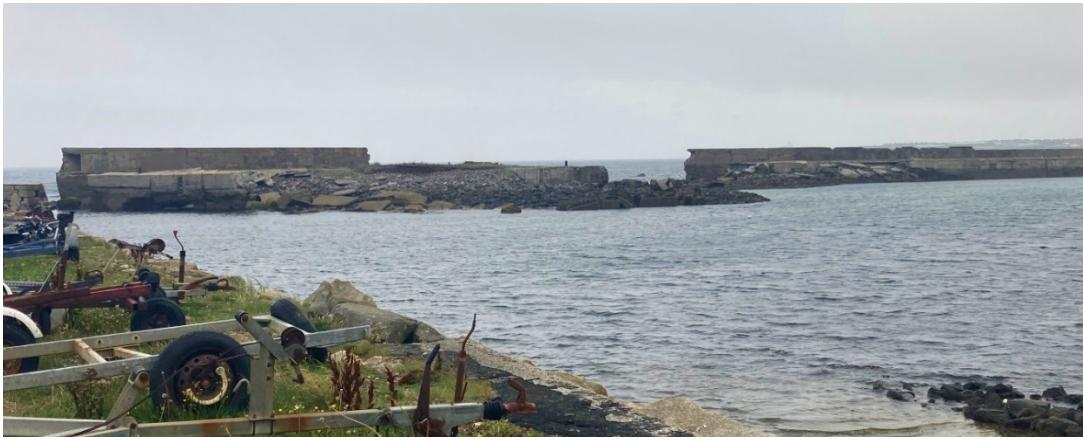
The large harbour at Sandhaven has been breached and is being damaged as a result of wave action due to a lack of maintenance of the infrastructure (Figure 8).

Figure 8. Deterioration of Sandhaven Harbour, Aberdeenshire (<https://scapetrust.org/sites-at-risk/site/14637>).

The castles, buildings, limekilns and Sandhaven Harbour are all structurally unstable, as well as being located at the coast edge or intertidal zone. Regular monitoring of their condition is recommended for management and safety reasons. Boddam Castle is in a populated area and has potential for high amenity value with improved site management and safe public access.

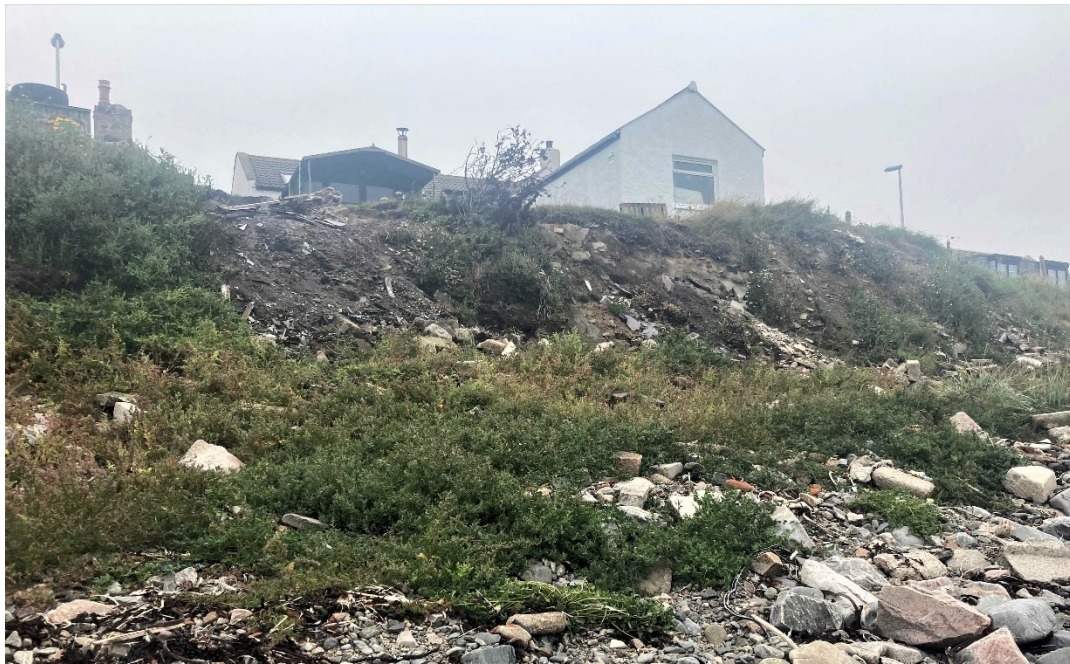
The low-lying coast at Inverallochy is showing erosion in some places, with some encroachment nearing properties located on the coast edge (Figure 9).

Figure 9. Coastal erosion, Inverallochy, Aberdeenshire

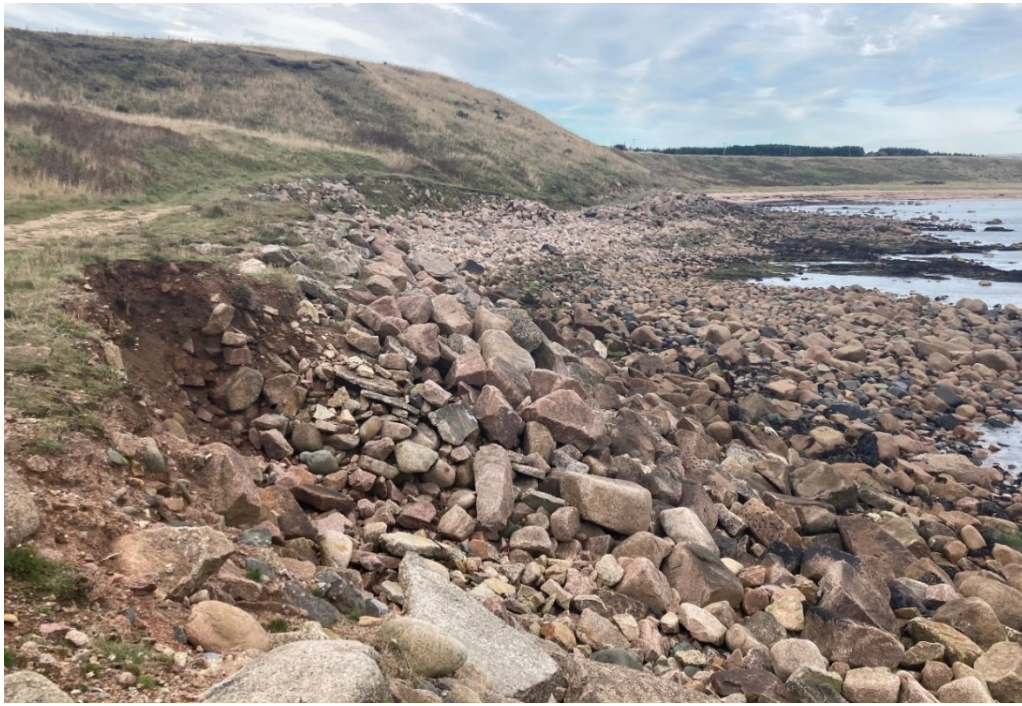
At Sandford Bay, severe erosion along the south end of the bay has perhaps been exacerbated by the adjacent hard coastal engineering and water discharge outlet for the nearby Peterhead Power Station (Figure 10). The severity of the erosion had resulted in the closure of the coastal path at the time of the CCZAS.

*Figure 10. Coastal erosion, Sandford Bay, Boddam, Aberdeenshire.*

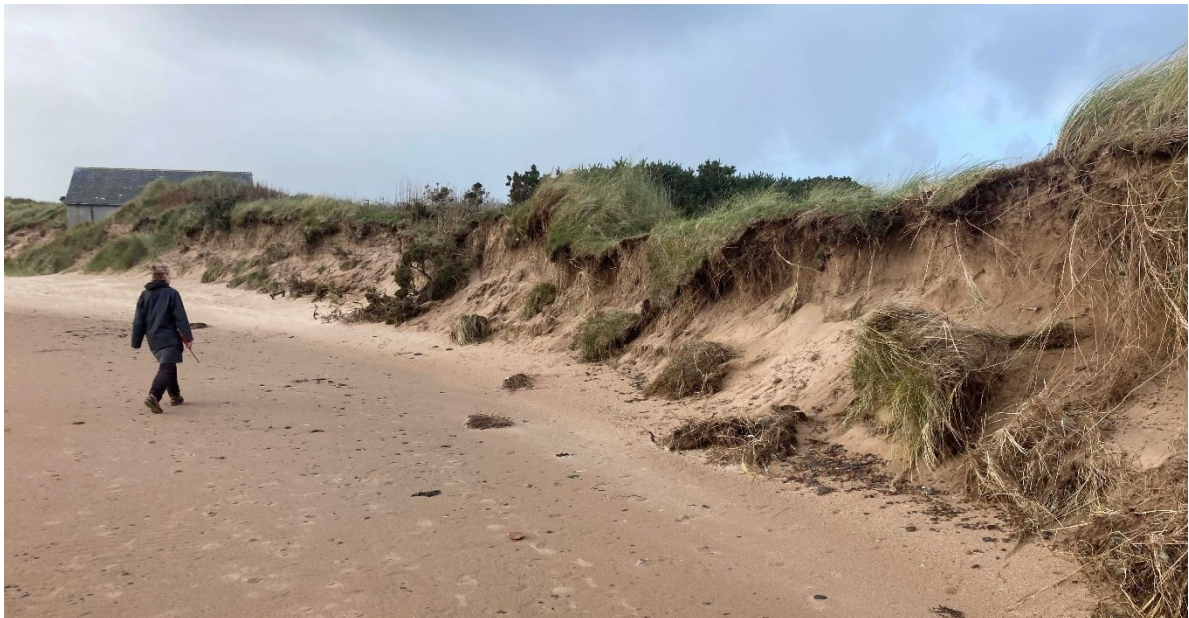
Recent erosion of the soft dune coast edge at Newburgh, Udny Links and the southern end of the open coast at Sands of Forvie were noted on the CCZAS (Figure 11A). Both of these sections of coast could be experiencing enhanced erosion due to their proximity to the channel and mouth of the river Ythan. Aeolian erosion dominates within the sand dune systems of Forvie and Foveran Links resulting in natural dune migration that both reveals and subsumes archaeological sites and material (Figure 11B)

*Figure 11A. Erosion of coast edge with recent vegetation slumping, Udny Links, Aberdeenshire.*

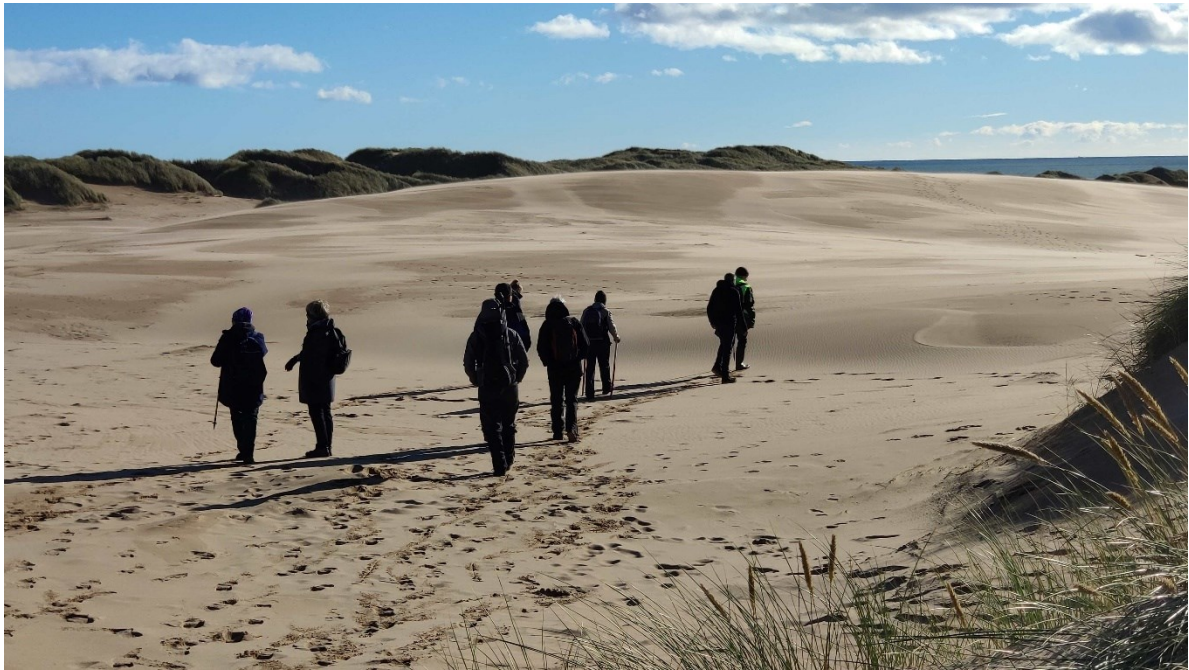
Figure 11B. General view of mobile sand dunes in parts of Forvie nature reserve, Aberdeenshire. Lithic scatters previously recorded in this location are currently buried.

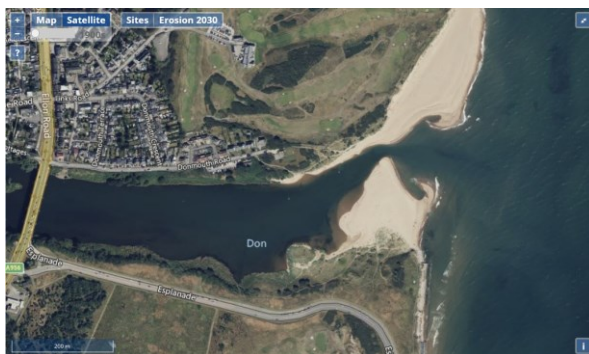
Figure 12A. Screenshot from SCAPE's Sites at Risk map of the position of the channel in a recent satellite image of the mouth of the river Don.

The areas showing the highest level of sustained erosion are the beaches and dune systems between Blackdog and the Bridge of Don. This stretch of coast was highlighted in the desk-based study as having both a very high underlying susceptibility to erosion and very high rates of erosion by 2030. Modelling by Dynamic Coast predicts hundreds of metres of coastline regression here by 2100. The CCZAS found this stretch of coastline to be showing more severe erosion relative to the rest of the coastline walked during the Aberdeenshire and City of Aberdeen CCZAS, although the erosion rates projected cannot be verified on a single field visit. The scale of the sand dune systems may mitigate against the more extreme scenarios of coastal loss. The most significant erosion has occurred at Donmouth North due to the northward migration of the river channel as it outflows into the North Sea (Figures 12A and 12B).

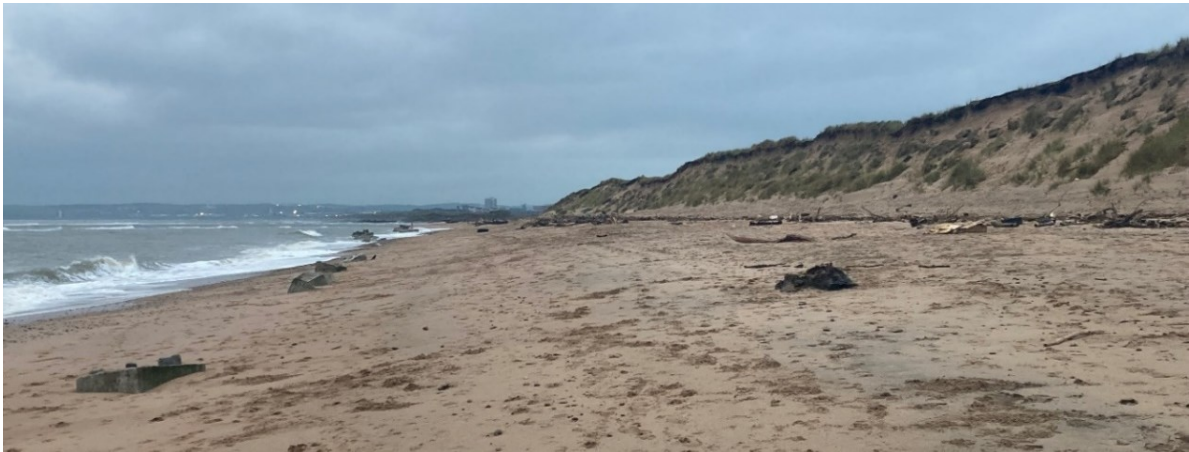
*Figure 12C. The position of anti-tank blocks indicate the extent of dune face regression at Balgownie Links, Donmouth North, City of Aberdeen.*

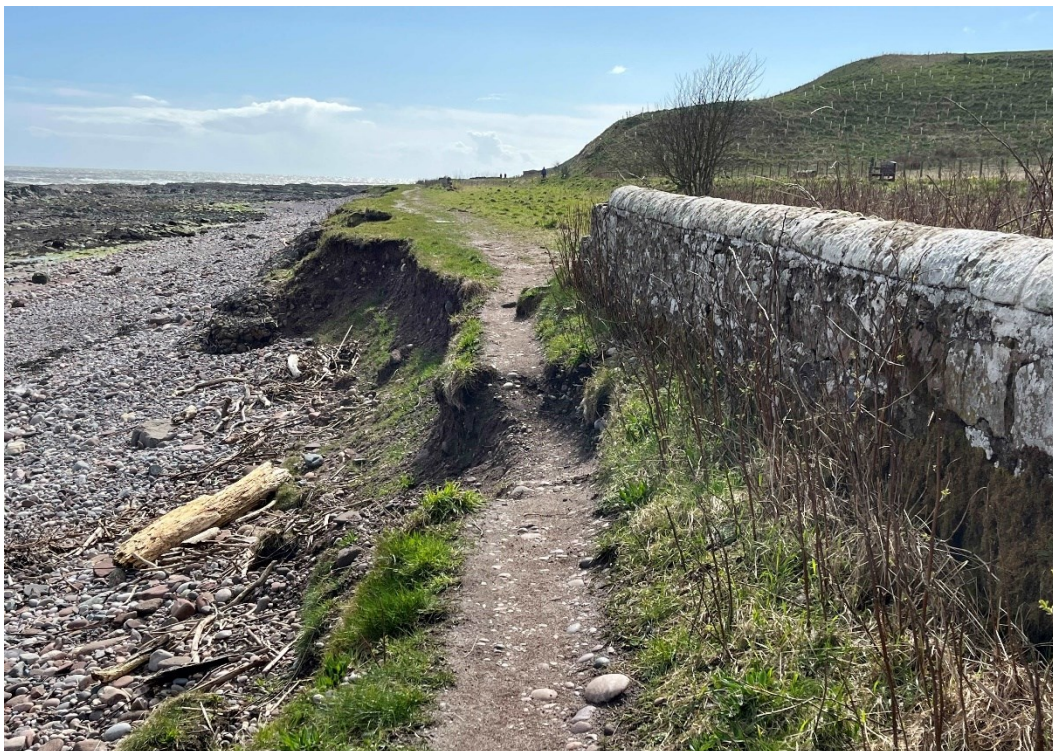
This section is comprised of generally stable low-lying shingle and rock platform terraces. However, notable stretches of erosion occur between Milton of Mathers and Seagreens, and between Gourdon and Inverbervie. In places erosion has been exacerbated on either side of recent rock armour and gabion basket coastal defences. These coastlines are an important amenity area and erosion is encroaching on coastal paths and damaging buildings and structures.

*Figure 13. Erosion of coast edge encroaching on path, Inverbervie, Aberdeenshire (<https://scapetrust.org/sites-at-risk/site/15793>).*

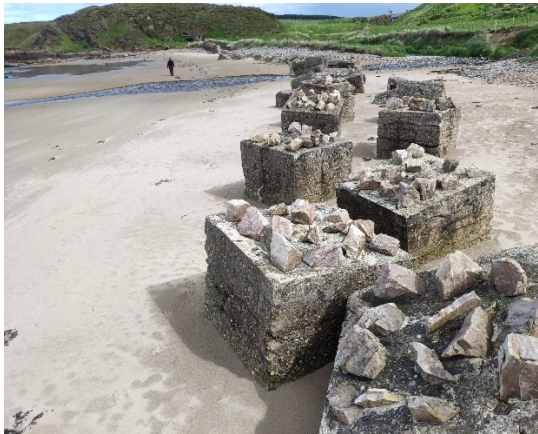
*Figure 15A. Anti-tank cubes, Sandend Bay, Aberdeenshire (<https://scapetrust.org/sites-at-risk/site/14724>).*

Second World War sites related to the coastal anti-invasion defences of Britain make up 33% of site types visited in the Aberdeenshire council area (and over 70% of sites surveyed between the Bridge of Don and Blackdog in the City of Aberdeen council area). The types of WW2 sites include anti-tank cubes (Figure 15A), pill boxes (Figure 15B) and anti-landing defences as well as examples of magazines, observation posts, gun emplacements (Figure 15C) and a radar-station (Figure 15D).

A double row of anti-tank cubes survive along the full length of Sandend Bay, and there are significant alignments along the coast from Blackdog to Bridge of Don. Many anti-tank cubes remain in their original position, providing good evidence of the position of the shoreline in 1940, however there are a number of instances where they have been moved and repurposed into an ad-hoc coastal defence, such as along the coast edge at Tangleha' ([SCAPE ID: 14482](#)), at Inverbervie ([SCAPE ID:14633](#)) and to defend part of the golf course at Cruden Bay ([SCAPE ID:15747](#)). At Whitelinks Bay west of Inverallochy tank cubes have been re-used to construct a

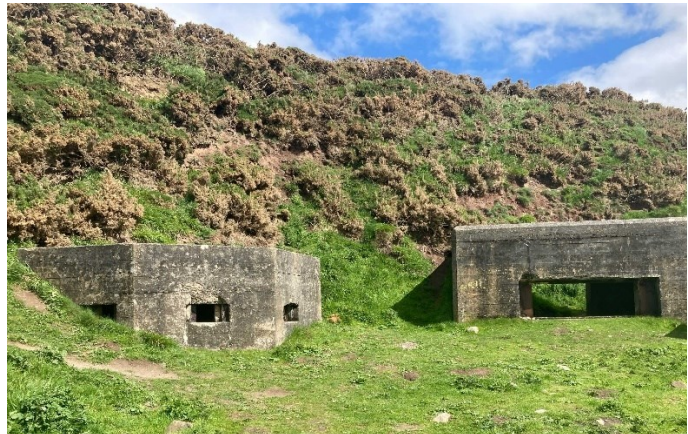
*Figure 15B. Type 24 pillbox and gun blockhouse, Sandend, Aberdeenshire (<https://scapetrust.org/sites-at-risk/site/14784>).*

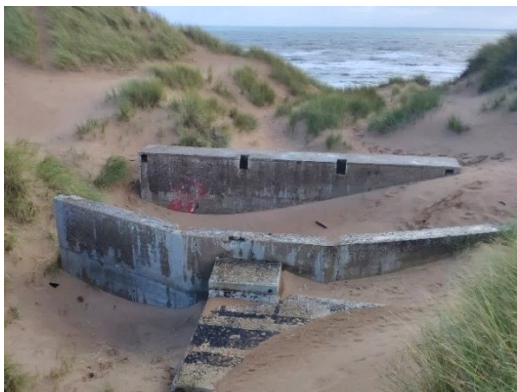
*Figure 15C. Naval gun emplacement, Foveran Links, Aberdeenshire (<https://scapetrust.org/sites-at-risk/site/14931>).*

In the dunes at Foveran Links are a collection of military remains including an unusual concrete gun emplacement (Figure 15C, [SCAPE ID:14931](#)), a red brick pillbox, which is a Balmedie variant design ([SCAPE ID:15743](#)) and the remains of intact sections of metal scaffolding anti-landing defences (Figure 18A). Nearby, a scatter of metal scaffold fittings may represent a construction or dismantling area, or a pile of unused fittings (Figure 18B).

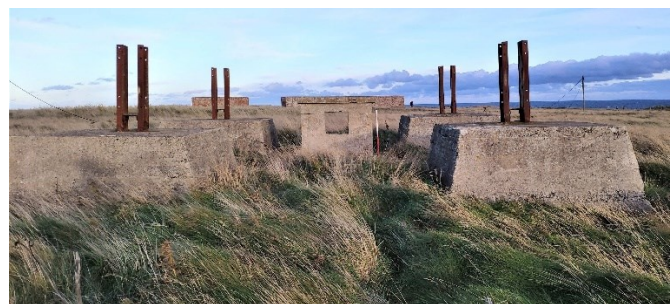
*Figure 15D. Radar station, Goats Hillock, Cruden Bay, Aberdeenshire (<https://scapetrust.org/sites-at-risk/site/15226>).*

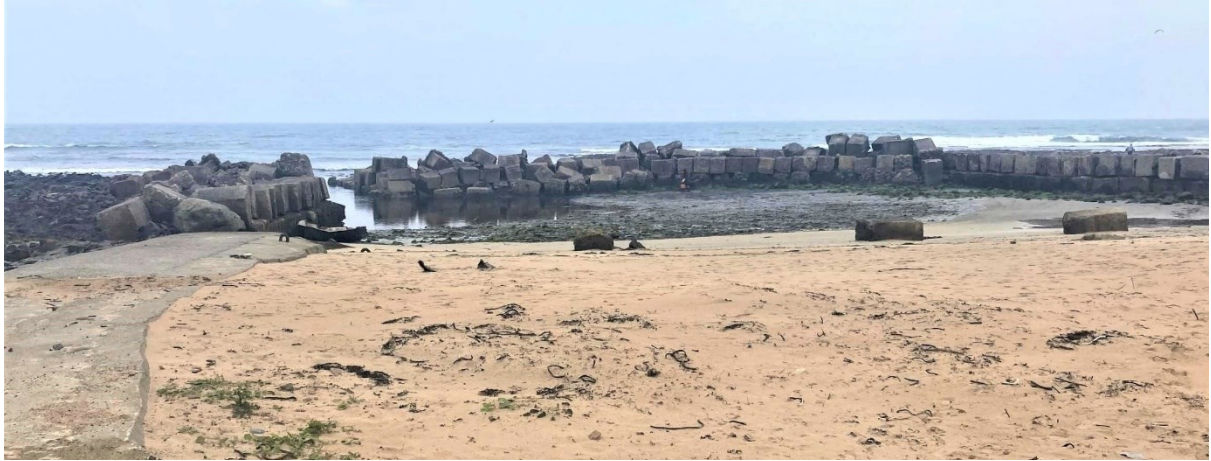
*Figure 16A. Anti-tank cubes repurposed as a small harbour, Whitelinks Bay, Aberdeenshire (<https://scapetrust.org/sites-at-risk/site/14810>)*

small harbour (Figure 16A) and to extend the breakwater at Cairnbulg Westhaven Pier ([SCAPE ID: 14533](https://scapetrust.org/sites-at-risk/site/14533)).

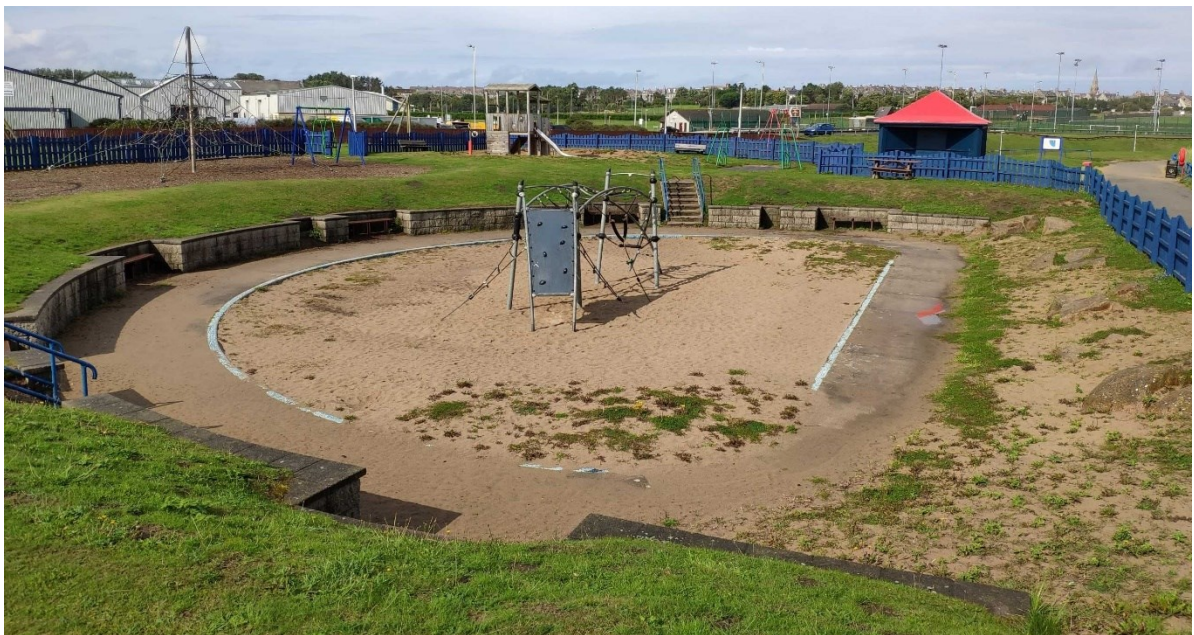
*Figure 16B. Gun emplacement repurposed as a playground, Fraserburgh, Aberdeenshire (<https://scapetrust.org/sites-at-risk/site/14745>)*

At the northern end of Fraserburgh Bay is a possibly unique reuse of a gun emplacement in a children's playground (Figure 16B).

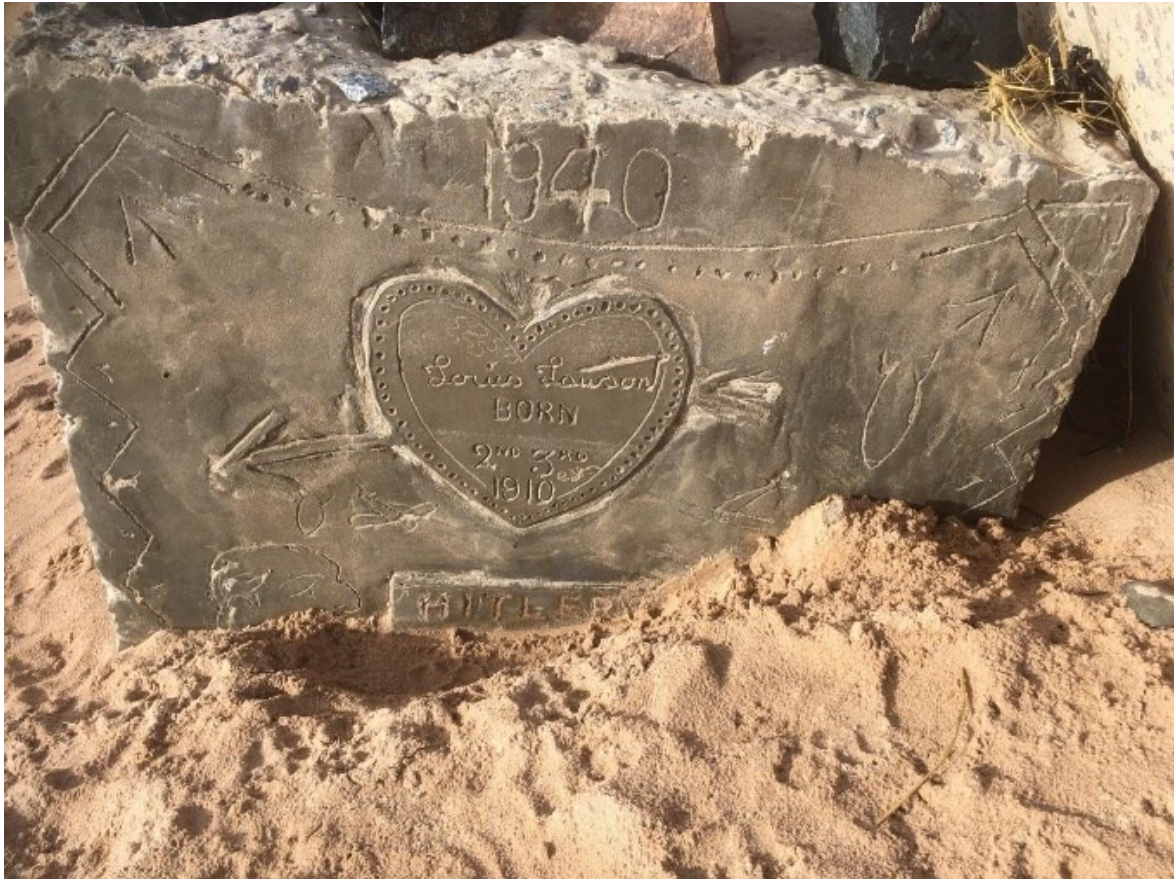
Figure 17. Decorated anti-tank block, Newburgh, Aberdeenshire (Photo: Jim Lister).

Anti-tank cubes were cast in situ by soldiers stationed in the area between 1940-41. A close look at the cubes can often reveal initials and designs pressed into the wet concrete when they were created. A partially buried cube situated at the mouth of the Cuttie Burn along the Craigewan Links, north of Peterhead, is inscribed with lettering JAMES ALEXANDER 17/10/40 ([SCAPE ID:15702](https://scapetrust.org/sites-at-risk/site/15702)) and the top face of a tank cube at Blackdog Links is inscribed twice with the date '1940' and has a number of shells pressed into the concrete, perhaps representing four leaf

clovers or flowers ([SCAPE ID: 14835](#)). Amongst the anti-tank cubes south of Newburgh along Foveran Links is one of the most elaborately decorated, adorned with sketches of two men, one of which is thought to depict Hitler, the date '1940' and a banner reading 'Hitler's Graveyard'. Centrally placed on the cube face is a heart pierced with an arrow, with the enclosed words 'Louis Lawson BORN 2<sup>nd</sup> 3<sup>rd</sup> 1910'. The cube was mostly buried during our survey but has been described by Barclay (2013) and photographed by Jim Lister in March 2021 (Figure 17).

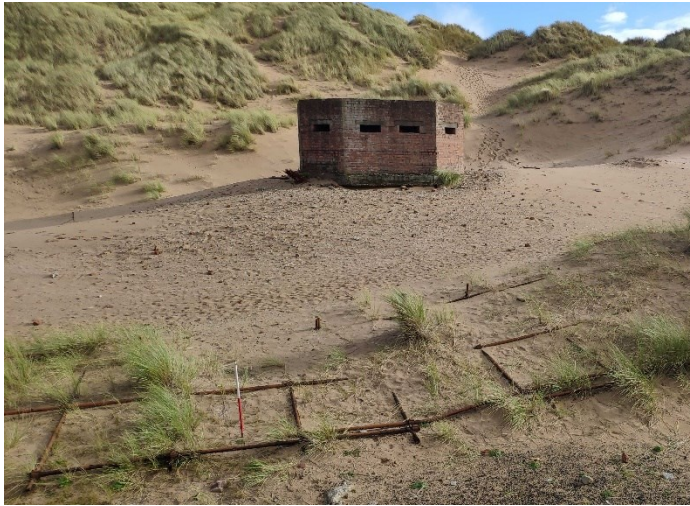
Figure 18A. Remains of metal scaffolding military defences and Type 24 redbrick pillbox, Foveran Links, Aberdeenshire (<https://scapetrust.org/sites-at-risk/site/14579>).

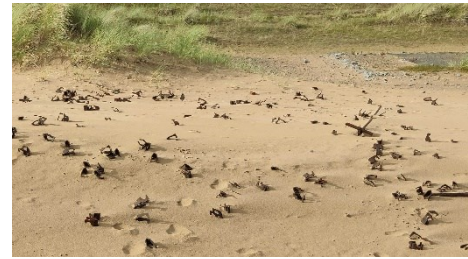
Figure 18B. Metal scaffold fittings scattered across the sand blow out, Foveran Links, Aberdeenshire.

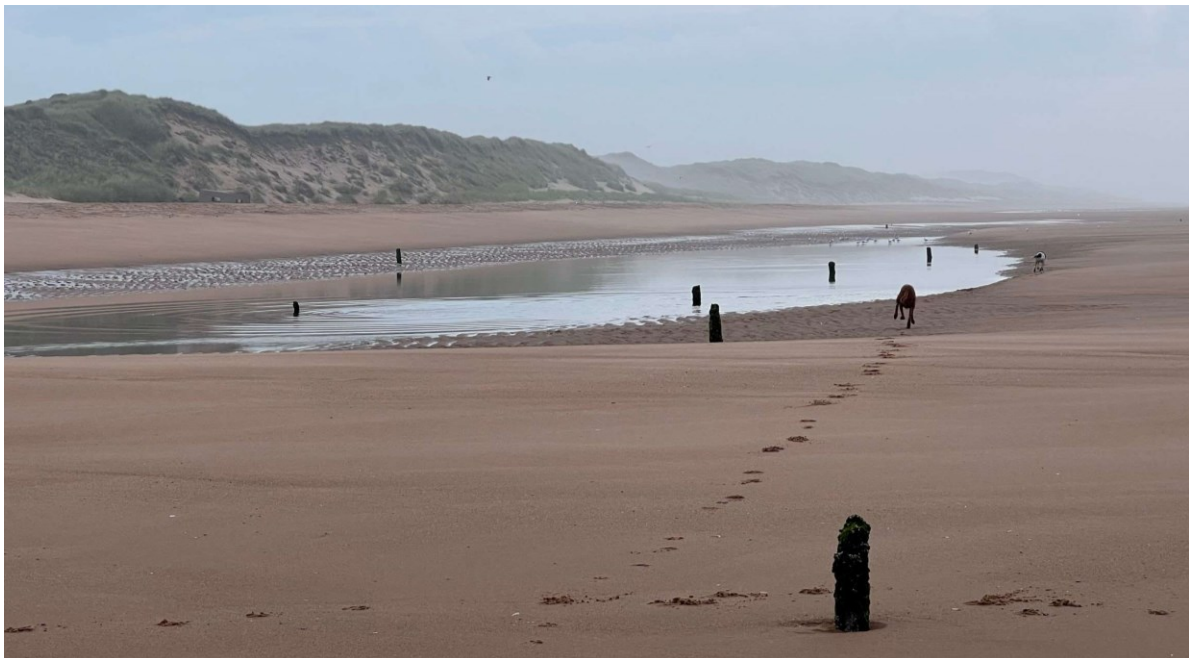
Figure 19. Example of wooden post remains which are found in a number of locations along the coast at Balmedie, Aberdeenshire (<https://scapetrust.org/sites-at-risk/site/15656/>). Photo Adam Coldwells.

Several groups of short wooden stakes and metal poles visible at low tide between Blackdog and Balmedie are most likely the remains of anti-landing defences (Figure 19). These remains are more poorly preserved along the long open coasts of the eastern Aberdeenshire coastline than similar defences in more sheltered areas of the Moray Firth. It is also difficult to distinguish between anti-landing posts and the remains of fixed salmon fishing stake nets in some instances.

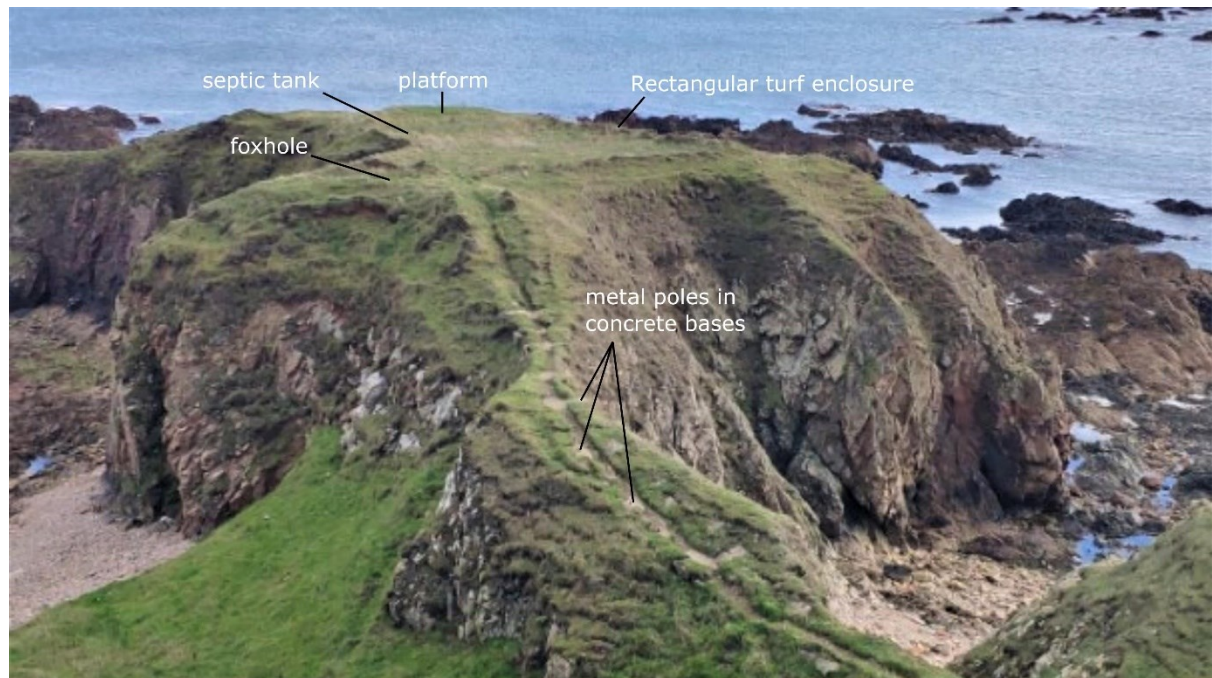
On a small promontory between Port Keppies and Poor Man of Broad Haven, Whinnyfold, is an interesting new site which has been tentatively interpreted as the remains of a military observation post ([SCAPE ID:15715](#), Figure 20). The site consists of a low rectangular turf

enclosure 20m x 11m and a ~3m diameter foxhole dug into the northwest corner. In addition there are the remains of a concrete and brick septic tank and a slightly raised concrete platform, 5m diameter, shallowly buried beneath the grass. The stumps of two parallel rows of metal poles set in concrete bases running across the promontory are perhaps the remains of a walkway. From this location there are clear uninterrupted views to Slains Castle, northwards and Aberdeen to the south which may suggest it is a lookout post, however, further research is needed for this site.

Figure 20. Military observation post site at Port Keppies, Whinnyfold, Aberdeenshire (<https://scapetrust.org/sites-at-risk/site/15715>).

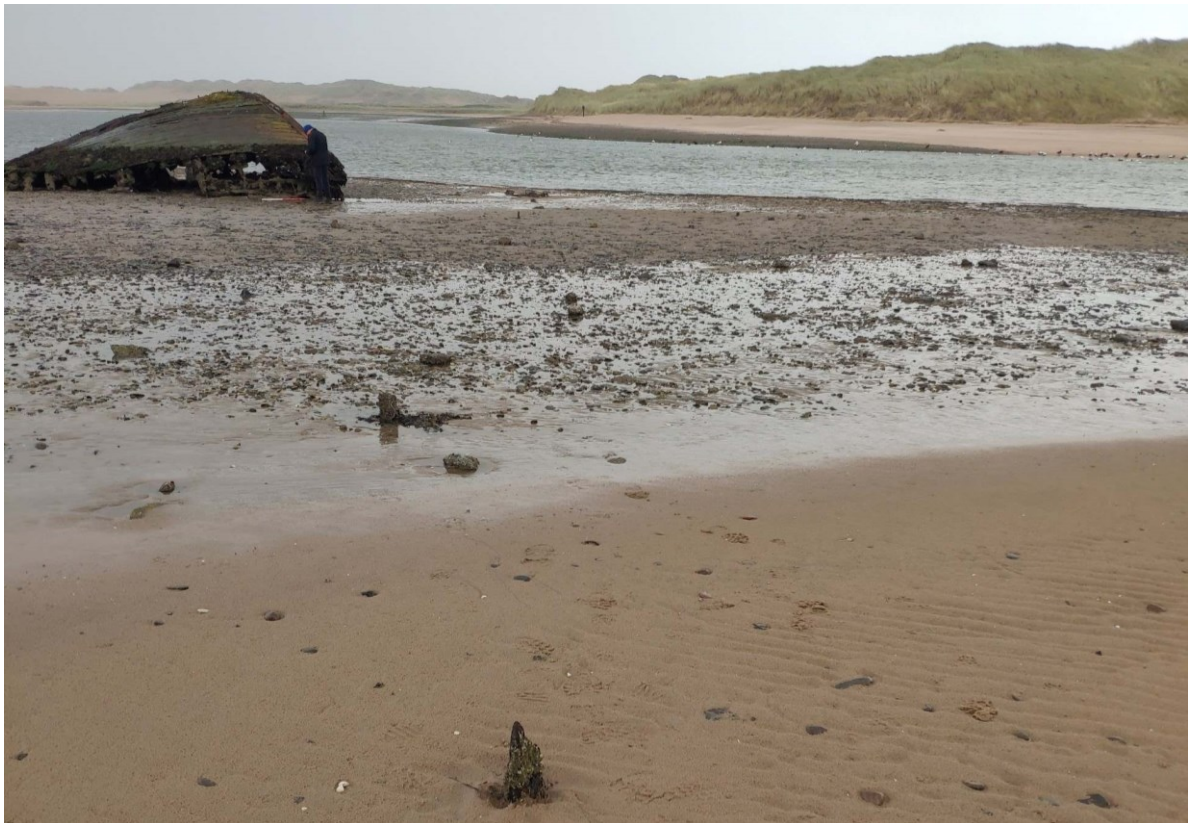
Figure 21. Remains of salmon fishing stakes, Holy Shore, Newburgh (<https://scapetrust.org/sites-at-risk/site/15741>) with unrelated wreck of 20<sup>th</sup> century wooden fishing vessel in the background (<https://scapetrust.org/sites-at-risk/site/15742/>).

Fishing related sites encompassed a variety of site types including fish smoking kilns at Sandend, ice-houses at Inverbervie ([SCAPE ID: 14956](#)) and Seagreens ([SCAPE ID: 15256](#)); and numerous winches, usually associated with harbours, landing places or fishing stations. (See also *Maritime – Landing places*). Only one certain example of the remains of a fixed net for salmon fishing was

recorded at Holy Shore, Newburgh (Figure 21), although a few of the anti-landing posts may actually be remains of salmon stake nets.

A new craft site recorded during the survey was that of the partial remains of a small wooden vessel, lying upside down on the beach at Holy Shore, Newburgh, Aberdeenshire (Figure 21 and [SCAPE ID: 15743](#)). The boat is carvel built with iron fittings and local information suggests that it is a post war fishing vessel.
