# Coastal Zone Assessment Survey Aberdeenshire & City of Aberdeen: Cullen to Milton Ness

The SCAPE Trust and University of St Andrews  
May 2023

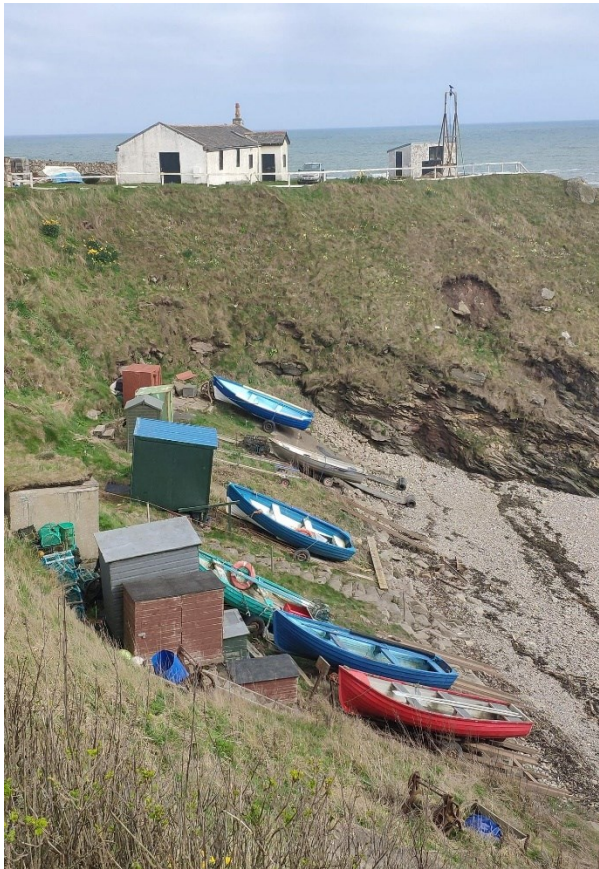
*Figure 22A. Portlethan, winch sheds, wooden rails, Blondin apparatus and net shed on the cliff top. Aberdeenshire (<https://scapetrust.org/sites-at-risk/site/14718>).*

There is abundant evidence of historic fisheries in onshore infrastructure in villages (highlights included in *Maritime – Landing places*) and fishing stations around the Aberdeenshire coast. Along the rocky coastline between Aberdeen and Stonehaven, they are found in tiny coves, often at the bottom of steep cliffs. Good examples of salmon fishing stations were recorded at Portlethen (Figure 22A); Altens Haven ([SCAPE ID:15161](#)); Burnbanks Haven (Figure 22B); Cove Harbour ([SCAPE ID: 15067](#)), Downies ([SCAPE ID: 15307](#)), and Newtonhill/Skateraw ([SCAPE ID: 14719](#)). On the cliff top above Altens Haven and Burnbanks, are rare survivals of cableways which lifted nets, other heavy gear, and fish from the shore to the top of the steep cliffs. We learned from residents that these were known locally as ‘Blondins’, named after the famous 19<sup>th</sup> century French tightrope walker Charles Blondin, who walked on a high wire over Niagara Falls. Blondin apparatus was the term used for iron and steel ropeways introduced into quarries in the late 19<sup>th</sup> century. Most of these tiny bays have a long history as fishing ports utilising the natural coves. In 1845 the New Statistical Account reported that together Portlethen, Downies, and Findon had 18 boats primarily engaged in white fishing. As the century progressed the salmon fisheries became increasingly important and the natural coves were developed into small salmon harbours with cableways, sheds for gear, winches, and railed slipways. Salmon fishing stations declined from the mid-20<sup>th</sup> century and had mostly ceased operation by the 1980s.

- Portlethen fishing station ([SCAPE ID:14718](#)) which includes the small fishing stations located along the rocky coast between Aberdeen and Stonehaven: Newtonhill/Skateraw (SCAPE ID: 14719); Cove Harbour (SCAPE ID: 15067); Downies (SCAPE ID: 15307); Burnbanks Haven (SCAPE ID: 15804) and Altens (SCAPE ID: 15161).
- Inverallochy, Boat Hive ([SCAPE ID:15676](#)) which includes landing places and winches on the Inverallochy shore (SCAPE IDs: 15675, 15677, 15673, 15672 and 15671).
- Foveran Links ([SCAPE ID: 14579](#)) includes the pillbox (SCAPE ID: 15743) and concrete gun emplacement (SCAPE ID: 14931).

We have highlighted fishing stations between Aberdeen and Stonehaven because they form a distinctive group of sites which collectively contain the physical remains of the many elements common to 19<sup>th</sup> and 20<sup>th</sup> century fishing stations. A handful of people still fish from some of them, but they are largely disused and many of the structural elements and equipment are in a state of disrepair. This includes slipways, rails, winches, and winch houses as well as the boats themselves. Rare survivals of the ‘Blondins’ at Portlethan and Burnbanks elevates the significance of these sites as important places of modern fishing heritage.

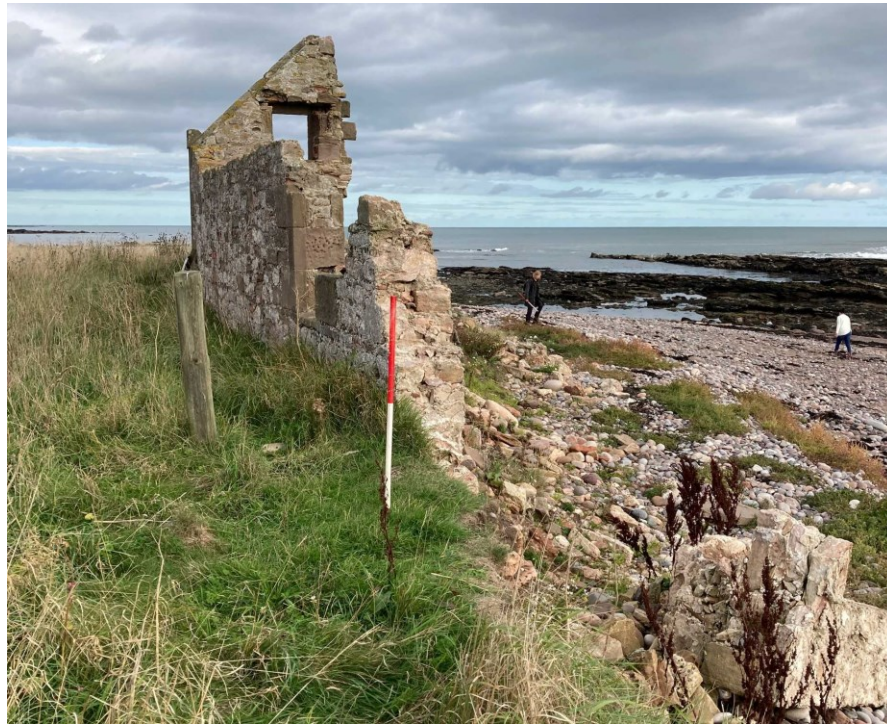
Figure 23. Eroding remains of salmon bothies, Milton of Mathers, Aberdeenshire (<https://scapetrust.org/sites-at-risk/site/15689>)

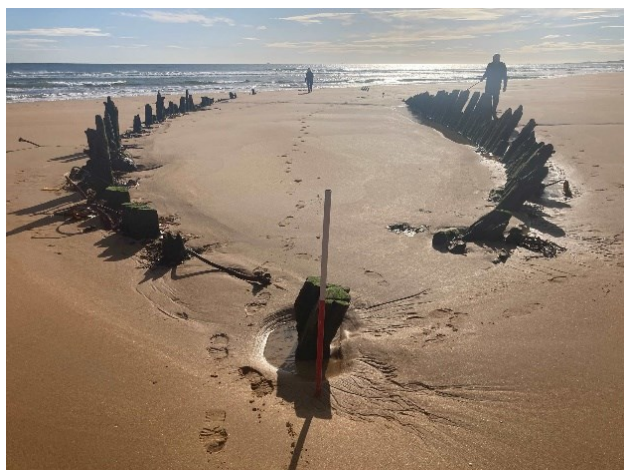
Figure 24A. Wooden remains of the *Excelsior*, Rattray Head, Aberdeenshire (<https://scapetrust.org/sites-at-risk/site/15688>).

The survey updated two existing shipwreck records in the Rattray Head area and an existing shipwreck record at St Combs. The striking remains of a large wooden vessel, wrecked ~1.5km south of Rattray Head lighthouse are thought to be the remains of the *Excelsior*, a Norwegian barque which was wrecked on the 22<sup>nd</sup> November 1881. At the time of survey, the visible remains measured 40m in length and 8.5m in width, with the ends of 60 wooden frame visible on the south side, varying in heights up to ~1m above the sand surface. The stem post as well as some of the frame timbers had been sawn (Figure 24A). Approximately 750m south of Rattray Head Lighthouse the remains of a single corroded metal post was recorded ([SCAPE ID: 15697](#)). This is the location of the stranding of HMS *Erne*, an early 20th century Destroyer, which was wrecked in 1915 (Canmore 290584). There is a good account of the salvage plans for HMS *Erne* on the [Lost in Waters Deep](#) website. The vessel was sold to the Forth Shipbuilding Co Ltd for £405 in 1915, but at least some of the ship remained as a wreck. The metal post/pipe was the only visible element in October 2022, the rest buried beneath the sand.

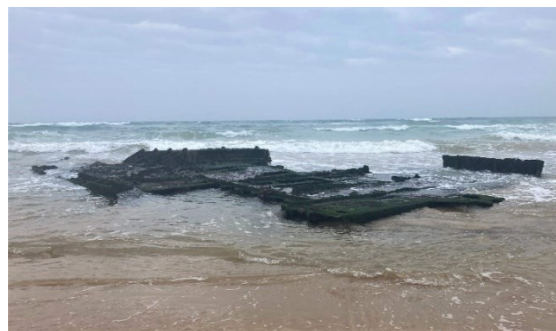
Figure 24B. Metal remains thought to be the remains of the *SS Anna*, St Combs, Aberdeenshire (<https://scapetrust.org/sites-at-risk/site/15679>).

The metal wreck recorded at St Combs (Figure 24B) could be the remains of the SS *Anna*, a steel cargo ship which ran aground near St Combs on 7<sup>th</sup> December 1959 during a storm (Wrecksite, 2023) although it could also relate to HER record NK06SE011 which describes a wreck which is thought to have been wrecked during WW2.

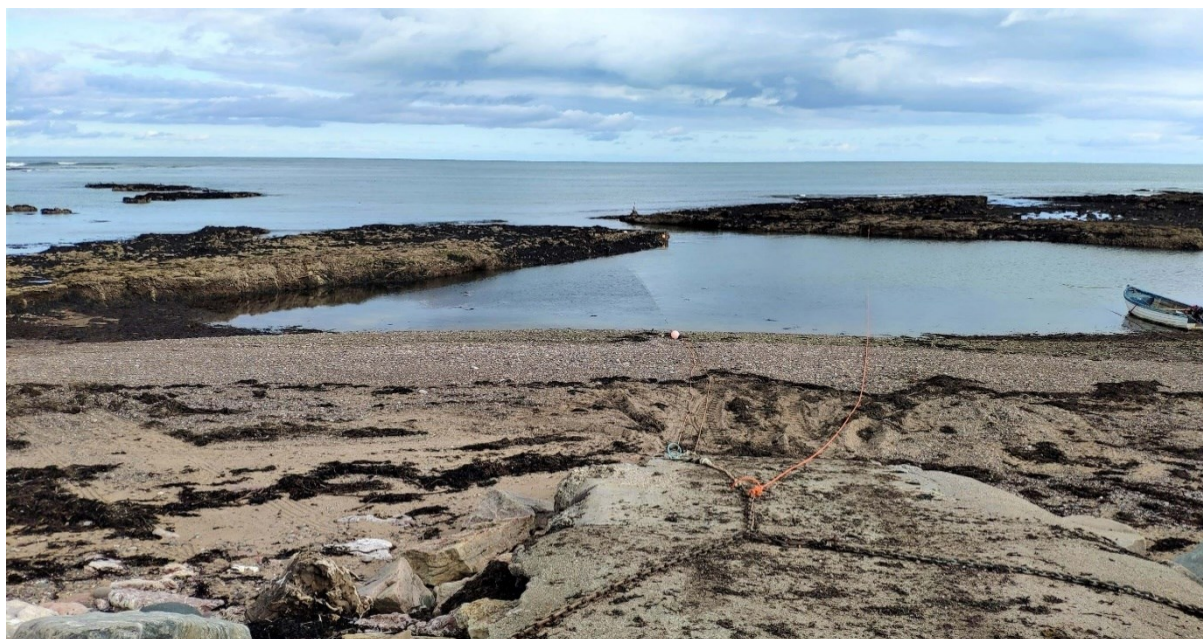
Figure 25. Modified rock cut natural harbour, concrete slipway in foreground, Milton Ness, Aberdeenshire (<https://scapetrust.org/sites-at-risk/site/14604>).

The Aberdeenshire coastline is home to numerous harbours, ranging from the large ports at Fraserburgh, Peterhead and Aberdeen, to small harbours serving local communities, such as the modified natural harbour at Milton Ness (Figure 25). Except for photographs, working harbours were not recorded in detail during our survey.

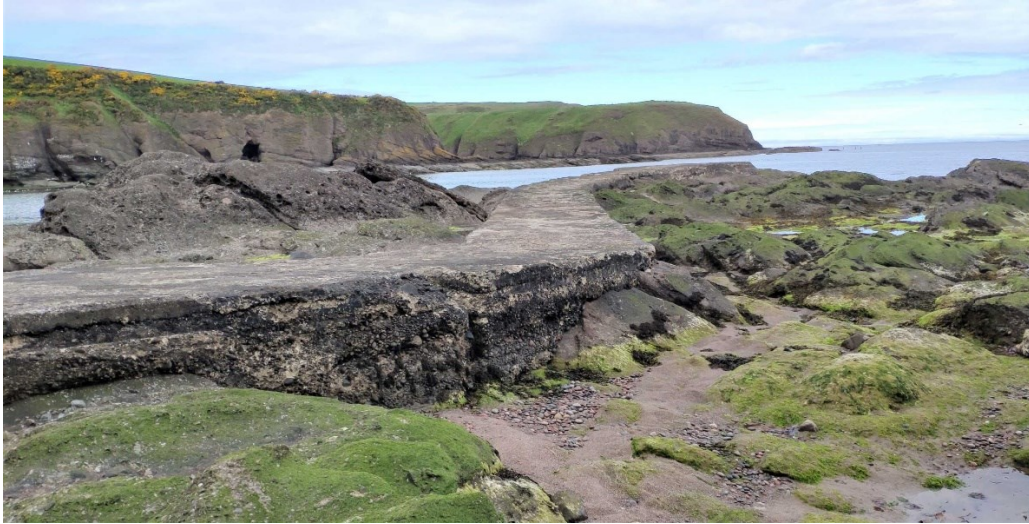
Figure 26. 20<sup>th</sup> century jetty at Pennan Mill Shore, Aberdeenshire, probably related to a salmon fishery (<https://scapetrust.org/sites-at-risk/site/14532>).

Five existing records of landing places were updated during the CCZAS and a further twelve new sites added to the record. The majority of the records relate to cleared slipways associated with fishing, such as those recorded at Whinnyfold, Pittentander (SCAPE ID: [15708](#) and [15709](#)), with other sites including a small jetty (and possible fish trap) at Waterside Wood, Sands of Forvie (SCAPE ID: [14688](#)), a concrete jetty at Pennan Mill Shore (Figure 26) and a quay at Cullykhan Shore (Figure 27).

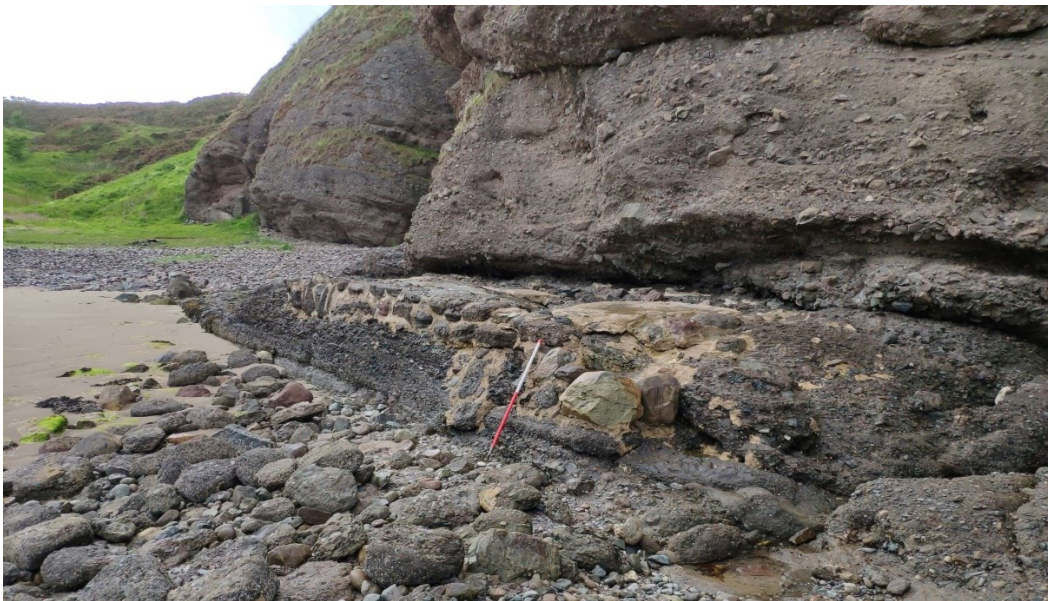
Figure 27. Old quay made of sandstone blocks situated at base of cliffs at north of Cullykhan Shore (<https://scapetrust.org/sites-at-risk/site/14484>).

The Old Quay at Cullykhan Shore appears on an 18<sup>th</sup> century estate map (Greig *et al.* 2012). It could be related to the remains of a castle on the cliffs above. If so, there is a possibility that the landing place may be medieval or early modern in date.

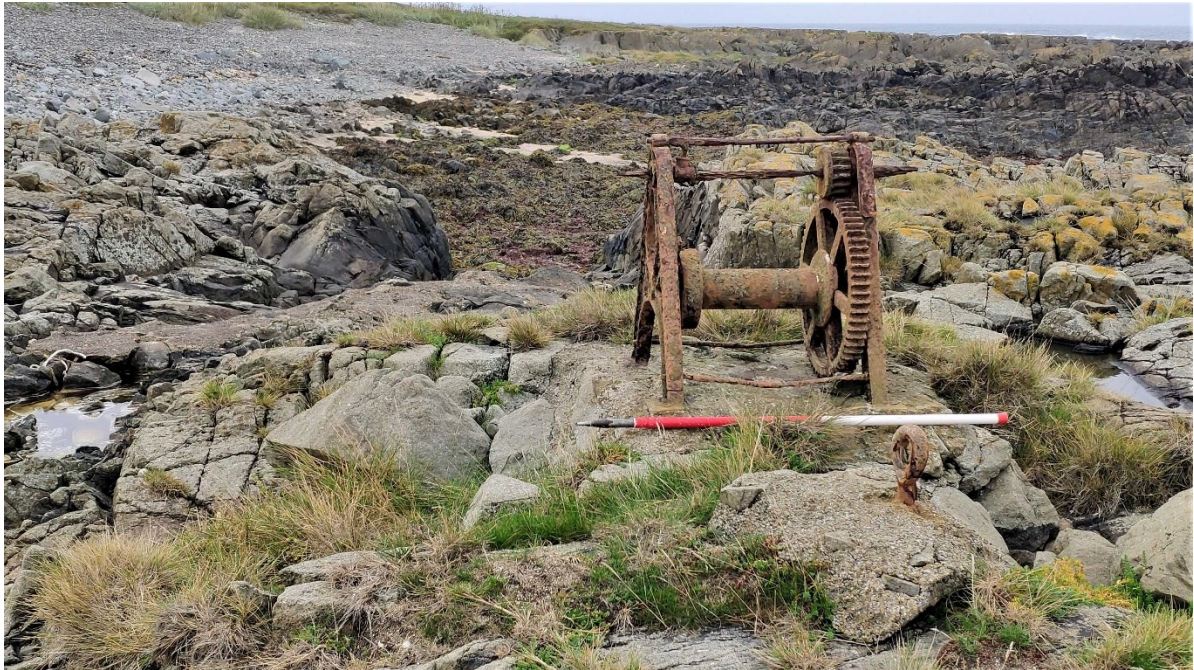
*Figure 28. Boat winch, mooring ring and naust on the south side of Inverallochy Boat Hive, Aberdeenshire. The winch is stamped with manufacturer "Tangyes Birmingham" (<https://scapetrust.org/sites-at-risk/site/15676>).*

There are a notable group of cleared slipways along a circa 1km stretch of the rocky foreshore of Inverallochy. We recorded four associated with winches: Scrath Craig ([SCAPE ID: 15671](#)); West Lake ([SCAPE ID: 15672](#)); Gowan Hole ([SCAPE ID: 15673](#)); and Boat Hive ([SCAPE ID: 15675 and 15676](#)). A former net drying yard (still in use as a drying green) is located adjacent to a cleared slipway, known as the Washing Hive ([SCAPE ID: 15677](#)). Together these sites tell the story of Inverallochy's fishing heritage.

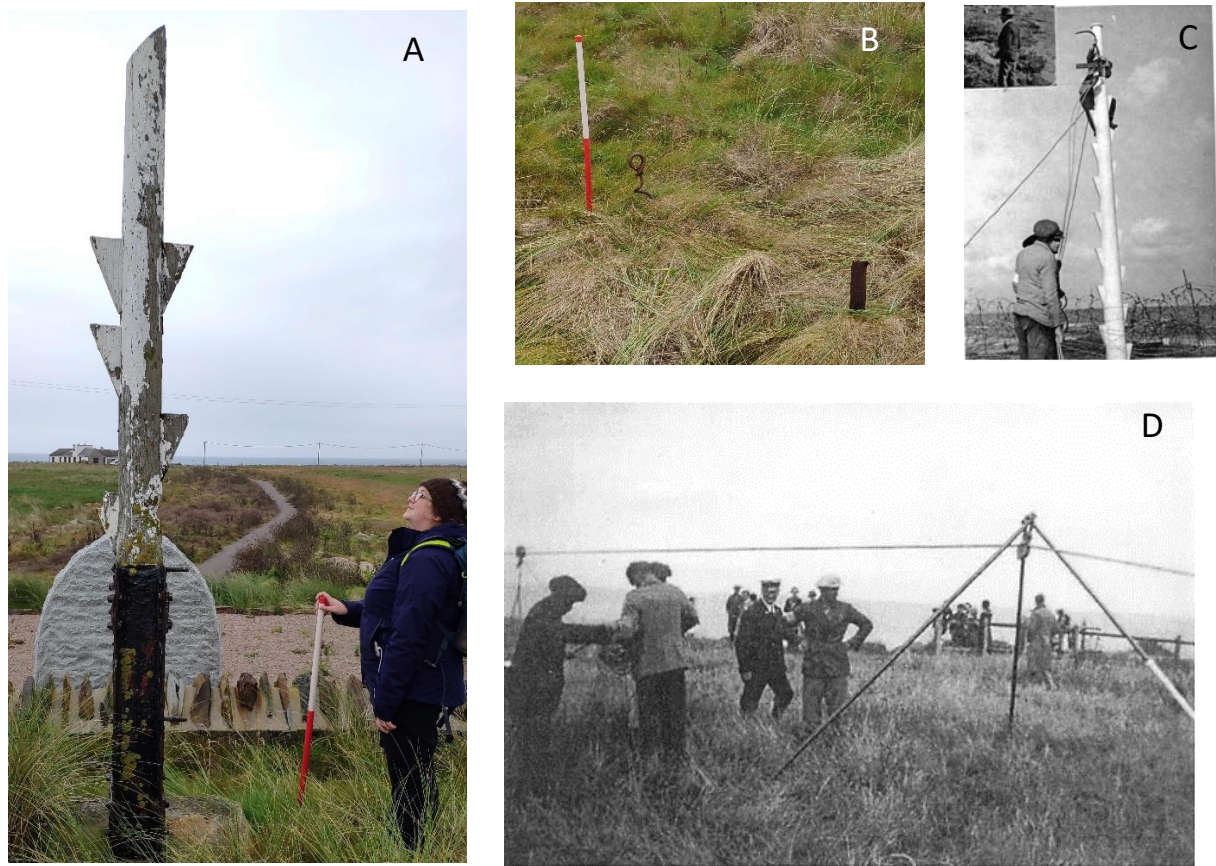
Figure 29. Remains of rocket apparatus, Inverallochy, Aberdeenshire. A. Rocket pole; B. Remains of tripod leg and securing peg. (<https://scapetrust.org/sites-at-risk/site/15670>).

C and D rocket pole and tripod in use in practise in Happisburgh, Norfolk during WW2.

At Cairnbulg Point, Inverallochy, a Rocket Apparatus and Life Saving Apparatus House (later a Coastguard lookout) are depicted on the 2<sup>nd</sup> edition Ordnance Survey. The rocket apparatus was developed in the early 19th century by Henry Trengrouse. A rocket carrying a thin line was fired to a ship in distress, and then used to set up a zip line and harness (breeches buoy) from ship to shore to rescue the crew. This life-saving equipment was installed at several fishing villages in the area in 1826 and regular training in its use carried out. What remains of the rocket apparatus at Cairnbulg is part of the rocket pole, locally known as the monkey pole, which is now located beside a memorial (Figure 29A) and the remains of a tripod leg and securing pin for the zip line (Figure 29B). The pole represented the mast of a ship during training sessions. During training a volunteer from the Rocket Brigade would climb the pole and catch the rope which enabled the breeches buoy to be set up between ship and shore (Figure 29 C and D). The apparatus could be taken to the scene of a wreck on a hand cart, which was kept at the Apparatus House. The rocket apparatus was last used at Cairnbulg in 1985 Brown (2014). We know of no other surviving *in situ* remains of rocket apparatus in Scotland.

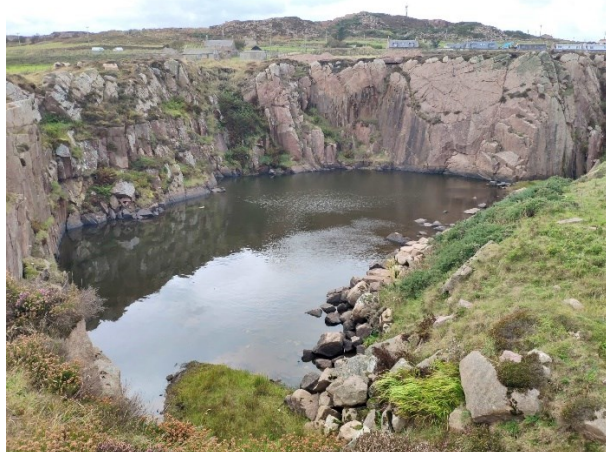
Figure 30A. Disused quarry pit at Boddam, Stirling Hill. The presently active quarry is just visible in the background (<https://scapetrust.org/sites-at-risk/site/14605/>)

There is a significant historic quarrying landscape along the hard cliff coast at Boddam south of Peterhead. Former quarry pits, buildings, spoil tips and the remains of the embankment of a mineral railway are all still visible. These date from the end of the 19<sup>th</sup> century. The Stirling Hill quarry at Boddam, further inland on the west side of the A 90, is still active.

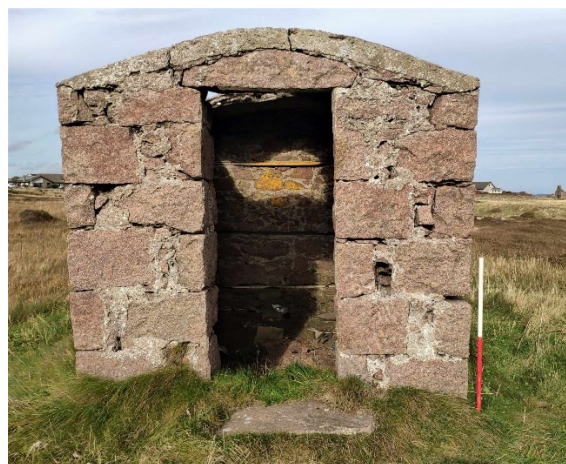
Figure 30B Possible gunpowder store at Boddam, Stirling Hill (<https://scapetrust.org/sites-at-risk/site/15231/>)

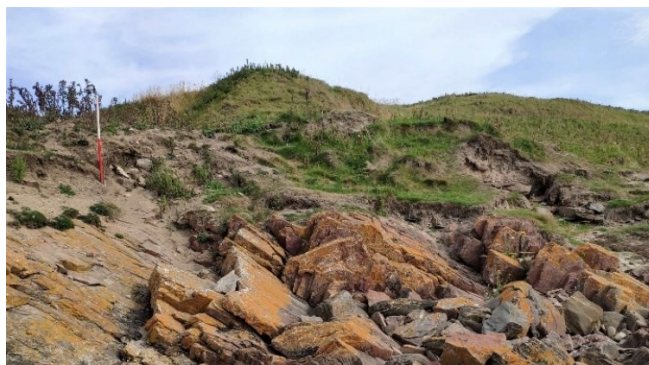
Between Sandend and Redhaven there are the remains of an historic coastal industrial landscape comprising former quarrying, limekilns, and buildings. We noted a possible new site of a limekiln eroding from the coast edge in addition to the two previously recorded at Sandend ([SCAPE ID:15667](https://scapetrust.org/sites-at-risk/site/15667/)). A ruinous building is probably related to either quarrying or lime burning ([SCAPE ID: 14698](https://scapetrust.org/sites-at-risk/site/14698/)).

Figure 31A. Possible site of eroding limekiln, Sandend (<https://scapetrust.org/sites-at-risk/site/15667/>)

Scape ID	Canmore ID	HER ID	Site Name	Site Type	Summary of vulnerability	Recommended Action
15667	290436	NJ56NE0317	Sandend	Lime kiln?	Coast edge. Erosion.	Monitor for further erosion and more structure revealed
<i>Settlement &amp; Agriculture - Buildings</i>						
14925	350364	NJ56NE0051	Red Haven	Buildings	Coast edge. Structural instability.	Monitor
15530	-	-	Gardenstown	Building	Coast edge. Erosion.	Monitor
<i>Landscapes of resource exploitation &amp; repeated human activity</i>						
14477	87194	NK02NW0032	Sands of Forvie	Lithic Working Site	Dunes, Aeolian	Monitor.
15731	-	-	Sands of Forvie	Lithic Scatter	Foreshore/ intertidal.	Regular walk along foreshore to note further material.
15734	165124	NK02NW0046	Sands of Forvie	Shell Midden	Coast edge. Slope instability.	Monitor.
15735	-	-	Sands of Forvie	Shell Midden	Dunes, Aeolian	Monitor.
<i>Religious</i>						
14562	19282	NJ76SE0002	Gardenstown, St John's Church	Burial Ground, Church	Cliff edge, landslip.	Monitor cliff.

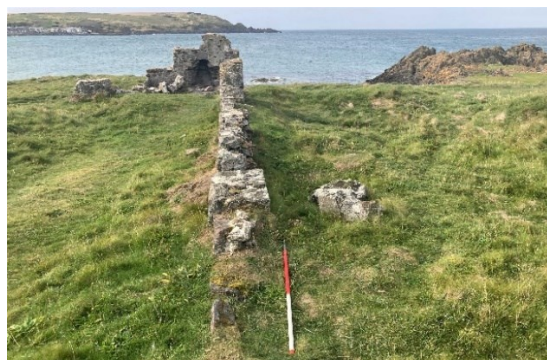
Figure 31B. Ruinous building in area of lime kilns and quarry, Sandend. (<https://scapetrust.org/sites-at-risk/site/14698/>)

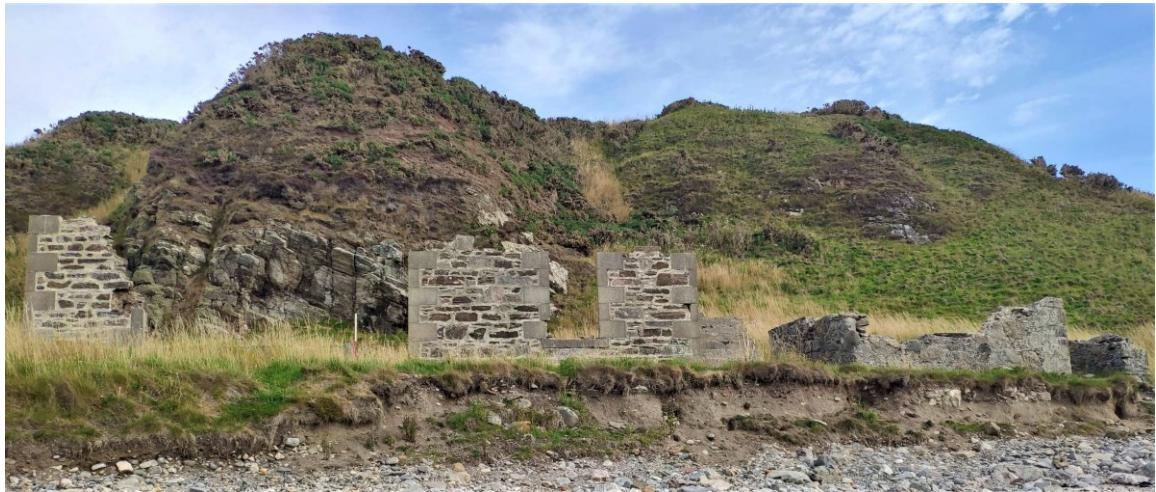
Figure 32. Eroding building and enclosure, probably associated with the quarry, Red Haven, Aberdeenshire (<https://scapetrust.org/sites-at-risk/site/14925>).

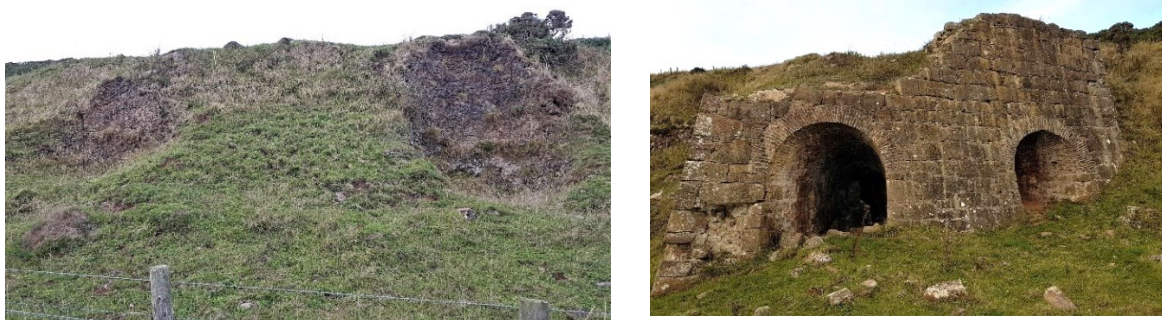
A succession of 18<sup>th</sup> century and later limekilns comprising a single and a pair of kilns and a three-draw kiln were recorded at East Mathers near Johnshaven (Figure 33). During WW2 one of the kilns was converted to an observation post for the Home Guard.

Figure 33. A pair of limekilns, and a three-draw limekiln, East Mathers, Aberdeenshire (<https://scapetrust.org/sites-at-risk/site/14473>).

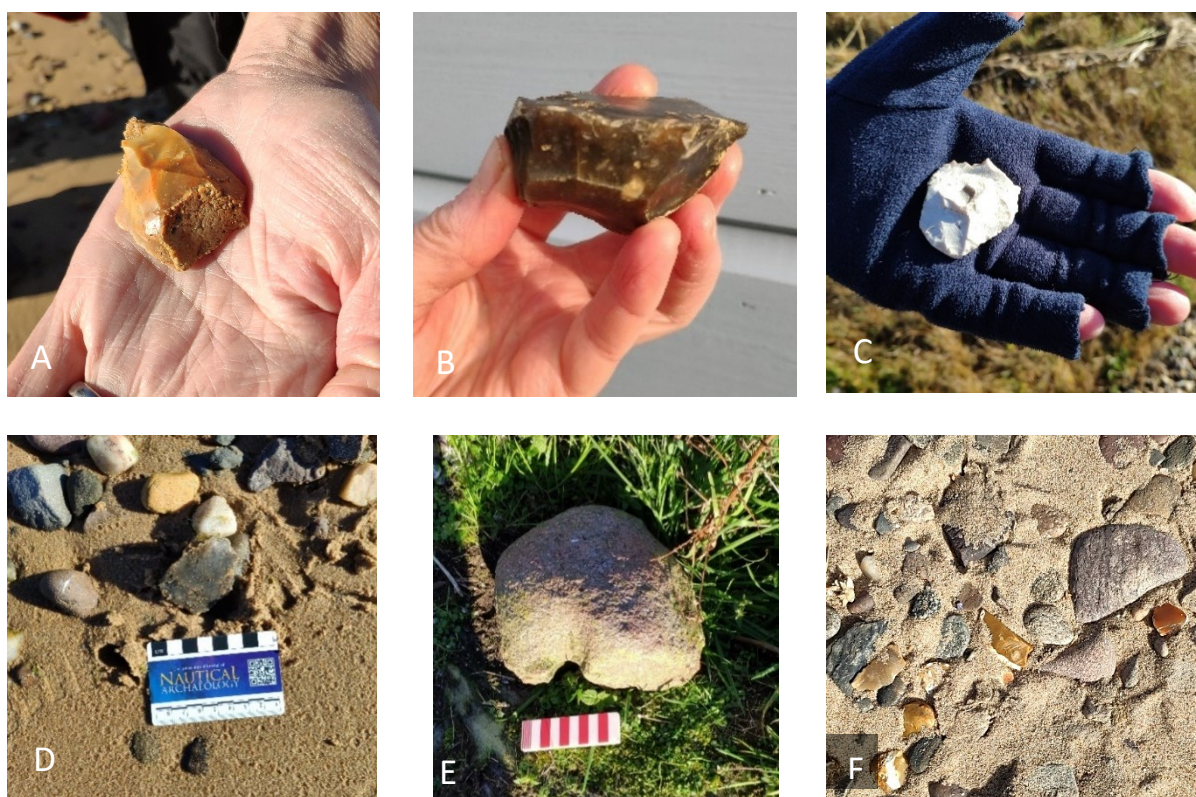
The sand dune systems of the Sands of Forvie reveal a rich history of prehistoric occupation. Blowouts within the dunes reveal old land surfaces containing extensive flint scatters. We observed abundant flint knapping debitage on previously recorded lithic scatter sites ([SCAPE ID: 14477](#); Figure 34F). Further inland, situated on the stable, vegetated dunes are hut circles, kerb cairns and a ring cairn. Three shell middens have been recorded in Forvie. These middens were excavated between 2010 and 2014 by Aberdeen University and dated to the 3<sup>rd</sup>-10<sup>th</sup> century AD (Noble *et al.*, 2016). One of the three middens, referred to as Midden C in the 2016 study, is situated on the coast edge and is actively eroding ([SCAPE ID: 15374](#)).

Two new sites were recorded during the October 2022 survey. The first of these is a dispersed lithic scatter ([SCAPE ID: 15731](#)) along the foreshore in front of eroding Midden C (Figure 34A-D). The second is a shell midden ([SCAPE ID: 15735](#)). The new shell midden was discovered within the sand dunes towards the southern tip of the Forvie Nature Reserve approximately 1km south of the previously recorded shell middens. The midden mound covers at least 10m x20m and contains burnt and fragmented mussel, charcoal, and fire cracked stones, revealed in the upcast from rabbit burrows across the mound. At this site a fragment of a rotary quern was also identified (Figure 34E). The composition and character of the mound looks similar to the shell middens previously excavated.

Figure 34 A-D, Examples from dispersed flint scatter along north shore of the river Ythan in area of shell middens. 34E, Rotary quern fragment found at new shell midden site. 34F, flint working area.

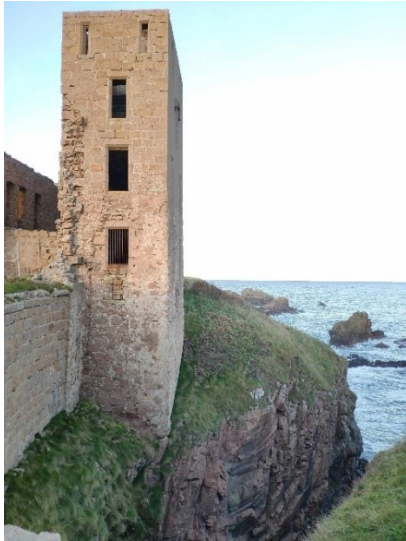
Castles, forts, and other coastal strongholds of all periods are under-represented in the CCZAS records because they are mostly situated on hard geology high cliff coasts. Many will be at risk of structural instability and periodic collapse of the cliffs upon which they stand. Two examples recorded in our survey are Slains Castle and Boddam Castle (Figure 35). Sections of the largely 19<sup>th</sup> century fabric of (new) Slains Castle are structurally unstable and built on the cliff edge. The surviving masonry of 16<sup>th</sup> century Boddam Castle is in a precarious structural condition. Remains of the curtain wall on the south side of the promontory is starting to collapse.

Figure 35A. Southeast section of Slains Castle at cliff edge (<https://scapetrust.org/sites-at-risk/site/14753/>).

<i>Castles and Forts</i>						
14753	21149	NK13NW0001	Slains Castle	Castle, Country House	Cliff edge. Structural instability.	Monitor for safety.
15297	21292	NK14SW0002	Boddam Castle	Castle	Cliff edge. Structural instability.	Monitor. Consider conservation and interpretation options.
<i>Military - WW2</i>						
<b>14579</b>	88830	NK02SW0005	Foveran Links	Anti Glider Posts	Dune. Aeolian. Structural decay.	Monitor.
15715	-	-	Whinnyfold, Port Keppies	Military Observation Site?	Cliff edge.	Monitor. Survey and historical research.

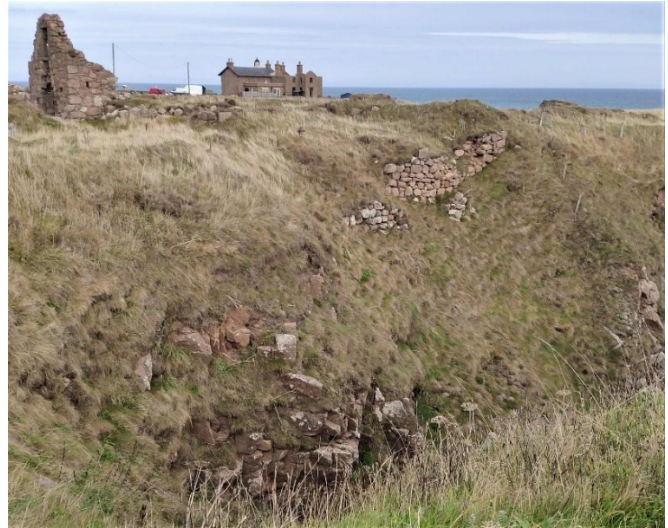
Figure 35B. South curtain wall of Boddam Castle on edge of gully (<https://scapetrust.org/sites-at-risk/site/15297/>).
