The application of an eroding coastal heritage site dataset to test models of coastal erosion susceptibility, and historic coastal change: a case study from Sanday, Orkney

Sarah Boyd - April 2019

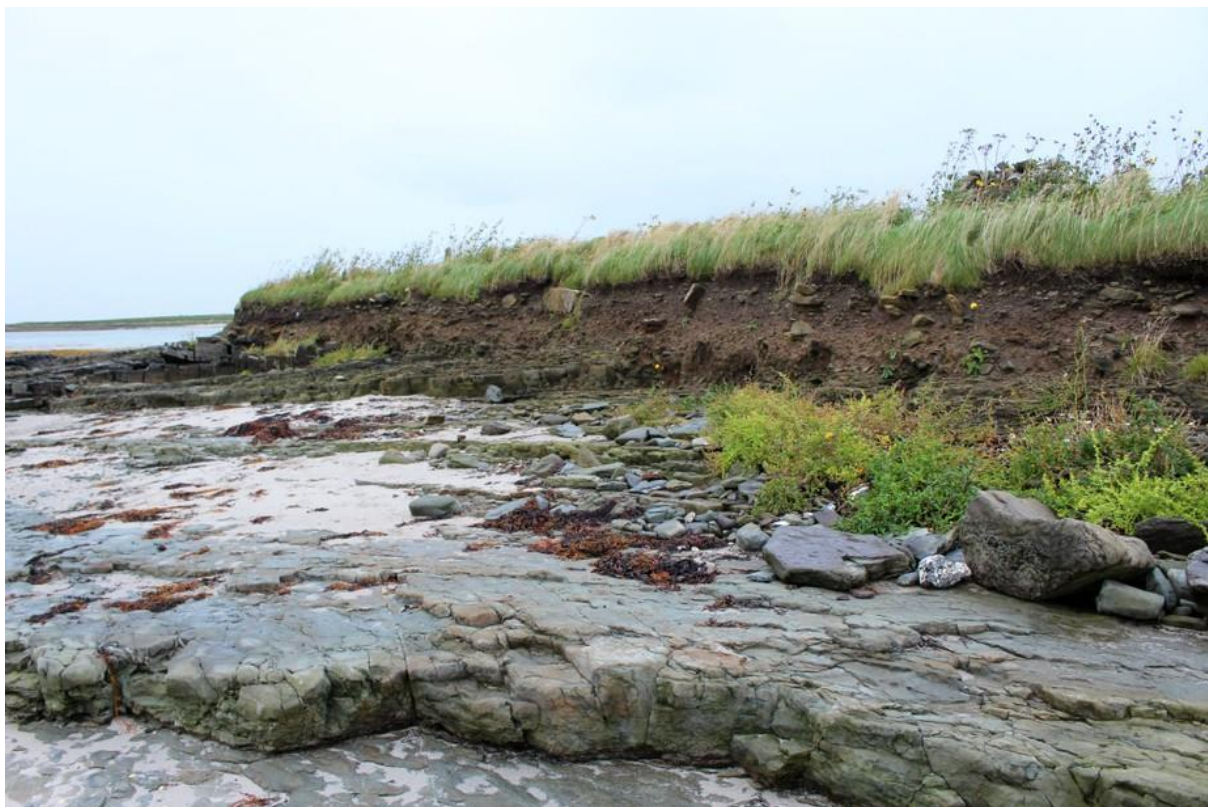
Figure 1: Photograph of priority site of Cleat [SCHARP ID: 6827] demonstrating the low-lying coastline with a thin layer of soft sediment on top of bedrock.

A typical example of an eroding site on this type of coastline is Cleat (SCHARP ID: 6827), in north east Sanday. This is a site which lies out with CESM ≥ 60 but is a priority site which has been documented as experiencing coastal erosion (Figure 1).

In this example of the coastal exposure of Cleat, the model suggests this part of the coast has a very low susceptibility to erosion, which disagrees with the erosional status of the archaeological site (Figure 2). However, the high level bedrock geology indicates inherent resilience which may be contributing to this lower CESM score, despite ground truth showing active erosion at the site.
