Scottish Coastal Archaeology and the Problem of Erosion

Coastal Zone Assessment Survey Highland: Inverness to Culbin

Sarah Boyd, Joanna Hambly

The SCAPE Trust and University of St Andrews
February 2023

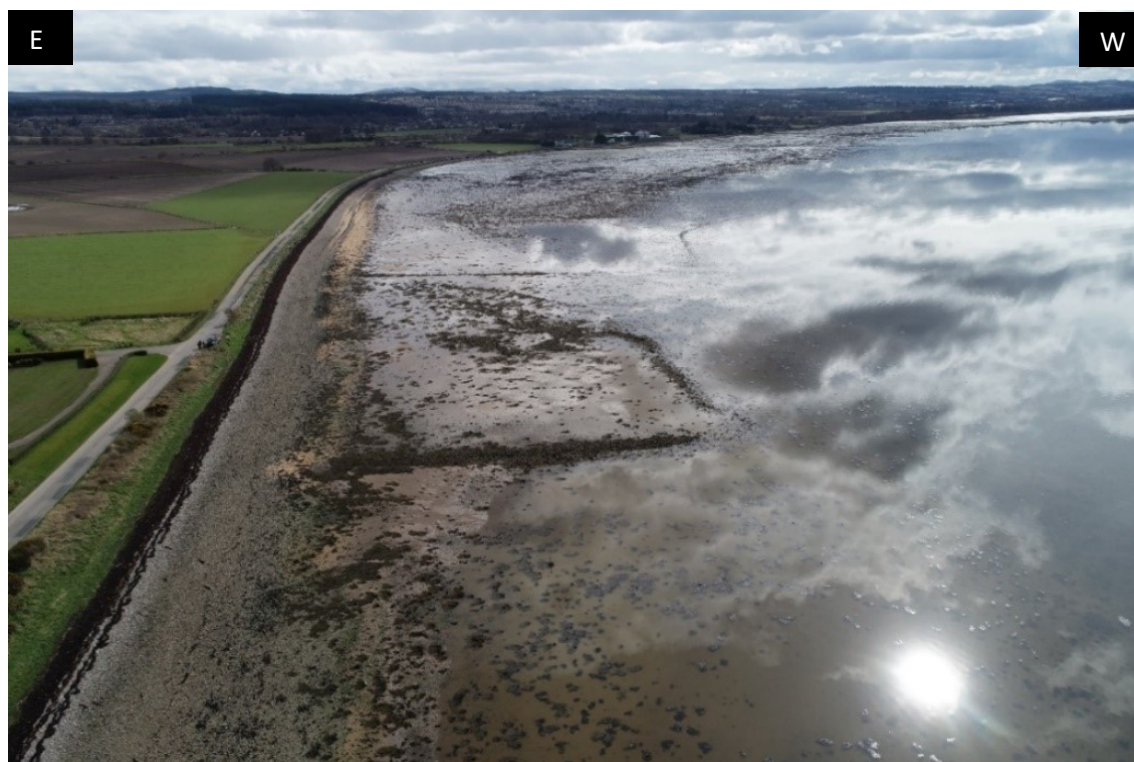
Figure 4. A typical example of low-lying soft coastline at Brecknish/Allanfearn, at the western end of survey area. Large boulder-built fish traps extend into the intertidal muds of the Moray Firth.

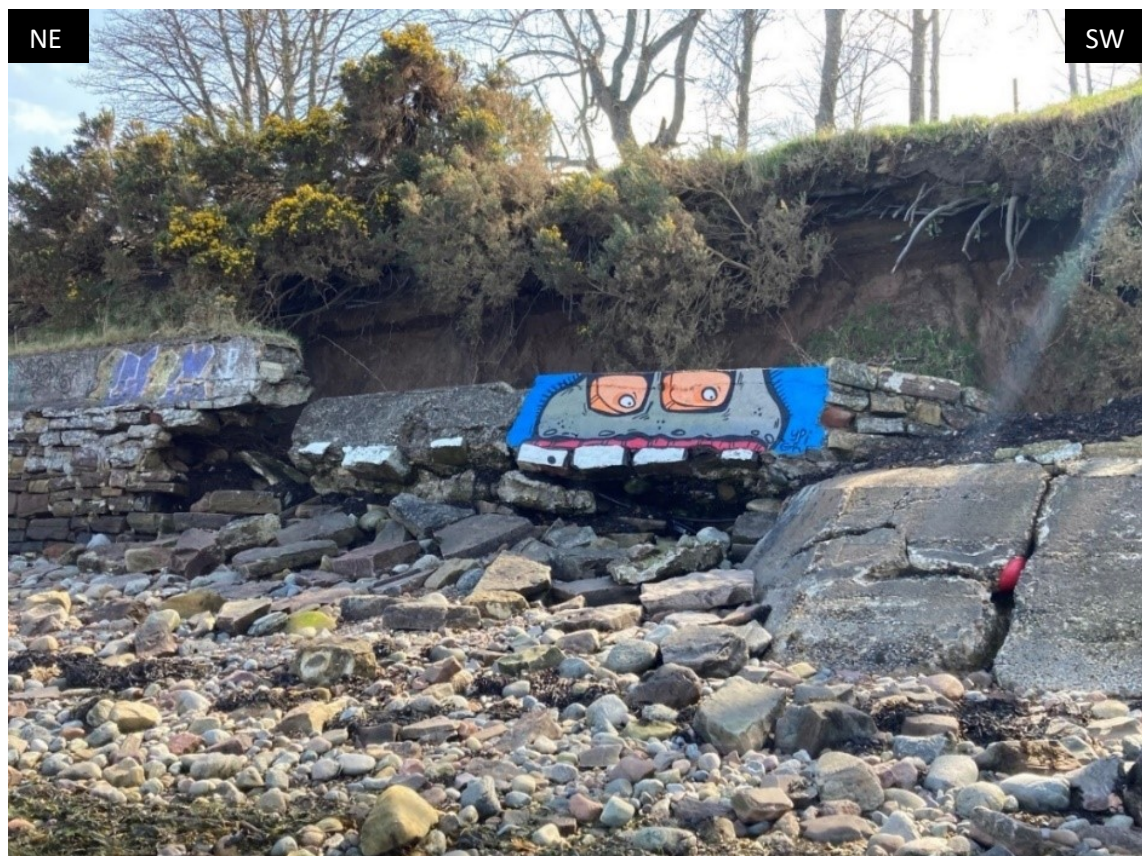
The coast edge at Milton of Culloden has seen recent erosion, with damage to stone and concrete sea walls (Figure 5). Anecdotal evidence from a local resident in the area estimated around two acres of land had been lost from the coast edge of their property over the past two decades due to storm damage and coastal erosion.

Figure 5. Damaged stone and concrete embankment at Milton of Culloden protecting soft sediment coastline behind

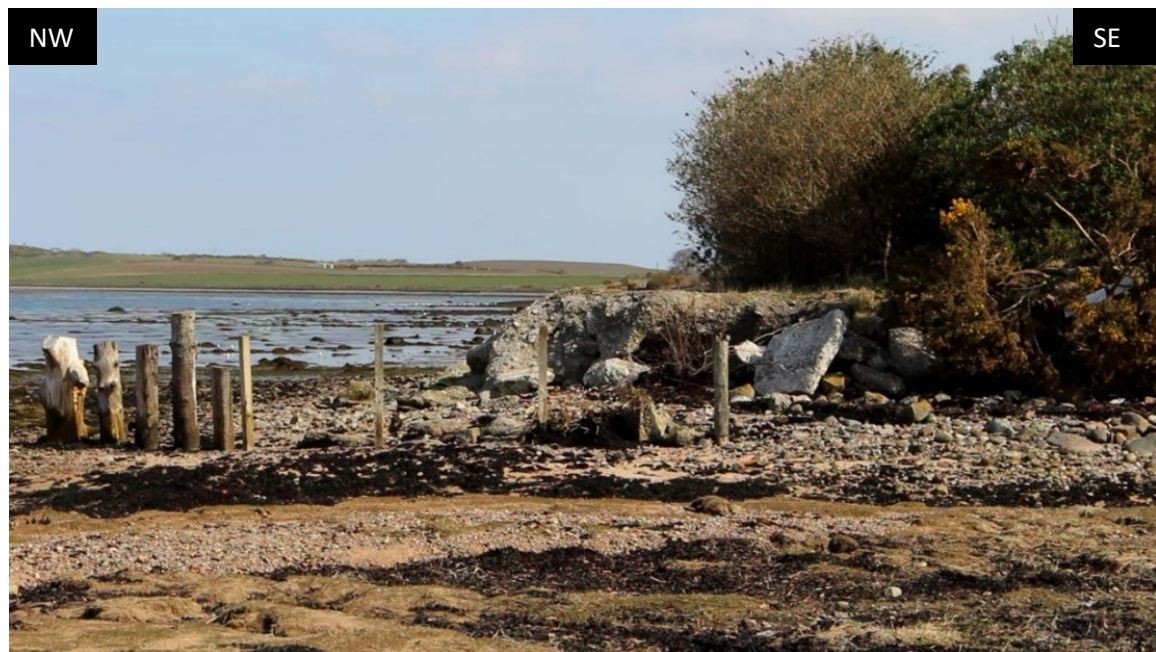
Figure 6. Eroding coast edge along the coastal stretch at Milton of Culloden.

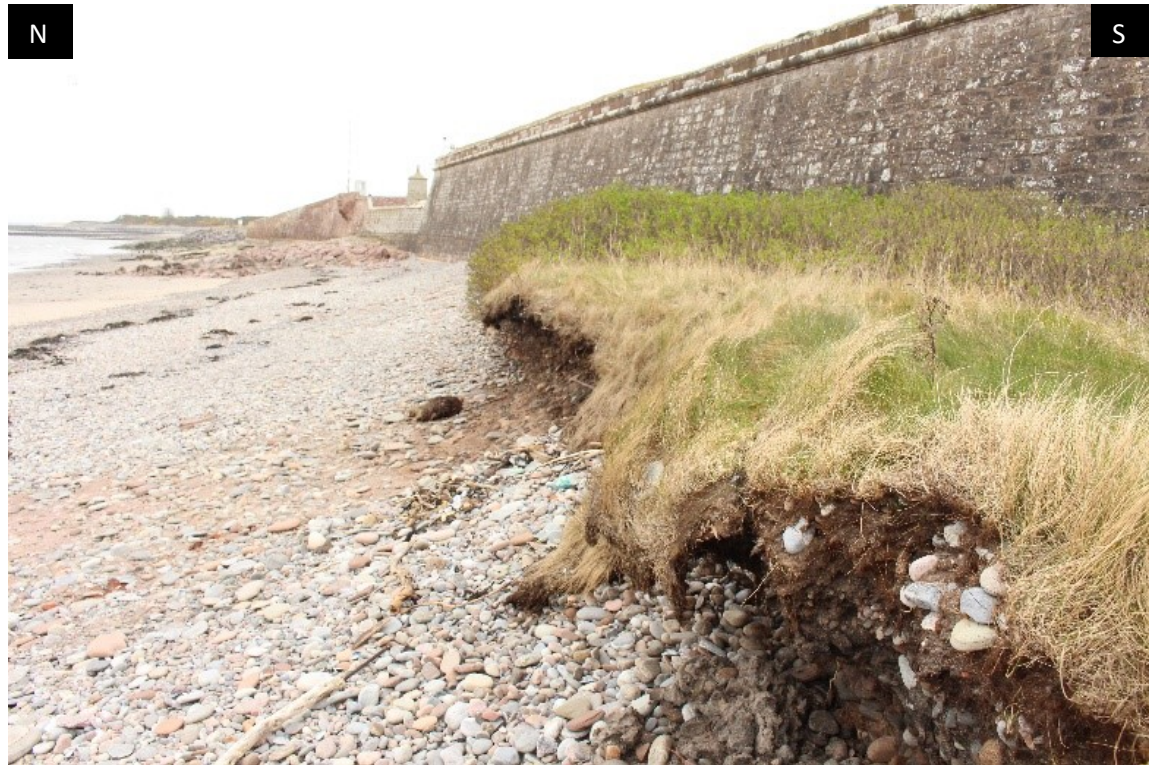
Evidence of recent erosion is noted around the external boundary of the Fort George fortifications. Sediment which has previously built up along the northern facing outer walls of Fort George on either side of the dog cemetery is showing signs of recent erosion wave action and scouring (Figure 8); also noted in 2010 (Kirkdale Archaeology, 2010a).

Figure 8. Active erosion of previously stabilised and vegetated gravel which had built up around the northern flank of the Fort George outer fortifications, on the eastern side of the dog cemetery.

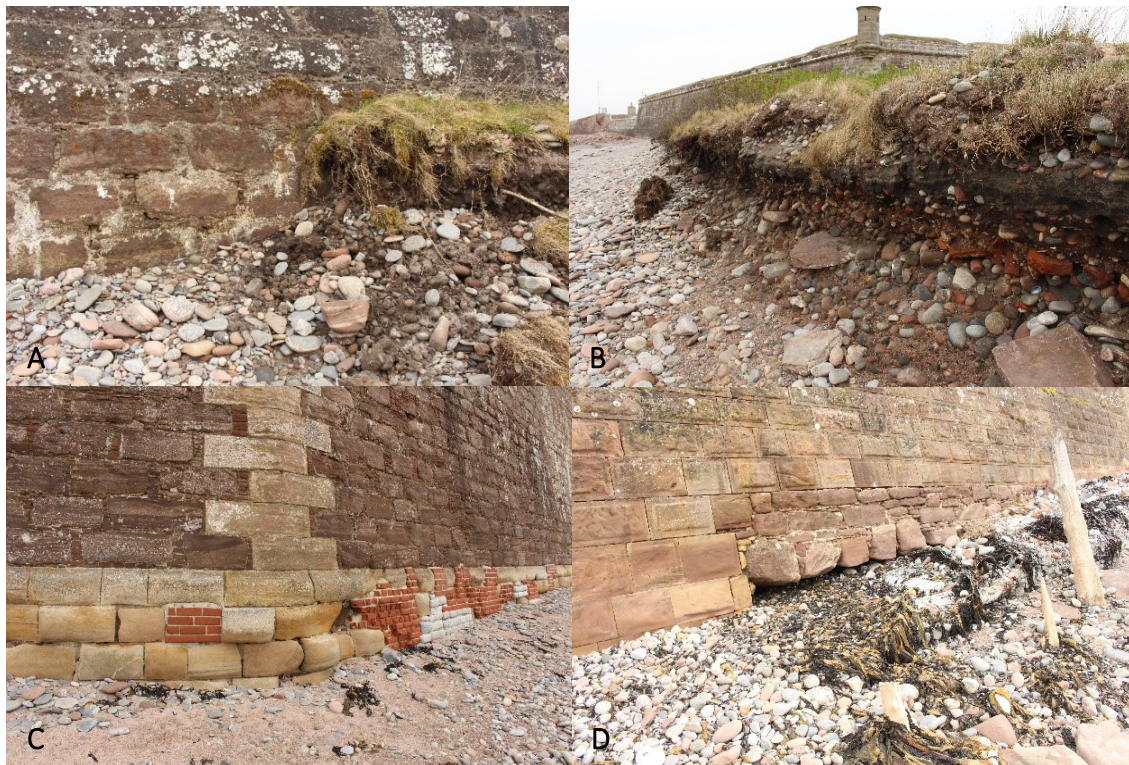
Stained masonry at the base of the walls indicated where there has been recent removal of sediment. (Figure 9A). Repairs to the base of the outer wall of the fortifications were also noted where damage has occurred, perhaps exacerbated due to a lack of sediment build-up to act as a buffer to protect these sections of wall (Figure 9C, D).

Figure 9. (A) Level of previous level of sediment is noted by colour variation in stonework, northern side of Fort George outer walls. Cherry-cocking dressed stone below sediment level suggests that wall has been exposed before. (B) Active erosion and undermining of sediment, on northern side of Fort George, to the west of the dog cemetery. (C) Repairs that have been made to base of outer wall. (D) Repairs to outer wall and damage at current gravel beach level. Wooden posts suggest past attempts of sediment stabilisation.

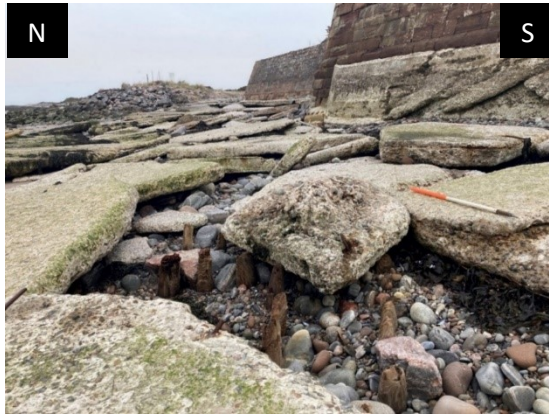
Further evidence of erosion affecting the northern side of Fort George can be seen in the heavily deteriorated Second World War landing platforms which have cracked and fragmented, revealing the wooden supporting posts beneath (Figure 10A). Landing platforms to the southwest of Fort George (Figure 10B) are also being affected by erosion, albeit to a lesser extent, (see also Kirkdale Archaeology 2010b).

Figure 10A. Concrete landing platforms on northern side of Fort George showing heavy deterioration due to coastal erosion, revealing wooden supporting posts underneath.

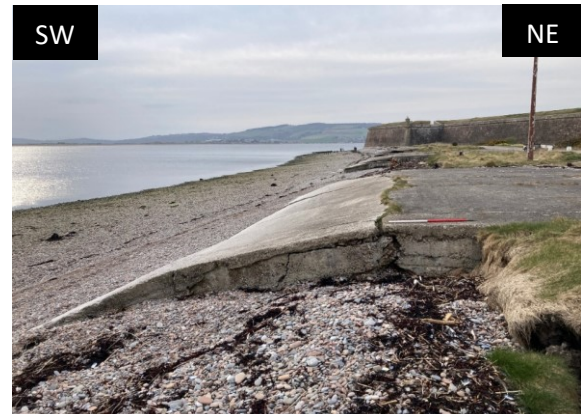
Figure 10B. Concrete landing platforms on the southwestern side of Fort George which are showing signs of deterioration.

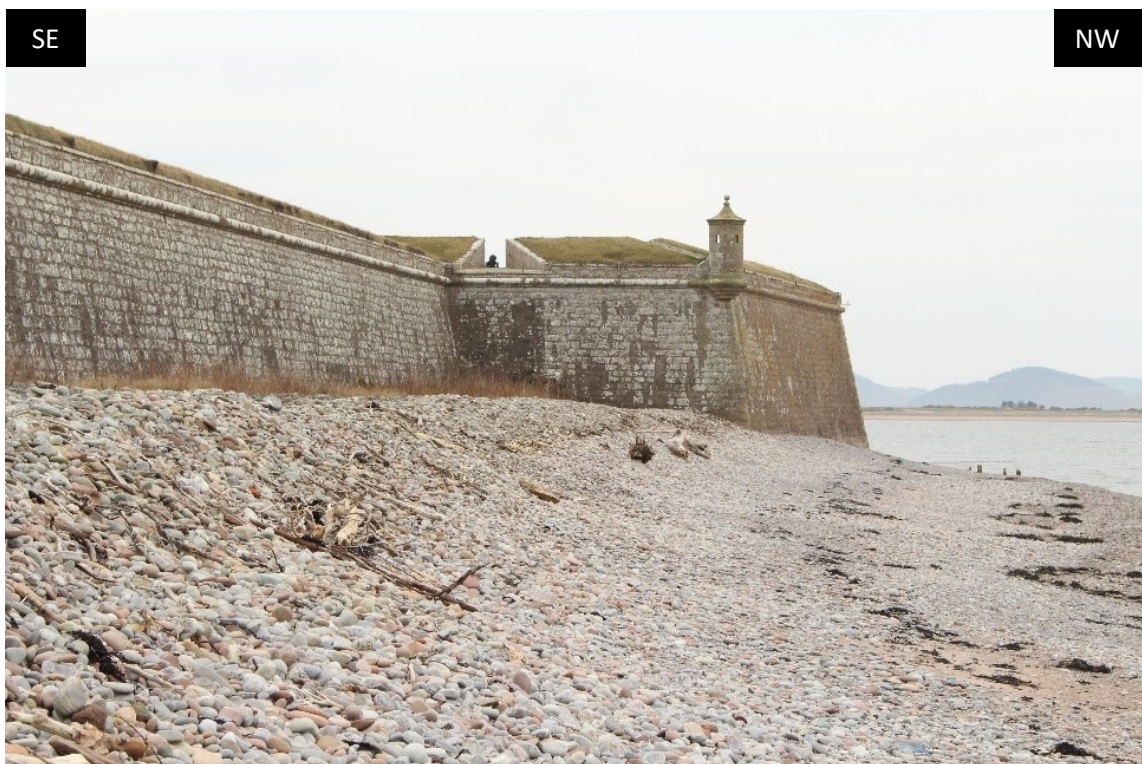
Conversely, sediment is accumulating along some sections of Fort George, for example against the western nose of the outer wall (Figure 11).

Figure 11. Gravel accumulated around the western nose of Fort George outer walls.

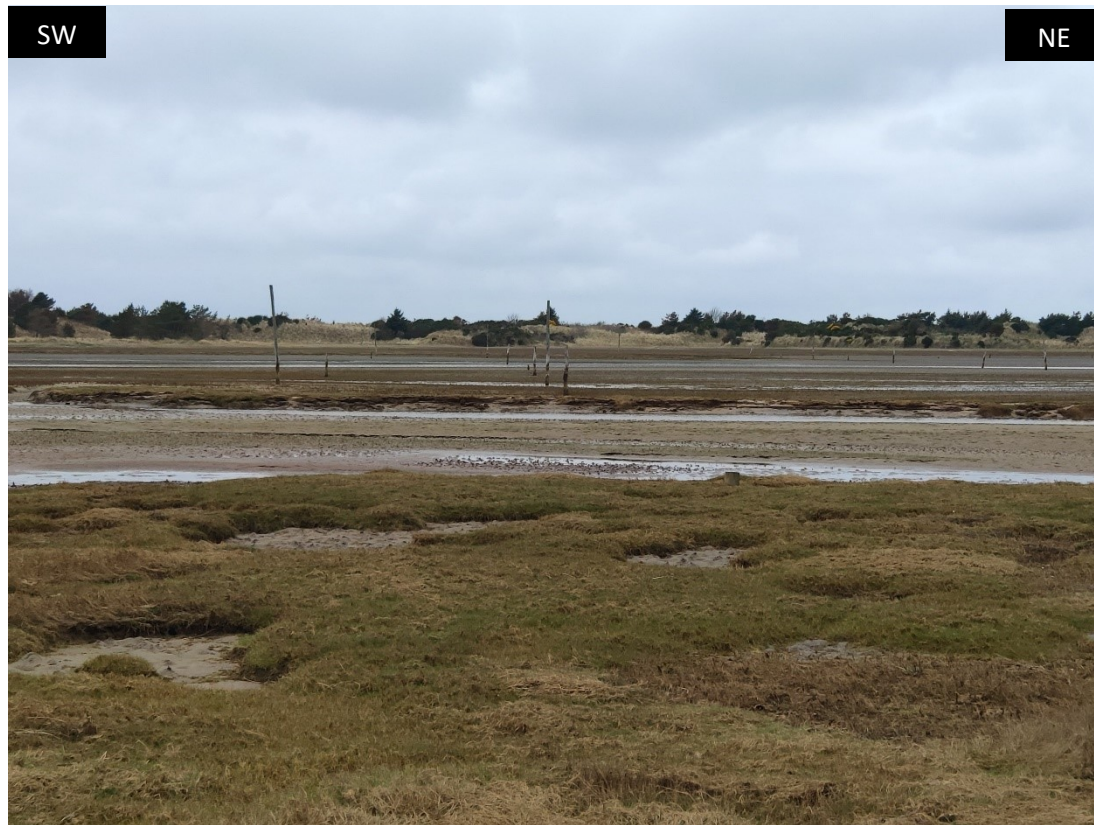
The Culbin area is highly dynamic with sediment accreting on The Bar, a large sand and gravel bar growing from west to east along the coastline. Sheltered by the bar is an expanse of developing saltmarsh, much of which is inundated at high tide (Figure 14).

Figure 14. View of saltmarsh looking towards the sand and gravel bar to the north. Numerous anti-landing posts across saltmarsh.

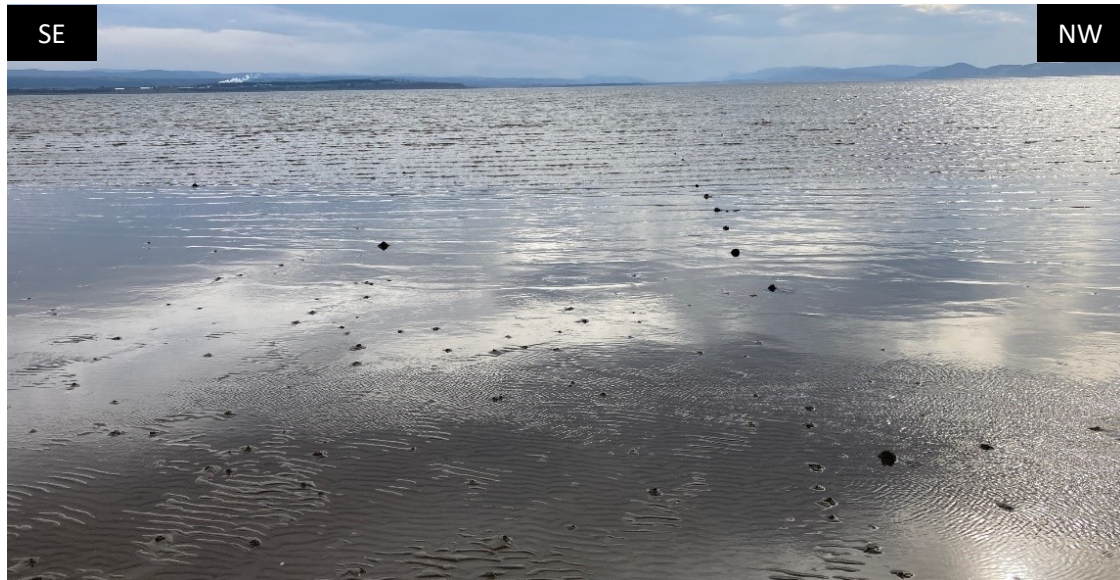
The most common of the maritime sites are those directly related to fishing (31% of known sites and 26% of new sites). The intertidal zone is home to numerous large stone-built fish traps and alignments of wooden stakes and posts, which are the remains of salmon stake nets. Most of the stake nets only survive as stumps visible at low tide (Figure 17).

Figure 17. The remains of a salmon stake net in the intertidal zone at Ardersier (<https://scapetrust.org/sites-at-risk/site/15367>).

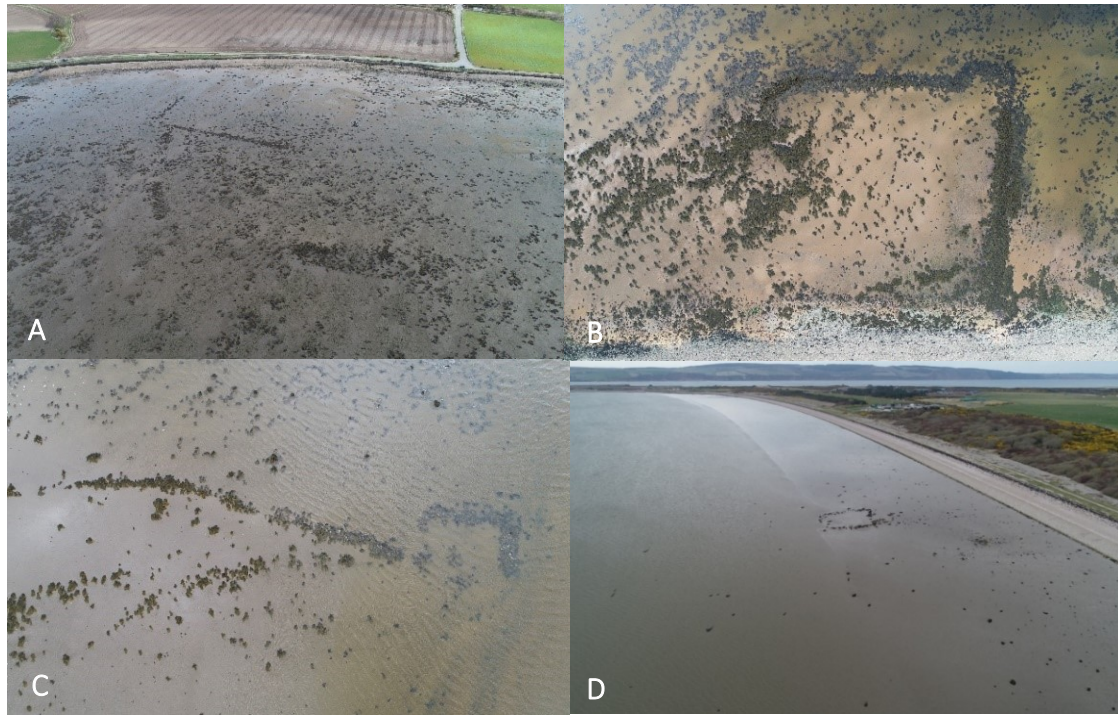
Stone-built fish traps are found in low-energy intertidal areas along the coast between Milton of Culloden and Ardersier and take a variety of forms (Figure 18; Figure 19). The majority (13) of new sites related to fishing were first identified in the Inner Moray Fish Trap survey (Dawson, 2004) and an additional four were identified during the April 2022 CCZAS survey.

The stone remains of fish traps of Brecknish, Allanfearn, Lonnie, Castle Stuart and Ardersier are a significant grouping and reflect the strong fishing heritage of the Inner Moray Firth communities. Some timber elements preserved within the stonework were observed at Brecknish. The structures have deteriorated to a point where they are fairly stable in the low energy intertidal zone. However, their location and relative invisibility from the shore makes them vulnerable to unintended disturbance or construction along these stretches of coast. The group of three fish traps between Allanfearn and Brecknish are the most complete.

Figure 18. Examples of stone-built fish traps in the intertidal zone of (A) Allanfearn (<https://scapetrust.org/sites-at-risk/site/15311>); (B) Brecknish (<https://scapetrust.org/sites-at-risk/site/15308>); (C) Lonnie, Castle Stuart (<https://scapetrust.org/sites-at-risk/site/15437>) and (D) Ardersier (<https://scapetrust.org/sites-at-risk/site/15371>). Also see report cover image.

All three fish traps located between Allanfearn and Brecknish [[SCAPE ID: 15308](#)], [[SCAPE ID: 15309](#)], [[SCAPE ID: 15311](#)], would benefit from detailed survey and historical research. To our knowledge there are no scheduled fish traps in the Moray Firth area and these could make good candidates.

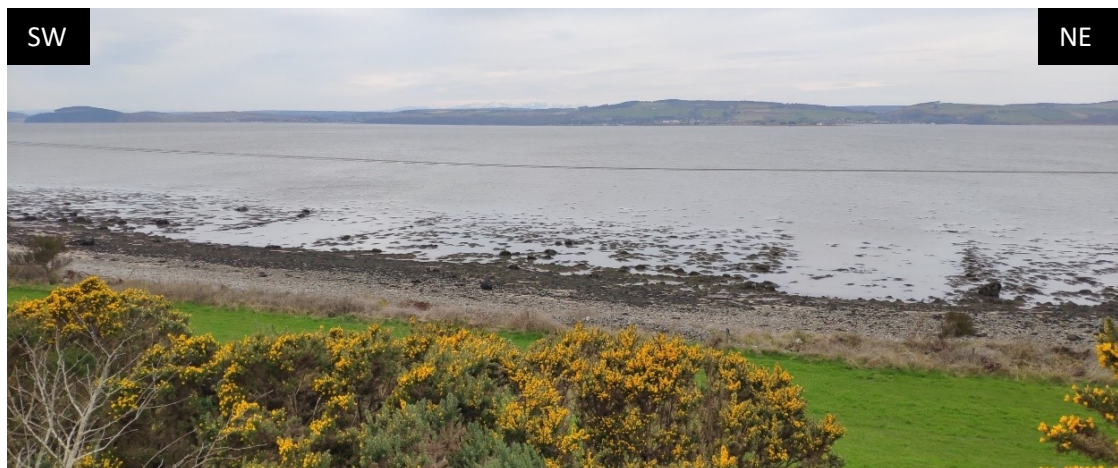
Figure 19. Local information identified these two sets of intertidal walls on either side of a cleared area at Mains of Connage as fish traps for flat fish. (<https://scapetrust.org/sites-at-risk/site/15426>).

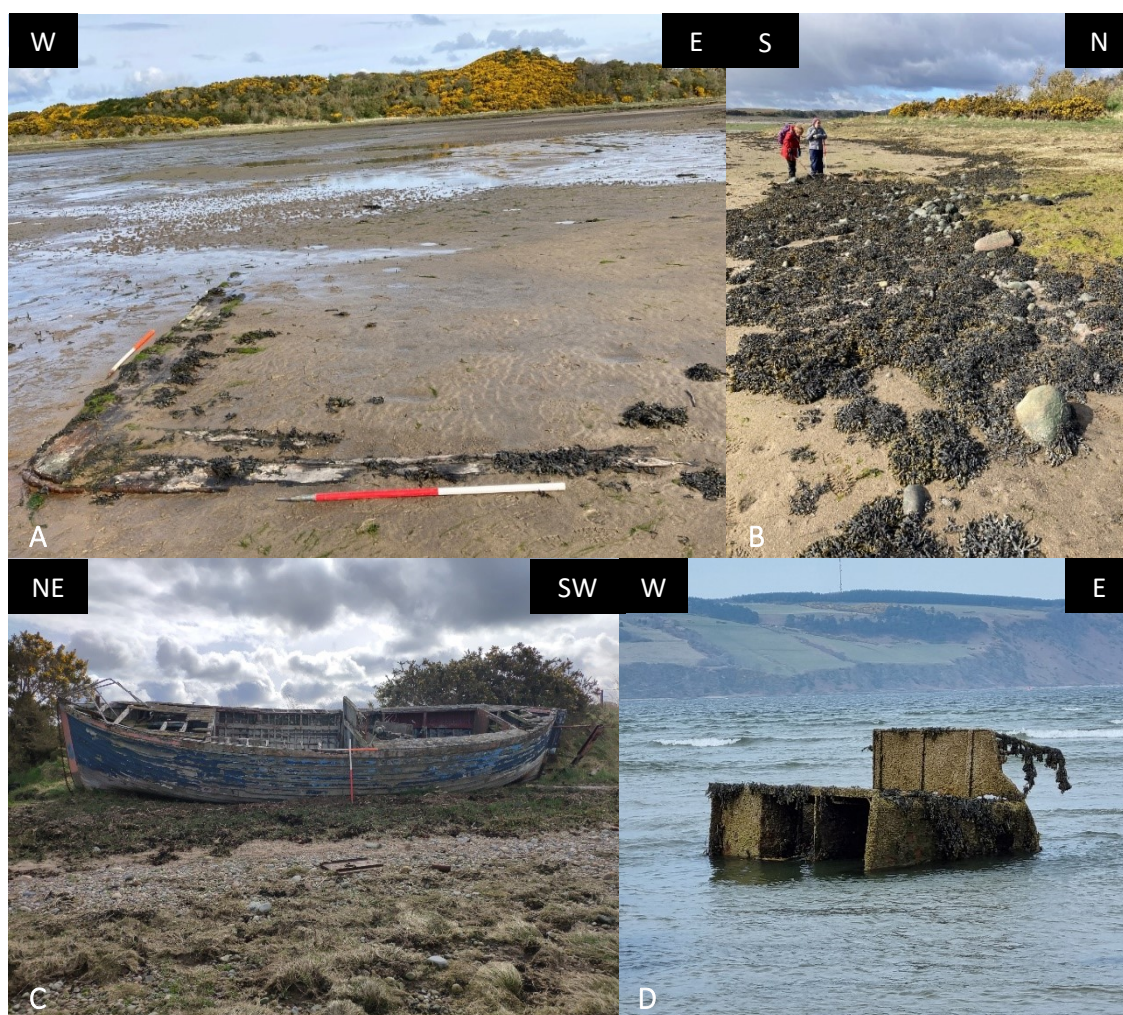
Two known site records relating to a metal wreck, just offshore at Whiteness Head were updated and five new records relating to boats and wrecks were added. These sites included the remains of three wooden crafts, a boiler and up to six ballast mounds at Lonnie (Figure 20). Additionally, patches of tar were noted which suggests the area has been used to haul up and maintain boats. When taken together, the evidence points to a possible dispersed boat graveyard at Lonnie. Intertidal wrecks and boat graveyards are under recorded in Historic Environment Records. Their location in the intertidal zone, and the sensitivity of the heritage assets, mostly dating to the late 19th and early 20th centuries, constructed of perishable wood and metal, makes them a vulnerable site type and an increasingly rare feature of Scotland's coastline.

Figure 20. (A) Stem post of a large wooden vessel Lonnie (<https://scapetrust.org/sites-at-risk/site/15463>); (B) Ballast mound with probable buried keel at Newton of Petty (<https://scapetrust.org/sites-at-risk/site/15459>); (C) Wooden fishing boat wreck at Lonnie (<https://scapetrust.org/sites-at-risk/site/15464>); (D) Metal boat wreck at Whiteness Head (<https://scapetrust.org/sites-at-risk/site/15488>).

The Whiteness Head wreck [[SCAPE ID: 15488](#)] is submerged except for upper parts and only properly visible at extreme low tides.

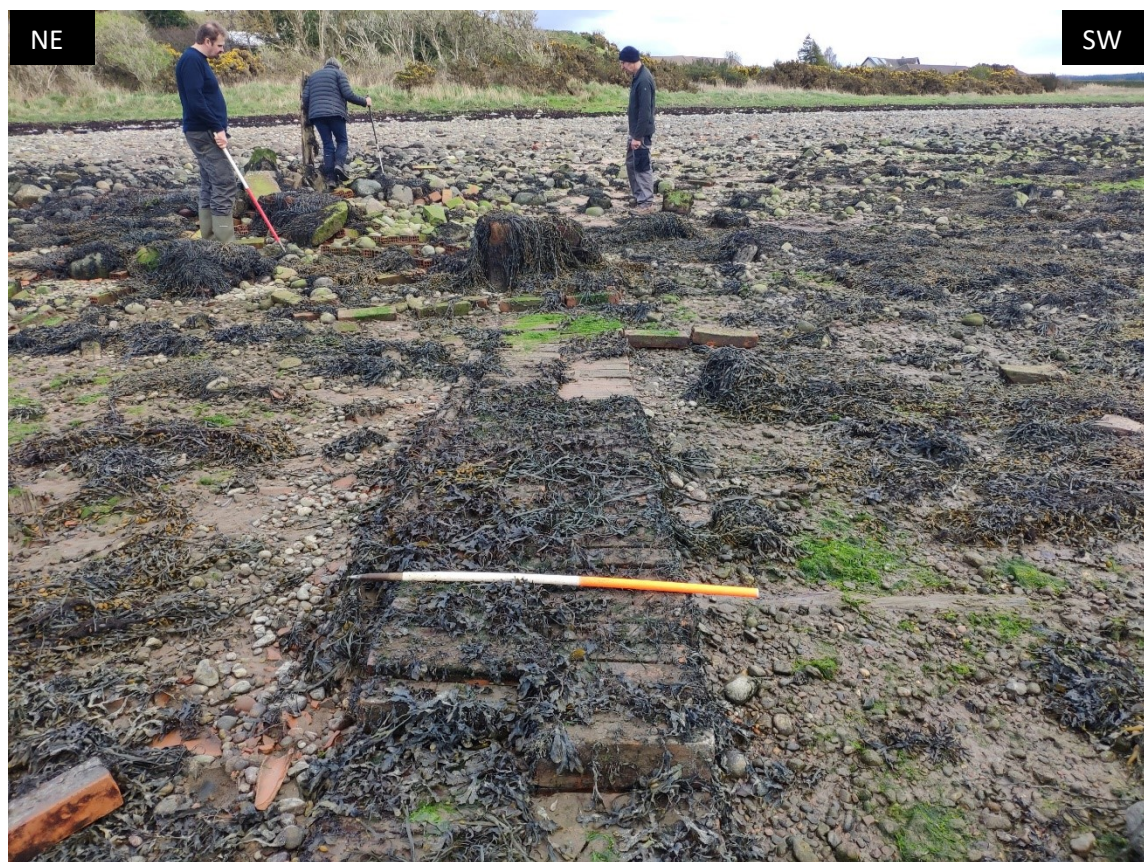
Notable among these is an unusual timber and tile jetty recorded at Brecknish (Figure 21). The jetty is constructed upon tree-trunk sleepers with a brick and tile top. It once served the short-lived Culloden Brick and Tile Works (established 1846, closed 1891) situated on the Fiddlers Burn at Lower Cullernie, which specialised in drainage tiles and large bricks. The jetty and associated building are shown on the 1st edition OS surveyed in 1869, but the jetty had gone and the building unroofed by the 2nd edition OS in 1903. Further detail about the site can be found in the North of Scotland Archaeology blog on Petty Industry (Ruscoe, 2019). This is an interesting and unusual site of local historic significance.

Figure 21. Remains of jetty constructed from wood and red brick, Brecknish (<https://scapetrust.org/sites-at-risk/site/15422>).

The individual sites of Brecknish Jetty [[SCAPE ID: 15422](#)], Scottack Tide mill [[SCAPE ID: 14458](#)], and the possible remains of a wooden vessel associated with a ballast mound at Newton of Petty [[SCAPE ID: 15459](#)], would benefit from detailed survey and recording. Following the survey, NoSAS have undertaken a detailed survey and recording of Brecknish jetty in 2022.

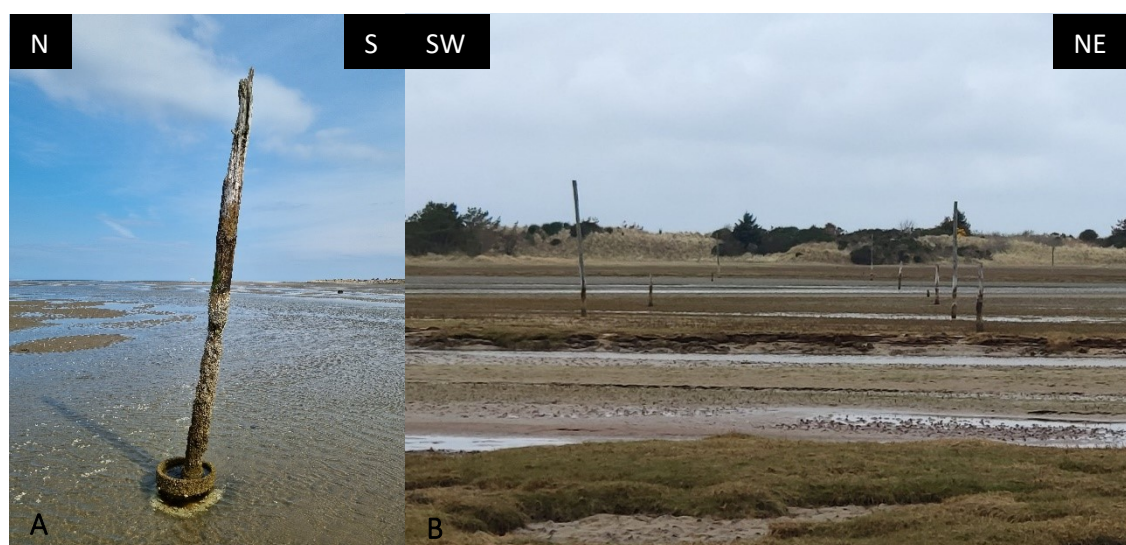
Most of the military sites visited relate to the Second World War. These include concrete gun emplacements, anti-tank cubes and concrete landing platforms around Fort George (Figure 10). Elsewhere, the well-preserved remains of expansive landscapes of anti-landing posts can be found across the intertidal sands of Whiteness Head and stretching

across the saltmarsh at Culbin (Figure 22). The posts at Whiteness Head are set into ceramic pipes which is unusual, and possibly the only extant example.

Figure 22. Anti-glider posts at (A) Whiteness Head (<https://scapetrust.org/sites-at-risk/site/15479>); (B) Culbin (<https://scapetrust.org/sites-at-risk/site/15319>).

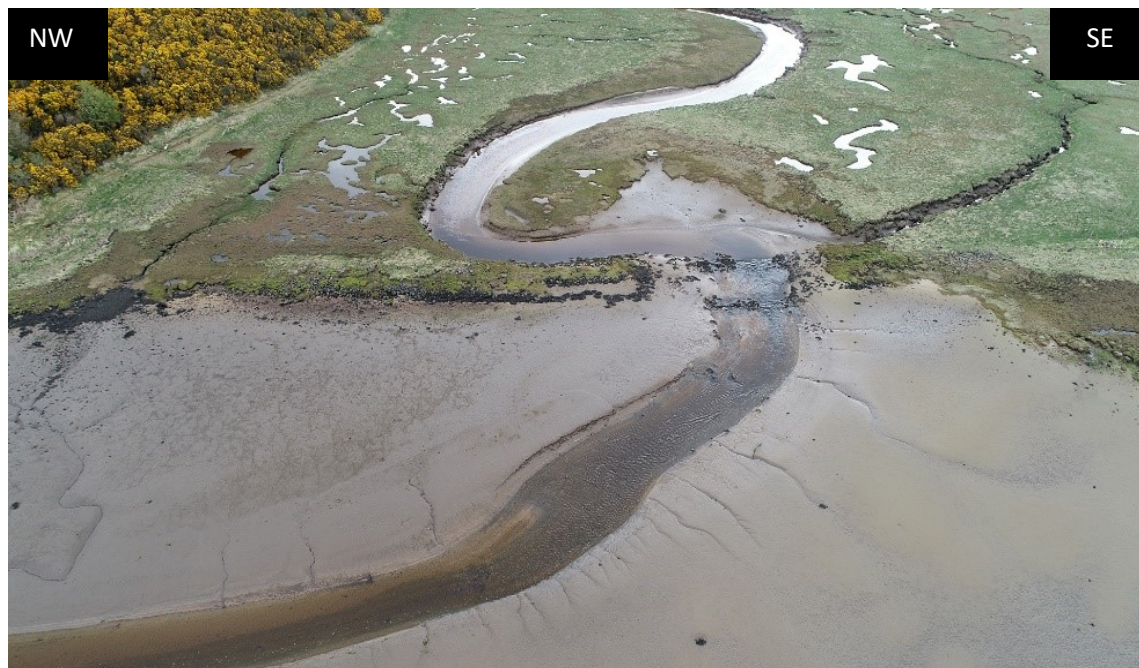
The tide mill at Scottack, Newton of Petty comprises the remains of a dike which dams the Rough Burn and hidden within vegetation to the northwest, the stone footings of a narrow rectangular building constructed on a slight platform just behind the coast edge. The dike is the most visible feature and can be traced for approximately 200 m. The dike consists of three parallel boulder walls filled with mud and shingle (Figure 23).

The tide mill at Scottack is a good example of a tide mill which are rare sites around the Scottish coast. It would benefit from an updated survey.

Figure 23. Remains of tide mill, Scottack (<https://scapetrust.org/sites-at-risk/site/14458>).

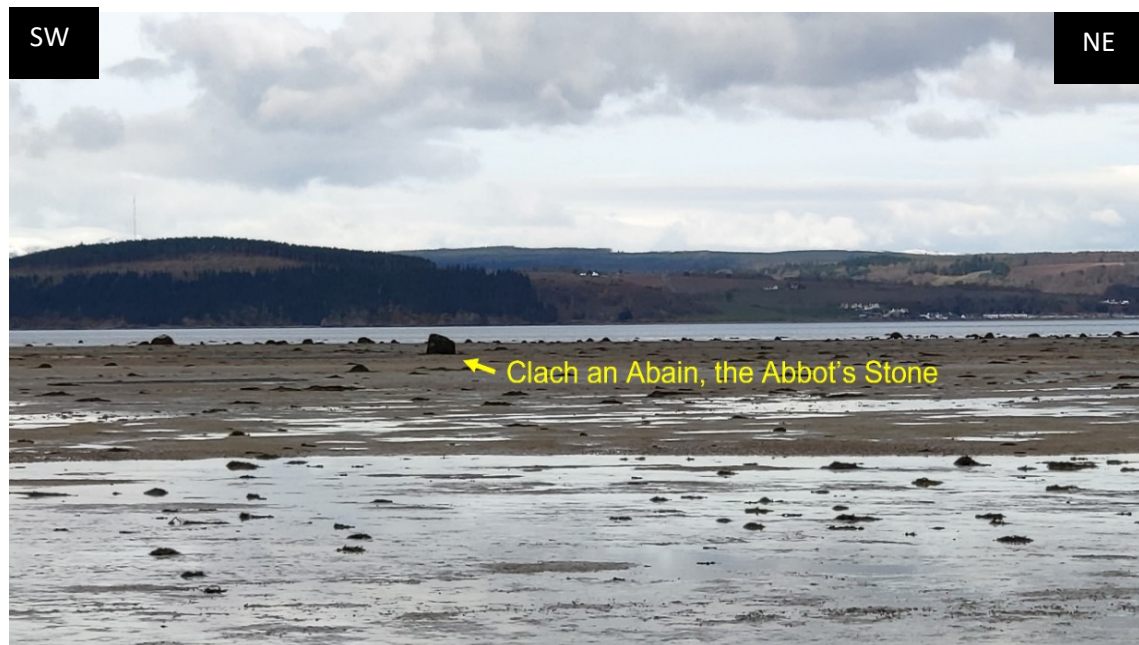
One notable natural feature with an historic association is the Clach an Abain, or the Abbot's Stone (Figure 24), the story of which is told in the Ordnance Survey name book:

Figure 24. The Abbot's Stone, (<https://scapetrust.org/sites-at-risk/site/15489>).
