Coastal Assessment Survey Inner Moray Firth

Dingwall to Tarbat Ness

September 1998

a report for
HISTORIC SCOTLAND

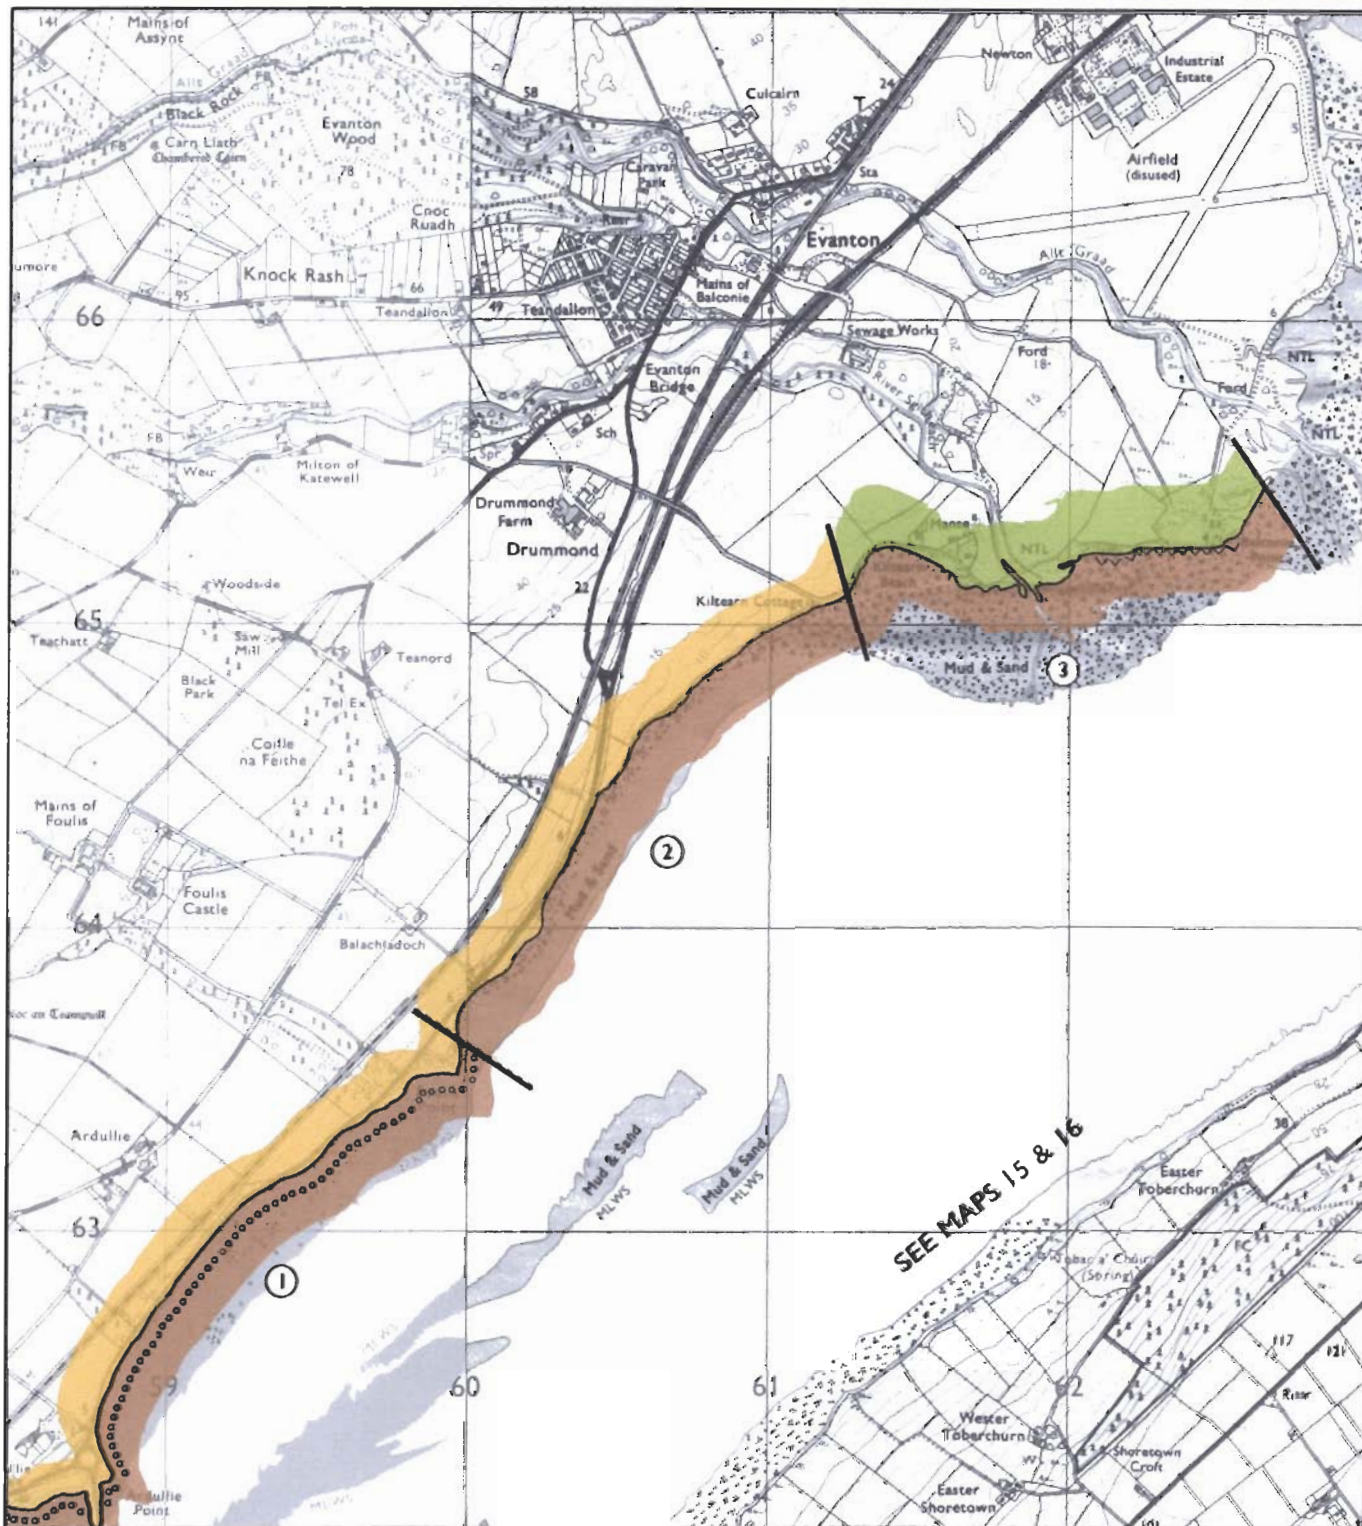
MAP 19: ARDULIE POINT TO BALCONIE POINT 1:25 000

Promontory at the head of two rivers. The hinterland consists of freshwater alluvium below 10m OD. The foreshore is mud and sand with boulders and shingle. River channels are visible at low water.

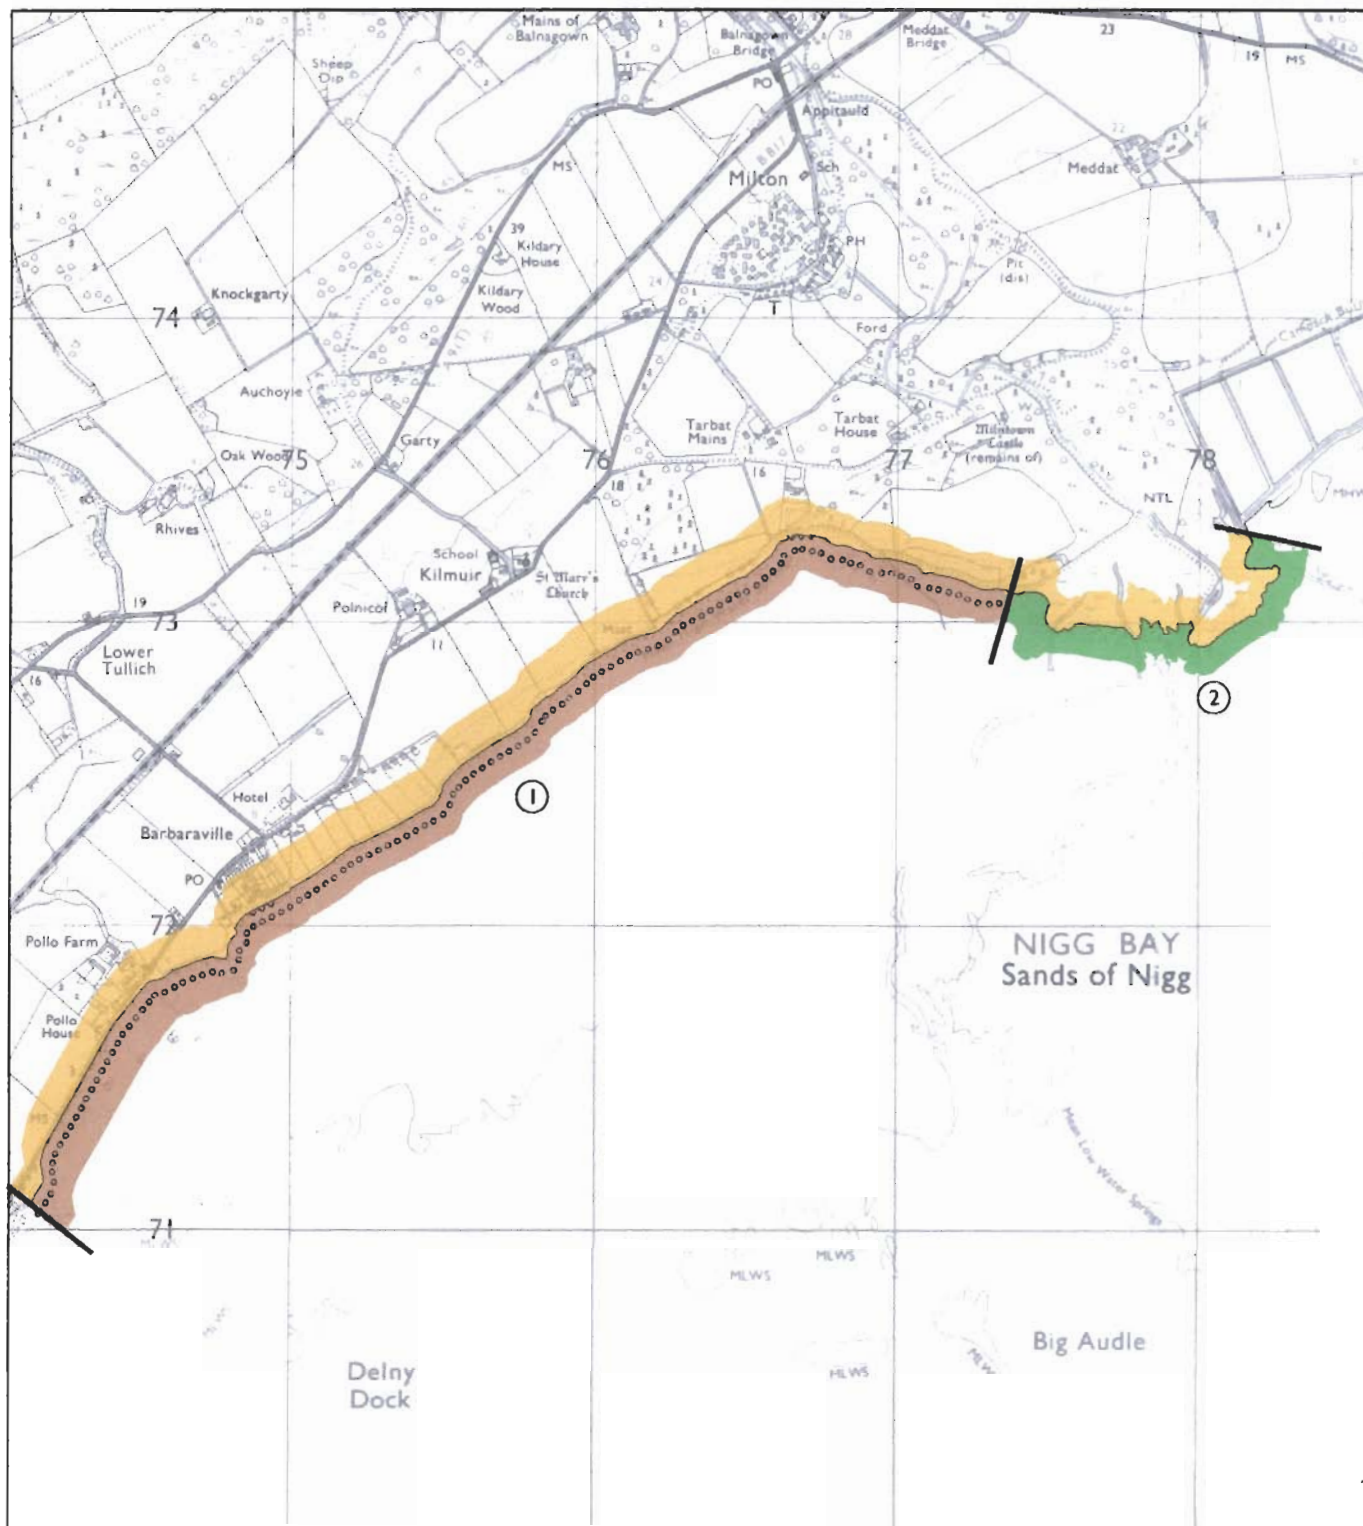
MAP 23: BALINTRAD TO MILTOWN CASTLE 1:25 000

Upper reaches of Nigg Bay consisting of a coastal
edge colonised by saltmarsh. The hinterland is
defended by flood banks and is low lying. The
basal deposits consist of marine derived sand and
gravel.

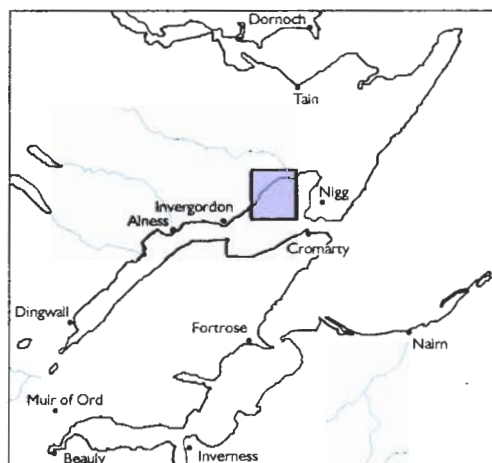
MAP 23: EROSION

The shoreline is dominated by mud and shingle and is well exposed at low tides. There is no indication that conditions are not stable.

Quarried stone defences protect this small hamlet. The shoreline is mainly shingle and at the time of the survey there was no indication that conditions are not stable.

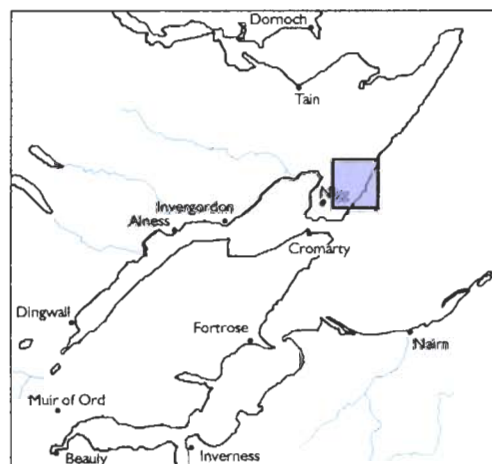
MAP 27: EROSION

Exposed precipitous cliffs continue northwards from Kings Cave. Stable rock platforms outcrop at the base of the cliff. Conditions are generally stable.

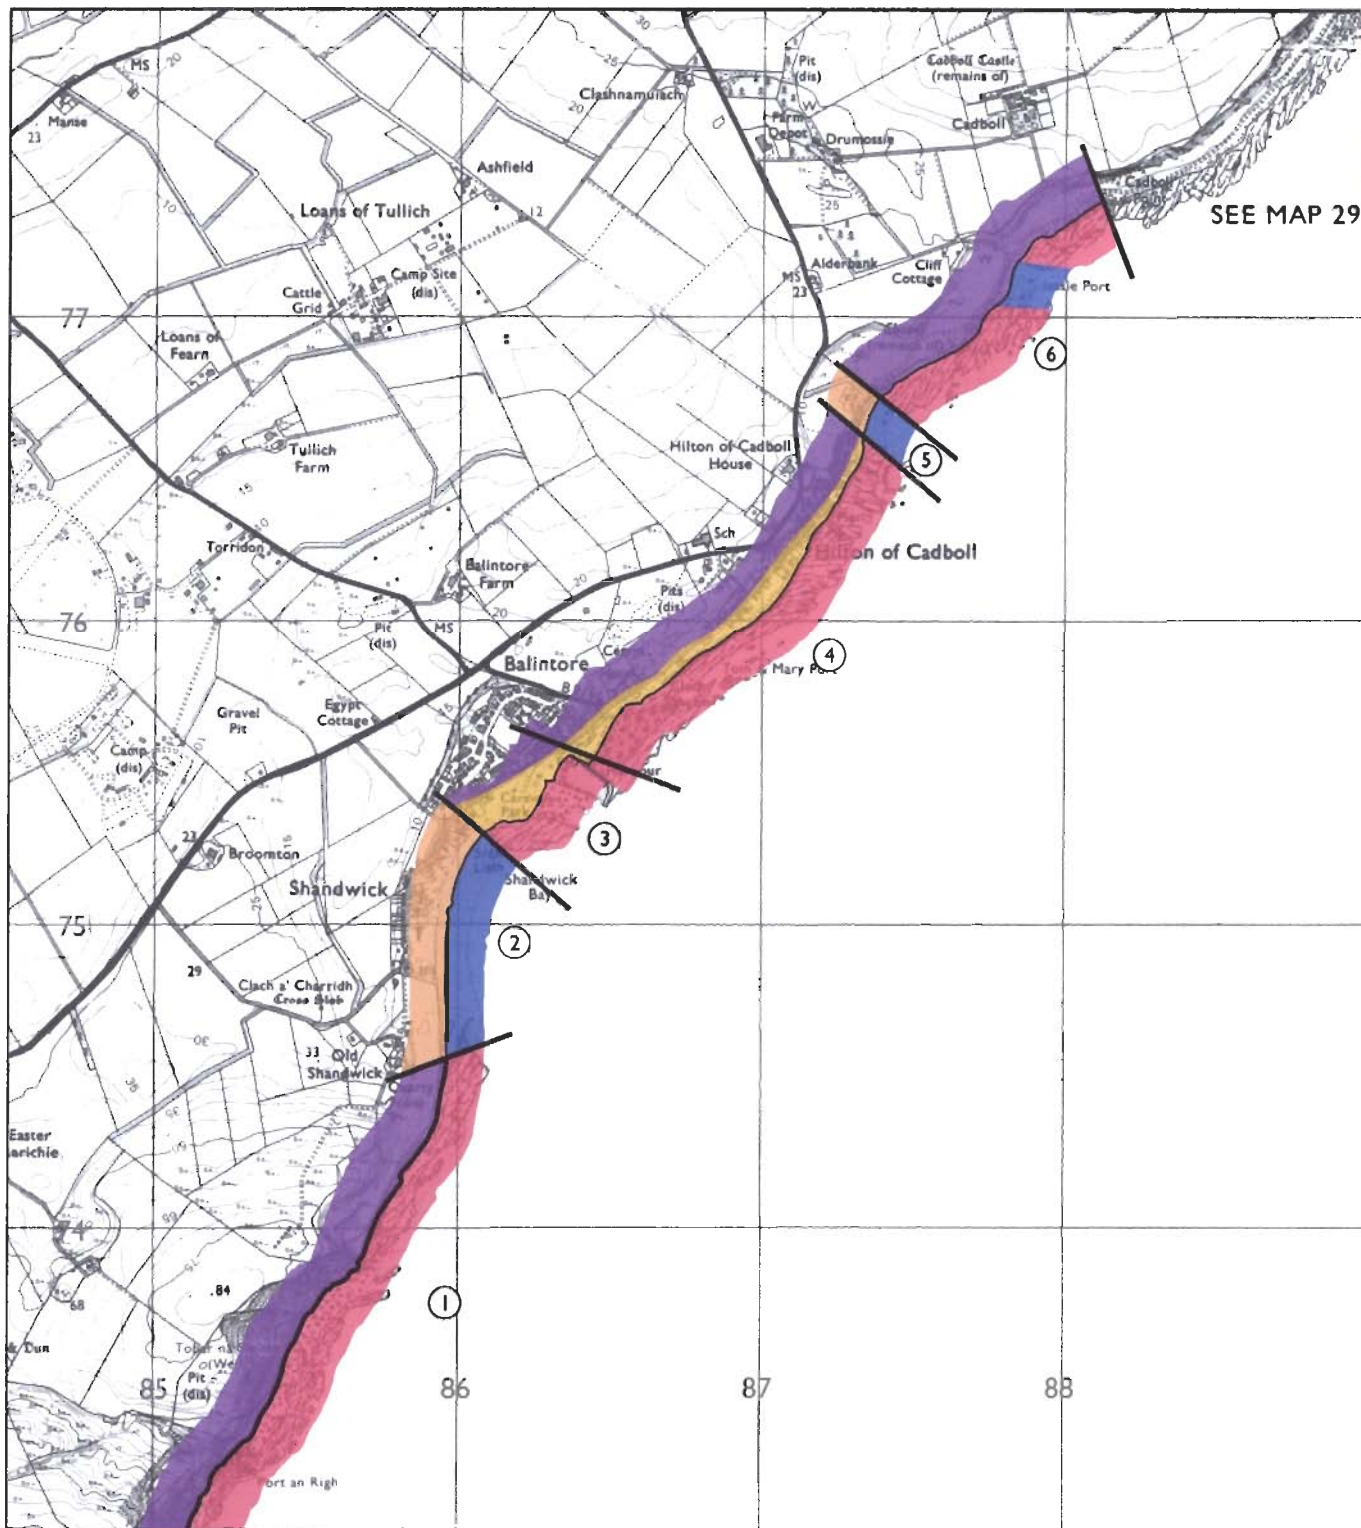
MAP 28: PORT AN RIGH TO CADBOLL

A small bay formed in a cleft of Old Red Sandstone outcrop. Sand entrapment with blown sand towards the backshore zone. The hinterland is low lying.

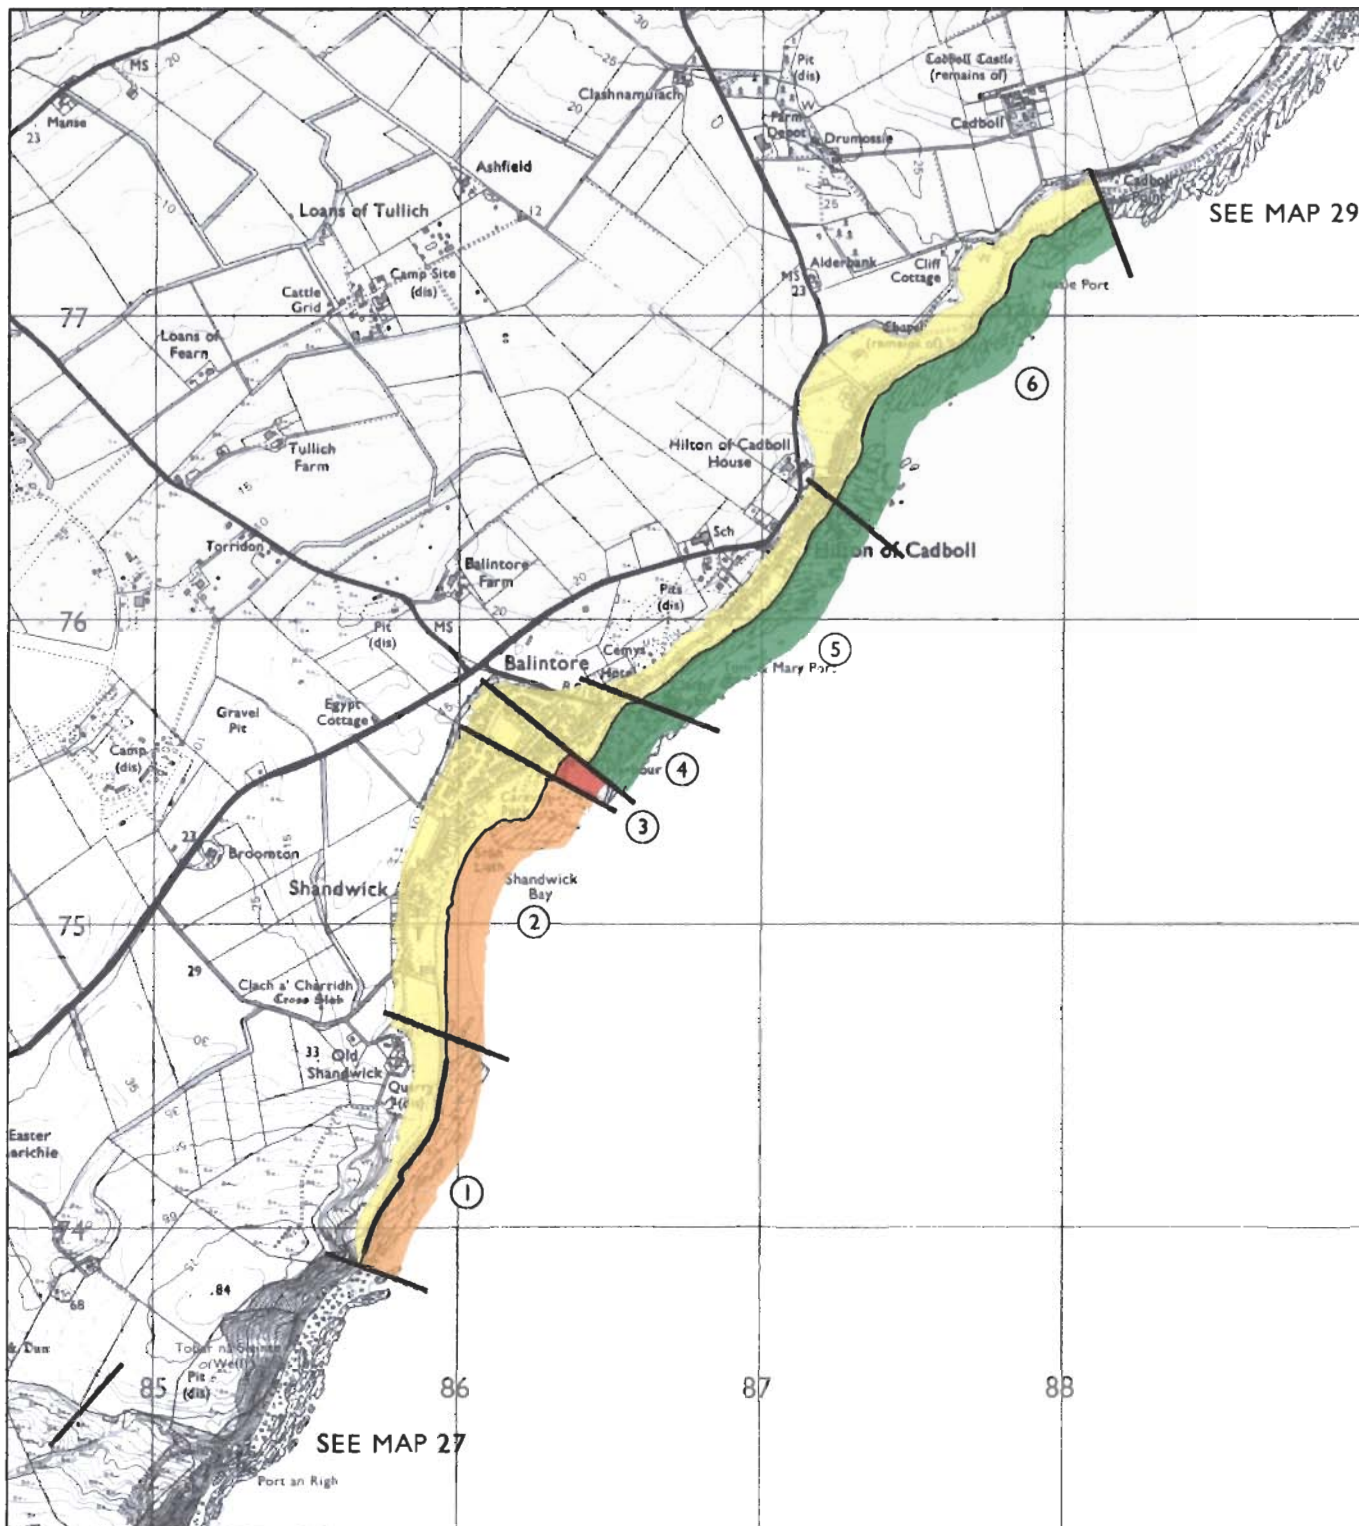
MAP 28: PORT AN RIGH TO CADBOLL

Exposed rock platform with accreting sand and shingle. No evidence for active erosion was seen.
