COASTAL ZONE ASSESSMENT SURVEY KINTYRE & ISLE OF ARRAN

Commissioned by
The SCAPE Trust
on behalf of Historic Scotland

Coastal Zone Assessment Survey Phase III Kintyre and Isle of Arran

Report No. 997

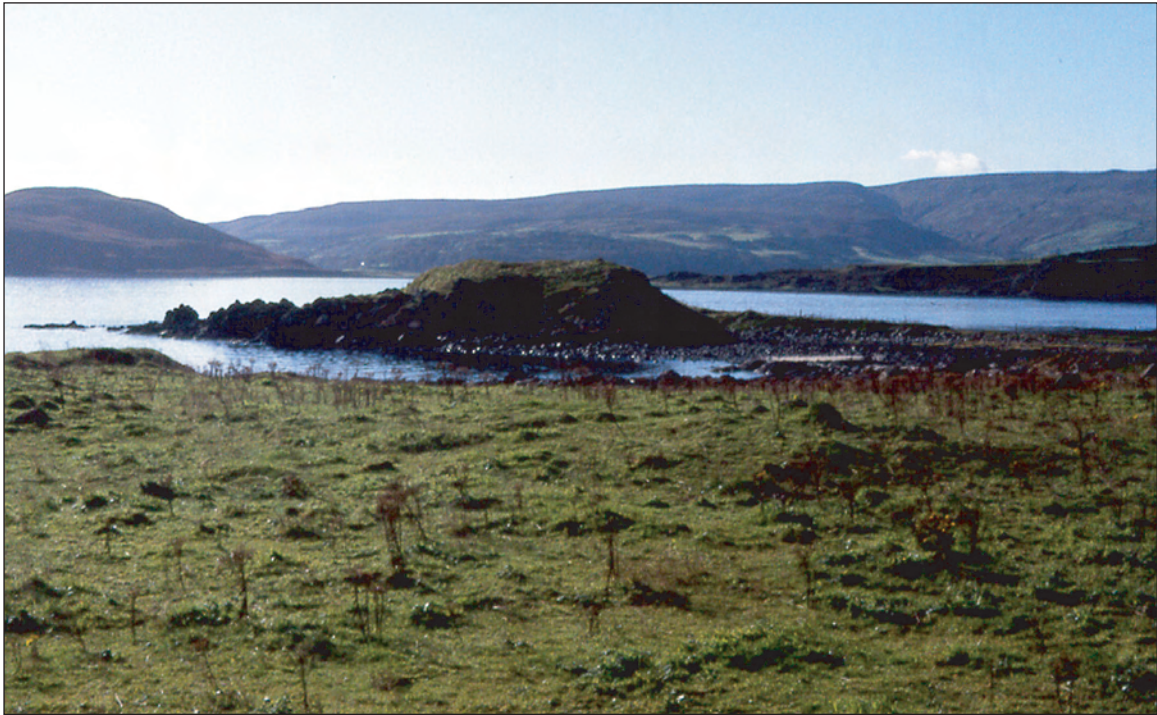
Plate 3 - View of Island Muller with causeway visible to right of picture, Kintyre.
(*Site 173, Map 11*)

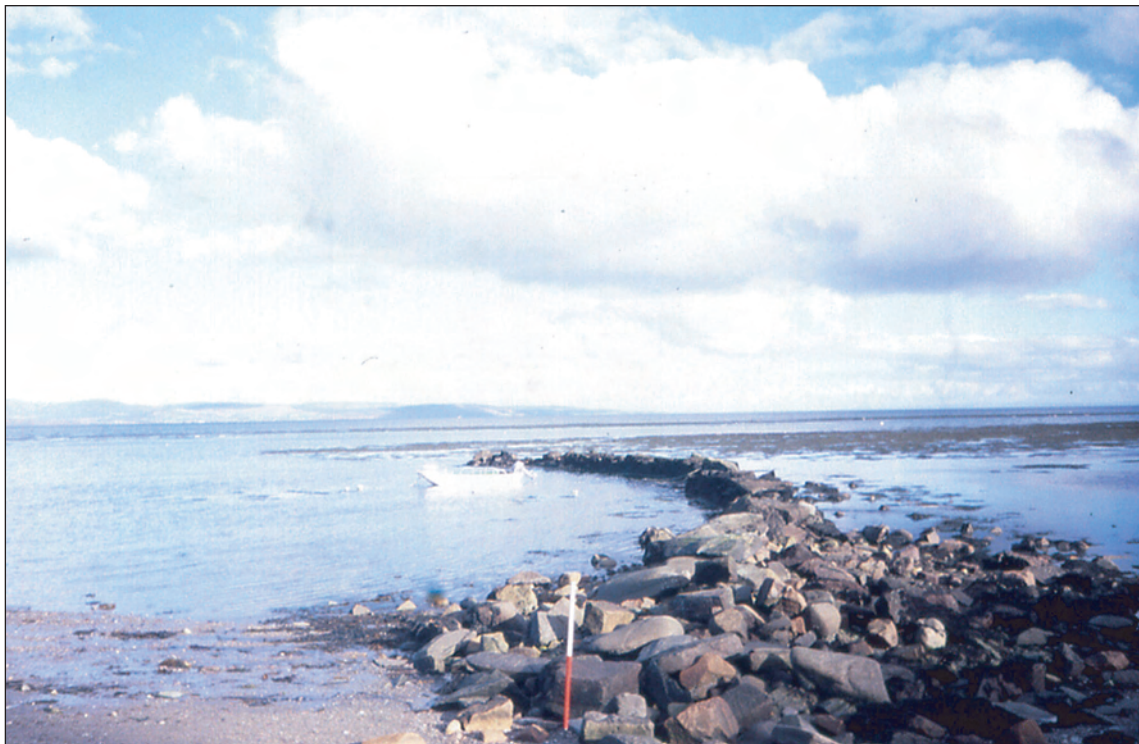
Plate 4 - Stone Jetty in Ardnacross Bay, Peninver, Kintyre.
(*Site 159, Map 11*)
