# Coastal Zone Assessment Survey

## Loch Ryan Report

The SCAPE Trust and University of St Andrews  
December 2023

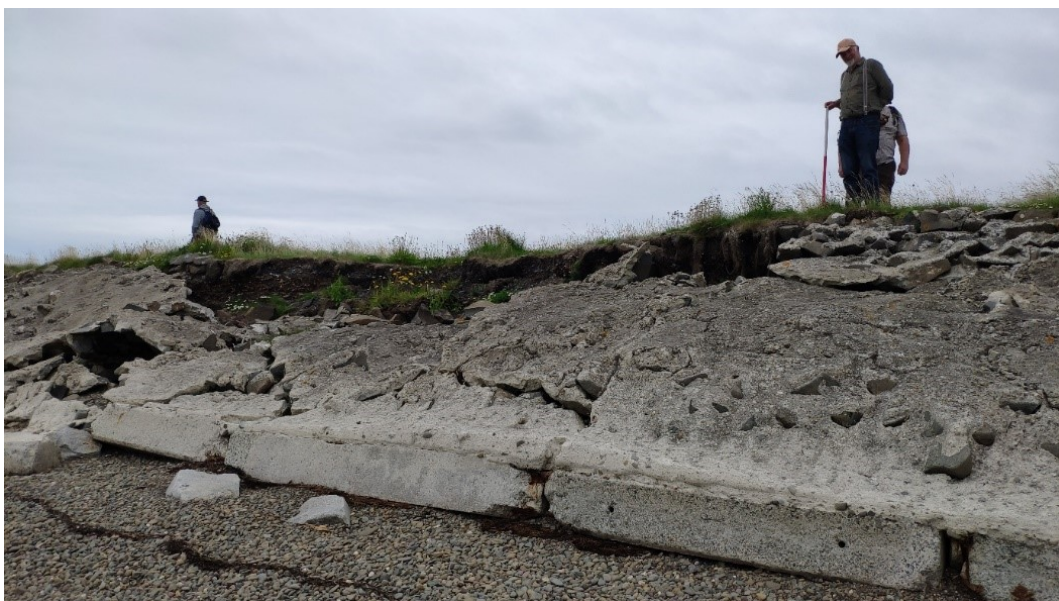
To the east of Stranraer, at Leffnoll Point, the concrete embankment of the former Cairnryan Military Railway is showing significant deterioration and the beginning of erosion of the coast edge sediments behind (Figure 4). Along the coastline at Innermessan there are substantial rock armour hard defences which are largely intact (Figure 5A). The remains of the Cairnryan Military Railway shipbuilding yard at Innermessan are protected by this coastal defence to the north and south of the site, but are still at risk of deterioration and being undermined by wave action, with the slipways and remains of the concrete pontoon being particularly at risk of further erosion (Figure 5B,C).

Figure 4. Deteriorating concrete railway embankment at Leffnoll

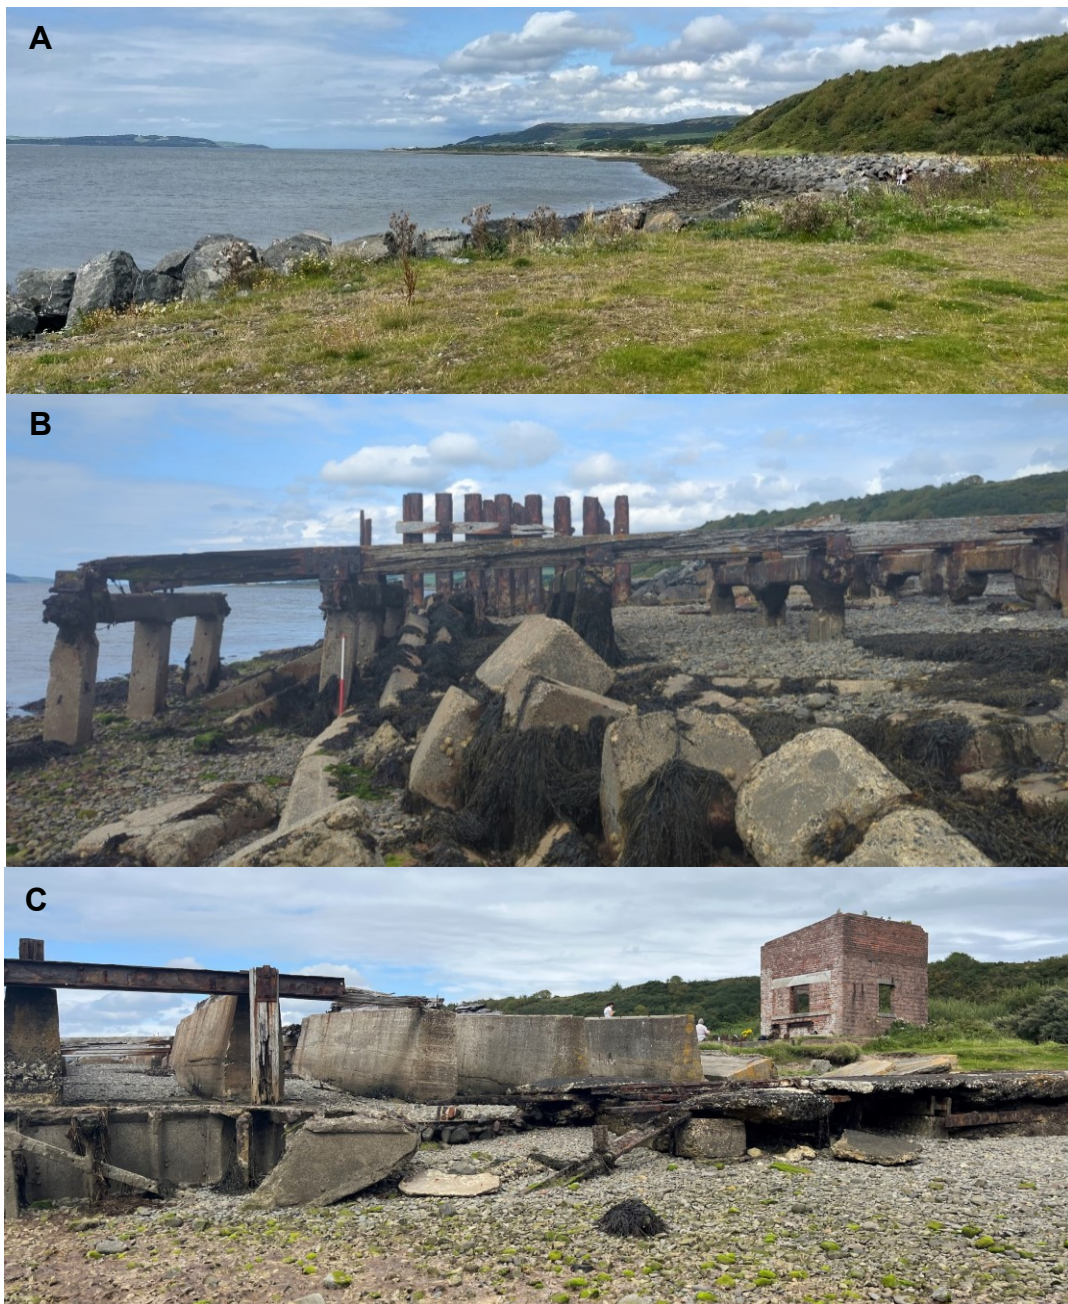
Figure 5. A. Coastline at Innermessan defended by rock armour; B & C. Infrastructure relating to the Innermessan Military Railway [SCAPE ID: [15815](#)] are at risk of deterioration and concrete elements being undermined, despite defences installed either side of the site.

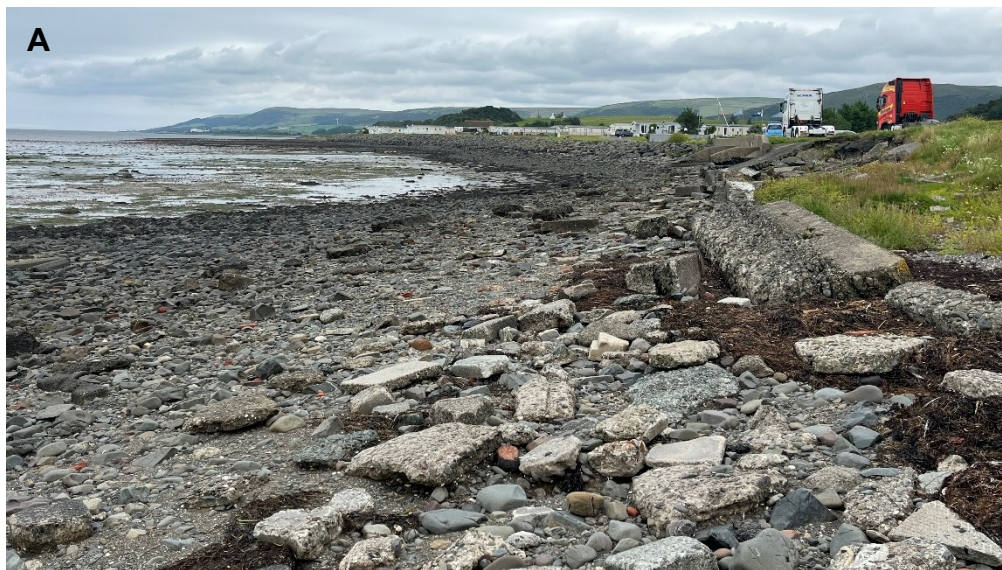
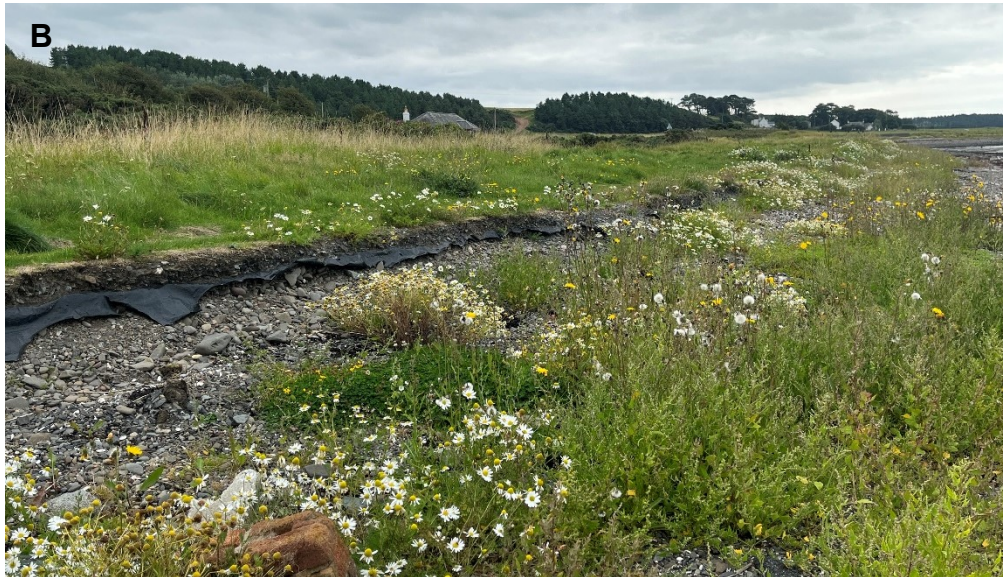
The broken up remains of concrete coastal defences are scattered over the shingle beach between Stranraer and Innermessan (Figure 7A). In places the coastal path is eroding and exposing geotextiles and base courses of the landscaped coast edge (Figure 7B).

Figure 7.A. Remains of broken up concrete coastal defence and B. erosion of now vegetated coastal track with geotextiles exposed, between Stranraer and Innermessan.

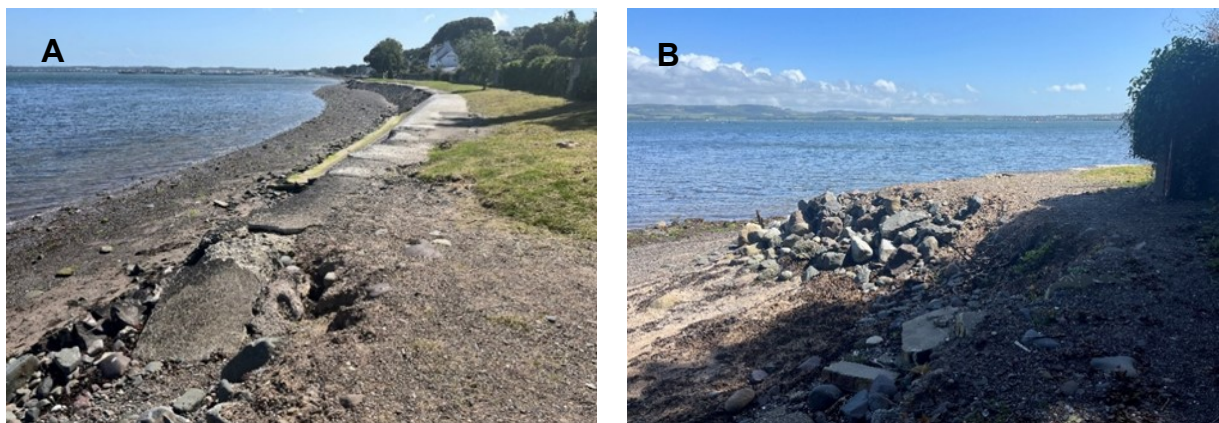
On the western extremity of the urban area of Stranraer, c.230m between Broadstone Road and McCulloch's Point, the coastline is defended by a stretch of concrete sea wall. Local volunteers informed us that these defences had suffered collapse in the previous year and had been repaired earlier in 2023. However, clear signs of further deterioration were noted, especially at either end of the concrete defence, indicated an ongoing battle with erosion along this coastal stretch. At the northern end of the sea wall, at the boundary between defended and undefended coast, an area of accelerated erosion has occurred where wave energy is intensified at the juncture between hard engineering and unprotected coast edge (Figure 8A, B).

Figure 8A. Damage to concrete coastal defence at McCulloch's Point. Figure 8B. Large erosion "bite" where coastal defence finishes, and wave energy is accentuated.

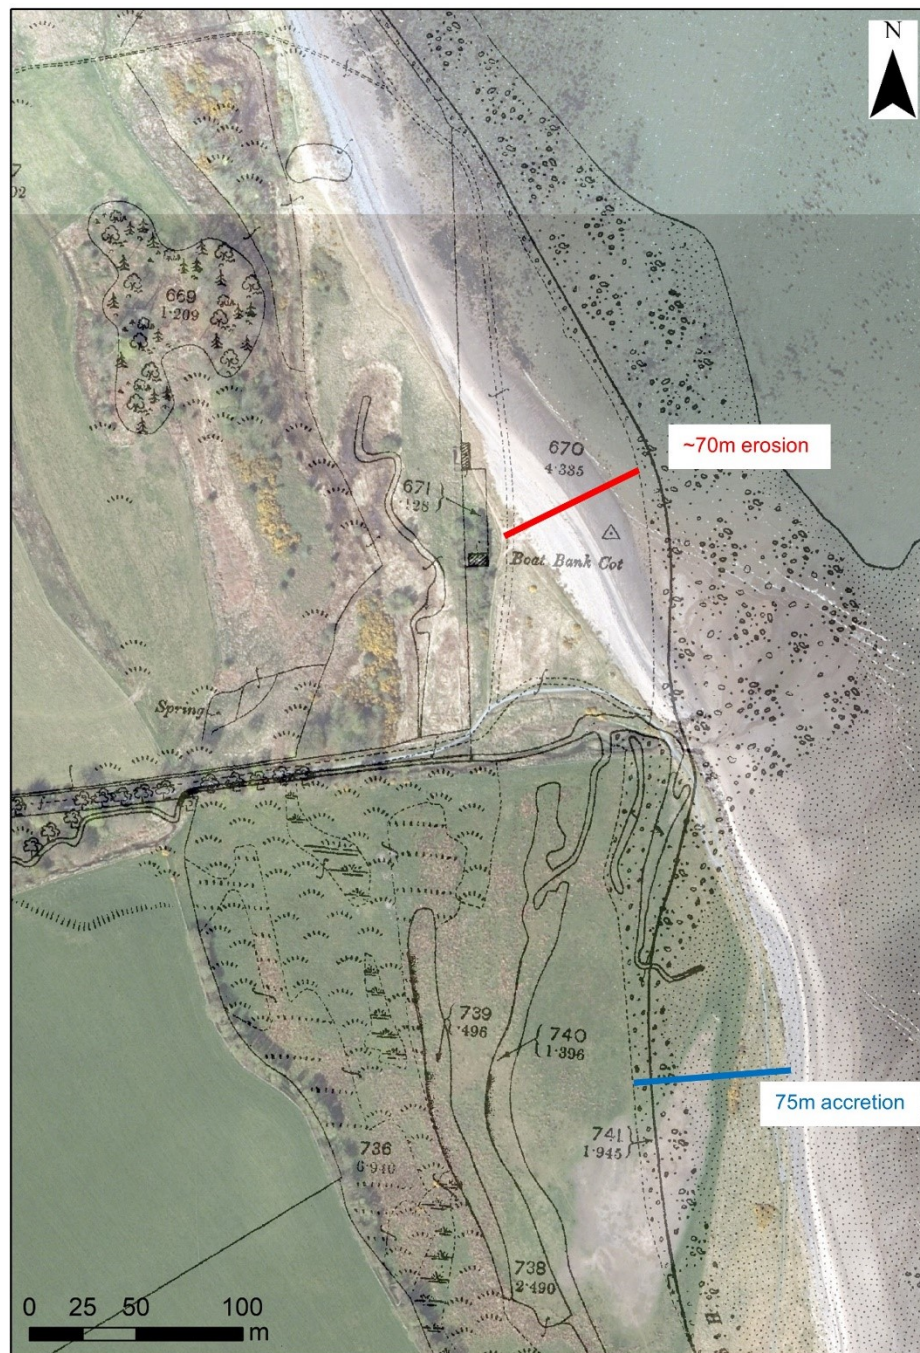
At the Corsewall Burn on the coast east of Kirkholm, erosion was noted to the north of the outflow, whereas the coastline appears to be accreting to the south. Significant historic coastal change has occurred along this coastline around the burn mouth, with approximately 70m of erosion north of the outflow and 75m of sediment accreting to the south of the outflow over the last 130 years (Figure 10).

Figure 10. Comparison of coast edge using modern satellite imagery (High Resolution (25cm) Vertical Aerial Imagery, Getmapping 2022) and 1893 historic mapping (1:2500 County Series 1<sup>st</sup> Revision [TIFF geospatial data], Scale 1:2500. Tiles: wigt-nx0368-2.tif, wigt-nx0369-2.tif, Updated: 30 November 2010, EDINA Digimap supplied service).

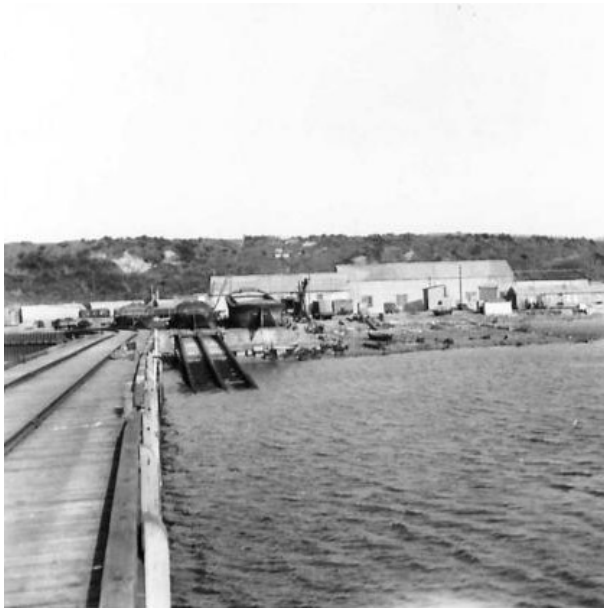
Figure 12. Photograph of Innermessan slipway and workshops taken from jetty, 1944. Courtesy of Imperial War Museum. Photographer: Sergeant Palmer. © IWM H 40156

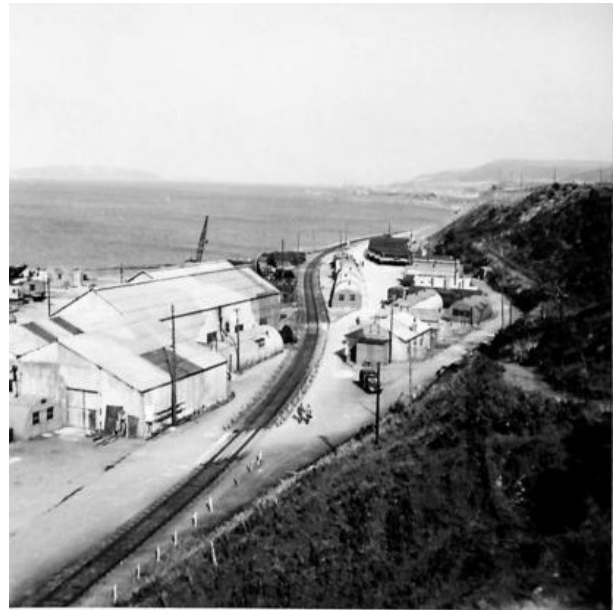
Figure 13. Photograph of Innermessan looking northwest from cliff. 1944. Courtesy of Imperial War Museum. Photographer: Sergeant Palmer. © IWM H 40123

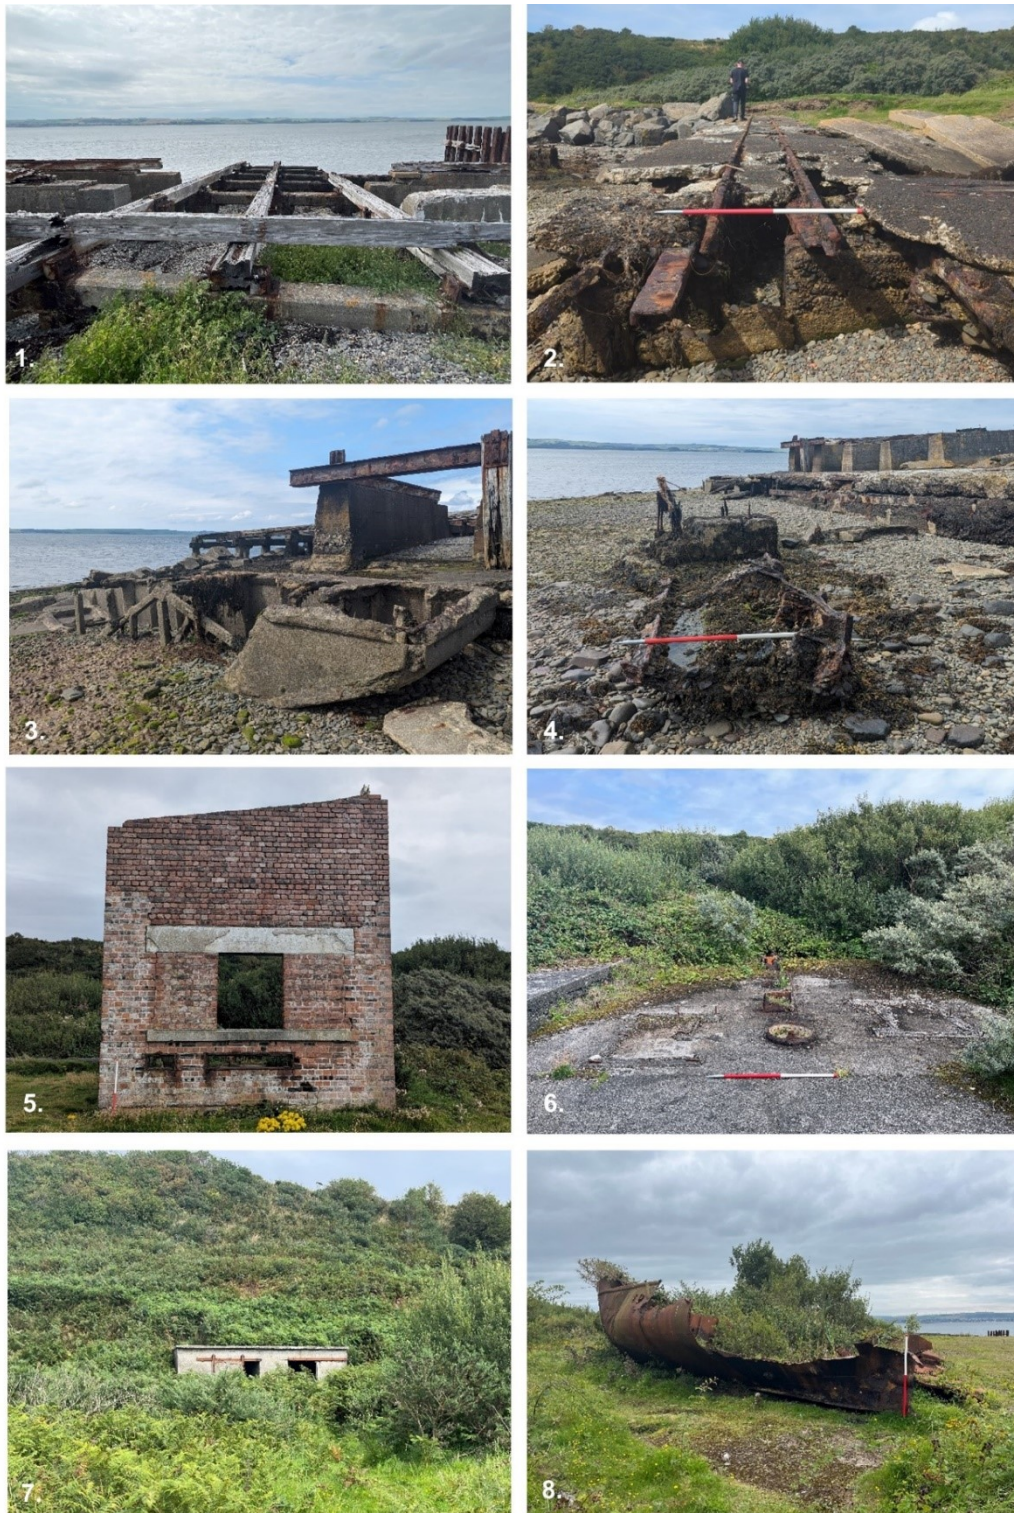
Approximately 40m inland of the site is the remains of an iron vessel, not thought to be related to the WW2 construction yard. A concrete shed is built against the raised shoreline slope face. Photographs of each main element observed across the site are shown in Figure 15.

Figure 15. Photographs of numbered elements located in Figure 10: 1) timber and concrete slipway; (2) railed slipway; (3) remains of concrete boat; (4) unidentified object (float?); (5) winch house; (6) concrete base; (7) concrete shed; (8) remains of hull of iron ship.

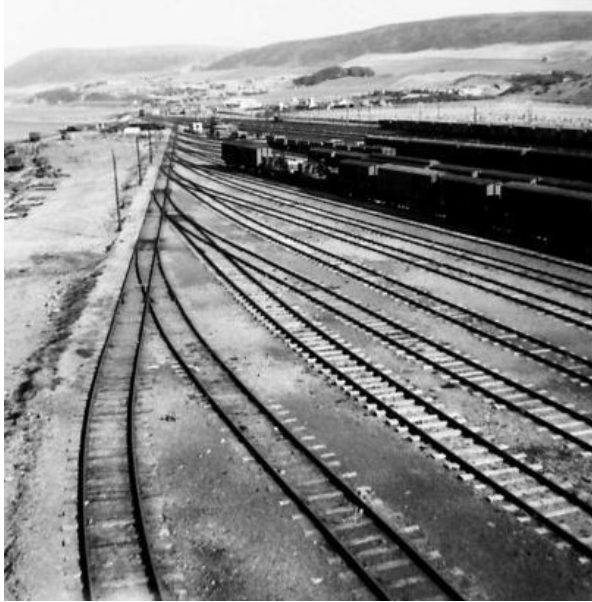
*Figure 16. Leffnoll Sidings looking northeast from water tower, 1944. Courtesy of Imperial War Museum © IWM H 40121.*

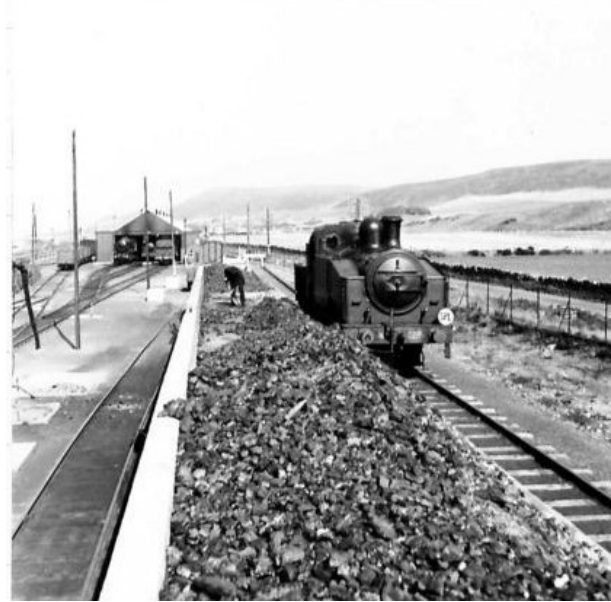
*Figure 17. Coal bunkers, Leffnoll sidings, 1944. Courtesy of Imperial War Museum © IWM H 40130.*

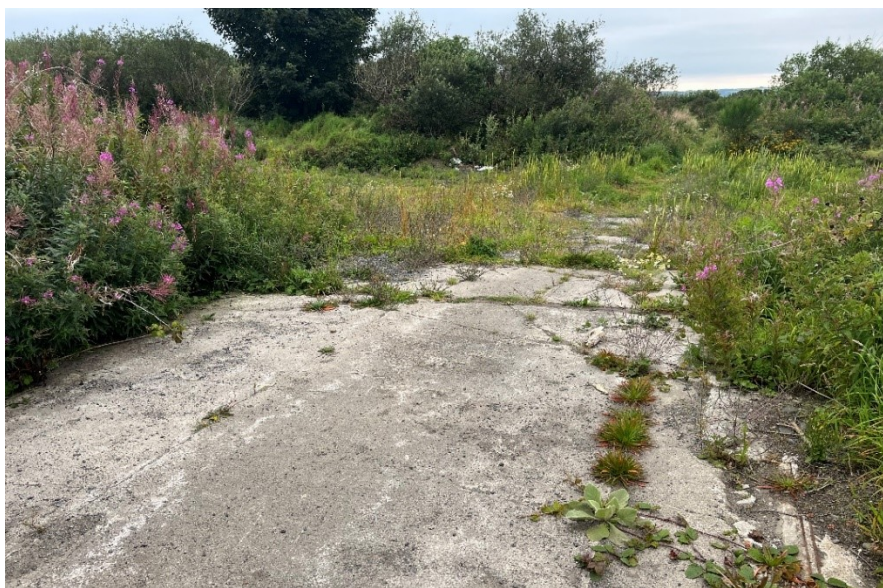
During the August CCZAS, the point was vegetated and almost all traces of the once extensive railway development at Leffnoll are now gone. Exceptions to this are visible patches of concrete underfoot, within which iron railings can be observed (Figure 18).

*Figure 18. Concrete remains with metal rails, Leffnoll Point (<https://scapetrust.org/sites-at-risk/site/15820>).*

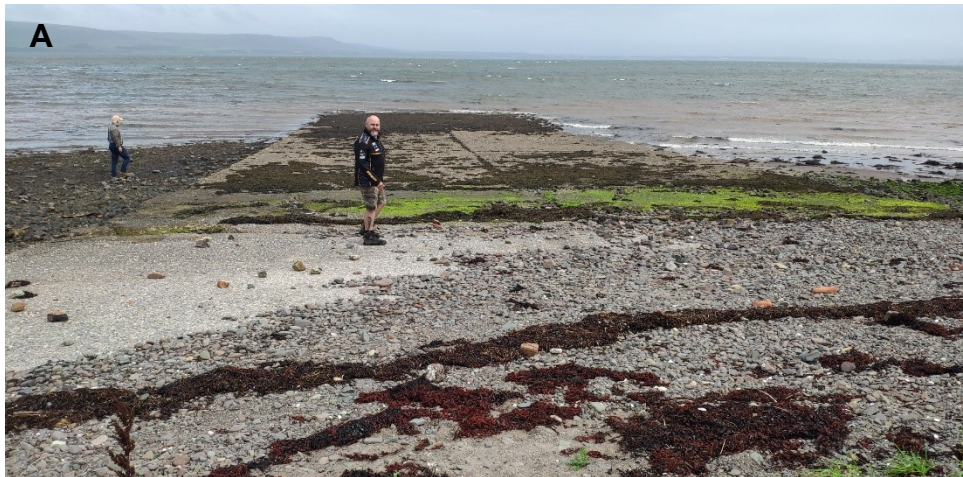
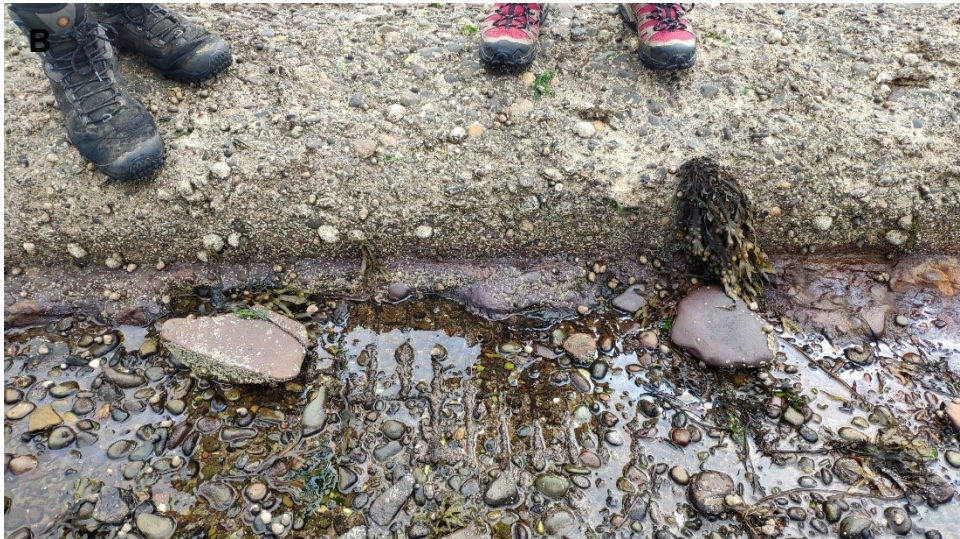
The two flying boat slipways, constructed from concrete with metal mesh extensions, are situated on Wig Sands (Figure 19A,B). The slipways were used to haul in flying boats for servicing and maintenance. The two mesh slipways extend much further offshore into the loch than is visible from the shore - the scale of the slipways can be appreciated on modern satellite imagery. Photographs were taken on the survey at approximately 1.5hrs off low tide.

Figure 19. Flying boat slipway (western slipway), Wig Bay. A. General view of slipway, looking southeast; B. Close up of iron mesh construction. (<https://scapetrust.org/sites-at-risk/site/12372>).

Two of these are the intertidal flying boat slipways in Wig Bay, which have a recommendation to monitor at 3–5-year intervals. The slipways are of reinforced concrete construction and have deteriorated since visited in 2015.

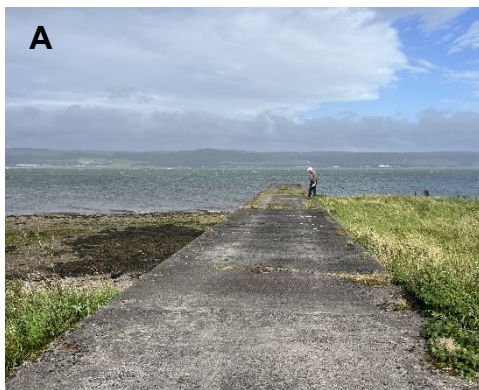
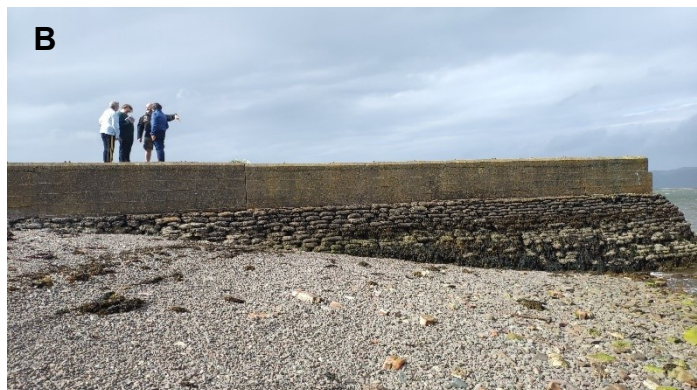
The fuel jetty, situated c.380m north of the Glenside slipway, was constructed around 1940 to service RAF Wig Bay. It has a similar construction to the Glenside slipway - a foundation of cement and stone chipping filled sandbags overlain by pre-cast concrete slabs of the same material (Figure 20A,B). Remains of an iron rail was observed along both sides of the jetty.

Figure 20. A. View along concrete jetty, looking northeast across Loch Ryan; B. Side view of jetty showing foundation of cement and stone chipping filled sandbags, and pre-cast concrete slabs of the same material. Looking north (<https://scapetrust.org/sites-at-risk/site/16173>).

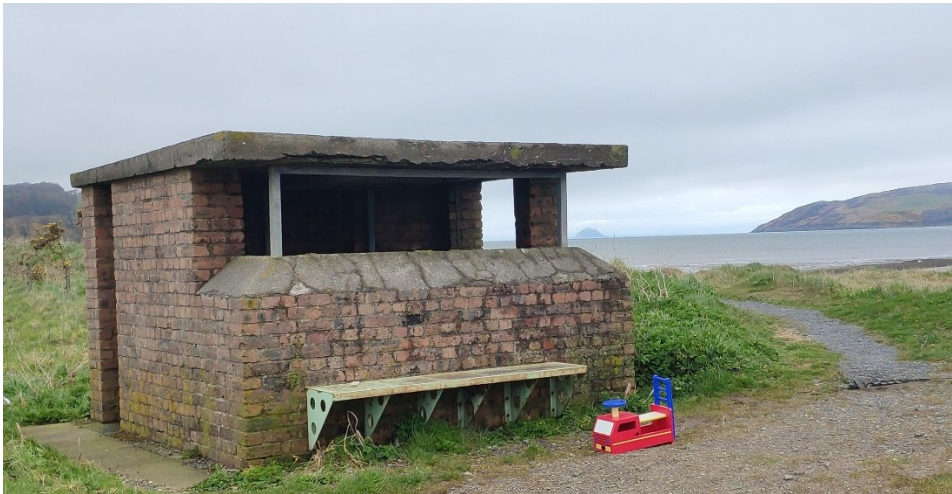
At the eastern end of Wig Bay is a solitary observation post, a rectangular structure built of red brick with a flat, reinforced concrete roof (Figure 15). Recently restored as part of the Solway Military Trail, the post is generally in good condition, with some cracking in the brick walls.

Figure 15. Observation post, Wig Bay. (<https://scapetrust.org/sites-at-risk/site/12370>).

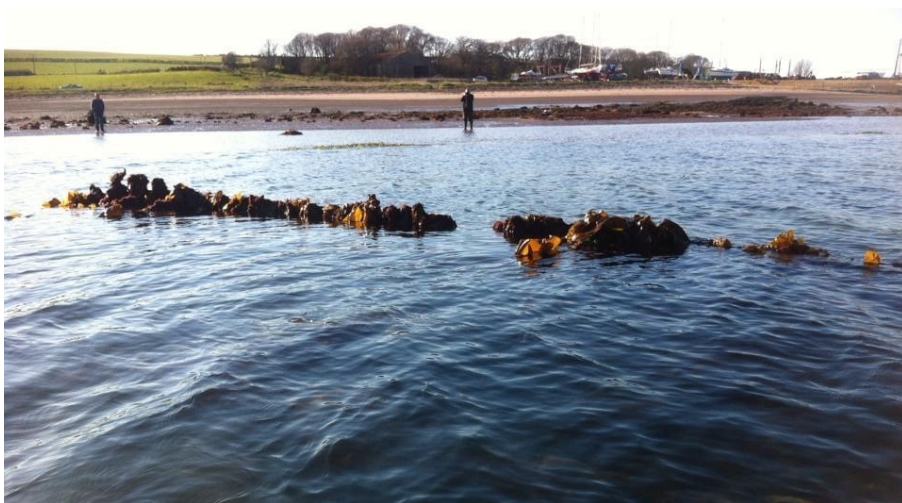
A known wreck site, situated just south of the slipway at Glenside, is thought to be that of a flying boat [SCAPE ID: [16224](#)]. The wreck was not visible at the time of survey, however, it has been extensively researched and photographed at a very low tide by survey volunteer, Matt Halliday (Figure 21). The wreck is situated in relatively shallow water and on an extremely low spring tide, it has been seen on satellite imagery to be completely out of the water. The ribs of the wreck are jagged, where they have been cut down to the aircraft's waterline, presumably during scrapping *in situ*. The keel of the wreck is covered in concretions and seaweed, but there are recognisable rivet patterns, which could match those of a Short Sunderland. The other aircraft type that the wreck could be is that of a SARO Lerwick - a type of aircraft retired from service after only 3 years (21 built, 11 lost, 4 of which were lost at Wig Bay). A suggestion for identification of the wreck is the Short Sunderland T9073 [Canmore ID: [299200](#)], as it was the only Sunderland at Wig Bay that caught fire as opposed to having "sank at moorings". This suggests that it would have been harder to have refloated the craft to be brought ashore for scrapping.

*Figure 21. View of wreck at very low tide, looking northwest towards the coast. Glenside slipway can be seen in top right of photograph (<https://scapetrust.org/sites-at-risk/site/16224>). Photo credit: Matt Halliday.*

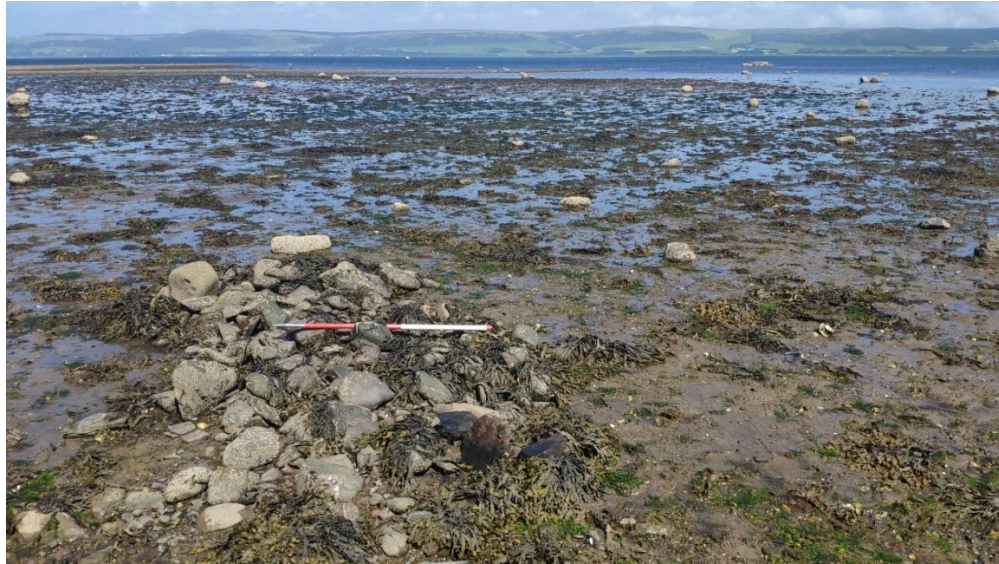
Close to the site of the old Waulk Mill, approximately 760m to the northwest of McCulloch's Point, a 4m x 1m pile of sub angular stone has been interpreted as the remains of a ballast mound of a small boat (SCAPE ID: [16171](https://scapetrust.org/sites-at-risk/site/16171), (Figure 22).

*Figure 22. Ballast mound in intertidal zone close to the site of the Waulk Mill (<https://scapetrust.org/sites-at-risk/site/16171>).*

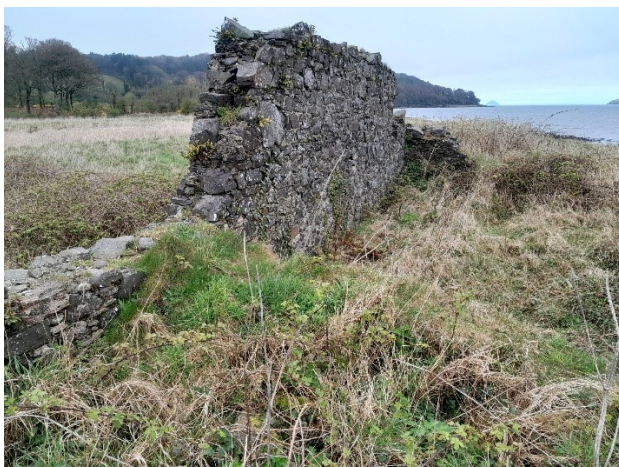
The ruinous remains of two small stone buildings on either side of a stone-walled enclosure oriented parallel to the shore were recorded at Wig Sands, east of Kirkcolm. The northernmost building is the smaller of the two, where only parts of the walls survive (SCAPE ID: [15807](https://scapetrust.org/sites-at-risk/site/15807), Figure 23). On the south side of the enclosure is the larger of the two buildings (SCAPE ID: [15808](https://scapetrust.org/sites-at-risk/site/15808), Figure 24). It has twentieth century brick extensions and modifications which relate to its re-use in the Second World War. The complex is mapped on the first and second editions OS. The site is not currently at risk of coastal erosion.

Figure 23. Boat Bank Cot, North. Surviving northwest corner of building, looking north (<https://scapetrust.org/sites-at-risk/site/15807>).

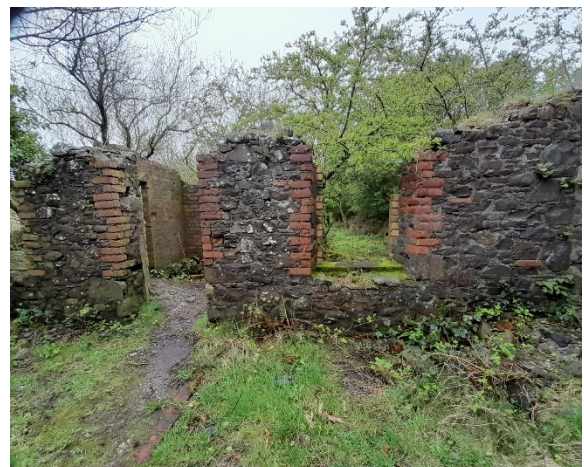
Figure 24. Boat Bank Cot, South. North wall with modified brick-lined openings and brick internal wall (<https://scapetrust.org/sites-at-risk/site/15808>).

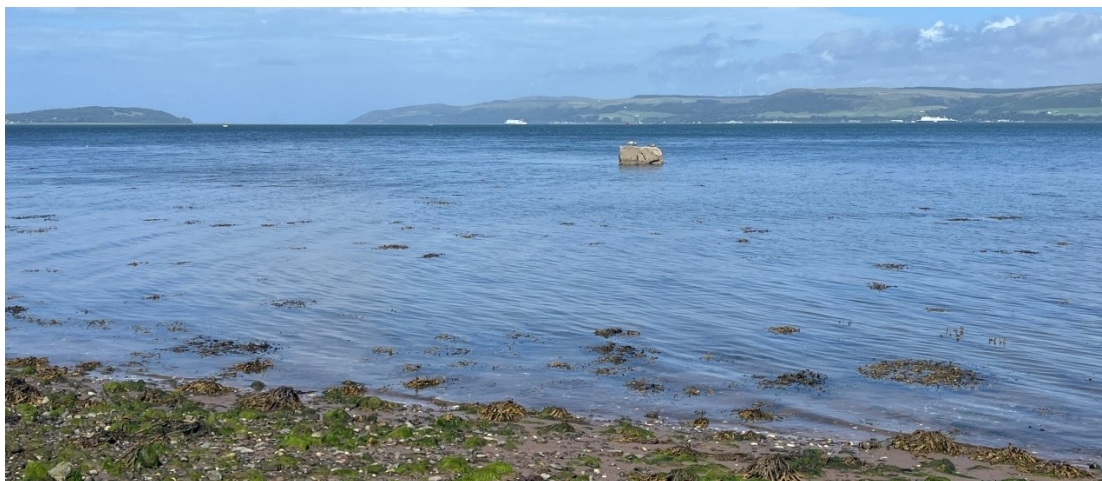
A notable example of a large boulder which may have been a boundary stone or marker is situated c.80m offshore at McCulloch's Point (SCAPE ID: [15843](#), Figure 25). This feature is known as the 'Broad Stone' on the second edition Six Inch historic Ordnance Survey (1893). It is described in the OS Name Book as:

Figure 25. The 'Broad Stone' boundary(?) or marker (?) stone (<https://scapetrust.org/sites-at-risk/site/15843>).

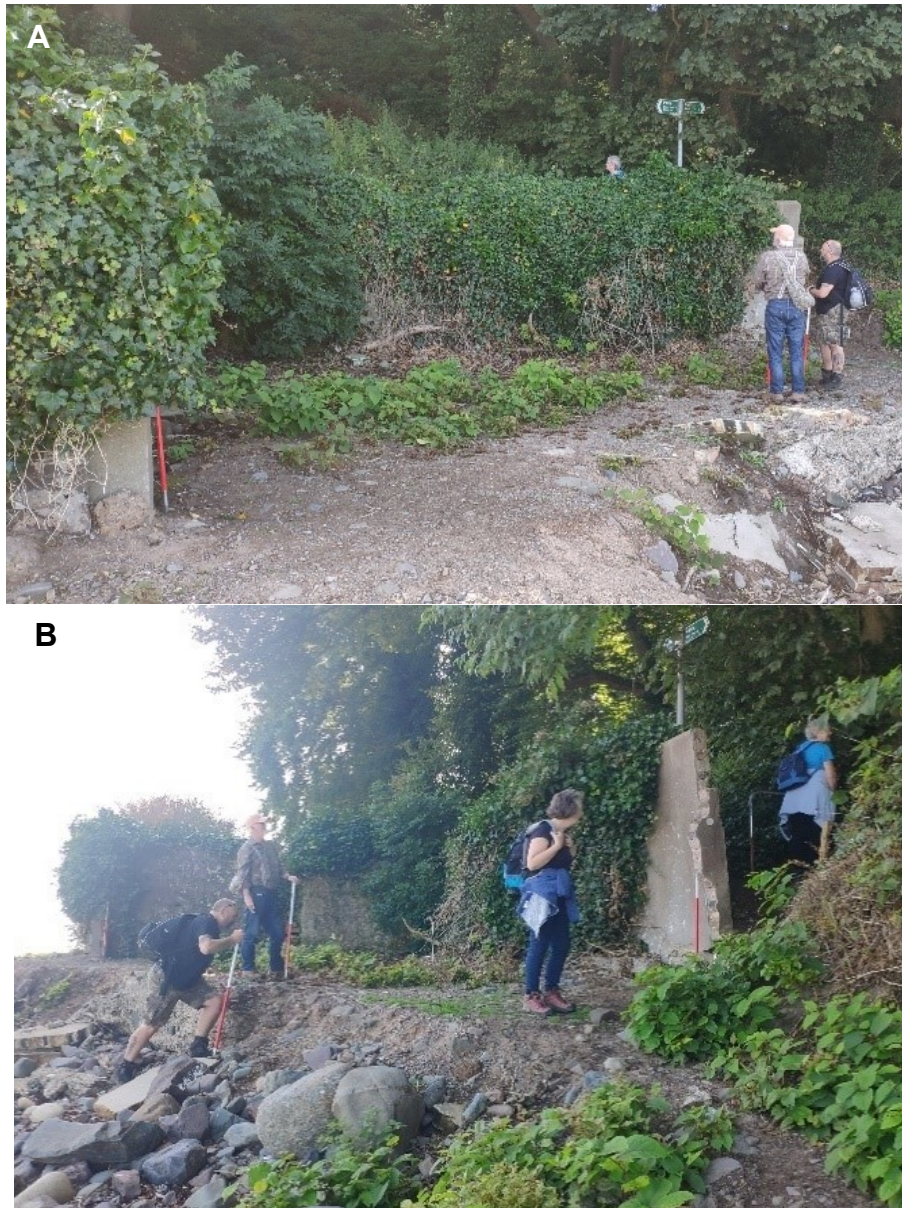
Situated on the coastal path at McCulloch's Point, there are the remains of a rectangular brick building, with only the south and west walls surviving (Figure 27A, B). The building is oriented N-S and dimensions are c. 12m X 6m, with surviving walls c. 2m high. The existing stone boundary/garden wall of Broadstone House forms the south wall with brick walls built against it to create the building. The building dates to sometime between 1847 and 1893, as it is depicted on the second edition but not the first edition Ordnance Survey. Interestingly, a jetty is mapped here on the first edition. Bricks within the construction are stamped with a "K" – these could be

A. Kenneth & Sons, Ayrshire, bricks ([Scottish Brick History](#), 2023). A track leads to the building which may have been a boathouse or shed.

Figure 27. Remains of brick building at McCulloch's Point/Broadstone House; A: south gable wall, looking south; B: general view, looking at west wall, looking northwest (<https://scapetrust.org/sites-at-risk/site/16170>).

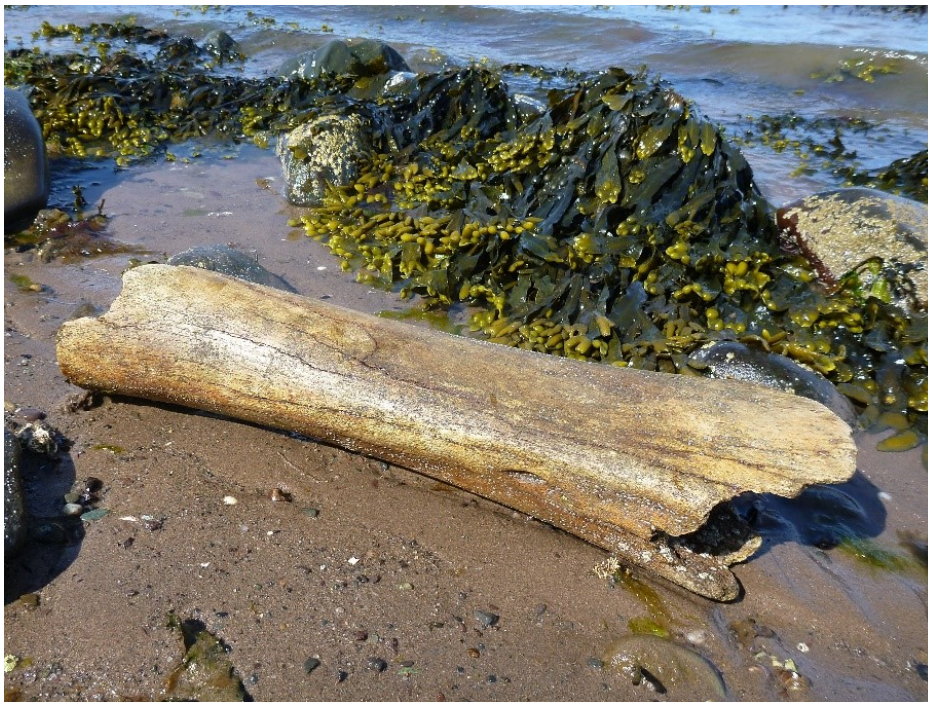
Two findspots relating to recent finds of a mammoth bone [SCAPE ID: [16157](#)] and mammoth tooth [SCAPE ID: [16159](#)] were visited during the survey. The mammoth bone, approximately 0.6m in length, was found in 2018 by Nic Coombey, [Solway Firth Partnership](#), when walking along the beach at McCulloch's point (Figure 28). The fragment of femur bone was found lying washed up on the sandy shore. It is 47,500 years old. In 2022, further north along the coast near

Figure 28. Photograph of femur bone lying on the sandy beach where it was discovered in 2018 at McCulloch's Point. Photo credit: Nic Coombey.
