Coastal Zone Assessment Survey

Moray: Culbin to Cullen

The SCAPE Trust and University of St Andrews
April 2023

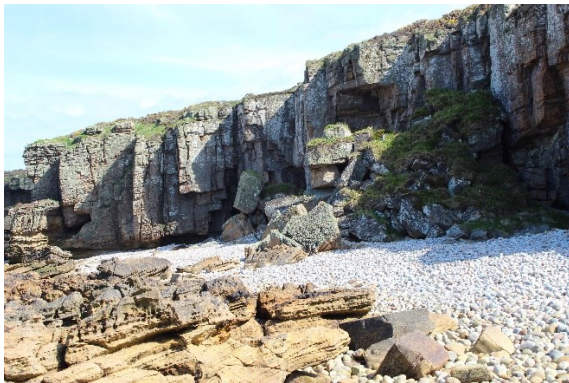
Figure 4A. Major cliff collapse, Covesea. This looks like it occurred some time ago.

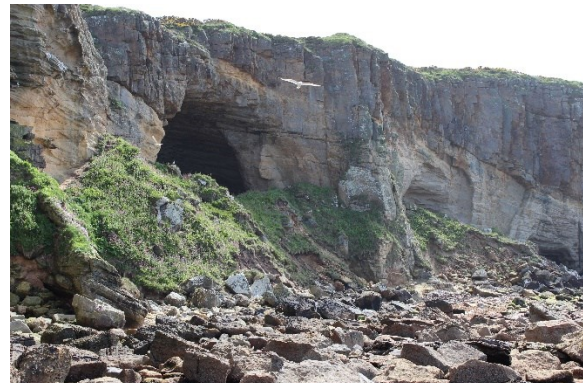
B. fresh cliff collapse around two of the Covesea Caves [[SCAPE ID 14280](#) and [14220](#)]

Caves at Covesea are a significant national heritage asset on the Moray coastline. These are under active investigation in a wider academic research project, however, occasional condition monitoring in the face of periodic cliff erosion and collapse would be useful.

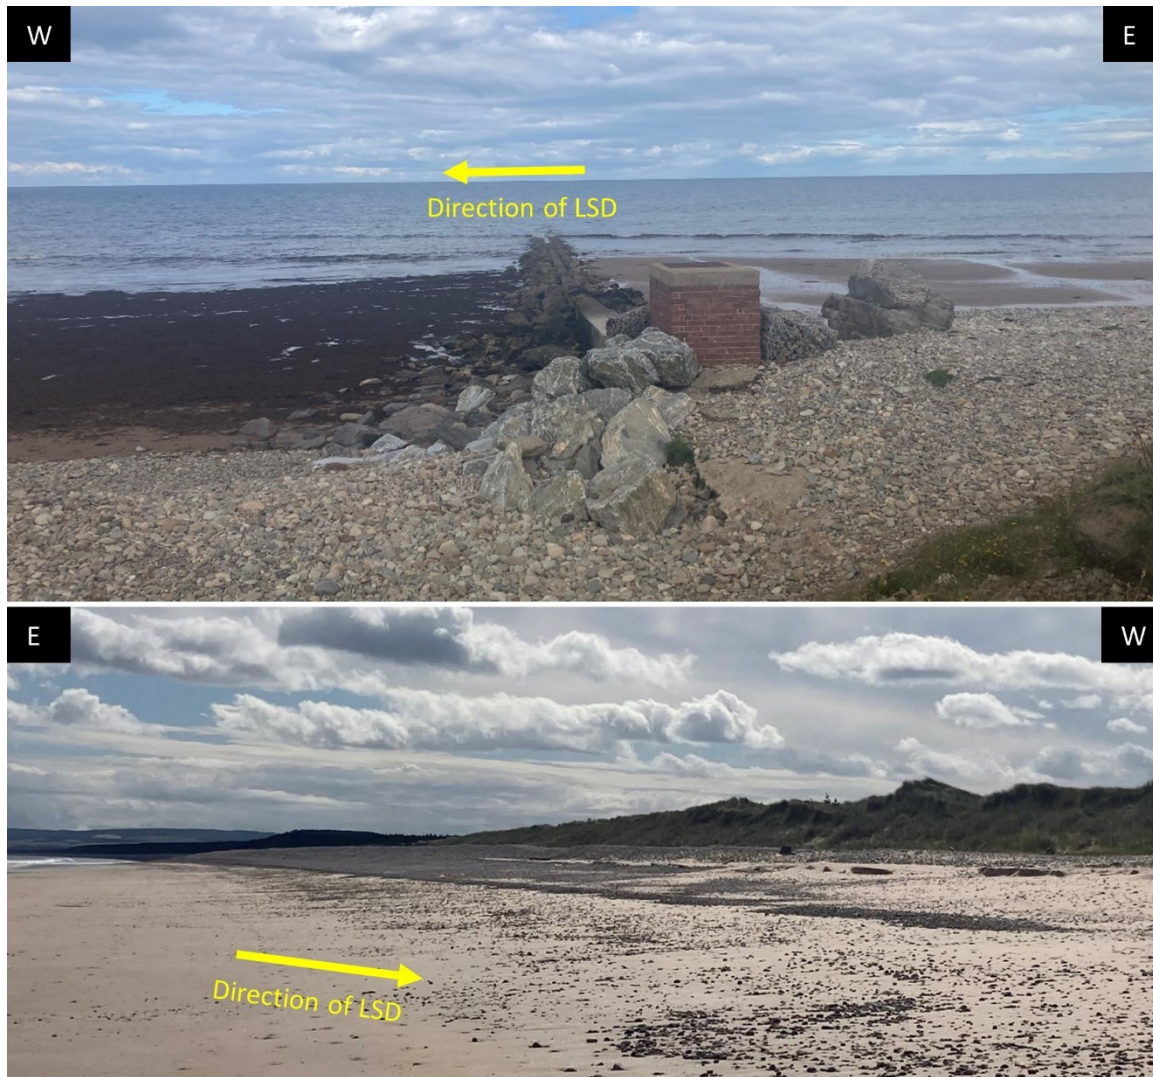
Figure 5. (A) Sewage pipe demonstrating westerly direction of longshore drift (LSD) of sand and shingle towards Spey Bay with a larger quantity and higher level of gravel on the eastern side of the pipe than on the western side. The pipe is defended using rock armour and gabions; (B) Transition between shingle and sand just east of Lossiemouth. Direction of LSD from east to west. At the time of the CCZAS in August 2022, the transition from the shingle dominated sediment originating from the Spey to the predominantly sandy beaches to the west, occurs at BNG 325270 869580.

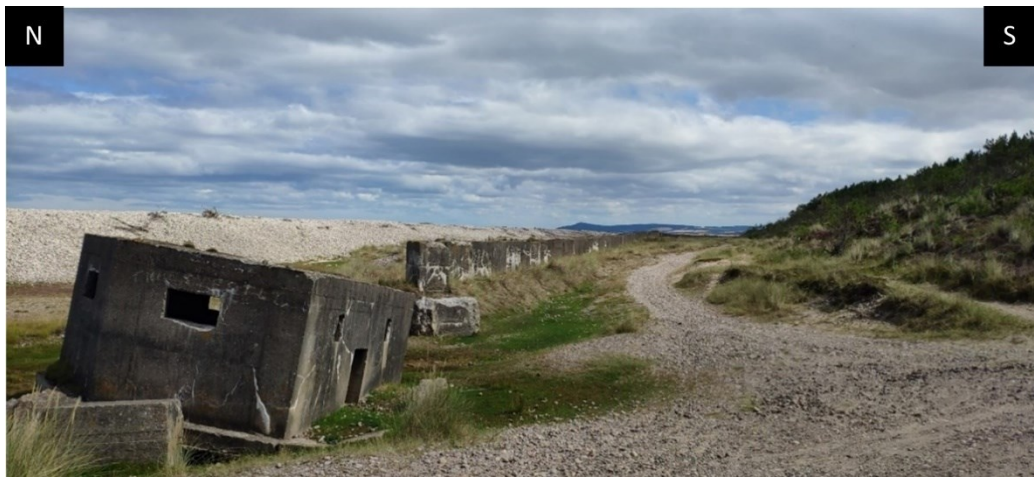
Figure 6. High shingle storm beaches have built up seaward of the anti-tank cubes and pillboxes running along the coast edge of Lossie Forest, in Spey Bay.

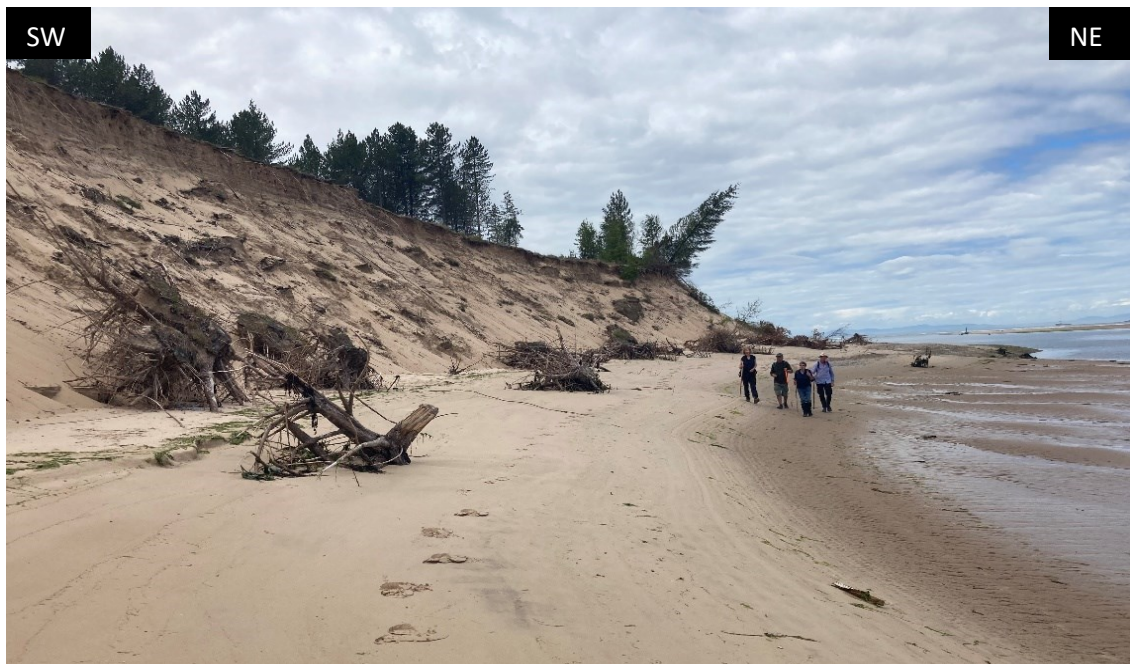
The eastern end of Culbin Sands coastline on the approach to Findhorn Bay is modelled to be eroding by 2030. The sand beach itself is very dynamic, with a number of shipwreck records that have previously been noted along this coast no longer visible, possibly now buried in the shifting sands. Long stretches of the high dune coast edge show recent erosion and sand slip. This erosion continues around the northwestern edge of Findhorn Bay and evidence of trees becoming unstable and sliding down the dune slopes is evident (Figure 8).

Figure 8. Recent erosion of high sand dune coast edge at Culbin Forest, on the west side of the mouth of Findhorn Bay.

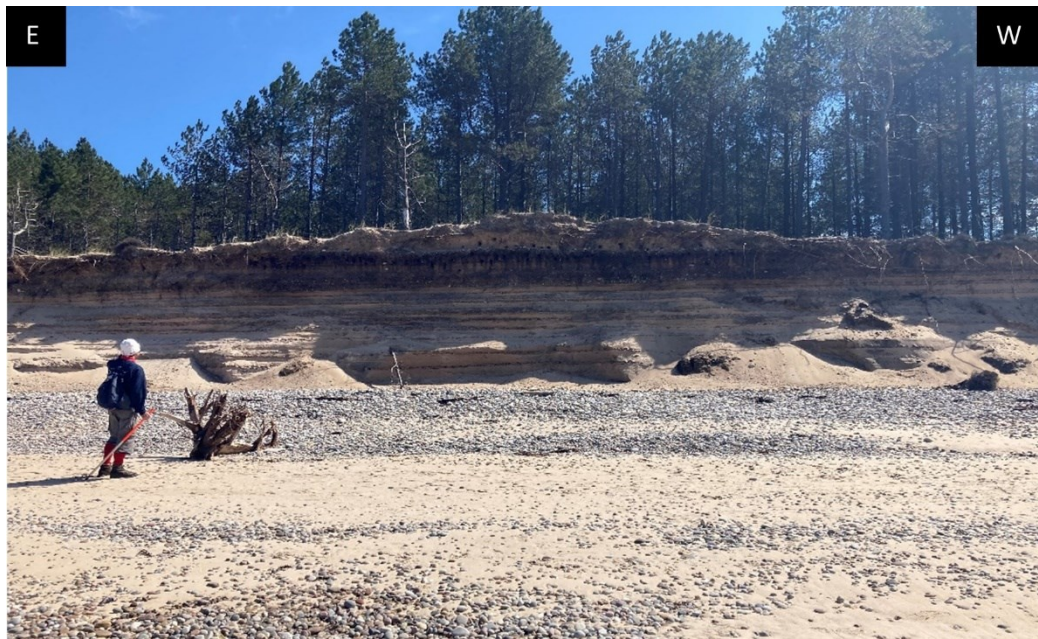
Figure 9. Freshly exposed cross section through the layered raised beach deposits at Burghead Bay

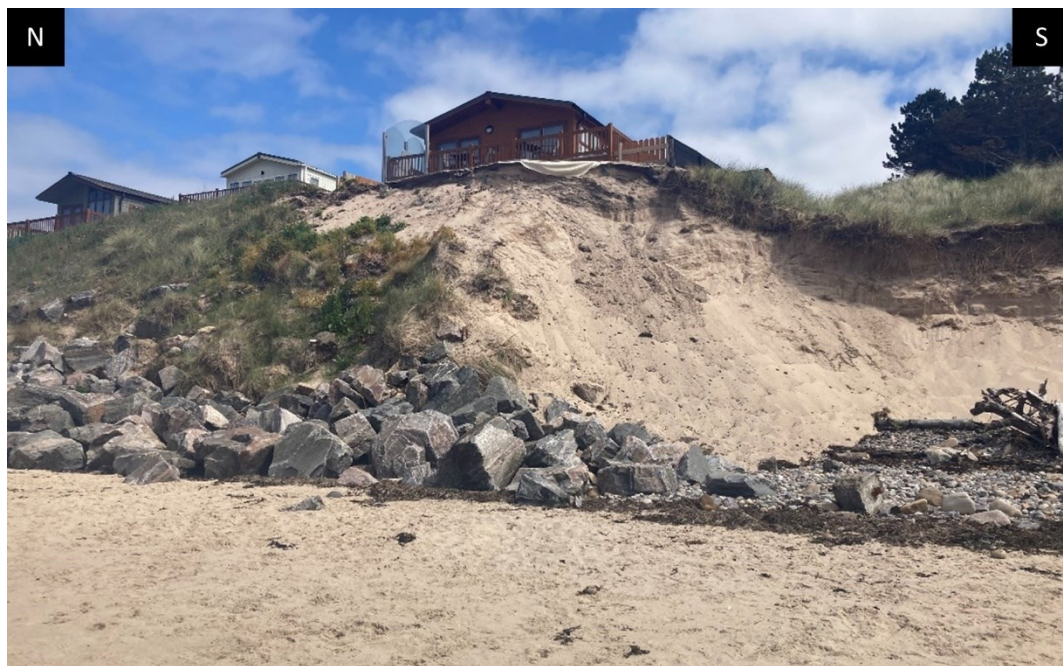
Figure 10. Erosion of sand dune coast edge at chalet part to the east of Burghead Bay. Eroding 'bite' at the end of the rock armour.

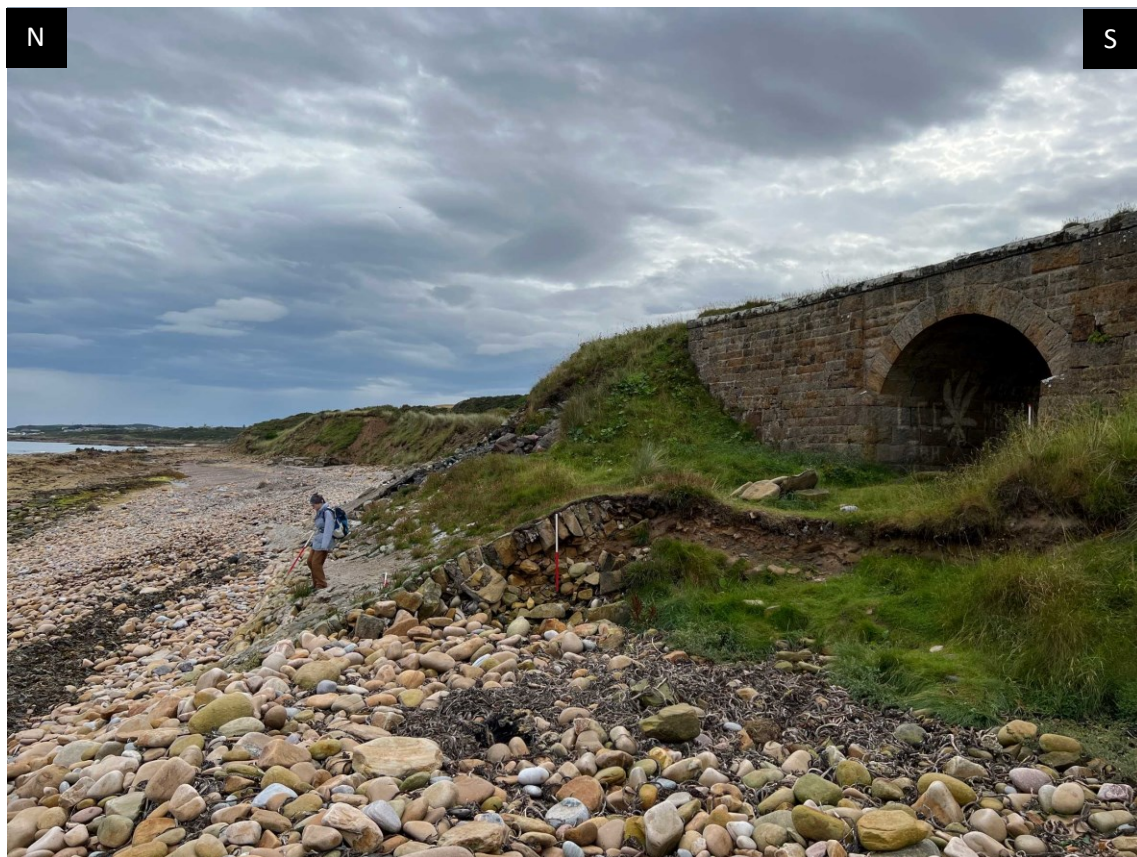
The Burghead and Hopeman Branch railway provided an extension of the main Highland railway, connecting Burghead to east Hopeman. The railway was built in 1892 and closed to passenger trains in 1931. The railway embankment hugged the coastline, and its footprint is now followed as a pedestrian and cycle path connecting the two settlements. Immediately east of Burghead, parts of the embankment are being undermined by coastal erosion. Local information suggests that the area has experienced accelerated erosion over the last 10 years (Figure 11).

Figure 11. Eroded embankment of Burghead Railway in foreground and background

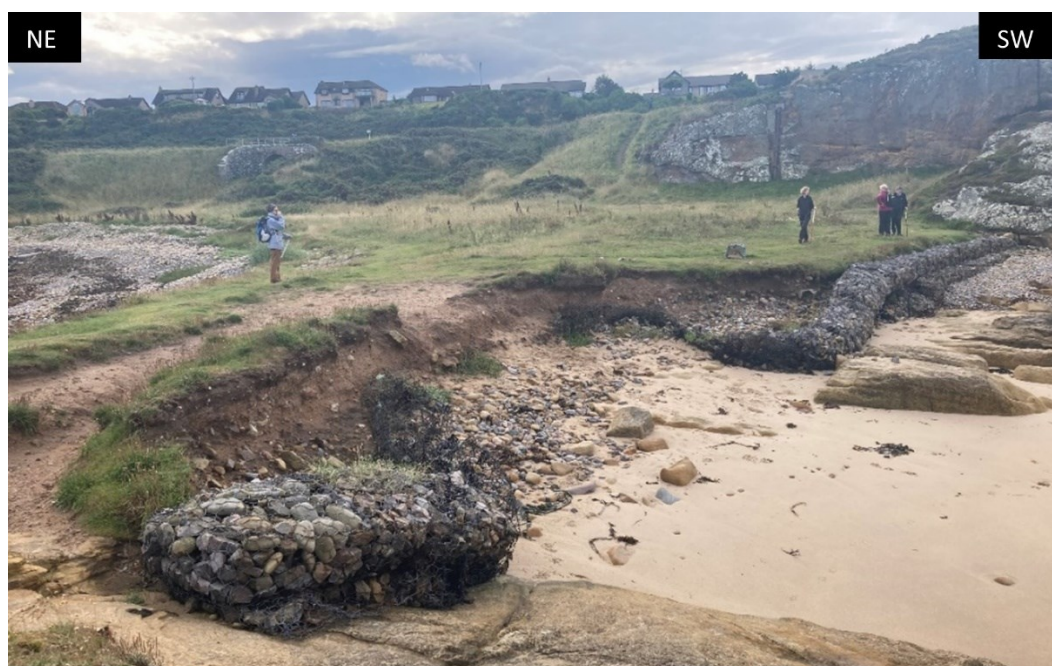
Cobble filled gabion baskets to protect the coastal path have failed at this location, (Figure 12).

Figure 12. Example of coastal defence which has failed, Cummingstown.

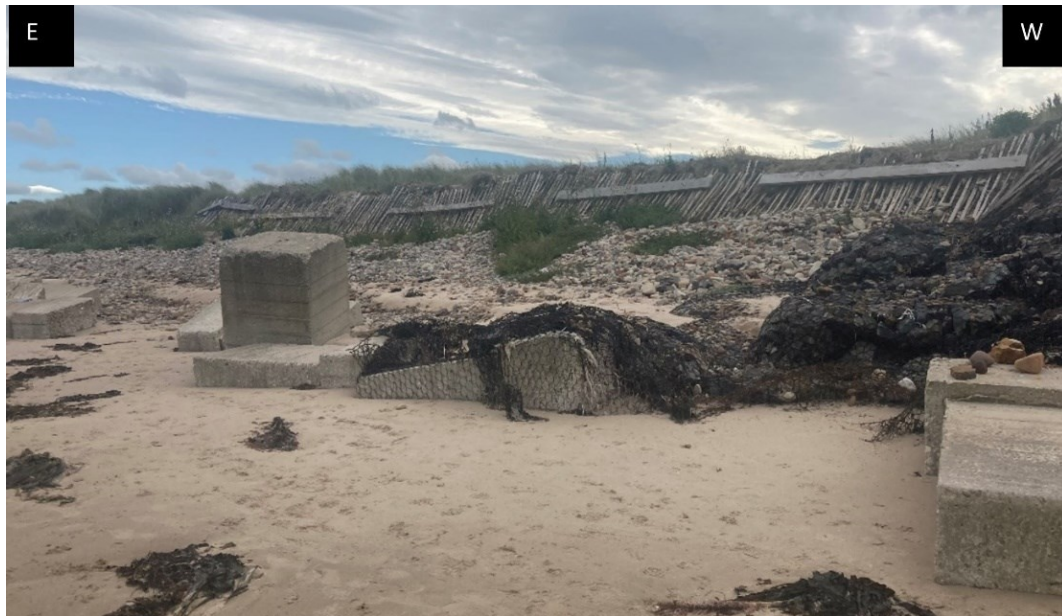
The position of the almost unbroken line of anti-tank cubes along Lossiemouth West Beach shows that the eastern and western ends of the sandy bay have experienced net erosion since 1940 and the central part of the bay is stable or slightly accreting. On a chance meeting with a coastal engineer who was monitoring trial soft engineering defences along the worst affected parts of the Moray Golf Course, we learnt that 1-1.5 m of coast edge was lost here over the previous 18 months (Figure 13).

Figure 13. The edge of the golf course was re-profiled in November 2021 and wooden fencing anchored to the base of the section. There are also the remains of failed gabions and tumbled anti-tank cubes.

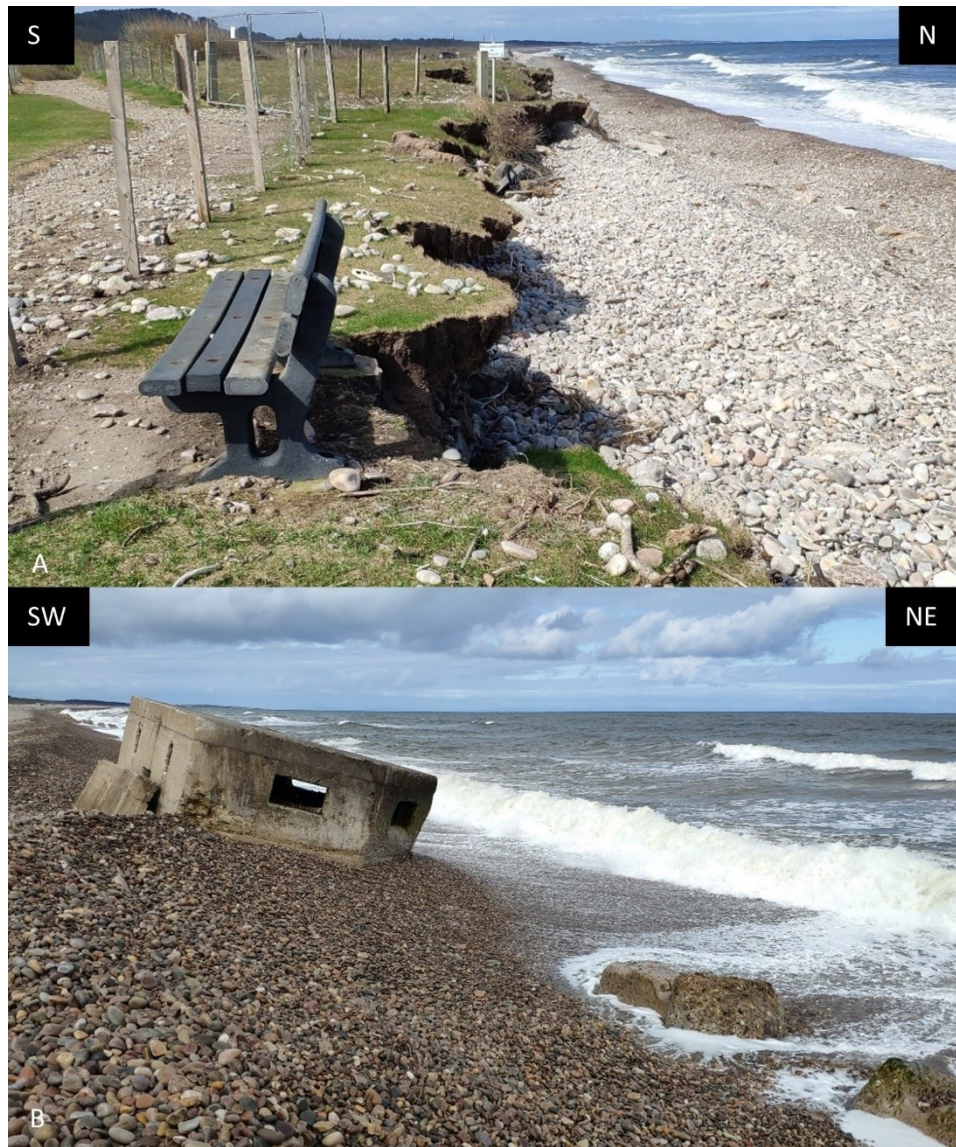
The coastline surrounding the mouth of the river Spey is experiencing rapid change and the west part of Kingston and first kilometre of the shingle beach west of Kingston is experiencing significant erosion. This erosion is clearly noted in relation to a park bench which is being undermined as the sediment beneath it is being eroded away and the position of pill boxes and anti-tank cubes in the wave zone (Figure 14). Beyond the first kilometre westwards, the beach is generally stable.

Figure 14. (A) Eroding coastline at Kingston; (B) Pillbox and anti-tank cubes within shingle beach in the wave zone, Kingston.

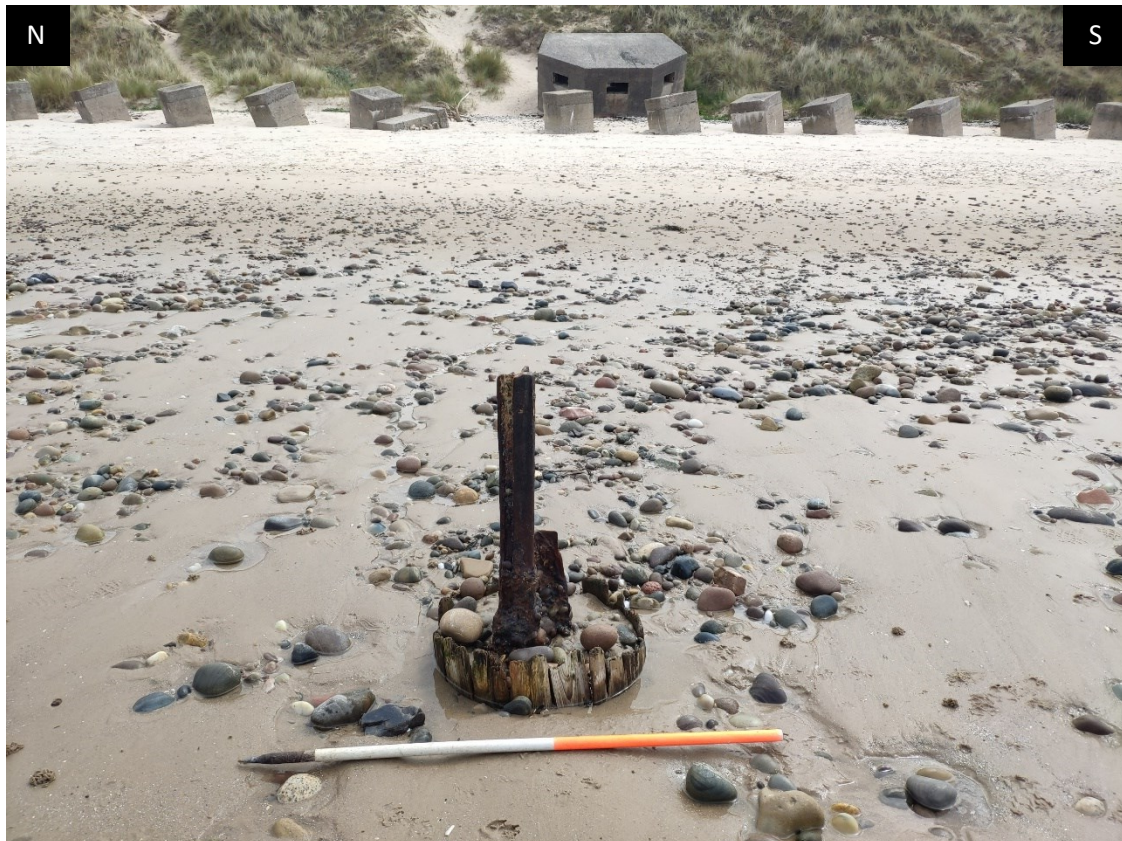
Along the Moray coastline, anti-landing posts are best preserved at Burghead Bay and Lossiemouth West Beach where numerous examples can be found in the intertidal zone. These posts are mostly wooden and in many cases, it is difficult to differentiate between them and wooden stakes associated with fixed fishing nets. At Burghead Bay, some posts are set into wooden barrels which is unusual, and the only example of barrels being used to secure anti-landing posts that we came across in the surveys (Figure 17).

Figure 17. Example of an anti-glider post within a wooden barrel. A line of anti-tank cubes and a Type 24 pillbox can be seen in the background (<https://scapetrust.org/sites-at-risk/site/15557>).

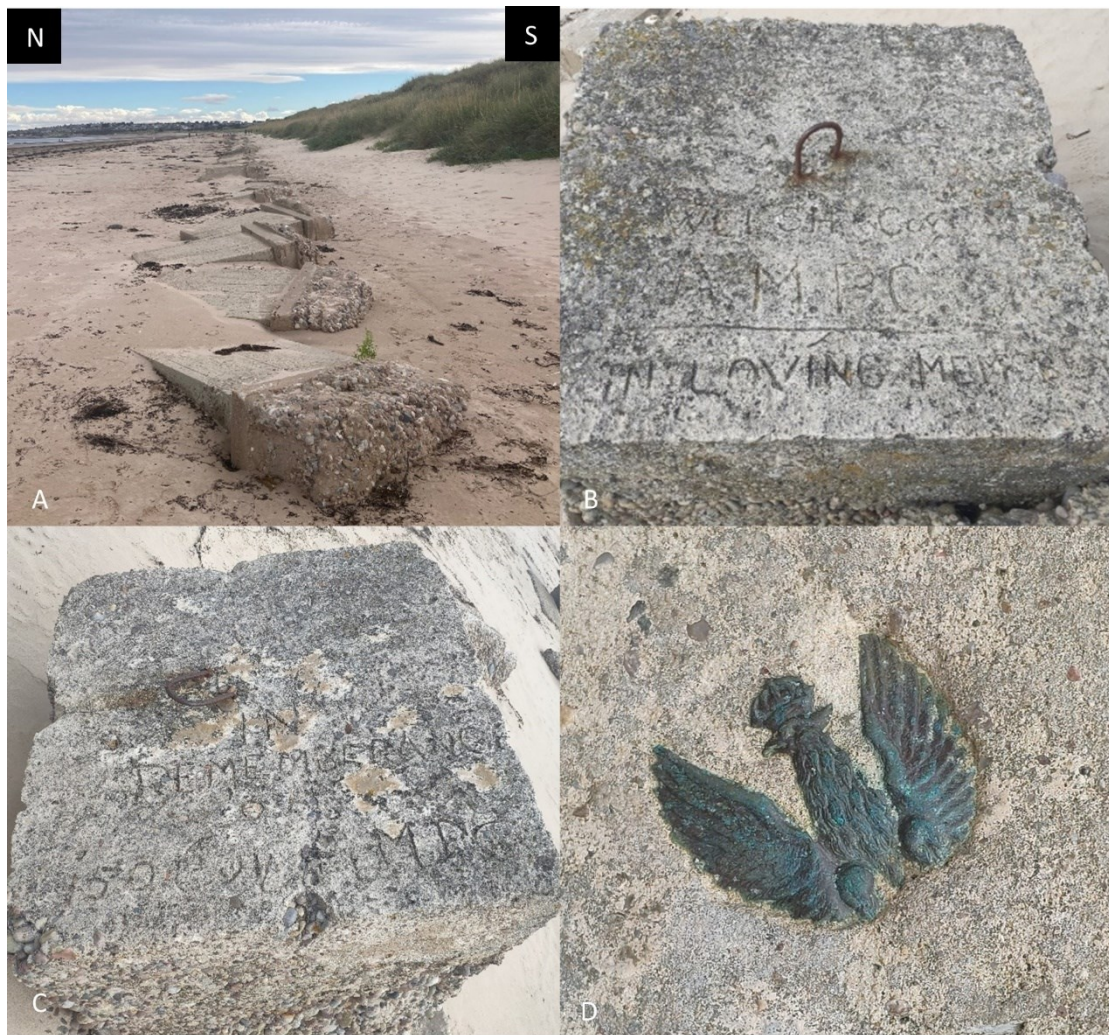
Anti-tank cubes and their associated pill boxes line the long beach stretches of Burghead Bay, Lossiemouth West Beach and Spey Bay, Innes Links between Lossiemouth and Kingston. These anti-tank cubes were cast in situ during 1940-41 by Polish and Welsh soldiers based in the area. Several tank cubes bear inscriptions, such as initials and names of individual soldiers or memorials to fallen comrades (Figure 18 B, C). A rare, if not unique, example of an eagle cap badge (the Polish army emblem) pressed into the surface of an anti-tank cube was spotted by a volunteer on Lossiemouth West Beach (Figure 18, D).

Figure 18. Examples of anti-tank cubes on Lossiemouth west beach (A) partially buried anti-tank cubes (<https://scapetrust.org/sites-at-risk/site/14376>); (B) inscribed WELSH Co AM. PO IN LOVING MEMORY, (C) inscribed IN REMEMBRANCE OF 150 COMMANDO, (D) Polish cap badge pushed into the surface of an anti-tank cube (<https://scapetrust.org/sites-at-risk/site/14208>).

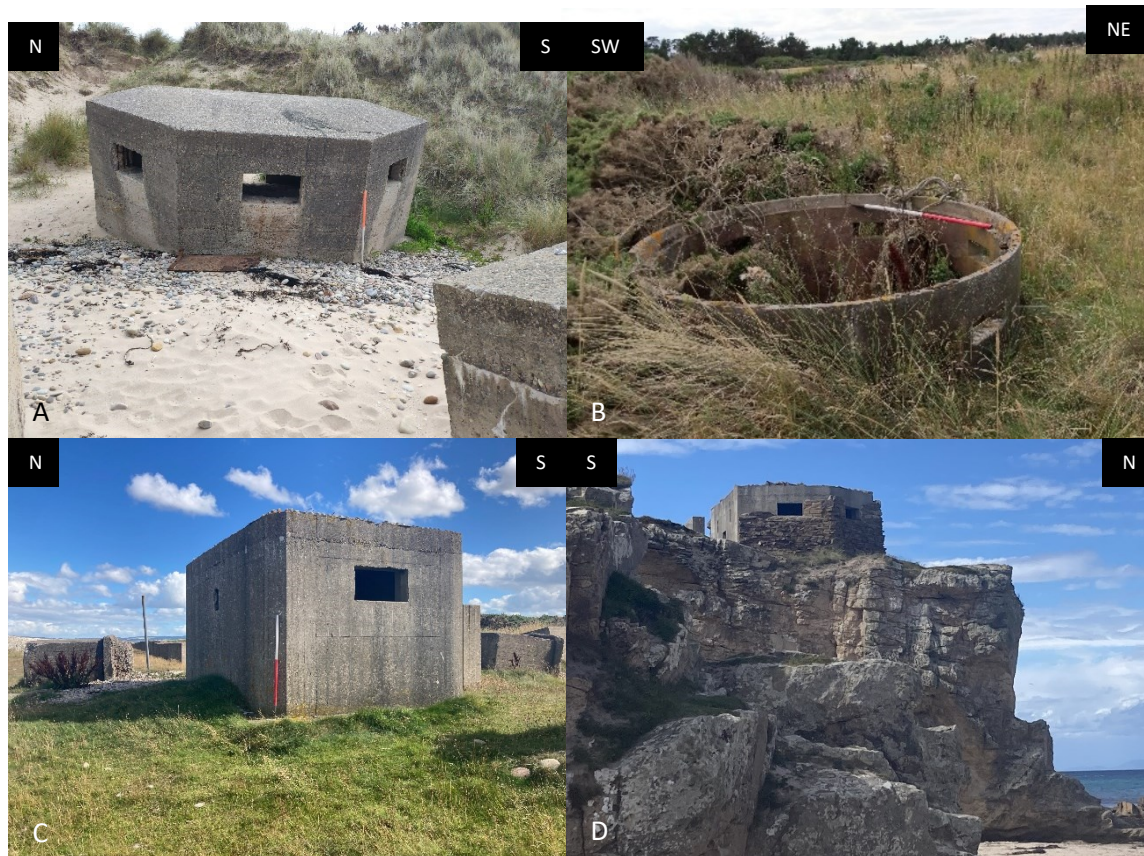
The majority of the pillbox records are of either Type 24 six-sided design, or rectangular medium machine gun type. Along the Spey Bay golf course are three examples of much smaller, round pillboxes. These are known as Norcon pillboxes and are simple constructions, made from concrete sewage pipe (Figure 19), (Barclay, 2013).

Figure 19. Examples of pillbox styles along the Moray coastline. (A) Type 24 six-sided pillbox, Burghead Bay (<https://scapetrust.org/sites-at-risk/site/14342>); (B) Round Norcon style pillbox, Spey Bay (<https://scapetrust.org/sites-at-risk/site/15650>); (C) Medium machine gun rectangular pillbox, Innes Links (<https://scapetrust.org/sites-at-risk/site/14259>); (D) Type 24 pillbox camouflaged with added stone cladding, Covesea Links (<https://scapetrust.org/sites-at-risk/site/14294>).

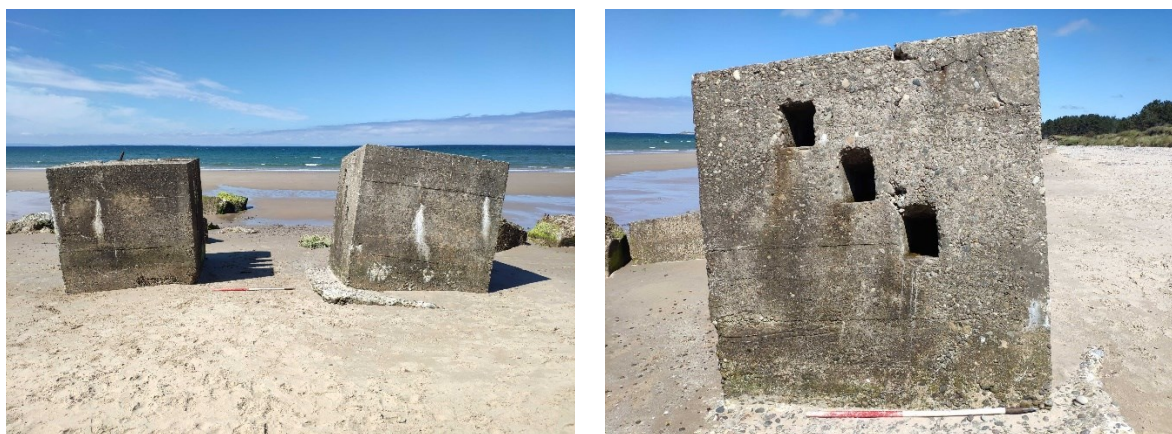
Figure 20. Roadblock in Burghead Bay (<https://scapetrust.org/sites-at-risk/site/15560/>)

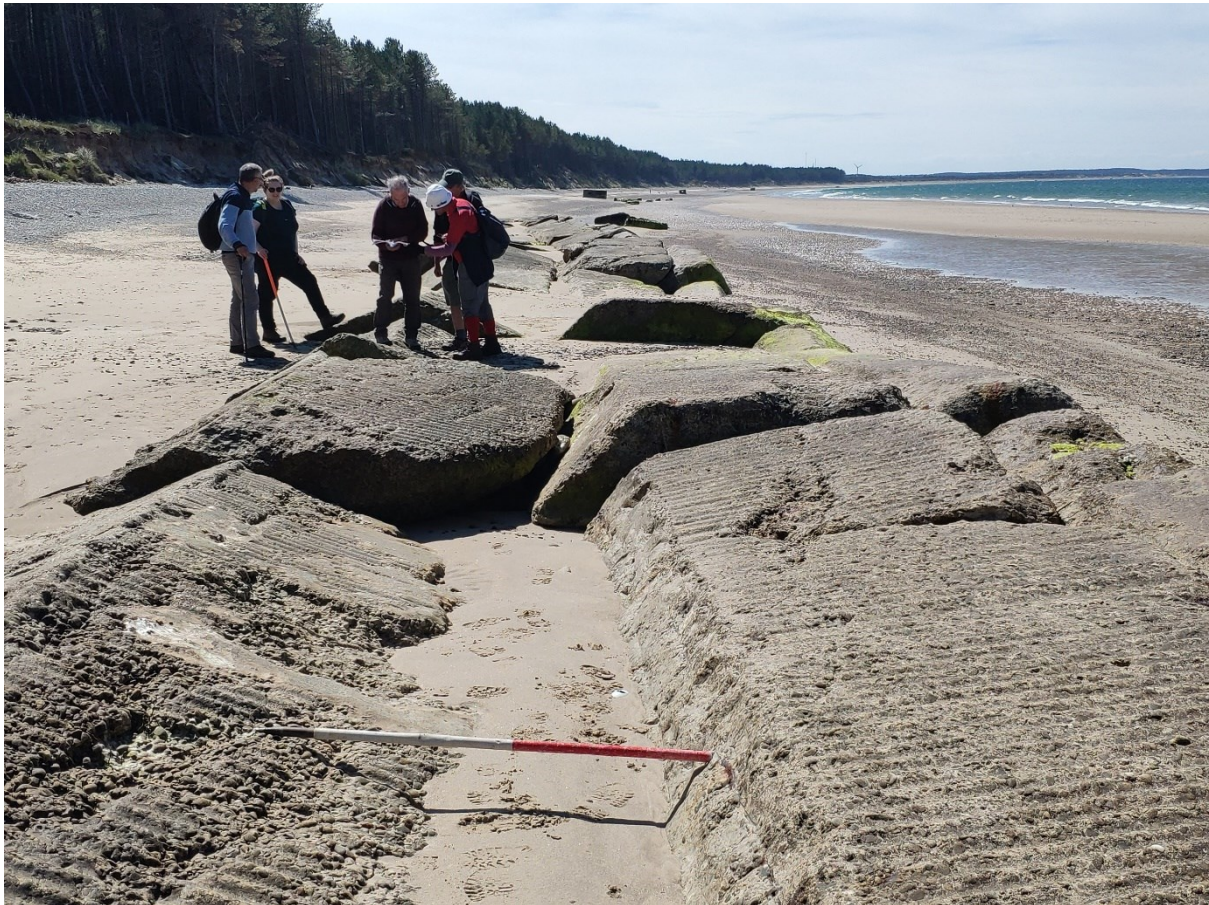
Figure 21. Fallen anti-tank wall, part of the D-Day rehearsals in Burghead Bay
(<https://scapetrust.org/sites-at-risk/site/15570/>)

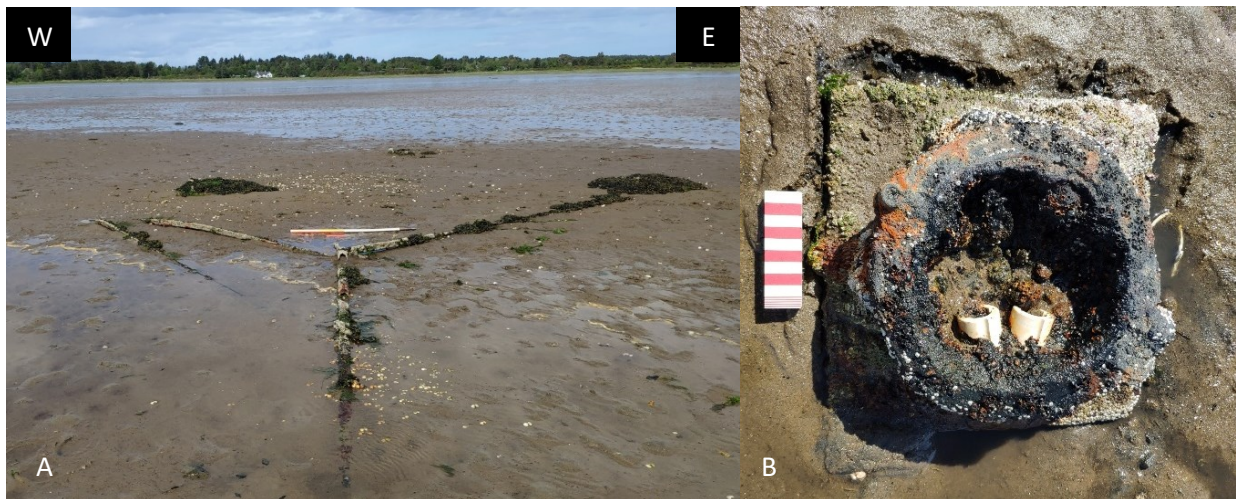
The remains of at least thirteen Drem lights survive within the mudflats of Findhorn Bay. The Drem lighting system, named after RAF Drem in East Lothian where they were invented in 1940, was developed to overcome difficulties caused by restricted forward and downwards vision by pilots flying long-nosed aircraft (especially Spitfires) as they came into land. The Drem system used a circular array of lights mounted on angled 10-foot poles which could be seen from different angles by pilots as they flew around their landing circuit, directing them towards the runway. The triangular metal tripod poles and some elements of the light fittings are still visible in Findhorn Bay (Figure 22). As far as we know, these are the only surviving *in situ* partial array of Drem lights. They are slowly deteriorating within the estuarine muds and vulnerable to eventual loss in the near future.

Figure 22. (A) Remains of DREM lighting pole related to Kinloss military airfield. (B) A close up of the remains of DREM light with electric bulb fittings visible (master record <https://scapetrust.org/sites-at-risk/site/15770>).

All intertidal wrecks, the Findhorn Bay boat graveyard, outlying Zulu vessels, and the Drem lights associated with Kinloss airfield are particularly sensitive to decay because of their location in the intertidal zone and composition from wood and metal materials. These are a priority for regular monitoring. Periodic drone survey of the Findhorn Bay vessels would be useful as there is existing drone photography to which future surveys can be compared.

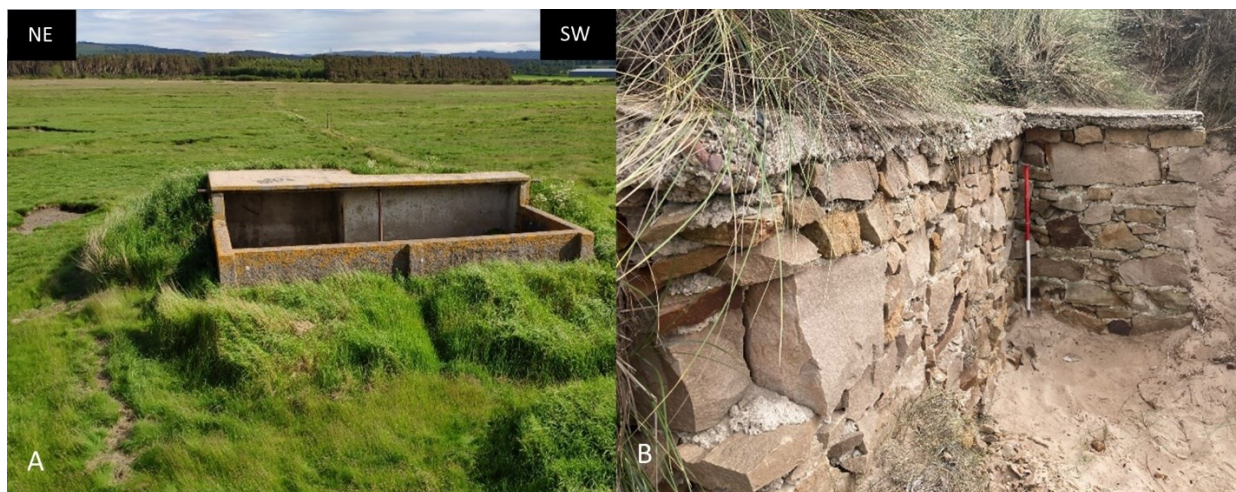
Sites of rifle ranges are a feature of the east coast of Scotland, marked in the vicinity of a great many coastal settlements on the first and second editions of the Ordnance Survey. They originated during a national panic of an invasion threat by the French Emperor Napoleon III in the 1860s, which never materialised. Many were re-used as practise ranges in the First World War. There is a well-preserved Napoleonic example at the head of Findhorn Bay (Figure 23A), and three separate examples at Innes Links dating from the 1860s, First World War and Second World War. A stone target from the Hopeman rifle range is eroding out of the sand dunes at the end of Hopeman East beach (Figure 23B).

Figure 23. (A) Napoleonic period rifle range and targets, Findhorn (<https://scapetrust.org/sites-at-risk/site/14247>); (B) remains of Napoleonic target platform eroding out of dunes, Hopeman East Beach (<https://scapetrust.org/sites-at-risk/site/15643>).

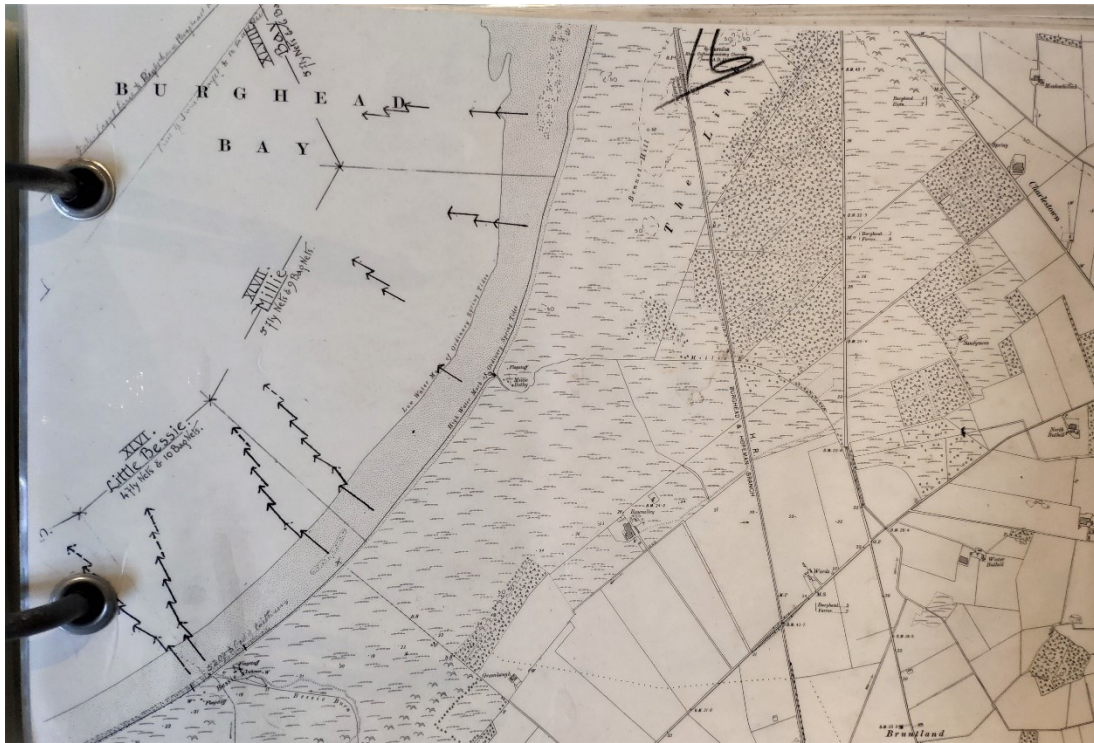
Figure 24. An example from Burghead Bay of the Moray Firth Salmon Fishing Co. maps that locate the positions of fixed nets under their ownership in the Moray Firth

Most of the new fishing sites recorded during the CCZAS are the remnants of posts and stakes from fixed fishing nets. Of great assistance to the identification of the numerous posts spotted in the intertidal zone was the records of the Moray Firth Salmon Fishing Co. (1908-1987) held in the Findhorn Heritage Centre. A series of maps show the position of every fly and bag net belonging to the Company along the Moray coast (Figure 24).

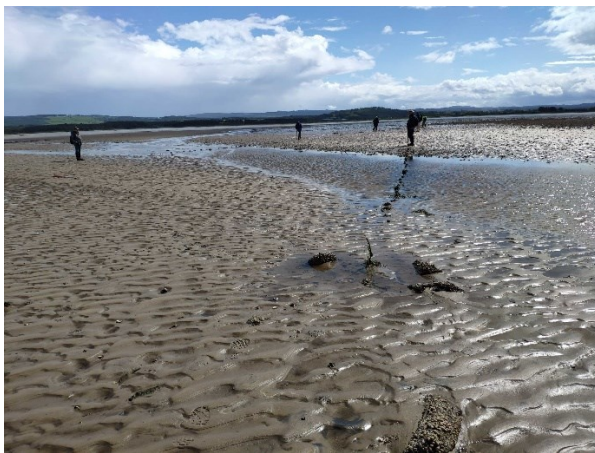
Figure 26A. Volunteers standing along V-shaped stakes of fishtrap.

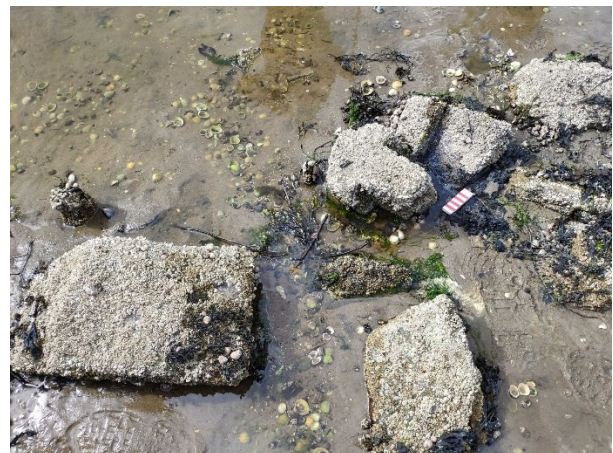
Figure 26B. Moulded stone and stakes typical of fishtrap structures.

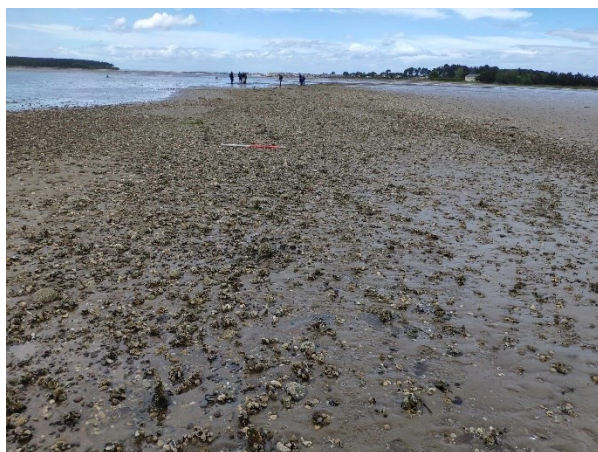
Figure 27A. General view of mussel scalp, looking north.

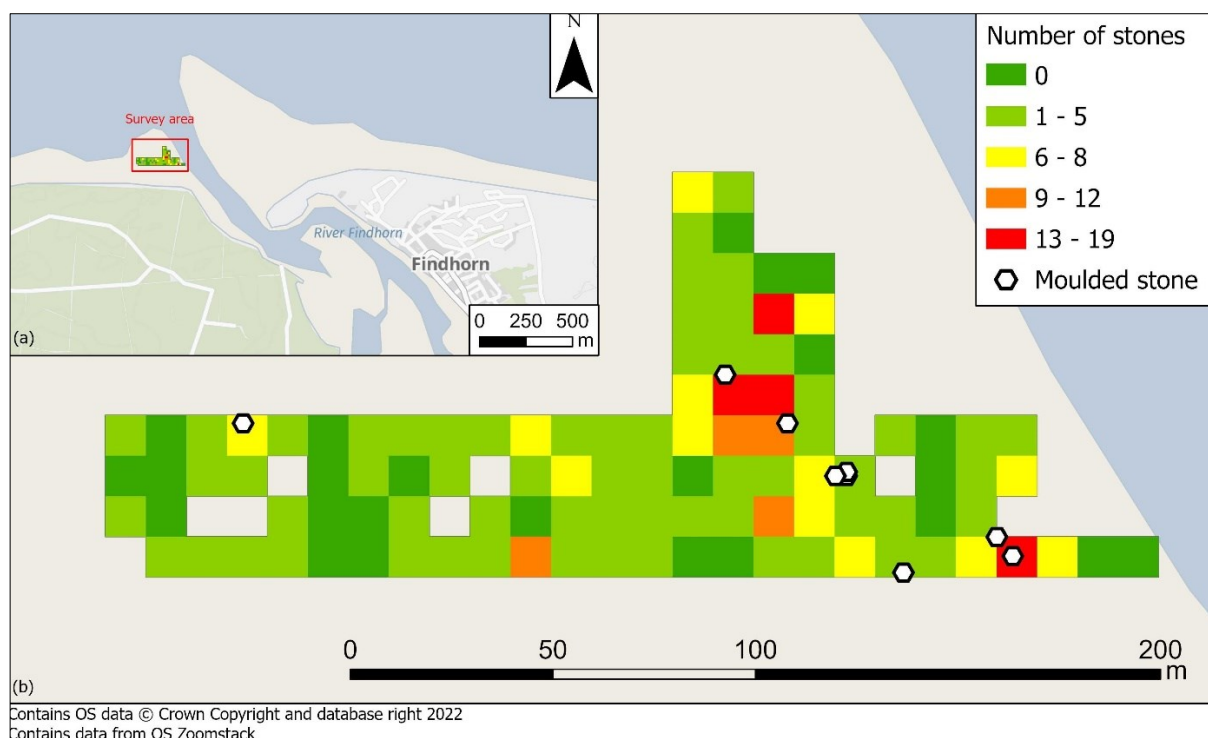
Figure 28. Map showing extent of the Old Findhorn survey carried out in 2003. (a) Location of survey in relation to Culbin Forest and Findhorn; (b) heatmap showing the number of stones recorded within each grid square along with the location of moulded stone identified during the survey. Created by Sarah Boyd using data from Tim Negus.

A shingle bar, also a natural mussel scalp, located at the mouth of the river Findhorn is the probable location of Old Findhorn, gradually inundated throughout the 17th century and washed away in a great flood on October 11, 1702. Nothing now remains of Old Findhorn, however in 2003 and subsequent years, Tim Negus and Findhorn Heritage surveyed stonework visible on the shingle ridge and plotted concentrations of larger and moulded stone as a proxy for the possible location of this part of the former village (Figure 28). Some of the moulded stone can be seen in Findhorn Heritage Centre.

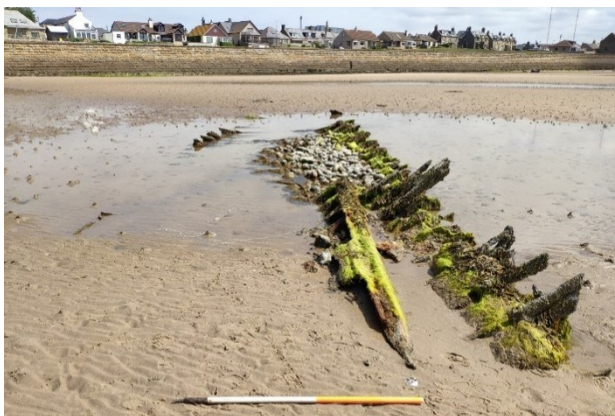
The survey updated two existing shipwreck sites at Culbin sands and Burghead Bay. Research carried out by Tim Negus has tentatively identified the wreck at Culbin sands (SCAPE ID:12890) as the Nairnshire, a schooner built in 1875 and wrecked in 1910. The second existing wreck record is that of the Olive, a vessel originating from Banff which became stranded in January 1865 (Figure 29A). The wreck location has been updated.

Figure 29A. Remains of the Olive, Burghead (<https://scapetrust.org/sites-at-risk/site/15550>)

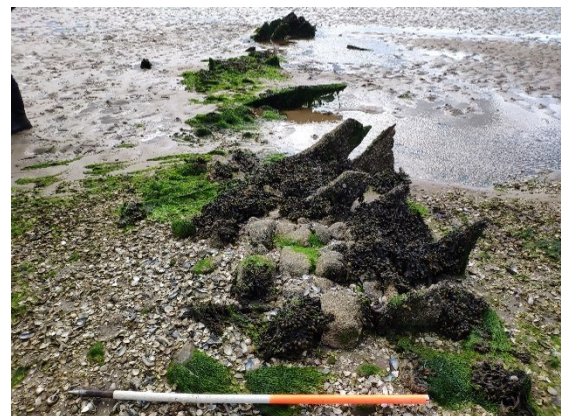
B. Remains of Zulu in the centre of Findhorn Bay (<https://scapetrust.org/sites-at-risk/site/15620>)

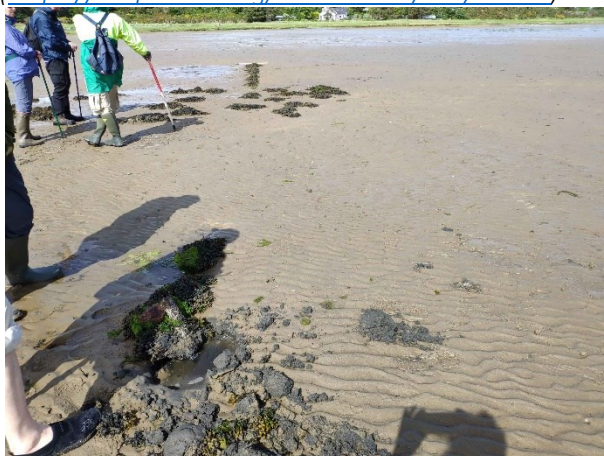
C. Mostly buried remains of Zulu to the east of Findhorn Bay (<https://scapetrust.org/sites-at-risk/site/15618>)

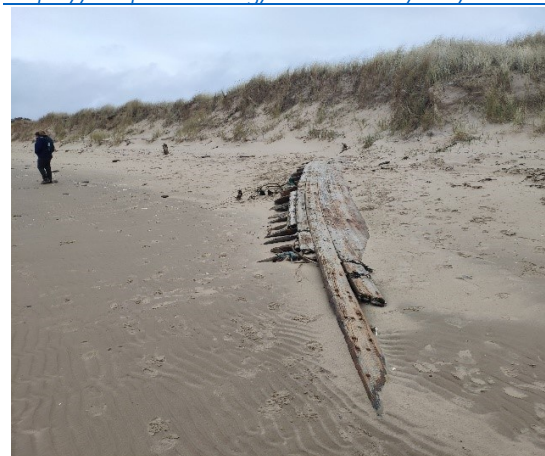
D. Fragmentary remains of Zulu 'The War Sprite' on Culbin Sands (<https://scapetrust.org/sites-at-risk/site/15516>)

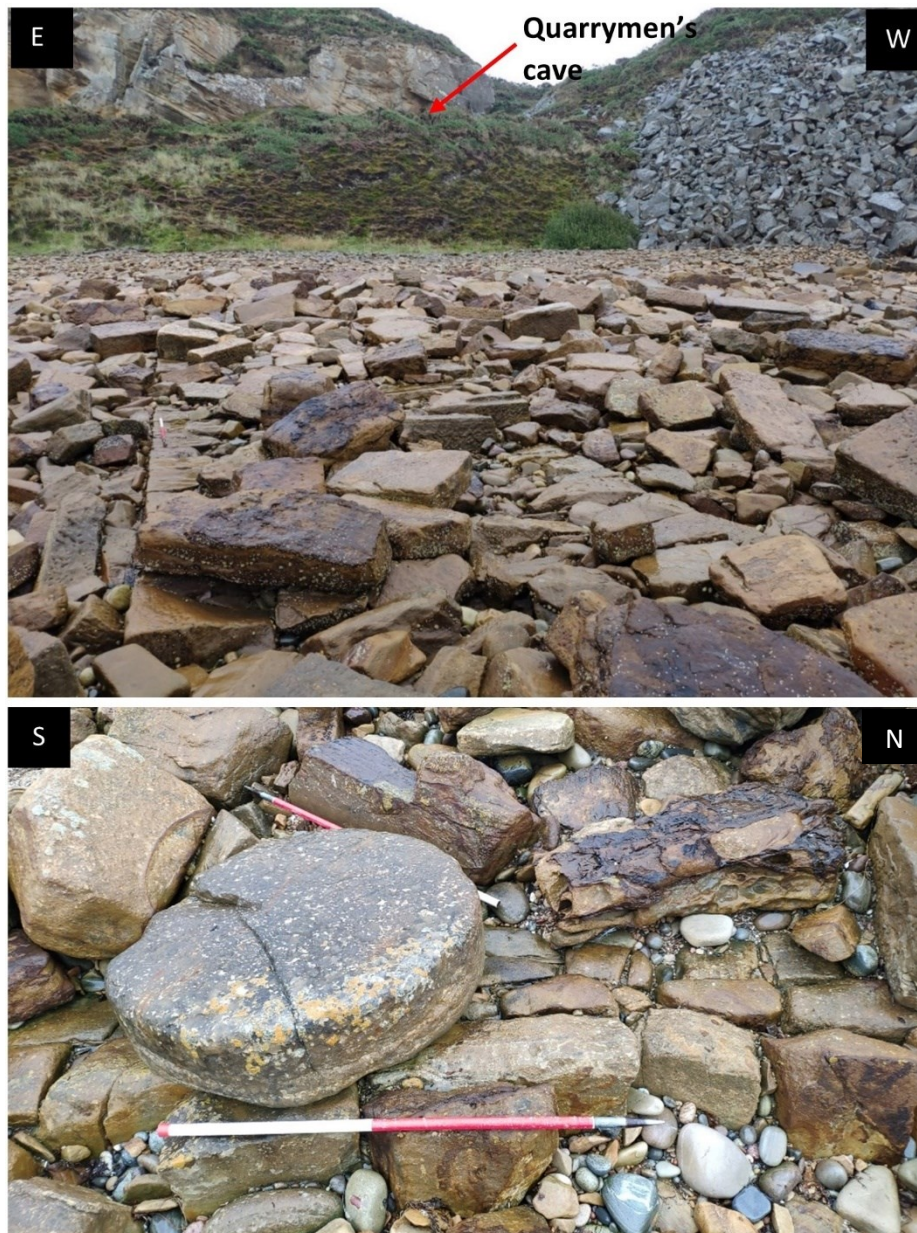
Figure 30. (A) Remains of Clashach Quarry harbour wall in the foreground, looking towards the quarry. The Quarrymen's Cave is visible in the sandstone cliffs; (B) A close-up of the millstone found within the remains of the harbour (<https://scapetrust.org/sites-at-risk/site/14279>).

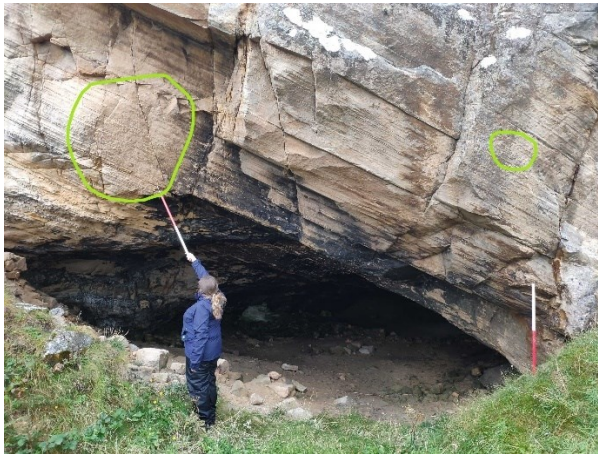
Figure 31 A. Location of ship graffiti outside Quarrymen's Cave

The Quarrymen's Cave, located in the sandstone cliffs at the edge of the quarry overlooking the harbour is an interesting cave containing internal walls and a fireplace and home to numerous masons' marks, mostly carved into the roof and walls at the entrance. Outside the cave, either side of the entrance, are three carvings of ships (Figure 31), (<https://scapetrust.org/sites-at-risk/site/14305/>).

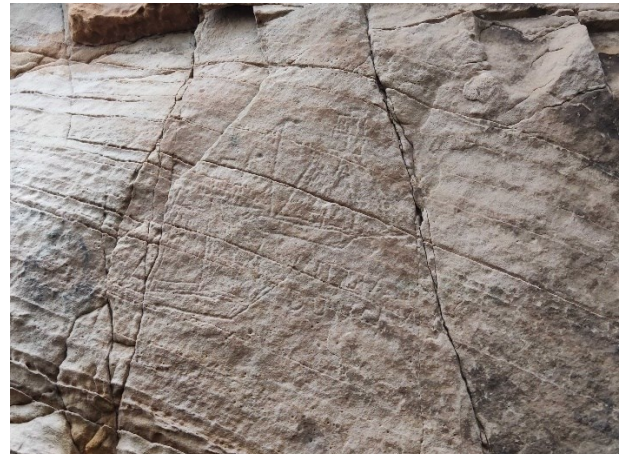
B. Two rigged sailing ships (schooners?) on the left

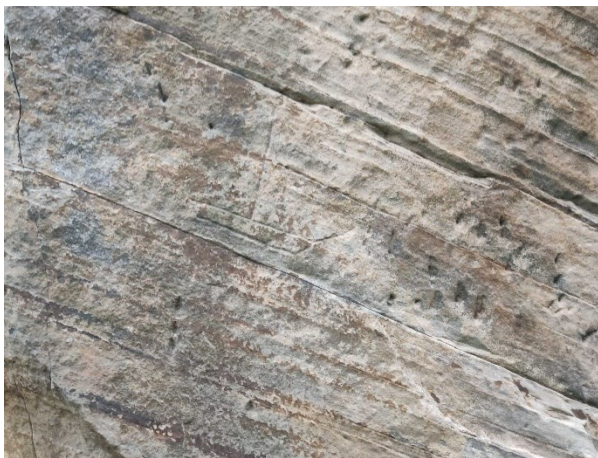
C. Unrigged small sailing ship on the right.

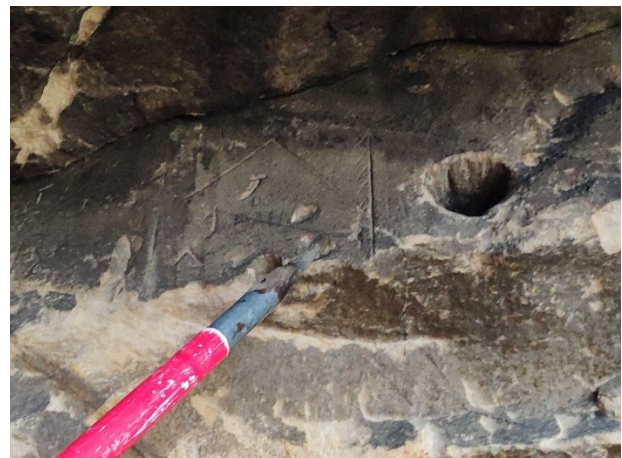
D. One of the numerous masons marks carved into the roof entrance overhang.
