Coastal Zone Assessment Survey

Moray: Culbin to Cullen

The SCAPE Trust and University of St Andrews
April 2023

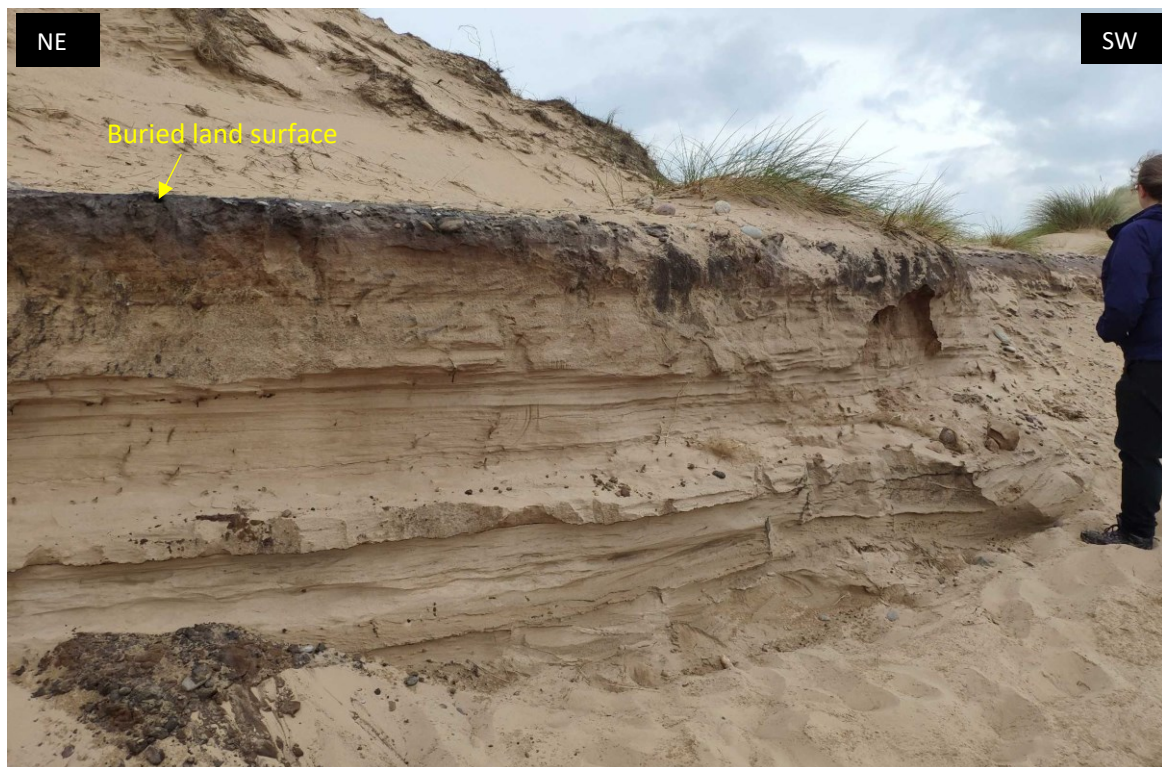
The dunes to the east of Findhorn village contain expansive areas of sand blow outs which have revealed an old ground surface, intermittently exposed over a wide area throughout the dunes. At the coast edge this old ground surface layer, which is rich in charcoal and fire-cracked stone can be traced for at least 60 metres (Figure 32). A summary of past investigations is available on the North of Scotland Archaeology Society (NOSAS) [blog](#) (Sharpe, 2020). Within the dune blow outs, Michael Sharpe has identified a debitage mound of deliberately struck quartz cobbles and a possible burnt mound. Thousands of lithics, as well as occasional pottery, beads and cremated bone have been recovered by surface collection over many years. Examples of flint arrowheads and tools from the area are displayed in Findhorn Heritage Centre. This is a very interesting landscape, extremely vulnerable to aeolian and coastal erosion as well as damage from vehicles and people. It would benefit from systematic survey.

Figure 32. Fresh vertical section revealing old ground surface layer buried within the sand dunes. Note the burnt appearance and abundance of fire-cracked stone incorporated into the deposit. (<https://scapetrust.org/sites-at-risk/site/14217>).
