Coastal Zone Assessment Survey South Ayrshire Report

The SCAPE Trust and University of St Andrews
November 2023

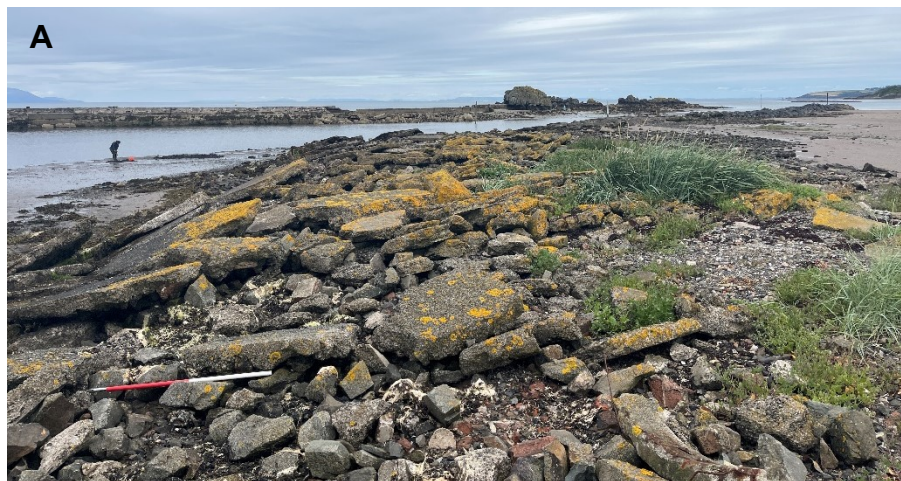
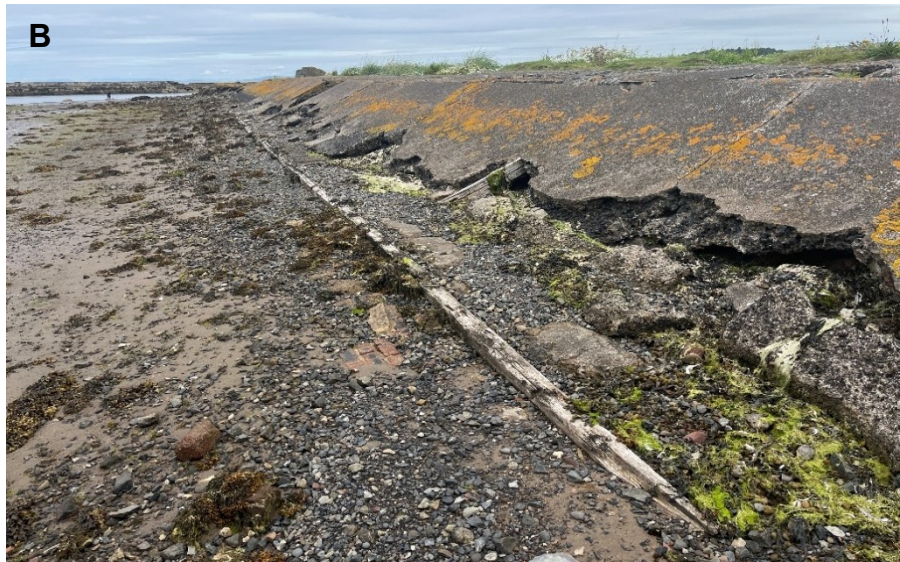
A lack of upkeep of harbour infrastructure at Maidens has resulted in a severely deteriorated east breakwater ([SCAPE ID: 7658](#), Figure 4A,B) with the breakwater surface broken up into a number of large slabs and rubble. Concrete degradation and collapse were also evident on the west pier.

Figure 4. Deterioration of concrete breakwater, Maidens. A. Breakwater with concrete broken up into large fragments, looking north; B. Undermining of breakwater concrete wall, looking north (<https://scapetrust.org/sites-at-risk/site/7658>).

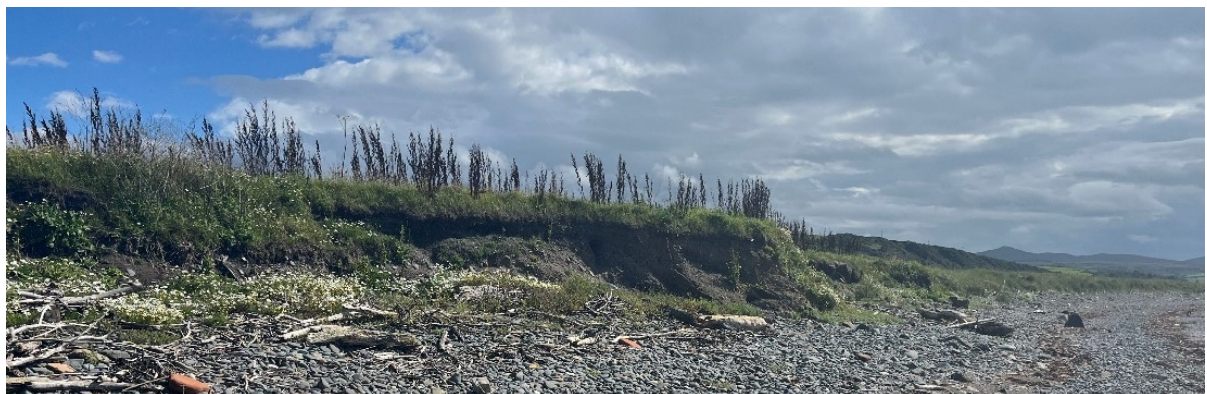
Between Low Balig and Ballantrae stretches of coastline are showing exposed superficial sediments and evidence of recent erosion and slumping (Figure 5). Along one section, agricultural fencing has been completely undermined through recent erosion (Figure 5A) and dumping has occurred further along the same stretch of coast, acting as ad-hoc coastal defence (Figure 6B).

Figure 5. Recent erosion of coast edge between Low Balig and Ballantrae.

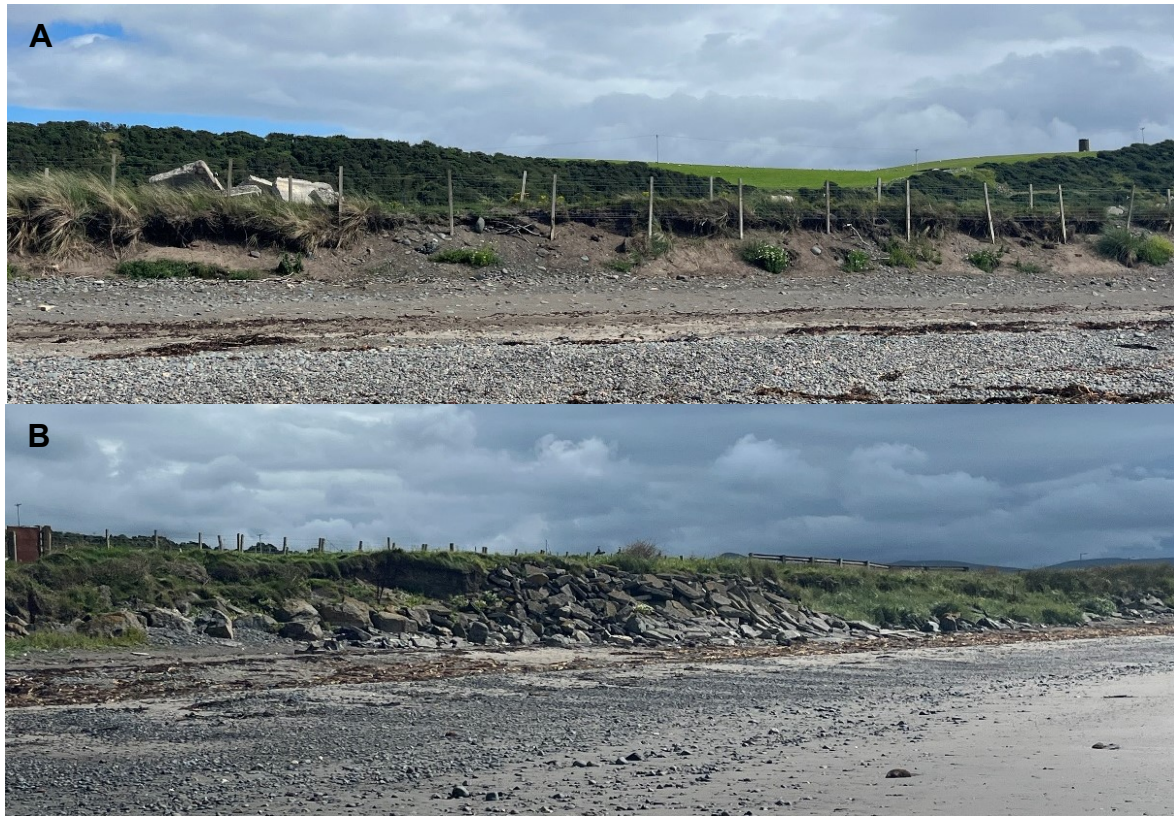
Figure 6. Erosion between Low Balig and Ballantrae. A. recent erosion of coast edge undermining fencing; B. dumping of concrete over coast edge as ad-hoc coastal defence.

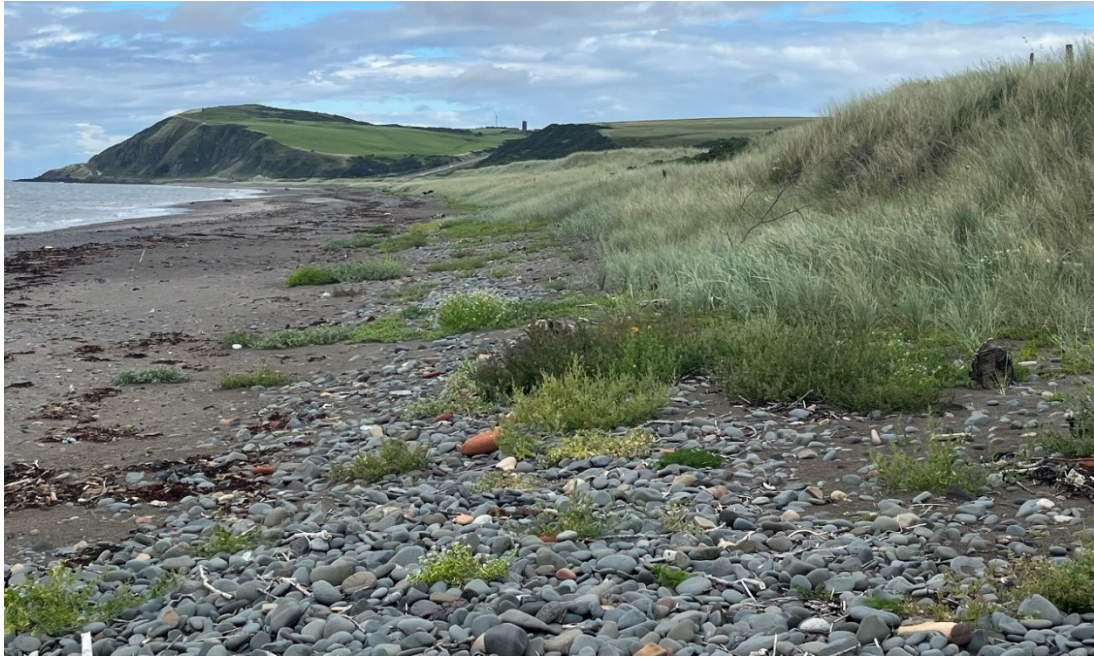
The stretch of coastline from Bennane to Low Balig was largely stable at the time of survey with vegetation extending into the upper shore zone (Figure 7). This section of coastline could be described as being in dynamic equilibrium and will undergo episodic erosion, followed by recovery.

Figure 7. Vegetated and currently stable coast edge between Bennane and Low Balig, north of Ballantrae, looking north.

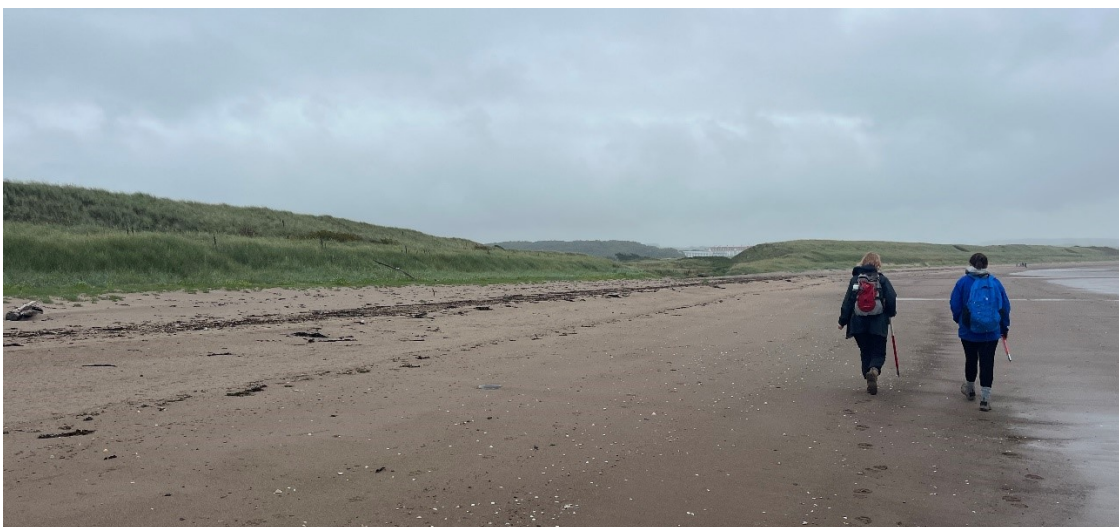
Walking south from Maidens around Turnberry golf course, the coast is mainly composed of basalts and basaltic andesite, which is largely resistant to erosion. Long-term erosion of the cliffs through wave action could cause episodic cliff collapse which could affect heritage situated right at the coast, e.g., the remains of Turnberry Castle which is precariously placed on the cliff edge. The coast opens out to the south into the long sandy beach of Turnberry Bay (Figure 8). At the time of survey, the bay appeared to be largely stable, with the coast edge vegetated and little sign of recent erosion or exposed sediments. There has been little change in the position of the coast edge when compared to the second edition Ordnance Survey, surveyed 1894. In fact, slight accretion was observed along the Turnberry golf course north of Milton Burn.

Figure 8. Typical view of stable, vegetated, coastline of Turnberry Bay, looking south.

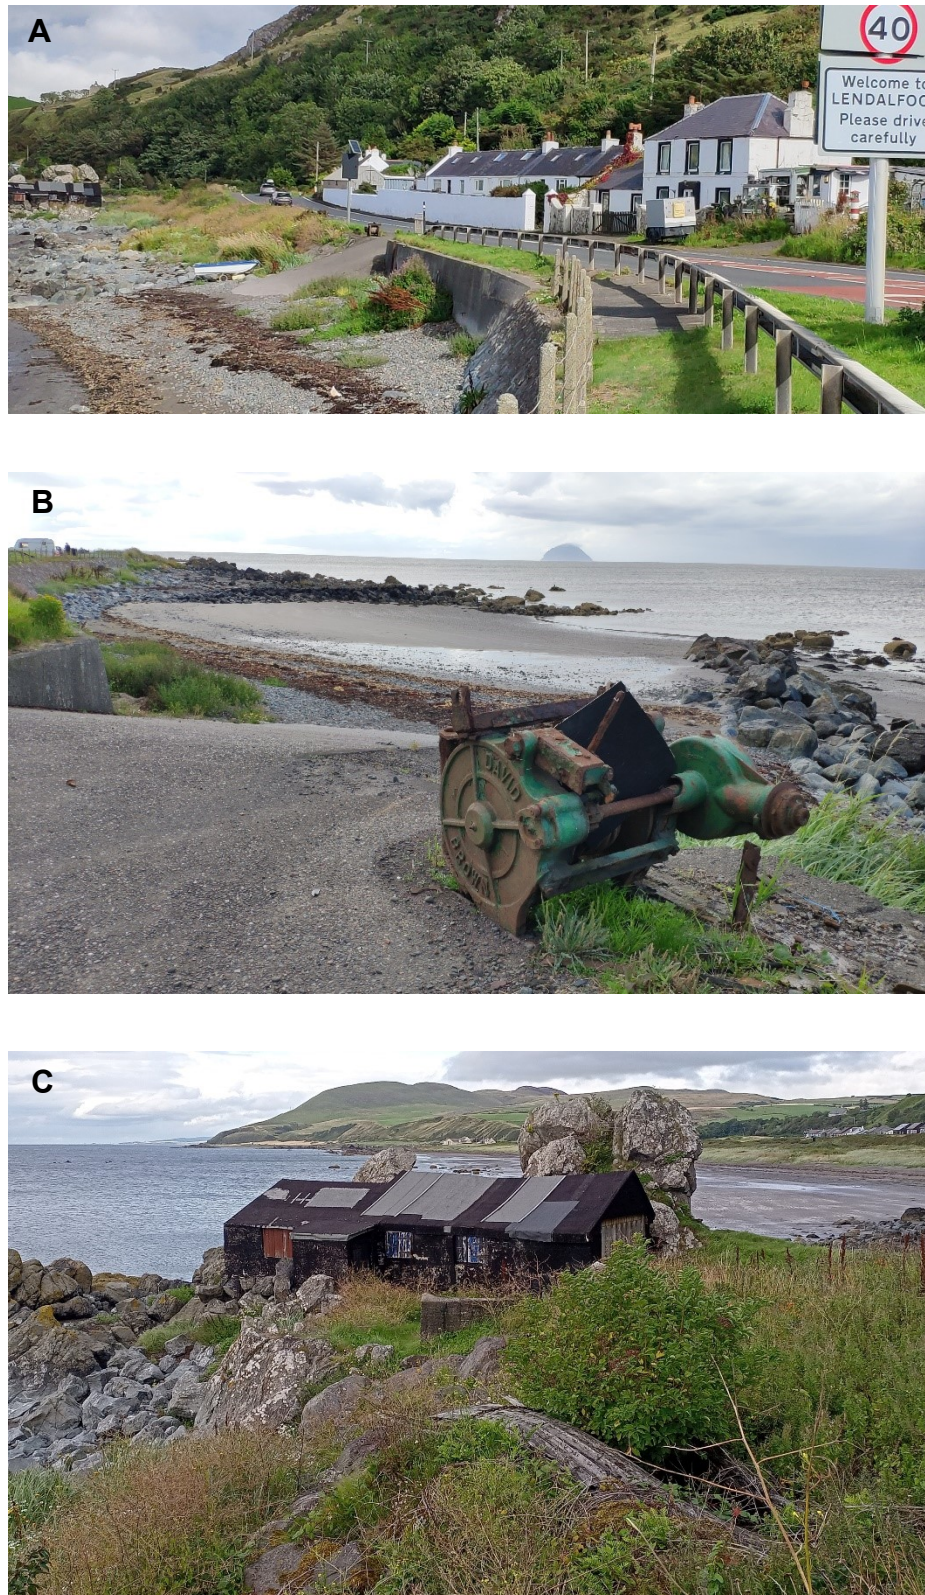
The two main locations with surviving fishing heritage were observed at Lendalfoot and Ballantrae harbour. The Carleton Fishery was built at Lendalfoot in 1832 (Ballantrae.org.uk, 2023, Figure 10A). The site consists of a row of small, terraced fishing cottages strung out along the main road, a concrete slipway leading down to the shore, and a cleared landing place lined with boulders on either side, known as Carleton Port (Figure 10B). Beside the slipway is a disused cast iron winch. On the rocky coast edge, the ramshackle remains of fishing sheds are still visible and in the nearby vegetation are the remains of a wooden boat (Figure 10C). The cottages are marked on the OS Six Inch (surveyed 1855) and OS 25 Inch (surveyed 1894), and both the Carleton Fishery and Carleton Port are named, however the fishing sheds are not mapped.

Figure 10. A. General view of Lendalfoot with row of small, terraced fishing cottages to east of road, and slipway to shoreside of road. Fishing sheds visible in the background. B. Concrete slipway and cast iron winch, with the cleared landing place visible in the background. Looking northwest; C. Fishing shed with remains of wooden boat in foreground, Lendalfoot. Looking northeast. (<https://scapetrust.org/sites-at-risk/site/15906>).

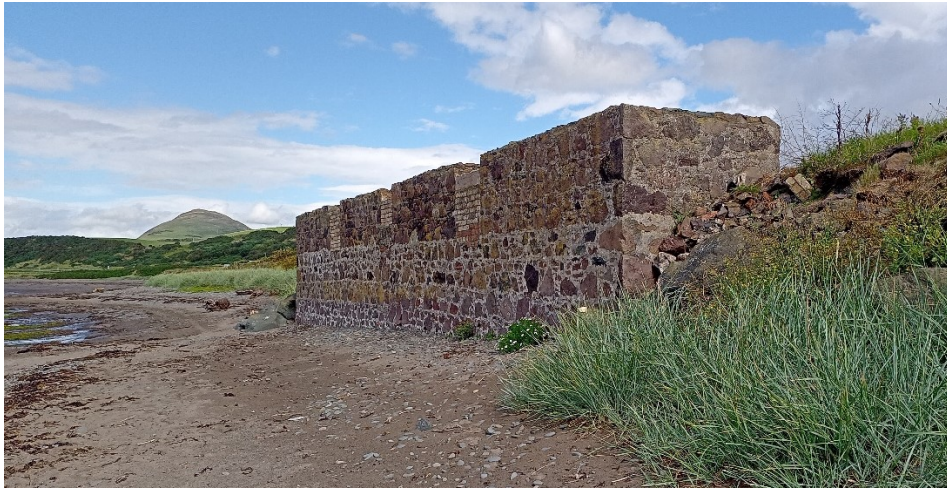
At Ballantrae harbour are the remains of a boathouse, situated at the coast edge (Figure 11, [SCAPE ID: 15884](https://scapes.org.uk/entry/15884)). The boathouse is stone-built with sections rebuilt in brick and it is now roofless. A nearby information panel at Ballantrae harbour describes the fishing along this coastline from Lendalfoot to Finnarts Bay as being predominantly salmon fishing, carried out using bag nets.

Figure 11. Remains of stone-built boathouse at shore edge, Ballantrae. Looking northeast. (<https://scapetrust.org/sites-at-risk/site/15884>).

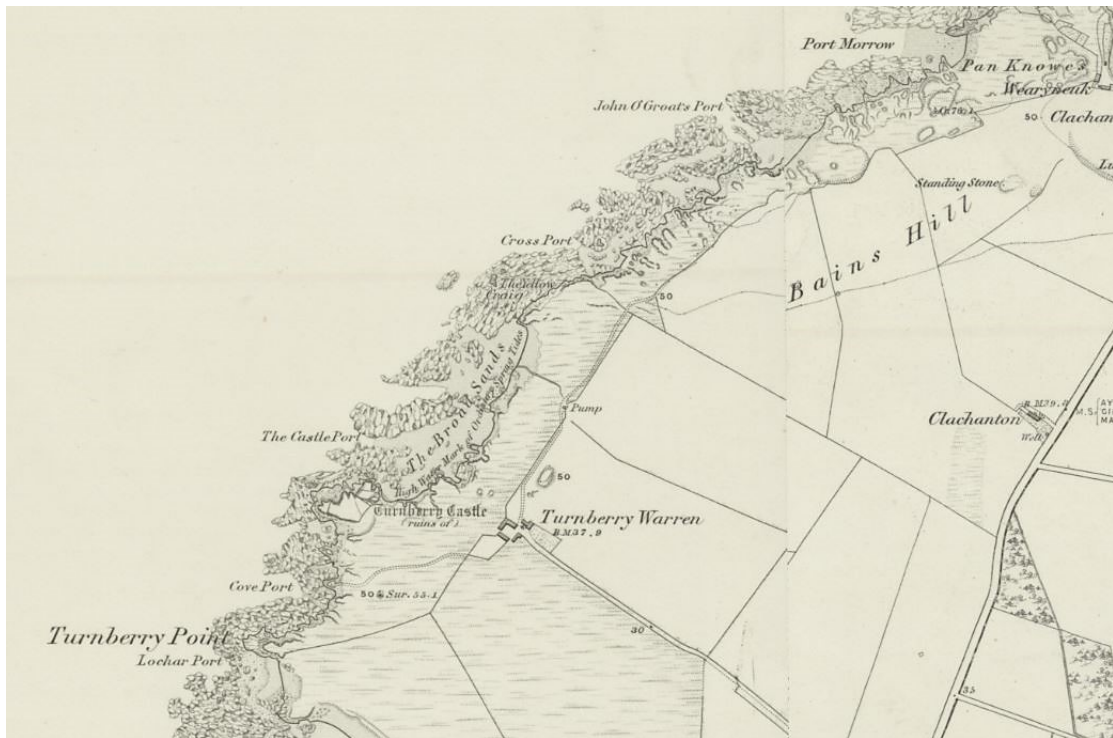
Figure 12. Port place-names on the Six-Inch Ordnance Survey Ayrshire map sheet XLIV surveyed 1857.

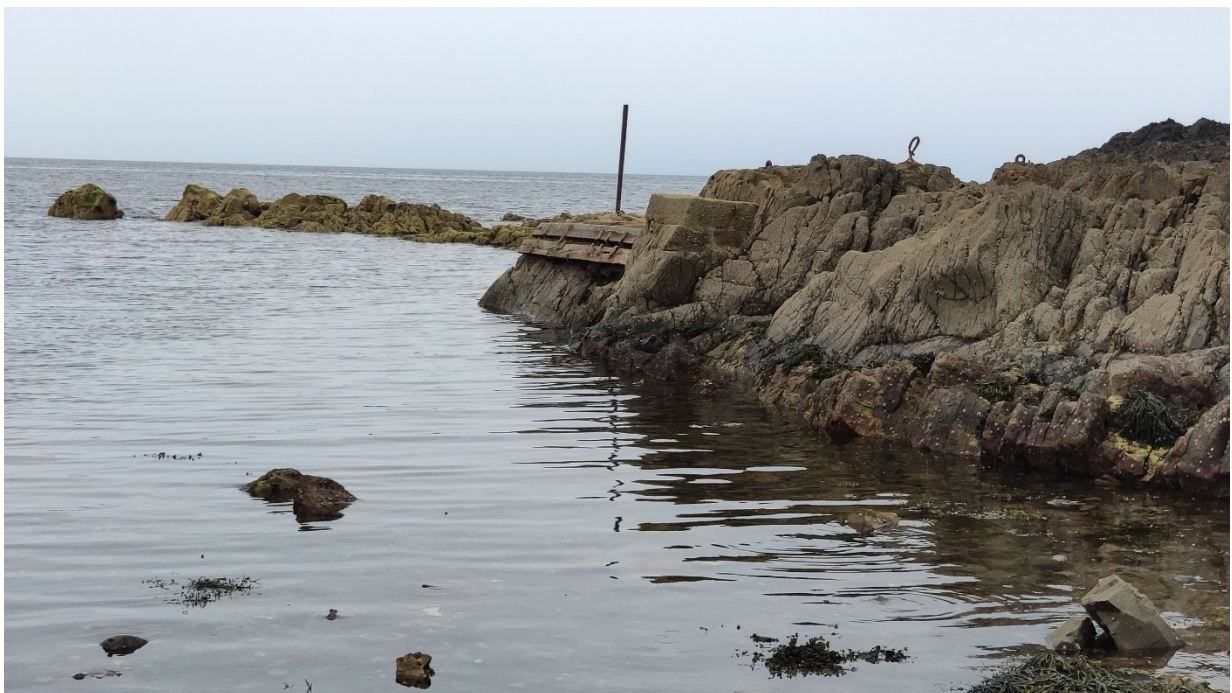
One of the few landing places not depicted on historic maps is the harbour associated with Turnberry Lighthouse ([SCAPE ID: 15957](#)). The 'harbour' is a modified natural rocky inlet extending to the base of the lighthouse enclosure with mooring rings lining the northern side. At the entrance to the inlet is a nicely constructed ashlar wall and smoothed section of rock and wooden shuttering which presumably represents the remains of a loading/ unloading point. Further into the inlet close to the base of the coast edge a spread of concrete over the rock platform leads to a further section of wooden shuttering to another loading/ unloading place. Construction of the Turnberry lighthouse started in 1871 and it was operation by 1873.

Figure 13. View of entrance to Turnberry Lighthouse harbour showing ashlar wall, mooring rings, and timber shuttering on smoothed rock. (<https://scapetrust.org/sites-at-risk/15957>).

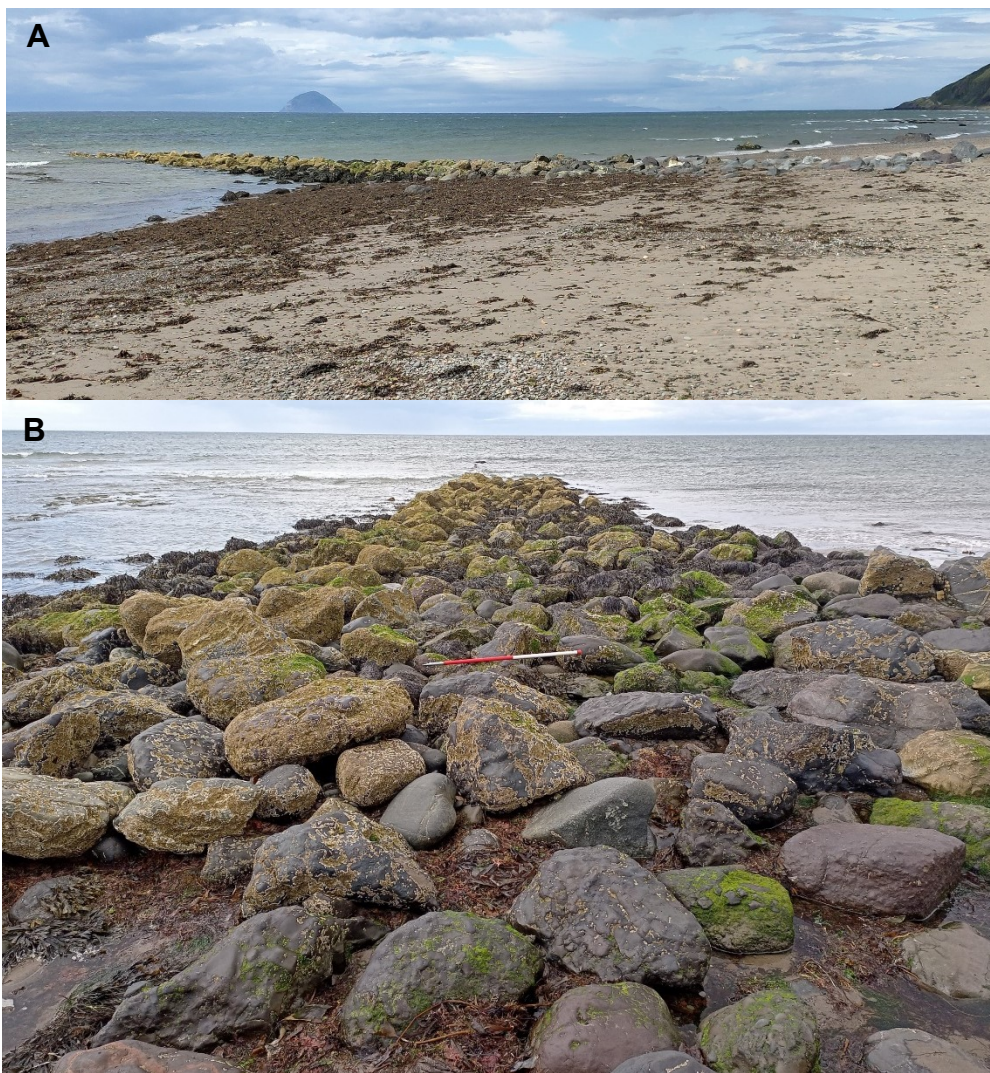
On the shore at Corseclays around halfway along Ballantrae Bay is a substantial stone jetty which is distinct from other informal landing places in the survey area ([SCAPE ID: 15917](https://scapetrust.org/sites-at-risk/15917)). The feature, c. 5m in width and many times longer, stretches from the shore out to sea (Figure 14). It is constructed from large subangular boulders, likely sourced from the foreshore. The name 'Port, Old Pier' is depicted in this location on historic 1st edition OS mapping (1855). The site is located close to the present harbour at Ballantrae (c.1.8km south of the pier) which was improved in the 1840s, so this 'Old Pier' may have gone out of use then. It is an unusual location for such a feature towards the centre of a sandy bay.

Figure 14. Boulder-built pier, Corseclays. A: General view, looking north; B: Detail of 5m wide intertidal section, looking west (<https://scapetrust.org/sites-at-risk/site/15917>).

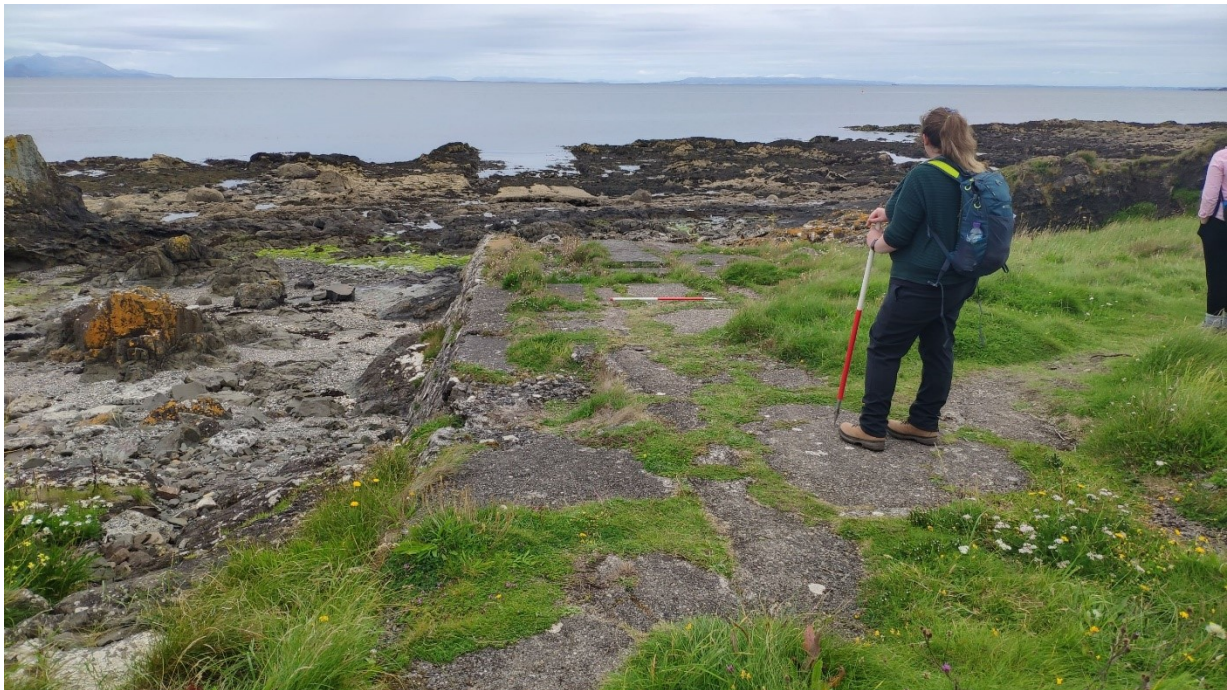
Another interesting landing place is the remains of a concrete slipway located in the former Maidens Shipyard, constructed in WW1, and associated with the development of Turnberry Airfield. It served the WW1 Motorboat shed, now gone. The Motorboat shed was reused

Figure 15. Concrete WW1 slipway at Maidens (<https://scapetrust.org/sites-at-risk/site/7659>).

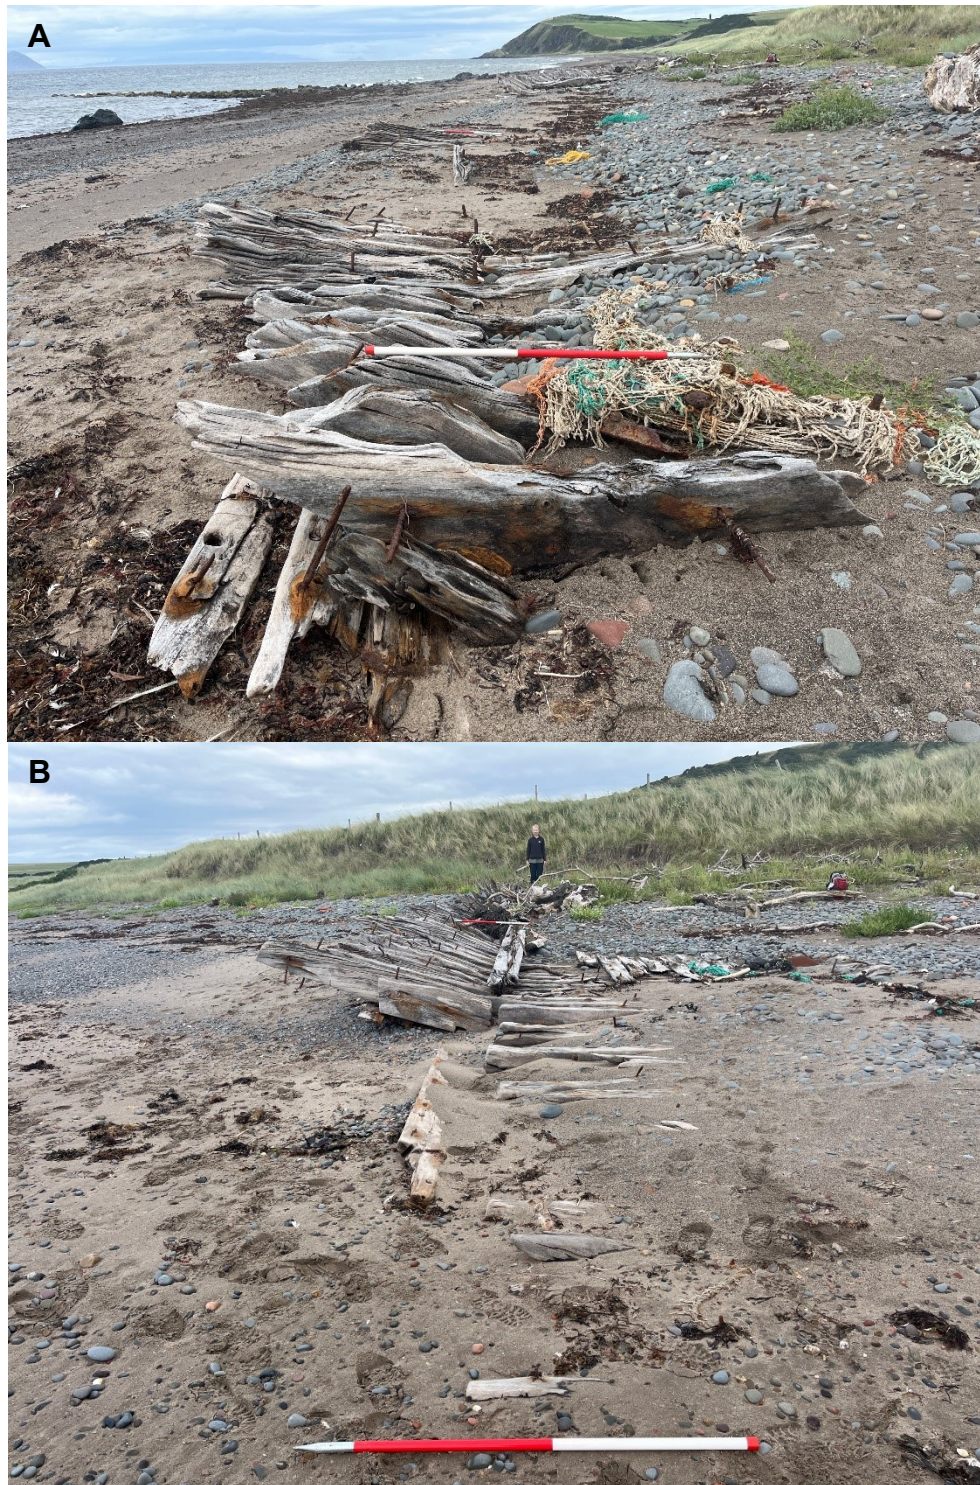
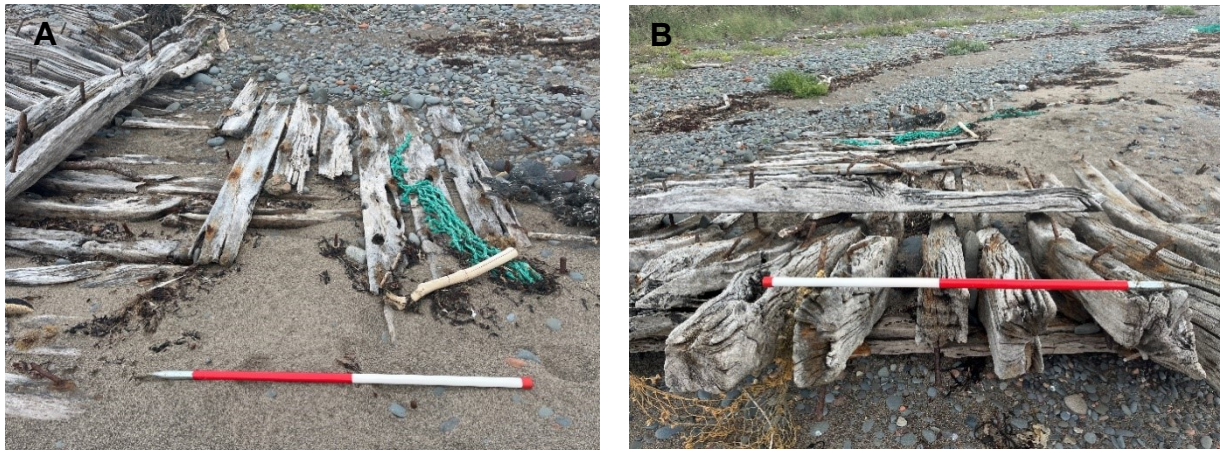
A wreck located at Low Balig (Corseclays), approximately 50m from the Corseclays pier, is situated within the sand on the upper part of the beach and broken into two main sections ([SCAPE ID: 16176](#)). The southern part of the wreck has dimensions of 14m in length x 4m at its widest point (Figure 16A). There are 26 frames in pairs visible, the spacing between each pair 20cm. There is also evidence of external planking, iron fittings and trenails/dowels. A fragment of a stringer timber survives in the centre. This part of the wreck is interpreted as a piece of one side of the vessel - probably the lower part close to the keel. The northern part of the wreck has dimensions of 20m in length x 6m at widest point (Figure 16B). There are 52 frames in pairs, each pair of frames are 16-20cm apart (Figure 16B). There are iron fittings and trenails/dowels and evidence of both internal and external planking (Figure 17) and a very large stringer (Figure 16B). This part of the wreck is interpreted as the rear starboard side of the vessel.

These are the remains of the schooner, the Richard, which was recorded on the Lloyds Register casualty returns as wrecked in October 1926, on a voyage from Northern Ireland to Denmark (Lloyds Register of Shipping 1926). All six crew were rescued by Rocket Apparatus (from Ballantrae?) according to the 'Casualty reports' in The Times (1926). A James Valentine photograph, taken in 1932, shows the wreck of the Richard stranded on the sand (Figure 18). At this time the wreck was still intact, with only one mast visibly remaining of the original four masts. It is not hard to imagine that this wreck would have been a well-known local landmark over the last century as it slowly deteriorated to its current state.

Figure 16. Timber remains of *The Richard*. A: General view taken from southern end of wreck, looking north; B: View of northern part of wreck, looking northeast towards coast edge (<https://scapetrust.org/sites-at-risk/site/16176>).

Figure 17. A. Northern part of wreck detailing A: internal planking; B: paired frames and the visible inner and outer planking.

The wooden wreck of the *Richard* is vulnerable to decay and dispersal. It has an interesting story and is well-known in the local area and a destination for walkers. We recommend regular monitoring, particularly after storms. This site would be suitable for interpretation at Ballantrae Harbour and for the installation of a fixed photo point for visitors to take photos to build up a timelapse photographic record showing seasonal and longer-term changes in the burial conditions of the wreck.

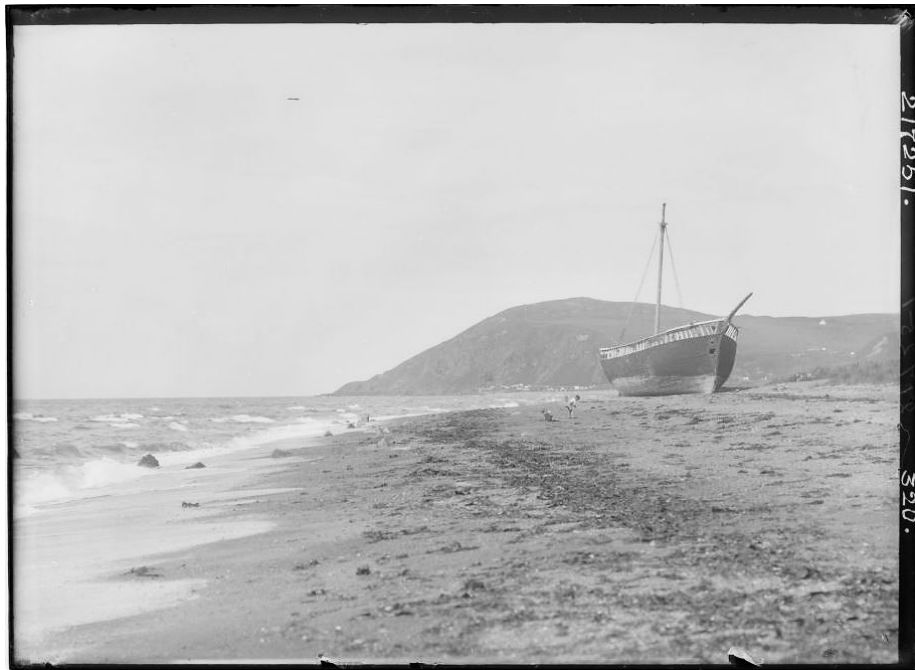
Figure 18. Photograph of The Richard wreck taken on 8 August 1932. Titled: Shore Road and Bennane Point, Ballantrae. James Valentine Photographic Collection. Courtesy of the University of St Andrews Libraries and Museums, ID: JV-217251.

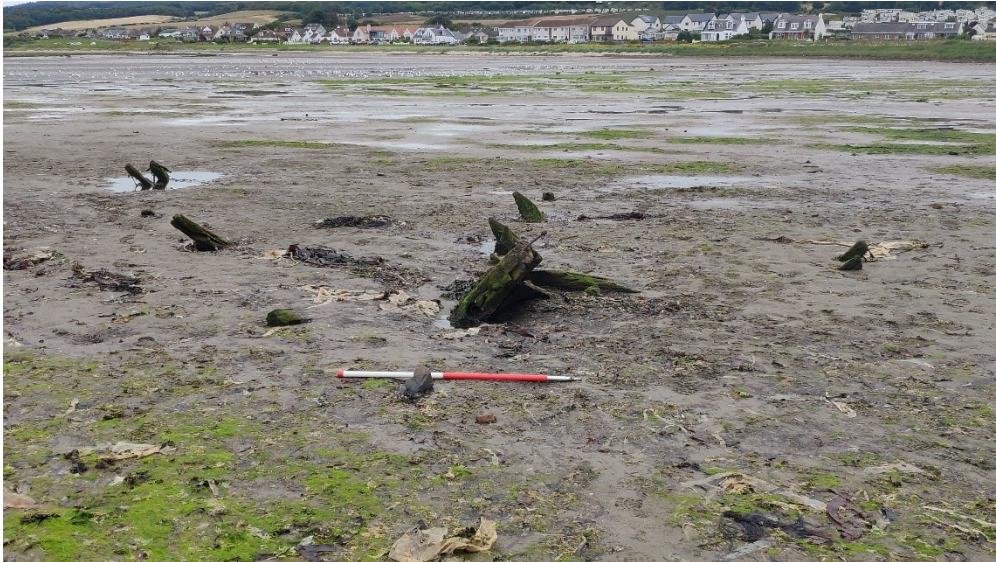
The scant remains of a wreck were also recorded close to the Maidens breakwater ([SCAPE ID: 7657](#)). This wreck was previously recorded in the 2003 CZAS of the Firth of Clyde (Sneddon, 2003). Since 2003, the wreck has become more buried in sand. The current visible extent measures 8m wide and 6m long. The frame survives up to the first futtock and part of the stern post is also visible. Ends of frames stick out on either side and it appears as though the vessel has split apart. There is now no sign of a diesel engine (Figure 19).

Figure 19. Wreck of wooden boat with iron fittings, Maidens Breakwater (<https://scapetrust.org/sites-at-risk/site/7657>).

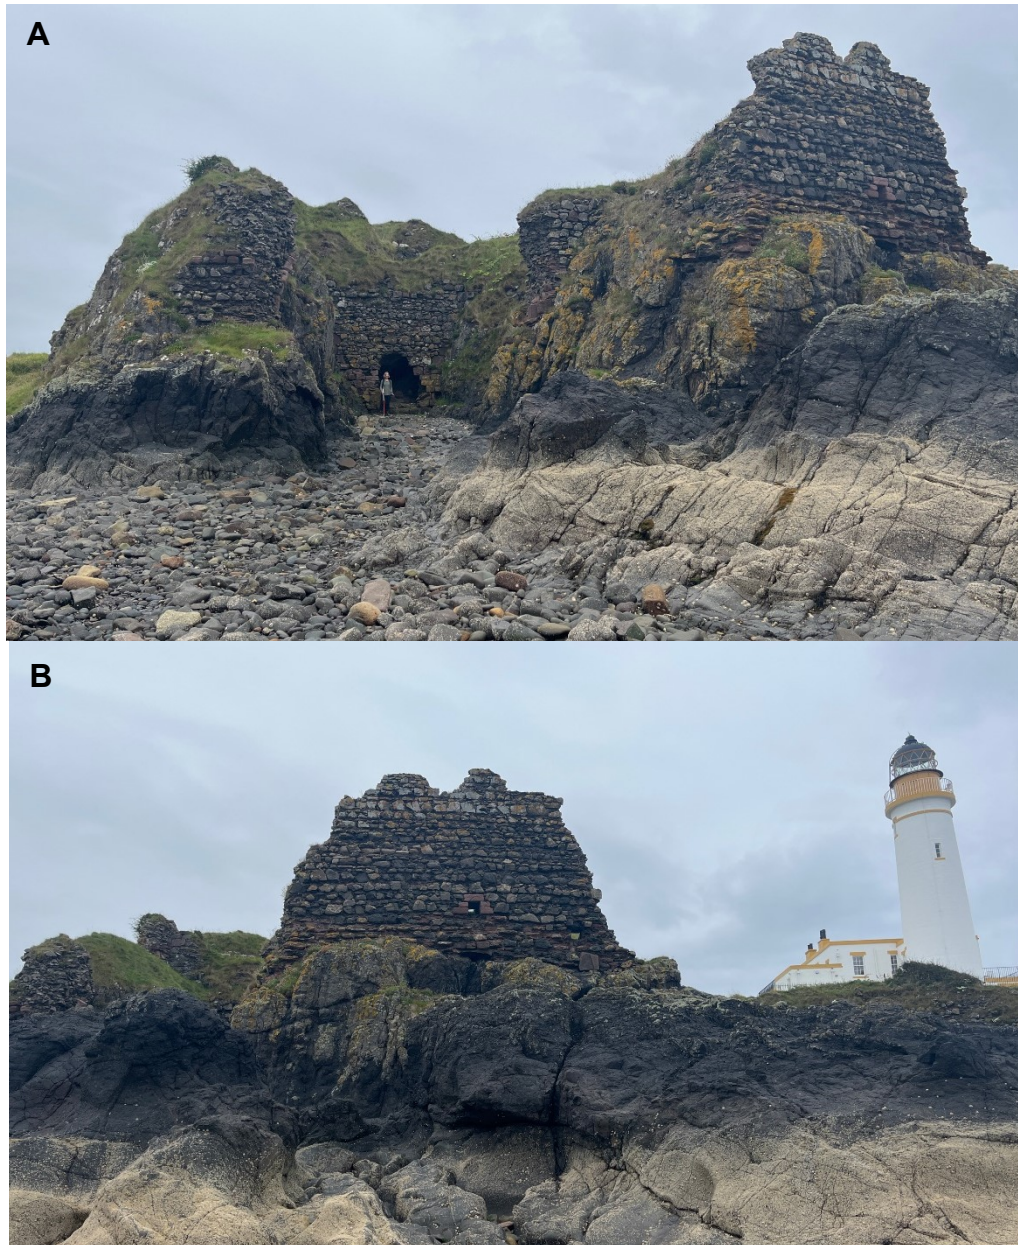
Perched on the cliff edge, approximately halfway along the coastline between Maidens and Turnberry, are the remains of Turnberry Castle, alternatively known as Bruce's Castle (Figure 20, [SCAPE ID: 15863](#)). The exact date that the castle was built is uncertain, but it was occupied in 1274 by the Martha, Countess of Carrick, and Robert Bruce Earl of Annandale (OSA, 1794). The castle was already in ruins by the time of its description in the OSA:

Figure 20. General view of Turnberry Castle. A: Remains of a stone archway over an inlet (a water gate?). At the back of inlet is an entrance within the wall built into the cliff face. Looking south; B: Remains of stone walling on coast edge, with Turnberry Lighthouse in background. Looking south (<https://scapetrust.org/sites-at-risk/site/15863>).

Turnberry Castle is of great historical significance and is vulnerable to further structural instability and collapse because of its precarious position on the cliff edge. The remaining stone walls are at risk from wave action, and especially susceptible to damage during storm events. As a scheduled monument [SM6183] HES will monitor its condition periodically, however, it is suggested that the site is visited every 3-5 years and after storm events.

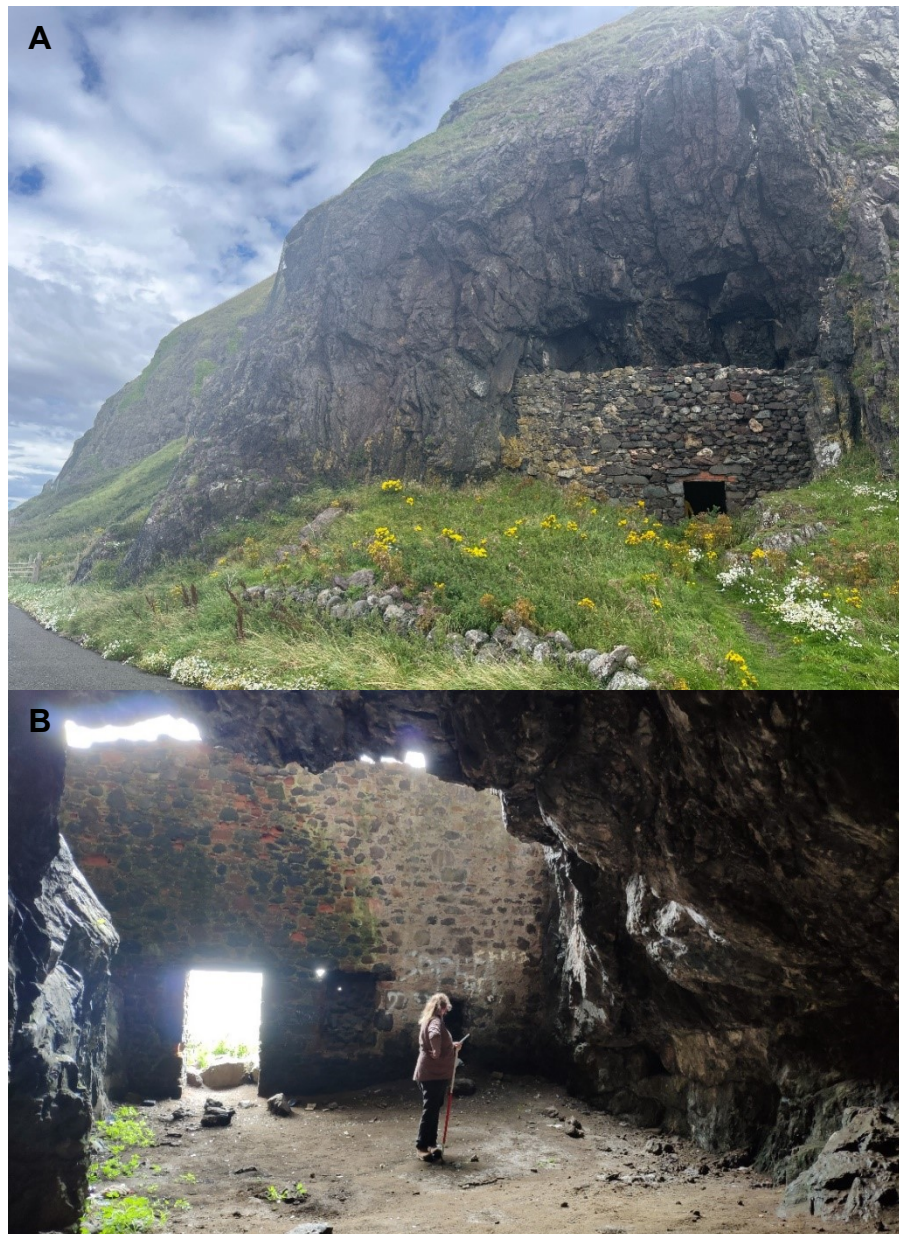
Carved out of the towering, chert, cliff face at Bennane, is the naturally formed Bennane Cave ([SCAPE ID: 15903](#)), which has been modified as a shelter (Figure 21A). A stone-built outer wall has been constructed across the entrance of the cave, which contains an open entrance, a window opening, which is now blocked, and a fireplace (Figure 21B). Inside the cave, a second stone-built wall divides the cave into a larger outer compartment and a smaller inner compartment. Approximately 150m to the south of the cave is a memorial stone for Henry

Ewing Torbet (Snib) who lived from 1912-1983 and was a resident of the cave for a time (Figure 22). The cave itself appears to be in good condition with a small amount of litter and some graffiti evident.

Figure 21. A. General view of exterior of Bennane Cave; B. View of interior of outer compartment of Bennane Cave, looking towards entrance (<https://scapetrust.org/sites-at-risk/site/15903>).

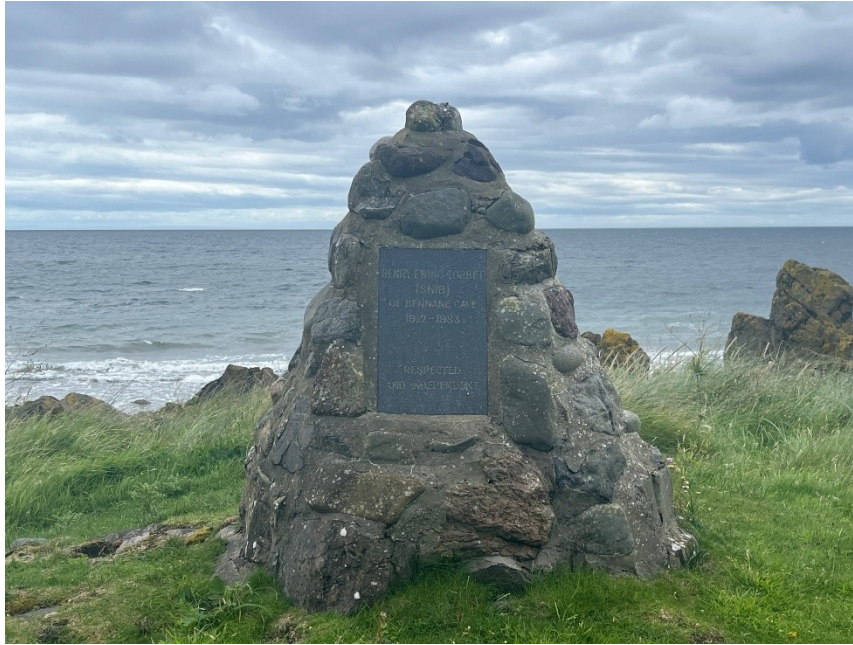
Figure 22. Memorial to resident of Bennane Cave. Inscription reads “HENRY EWING TORBET (SNIB) OF BENNANE CAVE 1912-1983 RESPECTED AND INDEPENDENT”

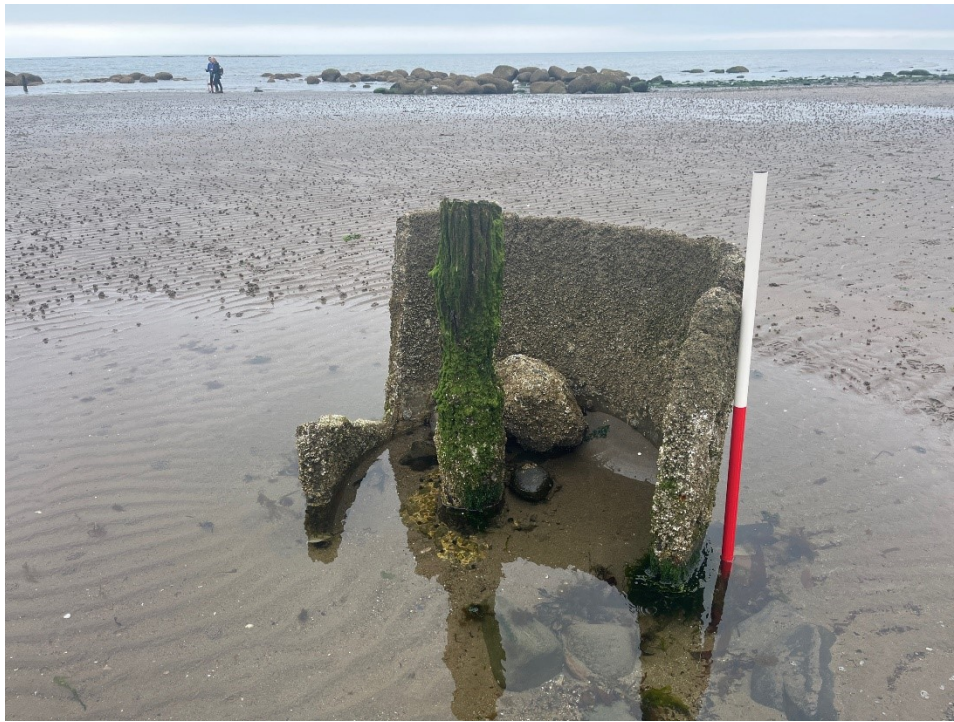
Observed on the sandy beach of Turnberry Bay is an alignment of three wooden posts running out to sea ([SCAPE ID: 16164](#)). Two of the posts could be accessed at the time of survey and one was partially submerged and viewed from the beach. The landward post was c.1m tall and 0.15m in diameter protected by a concrete pipe (Figure 23). The post was concreted at its base and cobble stones were noted within the pipe. Approximately 50m further seaward, the middle post had similar dimensions but was protected within a metal surround, below water height. The furthest of the three in the alignment was under the waves and no post was visible but the remains of a container/structure could be seen.

It is possible that the posts are military; related to the nearby WW1 and WW2 RAF Turnberry, or anti-landing defences (as documented on many similar beaches on the east coast of Scotland). However, the true purpose of the wooden post alignment remains uncertain.

Figure 23. Photograph of wooden post set within the remains of a concrete sewage pipe (<https://scapetrust.org/sites-at-risk/site/16164>).
