Scottish Coastal Archaeology and the Problem of Erosion

Coastal Zone Assessment Survey Stronsay Interim Report

Sarah Boyd, Joanna Hambly

The SCAPE Trust and University of St Andrews
November 2023

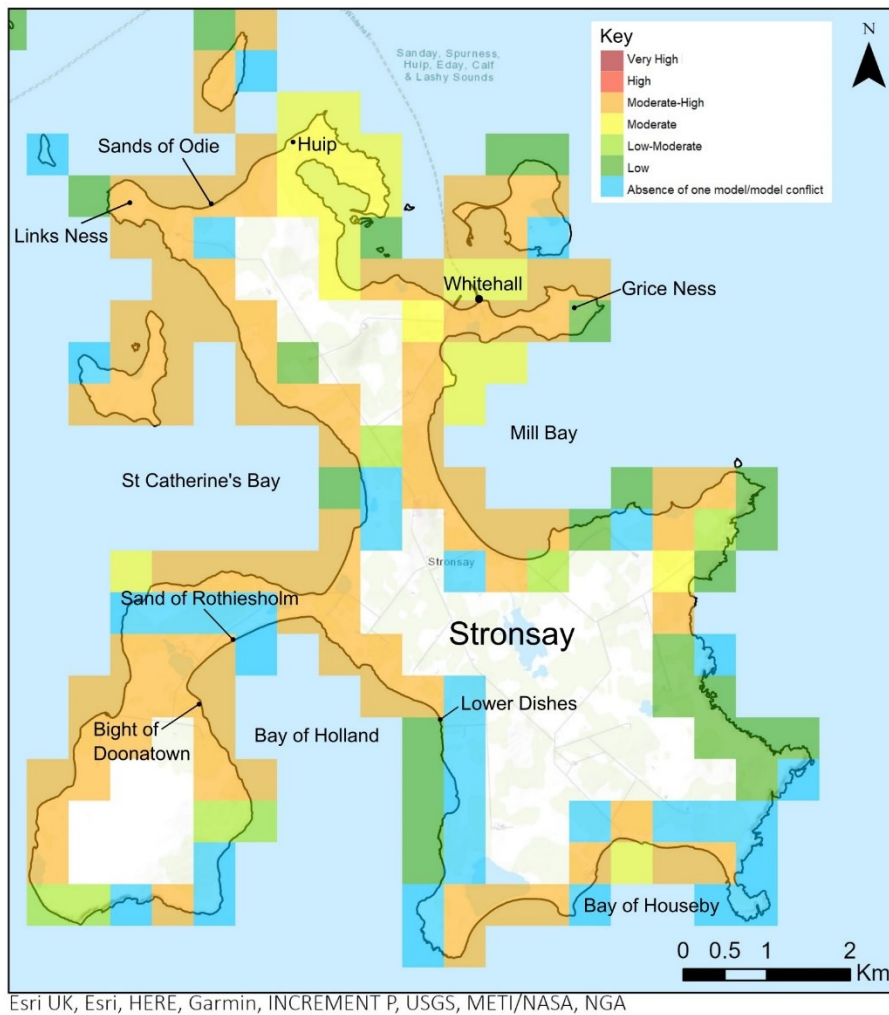
The resolution of 0.5 km² grid cells is deliberately chosen to give a broad overview of the nature of the coastline for walkover planning purposes (Figure 2). Within a red or orange grid cell there may be areas of accretion or no erosion, however the cell will also contain coastline with moderate to high susceptibility of erosion by 2030.

Figure 2. Modelled vulnerability of the Stronsay coastline. Red, orange and yellow cells denote coast which is experiencing erosion and therefore targeted during the 2023 CCZAS survey. Green cells denote coast that is not experiencing erosion and blue cells denote areas where there is a conflict between the models, or which are only included by one model.

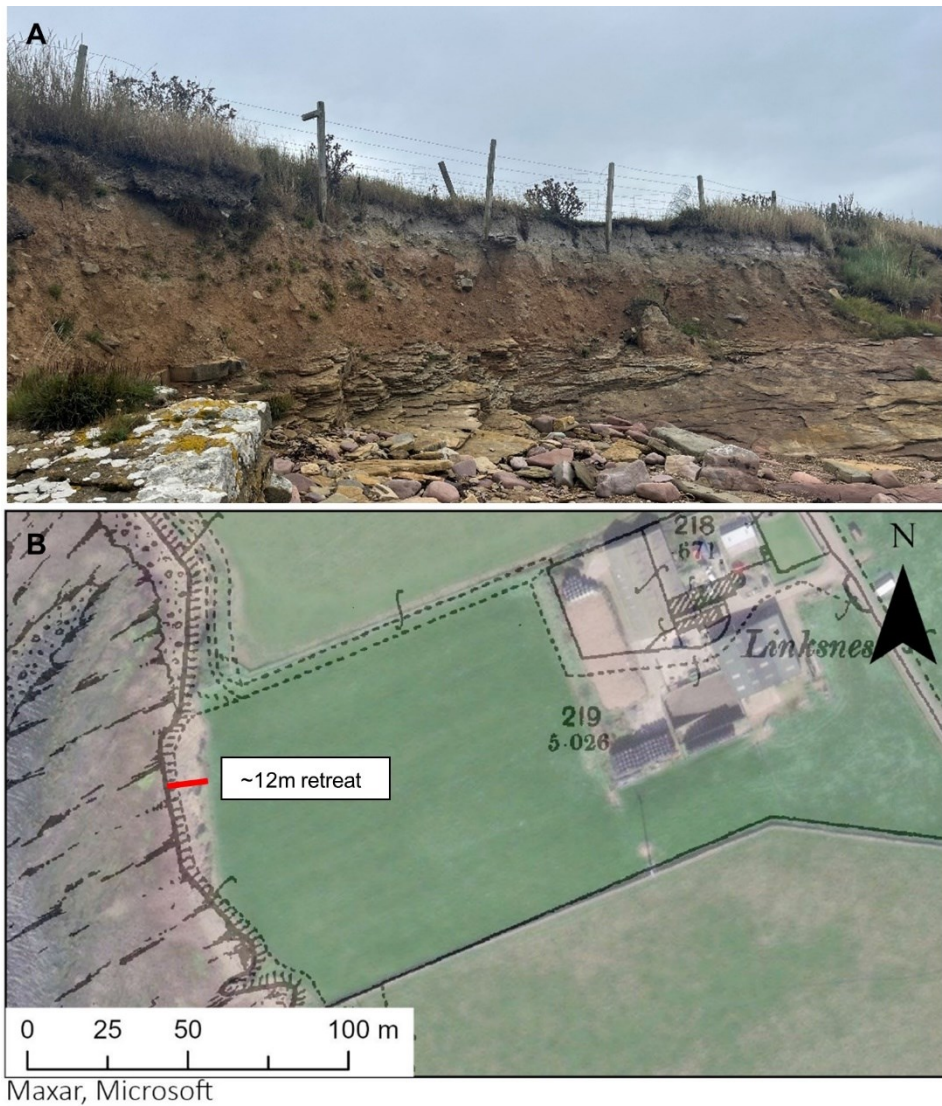
The desk-based coastal vulnerability modelling suggested that Links Ness and Sands of Odie contained areas of coastline susceptible to erosion and the walkover survey confirmed that erosion is occurring here with variable levels of coastal retreat when compared to historic 1900 mapping. To the west of Links Ness, the subsoils and glacial deposits which overlie the sandstone bedrock are actively eroding. Figure 4A shows a field boundary fence that has been completely undermined, leaving fence posts dangling in front of the eroded coastal exposure. This section of coastline has eroded by approximately 12m since 1900 (Figure 4B).

Figure 4A. Erosion of coast edge, undermining a fence and leaving posts freely hanging, Linksnes. Figure 4B. Comparison of coast edge using modern satellite imagery and 1900 historic mapping (1:2500 County Series 1st Revision [TIFF geospatial data], Scale 1:2500. Tiles: orkn-hy6229-2.tif, Updated: 30 November 2010, Historic, Using: EDINA Historic Digimap Service, <https://digimap.edina.ac.uk>, Downloaded 2023-10-09).

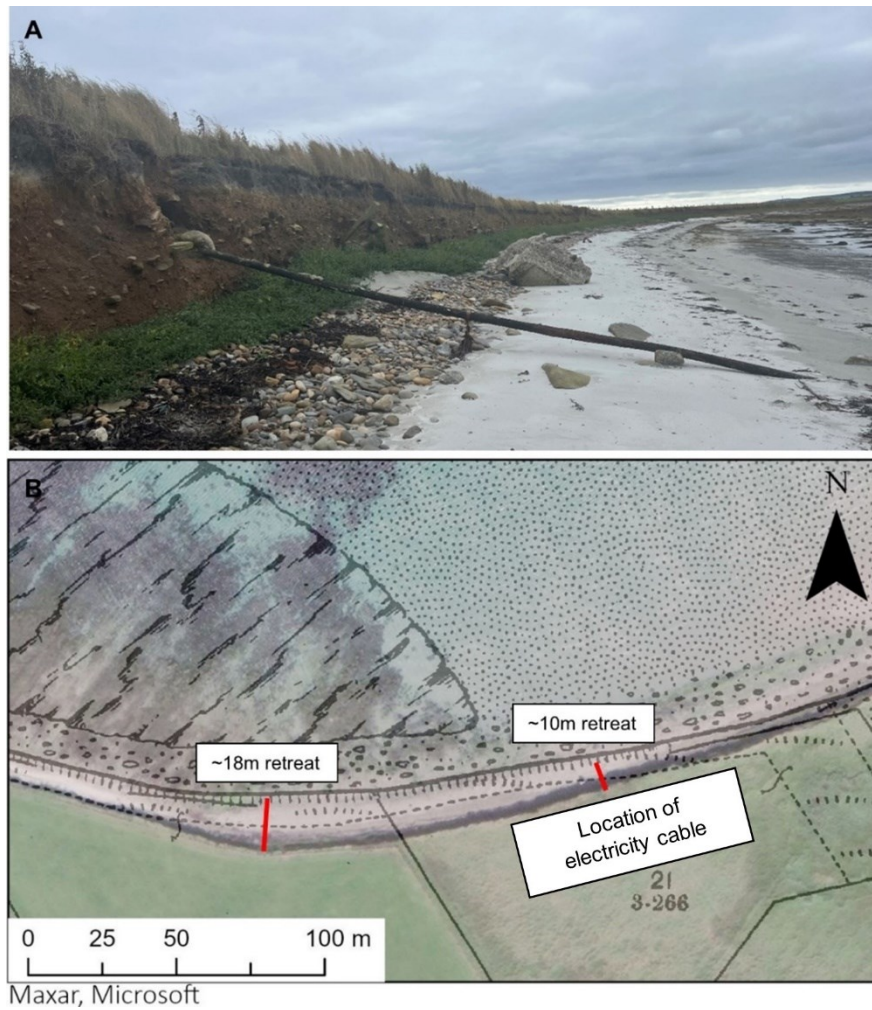
Figure 6A. Submarine mains electricity cable exposed from eroding coast edge, Sands of Odie. Figure 6B. Comparison of coast edge using modern satellite imagery and 1900 historic mapping (1:2500 County Series 1st Revision [TIFF geospatial data], Scale 1:2500. Tiles: orkn-hy6229-2.tif, Updated: 30 November 2010, Historic, Using: EDINA Historic Digimap Service, <https://digimap.edina.ac.uk>, Downloaded 2023-10-09).

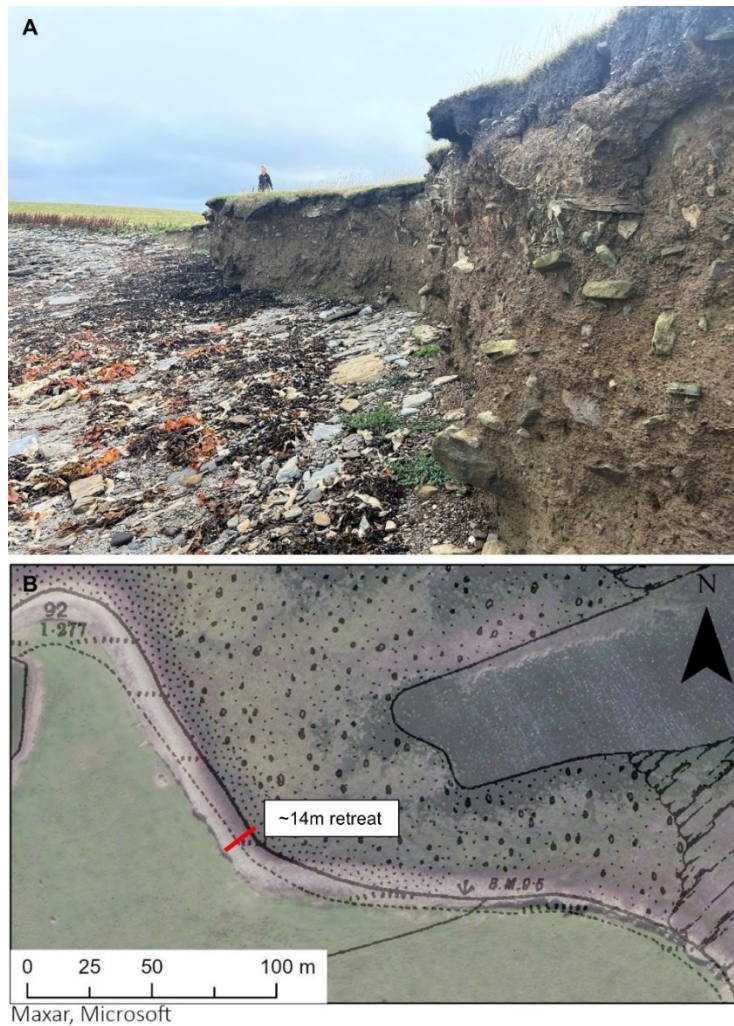
Erosion of superficial deposits is occurring along the north and southwest sides of the Grice Ness promontory; the overall change from 1900 to present most notable on the north with around 14m retreat occurring in some places (Figure 7). Numerous kelp walls and kelp burning pits are situated all around the coast edge of Grice Ness and the erosion is encroaching on some of these sites (Figure 8, SCAPE ID: 16185).

Figure 7A. Erosion of coast edge on northern side of Grice Ness. Figure 7B. Comparison of coast edge using modern satellite imagery and 1900 historic mapping (1:2500 County Series 1st Revision [TIFF geospatial data], Scale 1:2500. Tiles: orkn-hy6728-2.tif, Updated: 30 November 2010, Historic, Using: EDINA Historic Digimap Service, <https://digimap.edina.ac.uk>, Downloaded 2023-10-09).

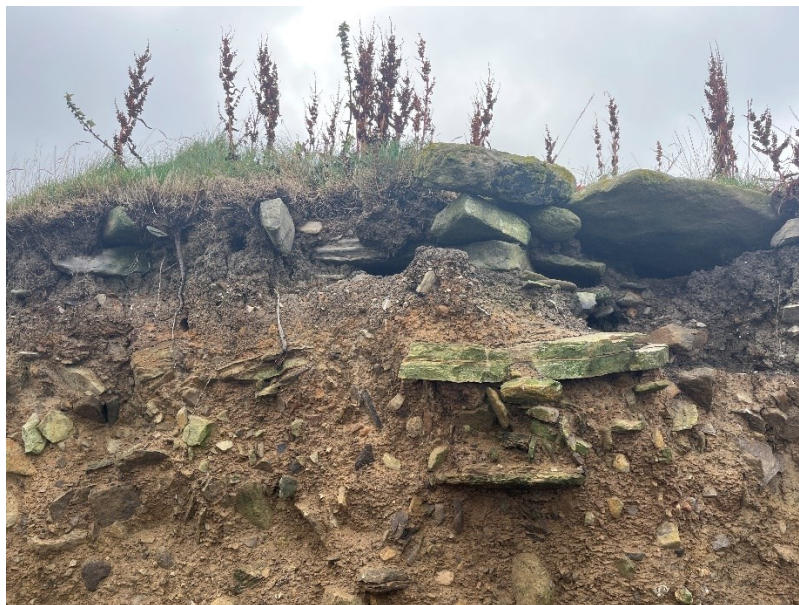
Figure 8. Kelp burning pit eroding out of coast edge, Grice Ness.

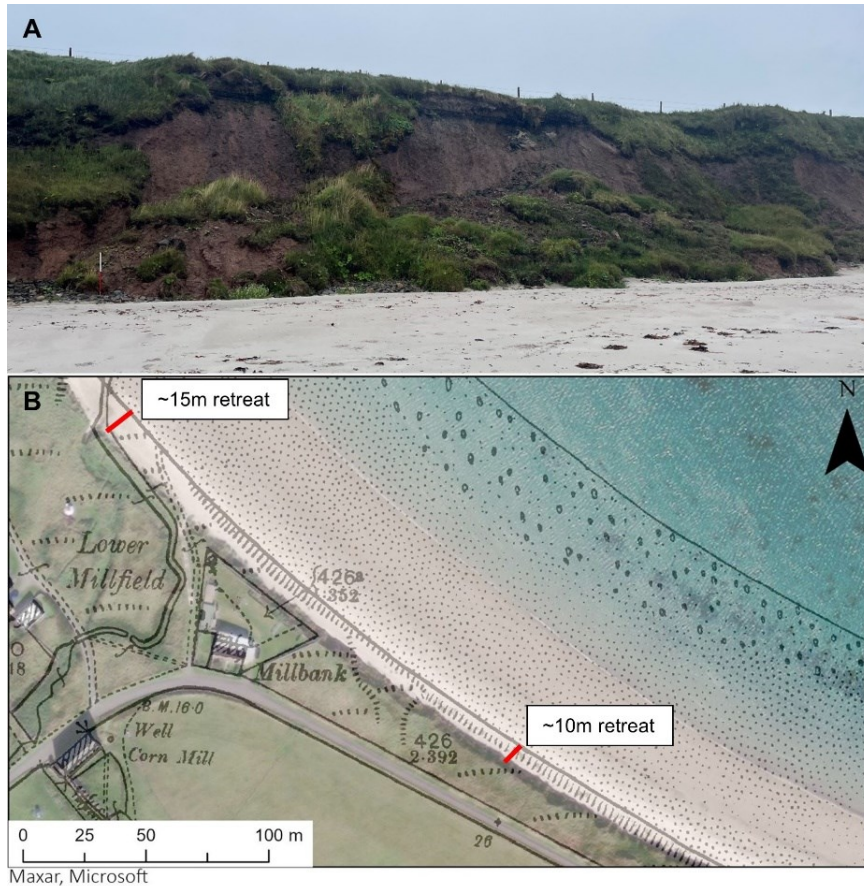
Mill Bay is a long sandy beach backed by a cliff of shelly glacial till, designated a Site of Special Scientific Interest (SSSI) for its Quaternary geological importance. No archaeological remains have been recorded on the coast edge here, although significant Mesolithic activity is known across the hinterland of Mill Bay ([Canmore ID 300439](#)). In the August 2023 survey, due to deteriorating weather conditions, only the southern portion of the bay was walked. The soft till is actively eroding and at the time of the survey recent slumping was observed (Figure 9A). When compared to historic mapping the coast edge has retreated by up to approximately 15m (Figure 9B).

Figure 9A. Recent slumping of coast edge composed of glacial till, Mill Bay. Figure 9B. Comparison of coast edge using modern satellite imagery and 1900 historic mapping (1:2500 County Series 1st Revision [TIFF geospatial data], Scale 1:2500. Tiles: orkn-hy6625-2.tif, Updated: 30 November 2010, Historic, Using: EDINA Historic Digimap Service, <https://digimap.edina.ac.uk>, Downloaded 2023-10-09).

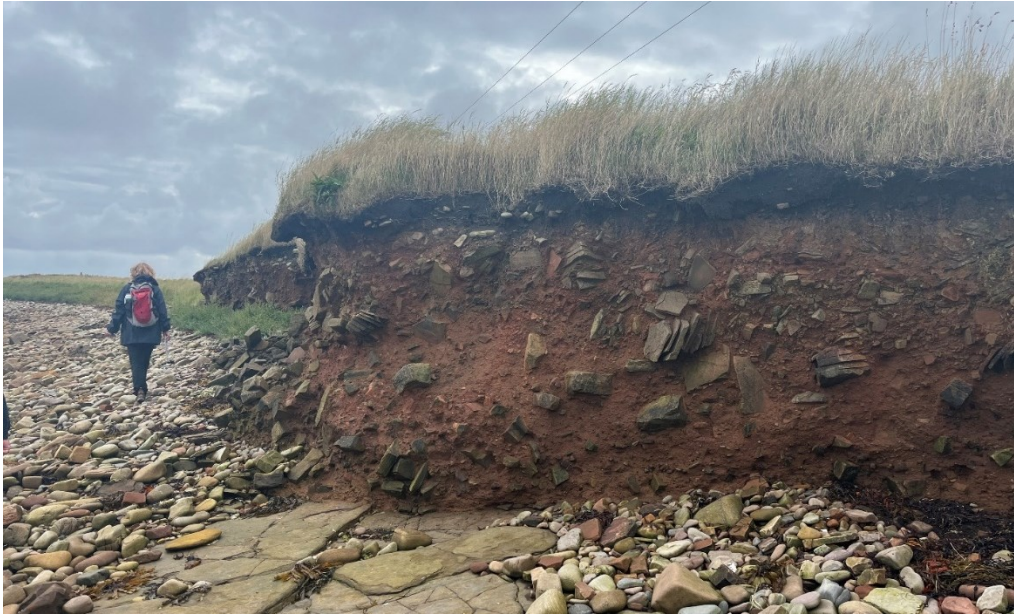
The area of the Bight of Doonatown, to the west of Sands of Rothiesholm, shows localised erosion mainly affecting the low lying glacial till over bedrock coast edge (Figure 10).

Figure 10. Erosion of coast edge, Bight of Doonatown, Sands of Rothiesholm.

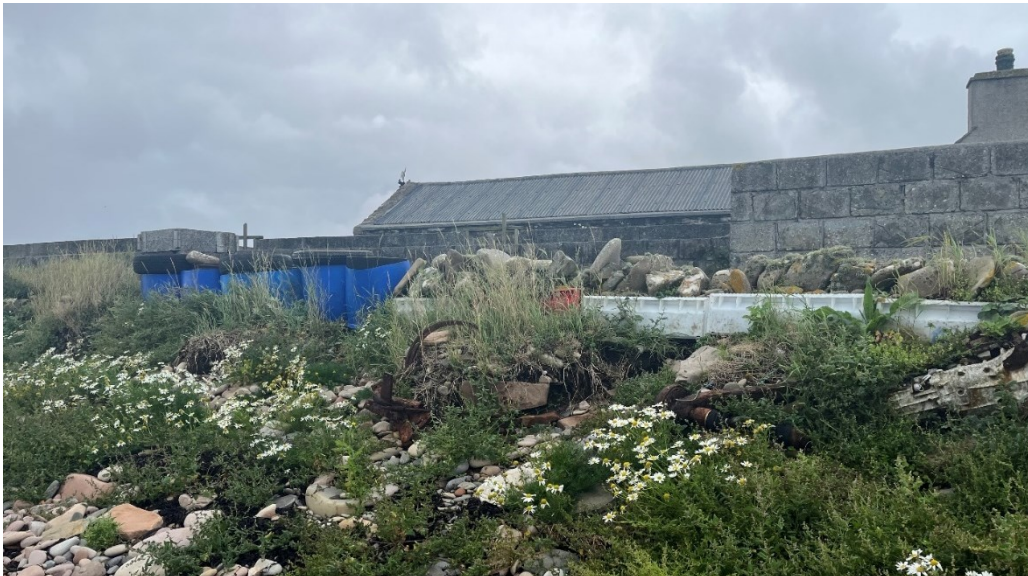
Nuisance erosion is obviously an historic and continuing issue for properties located close to the coast edge on Stronsay. Examples of defences observed during the survey ranged from ad-hoc arrangements, such as that observed at Furrewend, on the west side of the Bay of Holland (Figure 11), a patchwork of repaired stone walling protecting a farm at Banks (Figure 12) and much more substantial structures such as the reinforced concrete defence at Housebay Farm (Figure 13).

Figure 11. Ad-hoc coastal defences protecting farm buildings at Furrewend

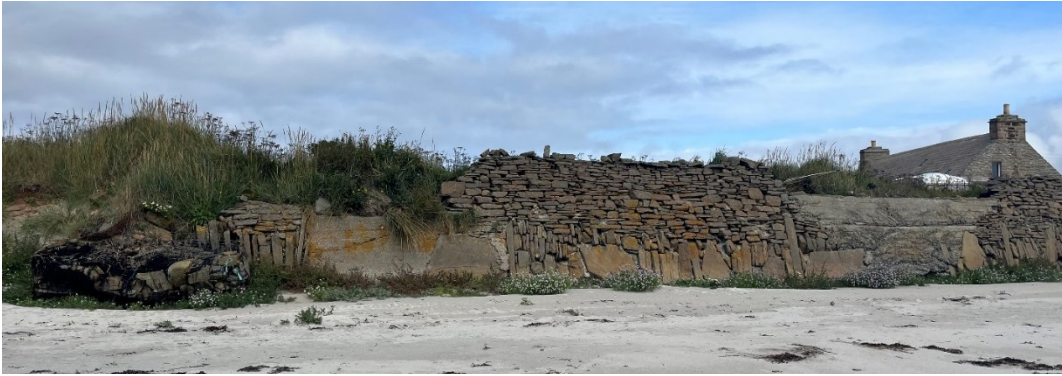
Figure 12. Multi-phase coastal defence at Banks.

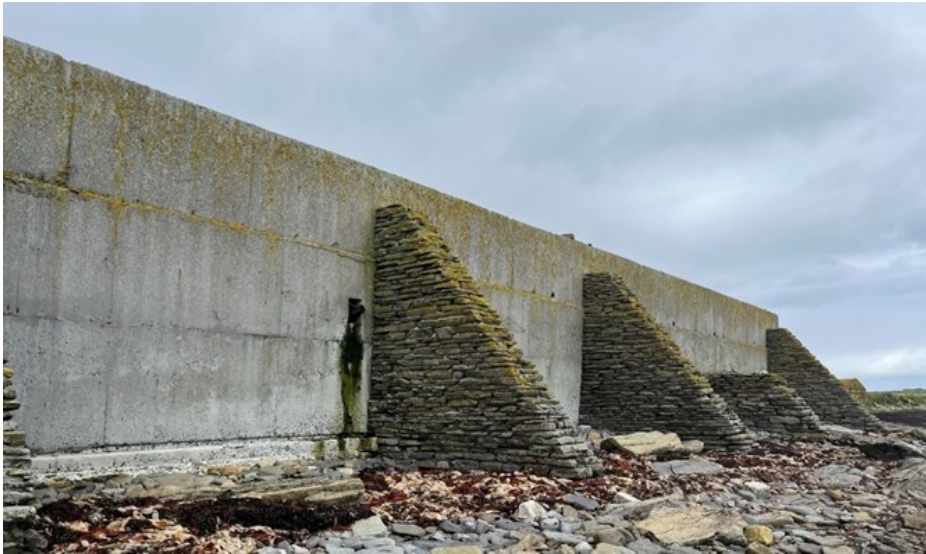
Figure 13. large concrete and stone built coastal defence for Houseby Farm.

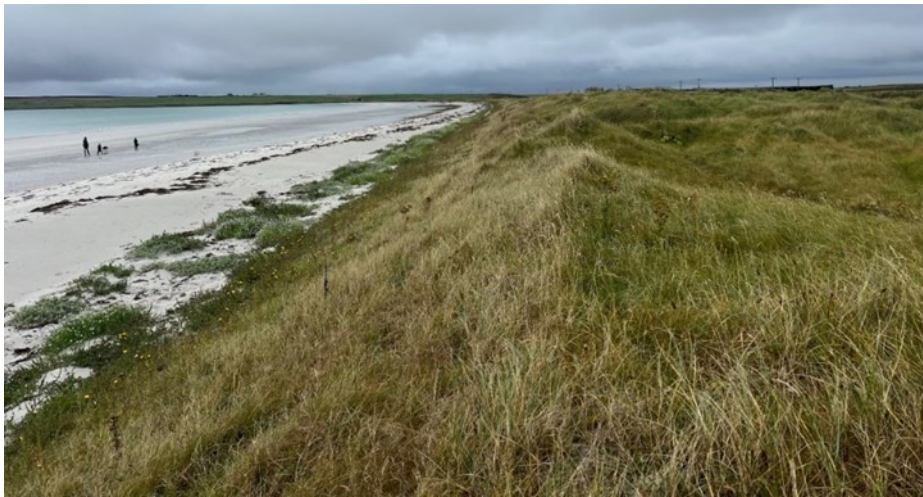
The Sands of Rothiesholm stretching across the north of Holland Bay is a long expanse of white sand beach backed by vegetated dunes (Figure 14). Storminess in 1993 caused severe erosion and exposed extensive settlement remains at the Sands of Rothiesholm. A report by Moore and Wilson (1995) described the exposed archaeology over a distance of 110m, including stone walls, midden, and two eroding mound structures ([SCAPE ID: 16122](#)). When visited in August 2023 Sands of Rothiesholm was stable and vegetated with no visible archaeological deposits or structures. Comparing the position of the coast edge between the 1900 historic mapping and modern satellite imagery, shows very little net change.

Figure 14. Currently stable coastline of Sands of Rothiesholm.

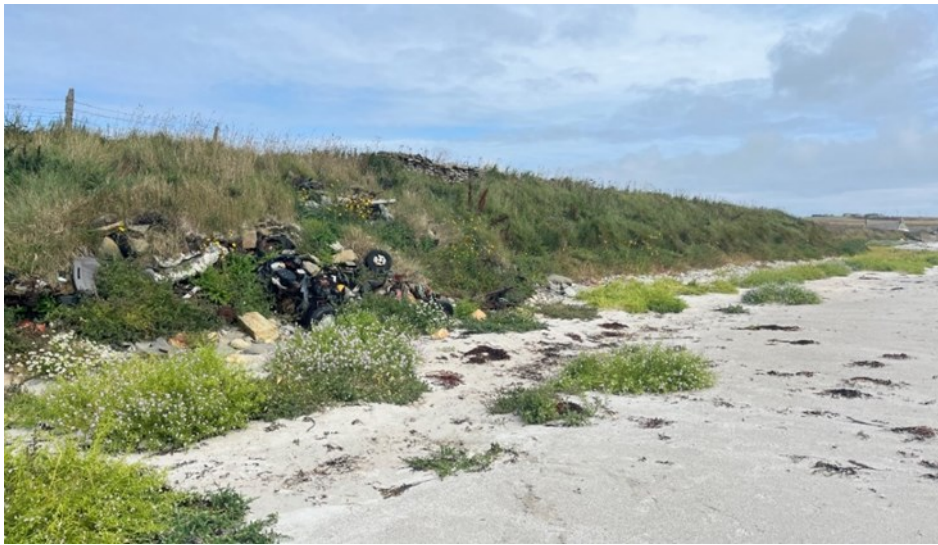
Erosion in the 1990s also severely affected the sandy coast edge at Dishes exposing ~55m of archaeological deposits and structures at a site known as Banks the Waspy and the Navsy ([SCAPE ID: 16012](#)). This included midden material containing animal and fish bone, burnt stone, clay lumps and charcoal, walling, a stone drain, stone lined pits, and slabs which could represent a trough or hearth. Artefacts including a steatite bowl have been recovered from the site (Moore and Wilson, 1995).

Figure 15. Currently vegetated coastedge with modern dumping, Dishes

At the time of the August 2023 survey, the coast edge along dynamic sandy beaches was generally vegetated and stable with little sign of the archaeological structures or deposits recorded previously. Local information also suggests that these areas have been stable for many years. However, the cycles of erosion that typify these coastlines cause the incremental loss of archaeological sites even though the coast edge itself recovers and so the archaeological resource continues to be at risk from erosion.

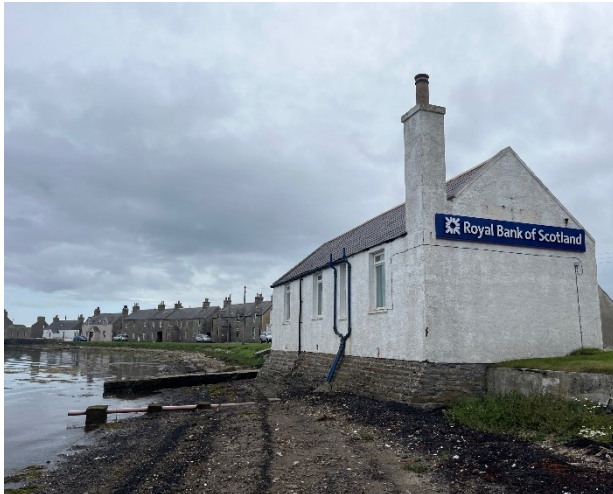
Many of the buildings in Whitehall village and Lower Whitehall have associations with the booming herring fishing industry in Stronsay during the late 19th and early 20th centuries (Figure 17). Three sites associated with the herring fishery have been added to the record. Situated right on the coast edge close to Whitehall’s west pier is the former customs house which was built to deal with the large volumes of cargo coming and going from Stronsay ([SCAPE ID: 16197](#), Figure 17A). On the eastern side of Whitehall, beside the Whitehall pier and ferry terminal, is the former fishmart ([SCAPE ID: 16198](#), Figure 17C). Inland from the coast is the imposing structure of a large stone built salt store, which was initially used by the herring fishery and later repurposed as a coal store ([SCAPE ID: 16199](#), Figure 17B).

Figure 17A. Former custom house built for herring industry, now a bank branch (<https://scapetrust.org/sites-at-risk/site/16197>).

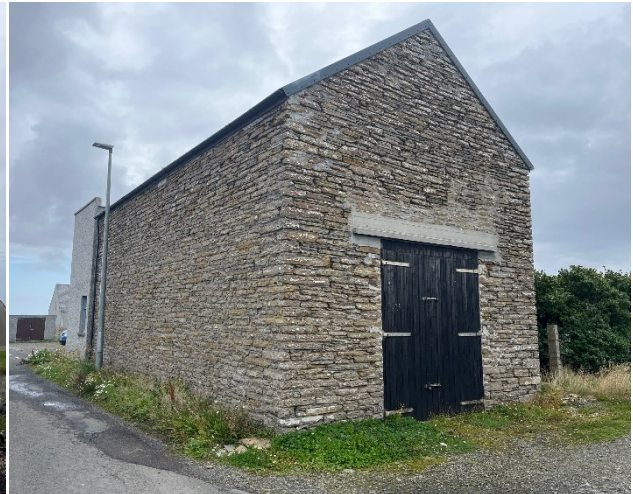
Figure 17B. Former salt store used for the herring industry and subsequently used as a coal store (<https://scapetrust.org/sites-at-risk/site/16199>).

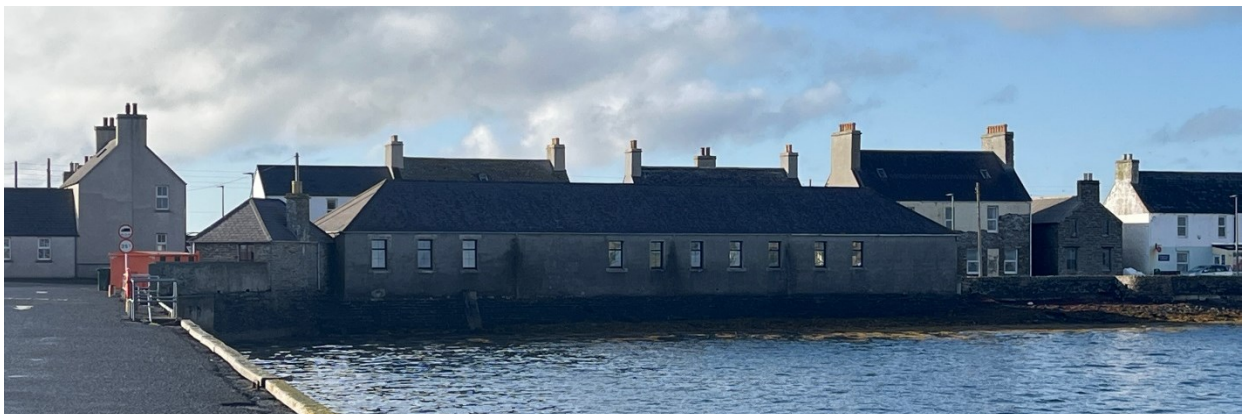
Figure 17C. Former Fishmart, now used as a café, hostel and public toilets. Situated on coast edge by ferry terminal (<https://scapetrust.org/sites-at-risk/site/16198>).

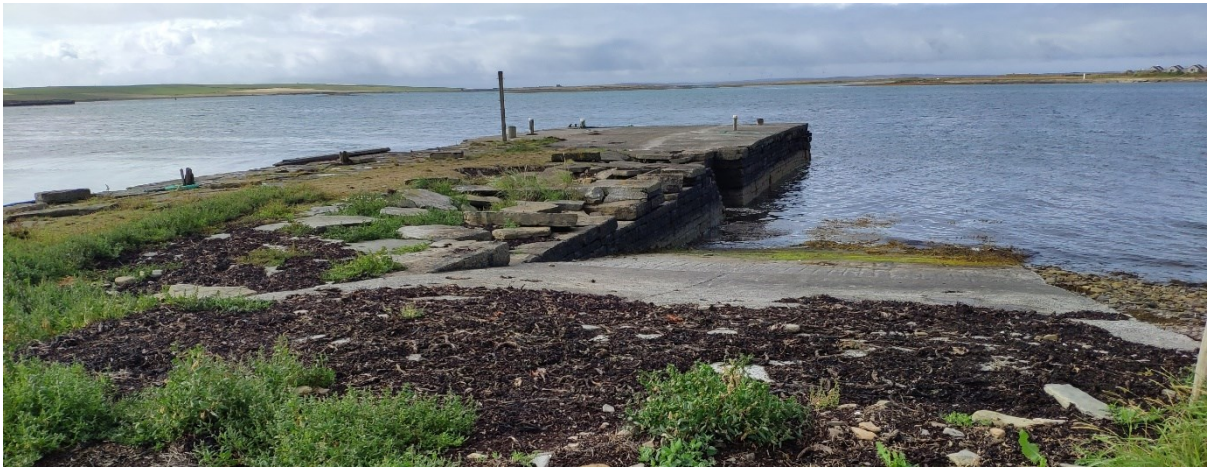
On the east side of Lower Whitehall at The Station is a stone jetty, known locally as the Station Pier. Immediately adjacent to the pier is a concrete slipway (Figure 18). The Station Pier was built in the late 1800s for the herring fishing industry. The concrete slipway is a more recent construction by the Monks living on Papa Stronsay as a landing place for their small craft. The pier has a cobbled stone top between the pier edge and slipway, a concrete end as well as areas of concrete patching. Several timber bollards line the length of the pier (SCAPE ID: 16084).

Figure 18. The Station Pier, and an adjacent concrete slipway. The Station Pier was built in the late 1800s for the herring fishing industry and the concrete slipway was built by the Monks living on Papa Stronsay as a landing place for their small craft (<https://scapetrust.org/sites-at-risk/site/16084>).

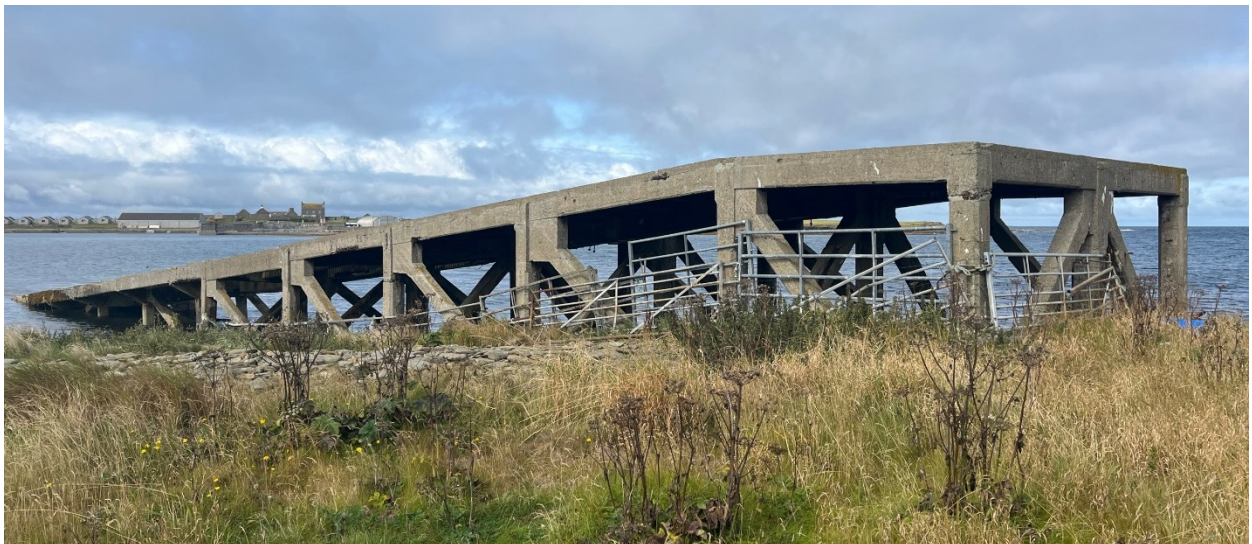
Thirty metres to the east of The Station Pier is the remains of a prefabricated, raised, concrete, slipway (SCAPE ID: 16203, Figure 19). The slipway was built in 1911 and originally terminated in a wooden shed which housed the lifeboat, the John Ryburn, for three years until 1915, when the lifeboat station was closed. The structure is currently fenced off and is deteriorating. Stronsay was once again home to a lifeboat from 1950-1972, however it was stationed in front of Whitehall Village, between the two piers. As far as is known, the concrete slipway was last used in 1915.

Figure 19. The Station concrete lifeboat slipway, built in 1911 (<https://scapetrust.org/sites-at-risk/site/16203>).

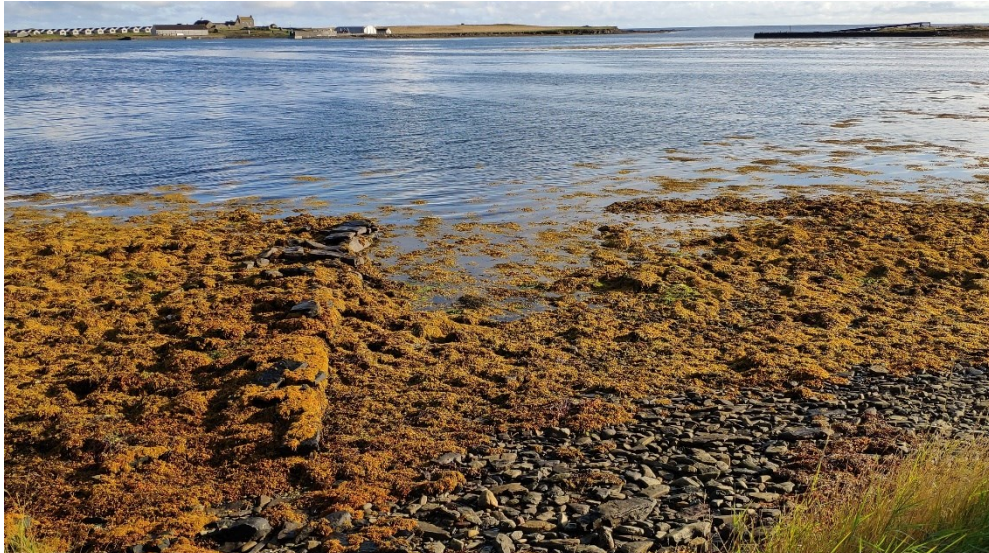
Also related to the lifeboat on the shoreline at Lower Whitehall are the remains of a small stone jetty and cleared slipway which was used by the lifeboat tender when the lifeboat was anchored offshore (SCAPE ID: 16206, Figure 20). The slipway and the stone jetty are tangible links to the history of the Stronsay lifeboat and the social history associated with it.

Figure 20. Small stone jetty and cleared slipway (<https://scapetrust.org/sites-at-risk/site/16206>).

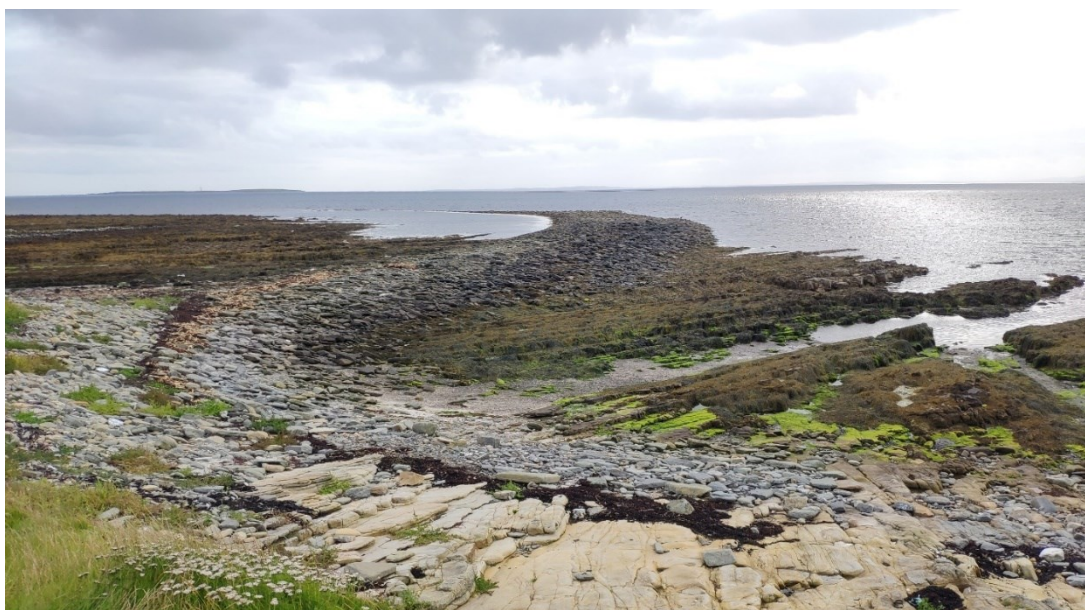
In the southeast of the island is a site known as The Dane’s Pier (SCAPE ID: 16136). The feature is composed of a large spit of cobbles and boulders, extending out westwards into the Bay of Houseby and arcing to the south (Figure 21). On the historic Ordnance Survey, the feature is annotated in antiquarian lettering as a pier and harbour. The 1845 Statistical Account, refers to the formation as the remains of an ancient pier but notes that it is not mentioned in historical records:

It is more likely this is a natural feature but historically may have been used by seacraft for shelter from time to time.

Figure 21. The Dane’s Pier (<https://scapetrust.org/sites-at-risk/site/16136>).

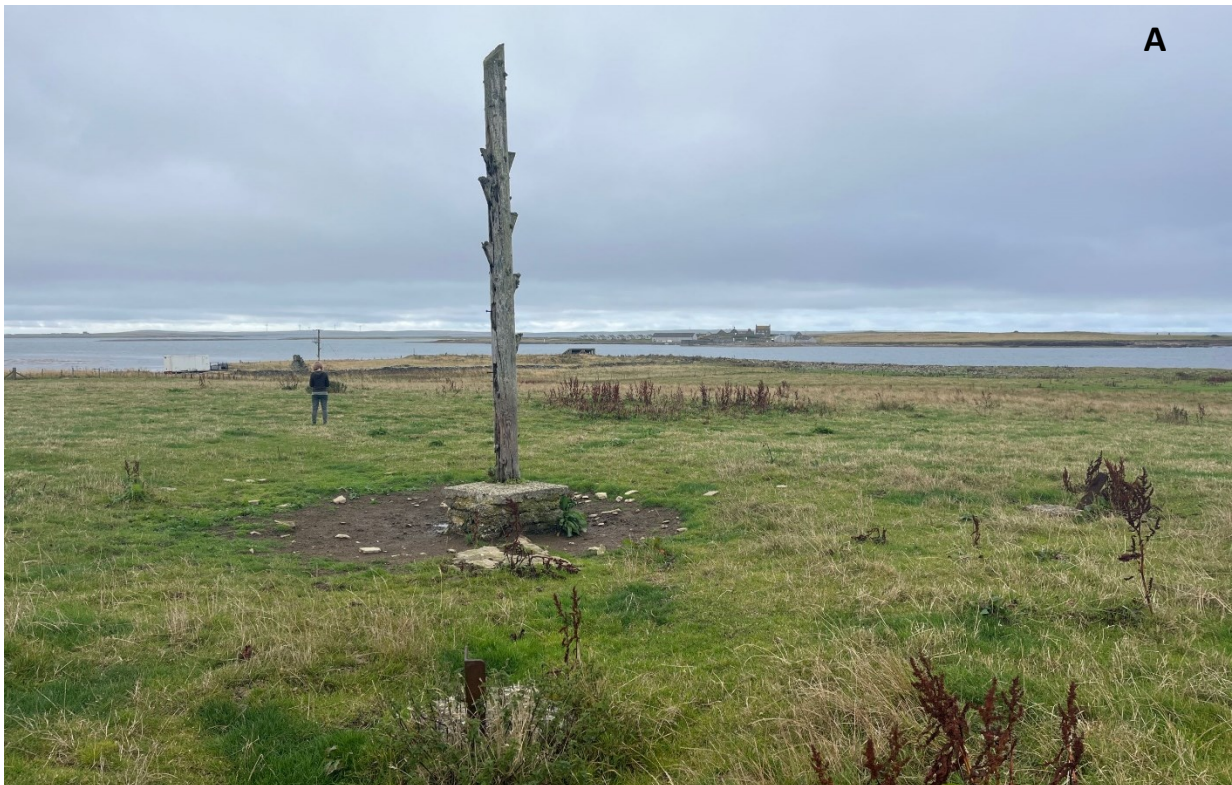
The rocket apparatus was developed in the early 19th century by Henry Trengrouse. A rocket carrying a thin line was fired to a ship in distress, and then used to set up a zip line and harness (breeches buoy) from ship to shore to rescue the crew. The apparatus could be taken to the scene of a wreck on a cart. Figure 22B shows historic photographs from Habbisburgh depicting a rocket pole and tripod being used in practice in 1940. We know of one other example of in situ remains of rocket apparatus in Scotland at Cairnbulg Point, Inverallochy (SCAPE ID: 15670). At Cairnbulg Point, there are the extant remains of a tripod leg and securing pin for the zip line as well as the rocket pole itself, however the pole has been painted and relocated to act as a marker for a memorial. As we have only come across one other example of a rocket pole on our surveys, the rocket pole at The Station is significant as a rare survival of coastguard history.

Figure 22. A. Rocket pole on concrete mount at The Station, Lower Whitehall (<https://scapetrust.org/sites-at-risk/site/16201>); B. Rocket apparatus in use in practise in Happisburgh, Norfolk in 1940. The rocket fires a line to the ship's mast (the pole) and a breeches buoy is set up to rescue the crew. © Imperial War Museum.

The rocket pole [Site 16201] at The Station is a very rare survival of a little-known piece of coastguard history. We have assigned a priority 2 status to this site which reflects its rarity and historic value and to support a recommendation for conservation. Nearby, the early 20th century prefabricated concrete lifeboat slipway [Site 16203] is also rare and of high local historic interest. An assessment of its condition and significance would help inform conservation and management options. Both sites are elements of a range of historic structures and buildings at The Station, Lower Whitehall associated with the coastguard and the herring fishery, which together tell important stories of Stronsay's past and are very accessible from Whitehall.

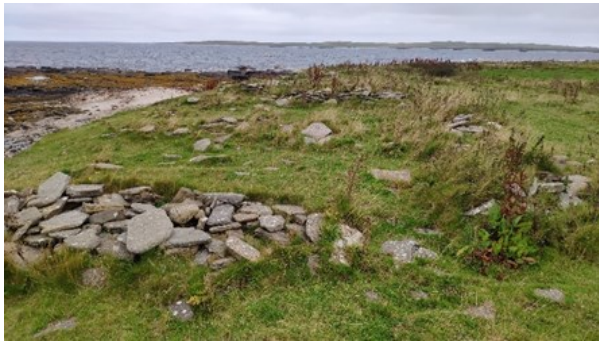
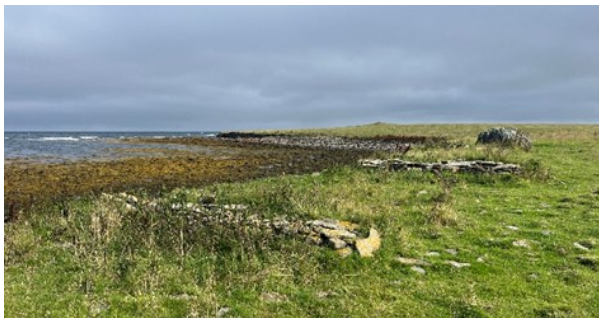
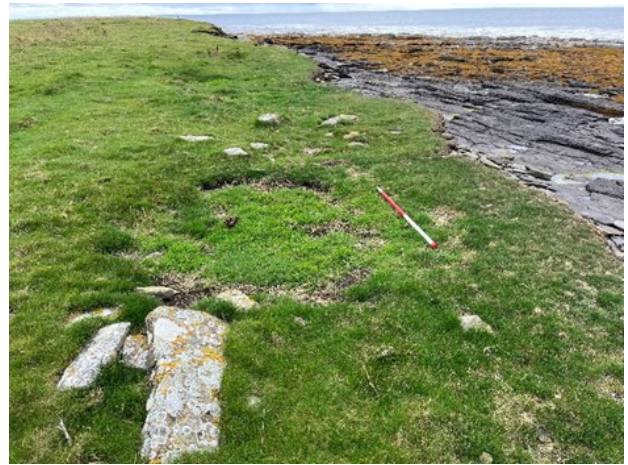
Seaweed based industry has been historically important in Stronsay. In the 18th to the early 20th century seaweed was burned and transformed into kelp for chemicals and the glass industry. Later in the 20th century tangle was harvested for the alginate industry. The Grice Ness promontory is home to countless drying walls and shallow stone-lined kelp burning pits spread along the coast edge (Figure 23A, SCAPE ID: 16185). The drystone walls occur singly, in pairs and in groups and are generally 4m x 1m in size (Figure 23B, C). The kelp burning pits are shallow, stone-lined, circular depressions generally around 3m in diameter (Figure 23D). The workings start on the north side of Grice Ness circa 350m east of the lifeboat slipway and continue, almost uninterrupted around the point to the south of the promontory, circa 300m east of Crooks Ness. Kelp burning pits are generally located just behind (inland of) the drying walls, but a handful are exposed in cross section in the coast edge. In places the drying walls are so thickly concentrated that they appear to merge to create temporary shelters or windbreaks (Figure 23B). These have the appearance of building foundations but are unlikely to be so. According to local information, kelping at Grice Ness continued into the 1920s. In the 1950s to the 1980s, tangle was once again harvested and dried (but not burnt). Each of the kelp walls were owned by individuals and households. Some of the more intact drying walls (or beeks) at the northwest end may date from these later periods.

23B. Concentrated kelp walls almost appear structural on south side of Grice Ness

Figure 23D. Circular kelp burning pits along south side of Grice Ness

A short walk from The Station, thickly clustered around the edge of Grice Ness promontory are the visible remnants of countless kelp and tangle drying walls and kelp burning pits which may span the history of kelping in Stronsay from the 18th to the 20th centuries [Site 16185]. These are unusual in their concentration and visibility, and a detailed survey would be a useful and timely contribution to preserving knowledge of this once important industry for the Island. At Latan, a free standing circular kelp kiln [Site 16070] is a rare survival of an 'improved' kelp burning kiln. A more complex example on the adjacent island of Papa Stronsay is designated as a scheduled monument ([SM 9289](#)).

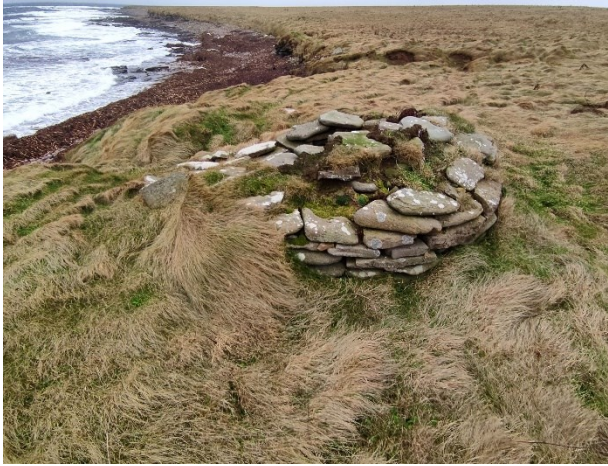
Kelping sites have also been recorded at Latan, Rothiesholm, in the southwest of the island on the western shore of Bay of Holland (SCAPE ID: 16071). A free-standing kelp kiln was visited at Latan in November 2023 (Figure 24). The structure is much engulfed by grass growth, and the east side is tumbled, however, the condition has not changed significantly since the photograph taken in 1979 on the Canmore record (182729).

Figure 24A. Free-standing kelp kiln, Latan. Looking south (<https://scapetrust.org/sites-at-risk/site/16070>). Photo credit: Ian Cooper.

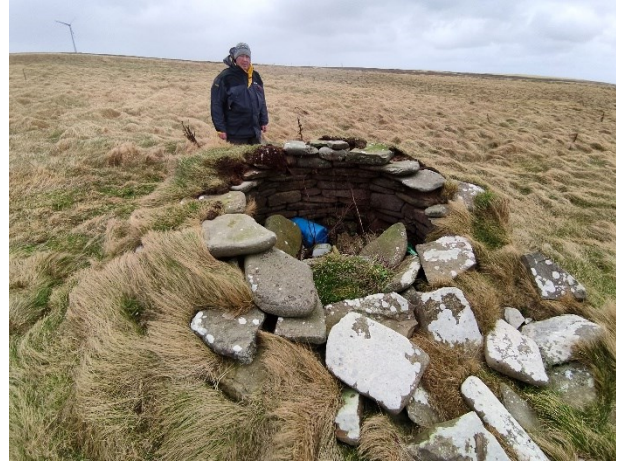
Figure 24B. View inside kiln, with tumbled east side. Looking northwest. Photo credit: Ian Cooper.

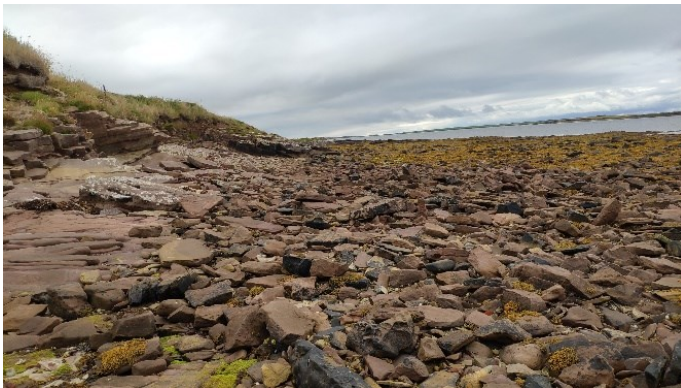
Thanks to local information, two new sites document the locations of former coastal quarries. The bedrock geology of Stromsay is predominantly that of Devonian Old Red Sandstone, prevalent across the Orkney islands. Both quarry sites are composed of sandstone belonging to the Eday and Lower Eday Flagstone Formation (BGS Geology Viewer, 2023). Linksness, Pier of Skerra (SCAPE ID: 16184) was once the site of a quarry which was active in the mid-late 19th century. The track which led down from the coast edge to the quarry is now eroded away however quarry evidence can still be observed in the form of angular quarried stone scattered on the foreshore (Figure 25A). A second potential quarry site was identified at Mervar, to the west of the Bay of Holland (SCAPE ID: 16188). Here, two tracks providing access to the rocky foreshore were noted leading down from the vegetated coast edge. Additionally, large blocks of quarried stone were observed nearby.

Figure 25A. Linksness, Pier of Skerra, looking SE. (<https://scapetrust.org/sites-at-risk/site/16184>)

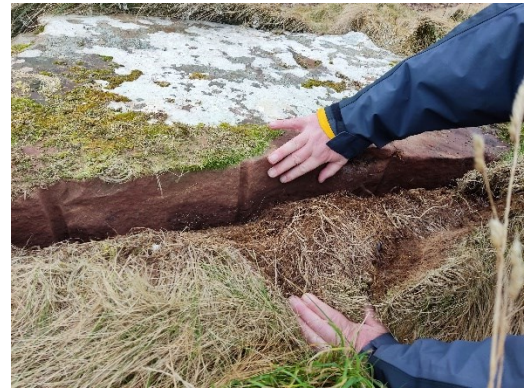
Figure 25B. Example of quarried stone left at coast edge, with quarry tool marks visible. Photo credit: Ian Cooper

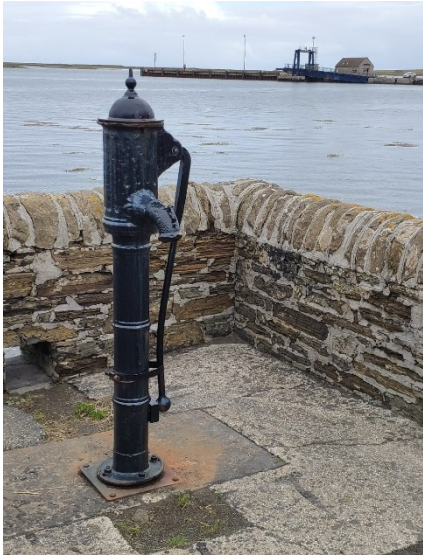
Two new sites recorded during the survey are nice examples of 19th and early 20th century infrastructure and engineering. The water pump on the sea front in Whitehall village (SCAPE ID: 16195, Figure 26A) predates the introduction of a mains water supply which came to Stromsay in 1911. The pump has recently been restored through the North Isles Landscape Partnership. Exposed on the sandy beach at Sands of Rothiesholm are the remains of a massive stone drain, now replaced by a concrete pipe protected by cassie stone walling (SCAPE ID: 16182, Figure 26B). This is a sluice for the Bu Loch, situated just inland of the coast edge at Rothiesholm. The sluice is marked on an estate plan dated 1869.

Figure 26A. Village pump, Whitehall
(<https://scapetrust.org/sites-at-risk/site/16195>)

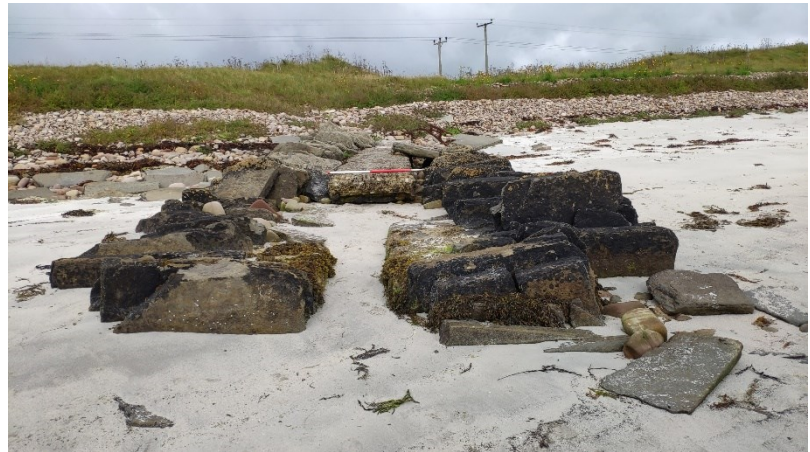
Figure 26B. Sluice for Bu Loch, Sands of Rothiesholm
(<https://scapetrust.org/sites-at-risk/site/16182>).

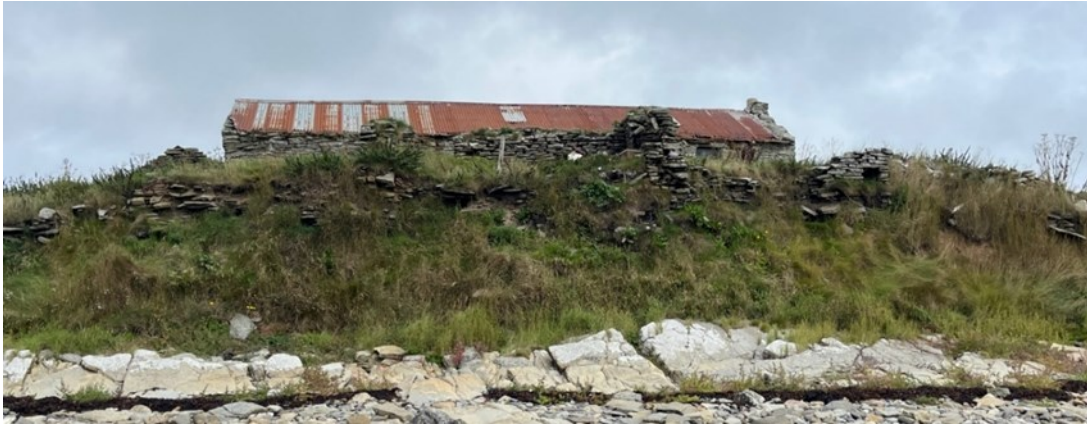
Below a derelict farmstead at Lower Dishes (SCAPE ID: 16080) we observed a settlement site which is actively eroding from the coast edge. The coastal exposure reveals building foundations, buried dry stone walling and paved floors. The period of these building remains is unknown, however, it is clearly a site which has seen multiple phases of occupation.

Figure 27. Structures eroding out of coastal section, Lower Dishes (<https://scapetrust.org/sites-at-risk/site/16080>).

We have assigned a priority 2 status to one settlement site at Lower Dishes (Site 16080) because even in well-vegetated summer conditions, a number of structures were exposed in the coastal cliff and it would be useful to record the section to better understand the stratigraphy and character of the archaeology that is present here. Settlement remains associated with Greenhill Broch on the edge of the airfield near Huip have also been assigned a priority 2 status. Extensive exposures of archaeological deposits were documented here in 1995 and there is evidence of relatively fresh erosion in places.

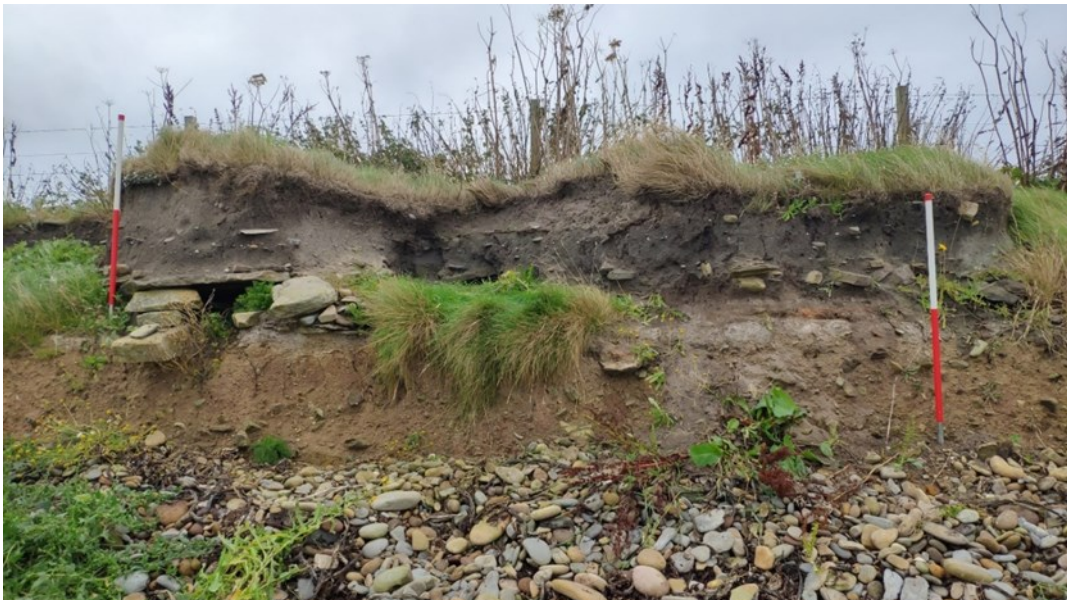
At Runthall, between Links Ness and Sand of Odie, in the northwest of the island, is another example of a settlement site eroding out of the coast edge (SCAPE ID: 16119, Figure 28). The site consists of walling and horizontally laid slabs. What look like stone drains are also visible and a possible hearth with layers of peat at the west end of the section. Medieval pottery has been recovered from this eroding site in the past.

Figure 28. Settlement site in eroding coastal section, Runthall (<https://scapetrust.org/sites-at-risk/site/16119>).
