Scottish Coastal Archaeology and the Problem of Erosion

Coastal Zone Assessment Survey Stronsay Interim Report

Sarah Boyd, Joanna Hambly

The SCAPE Trust and University of St Andrews
November 2023

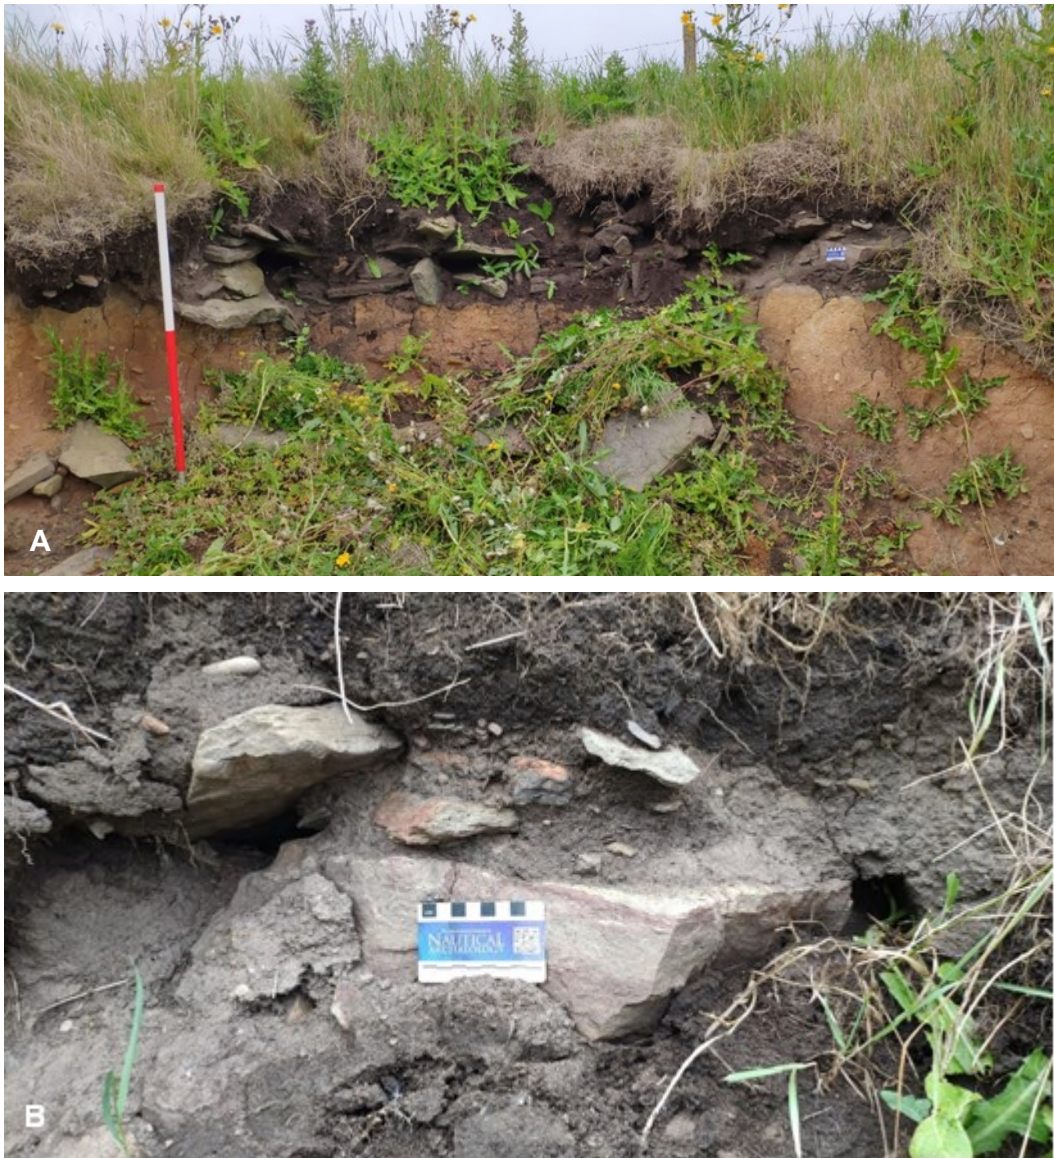
At Grobister, two new exposures of drystone walling, horizontal slabs and fire-cracked stone separated by circa 30m of slumped vegetation (SCAPE ID: 16178, Figure 29A) were recorded along the same stretch of coastline as Banks the Waspy and the Navsy. A very large sherd of coarse prehistoric pottery was also noted with a fragment recovered for identification (Figure 29B). The most likely interpretation of the site is a burnt mound or settlement site.

Figure 29A. Coastal exposure of wall and fire cracked stone at Grobister Figure 29B. Close up view of pottery sherd within exposure (<https://scapetrust.org/sites-at-risk/site/16178>).

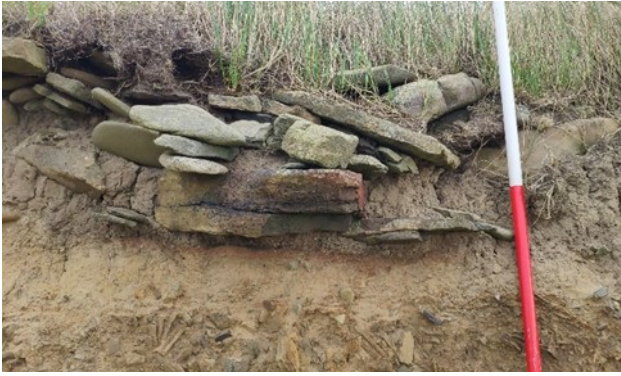
A new site at Huip consists of a lens of *in situ* burning approximately 1m wide and 0.5m, deep cut into the subsoil. Peat ash, charcoal, and rare fragments of cremated bone were observed in the section as well as a large slab of burnt stone over the burnt area and unburnt stone above (SCAPE ID: 16183, Figure 30A). The location near to Green Hill Broch indicates it could be a hearth linked with the broch and associated settlement (Moore and Wilson, 1995; SCAPE ID: 16037). A cremation site is also a possible interpretation.

Figure 30A. Possible hearth or cremation site, Huip (<https://scapetrust.org/sites-at-risk/site/16183>).

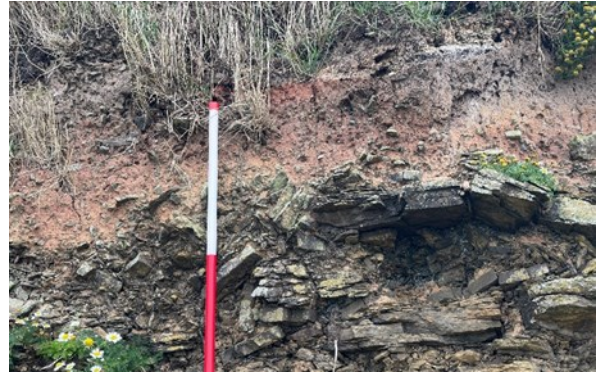
At Housebay Farm, immediately south of the farm mound occupied by the present farm is an area of *in situ* burning directly upon the underlying glacial till. The burning is not more than 20cm thick, with evidence of red scorching, ash, and charcoal all of which suggests this could be the remains of a hearth. A few limpet shells nearby may represent a possible midden spread (SCAPE ID: 16200, Figure 30B).

Figure 30B. Possible hearth, Houseby (<https://scapetrust.org/sites-at-risk/site/16200>).

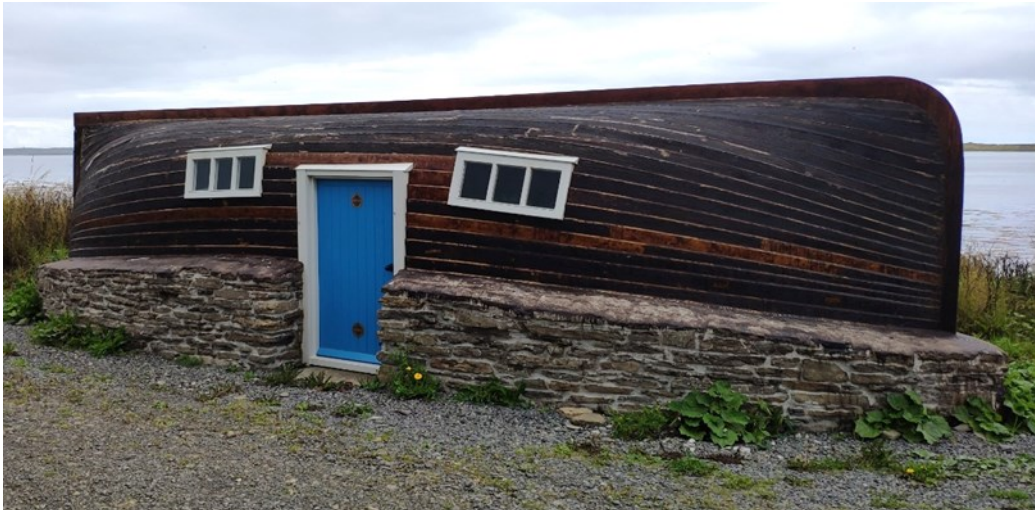
A completely different, and unique site which falls into the settlement category is the former wash house and coal store created from an upturned wooden boat hull on the waterfront in Whitehall village (Figure 31). The boat is a lifeboat from the *Athenia*, which was torpedoed in 1939 at the start of WW2. The building was restored in 2022 through the North Isles Landscape Partnership.

Figure 31. Wash house with roof made from lifeboat (<https://scapetrust.org/sites-at-risk/site/16192>).

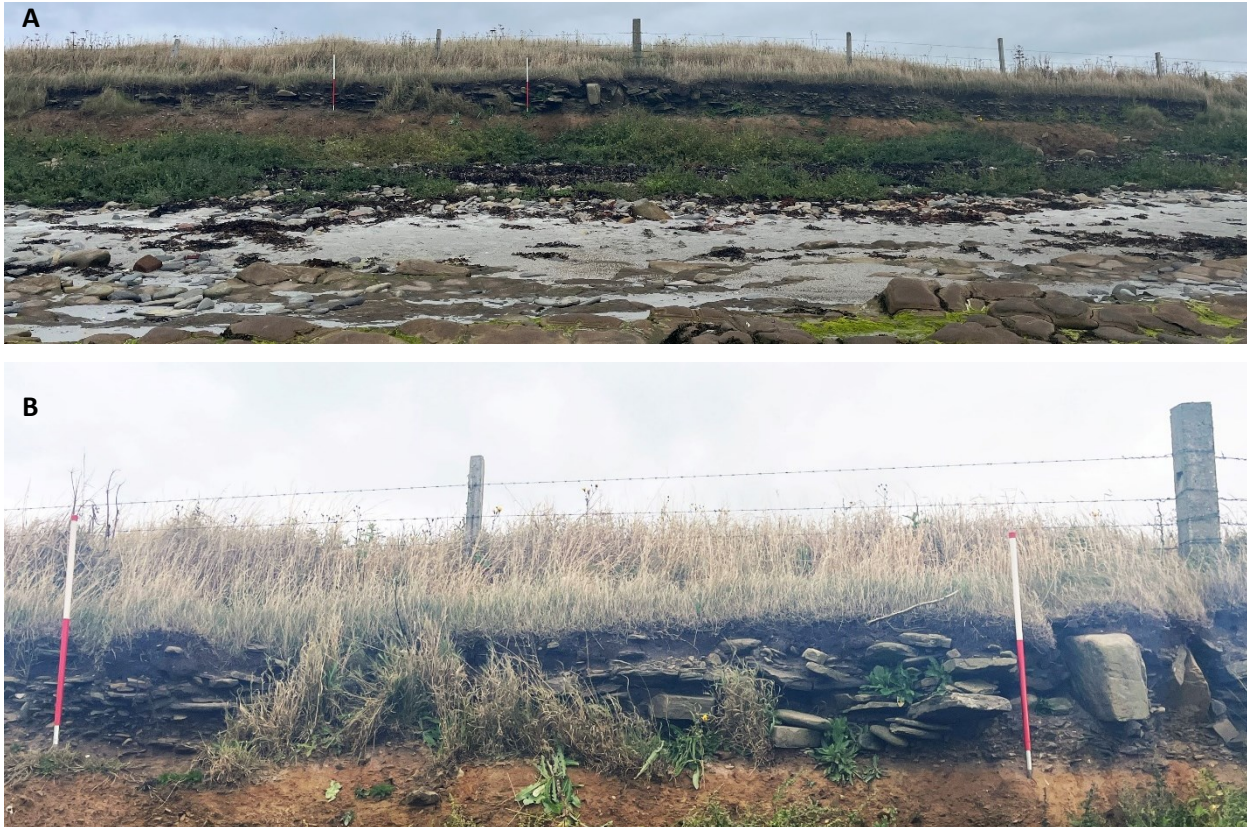
The third broch site visited during the surveys was at Greenhill, Huip, with fresh exposures extending along the coast edge for at least 20m. Archaeological monitoring carried out in 1995, noted several sections of tumbled masonry and a hearth which was in imminent danger of loss (Moore and Wilson, 1995). The surveyors also noted flat flagstones and masonry in front of the broch which were interpreted as outbuildings related to the broch and additionally the remains of a wall, hearth, burnt deposits and midden material. During the August 2023 survey it was difficult to identify individual structures described in the 1995 report as the coast edge described twenty years ago has eroded, however, structures such as tumbled walling and horizontal flat stones were observed in the section (Figure 32).

Figure 32A. Photograph of full length of site exposed along coast edge. Figure 32B. Closer view of tumbled walling within section, Greenhill (<https://scapetrust.org/sites-at-risk/site/16037>).

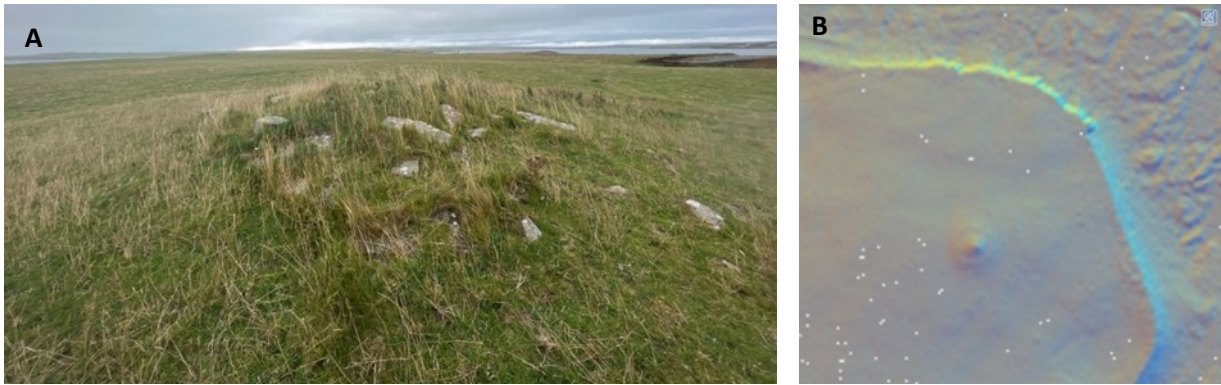
Two scheduled neolithic chambered cairns were visited during the surveys. On the eastern side of Grice Ness, approximately 50m inland from the coast is the chambered cairn of Cutter's Tuo (SCAPE ID: 16040, SM:1391). The conical shape of the mound topped with stone can be seen from many directions when looking across Grice Ness. The cairn is surrounded by a circular platform, the geometry of which can be seen clearly on modern lidar image (Figure 33). It is not at risk from coastal erosion.

Figure 33A. Grice Ness, Cutter's Tuo chambered cairn (<https://scapetrust.org/sites-at-risk/site/16040>). Figure 33B. LiDAR image of the cairn, clearly showing the cairn and surrounding circular platform (LiDAR DTM 50cm-1m-Eng, Scot, Wales. ©Environment Agency copyright 2022, ©Natural Resources Wales and Database Right, Crown copyright Scottish Government, SEPA, Fugro and Scottish Water (2012-2021). With thanks to Richard Pearson).

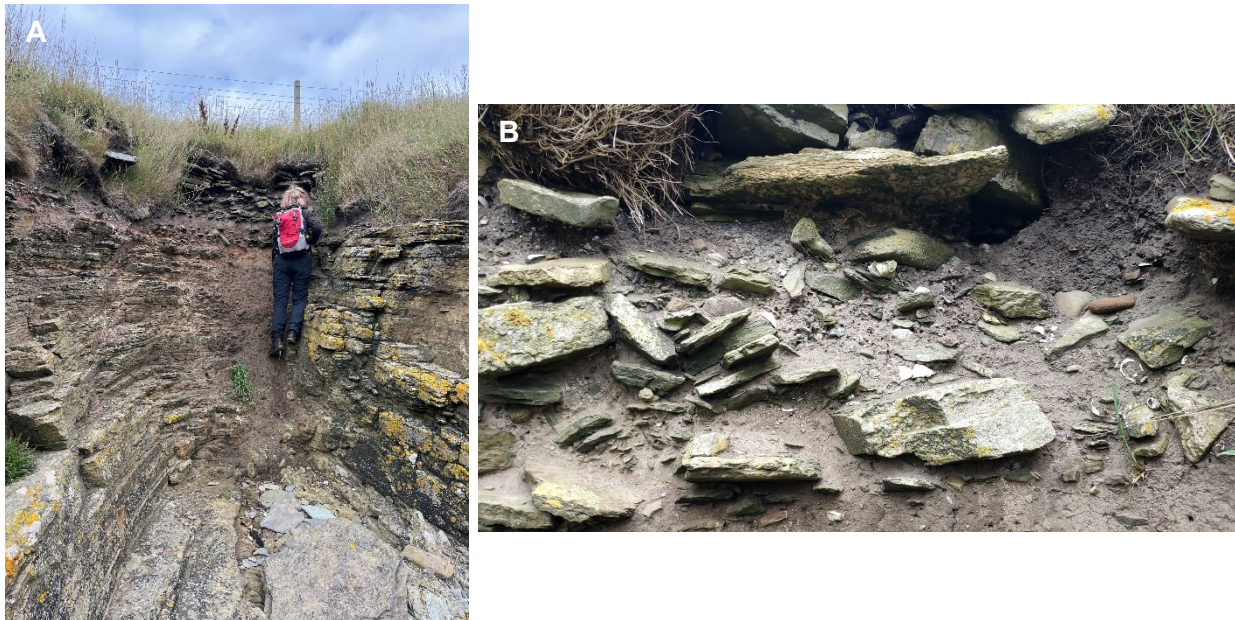
The second chambered cairn is that of the Ward of Houseby (SCAPE ID: 16142, SM1411). The mound itself is vegetated and appears to be largely stable. Investigation of the coast edge directly below the mound revealed a small section of archaeological deposits containing animal bone, peat ash and limpets (Figure 34). A piece of struck flint was also noted.

Figure 34A. General view of exposed section with midden material situated below the Ward of Houseby, 34B. Detail of deposits including animal bone, shells and peat ash (<https://scapetrust.org/sites-at-risk/site/16142>).

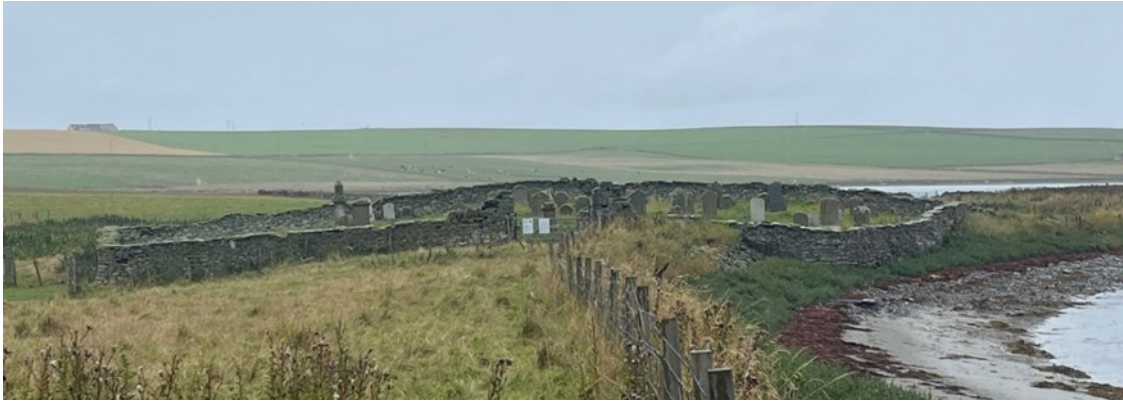
Situated between a small loch and the coast is the walled graveyard of St Peter's Church (SCAPE ID: 16131 and Figure 35). The graveyard is thought to have been last used in the 1930s. The northern wall of the graveyard is situated right on the coast edge and vulnerable to coastal processes.

Figure 35. View of St Peter's Chapel graveyard looking towards the northwest (<https://scapetrust.org/sites-at-risk/site/16131>).

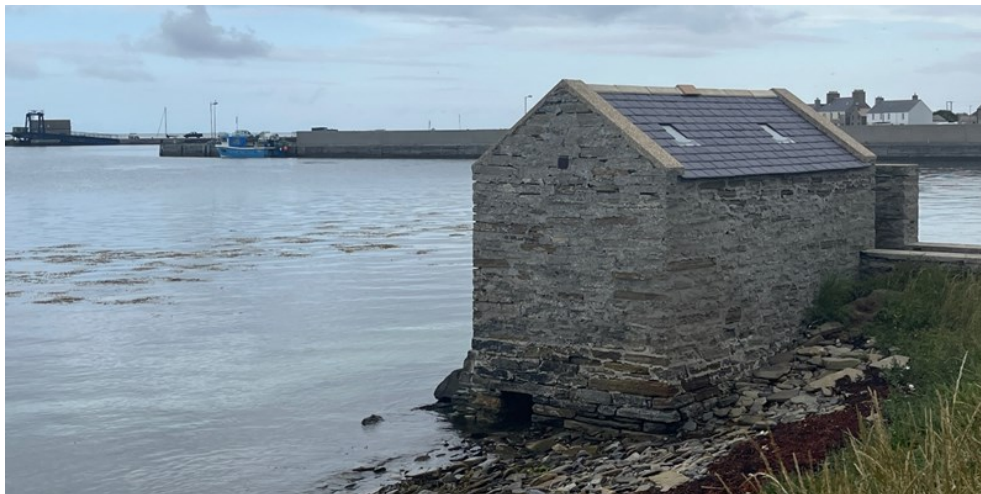
Also falling within the category of miscellaneous is a small stone built tidal toilet located on the coast edge at Whitehall village (SCAPE ID: 16193). Built for, and used by, workers in the herring fishery, this building is an interesting and rare sight on the foreshore. It is one of only two remaining in Orkney and has recently been restored by Stromsøy Community Council and North Isles Landscape Partnership.

Figure 36. Small stone built tidal toilet located on the coast edge. Built for, and used by, workers in the herring industry (<https://scapetrust.org/sites-at-risk/site/16193>).

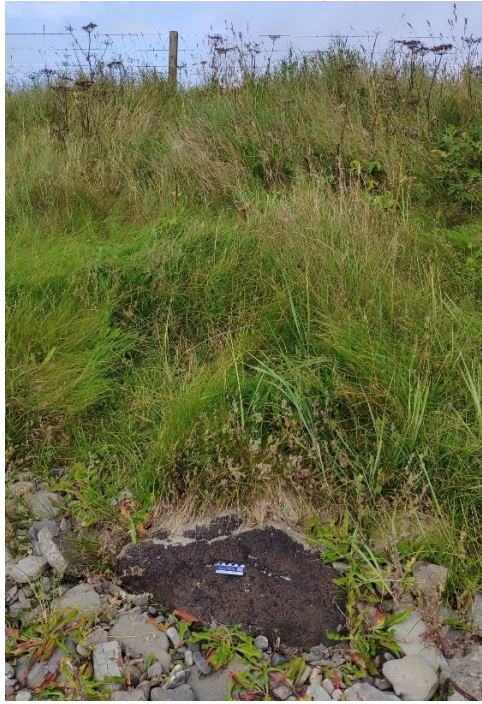
Figure 37. Boulder-sized lump of bog iron at base of coast edge, Grobister (<https://scapetrust.org/sites-at-risk/site/16186>).
