# COASTAL ZONE ASSESSMENT SURVEY FIRTH OF CLYDE

PROJECT 1309

A desk-based and walkover assessment  
carried out on behalf of  
Historic Scotland,  
Firth of Clyde Forum  
and  
The SCAPE Trust

David Sneddon

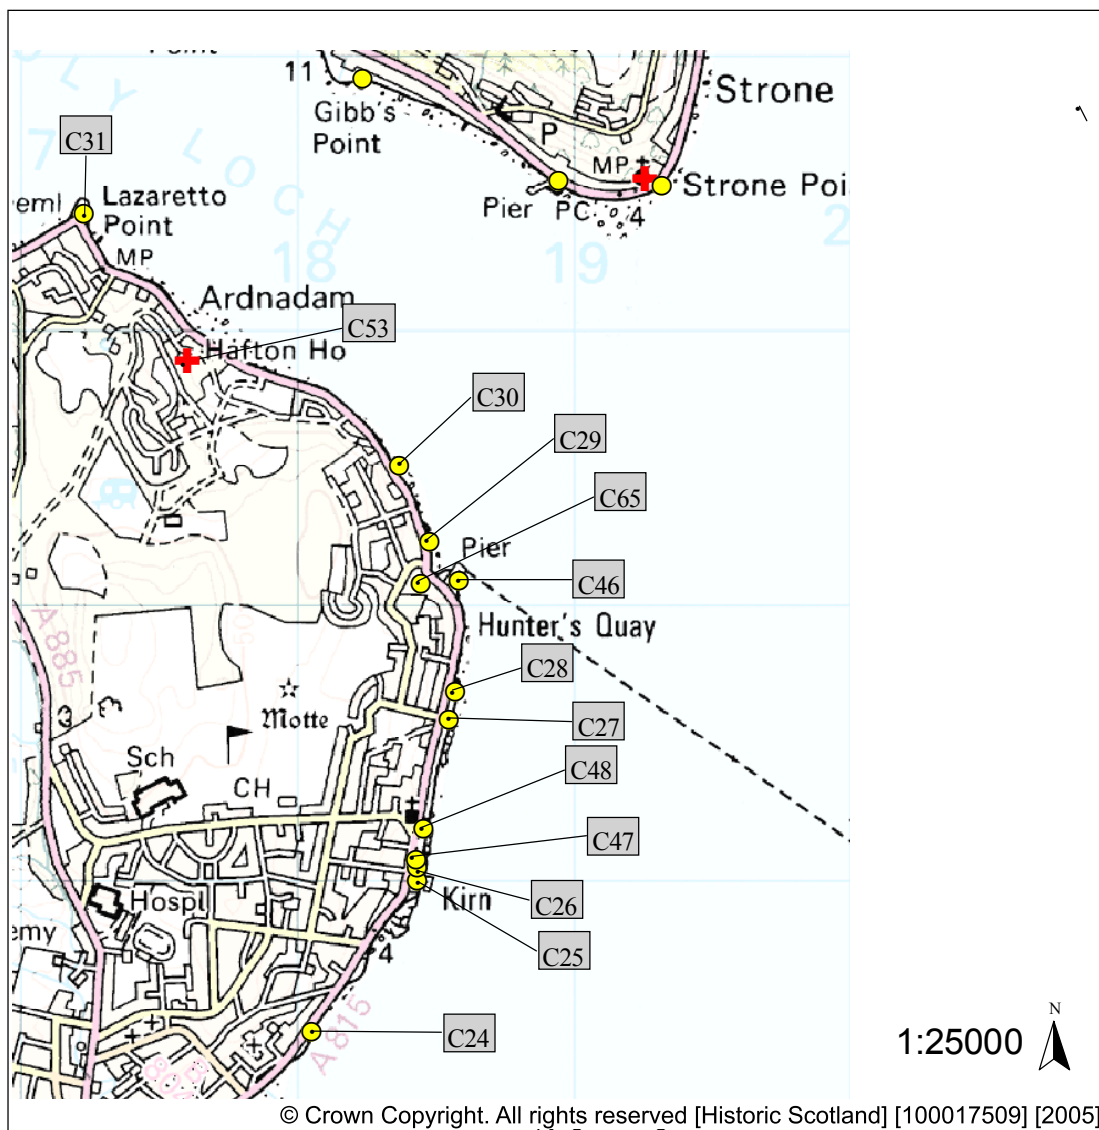
This section of coastline extended from the western side of Lazaretto Point to the small bay to the north of Dunoon Harbour. The dominant composition of the intertidal area is that of rock platform resulting in a relatively stable stretch of coast. Sea defences stretch over all of this area protecting the built up areas situated behind the coast edge.

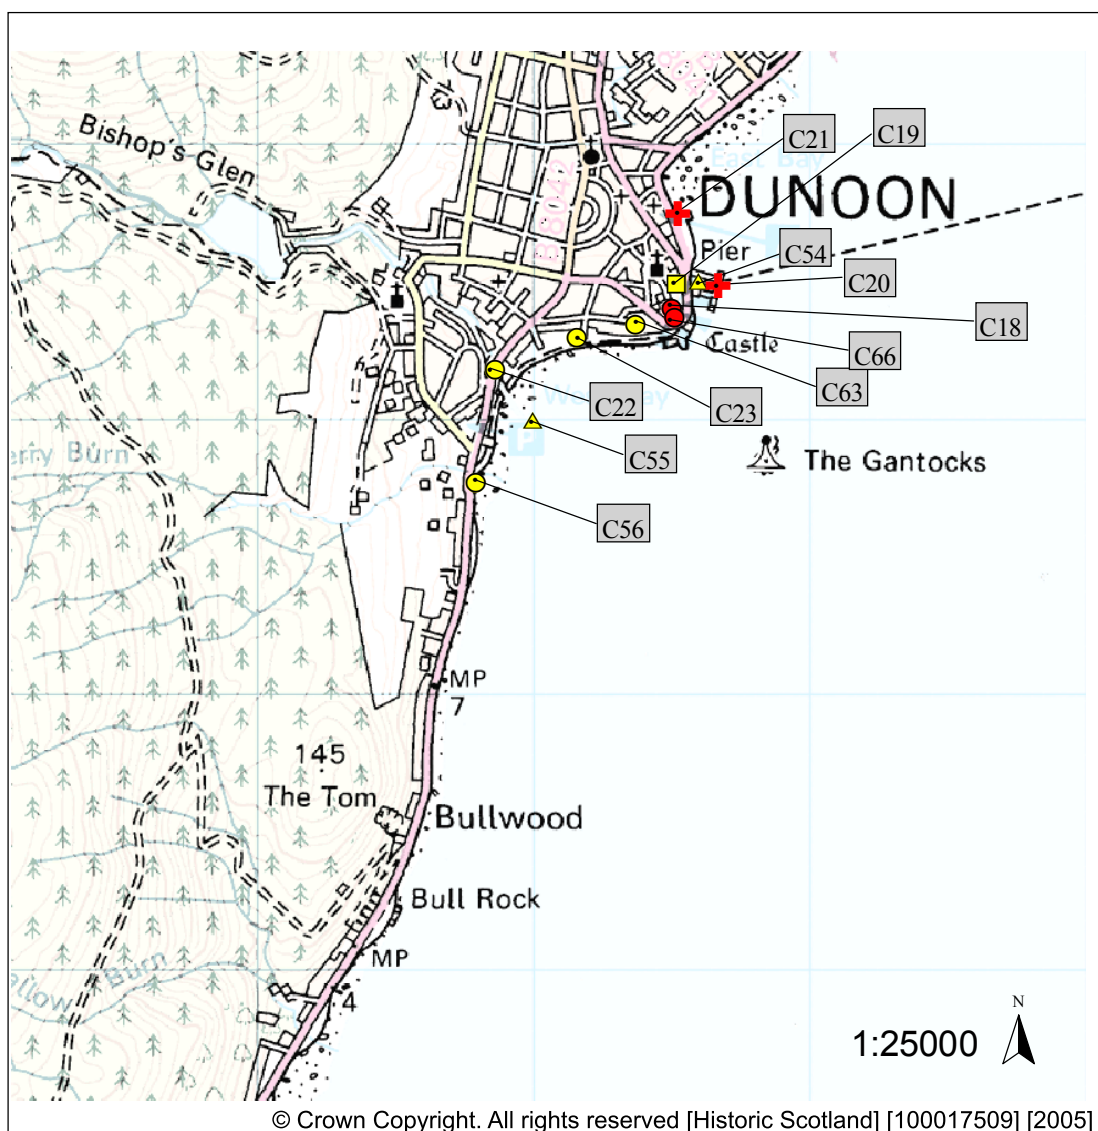
The section of coastline extended from Dunoon Harbour in the north to Cluniter in the south. This is a relatively straight section of coastline. The area around Dunoon has been heavily modified by shore defences and Harbour/Pier constructions. The intertidal area to the south alternates between stretches of rock platform and sand deposits. Sea wall stretches along the majority of the coastline covered by Map 3. There were no areas subject to active erosion with the coastline being stable or accretional/stable.

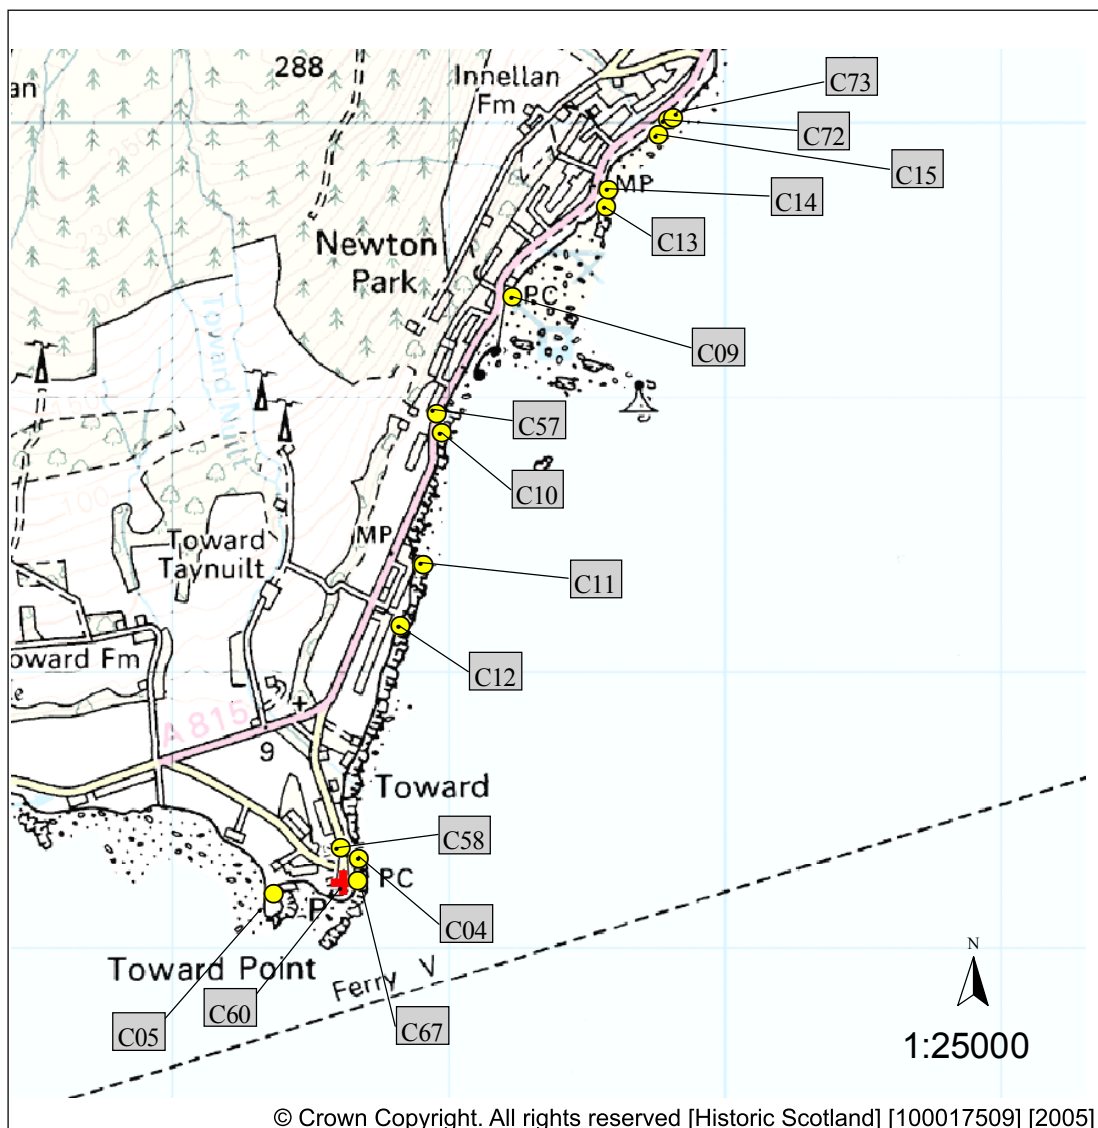
This section of coastline extended from Innellan on the eastern facing shore round Toward Point and along to Ardyne Point at the south western tip of the Cowal Peninsula. A mixture of sand deposits and rock platform shape the intertidal area of both the eastern and southern coasts. Sea wall defences are much more prominent on the eastern coast compared to the southern due to the majority of built up areas being located in this area. The majority of the coastline covered by Map 4 was categorised as erosional and stable. Only one small section of actively eroding coast was present south of Toward Farm and did not threaten any visible archaeological remains. The disused oil rig yard at Ardyne Point has heavily modified the natural coastline.

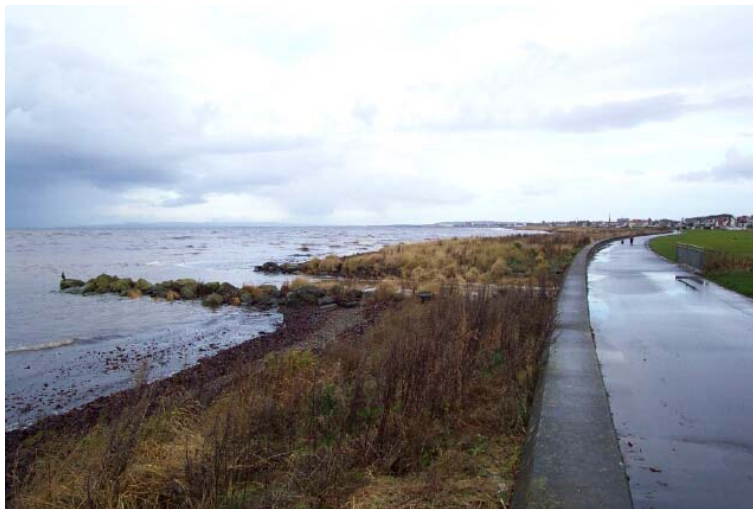
*Plate 14:*  
*Slaphouse burn lined with geotextiles and riprap groynes.*

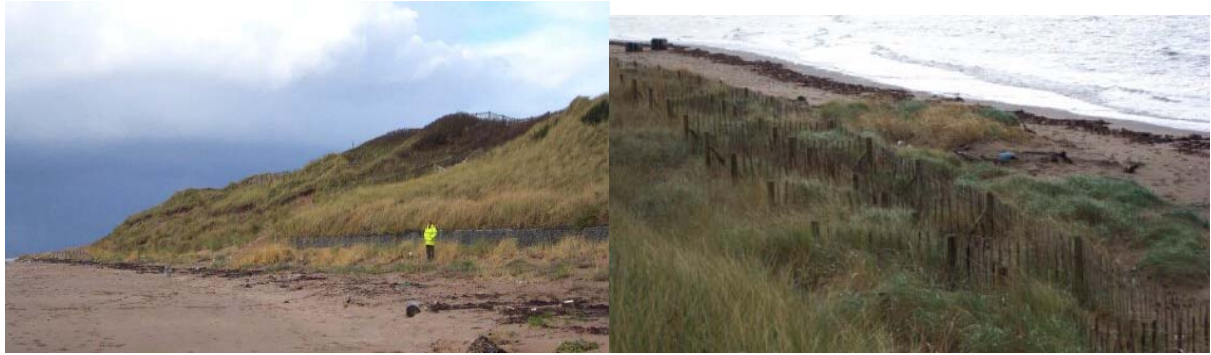
*Plate 15:  
Brushwood fences protect dunes north of Pow Burn.*

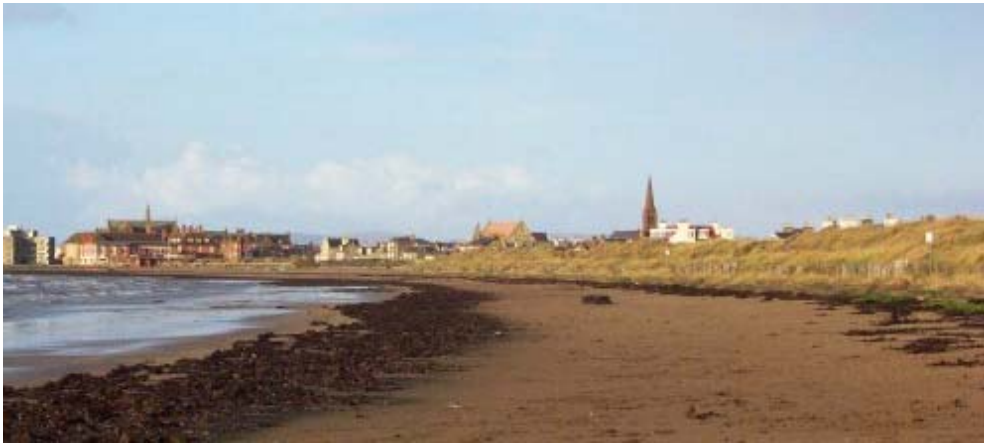
*Plate 16:  
Managed dunes at Troon.*
