Coastal Assessment Survey Inner Moray Firth

Inverness to Dingwall

**MORAY, BEAULY AND CROMARTY FIRTH
COASTAL ASSESSMENT 1998**

Report No. 446

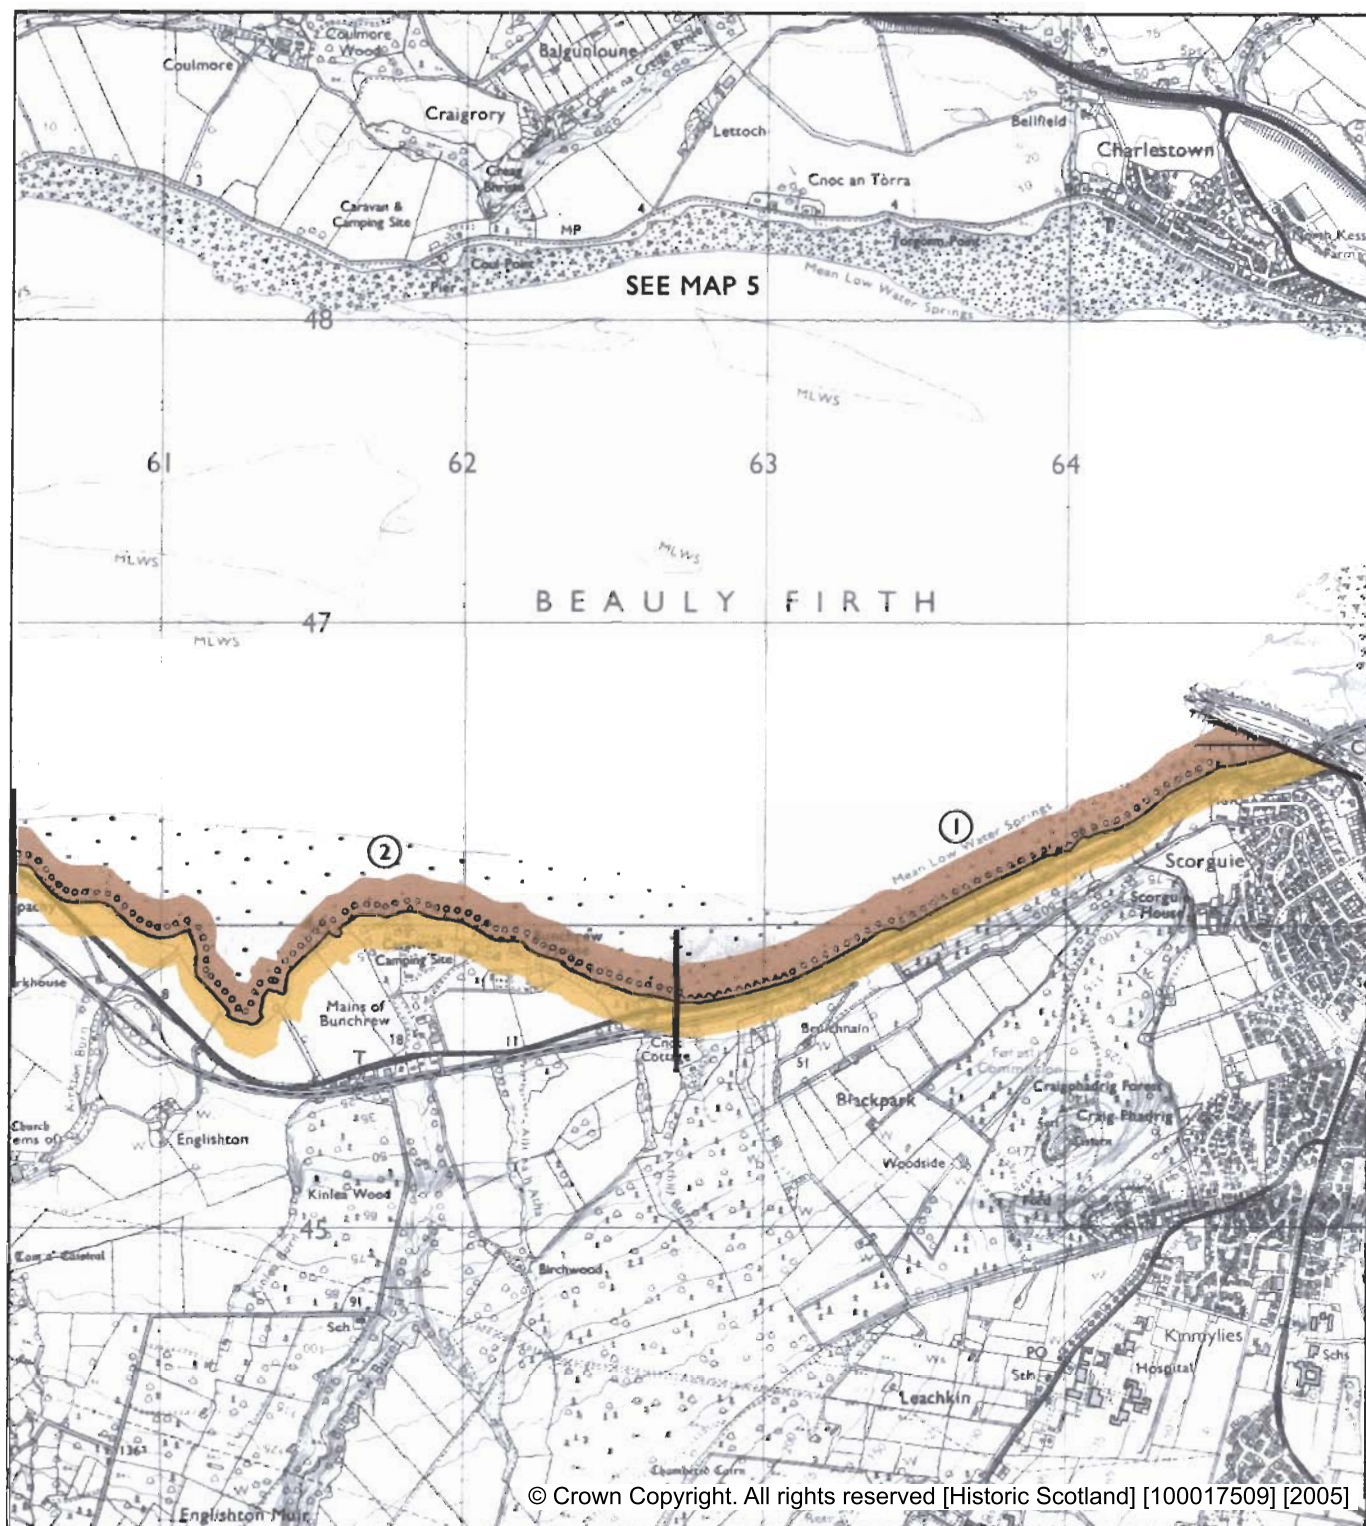
MAP 1: CLACHNARRY TO PHOPACHY

Curvilinear low cliff-edge backed by marine derived sands and gravel consolidated by boulder clay. Estuarine tidal flats of mud and shingle.

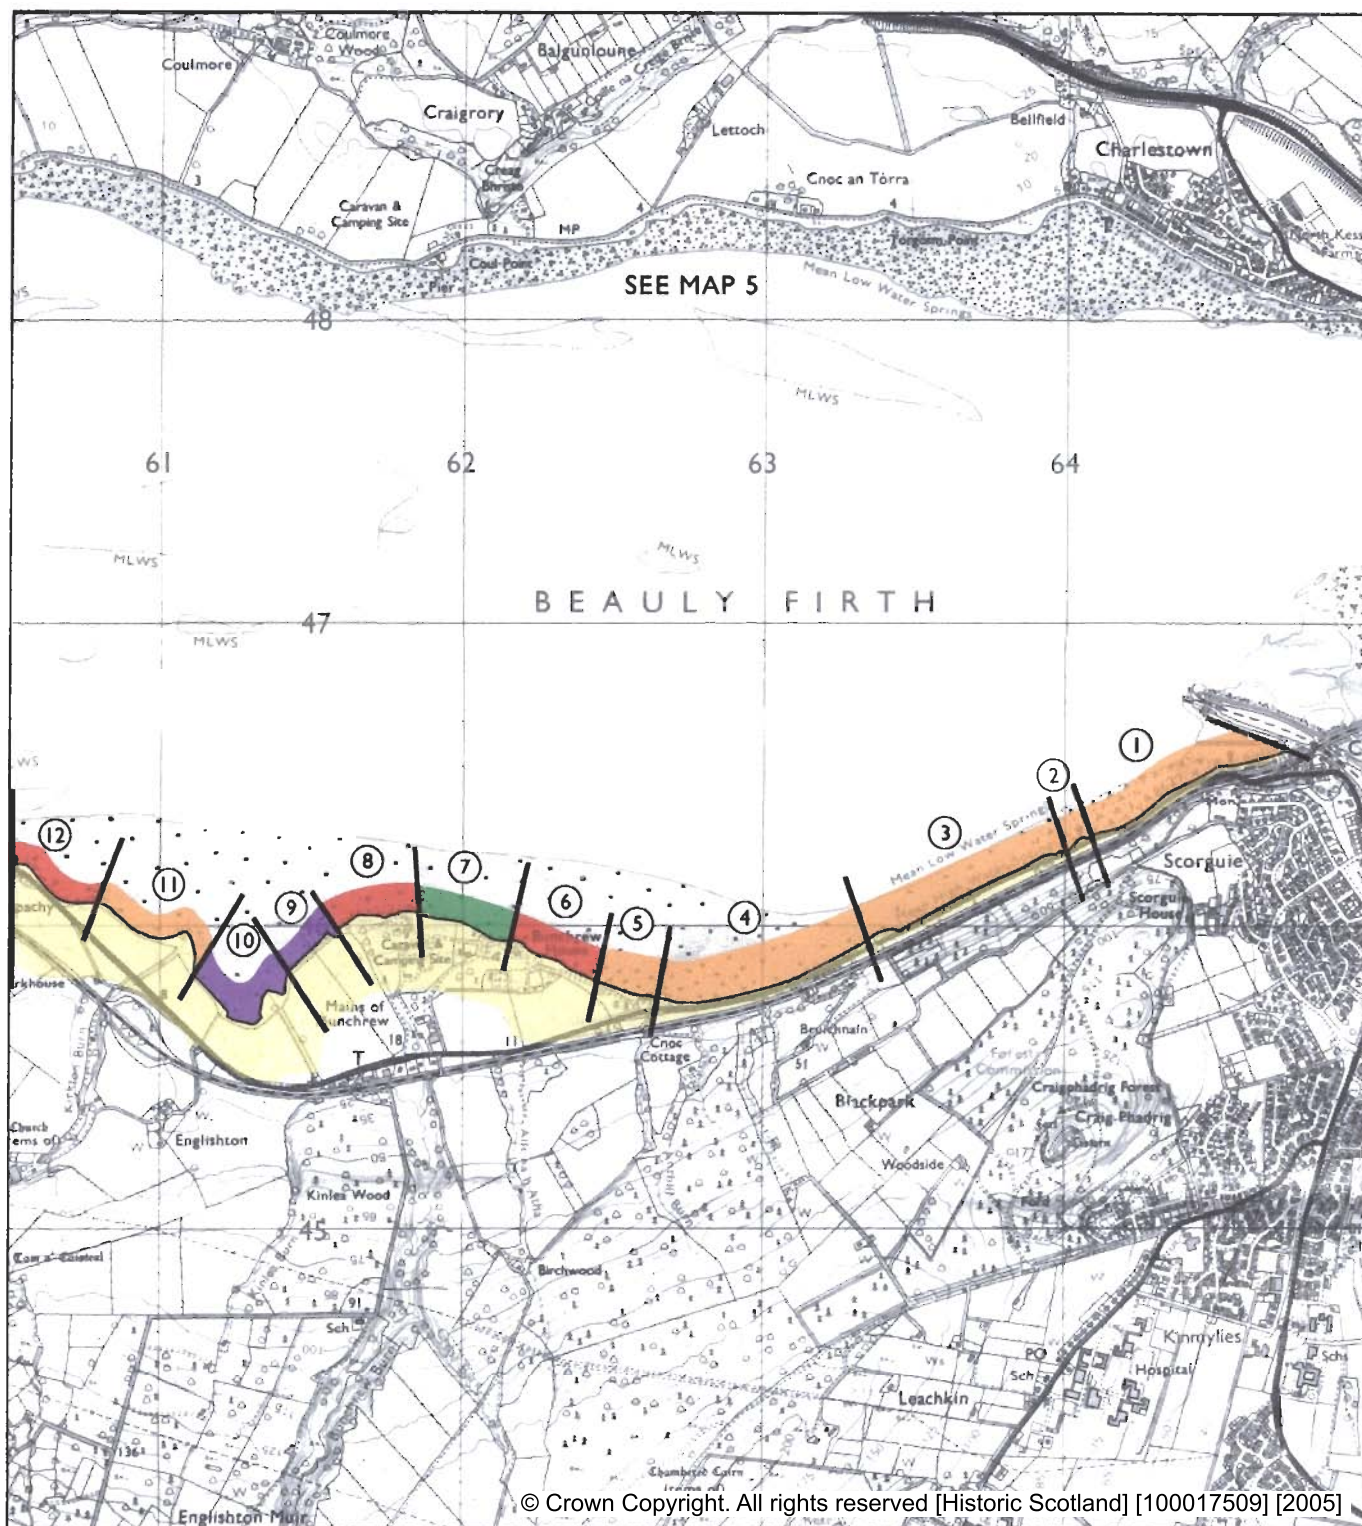
MAP 1: CLACHNARRY TO PHOPACHY

Backshore well vegetated with an eroding saltmarsh at the HWM caused by scouring in storm conditions. Mud and shingle are exposed on the tidal flats.

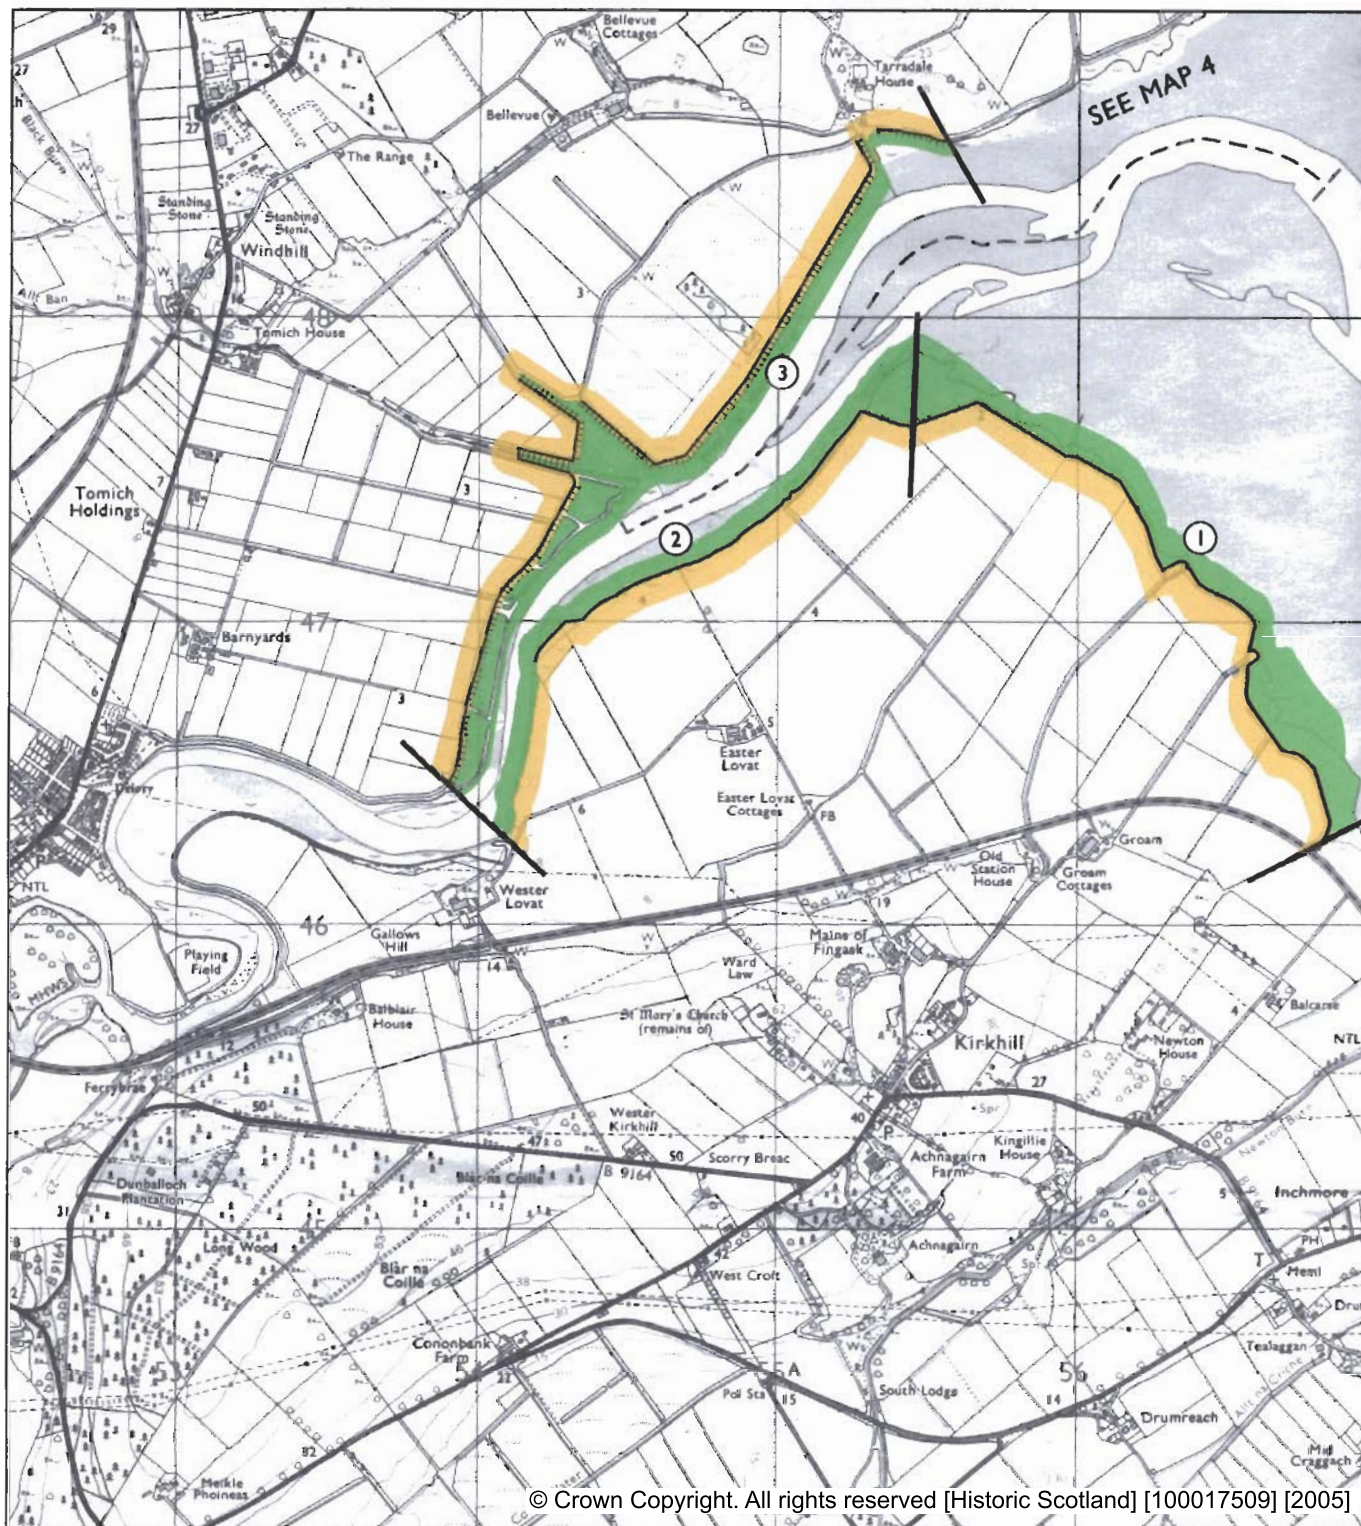
MAP 3: BALCARSE TO TARRADALE HOUSE

Floodbanks protect the riverside, which is colonised by saltmarsh vegetation. Meandering river channels are exposed at low tide.

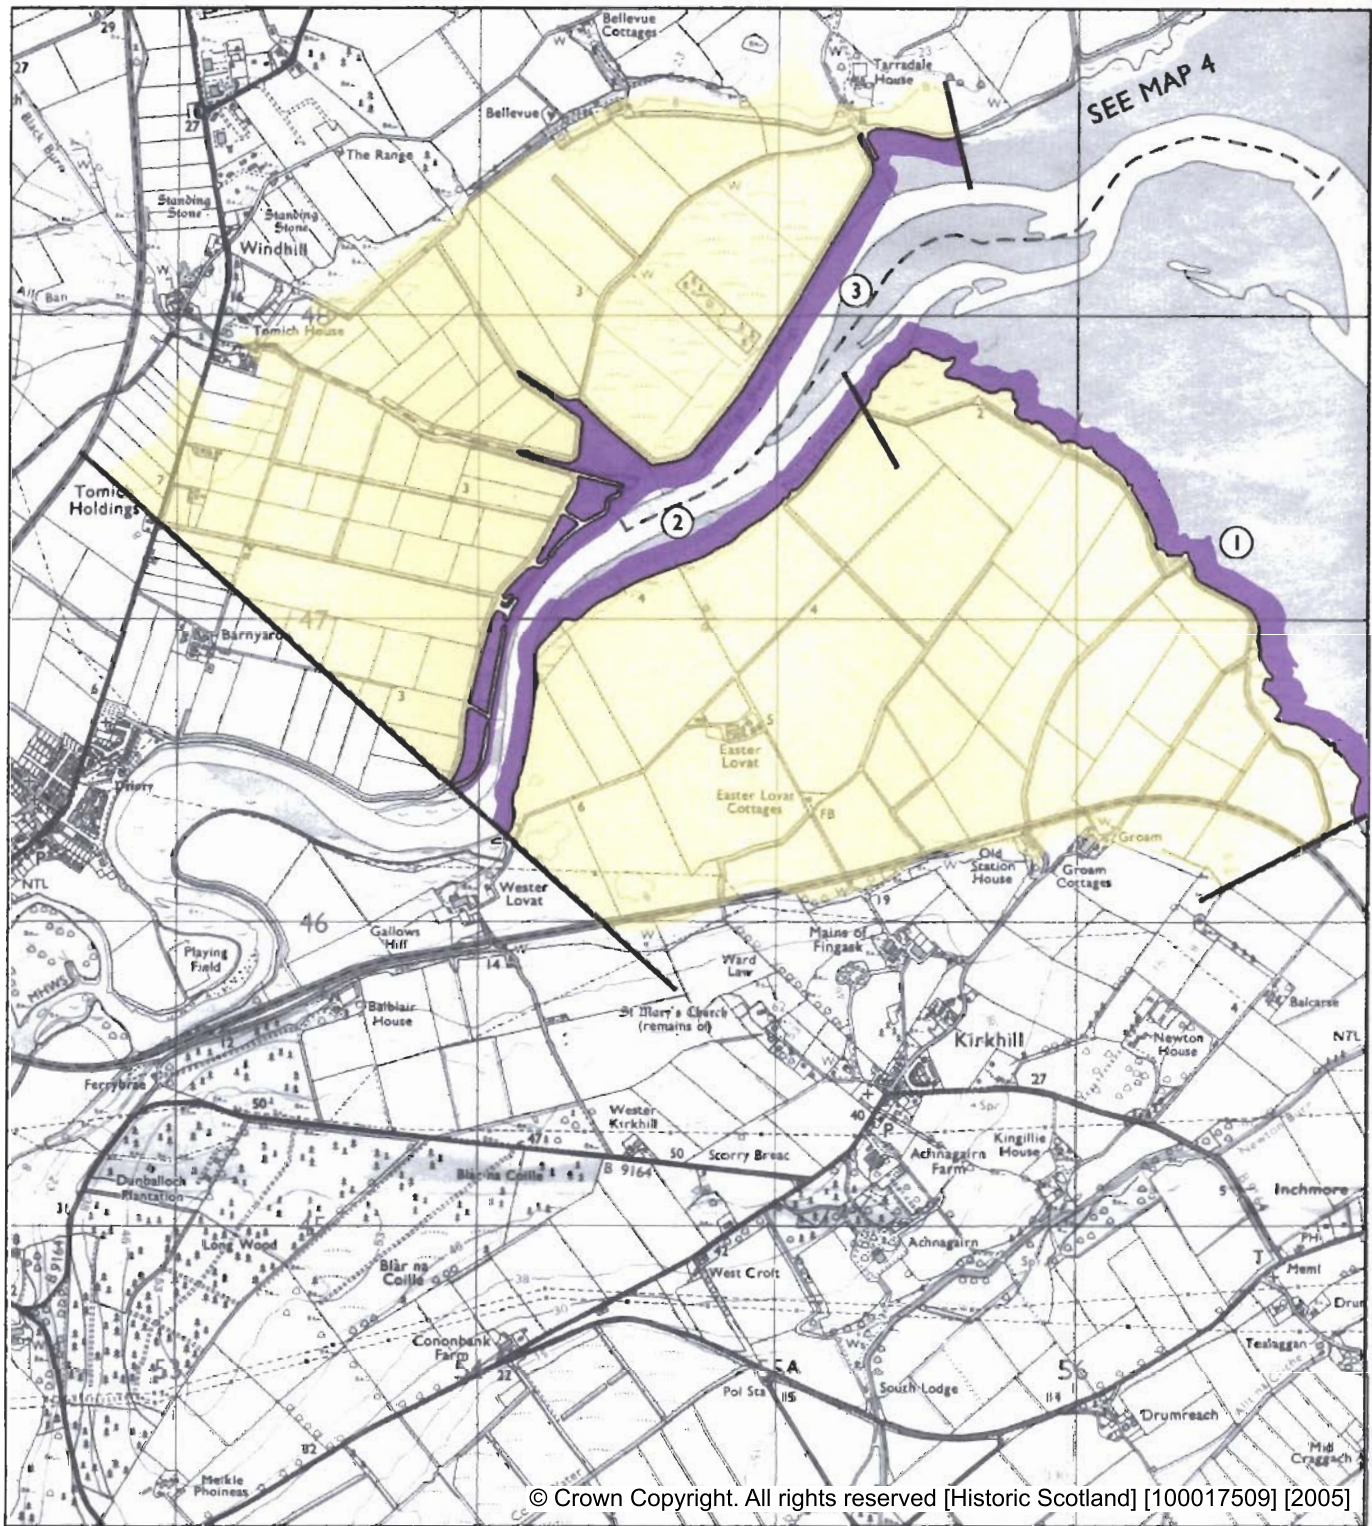
MAP 3: BALCARSE TO TARRADALE HOUSE

Northern shore of outer tidal reaches of the River Beulay. Undergoing erosion in parts of the river channel and is leading to accretion of mud on the exposed banks. Suspended sediment from further upstream is liable to accrete at the mouth of the river.

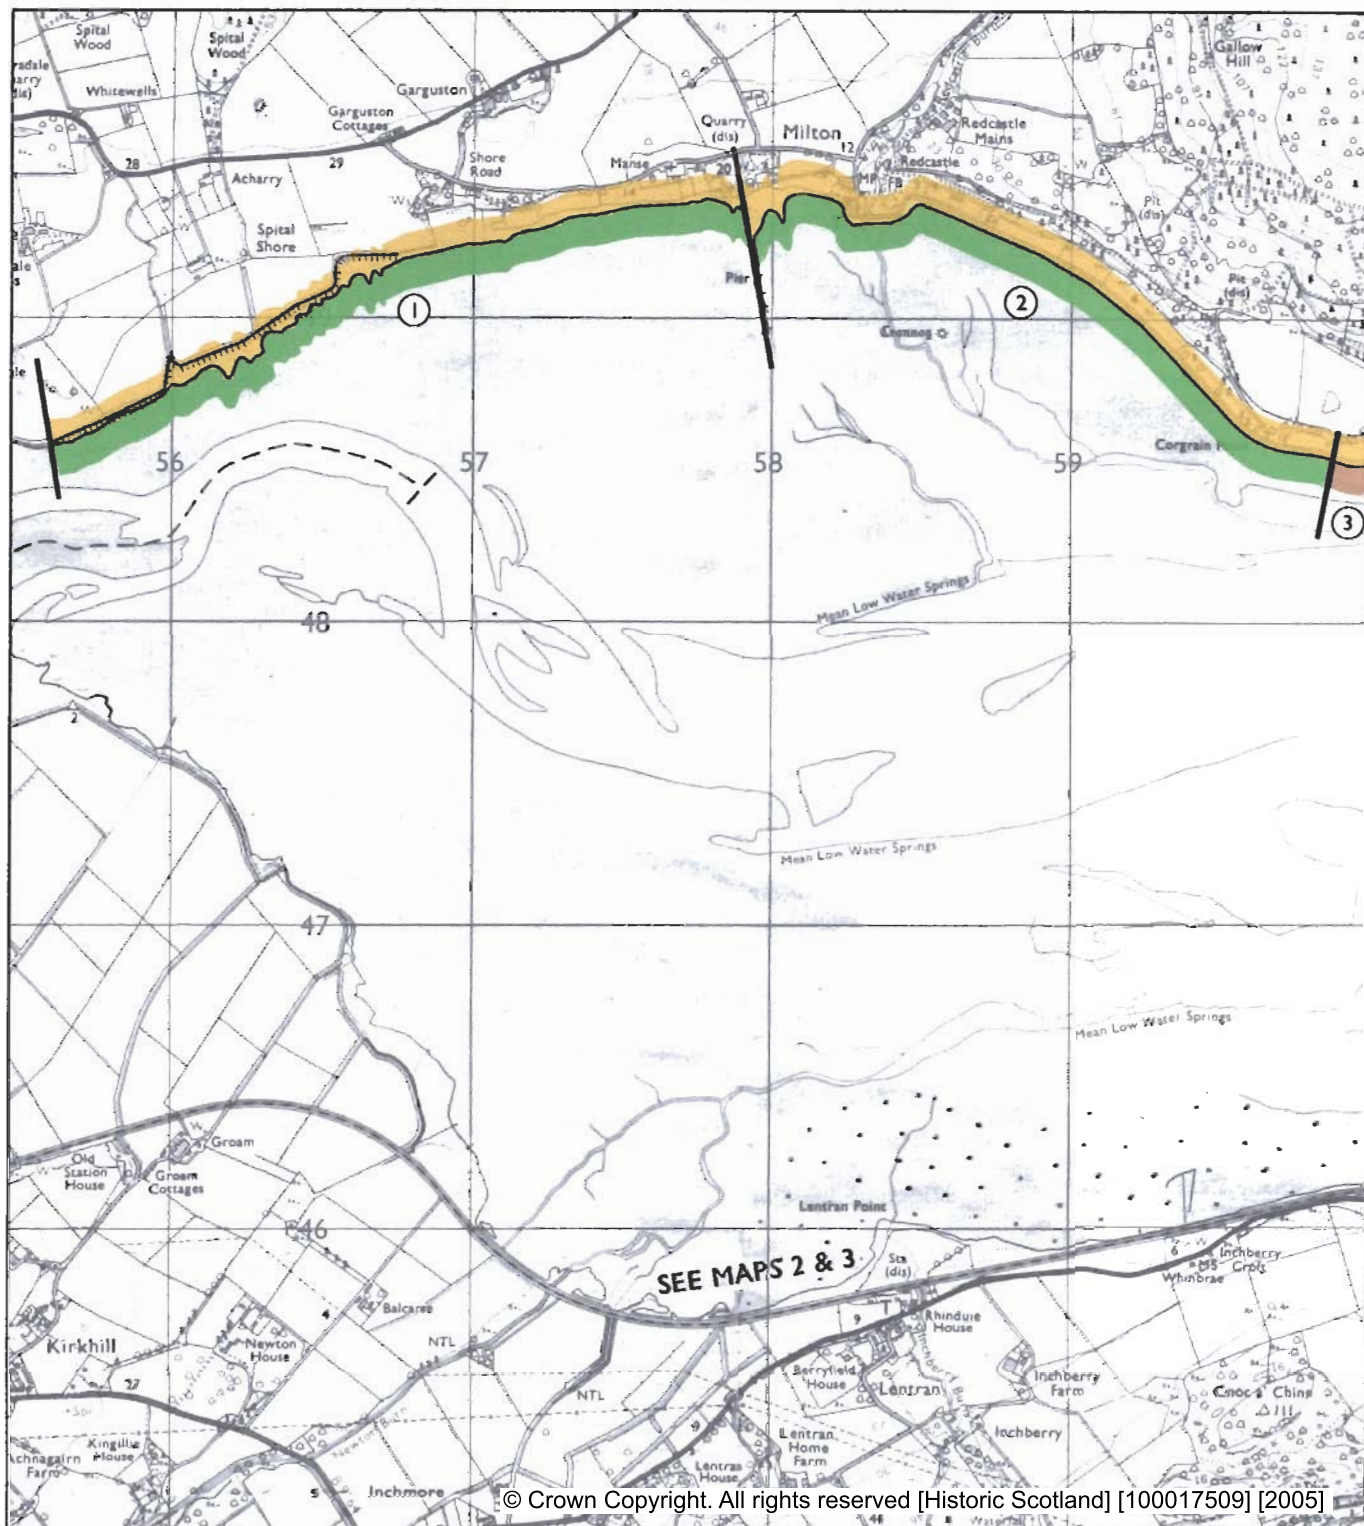
MAP 4: TARRADALE HOUSE TO CORGRAIN POINT 1:25 000

Extensive tidal mud flats meet saltmarsh at the coastal edge. Hinterland wooded. This unit incorporates the site of the crannog at Redcastle.

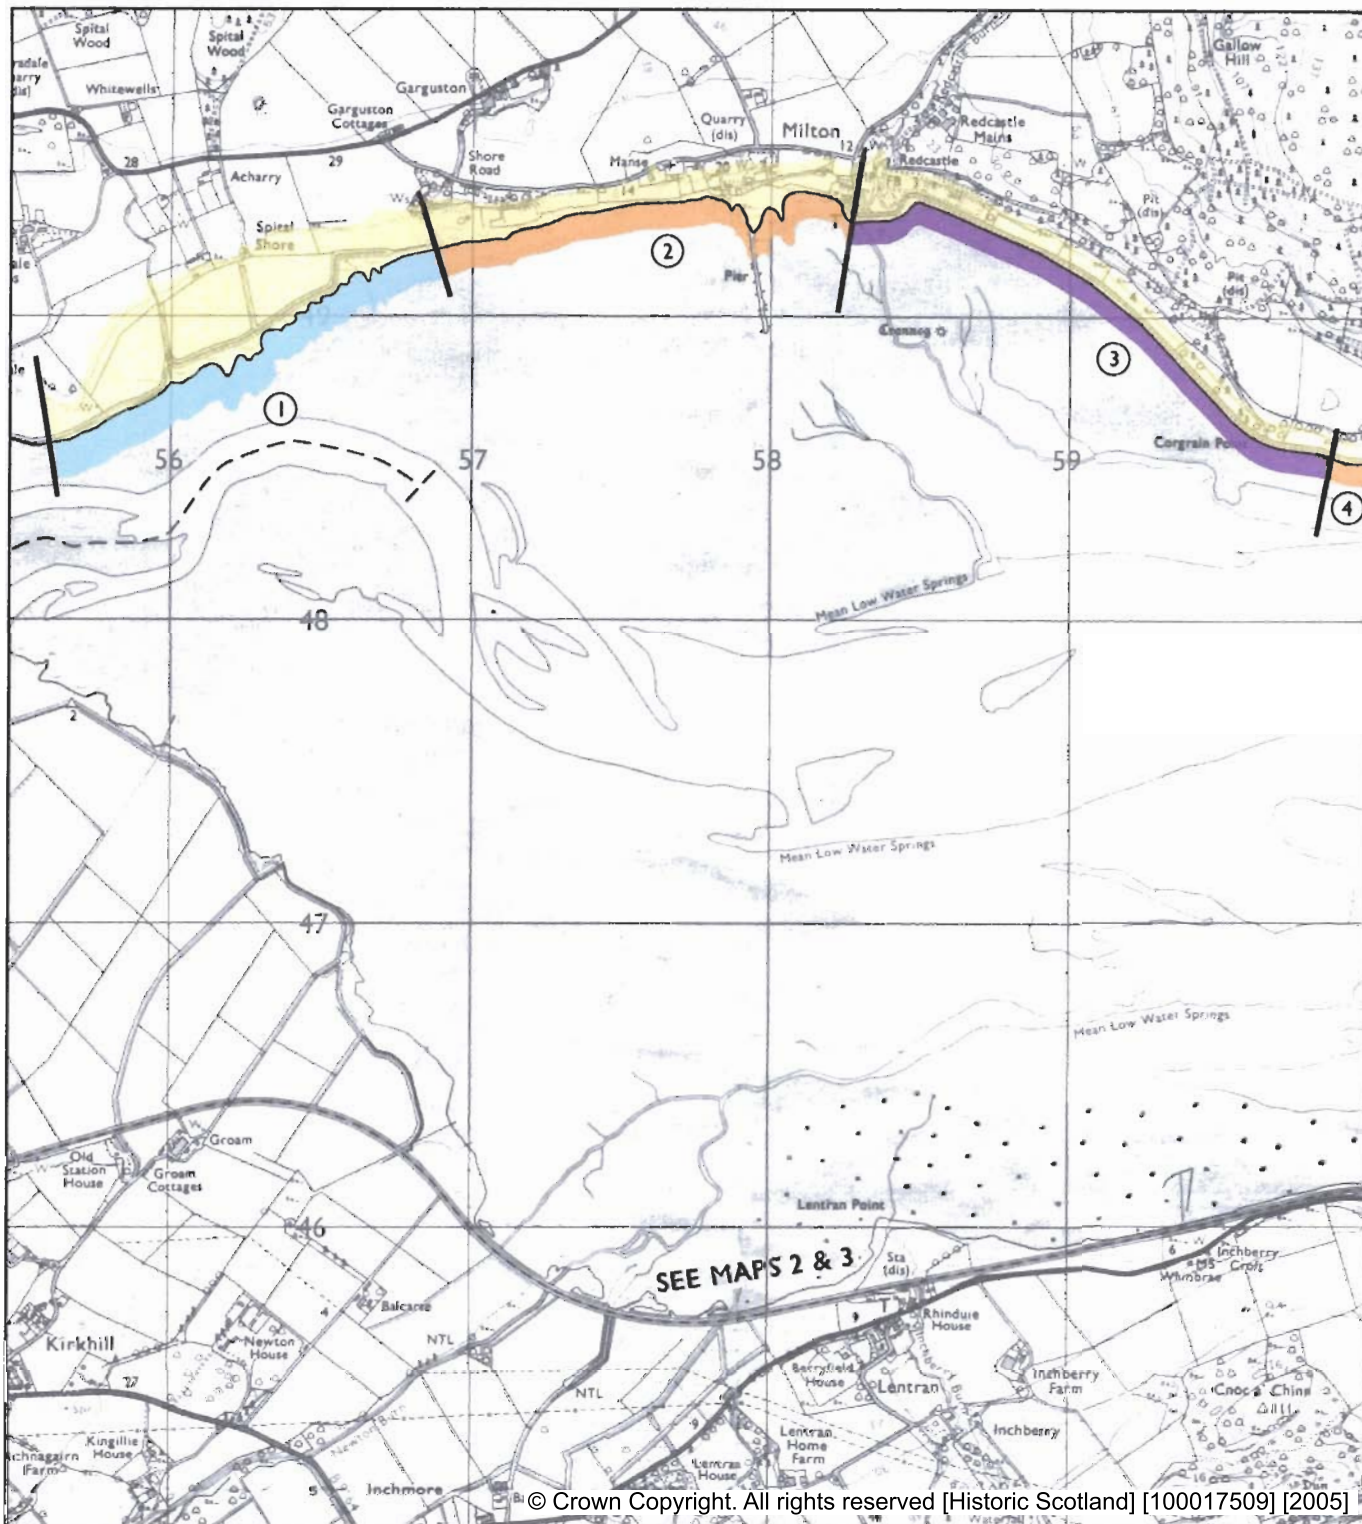
MAP 4: TARRADALE HOUSE TO CORGRAIN POINT 1:25 000

1. East of TARRADALE HOUSE to south of
SHORE ROAD
NH 565 490
1.4km
Accreting or Stable
High earthwork floodbanks defend the hinterland
and saltmarsh is well established on the
backshore. Conditions are stable with mud
accreting on foreshore.
 2. South of SHORE ROAD to REDCASTLE
NH 576 494
1.4km
Stable or Eroding
Head of the Beaully Firth with accreting mudflats
owing to its sheltered aspect and constant
sediment supply. At the HWM some local erosion
of the saltmarsh vegetation and underlying clay is
occurring. At Redcastle the clay is eroding
forming a step as the material that has fallen from
the low edge continues to grow.
 3. REDCASTLE east to CORGRAIN POINT
NH 592 490
1.9km
Both Accreting and Eroding
A fairly stable stretch of coastline with some local
erosion at HWM. The foreshore is wide with
accreting mud and shingle
-

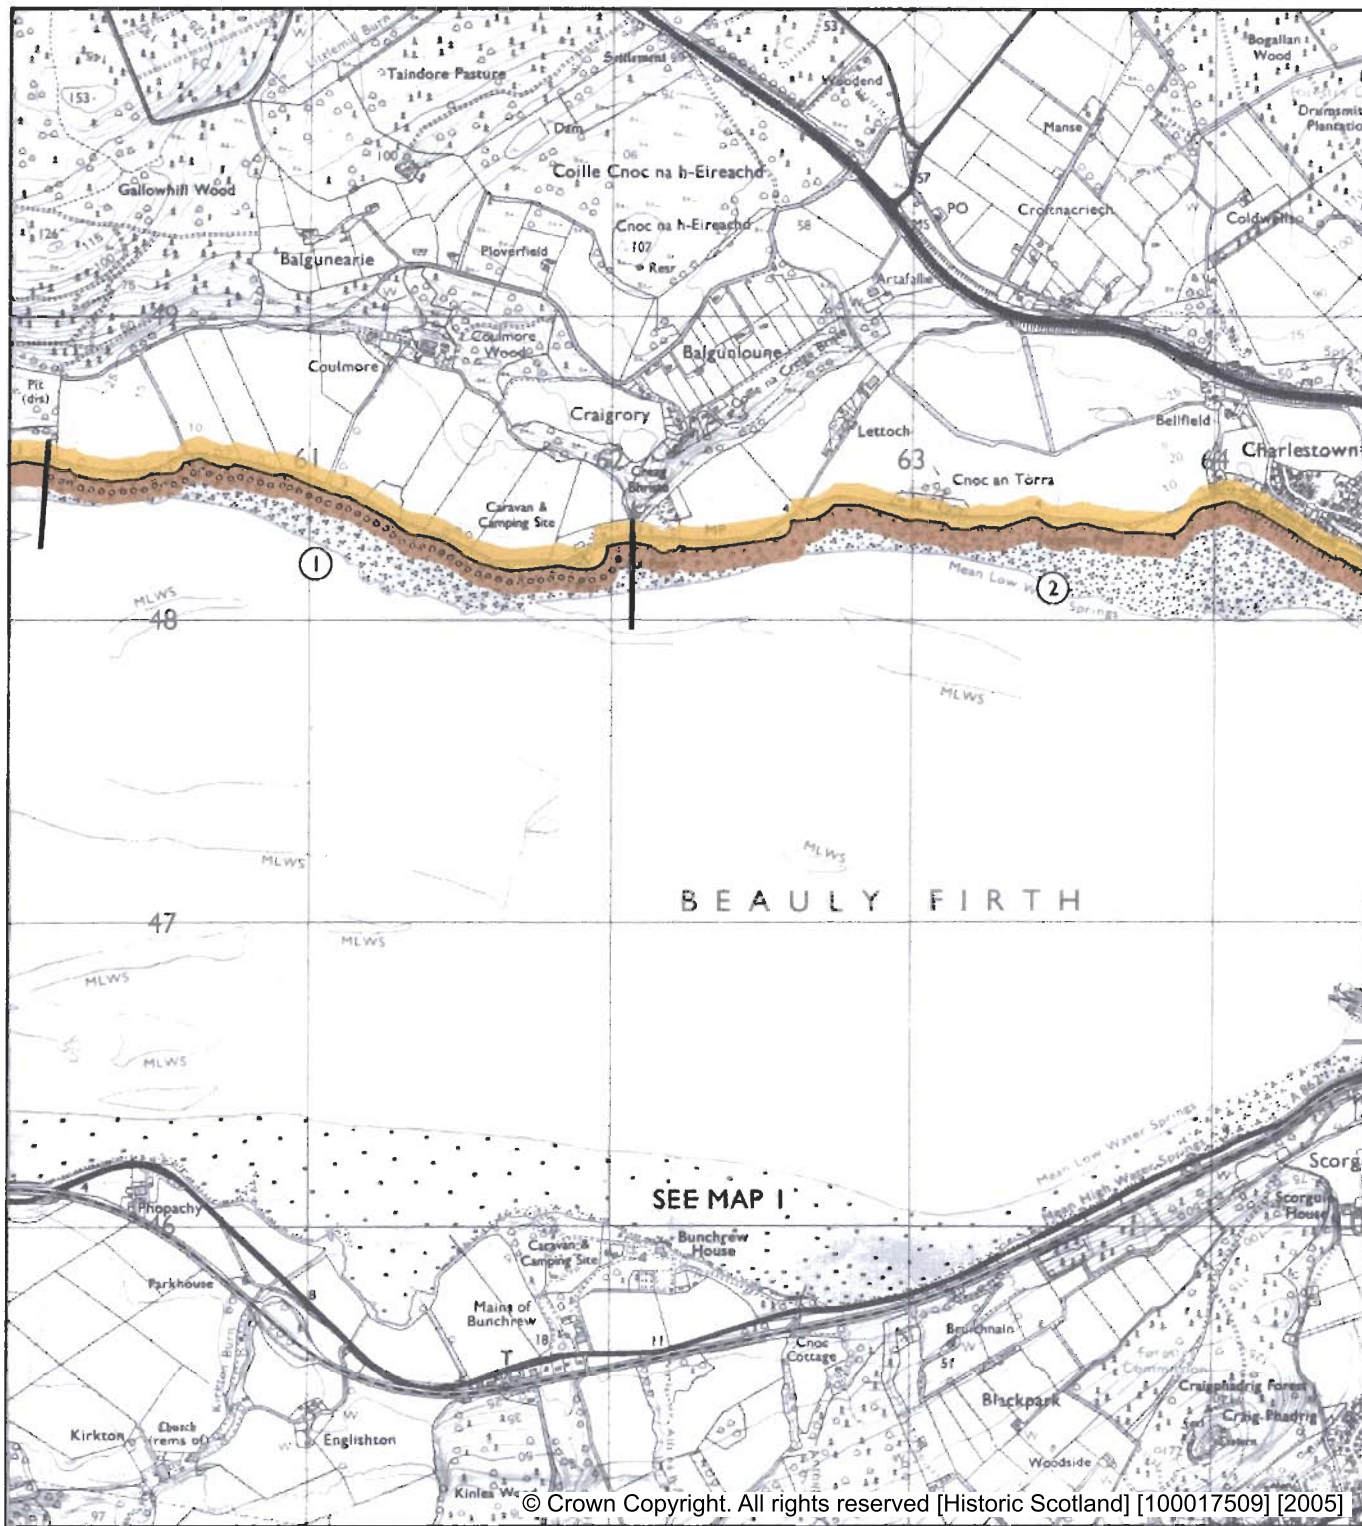
MAP 5: CORGRAIN POINT TO CHARLESTOWN 1:25 000

The hinterland consists of farmed land. Urban development occurs at Charlestown.

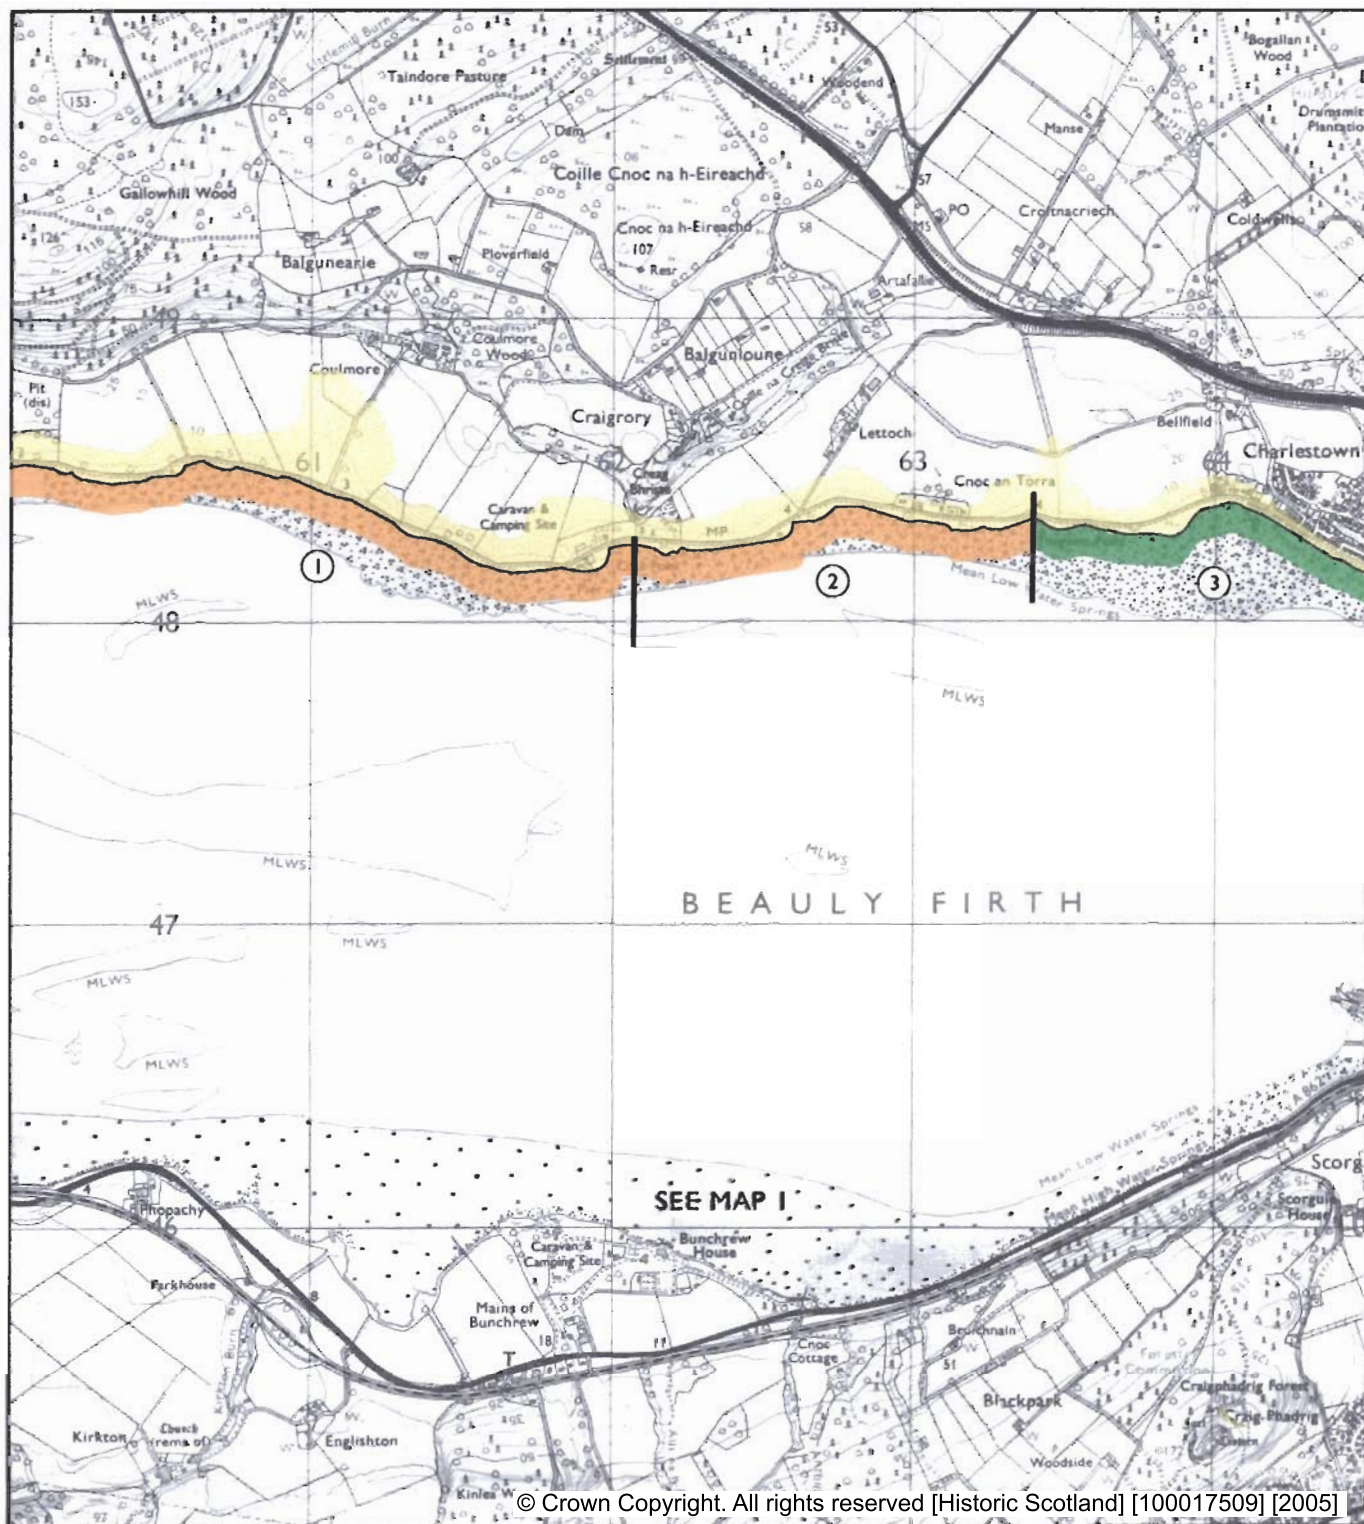
MAP 5: CORGRAIN POINT TO CHARLESTOWN 1:25 000

The intertidal zone is noticeable narrower than further down the coast with no evidence of instability. At North Kessock stability is being maintained owing concrete sea walls.

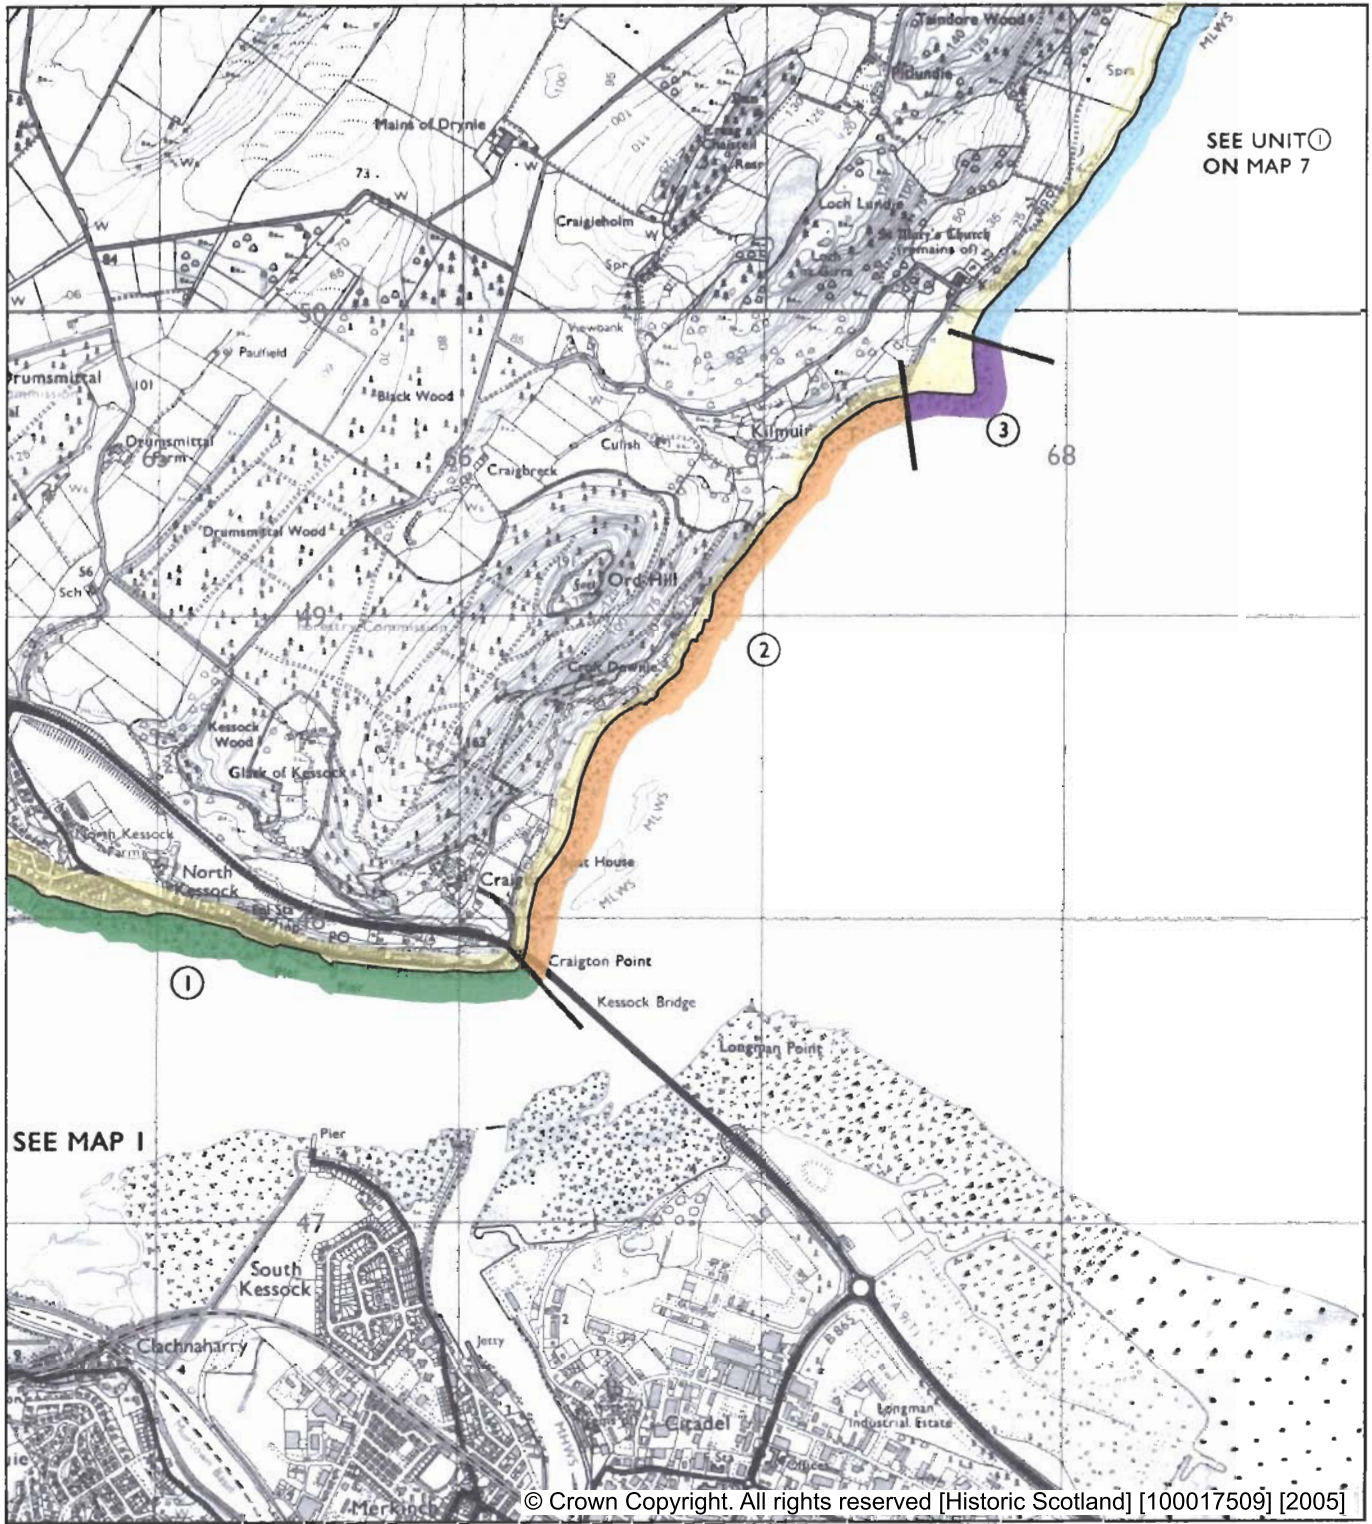
MAP 6: CHARLESTOWN TO KILMUIR

This section of coastline appears to be stable owing to the resilient nature of the underlying sandstone geology. Towards the base of the cliffs rock fall is vegetated providing stability to this region.

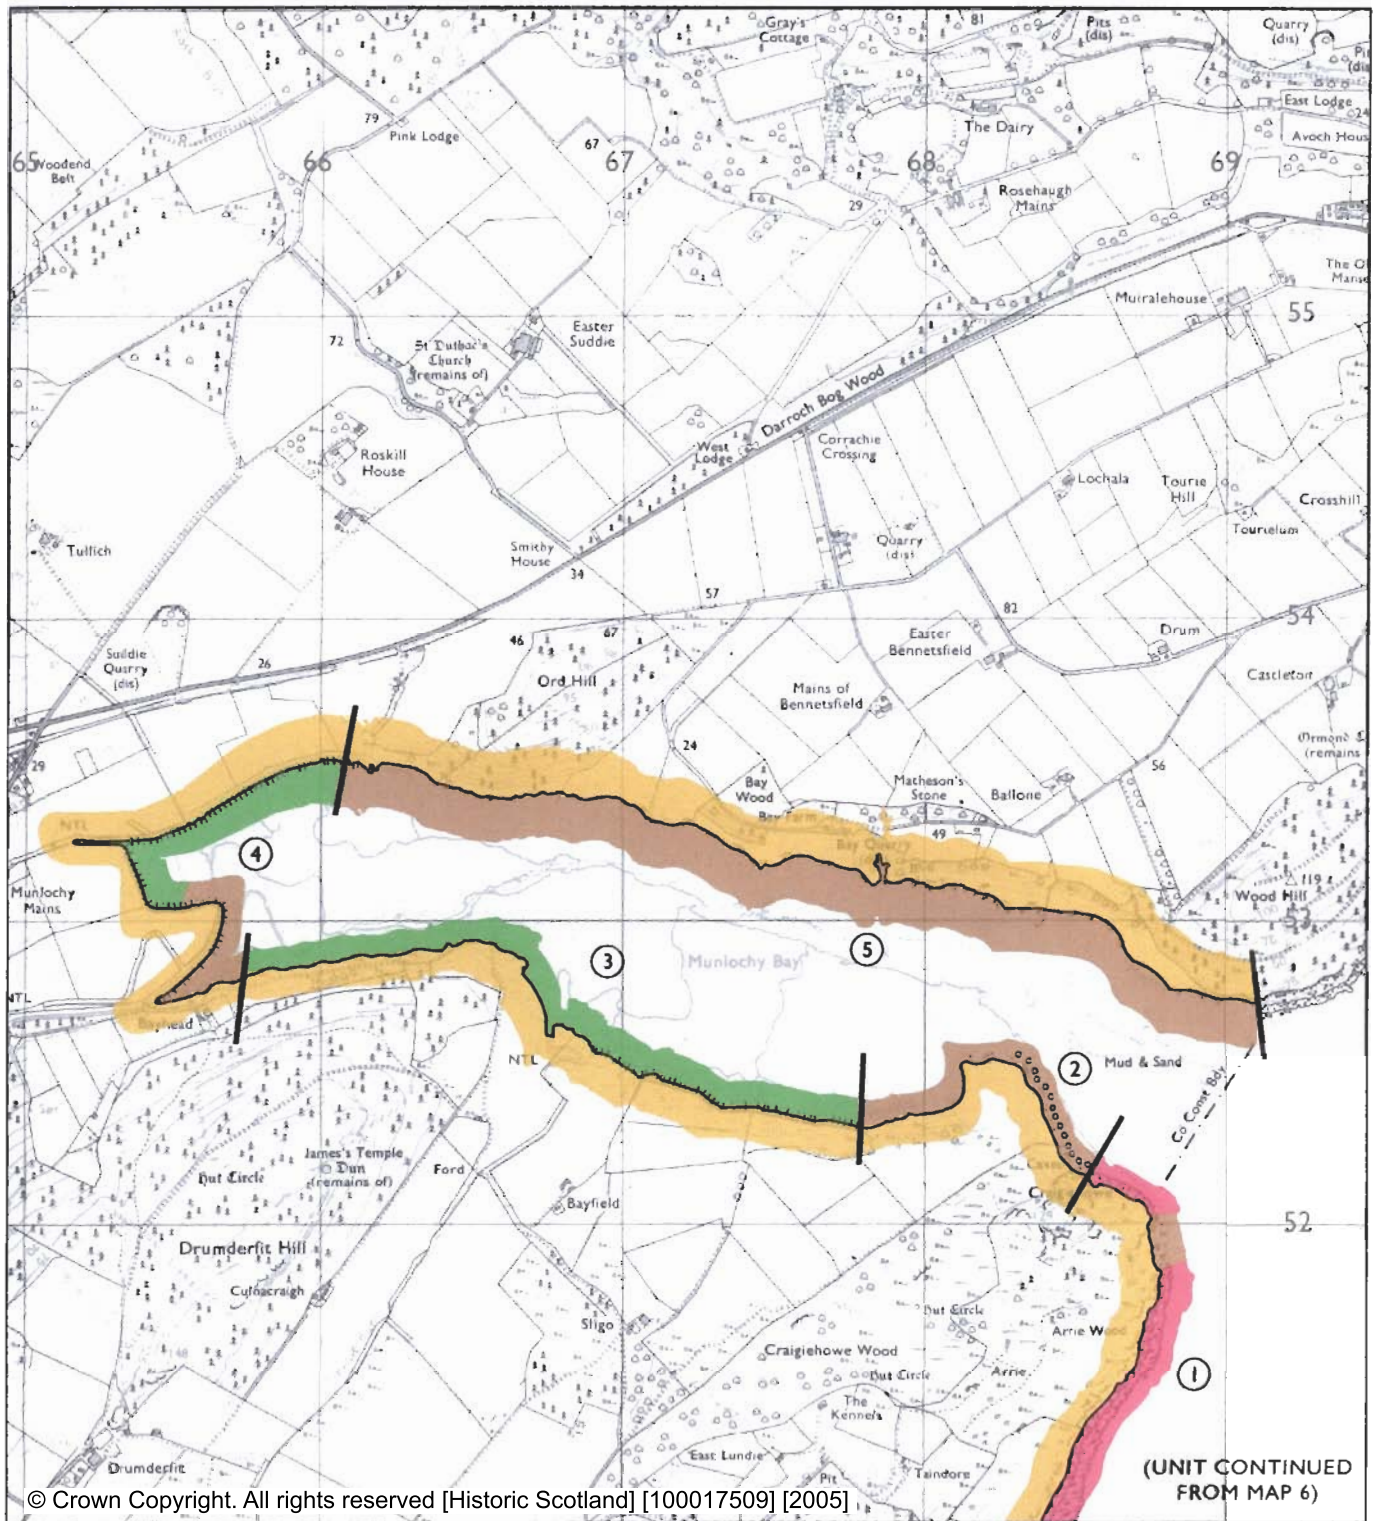
MAP 7: KILMUIR TO WOOD HILL

Forming the northern shore of Munlochy Bay this section of coast is linear and unbroken with uniformity to the mouth of the bay. The foreshore comprises mainly mud and sand. The hinterland is below 10m OD and consists of marine deposits.
