Coastal Assessment Survey Inner Moray Firth

Inverness to Dingwall

**MORAY, BEAULY AND CROMARTY FIRTH
COASTAL ASSESSMENT 1998**

Report No. 446

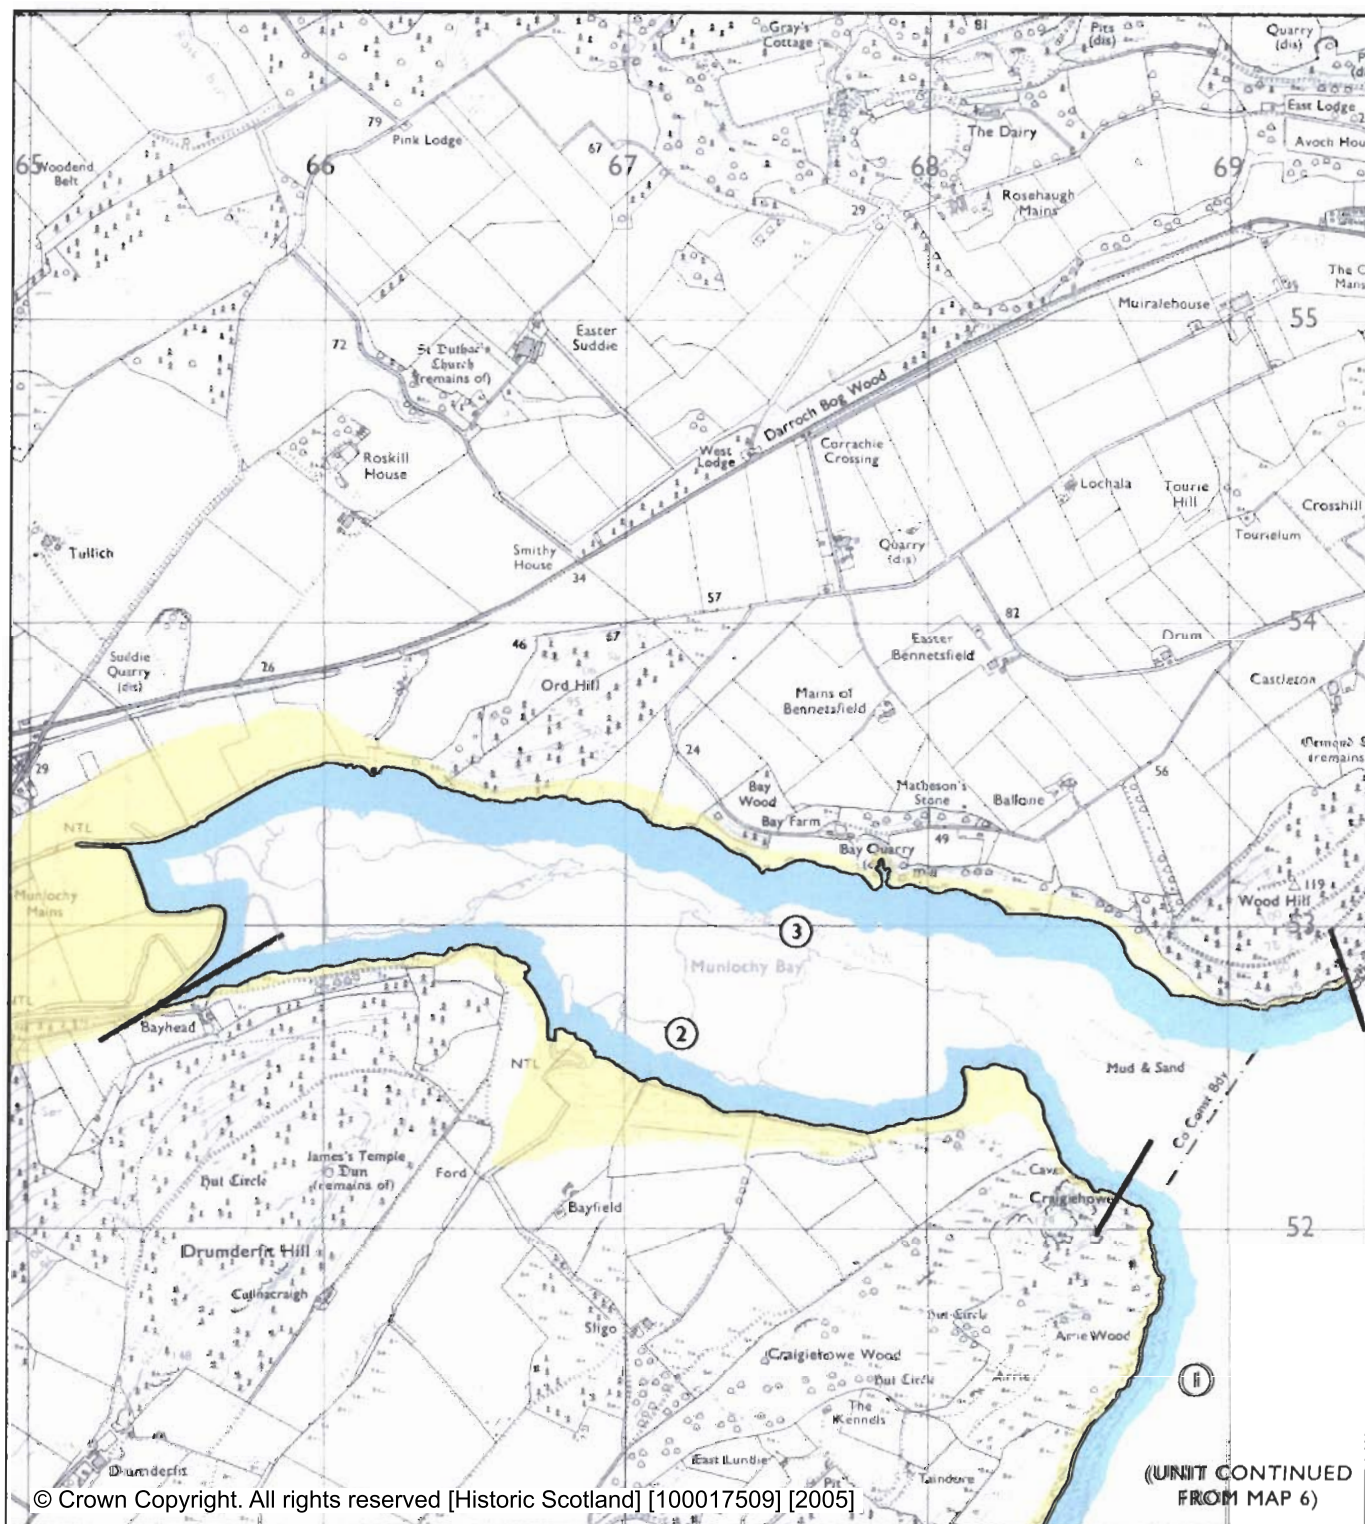
MAP 7: KILMUIR TO WOOD HILL

The north shore of Munlochy Bay is sheltered leading to accretion of the exposed tidal flats caused by sediment entrapment within the bay. Rabbit erosion on a low cliff face is occurring at NH 6853 5292.

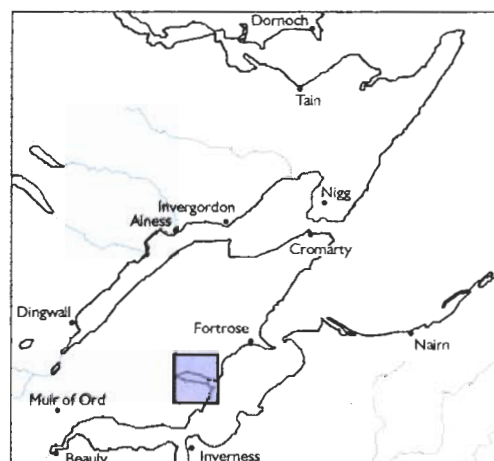
Map 8: AVOCH BAY TO FORTROSE

Hinterland Geology and Coastal Geomorphology: Upper Old Red Sandstone continues as the basement geology. At Rosemarkie, boulder and undifferentiated drift deposits dominate the cover lithologies in the hinterland. The dominant geomorphic feature within this unit is the cusped foreland of Chanory Ness and Point. This feature is postulated to have formed by the movement of material in a south westerly direction along the coastline of the Inner Moray Firth and in a westerly direction of the Beaulay Firth coastline (SMP 1996). From Avoch to Fortrose the shore frontage is developed with a coastal edge consisting of a low plateau of erodable marine deposits and alluvium. Chanory Ness has dune cover and stepped shingle beaches. From the Ness to Rosemarkie Bay the predominant beach cover is sand.

Erosion class: South of Avoch fishing village a vertical concrete sea wall protects the shore road. Immediately south of the harbour and at the mouth of a small stream gabion basket protection has been utilised. Seawalls defend the road between Avoch and Fortrose. Rock armour protects the coast further towards Fortrose. The degraded condition of short stretches of seawall and timber groyne systems indicate minor backshore erosion taking place in the area. Chanory Ness is subjected to a relatively low fetch to the south west and has been undergoing wave induced erosion over a number of years (SMP 1996). In the short term, a greater part of the ness is stable or accreting with high banks of vegetated shingle. Chanory Point is accreting outwards but is at the same time eroding according to the nature of seasonal tide conditions.

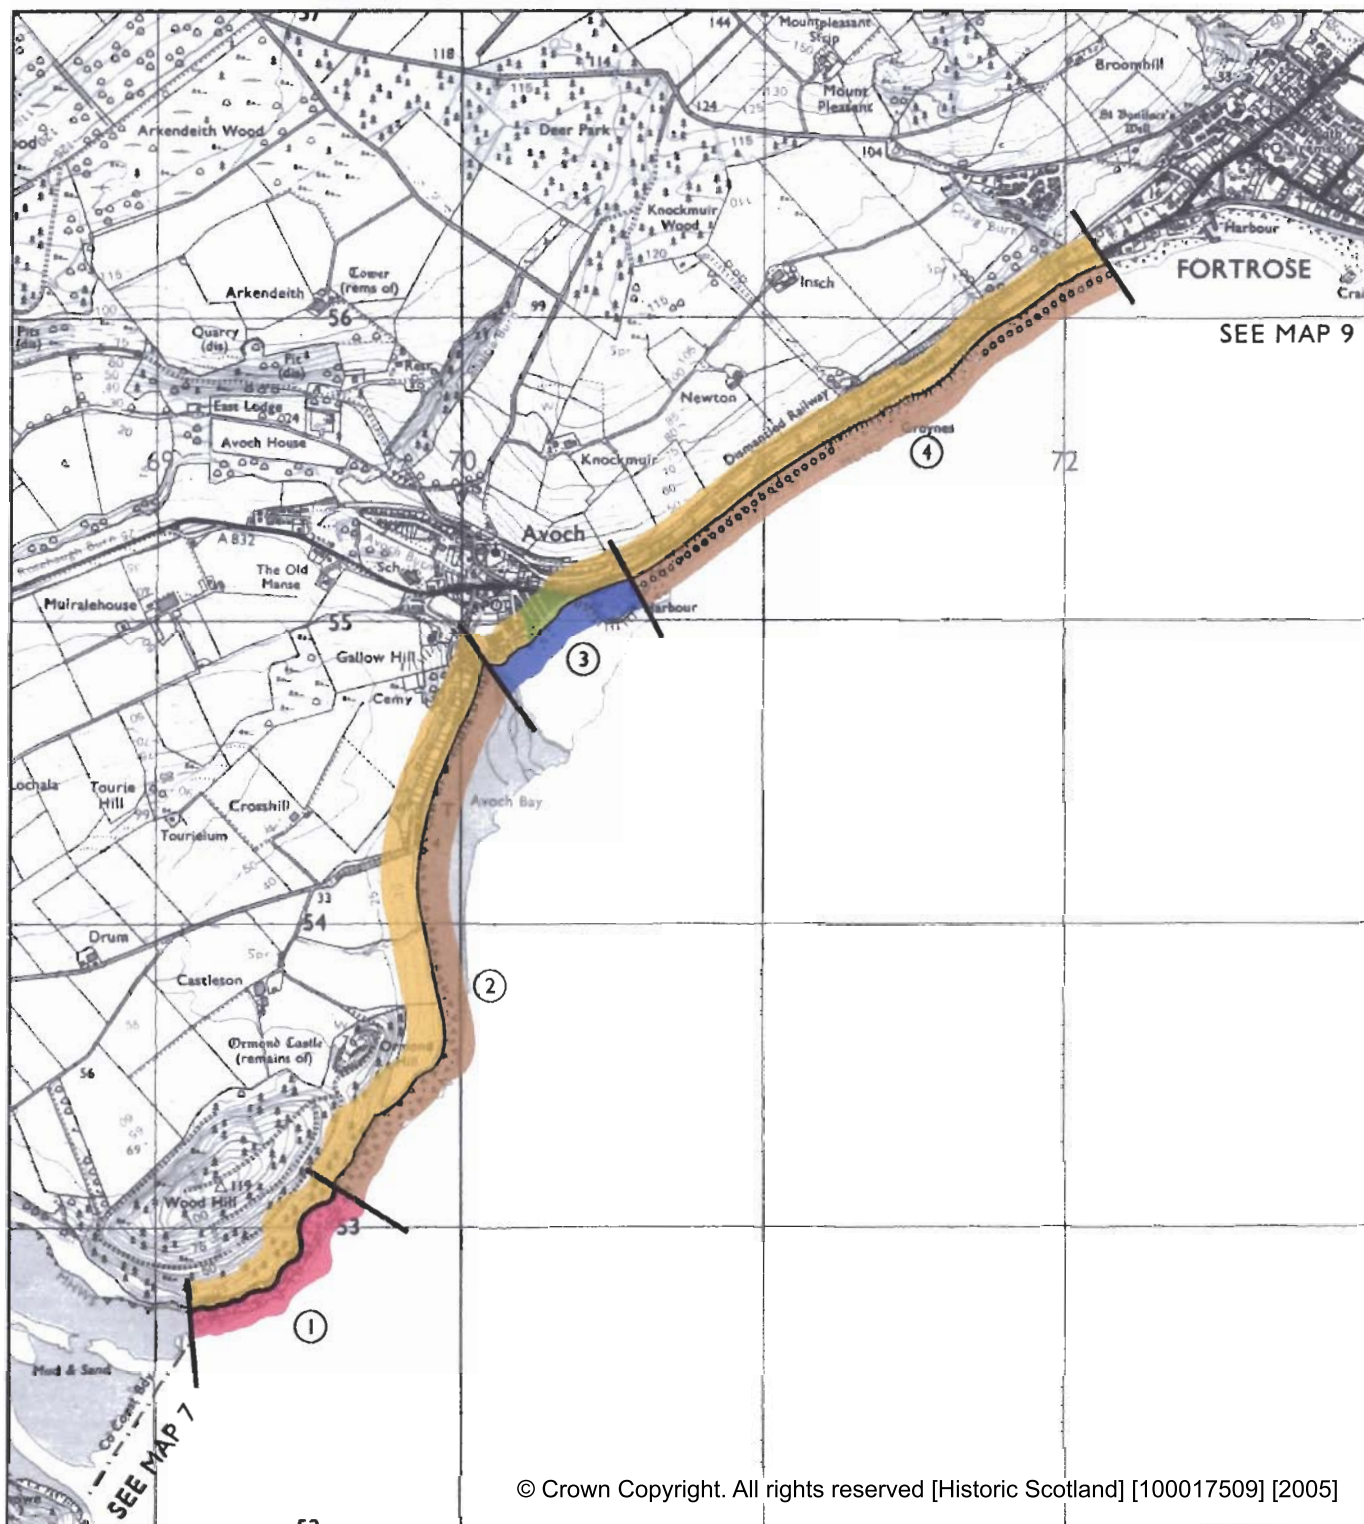
MAP 8: WOOD HILL TO FORTROSE

The hinterland is dominated by marine deposits, which support woodland. The foreshore is a mixture of mud and shingle with shore protection. This section of coastline is exposed.

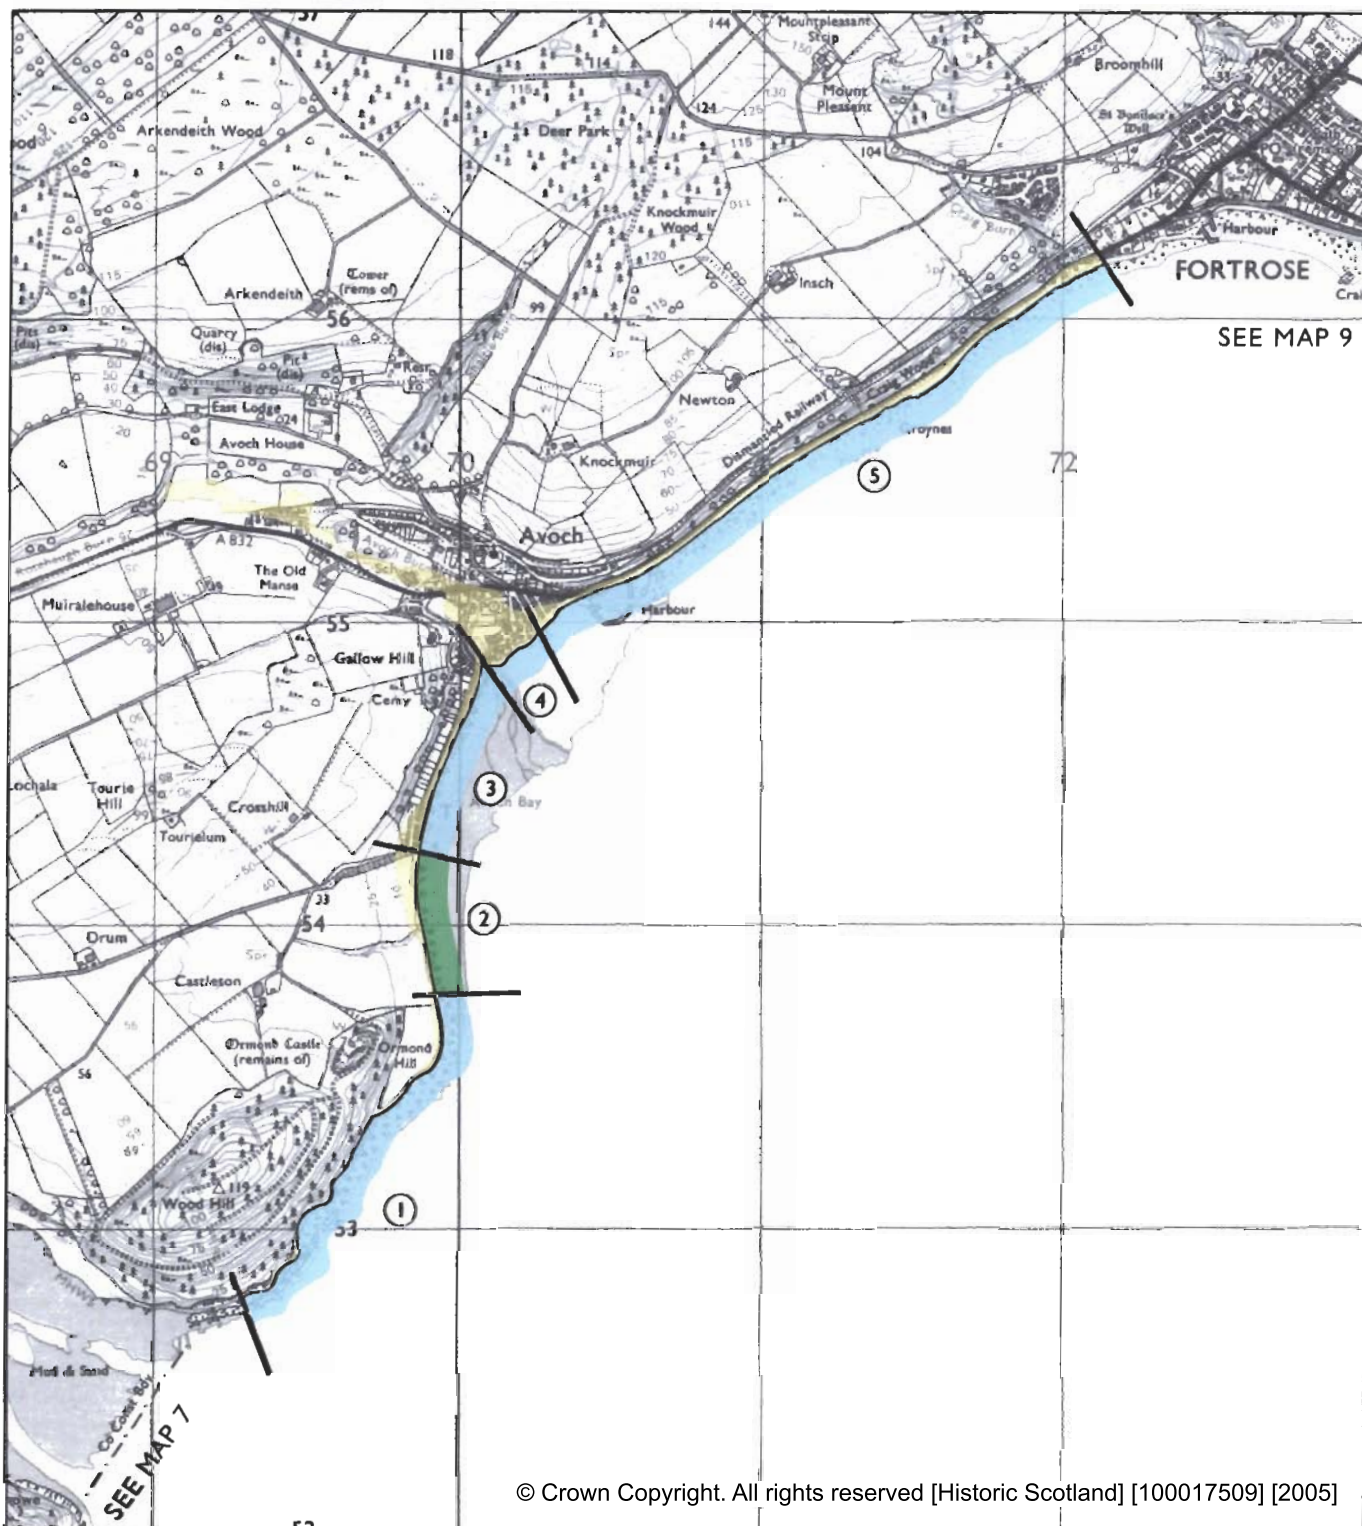
MAP 8: WOOD HILL TO FORTROSE

Rubble sea-defences and groynes on the shore. Shingle banks are stabilised by vegetation. Stable conditions prevail. A c.50m section of erosion has occurred on the neck of the pier at Avoch and is now defended by rubble. Turf behind has been scoured by wave action. On the whole conditions are stable.

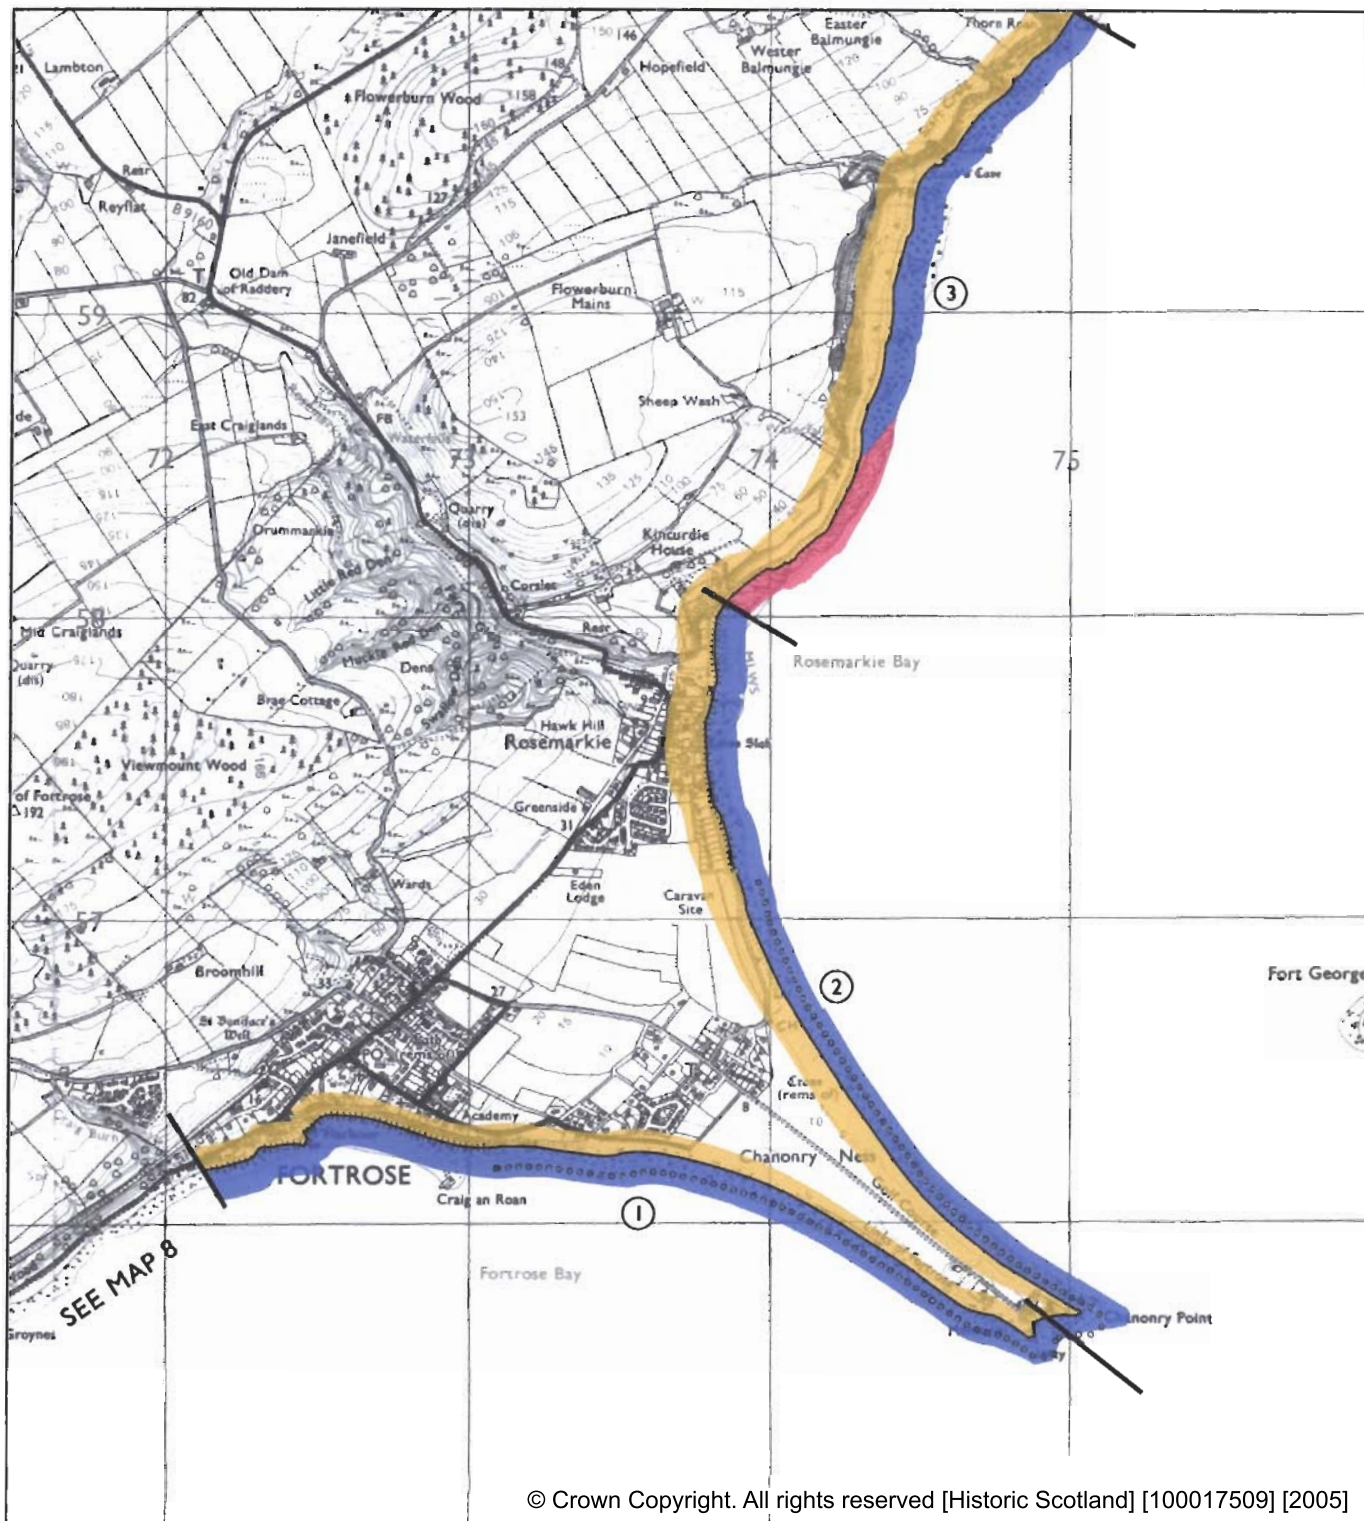
MAP 9: FORTROSE TO SCART CRAIG

Escarpments rise over c.20m above OD. A dune has been formed by accreting sand blown up onto the low postglacial platform, which lies at the base of the degraded cliff.

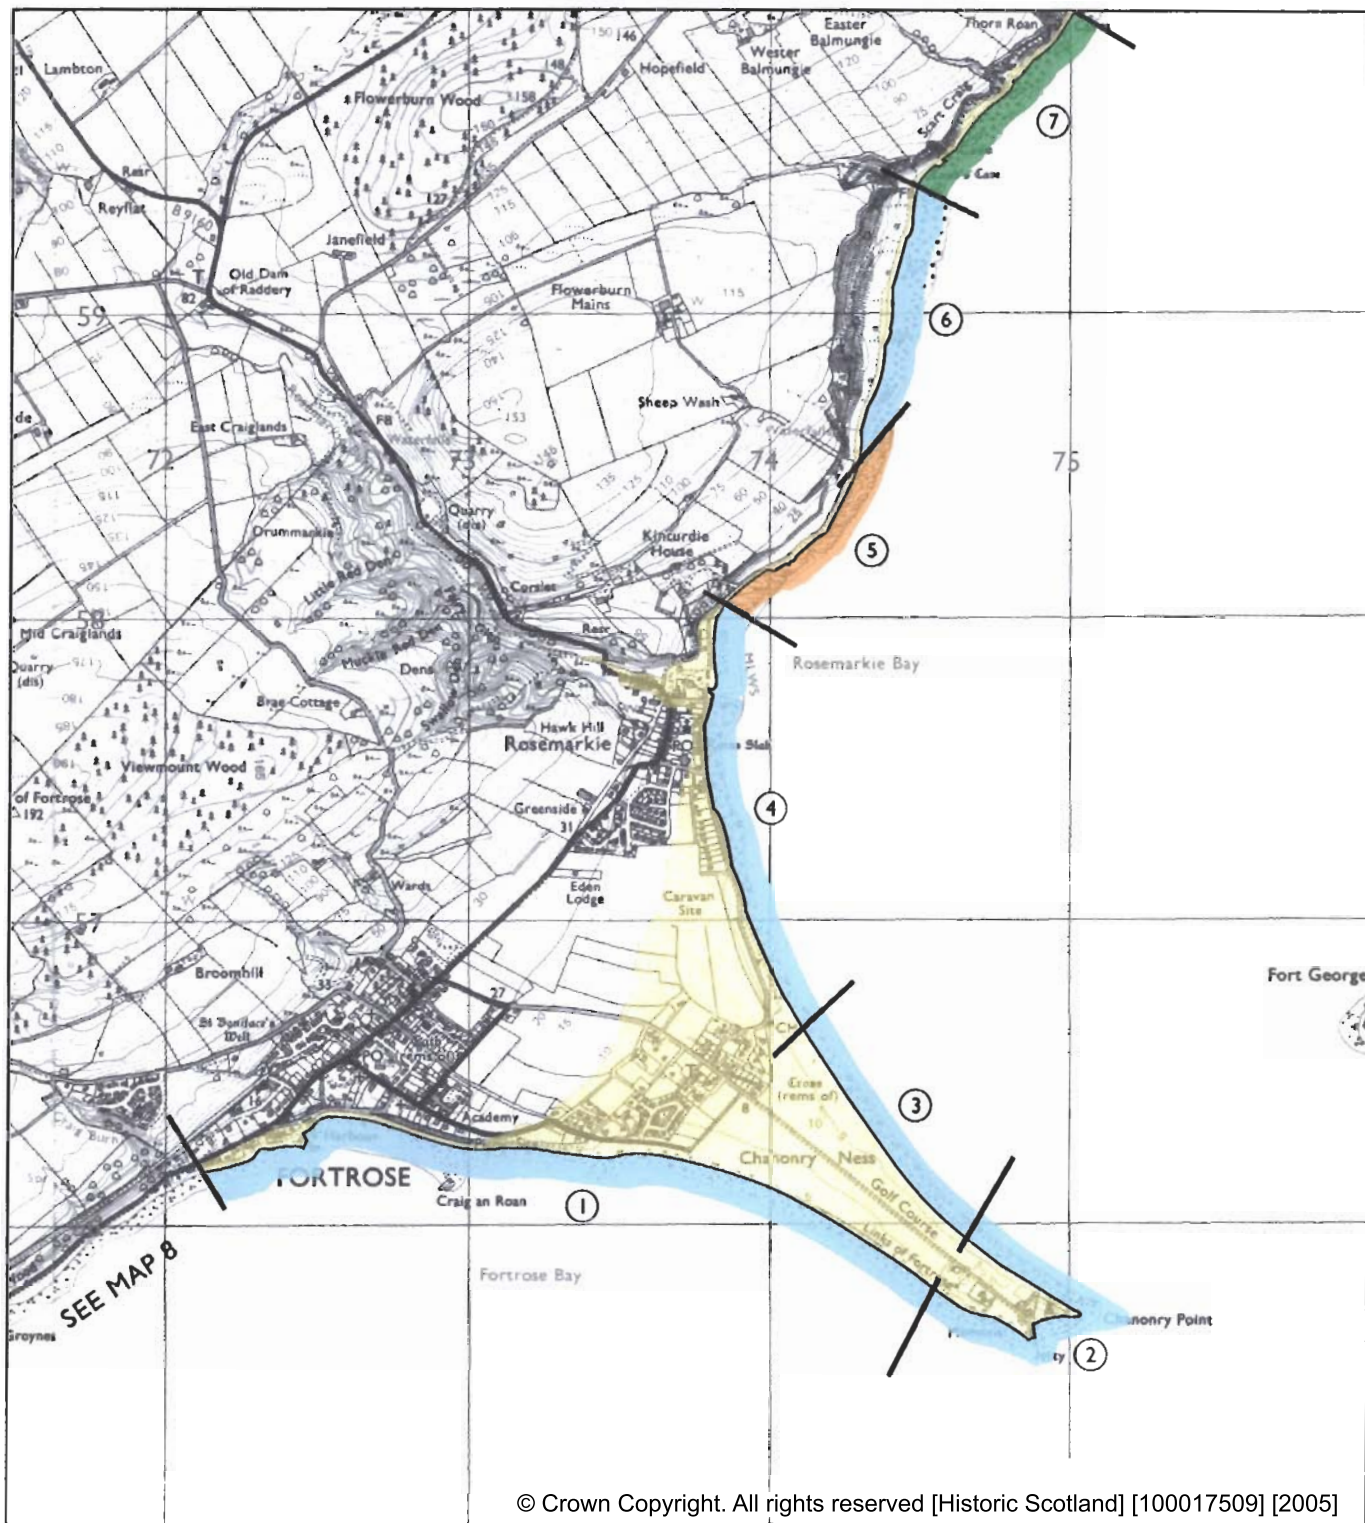
MAP 9: FORTROSE TO SCART CRAIG

Outcropping Old Red Sandstone platform is fairly resilient to attrition by wave action. Shingle is banked up on a wide backshore. Conditions at the time of the survey remain stable.

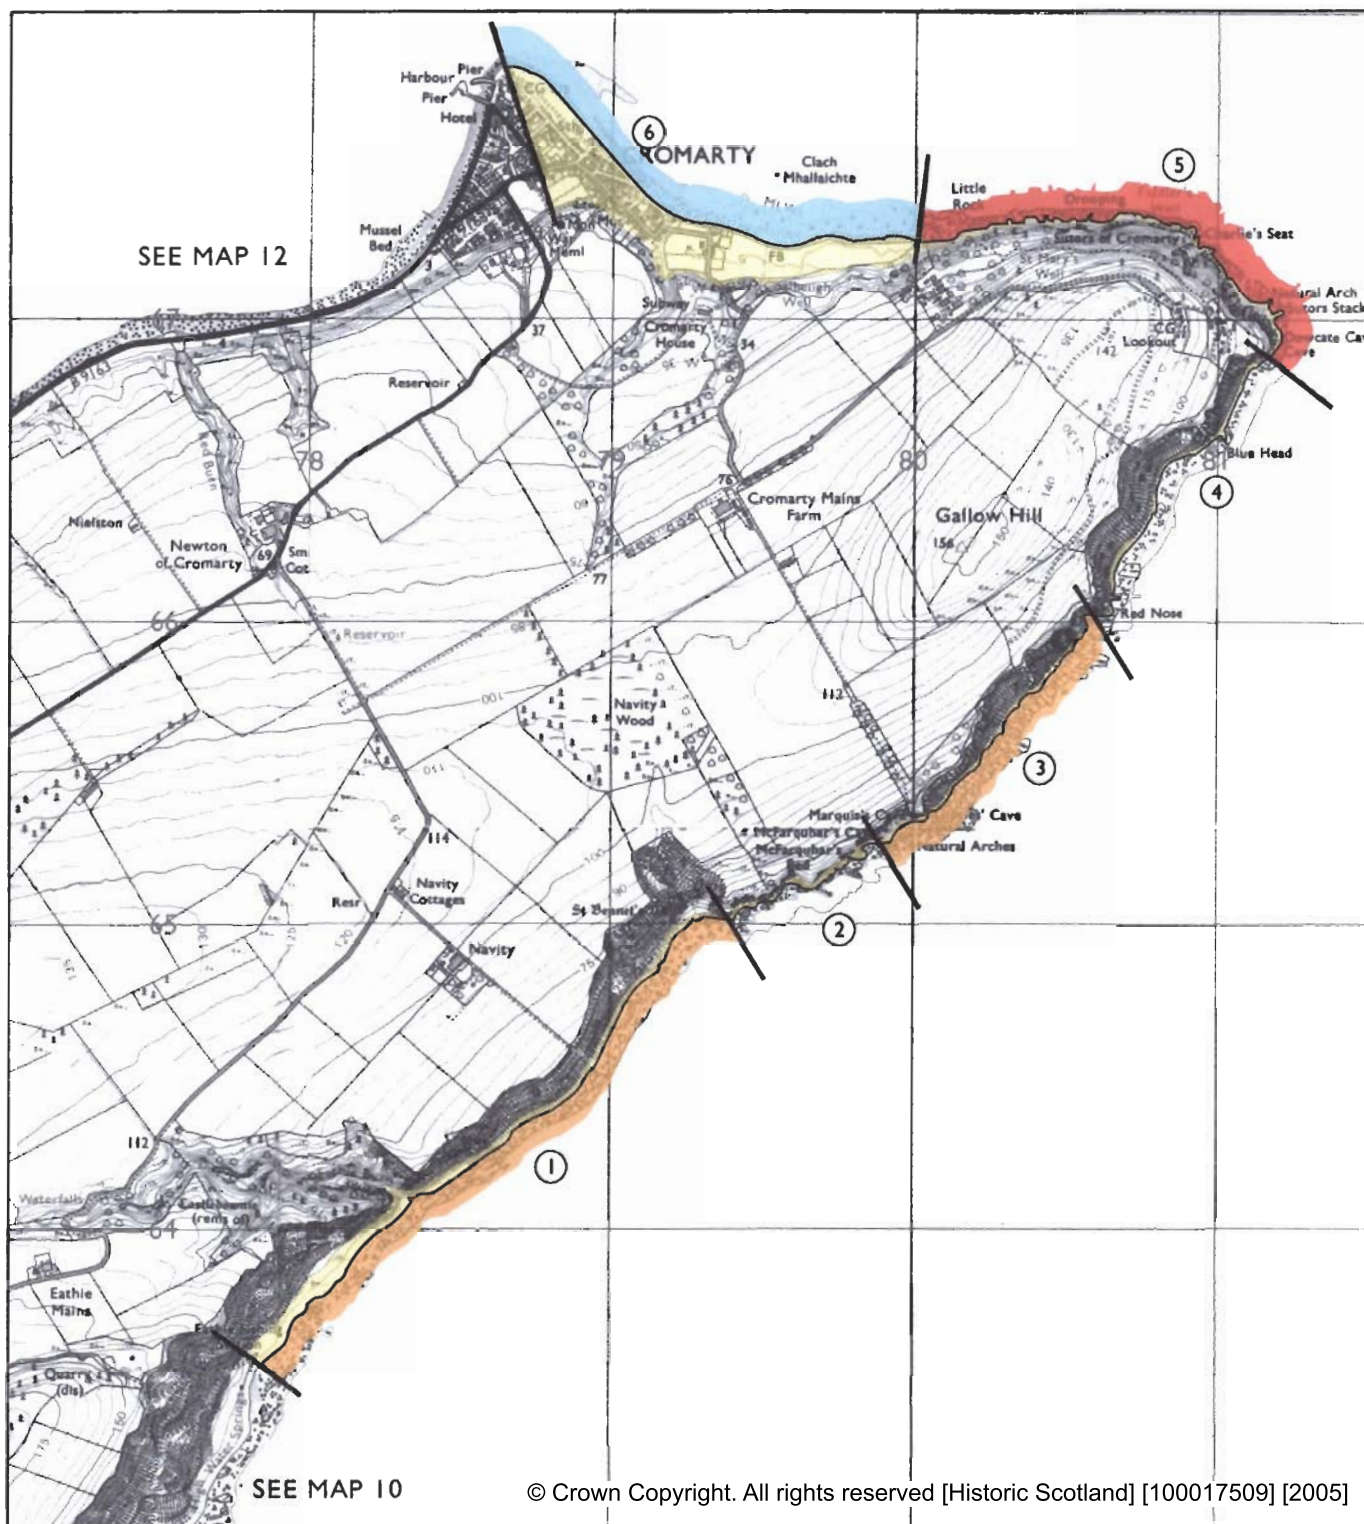
MAP 11: EATHIE FISHING STATION TO CROMARTY 1:25 000

Defended by concrete sea defences this unit appears to be fairly stable with sand and shingle banked up at the MHW. Sediment supply appears to be ongoing caused by longshore drift from within the Cromarty Firth.

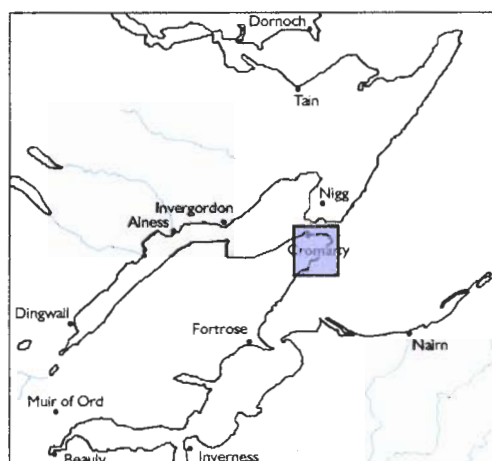
Map 12: CROMARTY TO SHORE MILL

Hinterland Geology and Coastal Geomorphology: The underlying basement geology in this sector of coastline is undifferentiated thin bedded Lower Red Sandstone. The drift deposits consist of boulder clay which has been sculpted at the coast by post-glacial marine terraces. The raised beaches continue west along the shore of the Cromarty Firth. The wide foreshore is dominated by shingle and mud which are exposed as mudflats down to the LWM.

Erosion class: This section is sheltered by the promontories of the Sutors. The low coastal edge has easily eroded sands and gravel which are prone to erosion by wave action. At Cromarty a promenade defends the town. Parts of the coastline beyond Cromarty shows evidence of accretion and stability. Local erosion has been observed as effecting saltmarsh at the backshore. The mud flats toward the LWM are accreting.

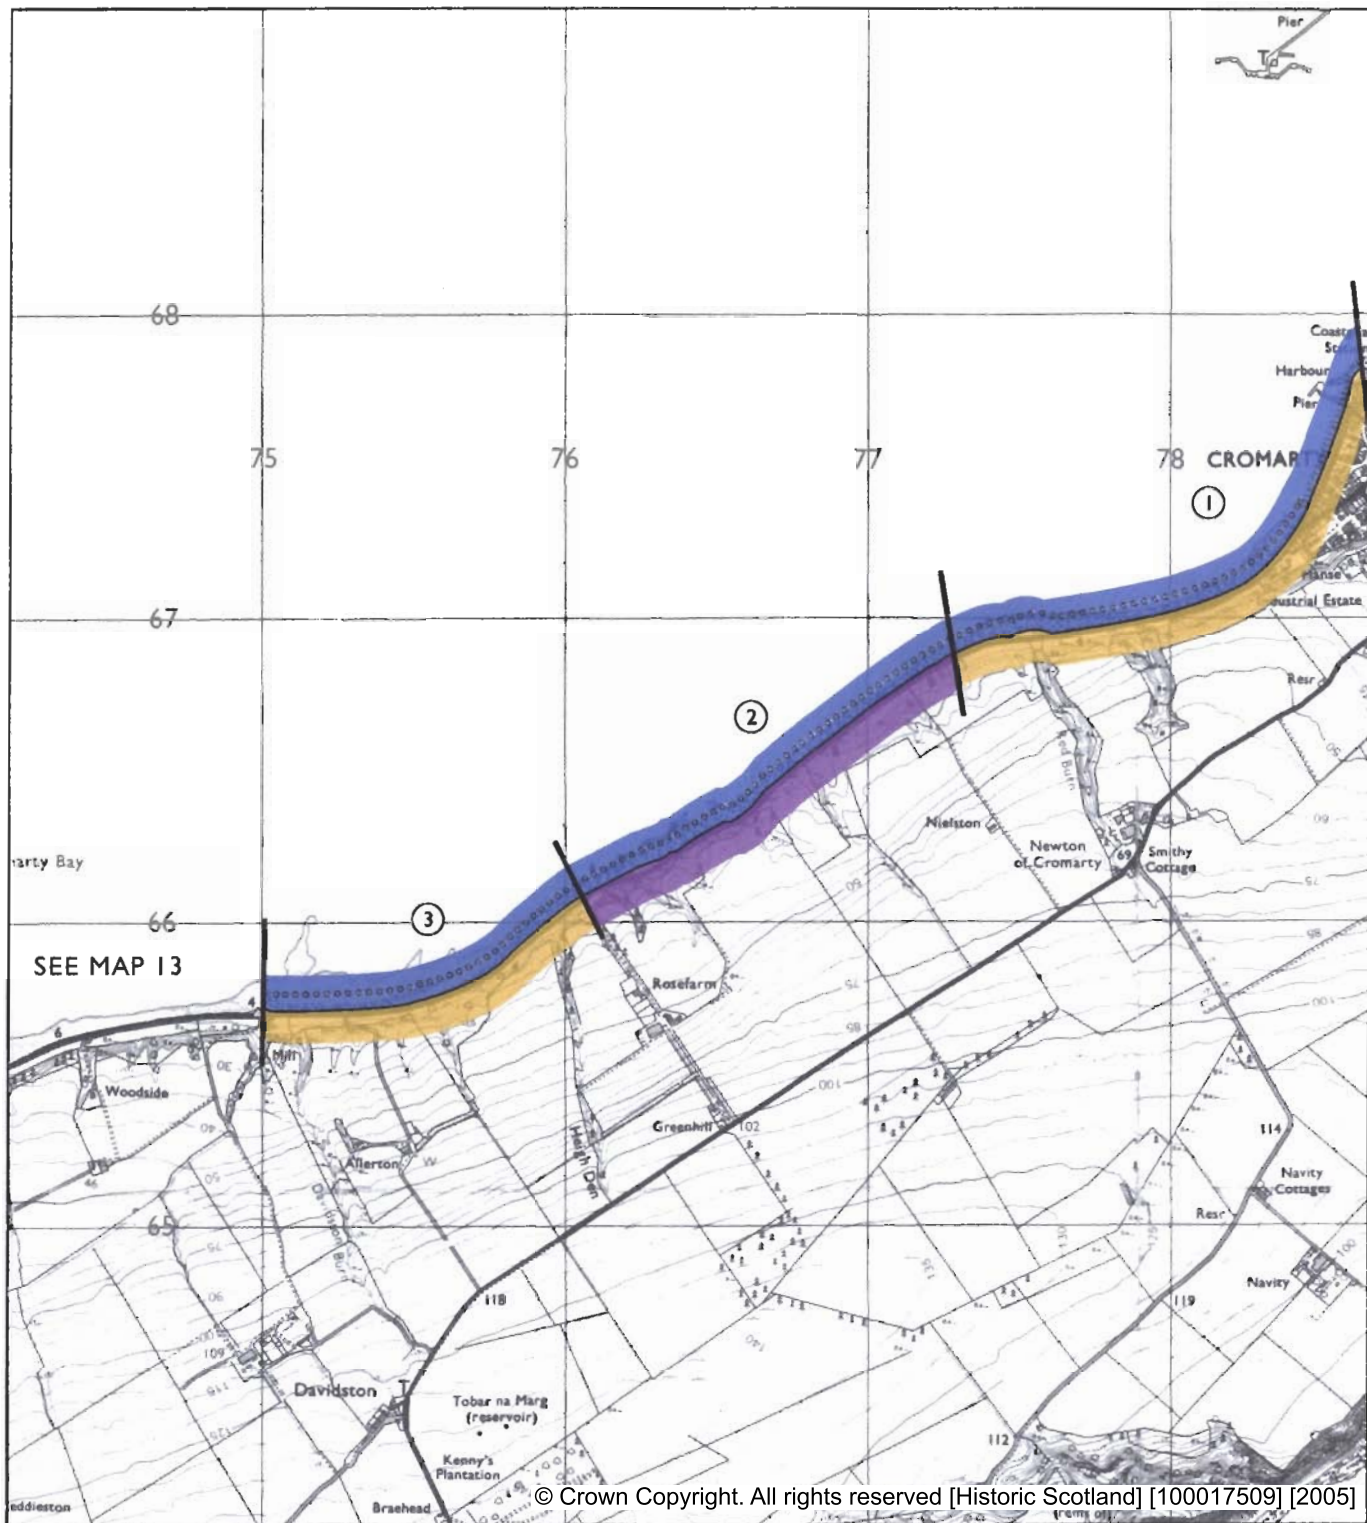
MAP 12: CROMARTY TO SHORE MILL

Relict Postglacial shoreline on south side of Cromarty Bay. Foreshore dominated by shingle. Hinterland consists of marine sand and gravel.

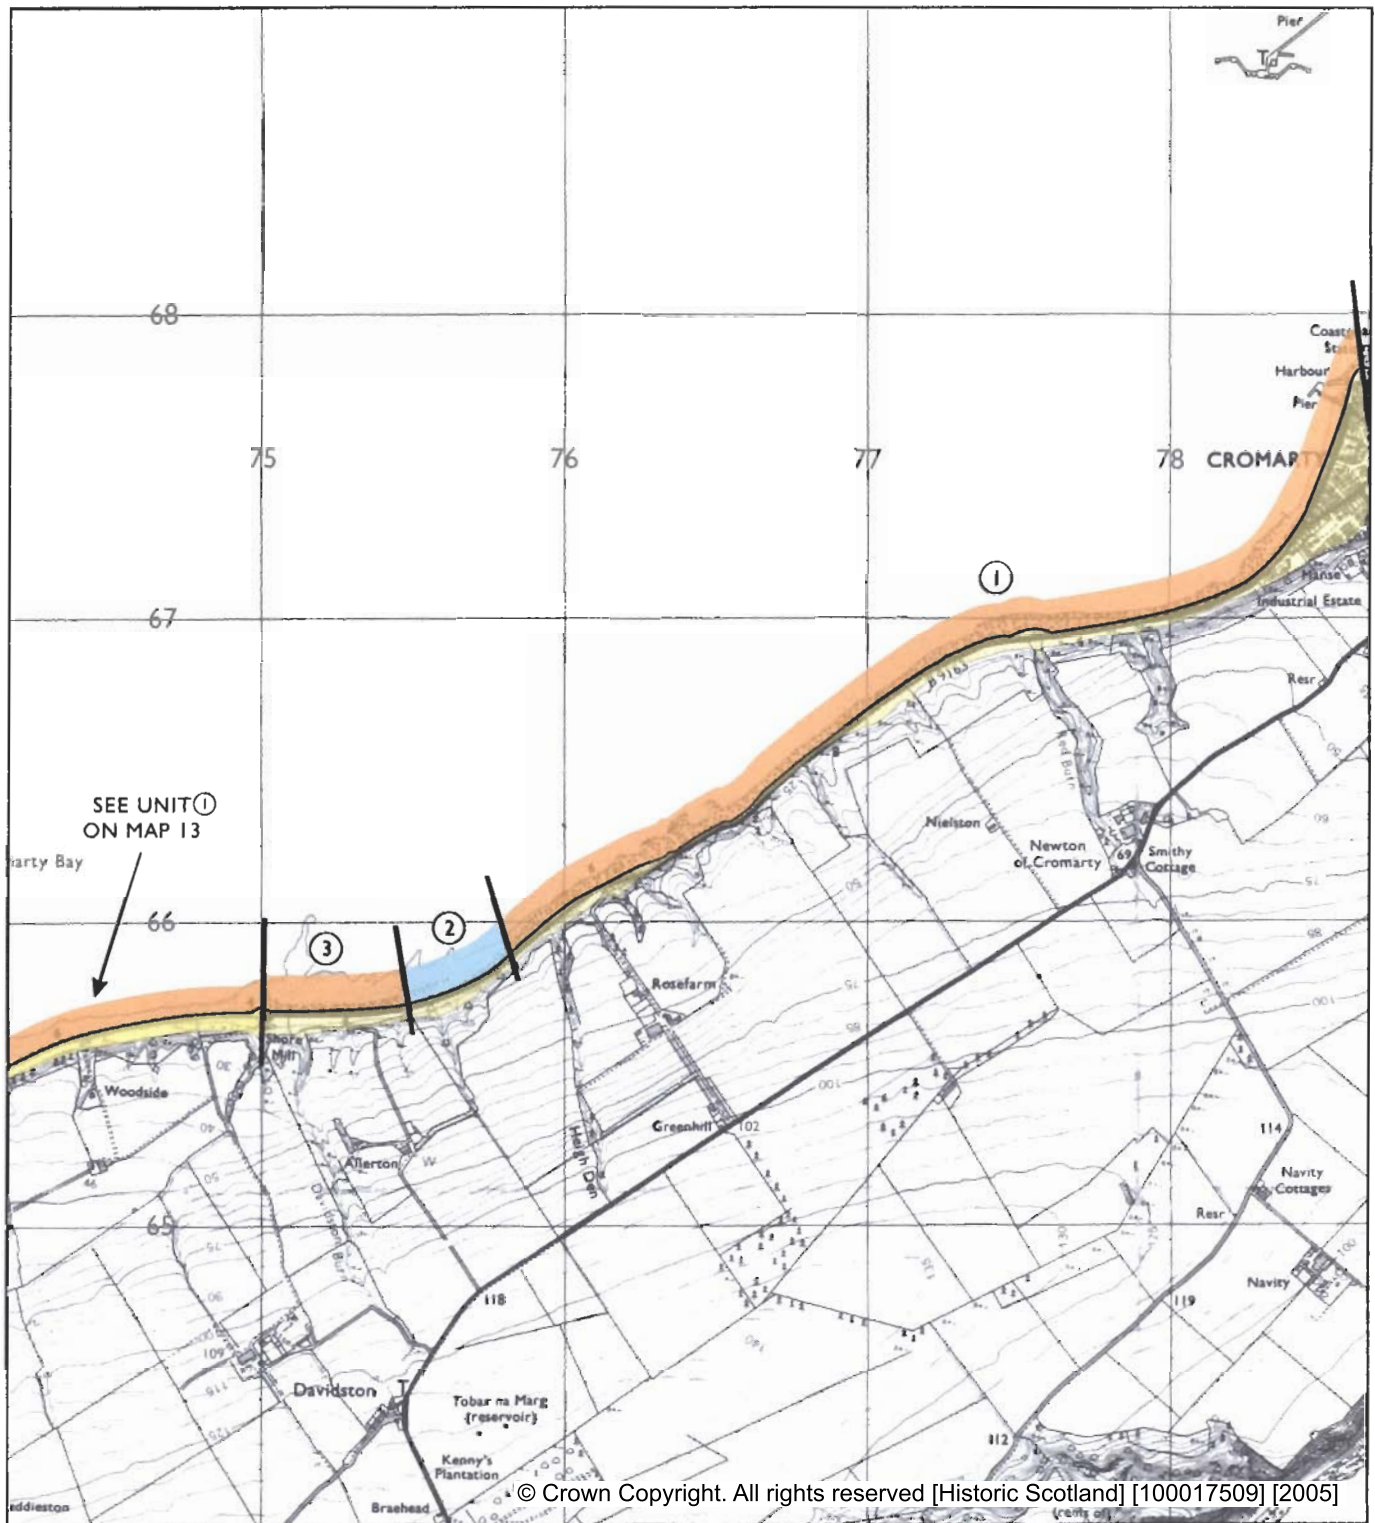
MAP 12: CROMARTY TO SHORE MILL

A sea wall defends the length of this unit of coastline. The backshore rests on marine sand and gravel. The foreshore consists of mud and gravel which appears to be accreting and eroding according to the distribution of the sediment.

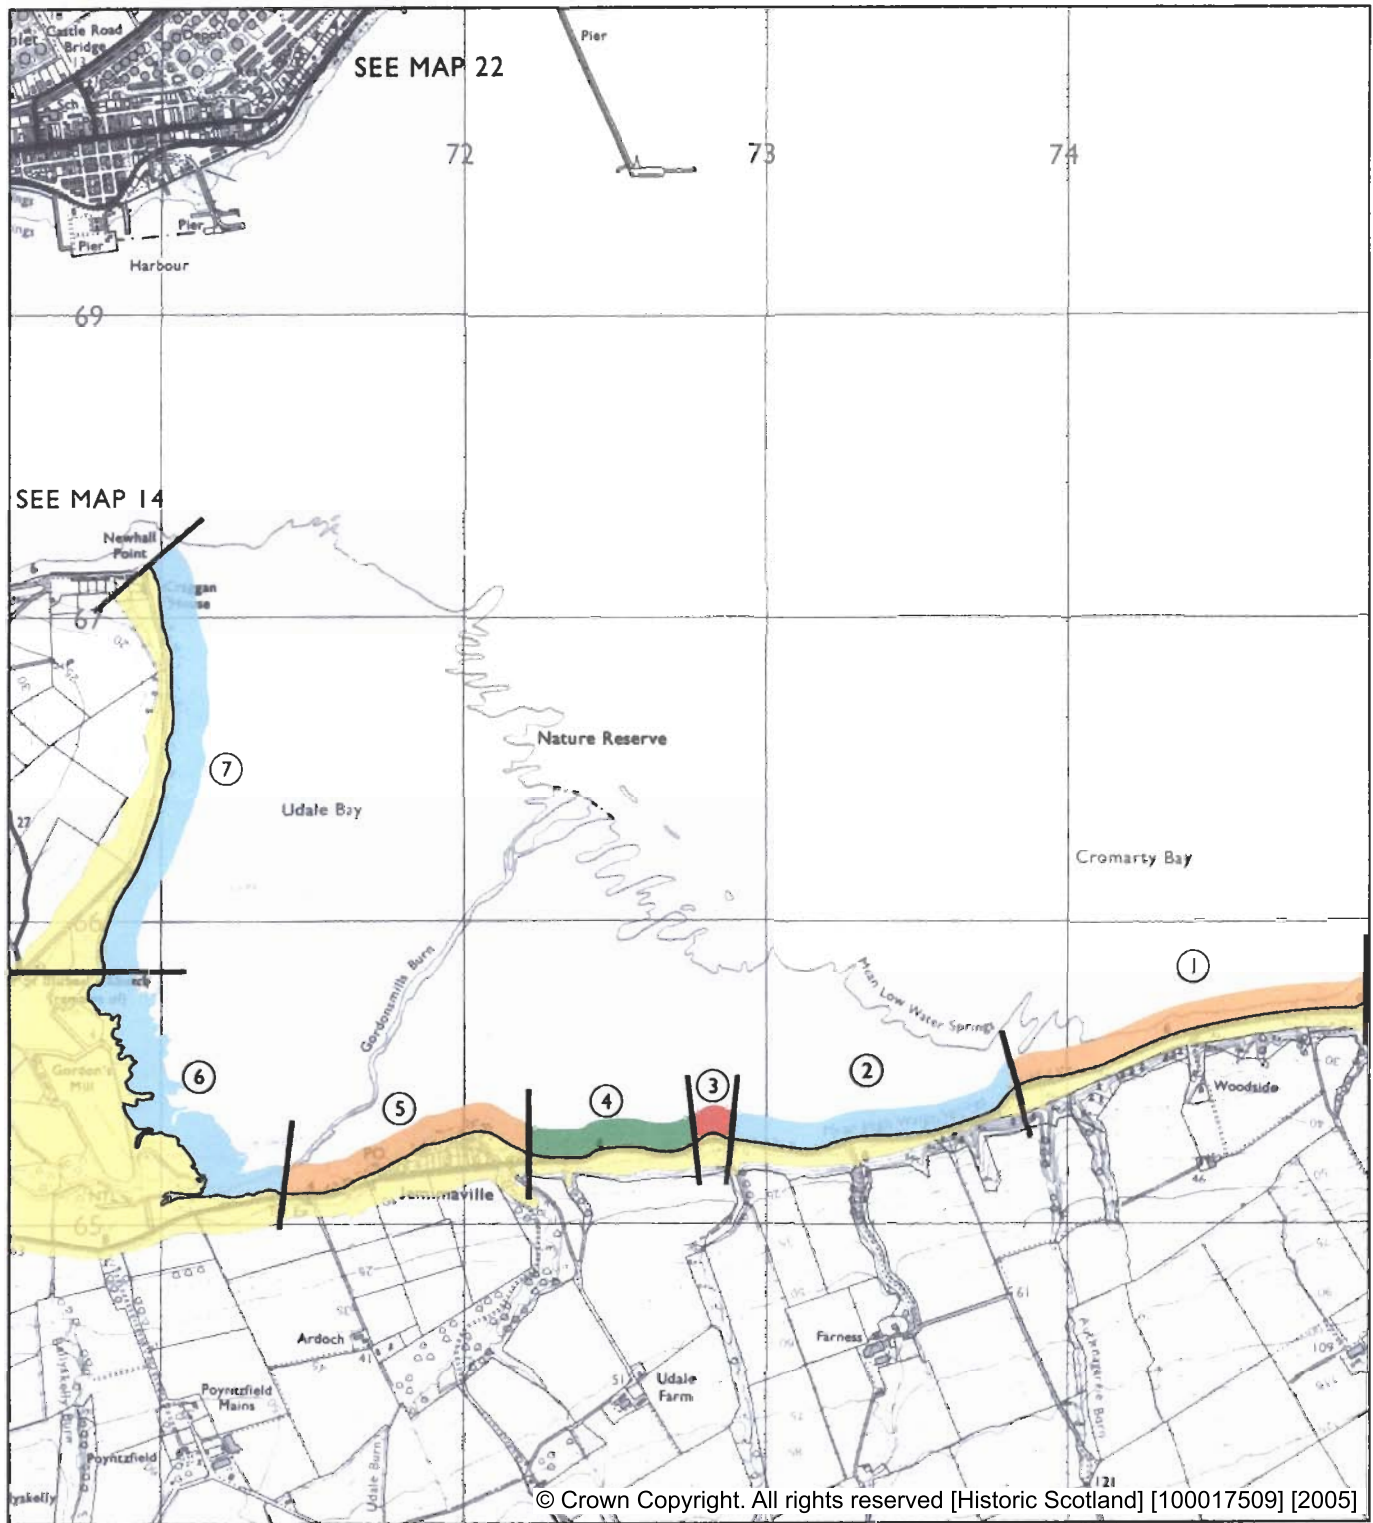
MAP 13: SHORE MILL TO UDAL BAY

Sea defences guard Newhall Point. Cobble and sand is banked up at the HWM. The foreshore is accreting with mud flats extending to about 1.5km.

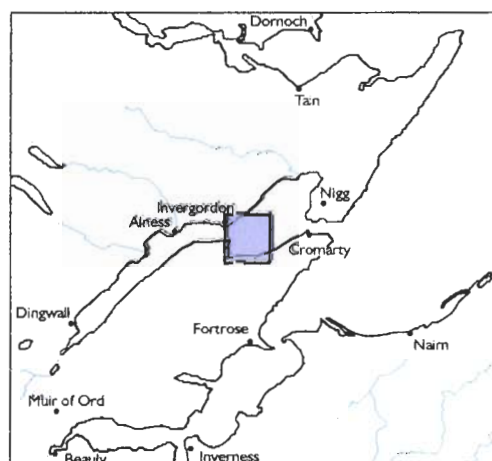
Map 14: NEWHALL POINT TO ALNESS FERRY

Hinterland Geology and Coastal Geomorphology: Middle and Old Red Sandstone continues to form the basement geology. This is overlain by boulder clay and morainic drift deposits. Well defined Post-glacial raised beach platform extends westwards along the coast. The foreshore is a mixture of shingle, boulders and sand. Extensive mudflats are exposed down to the LWM.

Erosion class: Sea defences protect Newhall Point where cobble and sand is banked up at the HWM. Here conditions were seen to be stable. North west of Inch, rubble armouring down to the foreshore margin is eroding. Unvegetated soft marine deposits are prone to erosion by deflation and overtopping at the backshore. Rabbit erosion within the cliff is occurring at NH 728 653.

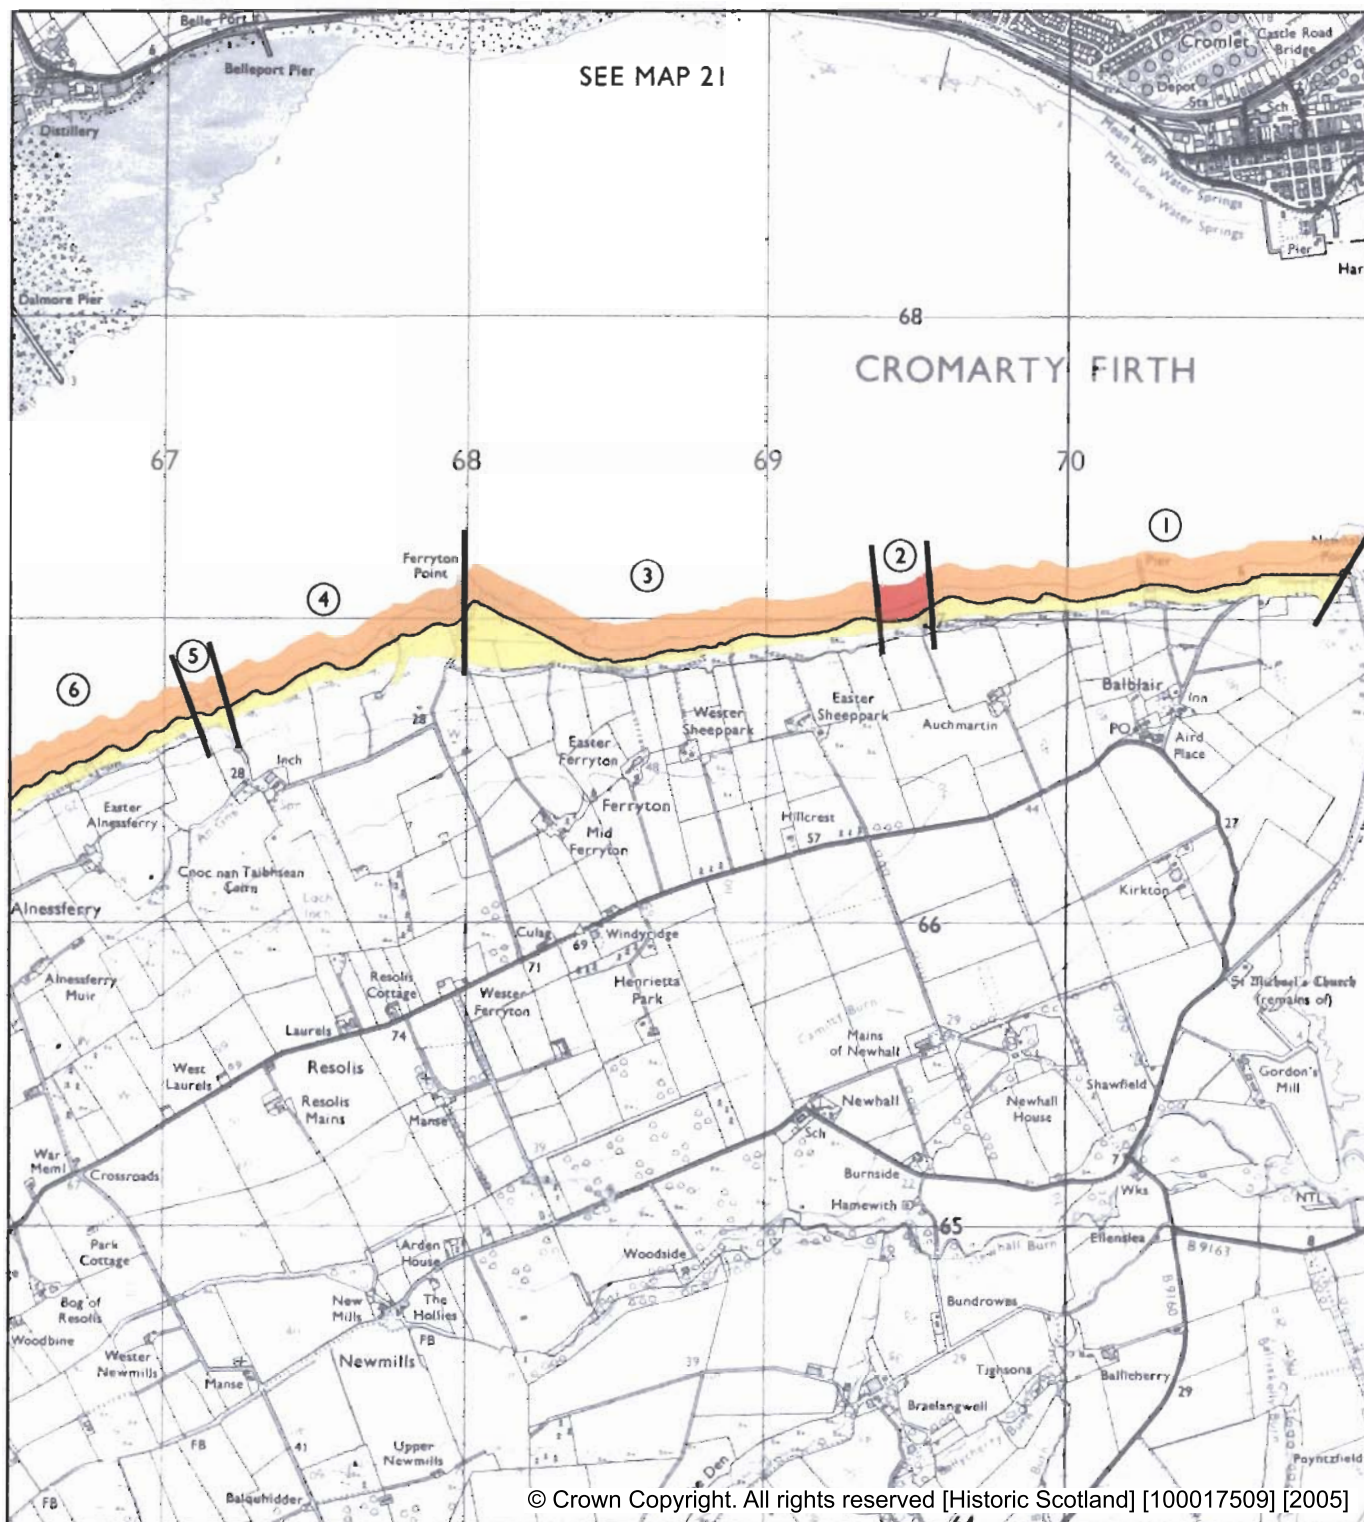
MAP 14: NEWHALL POINT TO ALNESS FERRY 1:25 000

This unit is effected at the foreshore by rubble dumping. The shingle and mud foreshore appears to be stable
