Coastal Assessment Survey Inner Moray Firth

Inverness to Dingwall

**MORAY, BEAULY AND CROMARTY FIRTH
COASTAL ASSESSMENT 1998**

Report No. 446

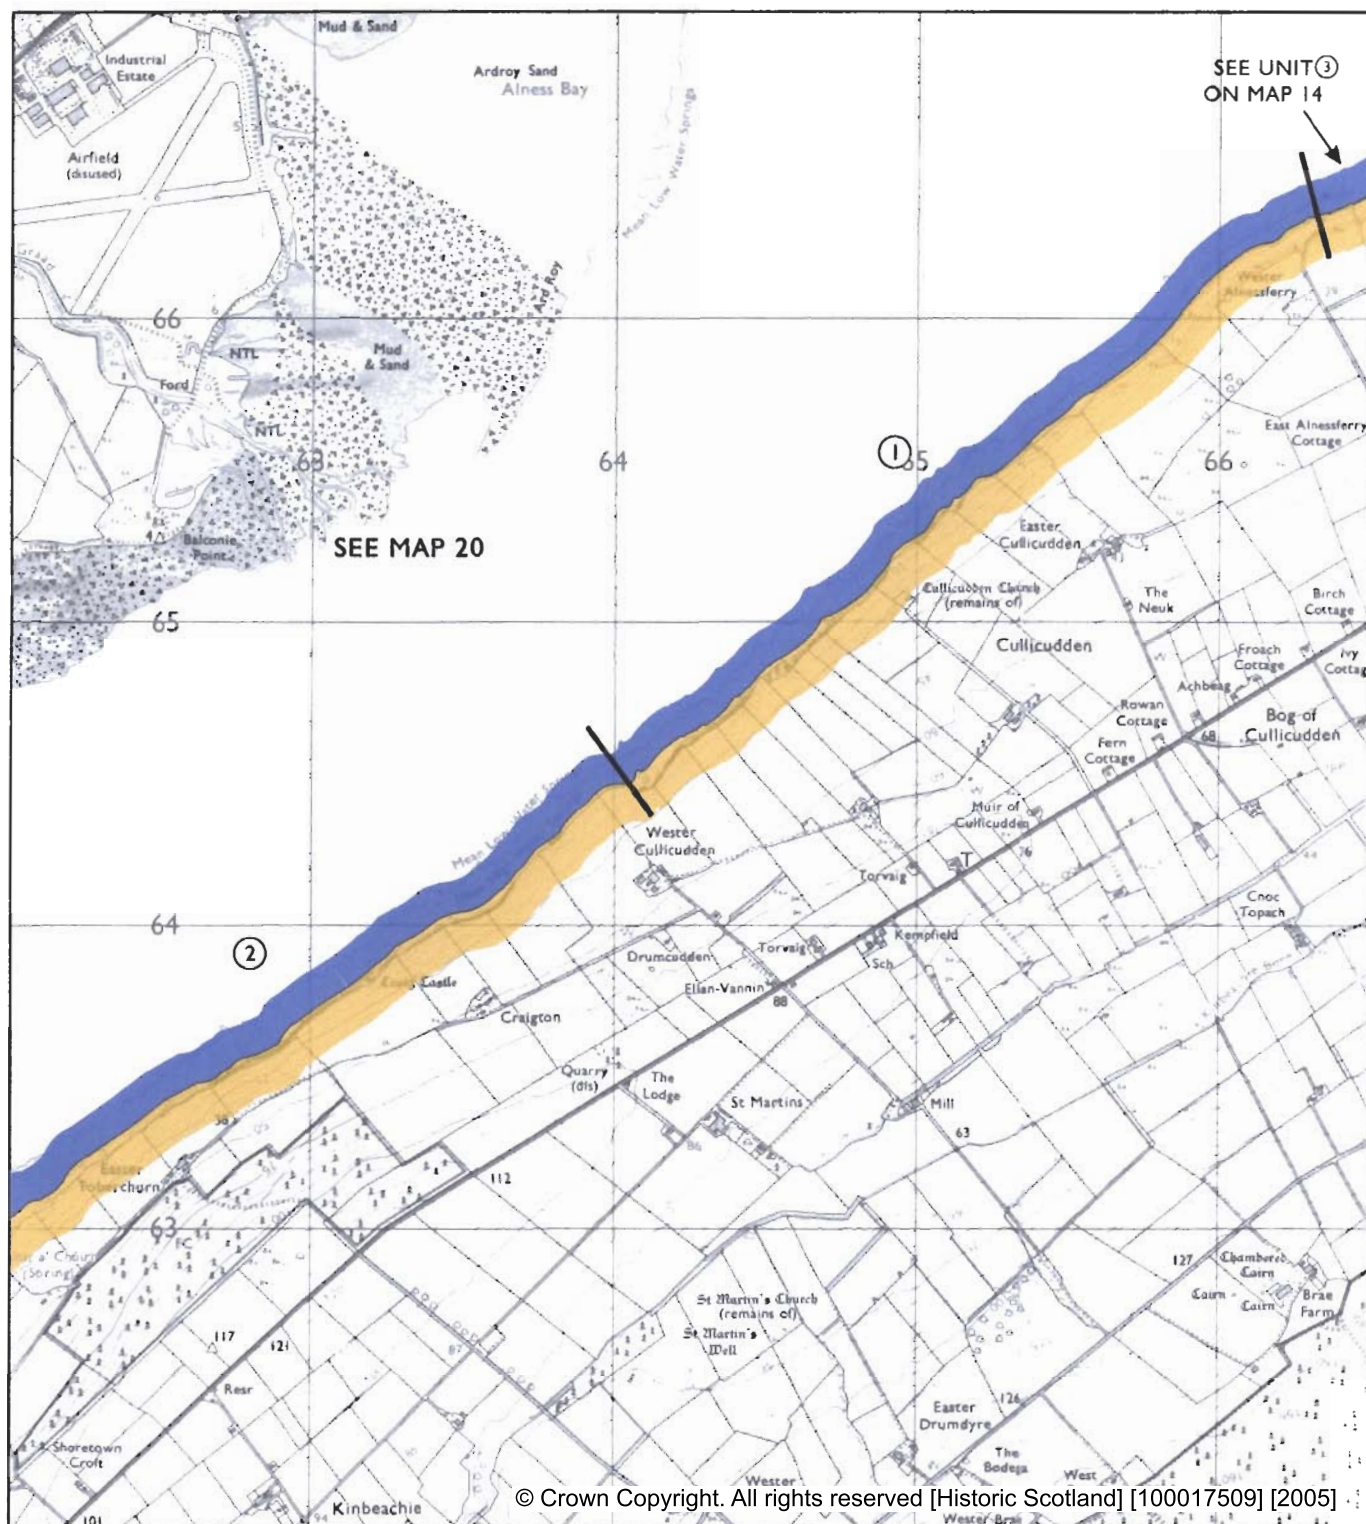
MAP 15: ALNESS FERRY TO EASTER TOBERCHURN 1:25 000

Linear stretch of coastline with cliff becoming steeper towards Wester Cullicudden. Raised beach deposits continue backing onto a foreshore dominated by sand and shingle.

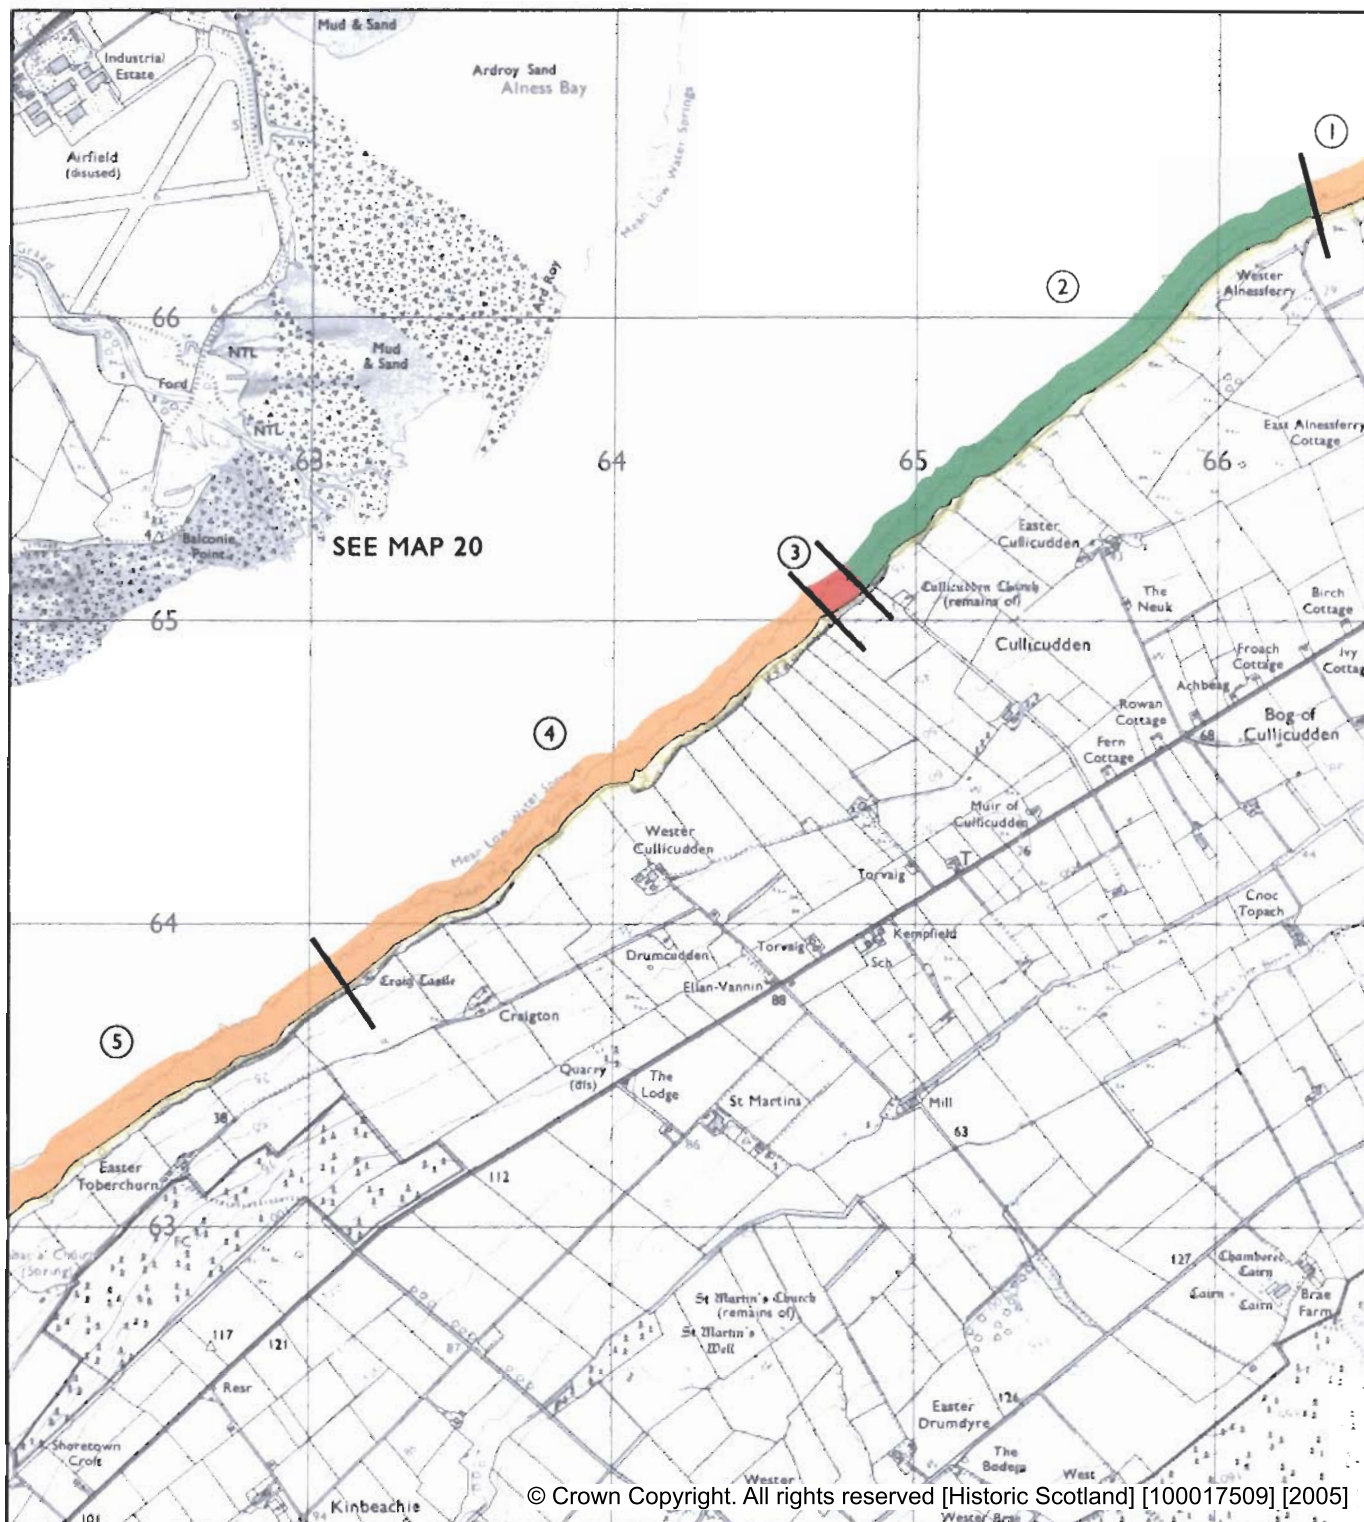
MAP 15: ALNESS FERRY TO EASTER TOBERCHURN 1:25 000

This unit of coastline consists of cobbles and shingle banked at the HWM. Slight erosion is occurring along the MHWMS where marine gravel outcrops or where vegetation is poor. The beach becomes sandier offshore but there is no evidence for active erosion.

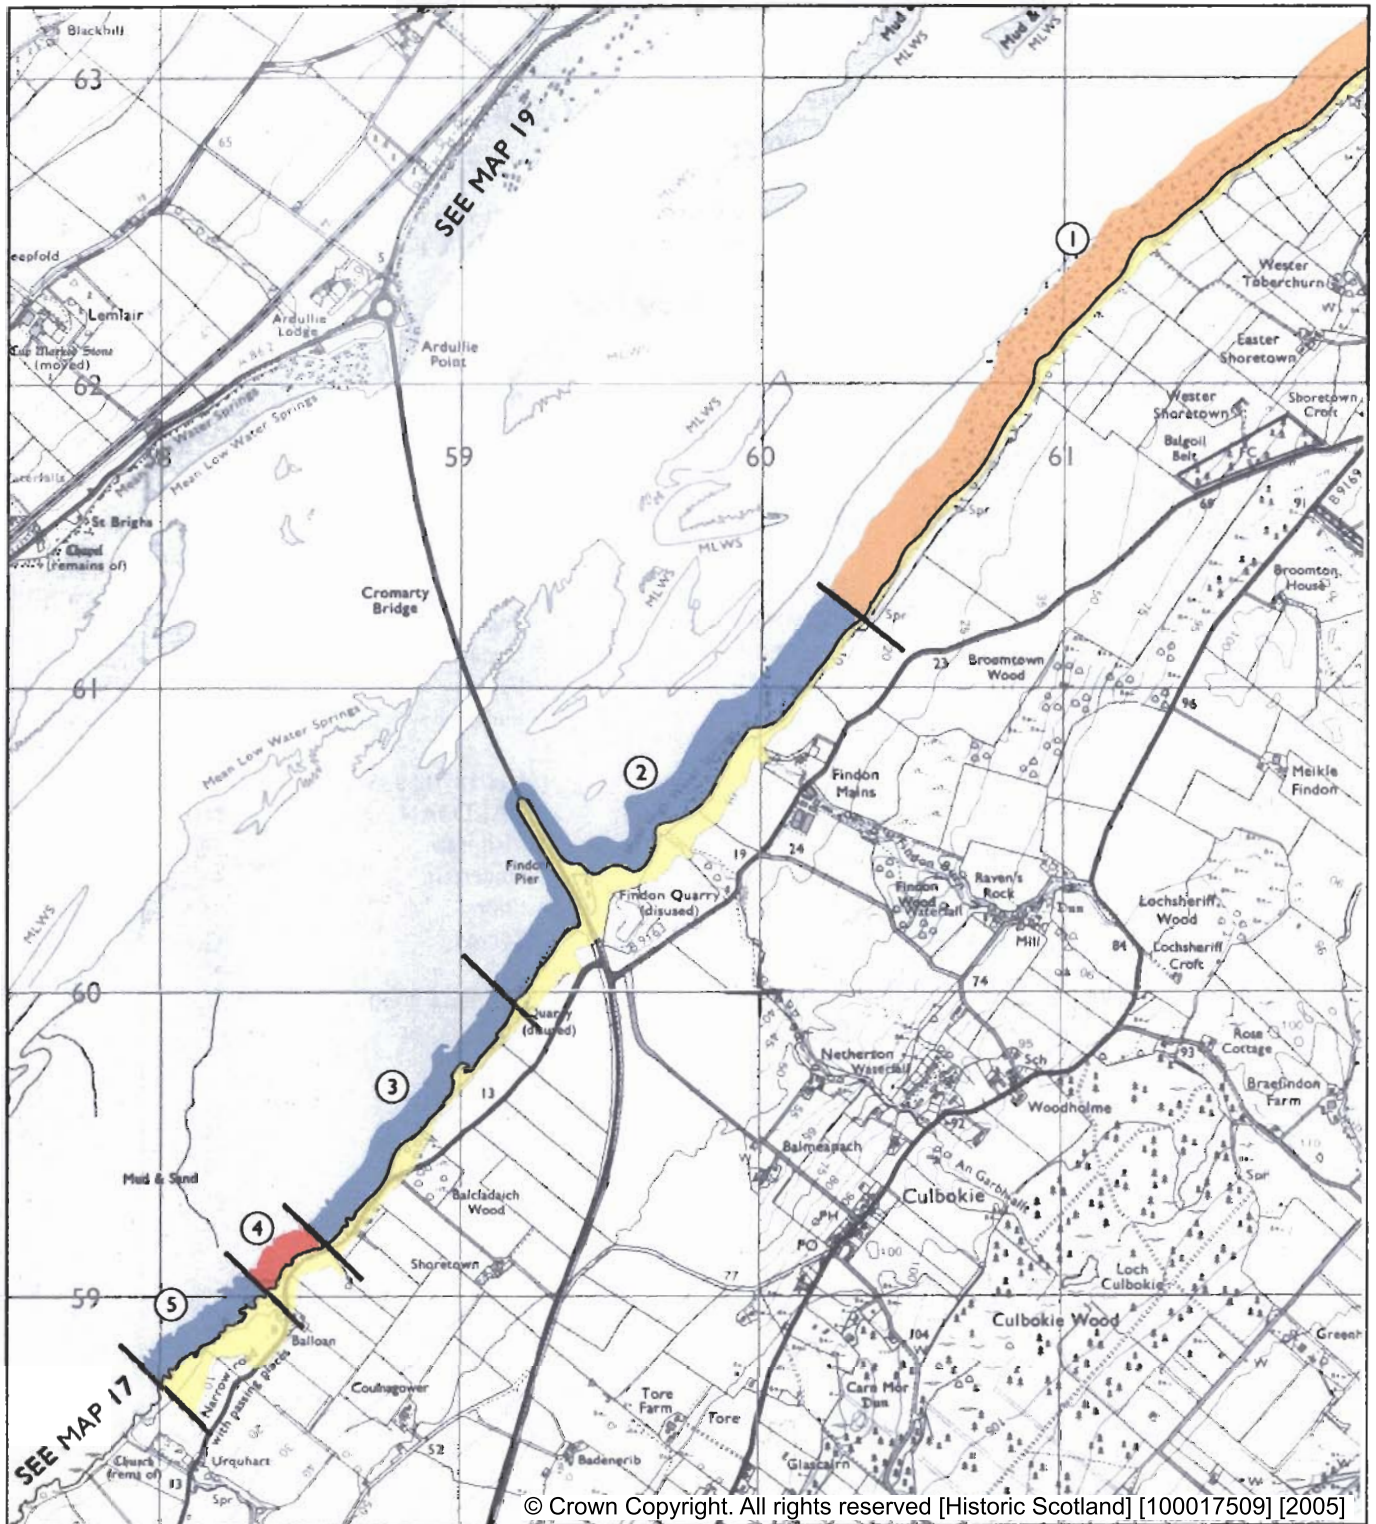
MAP 16: EASTER TOBERCHURN TO ALCAIG 1:25 000

Accreting mud and sand on the foreshore with channels exposed at the LWM. Shingle build up suggests stable conditions.

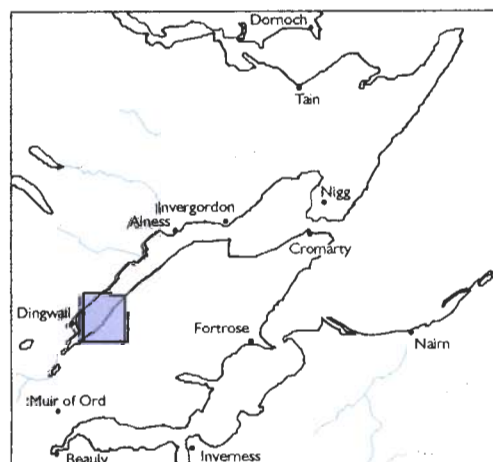
Map 17: ALCAIG TO DINGWALL

Hinterland Geology and Coastal Geomorphology: This section forms the macro-tidal head of the Cromarty Firth. The basement geology to Conon Bridge is Middle Old Red Sandstone. Drift lithologies are predominantly boulder clay and morainic drift. Towards Conon Bridge the three aforementioned marine incursions are represented and marine terraces are present at Dingwall. The Conon floodplain is comprised of alluvium and colonised with alder carr. Towards the outer basin of the river sinuous bends and mid channel shoals traverse extensive mud flats that dominate the intertidal area.

Built Heritage and Archaeology: The foreshore sites in this area include evidence of the 19th century Alcaig to Dingwall ferry, such as the ferry pier, causeway and wooden jetty posts. The multitude of sites indicate a dynamic environment in which sites are both damaged by coastal erosion and rendered unusable due to silting and accretion. On the northern shoreline four salmon bothies were recorded all in poor states of repair. This area of the firth was used as a ferry route prior to the construction of the railway to Dingwall in the late 19th century, consequently the area contains a number of sites pertinent to the ferry. The mid-channel features require future monitoring using a boat for access.

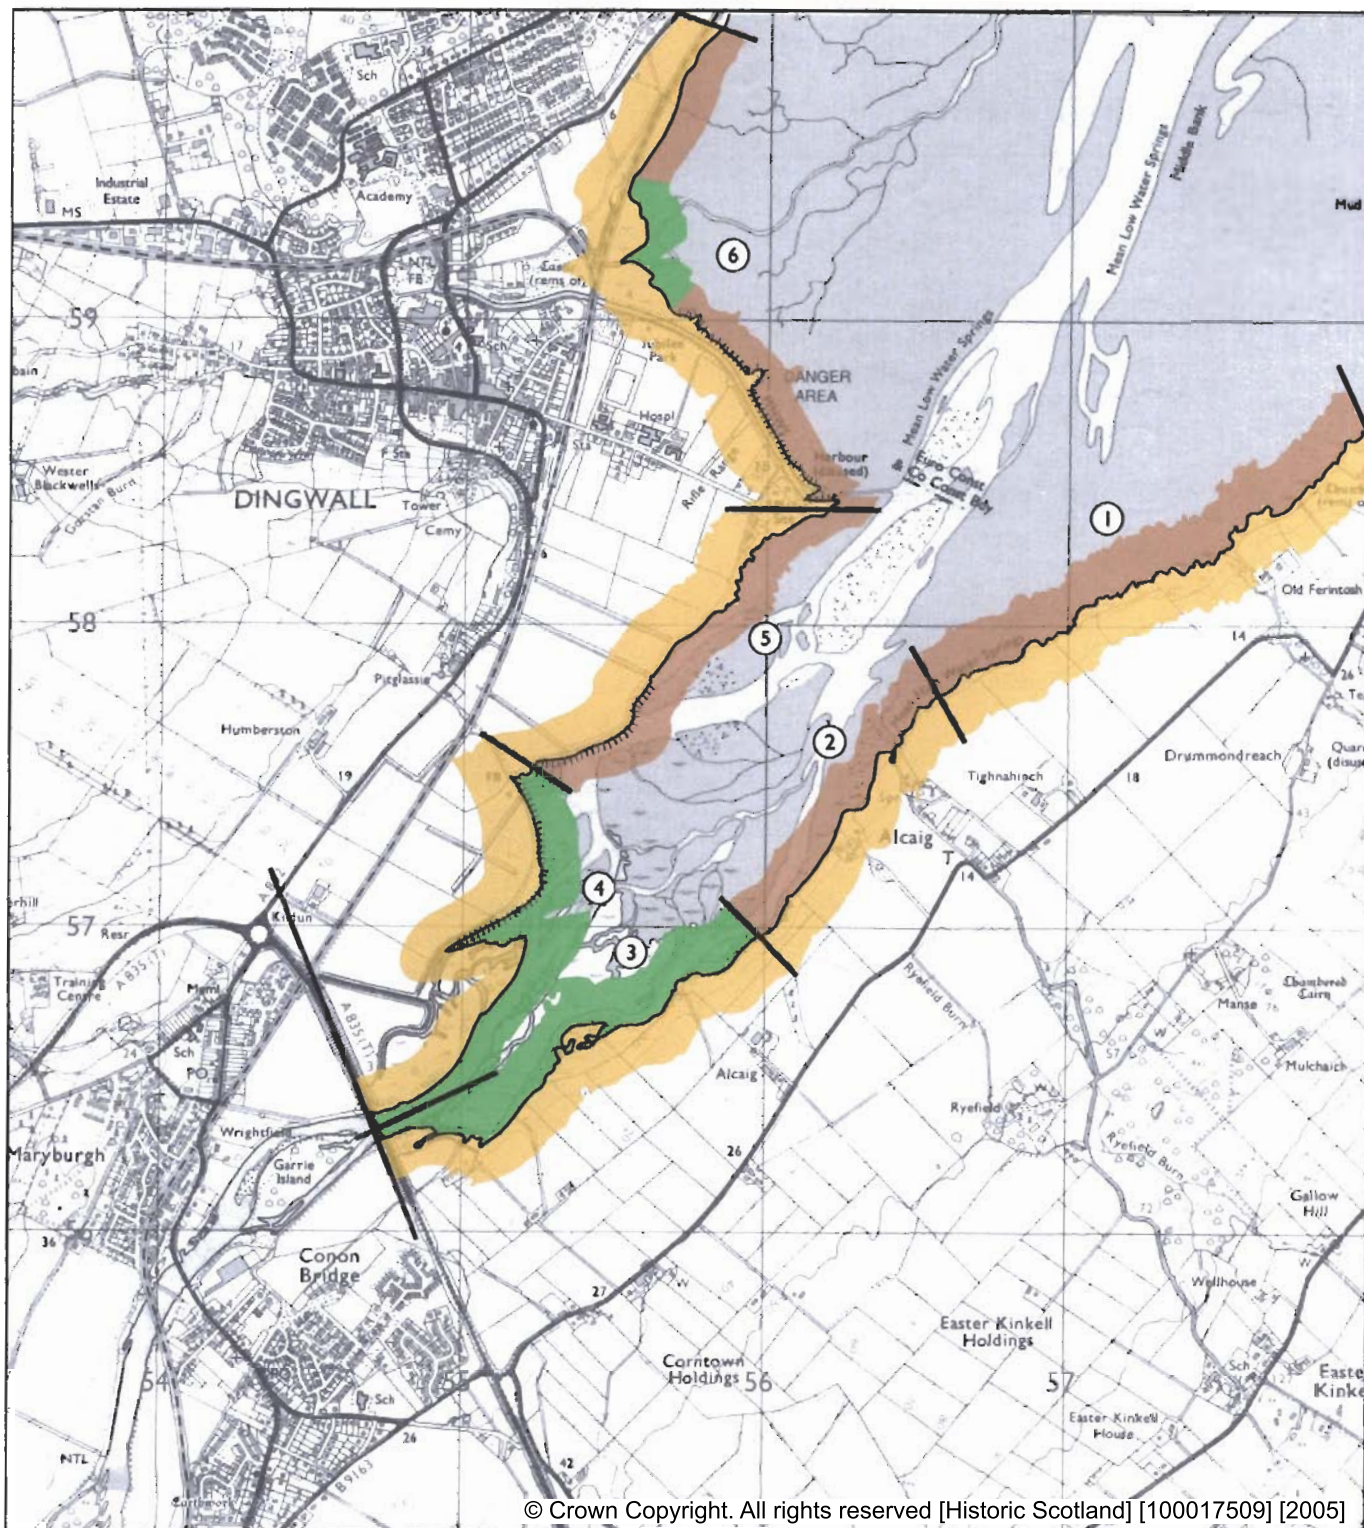
MAP 17: ALCAIG TO DINGWALL

Marine sands and gravel underlie carse clays within the hinterland that is low lying and developed. This unit incorporates the canalised channel for the disused harbour with saltmarsh formation towards the town of Dingwall. Estuarine mud flats continue.

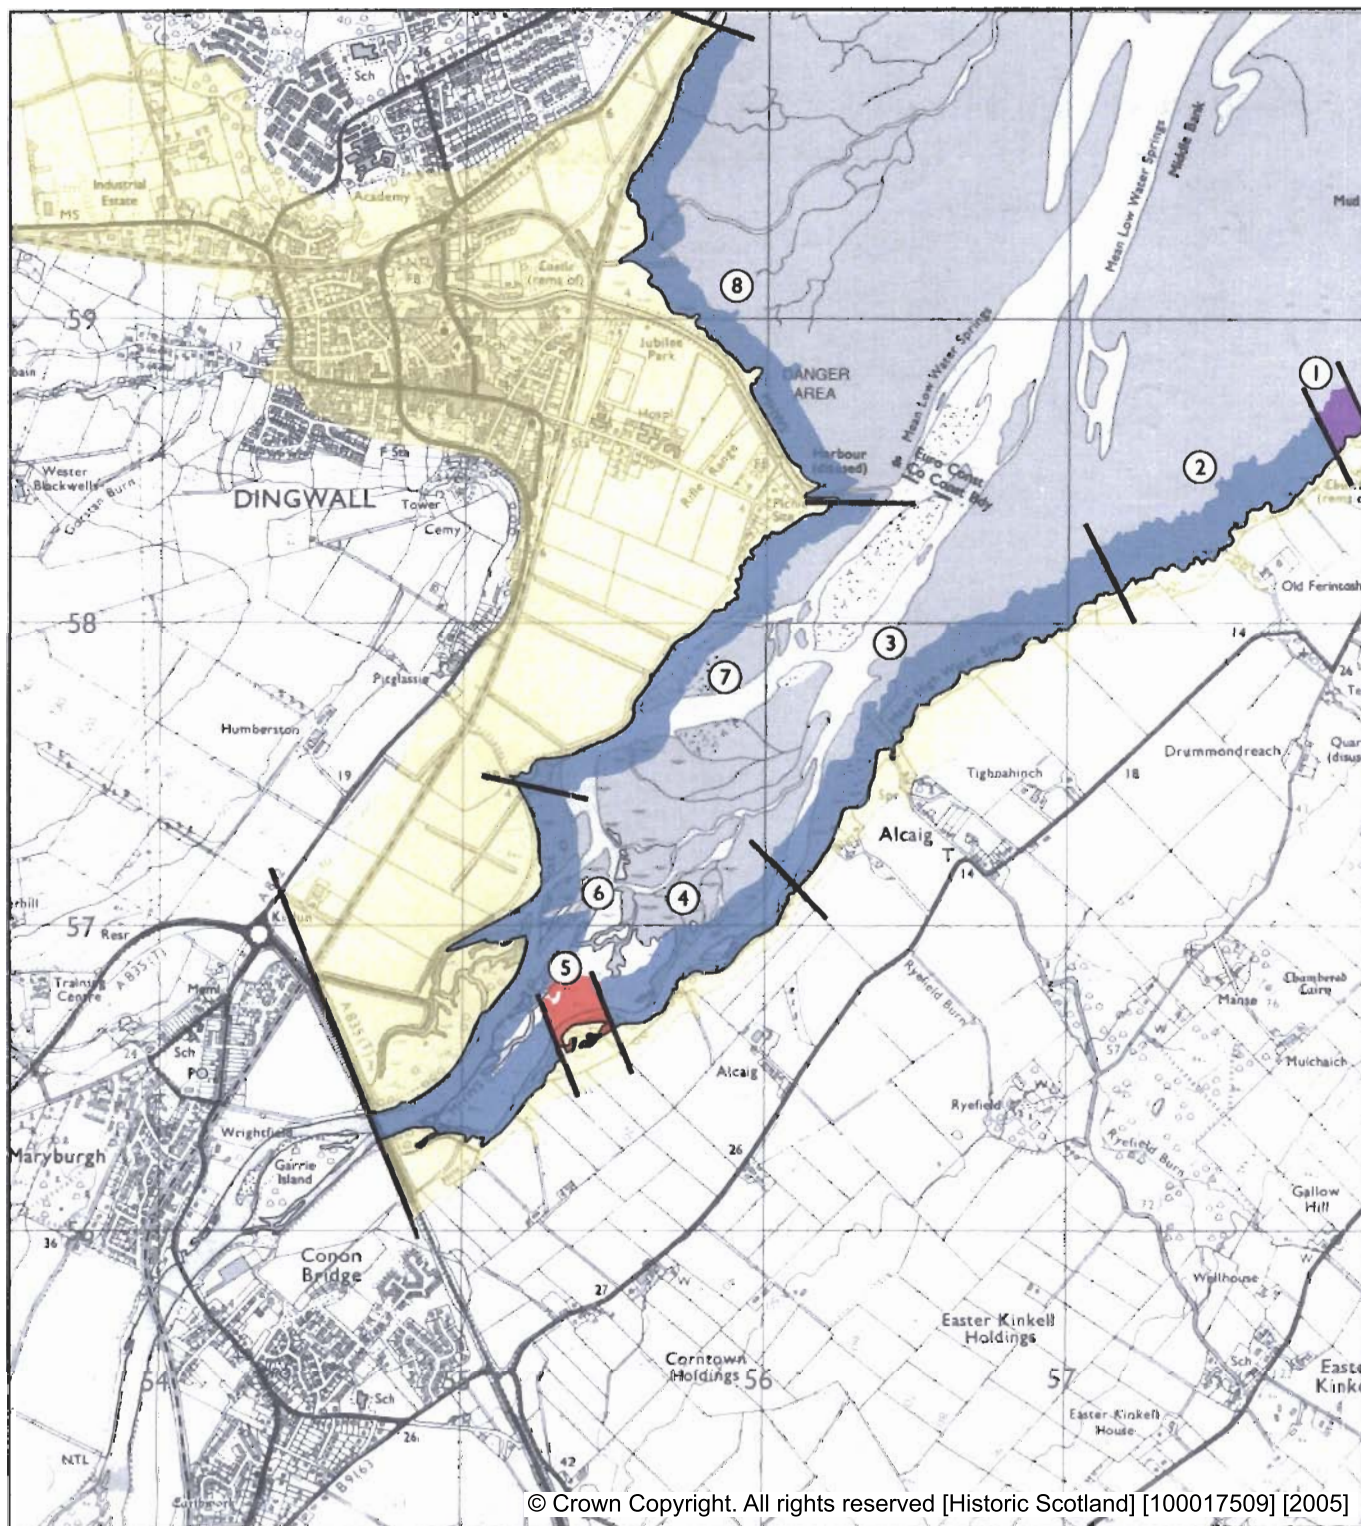
MAP 17: ALCAIG TO DINGWALL
MORAY FIRTH SURVEY Grid ref: NH 54-58/55-60

Saltmarsh and flood defences traverse this unit of coastline. Mud is accreting on the foreshore.

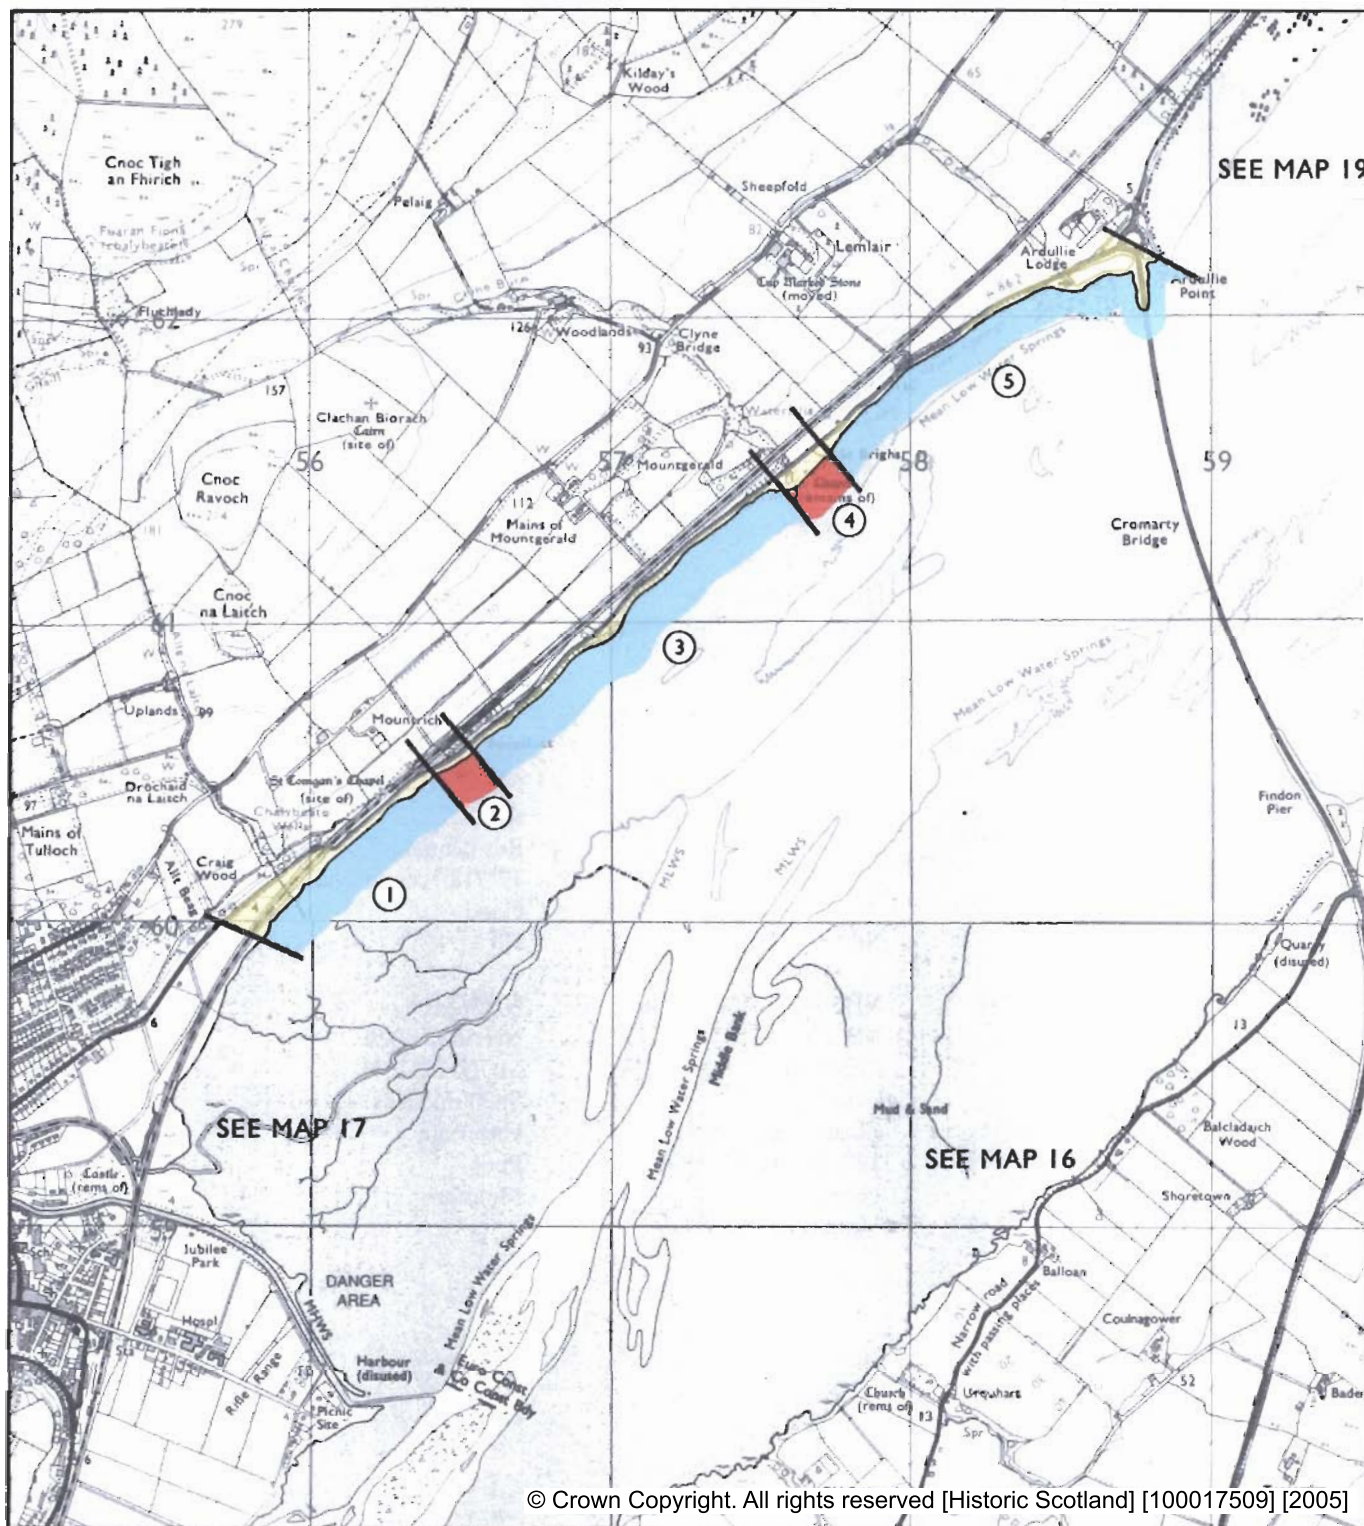
MAP 18: DINGWALL TO ARDULIE POINT

This unit is defended by quarried stone to protect the A862 road and the headland of Ardulie Point that holds the northern piers of the Cromarty Bridge. The foreshore is accreting mud, cobbles and mud that are extensively exposed at the LWM.

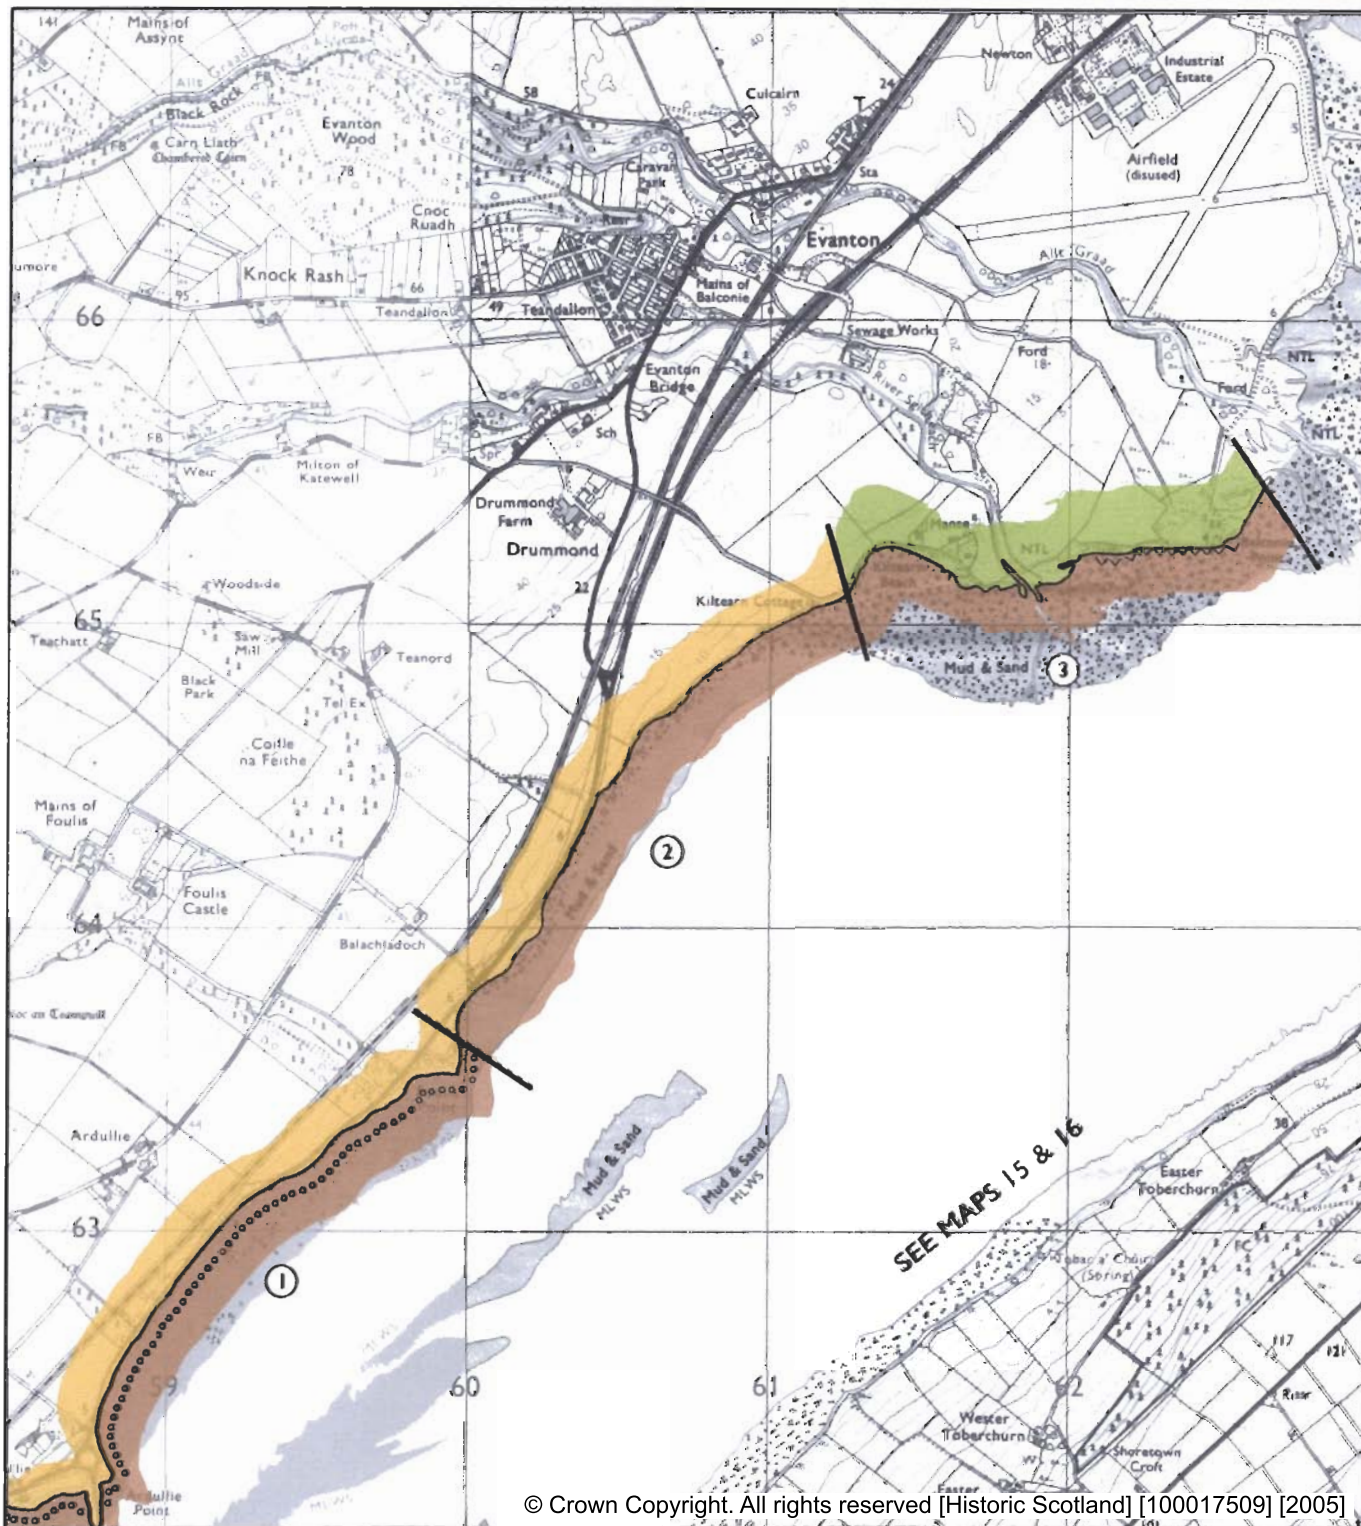
MAP 19: ARDULIE POINT TO BALCONIE POINT 1:25 000
MORAY FIRTH SURVEY Grid ref: NH 59-63/62-67

Promontory at the head of two rivers. The hinterland consists of freshwater alluvium below 10m OD. The foreshore is mud and sand with boulders and shingle. River channels are visible at low water.

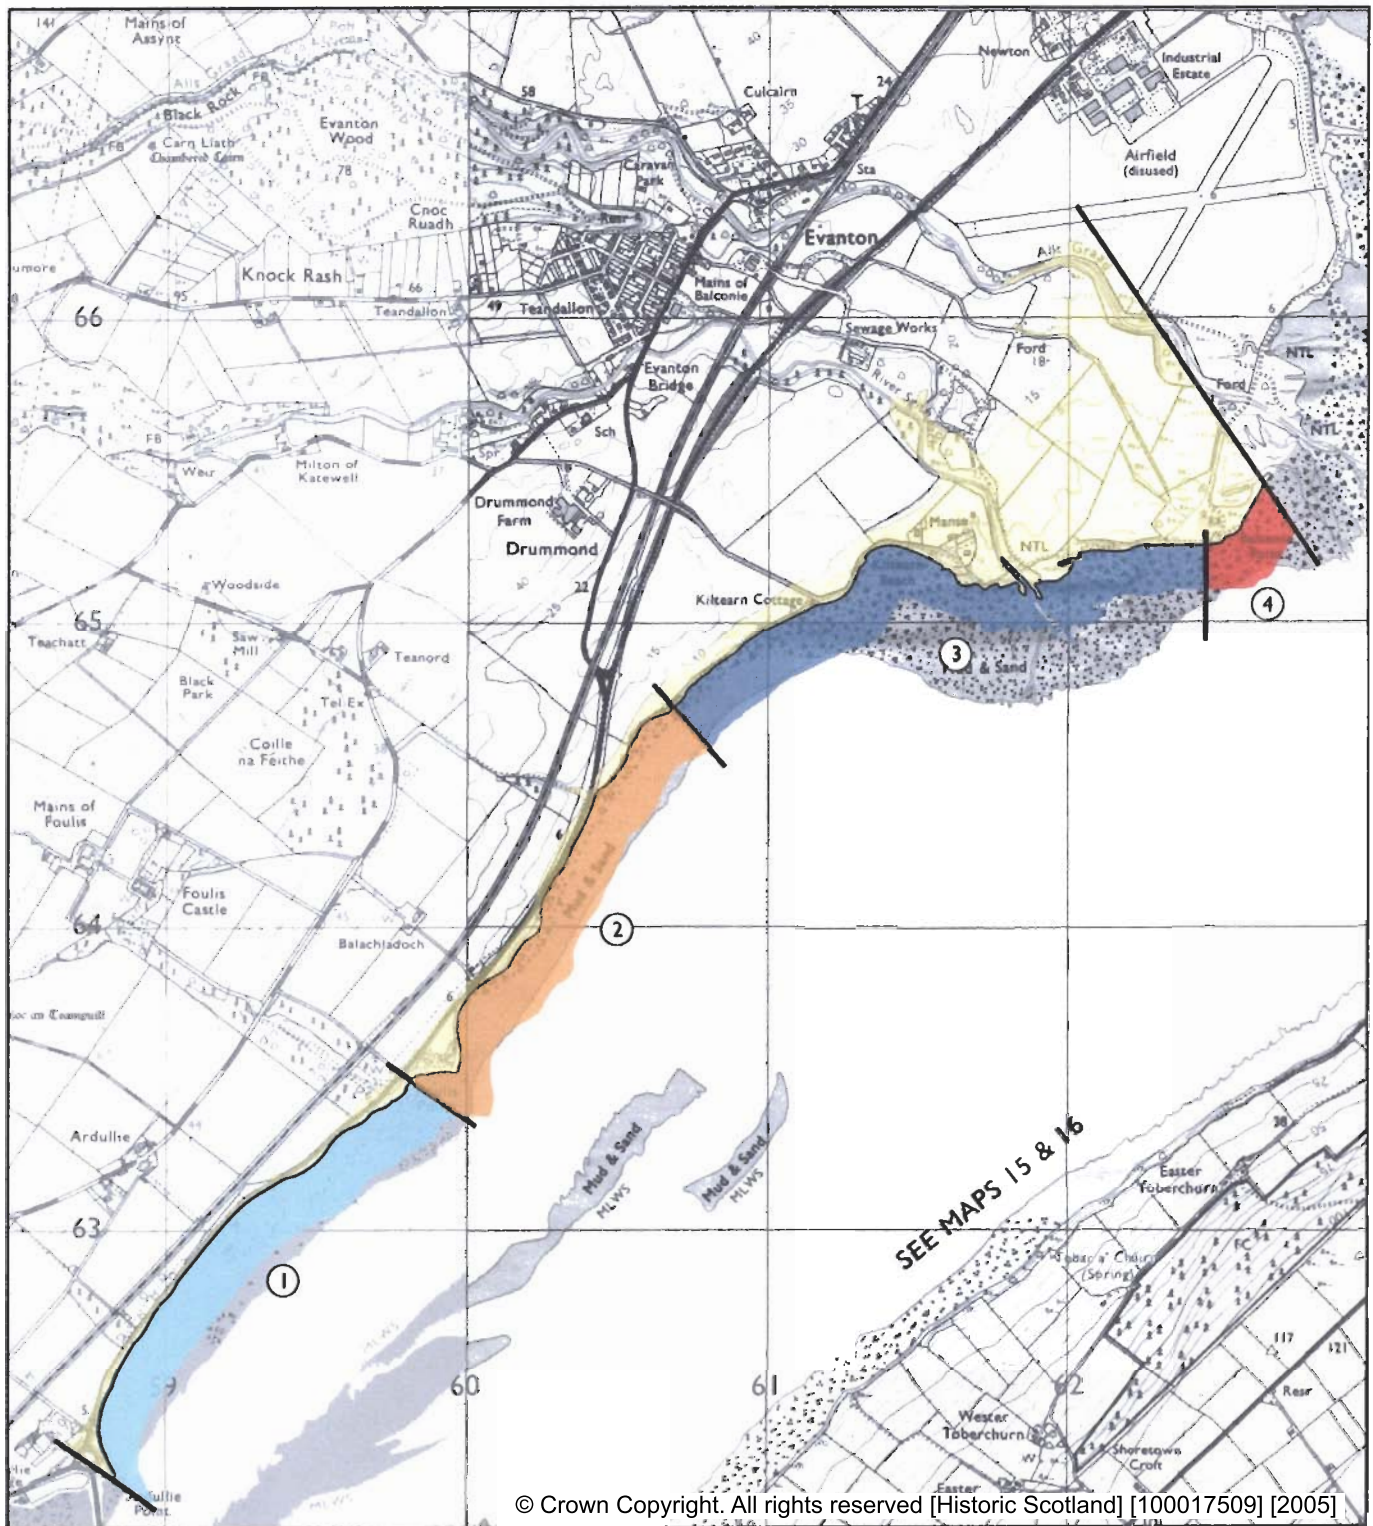
MAP 19: ARDULIE POINT TO BALCONIE POINT 1:25 000

The cliff is eroding in places and the softer merge deposits failing as a result of scouring at the low water mark. Rubble sea defence continues through this unit but their effectiveness appears to be poor.

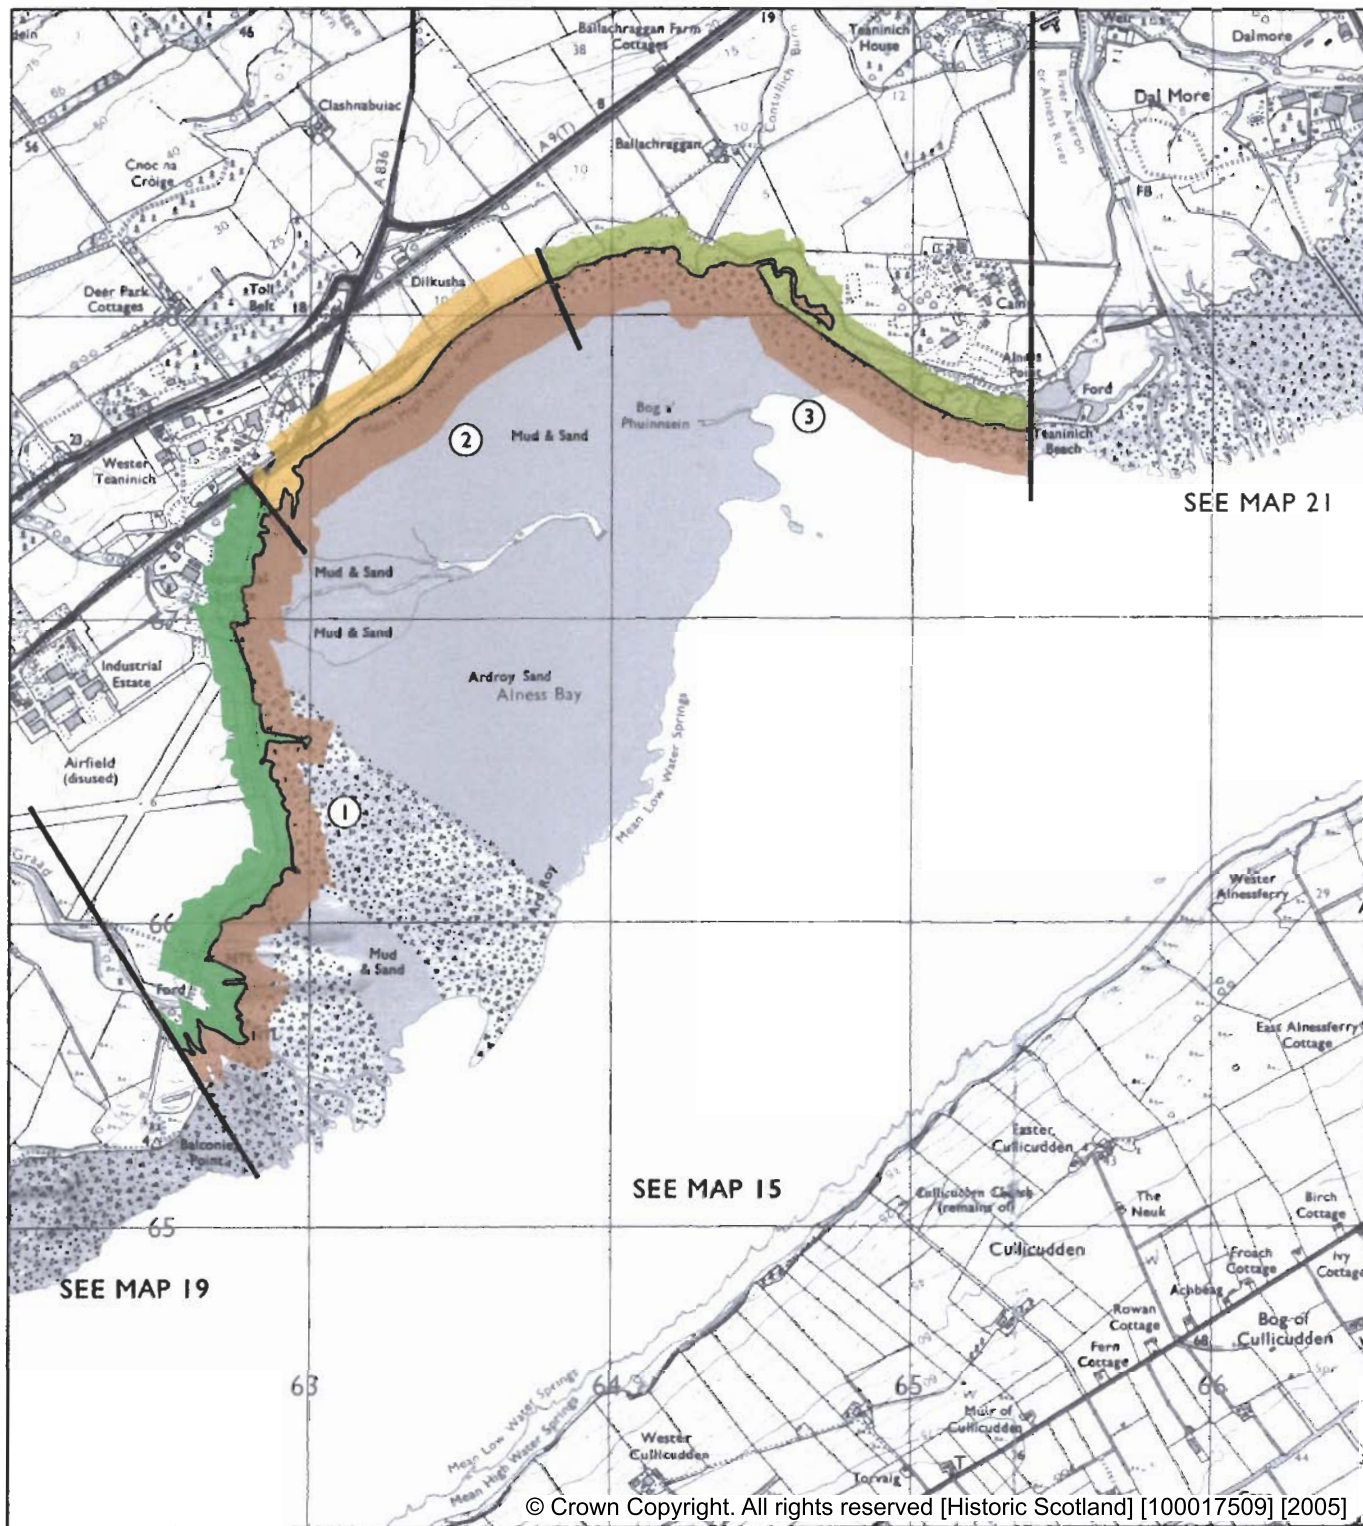
MAP 20: BALCONIE POINT TO ALNESS POINT 1:25 000

Small embayment with developing saltmarsh intersected by numerous drainage channels. The hinterland is low lying. The foreshore consists of mud and sand exposed over a wide area at low tide.

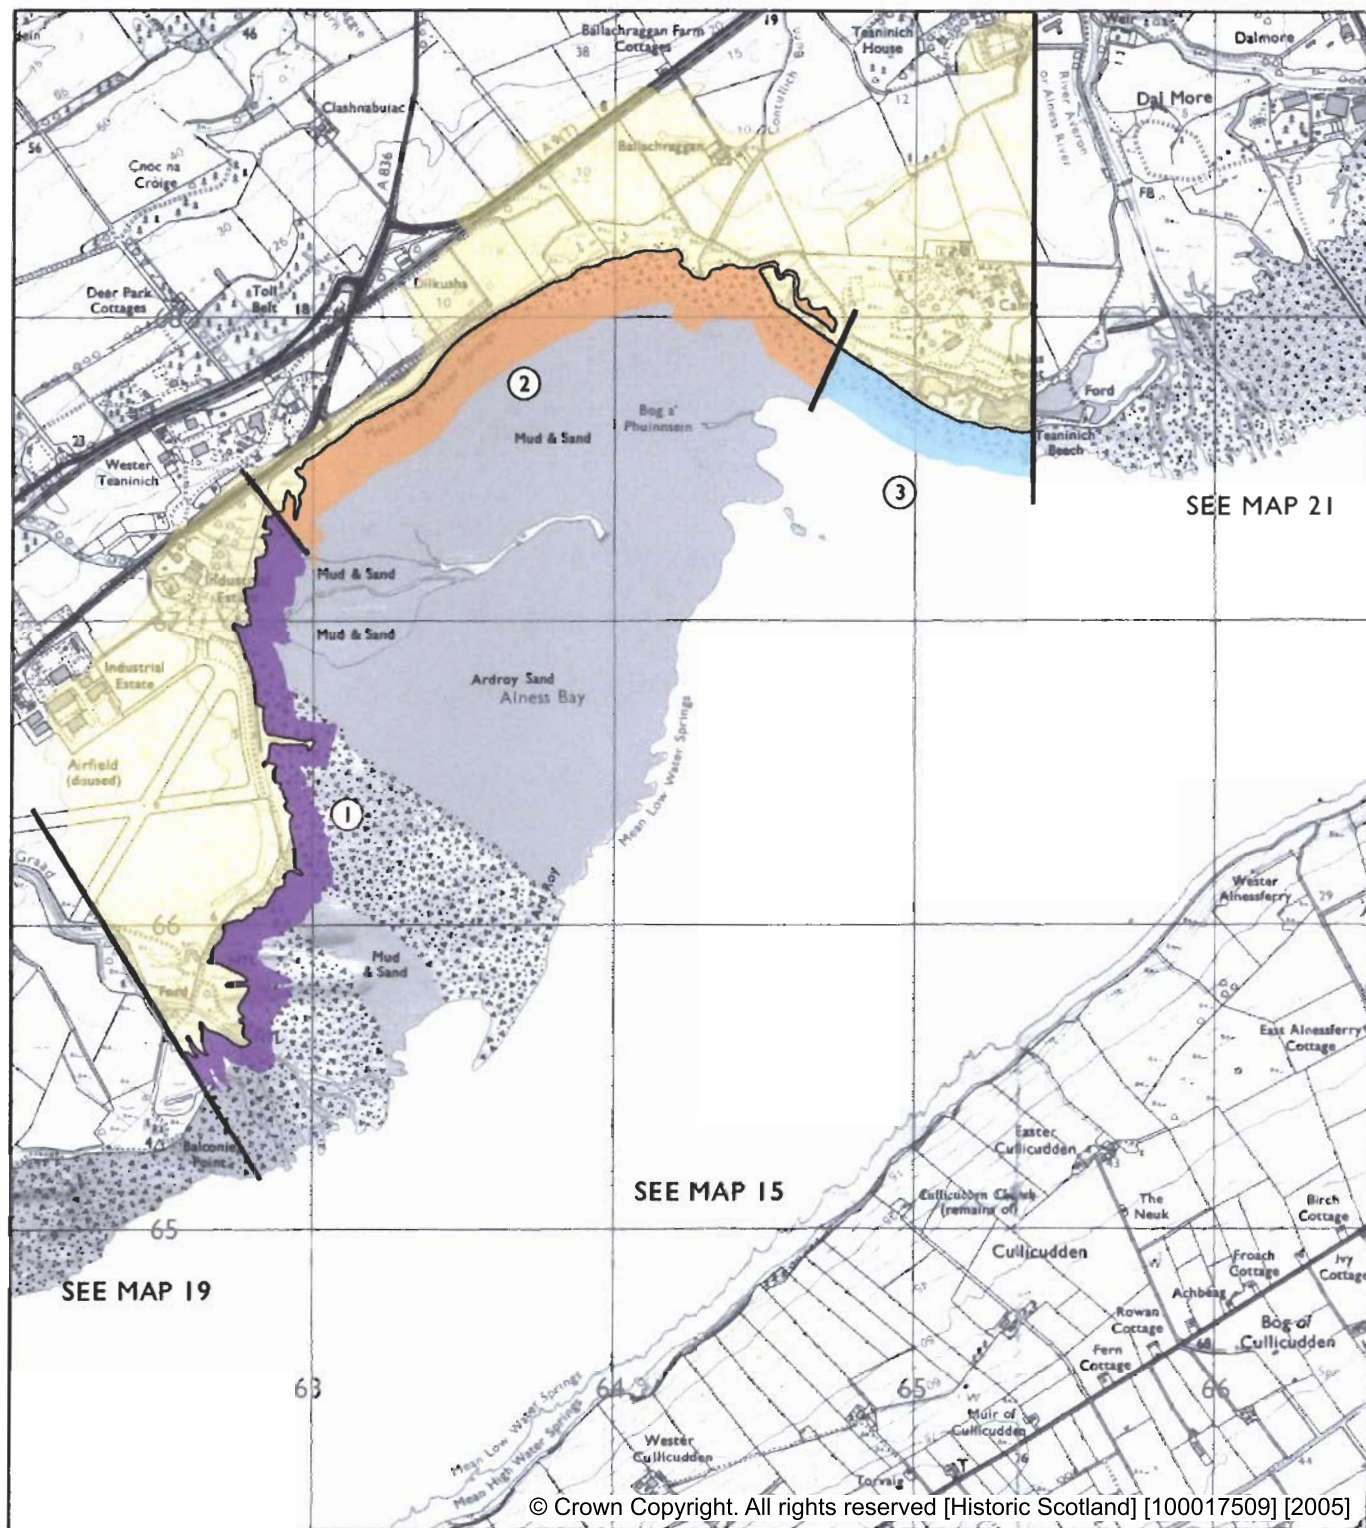
MAP 20: BALCONIE POINT TO ALNESS POINT 1:25 000

Estuarine sediment is accreting at MHWS mark with shingle and merse colonised by saltmarsh. There is no indication to suggest that conditions here are not stable.
