Coastal Assessment Survey Inner Moray Firth

Inverness to Dingwall

**MORAY, BEAULY AND CROMARTY FIRTH
COASTAL ASSESSMENT 1998**

Report No. 446

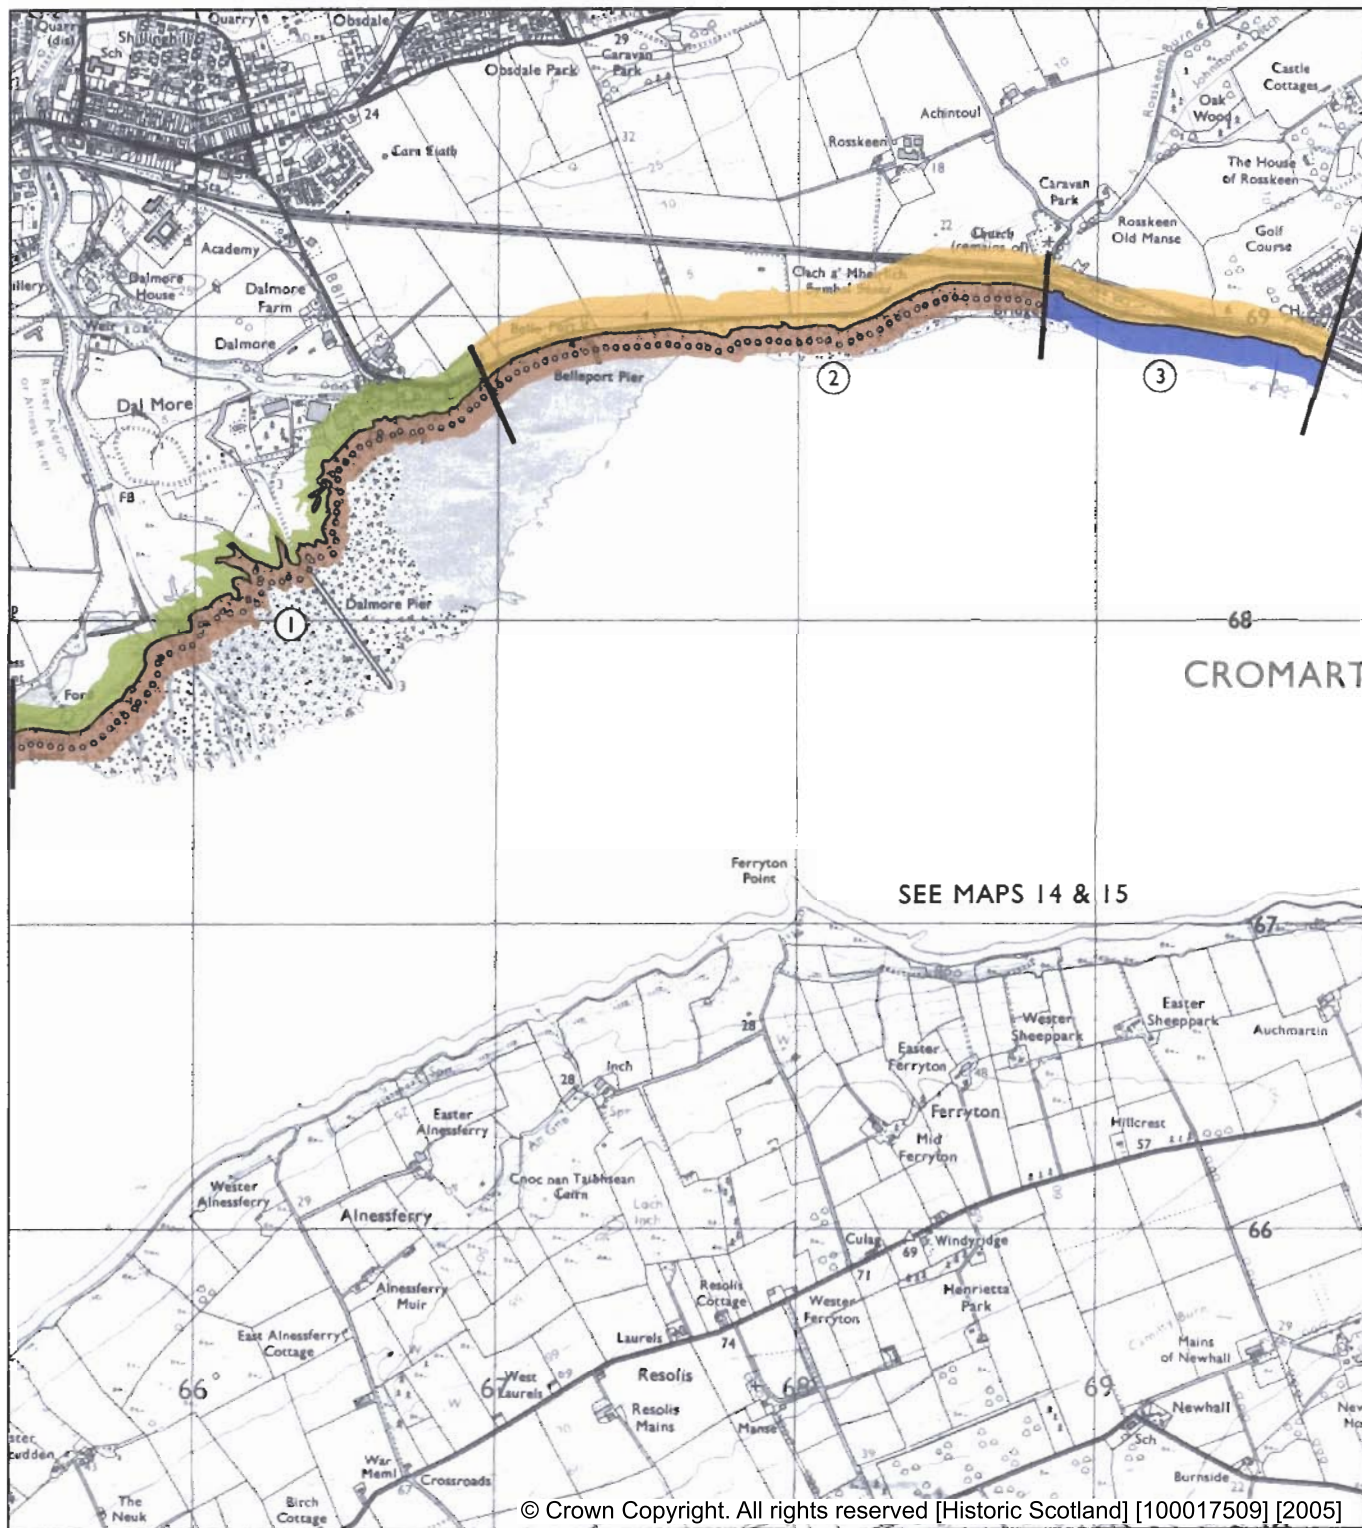
MAP 21: ALNESS POINT TO INVERGORDON

The hinterland consists of raised beach and marine deposits and has been heavily modified by industrial development. The foreshore is narrow and consists of mud and shingle

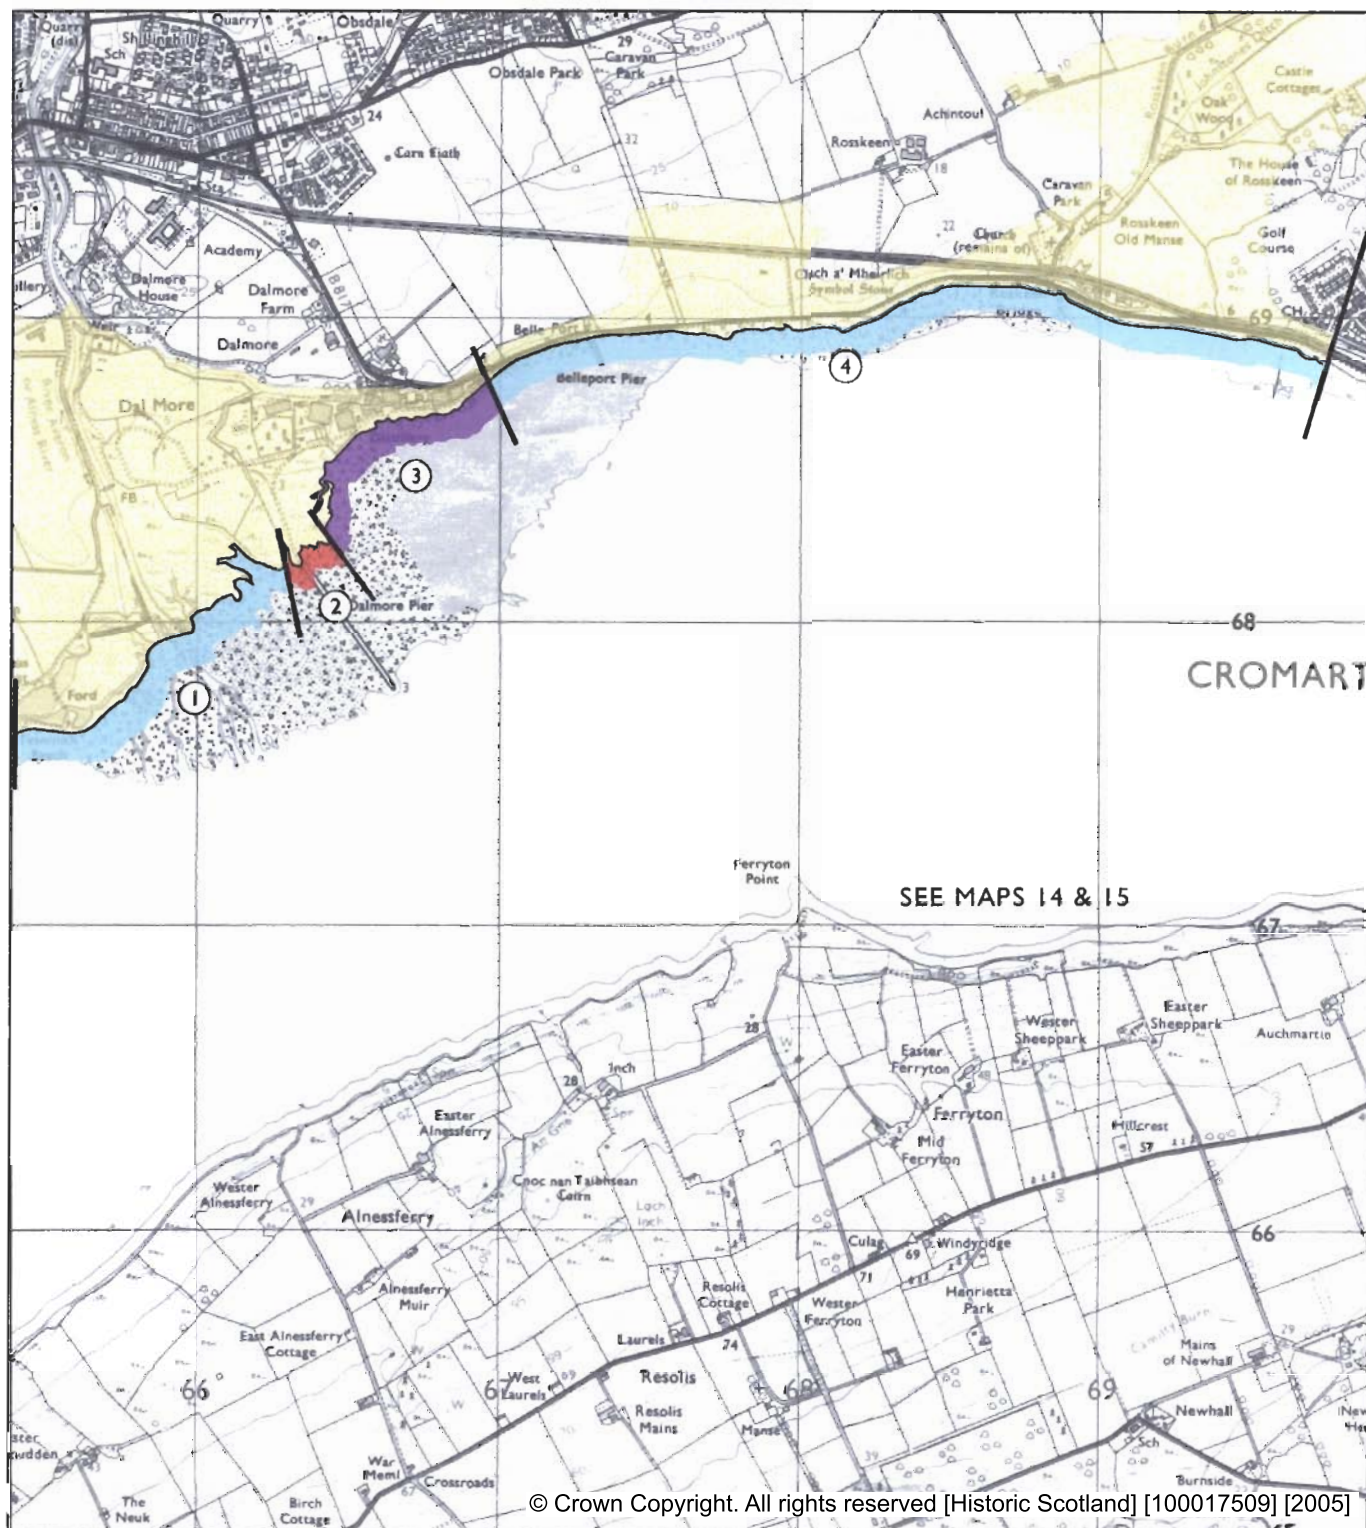
MAP 21: ALNESS POINT TO INVERGORDON 1:25 000
MORAY FIRTH SURVEY Grid ref: NH 66-69/65-70

The foreshore appears to be stable with accreting mud. At Belle Port pier the shore is heavily armoured to defend the B817 trunk road.

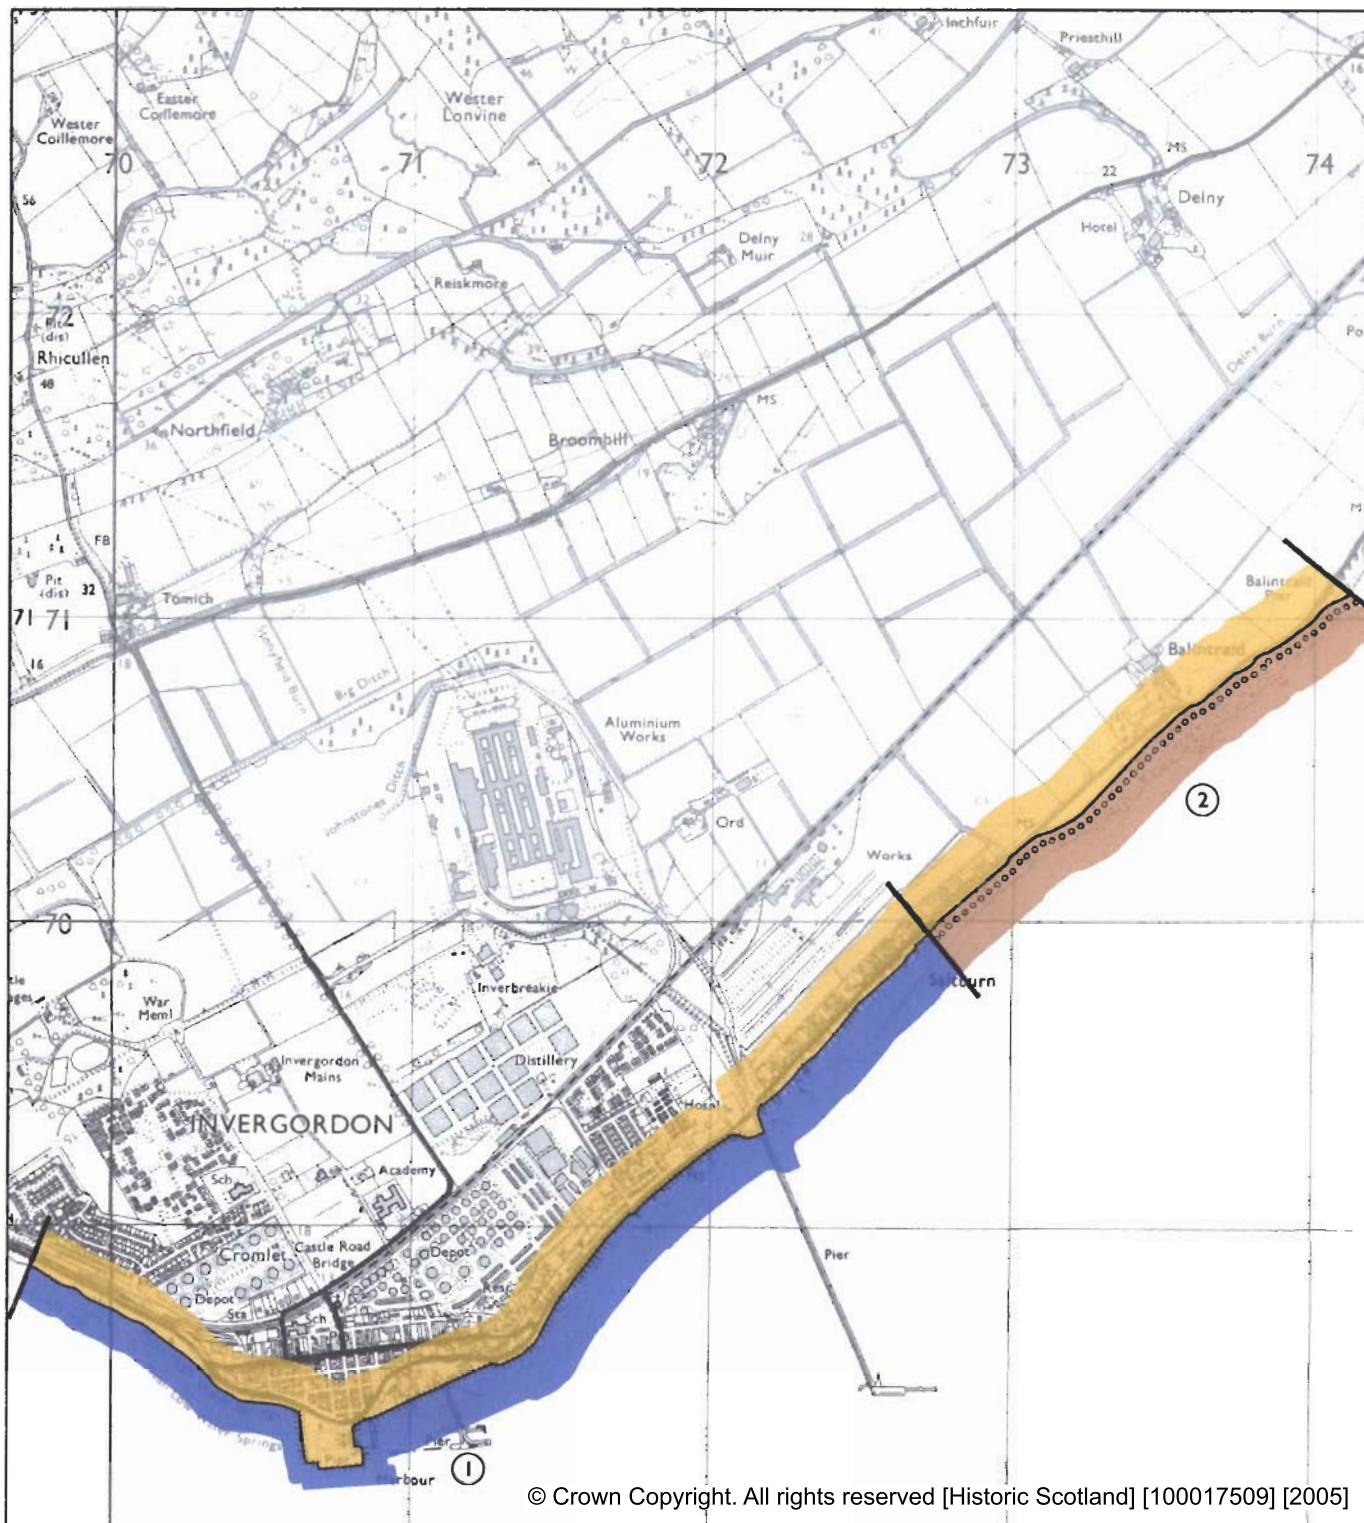
MAP 22: INVERGORDON TO BALINTRAIID

The hinterland consists of raised beach deposits behind a linear coastal edge. The foreshore consists of a mud and shingle on tidal flats.

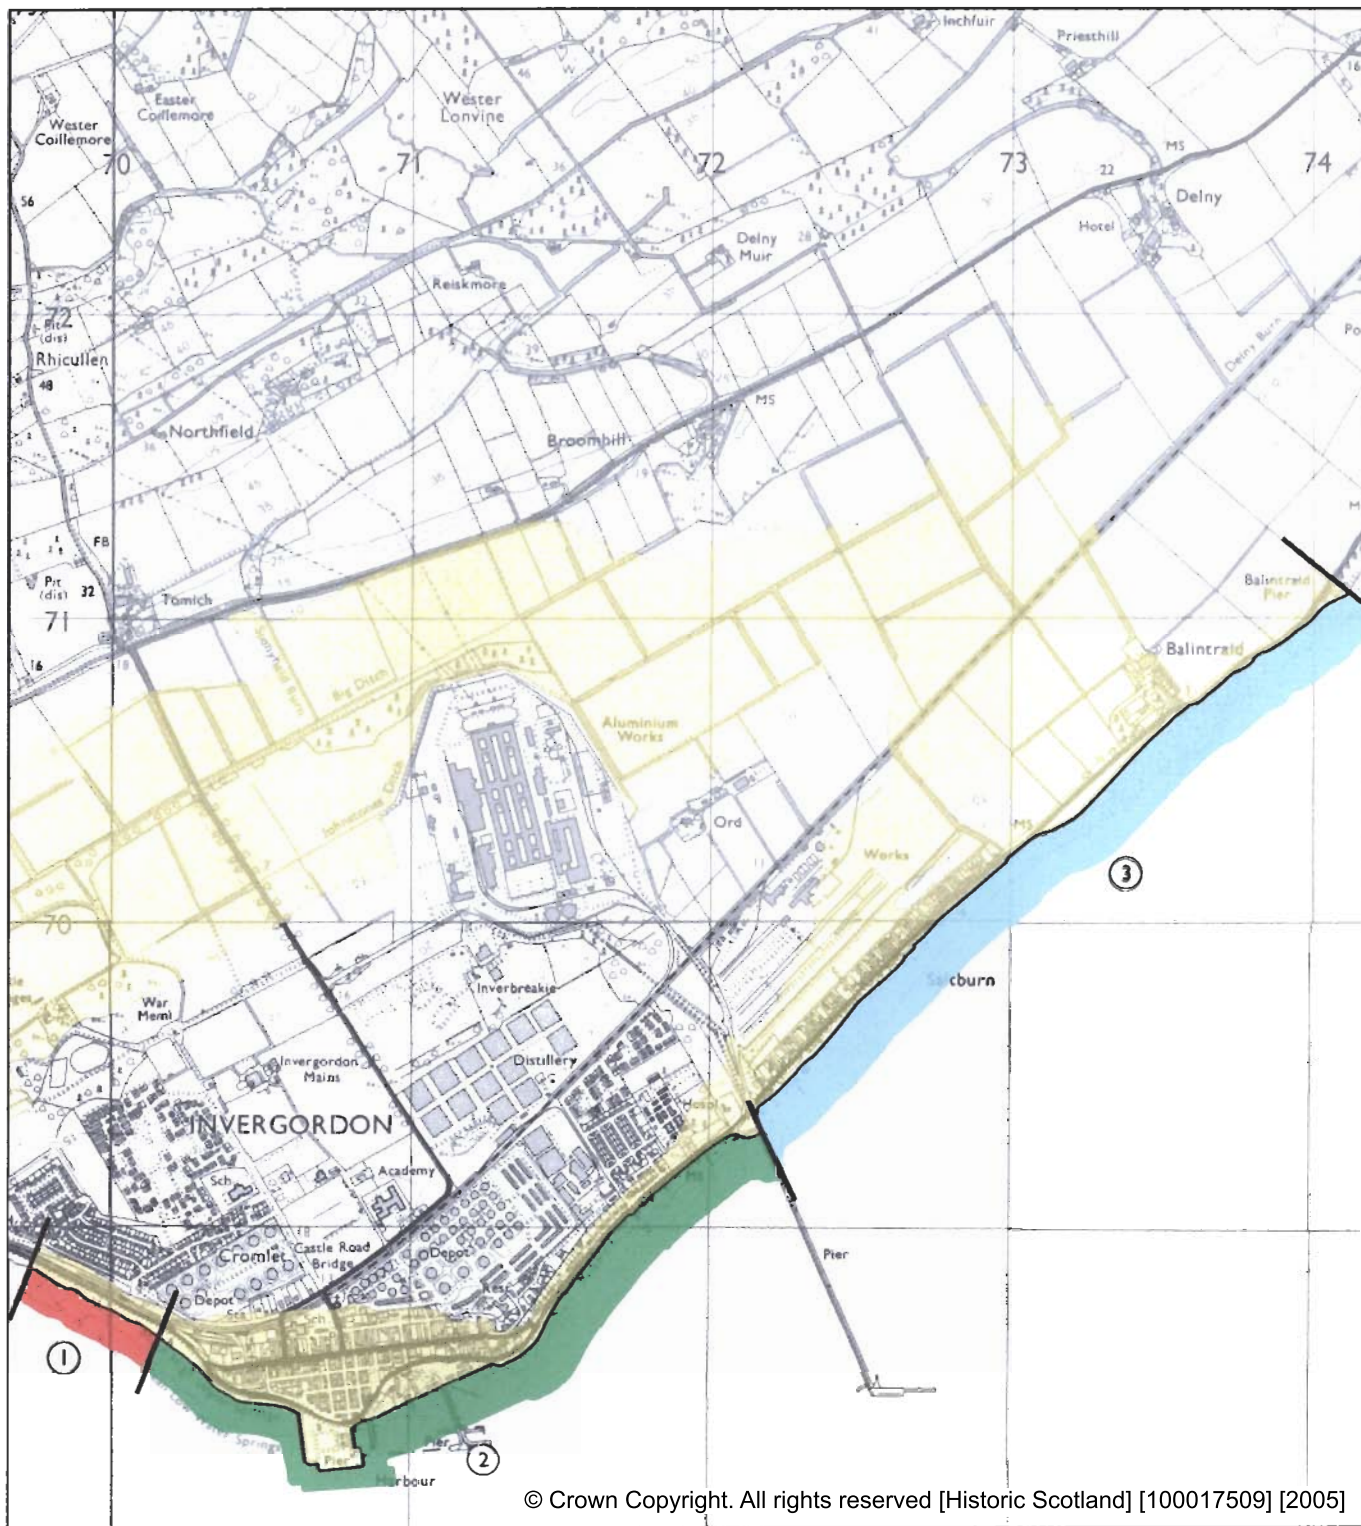
MAP 22: INVERGORDON TO BALINTRAID

Saltburn town is defended by a concrete promenade fronted by quarry stone and there no indication of erosion. The beach is mainly sand and appears to be stable. At Pollo House region the shore is protected by natural outcropping sandstone.

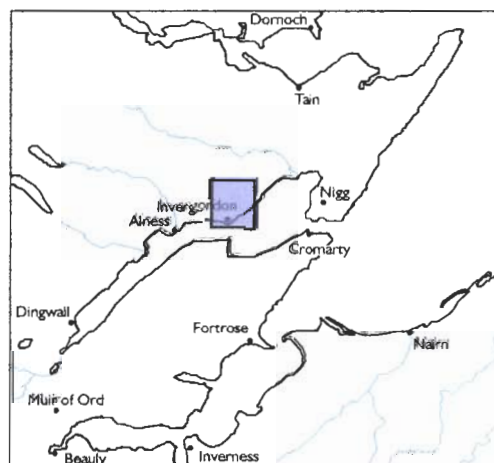
Map 23: BARBRAVILLE TO EAST OF MILTOWN CASTLE

Hinterland Geology and Coastal Geomorphology: This unit of coastline forms the sheltered head of Nigg Bay and is underlain by Upper Old Red Sandstone. The drift cover in this area is dominated by marine deposits. Raised beach deposits are extensive forming a series of sinuous degraded cliff-lines that converge into a single cliff towards Tarbat House. A plateau below 10m OD has been formed. Development in the area is low.

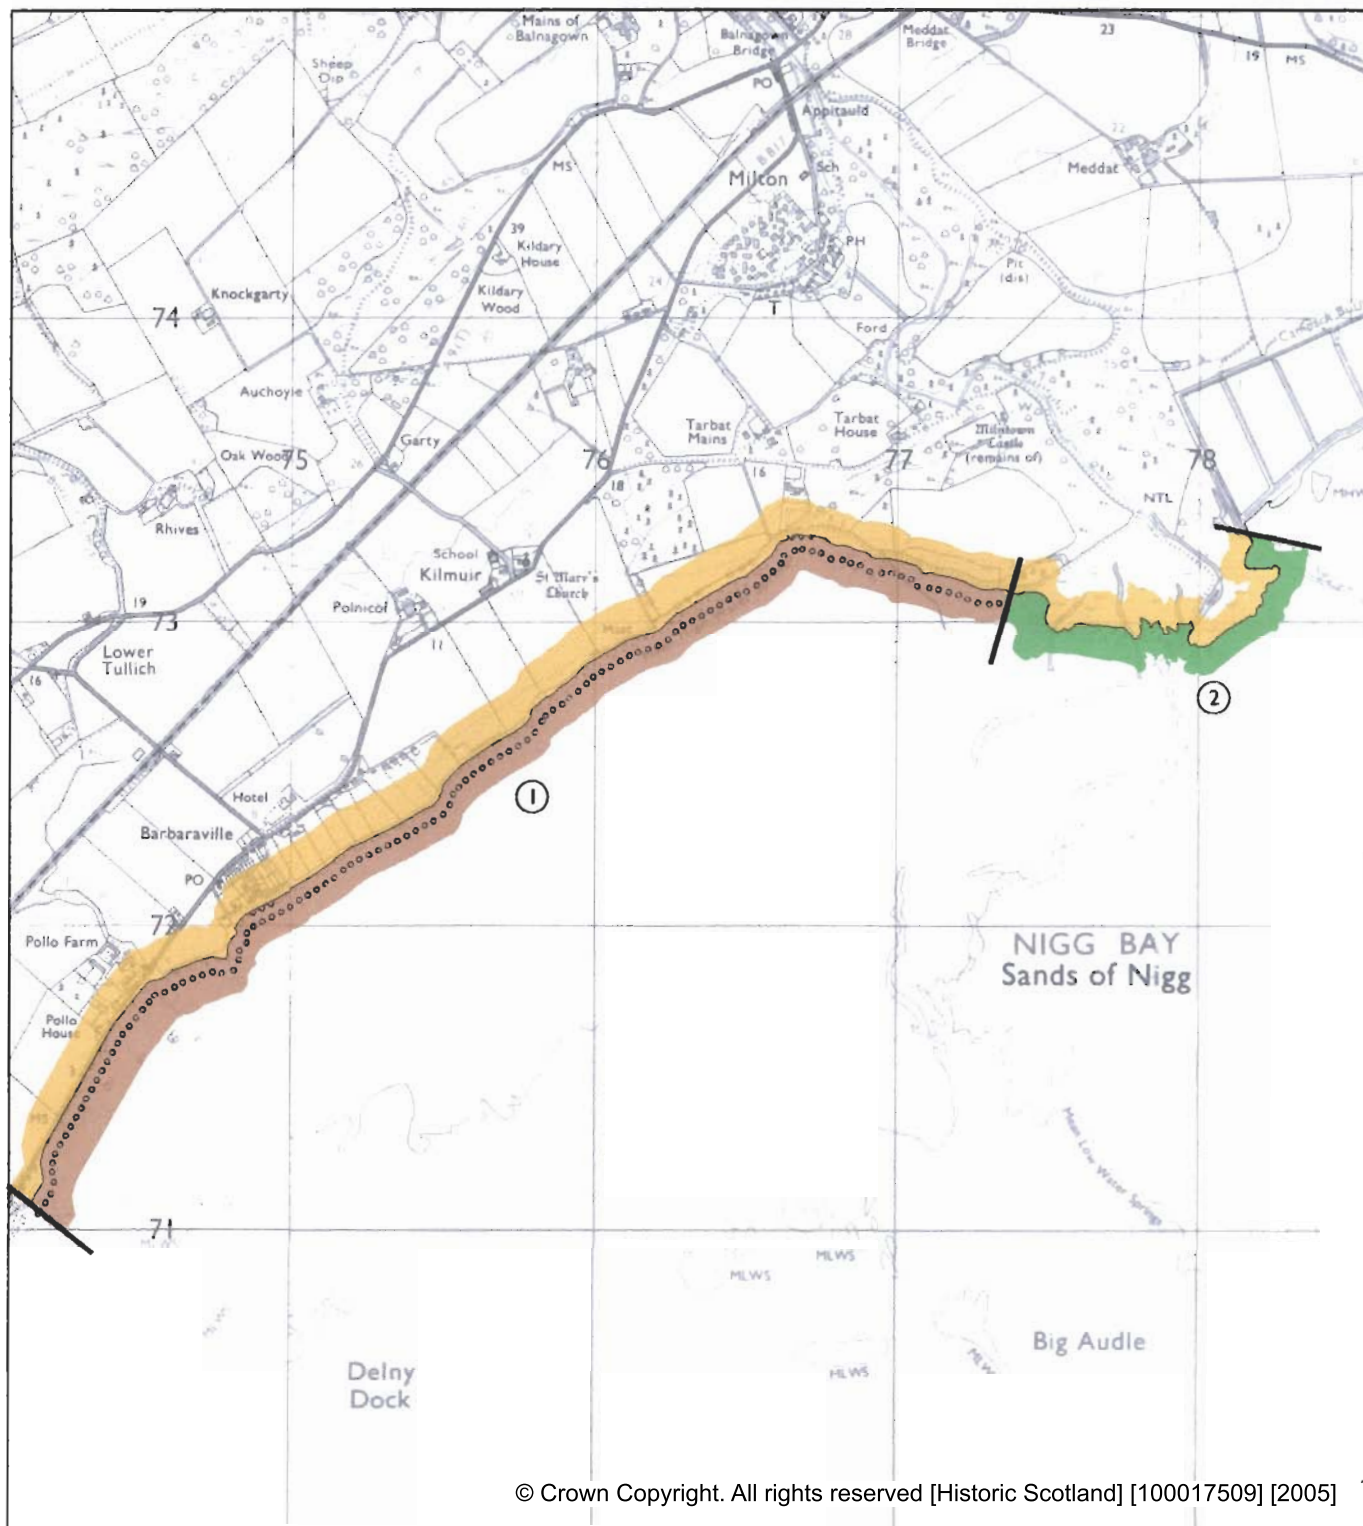
MAP 23: BALINTRAD TO MILTOWN CASTLE 1:25 000

Upper reaches of Nigg Bay consisting of a coastal
edge colonised by saltmarsh. The hinterland is
defended by flood banks and is low lying. The
basal deposits consist of marine derived sand and
gravel.

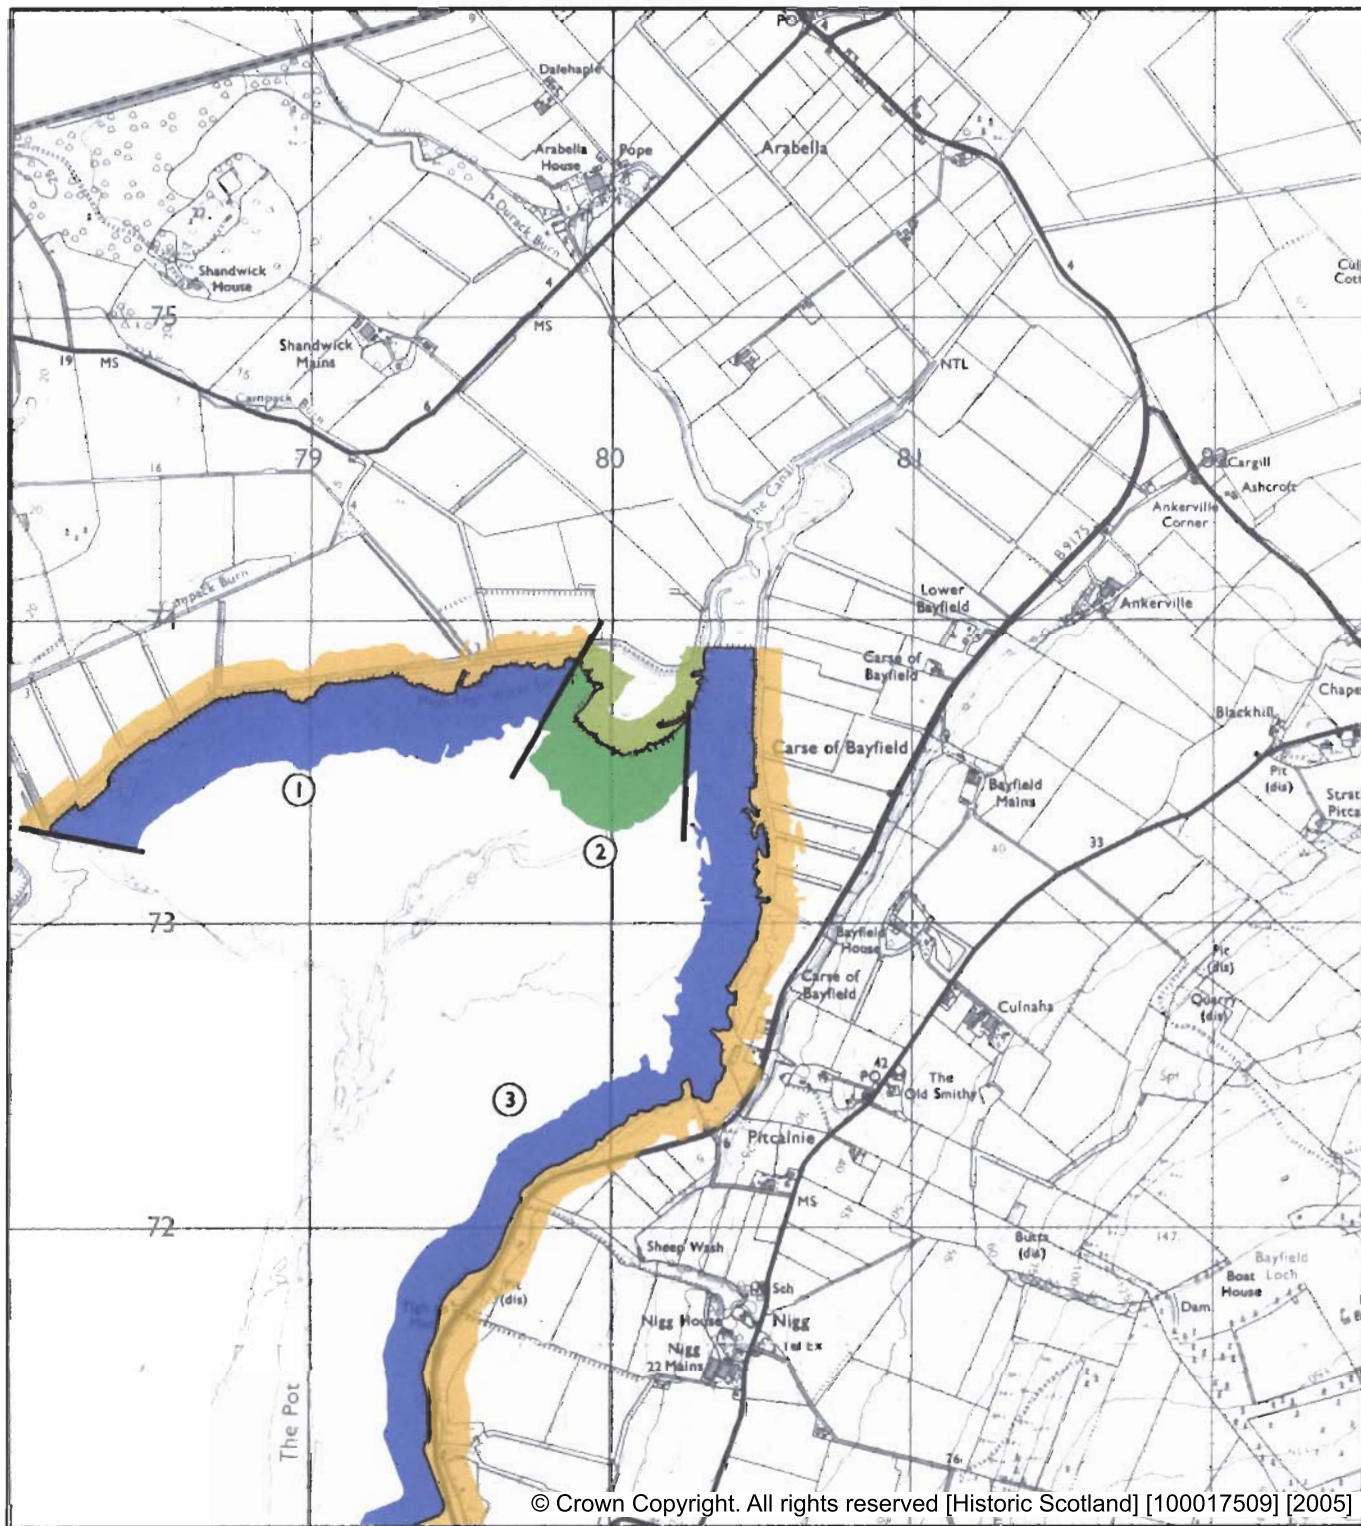
MAP 24: MILNTOWN CASTLE TO NIGG MAINS

Irregular shoreline with carse clays overlying marine sand and gravel in a low-lying hinterland. The foreshore consists of tidal sand and mud flats.

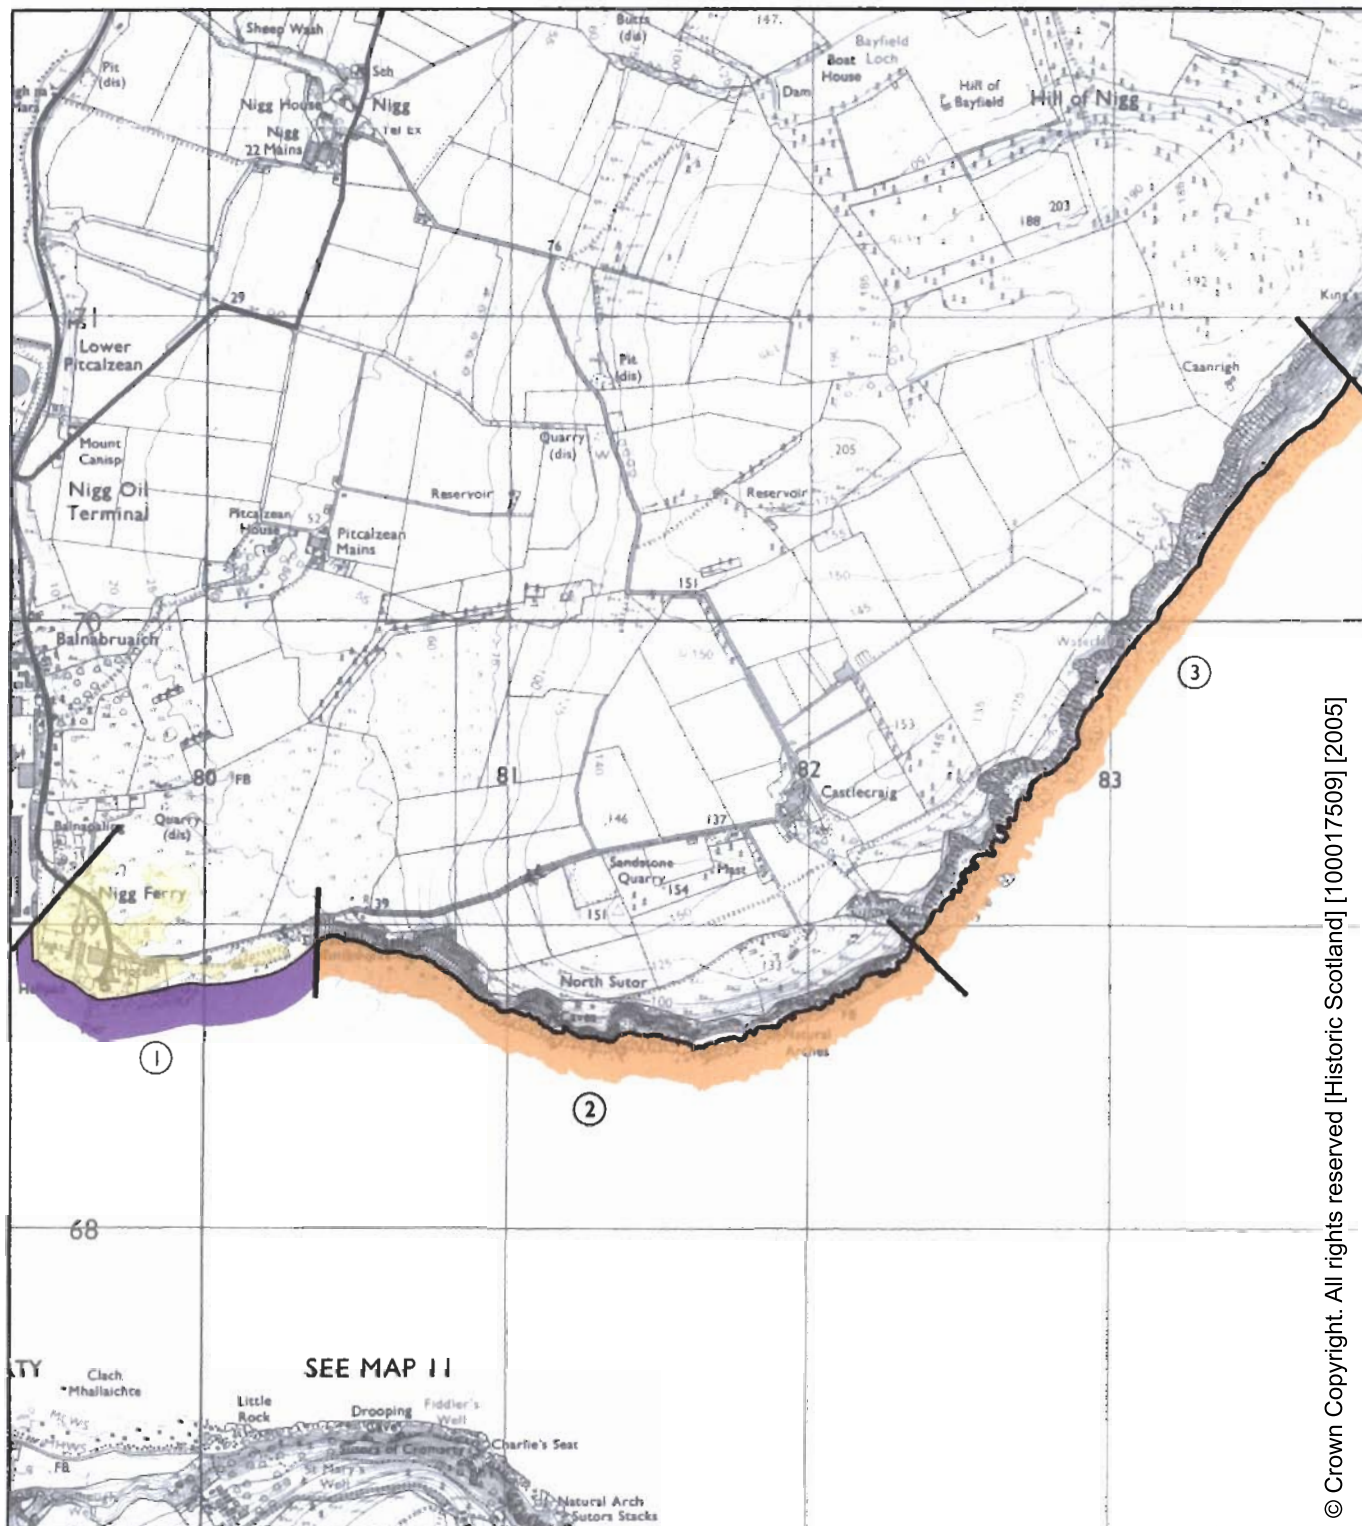
Exposed precipitous cliffs overlook a rock platform shoreline. The cliff base is undergoing constant erosion by wave attack but the rate of erosion is considered to be slow owing to the resilient nature of the sandstone cliff and sea platforms.

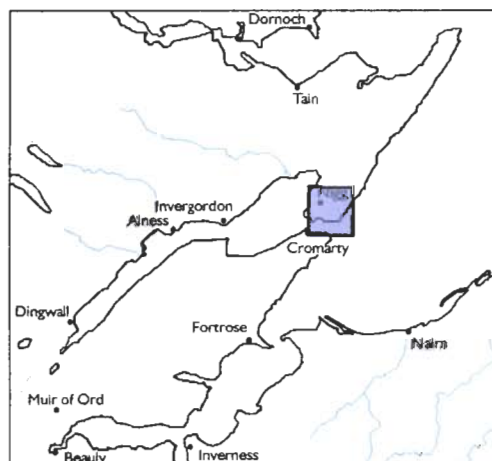
Map 27: KINGS CAVE TO PORT AN RIGH

Hinterland Geology and Coastal Geomorphology: This section of coastline is exposed to the full force of gales from the NE quadrant. Undifferentiated schist of the Moine Series extend northwards. Precipitous cliffs rise to above 150m. The cliff edge is highly indented overlooking exposed abrasion platform and gullies. A narrow discontinuous platform forming a marine terrace runs parallel with the shoreline. Morainic drift forms a thin mantle over the near-surface sandstone outcrops.

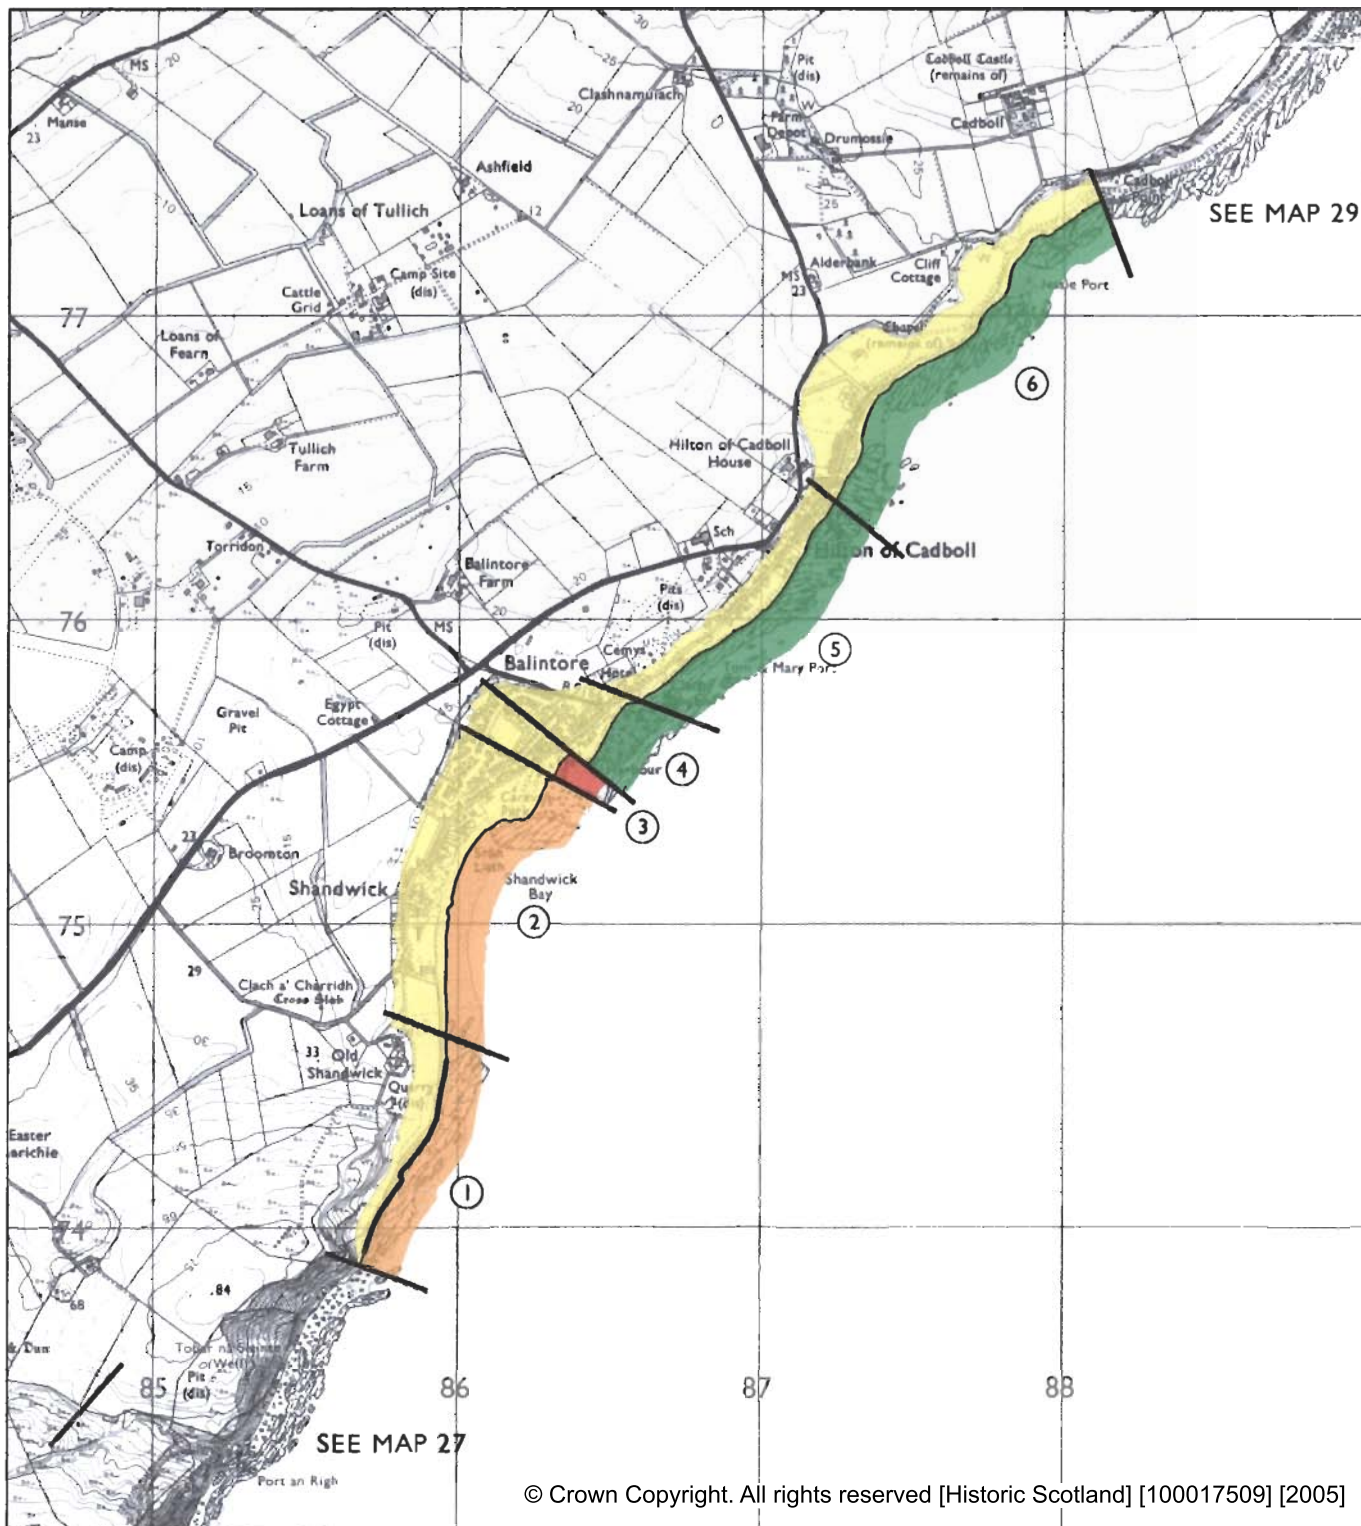
MAP 28: PORT AN RIGH TO CADBOLL

Exposed rock platform with accreting sand and shingle. No evidence for active erosion was seen.

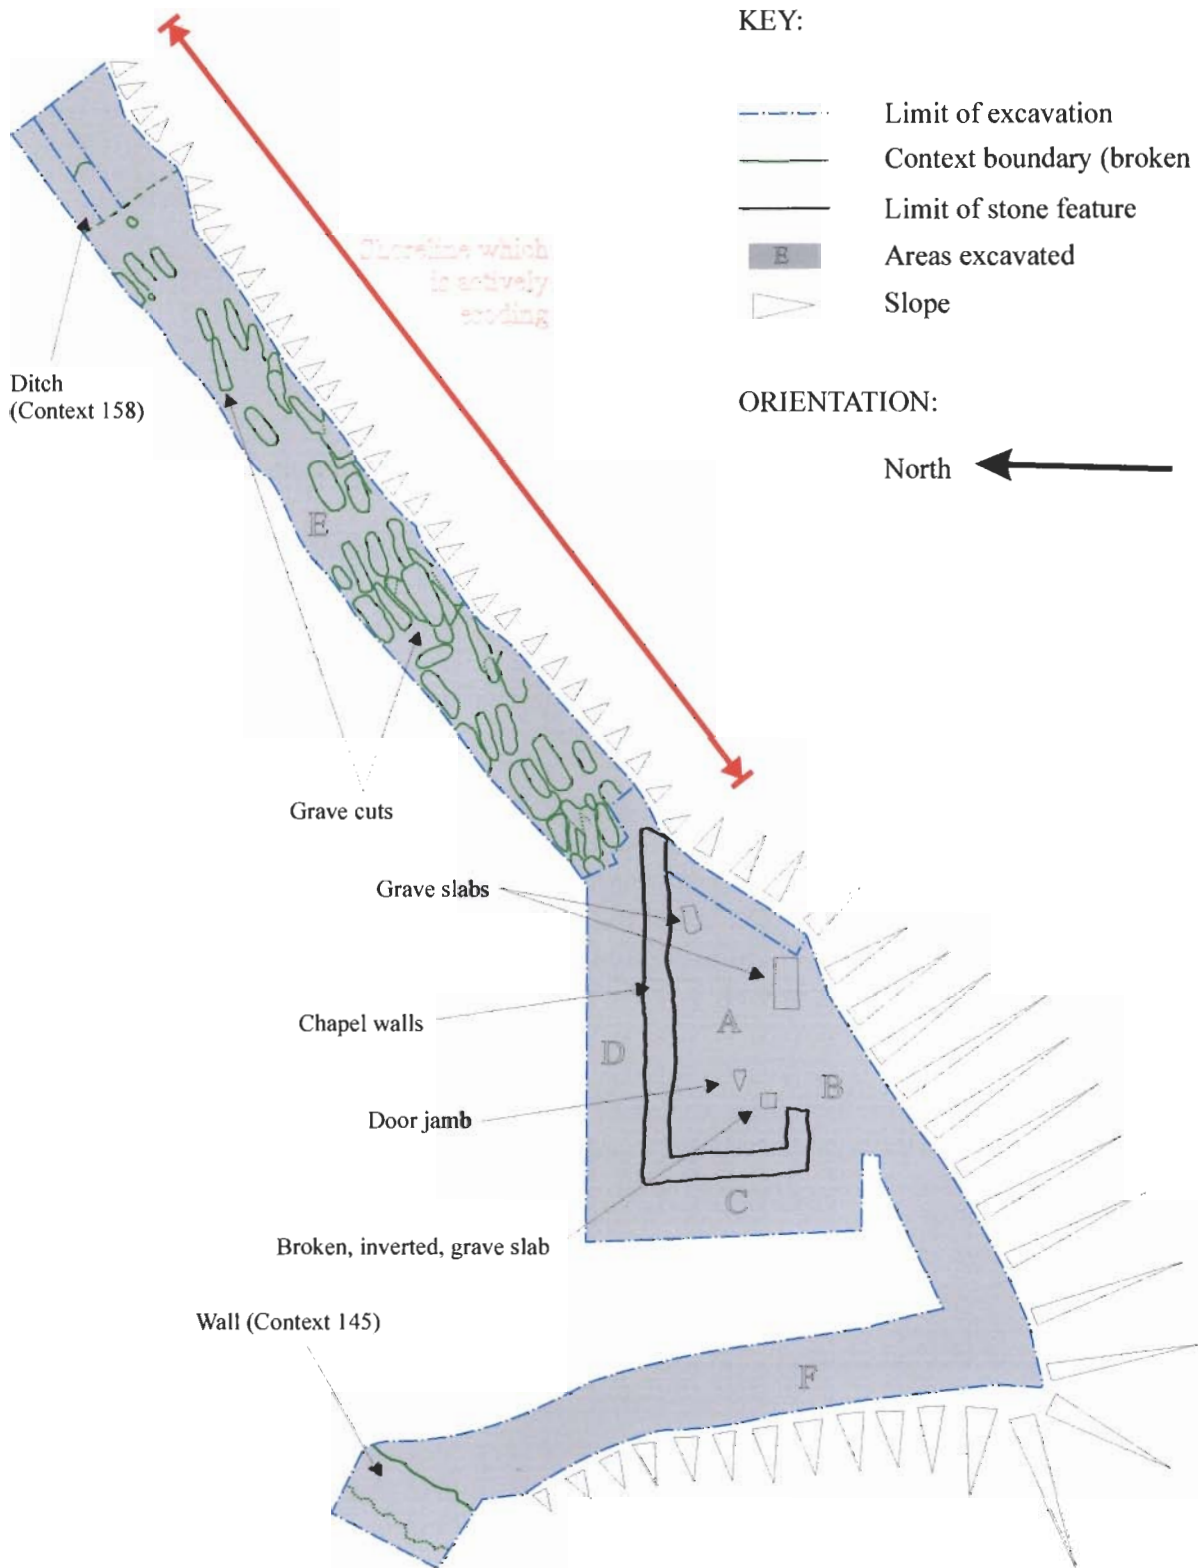
Figure 11: Site plan of Cille Bhrea chapel (courtesy of AOC Scotland).

- cleaning and recording the site before excavation
- cleaning and recording the erosion face
- excavating the church, complete with a 2m wide strip all round it (Areas A, B, C & D in (Figure 4*))
- excavating a 3m wide strip along the erosion front of the site (Areas E & F in (Figure 11))
- recording the church structure in full.

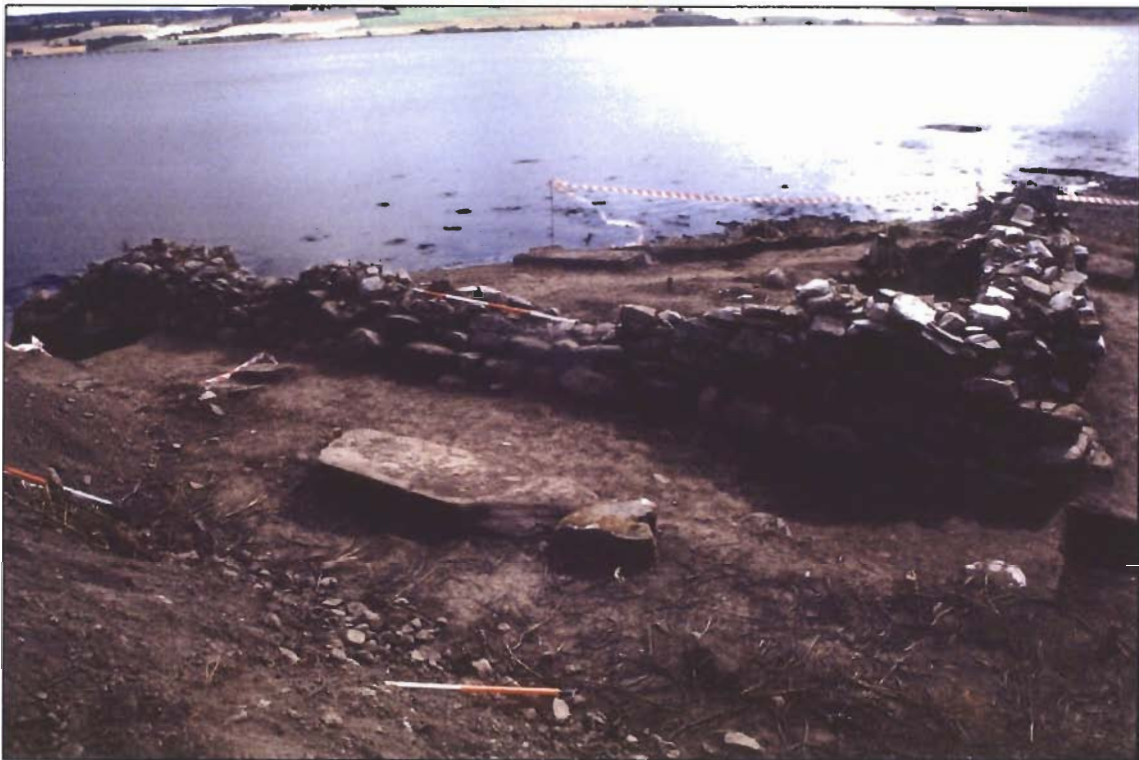
Plate 1. Chapel site at Cille Bhrea and eroding cliff edge

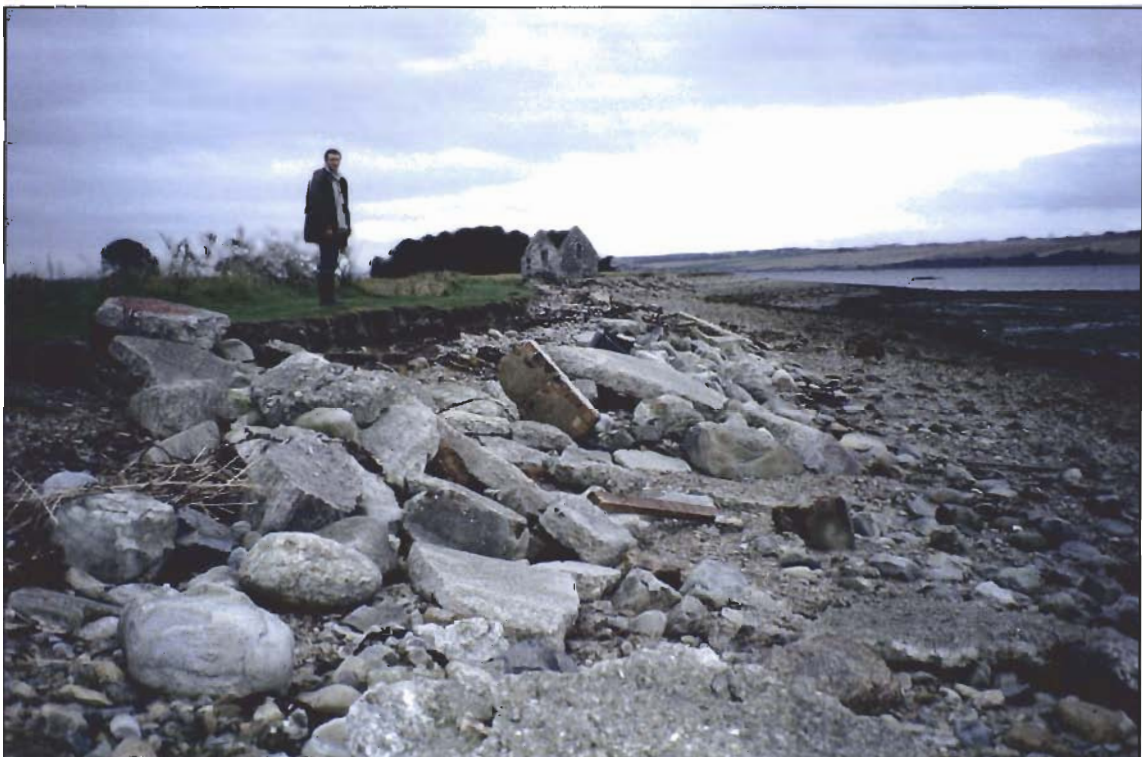
Plate 2. Kilmuir foreshore showing dump defence and erosion.

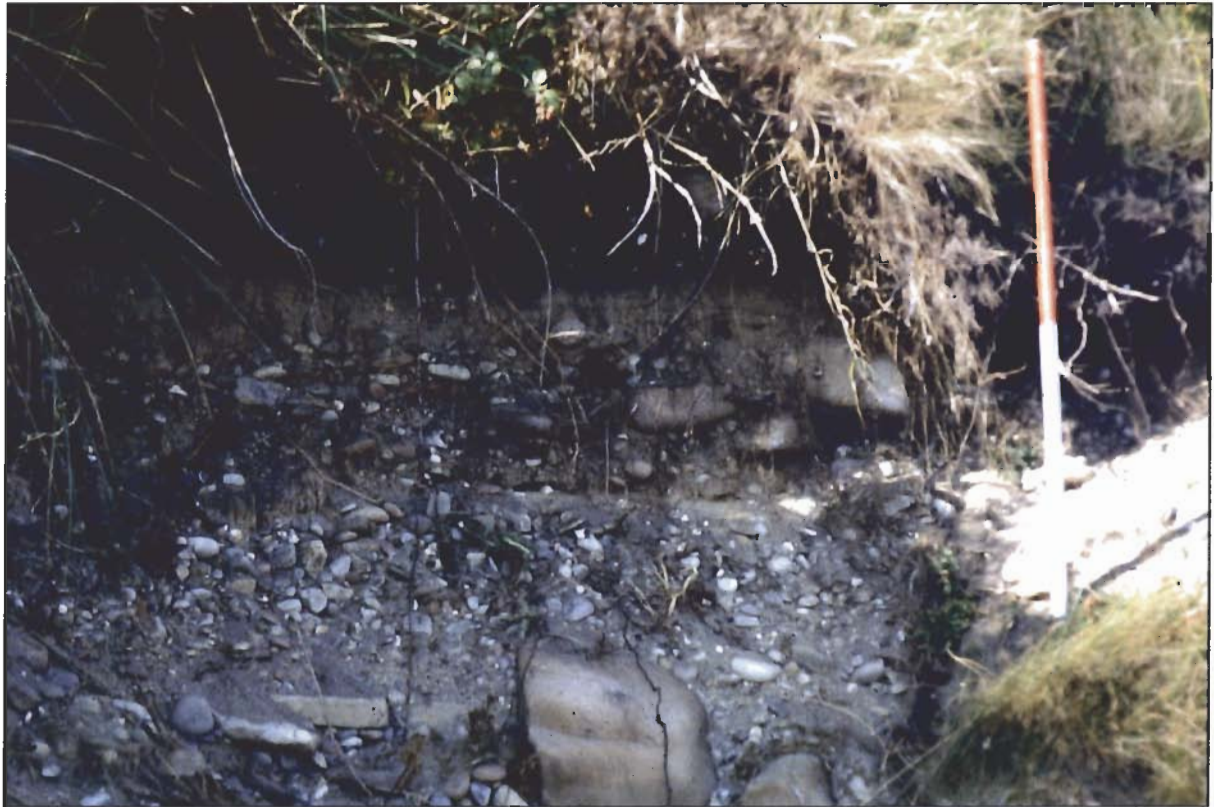
Plate 3. Eroding shell midden at Port An Righ.
