ORKNEY COASTAL SURVEY 1999

Sanday & North Ronaldsay

Hazel Moore &
Graeme Wilson
EASE Archaeology

Commissioned by
ORKNEY ARCHAEOLOGICAL TRUST

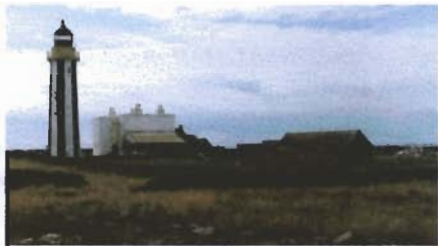
Site SY12: Start Point lighthouse

An unlit beacon was built at Start Point in 1802 for the purpose of warning off ships which otherwise might be lured by the light on North Ronaldsay into straying too far to the east and the low-lying coast of Sanday. The beacon was topped by a large ashlar ball, later reused on the beacon at Dennis Head, North Ronaldsay. In 1806, it was fitted with the first revolving light in Scotland. Rebuilt in 1870, the 21m high brick tower was later painted in striking vertical stripes of black and white. It went to automatic in 1962 and is now a listed building. The original two-storied keepers cottages survive and are currently under renovation. To the south side of the lighthouse complex, a farmstead, of traditional design and construction, which incorporates a corn-drying kiln (surveyed) is now ruinous. Ref.: RCAHMS & NMS (1998) 'Scottish Farm Buildings Survey: 2, Orkney' #35 (corn-drying kiln); Wilson, B (1975) 'The lighthouses of Orkney'; Ritchie, A (1985) 'Exploring Scotland's heritage: Orkney & Shetland' #5; RCAHMS (1980) #201; Burgher, L (1991) 'Orkney: An Illustrated Architectural Guide' #82.

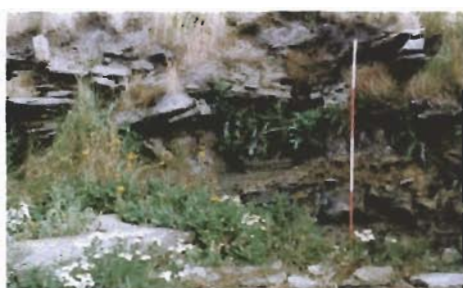
The remains of a small structure are exposed in an eroding coastal section. A concrete plinth, covered by turf and topsoil, is set over a layer of redeposited till, which in turn is based on a foundation coursed of flat slabs. The section extends for almost 5m and is up to 0.5m high: inland, the outline of square or sub-square structure, measuring 5m across, is visible. These remains may be part of a WWII building associated with the radar station at Whale Head (SY23, HY74SE23).

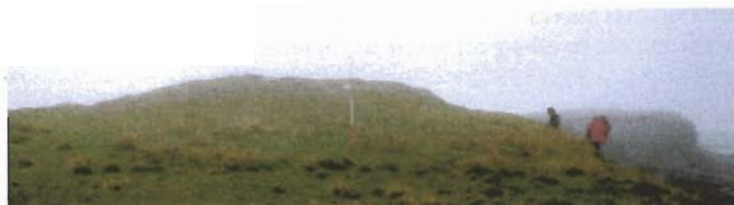
Site SY44: Tres Ness chambered cairn

A low mound, which may be artificial, lies adjacent to the coast edge. It is sub-oval in shape, measuring some 25m by 12m and stands no more than 1m high. A modern marker cairn has been constructed on its highest point. The seaward side of the mound has been damaged by coastal erosion and stonework, which appears to be of a structural nature, is exposed in an erosion face which extends for 10m and is up to 1m high. This area is used by nesting fulmars. To the north side of the mound can be seen the faint outline of a curvilinear earthwork. This is up to 2m in width and extends for 15m or more inland, running to the west of the mound. The Ref.: Orkney Name Book No.2, 1879; RCAHMS (1946) #446; RCAHMS (1980) #156.

Tres Ness is rich in archaeological sites. One of the most impressive sites is located in an elevated position at the tip of the ness. Here a large chambered cairn (SY44) has been damaged by coastal erosion. Recent investigations at the site indicate that the cairn may comprise up to three separate phases of construction. It has been scheduled as an ancient monument but remains at risk from continued sea erosion.

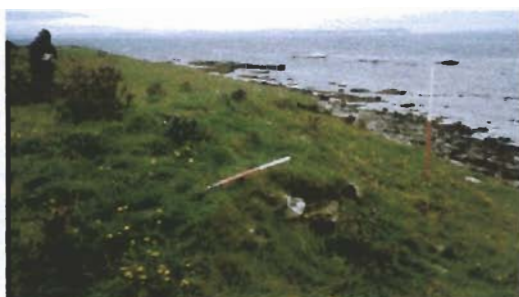
Site SY136: Ness of Brough

The ruins of a drystone structure lie at the south end of a **small shingle** beach. Measuring 10m by 7m, the walls stand up to 2.5m high and are 1m thick. The core of the wall is filled with **boulder clay**. The doorway is 2m wide and faces south. The nearby beach is suitable for fish-drying and it is possible that this **structure** may have been used as a boat house or store.

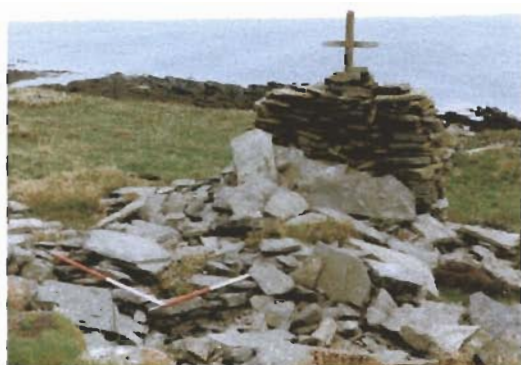
Site SY146: Rethie Taing

island	map	site code	grid reference	OR no.	site type
Sanday	11	SY146	HY6511 4424	140	Possible chambered cairn
NMRS no.		Status		HS index no.	placename
HY64SE39					Rethie Taing
Location to coast		condition		recommendation	date range
On coast edge		Fair/poor		Survey	4th-3rd mill BC

A grassy mound which lies on the coast edge has been damaged by erosion. It appears to have been originally circular or sub-circular and about 25m in diameter. The mound is prominently sited on a natural knoll, on a short headland. It extends, beneath a drystone wall, into a cultivated field and has been truncated by ploughing. On the seaward side, the erosion face is uneven and overgrown but sections of walling and part of a probable passage are visible. The passage is about 1m wide; its walls stand up to 0.4m high and can be traced into the mound for 1.6m. Ref.: RCAHMS (1980), #4.

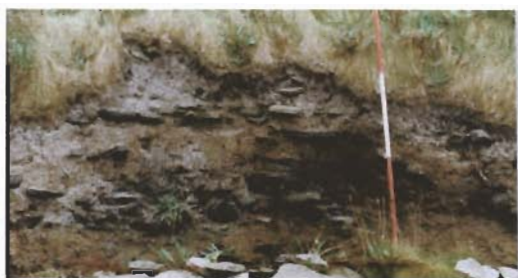
Site SY155: Runna Clett

island	map	site code	grid reference	OR no.	site type
Sanday	11	SY155	HY6659 4540	142	Mound & coastal exposure
NMRS no.		Status	HS index no.	placename	
HY64NE3				Runna Clett	
Location to coast	condition	recommendation	date range		
On coast edge	Fair/poor	Survey	Unknown: ?prehistoric

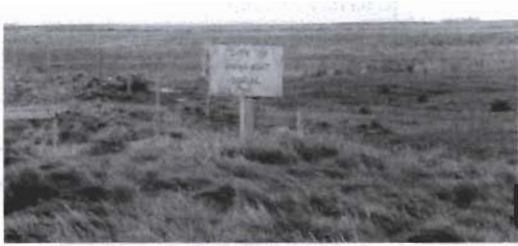
Site SY159: Scar boat burial

island	map	site code	grid reference	OR no.	site type
Sanday	12	SY159	HY6780 4584	259	Site of boat burial
NMRS no.		Status	HS index no.	placename	
HY64NE7		Scheduled	6162	Quoybanks, Scar	
Location to coast		condition	recommendation	date range	
On coast edge		Fair	Monitor	1st mill BC-1st mill AD

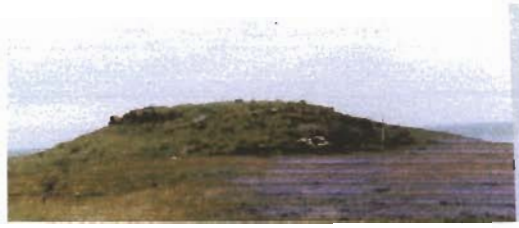
Site SY165: Whitemill Point

island	map	site code	grid reference	OR no.	site type
Sanday	12	SY165	HY6997 4633		Mound
NMRS no.		Status	HS index no.	placename	
HY64NE8				Whitemill Point	
Location to coast	condition	recommendation	date range		
On coast edge	Fair/poor	Monitor	Unknown: ?prehistoric/18-20th

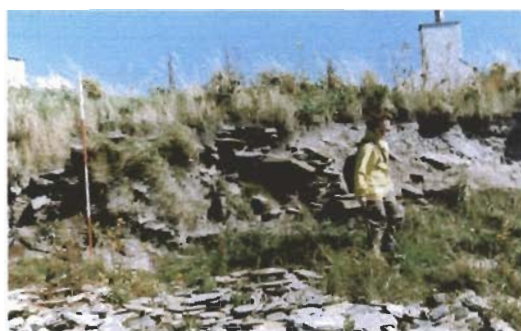
Site SY191: Tofts farm and mound,
coastal exposure

Tofts farm is situated on a massive artificial mound, measuring at least 100m in diameter and 3m in height. At the coast edge, the peripheries of the mound have been eroded by the sea and archaeological deposits are exposed in the section. Given their location in relation to the mound as a whole, it should be noted that these deposits may not be generally representative. They include substantial layers of highly organic soil, up to 2m deep, and soils containing frequent bone, shell (limpet and winkle, particularly) and peatash inclusions. Several flint fragments were noted. Concentrations of stone, which may be structural, are exposed but cannot be readily interpreted because the section face has slumped and is uneven. The erosion face extends for some 20m along the coast. Sherds of brown glaze ceramic, of 19thC date, and fragments of iron occur in the uppermost layers, but there are otherwise no diagnostic artifacts visible in the section. The base of the section is obscured by a storm beach. Ref.: RCAHMS (1980), #92.

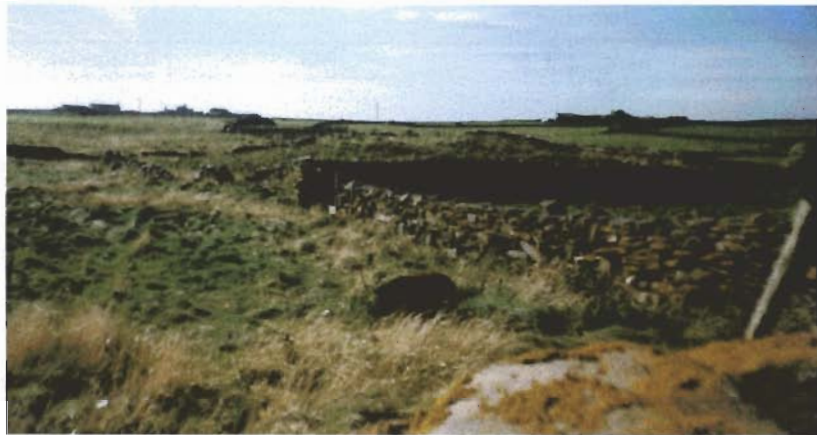
Site NR21: mound

Two mounds lie close to the coast edge. One is well defined, has a diameter of 9m and stands up to 0.75m high. It lies some 20m from the coast. The other, 50m further north, is oval in shape and measures 10m by 16m by 1m high. It lies on the coast edge and is eroding; some stone is visible in the erosion face but it is possible that the mound is at least partly natural in origin. Nearby, a 19th-20th C midden dump is exposed in the coastal section.

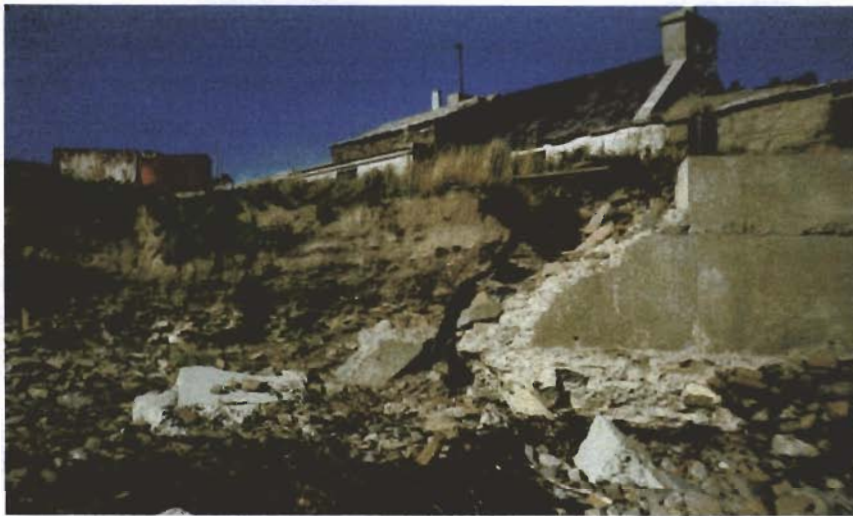
Site NR25: Westness Farm, damaged sea wall with archaeological deposits exposed

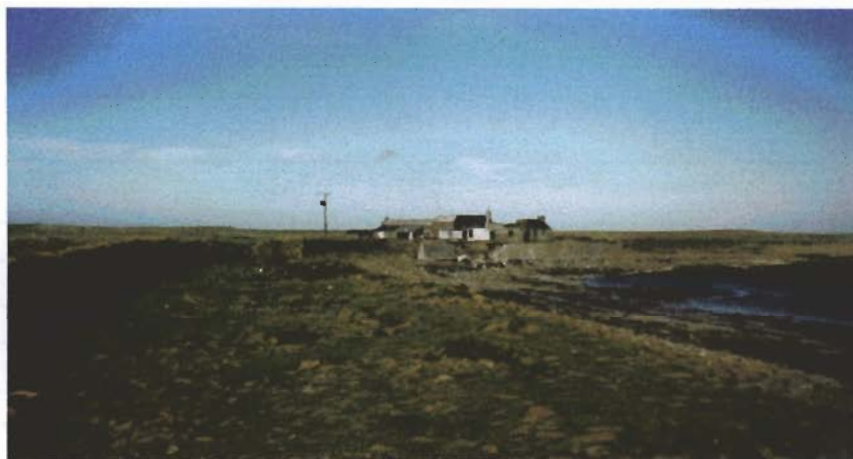
Site NR25: general view from east

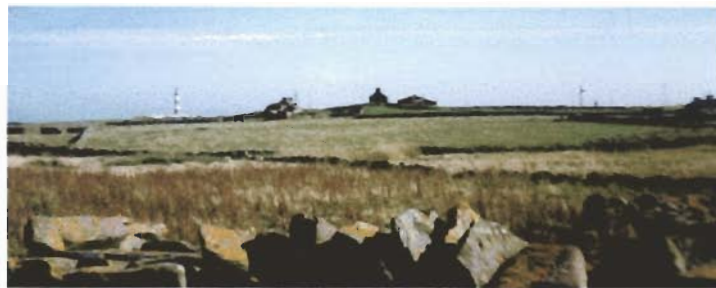
Site NR29: Eastings Farm and mound

The abandoned farmstead at Eastings is built over a substantial artificial mound which stands up to 1.5m high. It is located some 50m from the coast edge. On the coast, shell midden, comprising solely of limpet, is exposed in the eroding section. The section extends for 4m and is up to 0.5m deep. Ref.: RCAHMS (1980), #111).
