Shetland Coastal Survey 1998

Shetland Coastal Zone Assessment Survey 1998

South Mainland

EASE Archaeological Consultants
Unit 8, Abbeymount Techbase
2 Easter Road
Edinburgh

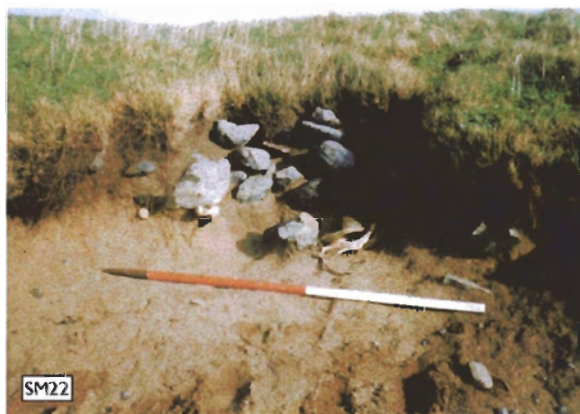
SM99 (HU42NW5)

required to determine the extent of archaeological deposits. This site should be given special attention since it is located in the near vicinity and may be associated with the graveyard at Mail. This site has yielded several carved stones and Viking artefacts and appears to have been a centre of influence from the Iron Age period onward.

Good
Survey

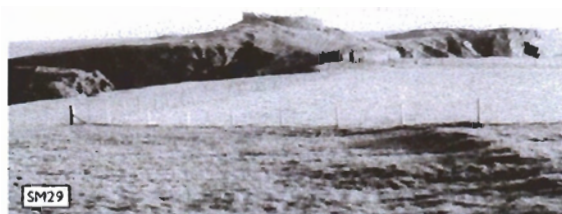
The Broch of Burralland stands on a promontory, surrounded by high cliff, across the sound from Mousa Broch. Defended by substantial ramparts, the broch is well preserved and is surrounded by numerous buildings. The remains are slowly being degraded by animal disturbance and by the advance of a storm beach. Several structures are actively eroding over the cliff edge and the immediate hinterland of the broch has been denuded of vegetation. The individual elements

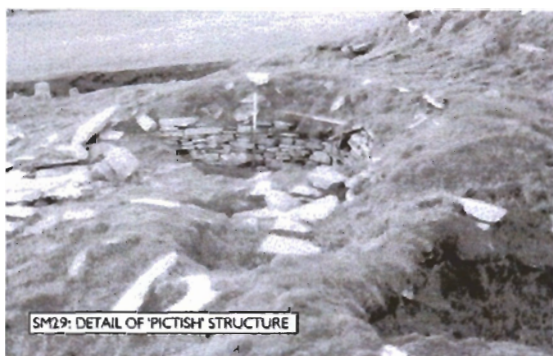
(vi) This structure is very poorly defined. It lies between the enclosure (v) and building (vii). Traced from slight topographic evidence, it is

estimated to measure about 8m by 5m. The rear of the building abuts the enclosure bank. A small amorphous mound to one side may be an associated feature.

(vii) This building is irregularly oval in plan. It is approximately 9m long and varies between 4m and 6m in width. It is entered via an elongated entrance passage which faces seaward, away from the broch. The passage is 5m long by 1.5m wide. A small recessed area or cell is formed from a bow in the wall. This lies at the inner end of the entrance passage. The exterior wall face stands up to 0.3m high and is grass-covered. In the interior parts of an internal revetted wall face are exposed to a height of 0.6m. The walls probably survive to a greater height than this, however, since the floor level has been raised through infilling with rubble and debris.

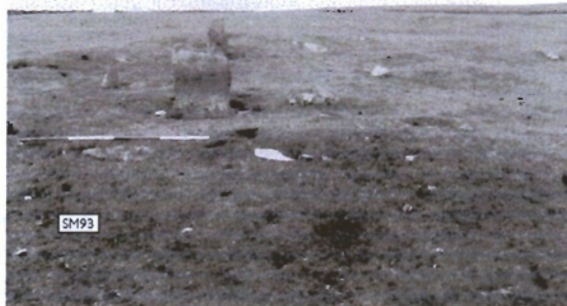
Two grassy mounds lie inside a circular enclosure, some 40m from the coast edge. There is little to indicate the nature of this site, but it is possible that the mounds represent prehistoric burial monuments or burnt mounds.

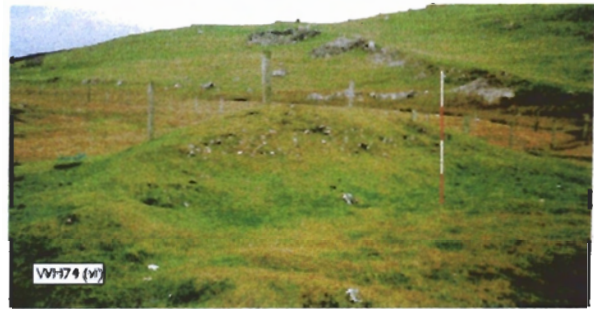
(i) A structural complex, apparently comprising a house with a courtyard or annex is located less than 5m from the coast edge. The house is sub-circular in shape, measuring 12m in diameter. The landward end of the building is set into the natural slope. The enclosing bank stands to 1m high and varies in width from 1m to 2.5m. It is covered with turf but appears to be formed from earth and stone, with some internal and external stone revetting. The banks at the entrance are thicker than elsewhere, forming a short passage. The interior is relatively level and no trace of any internal divisions or features are visible.

A second chamber or courtyard adjoins the front of the building. This is also sub-circular in plan and

measures 11m in width by 5m in length.

(ii) To the NE side of this complex, and possibly forming a part of it, there is an amorphous mound. It measures 5m in diameter and stands up to 1.6m high. The centre of the mound has been disturbed and is eroding. Stone which may be of structural nature is visible in the exposures. To the S side, a small and incomplete stone setting appears to have been set into the mound and may be a secondary feature. A curving line of large orthostatic stones extends from the mound to the coast edge.

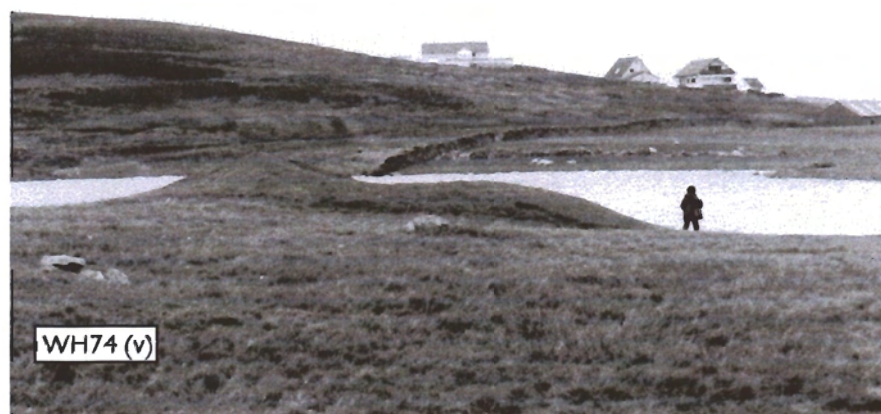
A group of earthfast stones define a much reduced structure, which may be the last remains of a cairn. Sub-circular in shape, the structure is estimated to

measure some 7m in diameter. A central area, which may be cist or small chamber, measures 1m by 1.3m.

Poor
Survey

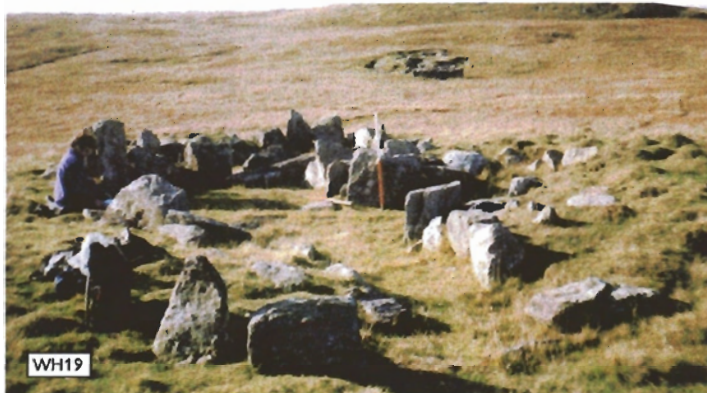
WH20 (HU56NE5)

defined by a stone-faced wall which has a core of soil, ash and debris. It comprises two compartments which are linked by a narrow passage. The outermost may have served as an unroofed courtyard. The inner compartment, altered during occupation, appears to have been divided into a series of alcoves or recesses. Excavation recovered a large number of stone tools and quern fragments, together with pottery and steatite vessel sherds. Although the site has not been dated, the architectural style and finds assemblage indicate a Bronze Age date. It is not threatened by coastal erosion but is becoming dilapidated and possibly unstable in places, largely as a result of having been left open without consolidation or sufficient maintenance. The walls are mined with rabbit burrows, with upwards of 10% of the site area affected.

Good
Monitor

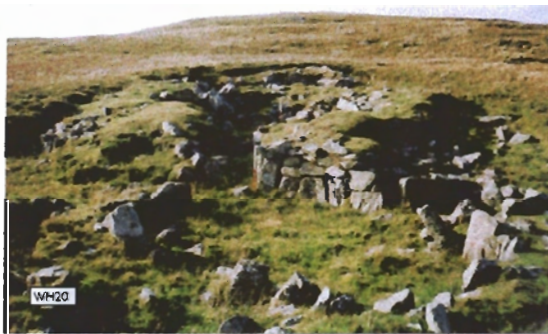
WH22

HU 595 662
Hamara Neap
Enclosure
Indeterminate
