# Coastal Assessment Survey Solway North Coast

September and October 1996

Volume 1 of 3: Introductory material, and the western part of the coast:

Carrickcarlin Point to Crook of Baldoon Map sets 1 to 19

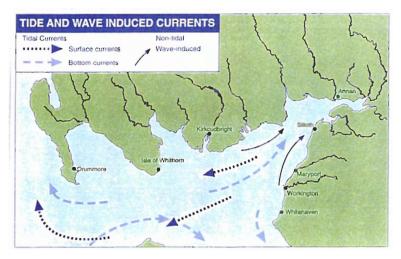
Figure 1 Tidal Currents (after Solway Firth Review 1996, 46)

Figure 1 demonstrates the principal movement of residual currents and the general trend of sediment transportation. Much of the work concerning sediment transportation in the Solway Firth has been established from study of radioisotopes originating from Sellafield (more particularly Cs<sup>137</sup>) and the distribution of sea-bed and surface markers and sea-borne domestic waste.

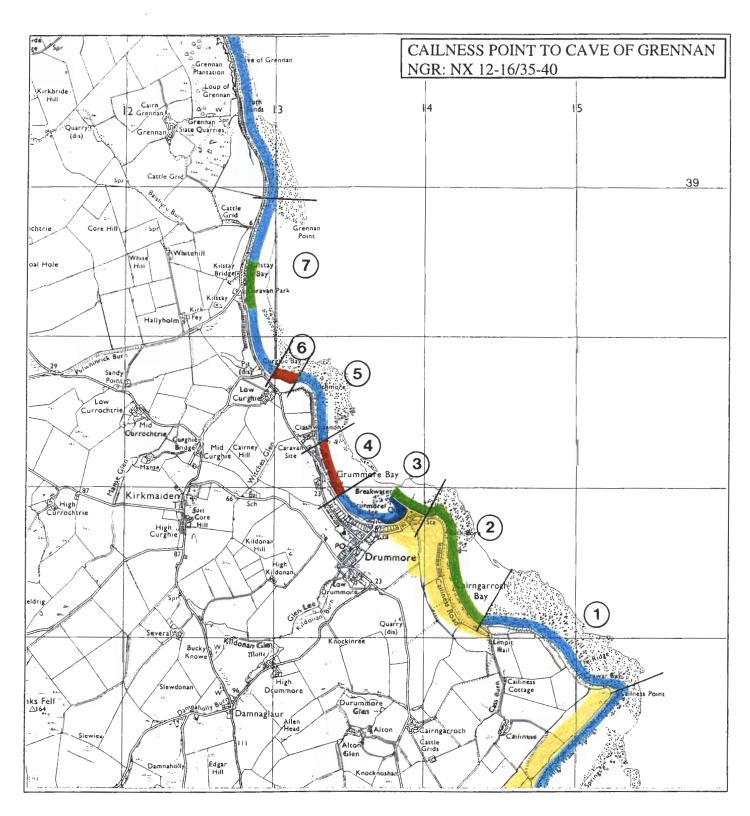
With an exposed north-easterly aspect this area of coast is undergoing serious erosion from storm damage. A concrete sea has been displaced and large concrete blocks lie c.10m from the bank that they were revetted into. Some 30m of wall has been breached and in an attempt to consolidate the bank, modern building rubble has been tipped along the foreshore. Mass movement is being accelerated due to the scouring out of the softer material, namely till behind the existing sea wall.

A concrete sea wall protects the coastal road that skirts Kilstay Bay to Grennan Point. The bay has an exposed easterly aspect and its intertidal zone is wide with sand and shingle. Shingle has been banked against the foreshore and this stretch of shore appears to be stable and accreting in parts.

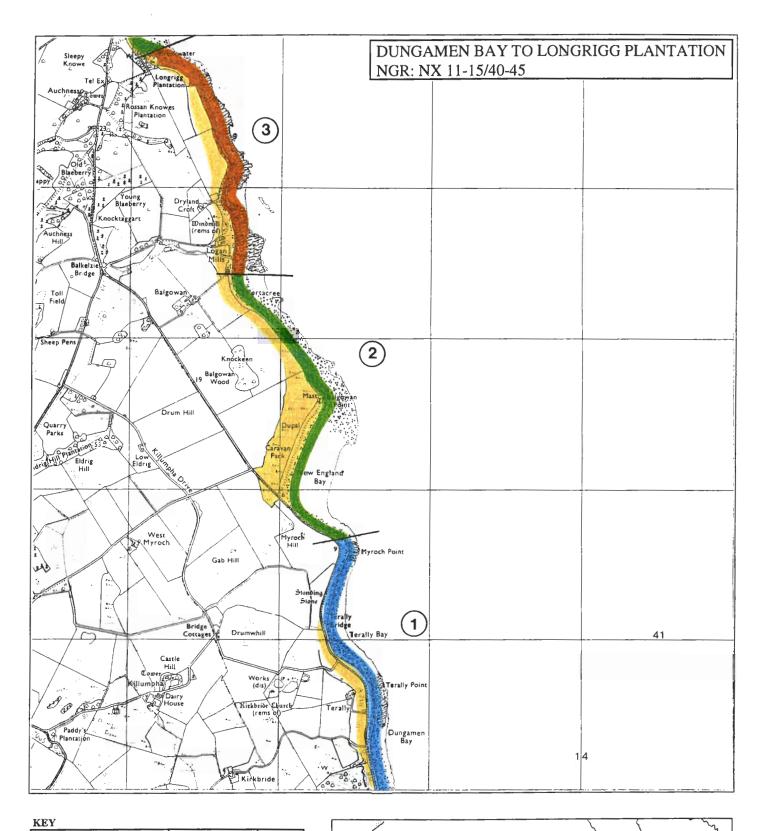
This unit has an exposed easterly aspect and consists of outcropping cleaved and dipping greywackees. Erosion is occurring albeit very slowly as the base of the rock is abraded.

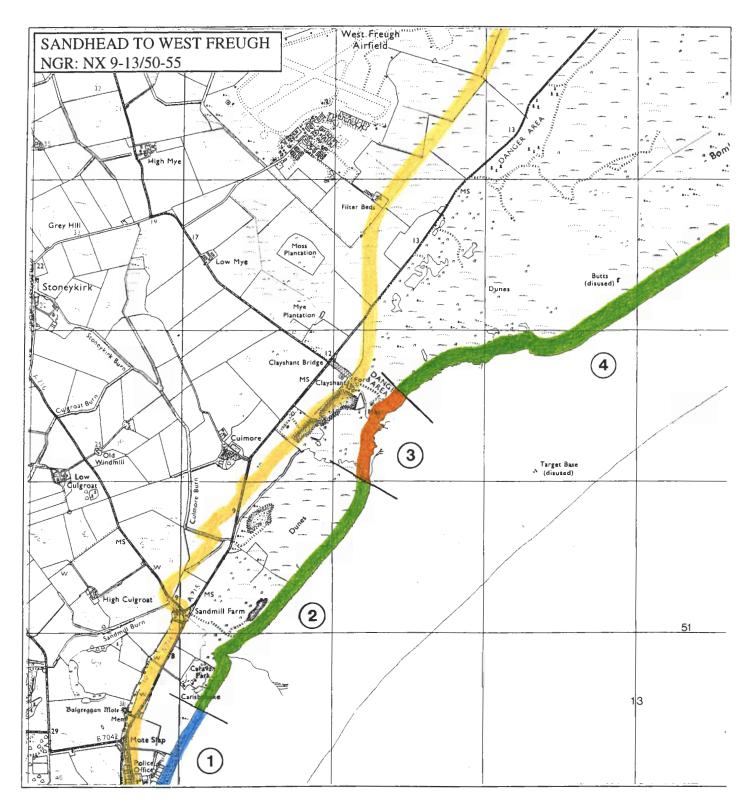
This unit consists of sand dunes that are eroding due deflation and water erosion from a burn that flows past Clayshant farm. The loss of sand in the backshore region appears to be severe in parts.

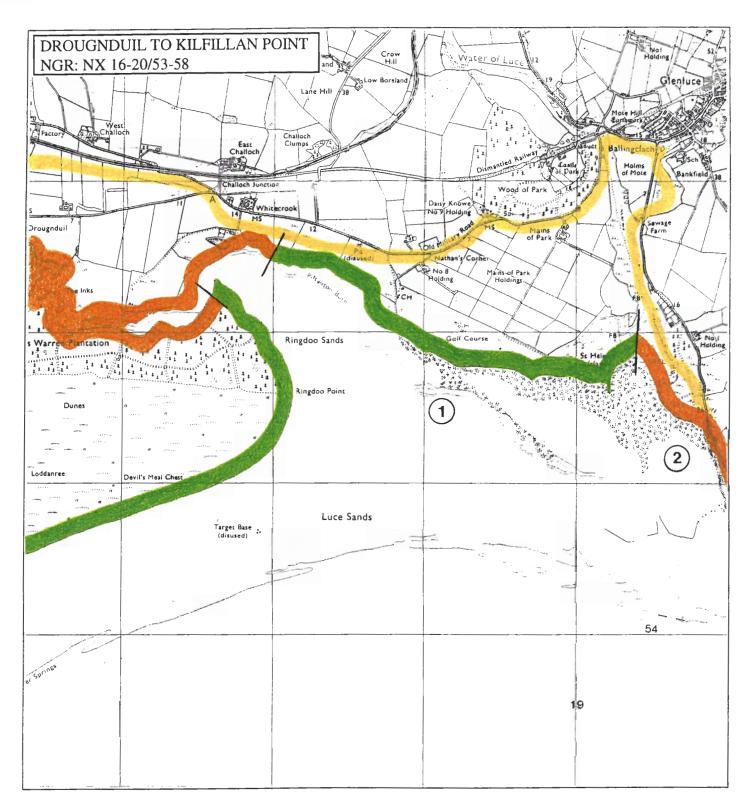
## **MAP 7: EROSION**

## 1. PILTANTON BURN to ST HELENA
