Coastal Assessment Survey Solway North Coast

Volume 2 of 3:

Crook of Baldoon to Dalbeattie

A Report for HISTORIC SCOTLAND

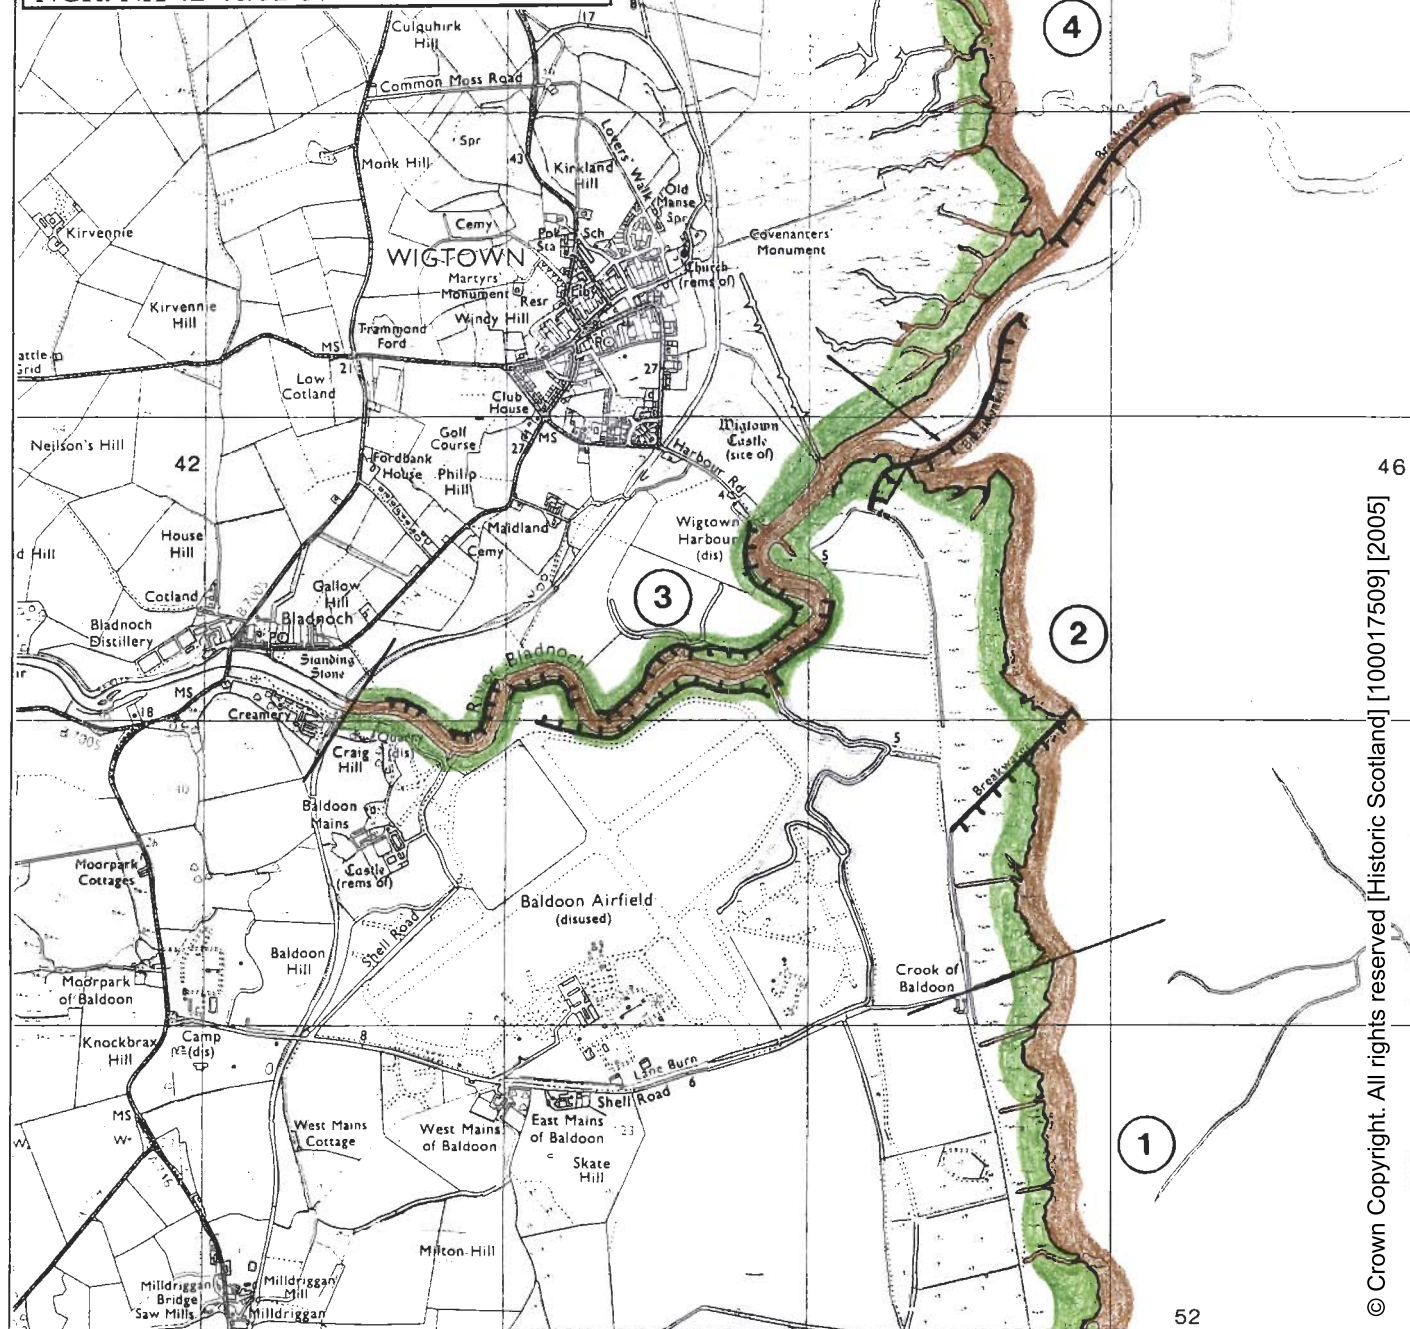
Map 20: Hinterland Geology and Coastal Geomorphology

Breakwaters have been employed to reduce sediment drift along the coastal edge. Drains intersect the marsh at regular intervals. Mud is accreting forming steep banks. Arcuate slope failure on the inner channel edges near the HWM shows that this region is dynamic and prone to occasional erosion.

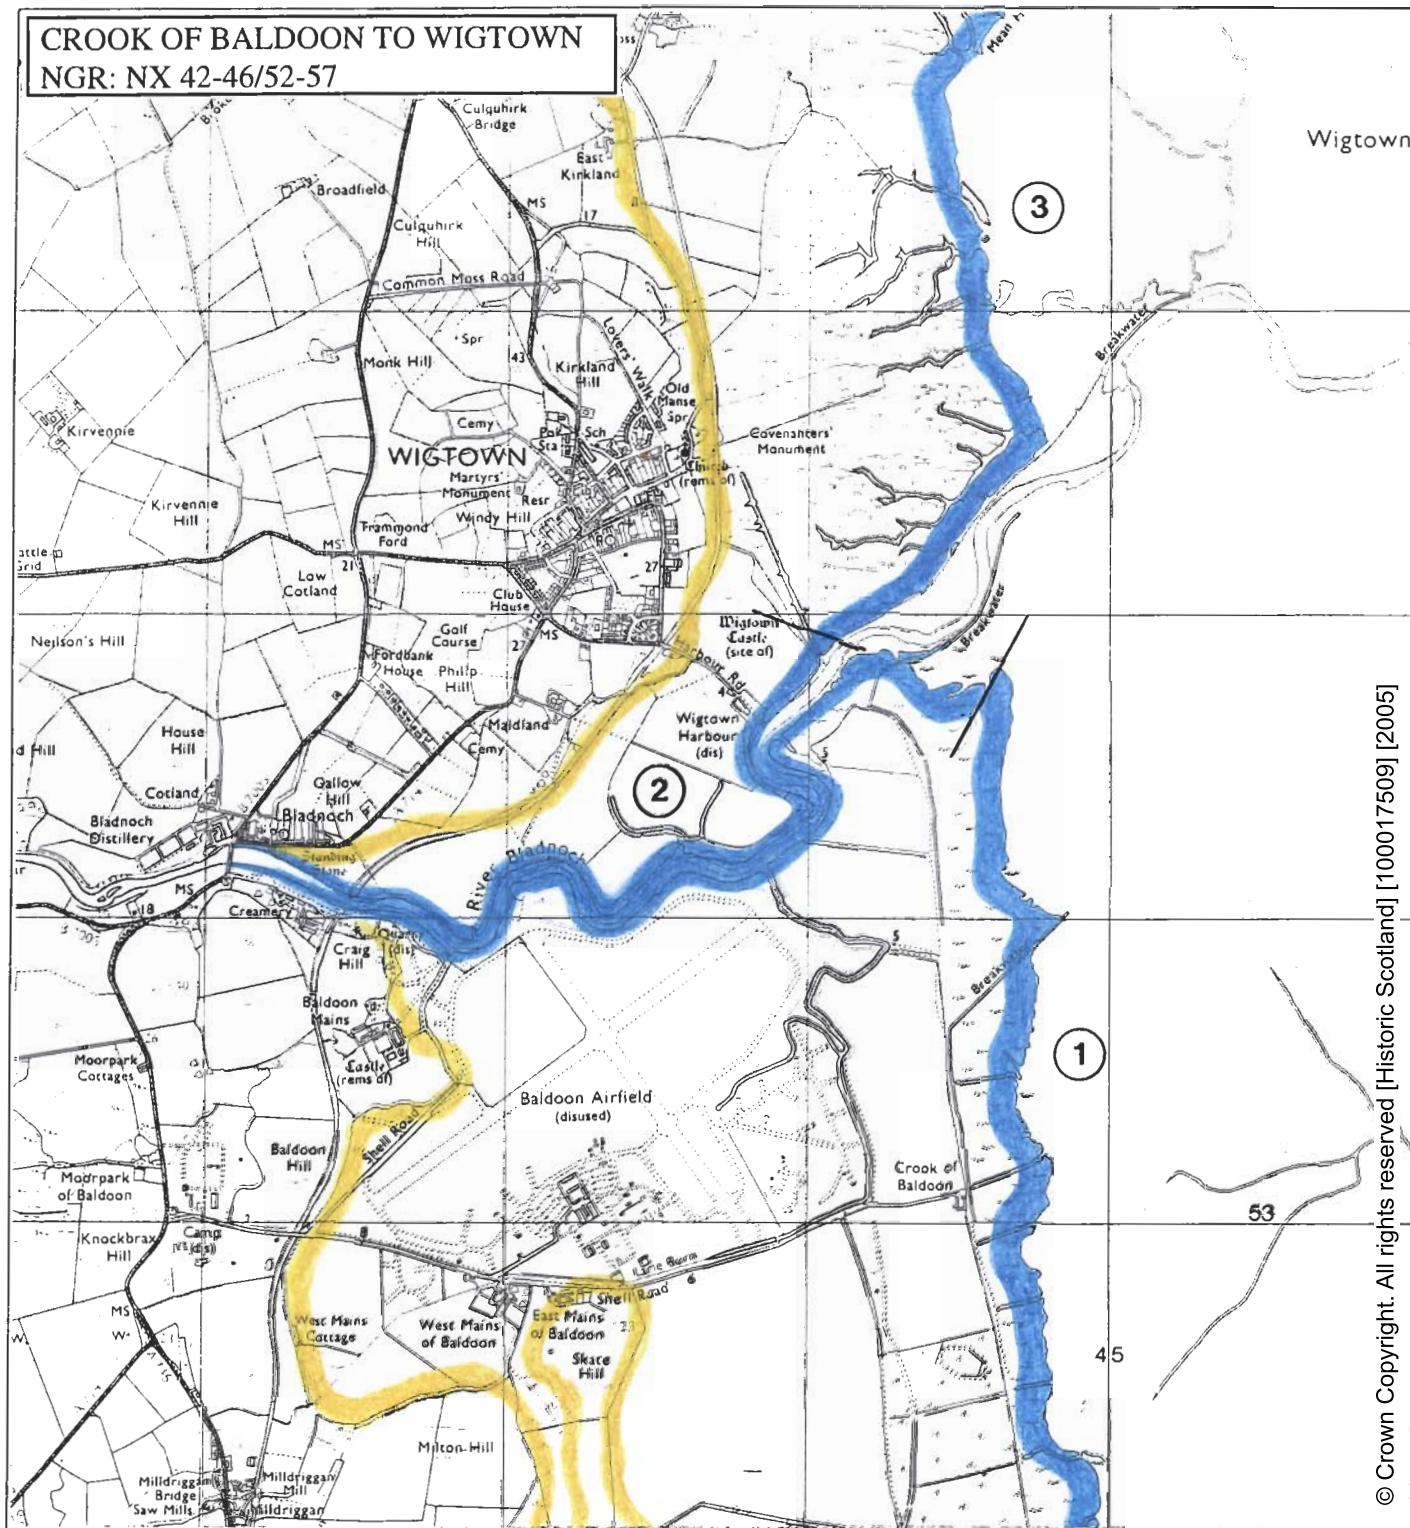
CROOK OF BALDOON TO WIGTOWN NGR: NX 42-46/52-57

This unit is a saltmarsh formed by the formation of alluvium on the east side of the River Cree estuary. This wide stretch of marsh is deeply incised by drainage channels. In places arcuate slope failure is occurring on the edge of some of the channels. Due to the high sediment loading the general trend for this region is accretion.

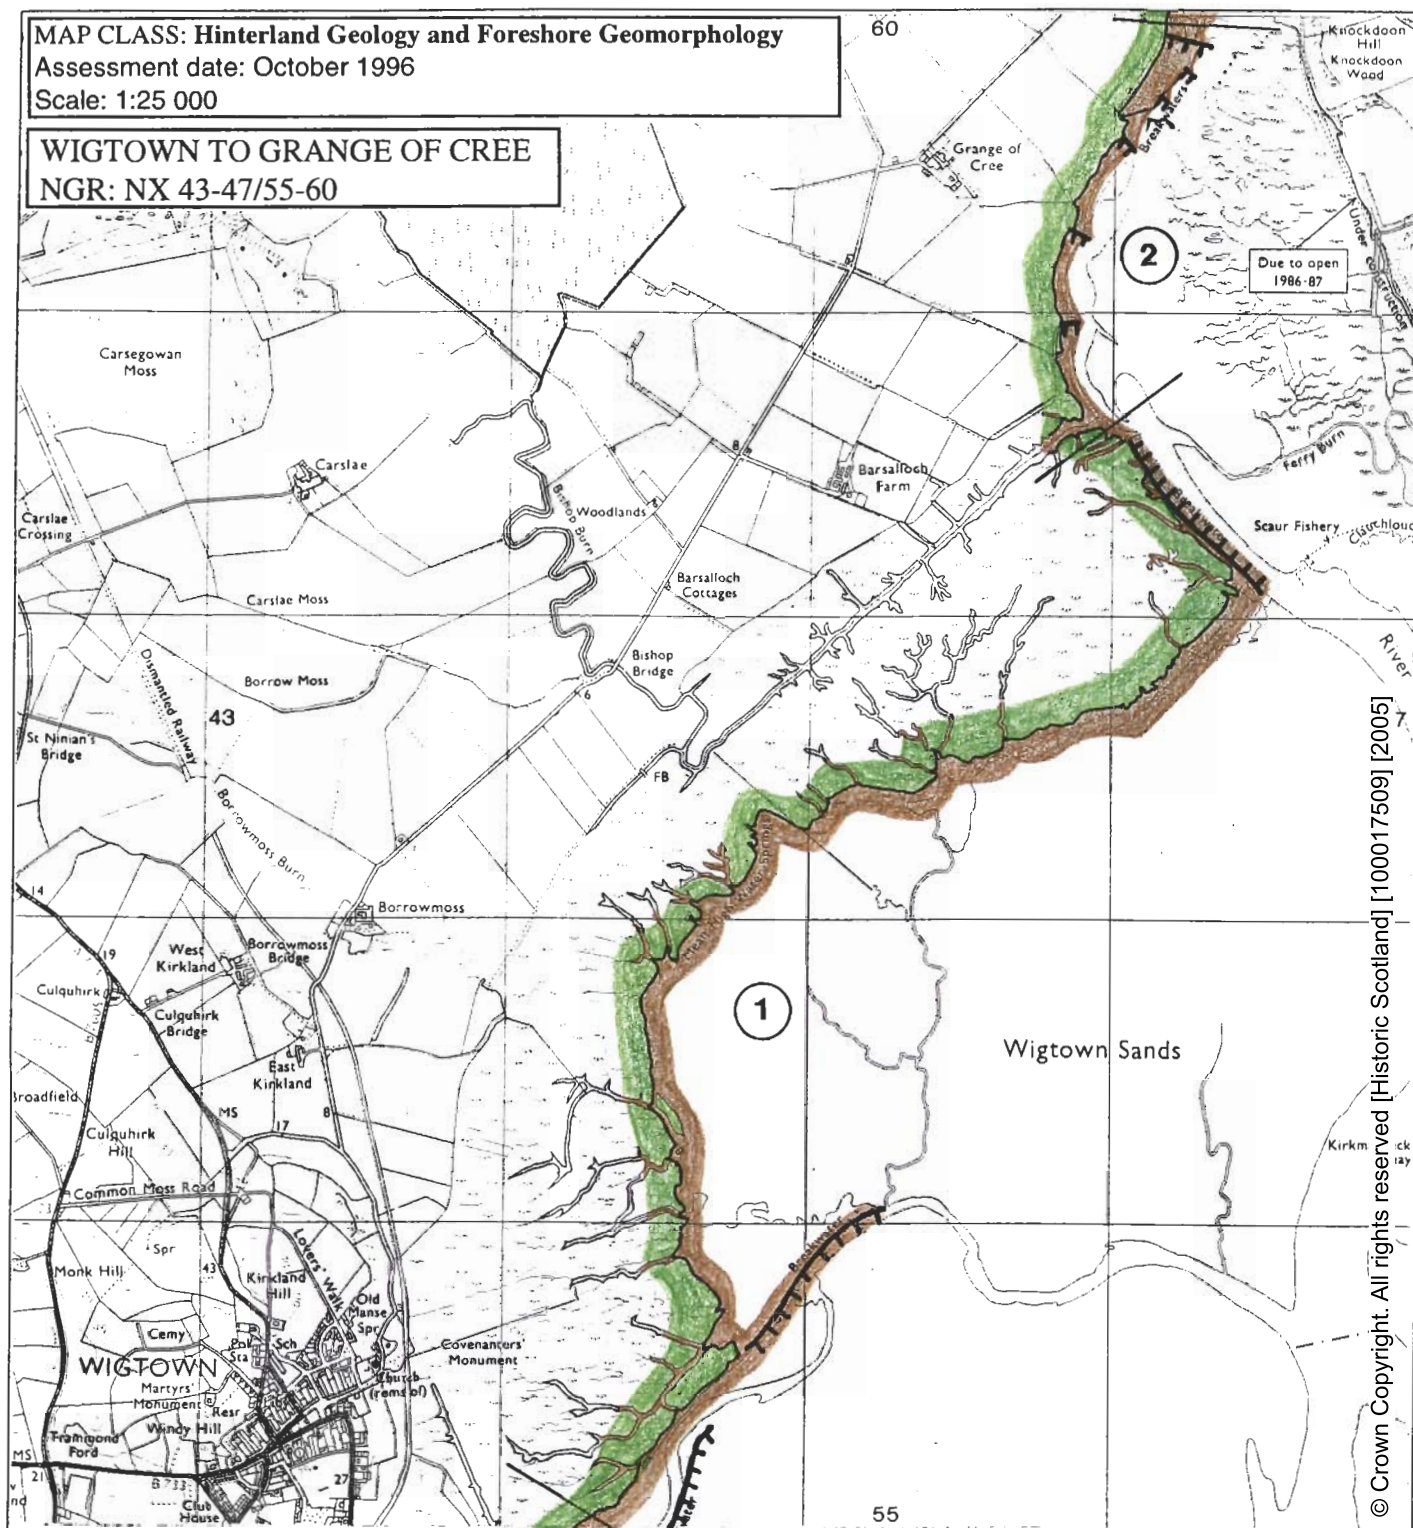
NGR: NX 43-47/55-60

This unit is a saltmarsh formed by the formation of alluvium on the east side of the River Cree estuary. This wide stretch of marsh is deeply incised by drainage channels. In places arcuate slope failure is occurring on the edge of some of the channels. Due to the high sediment loading the general trend for this region is accretion.

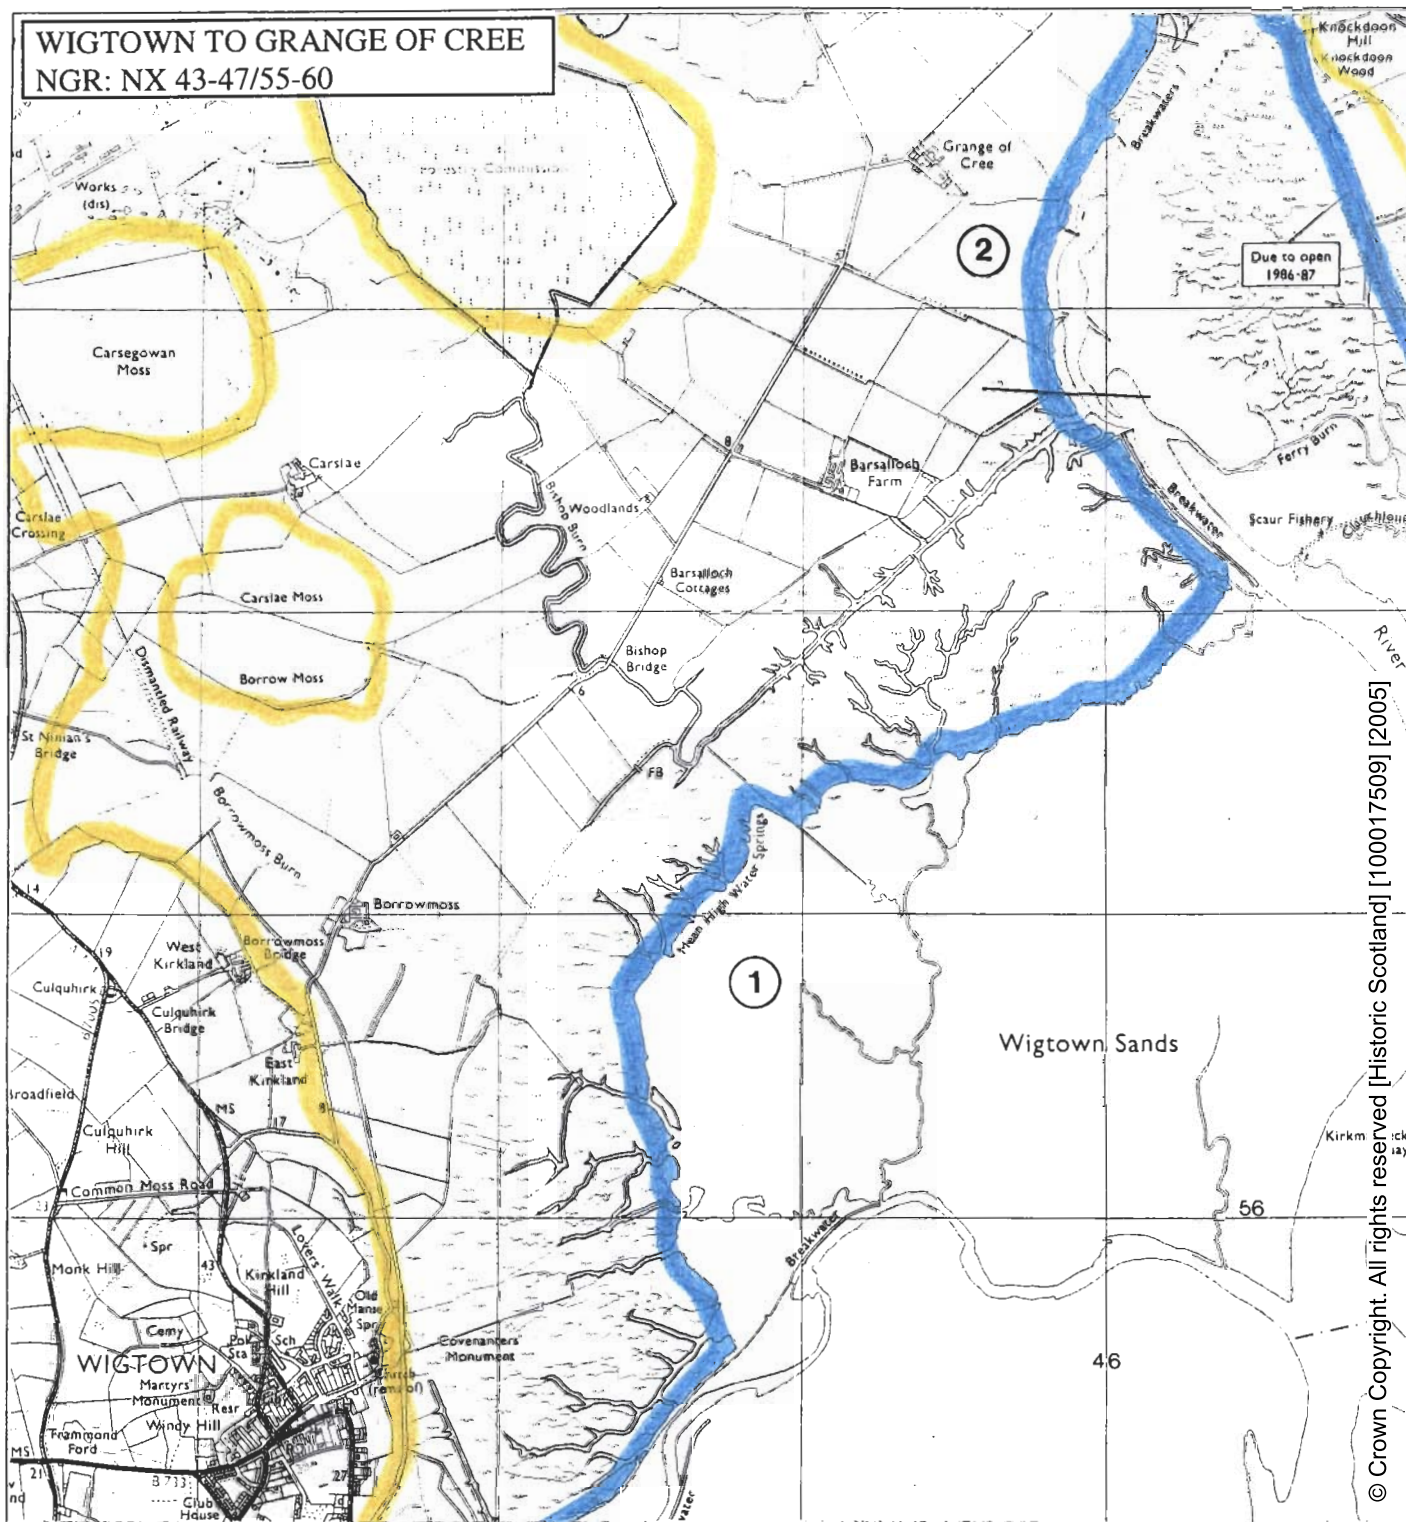
The narrow lower tidal reach of the River Cree. This unit consists of eroding soft mud banks with accreting mud on the edge of breakwaters. Stands of *Phragmites sp* are established which are excellent at trapping silts leading to increased sediment build up.

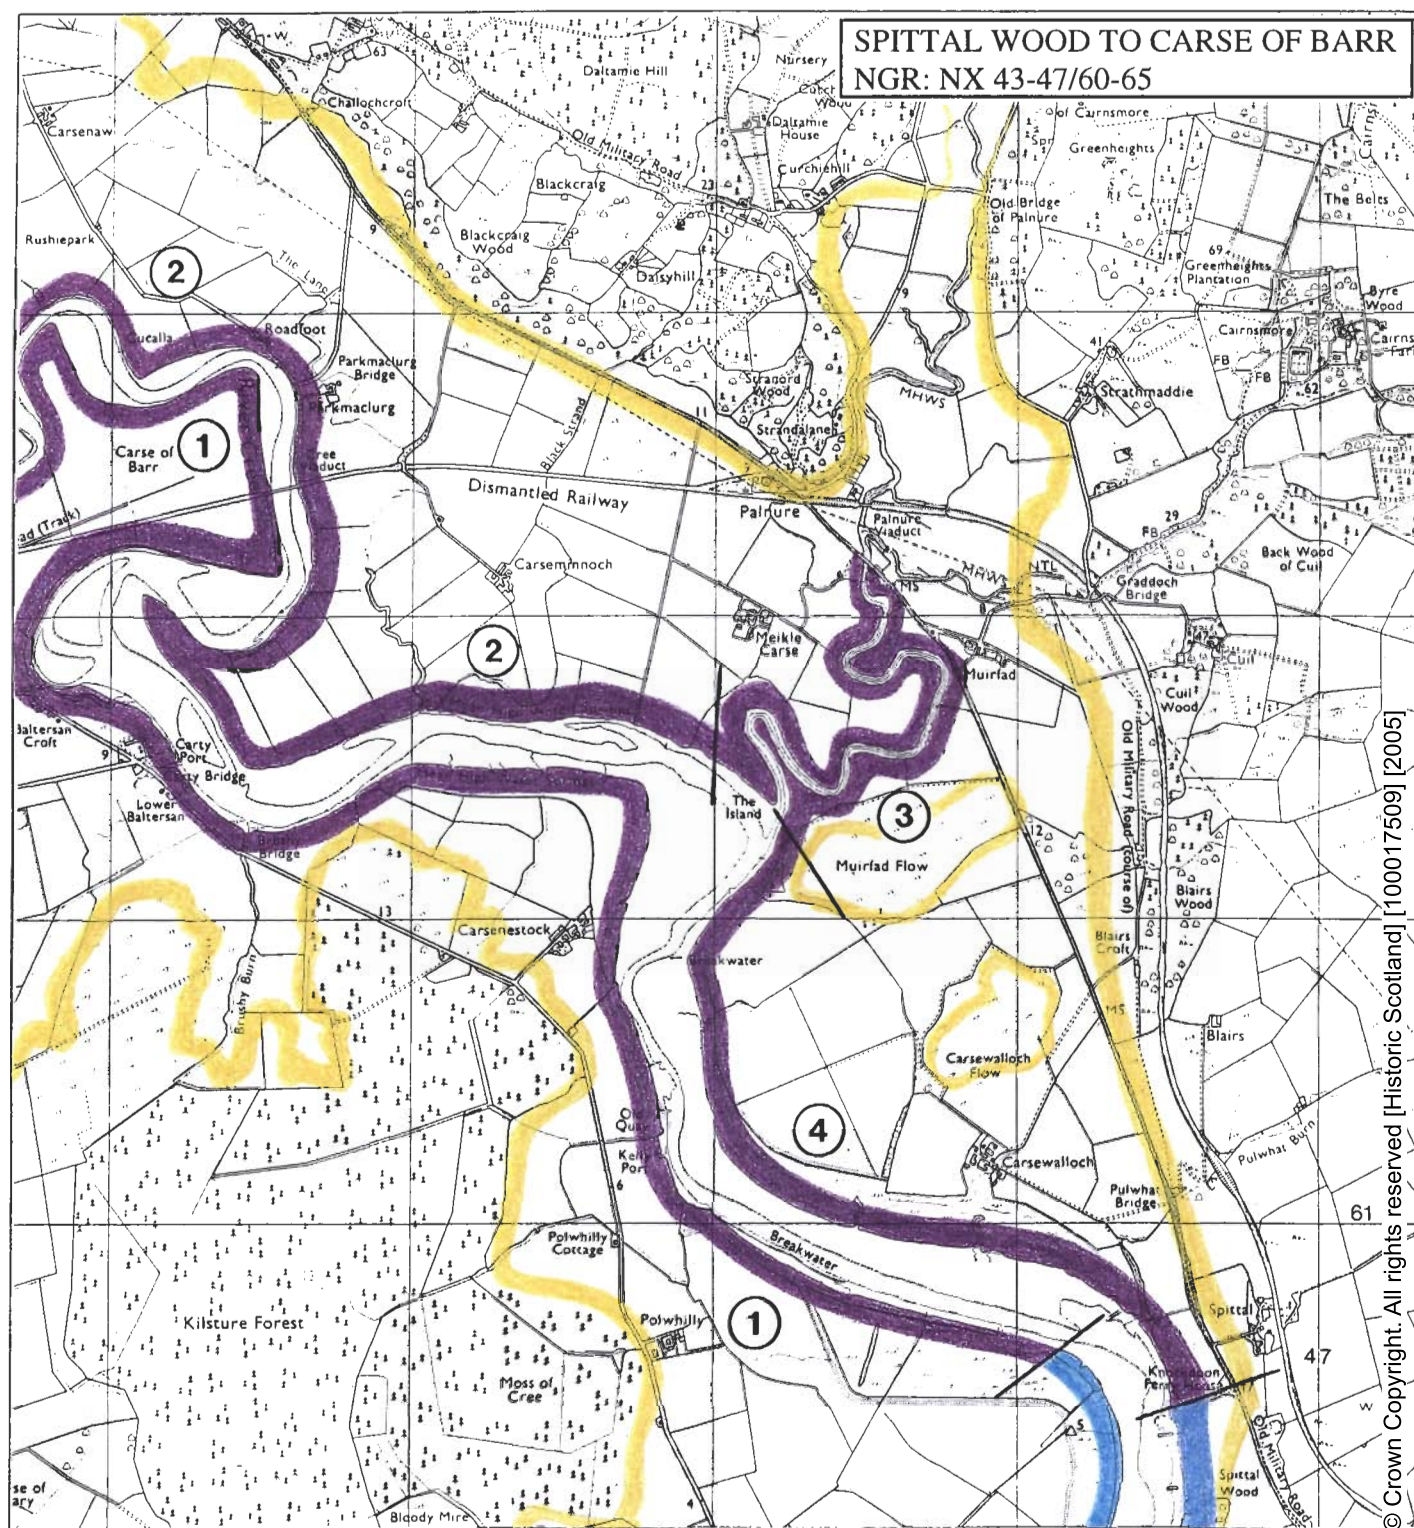
A curving stretch of the lower tidal River Cree. Parts of the bank display slope failure at the SHWM. As the main river channel is on the western side mud is now accreting on the eastern side of the channel.

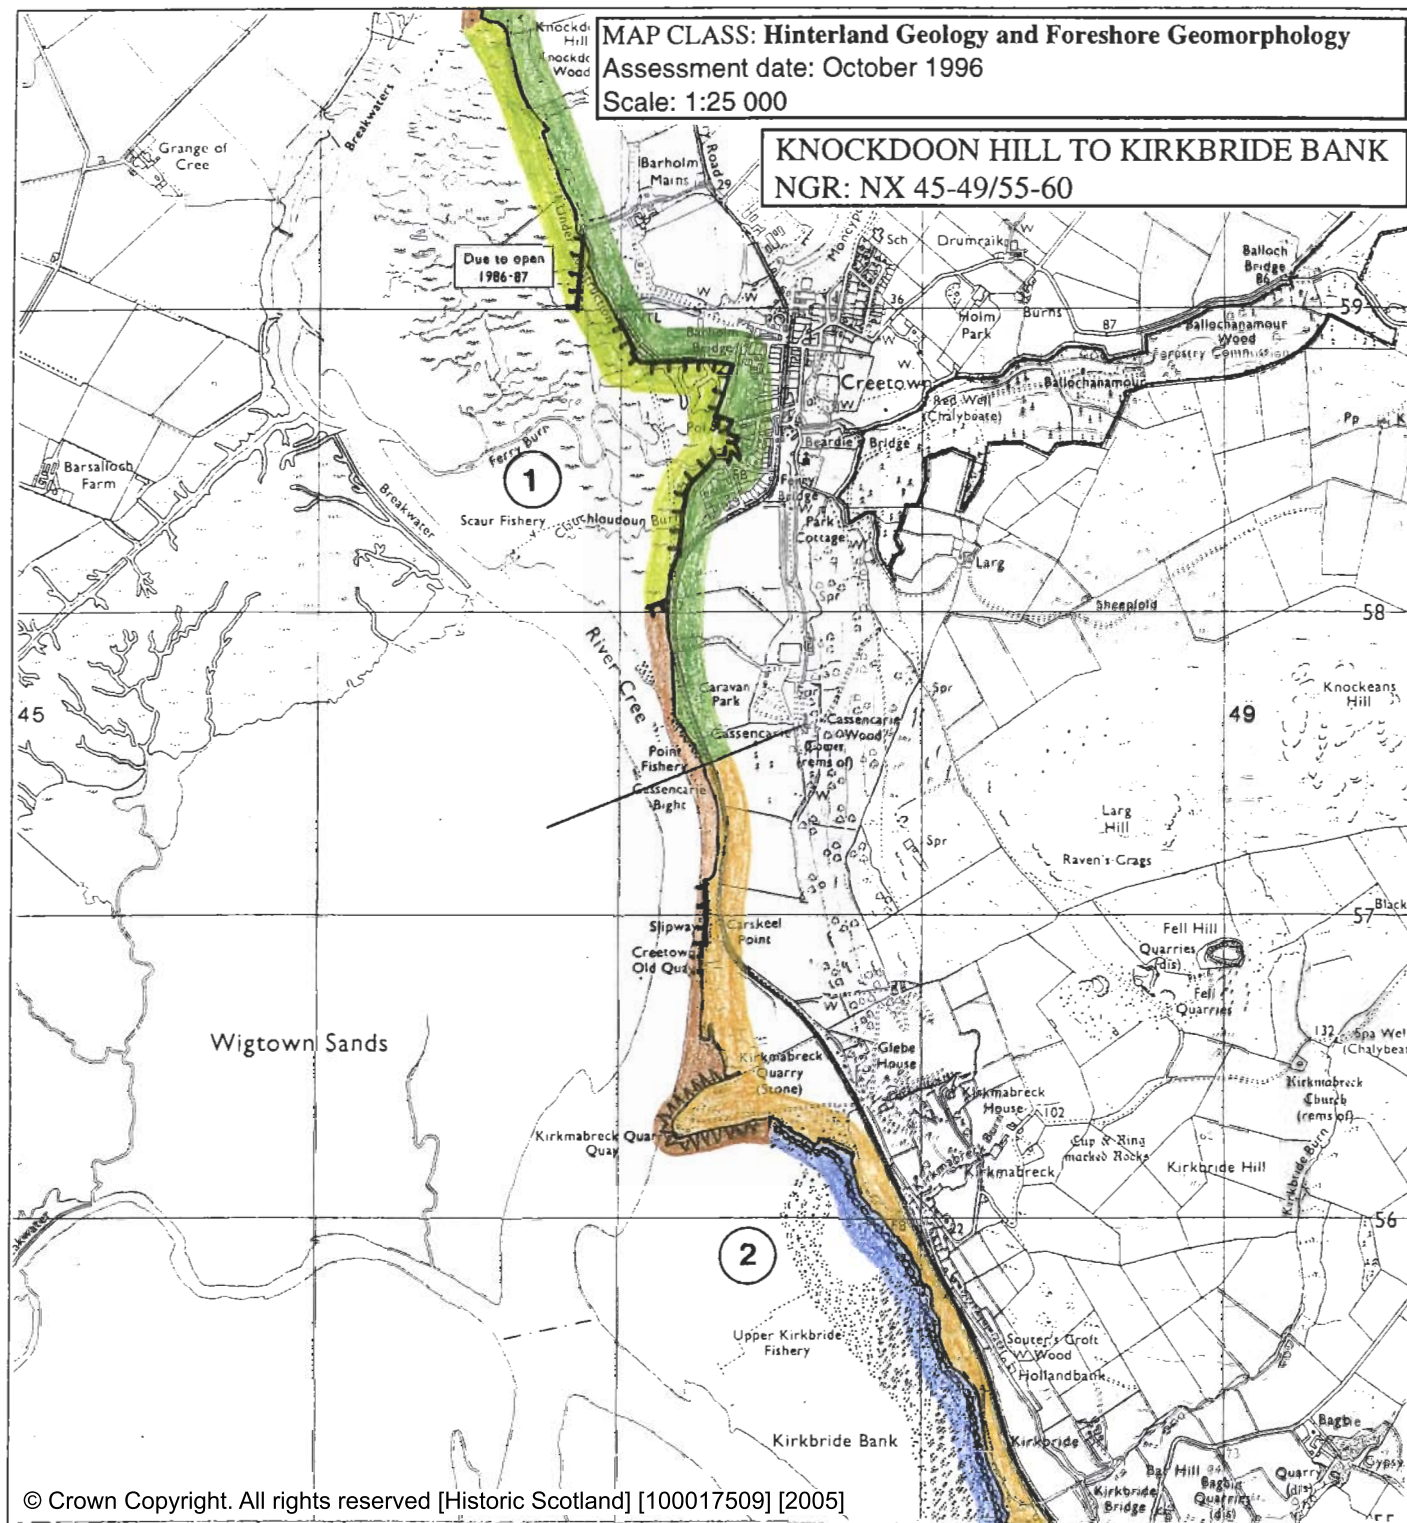
Middle tidal reach of Wigton Sands with marine sands and gravels on the hinterland. The foreshore consists of alluvial silts towards Point Fishery that gives way to salt-marsh further south. South of Kirkmabreck Quay the foreshore changes markedly to poorly sorted boulders intermixed with fine alluvial sand and mud.

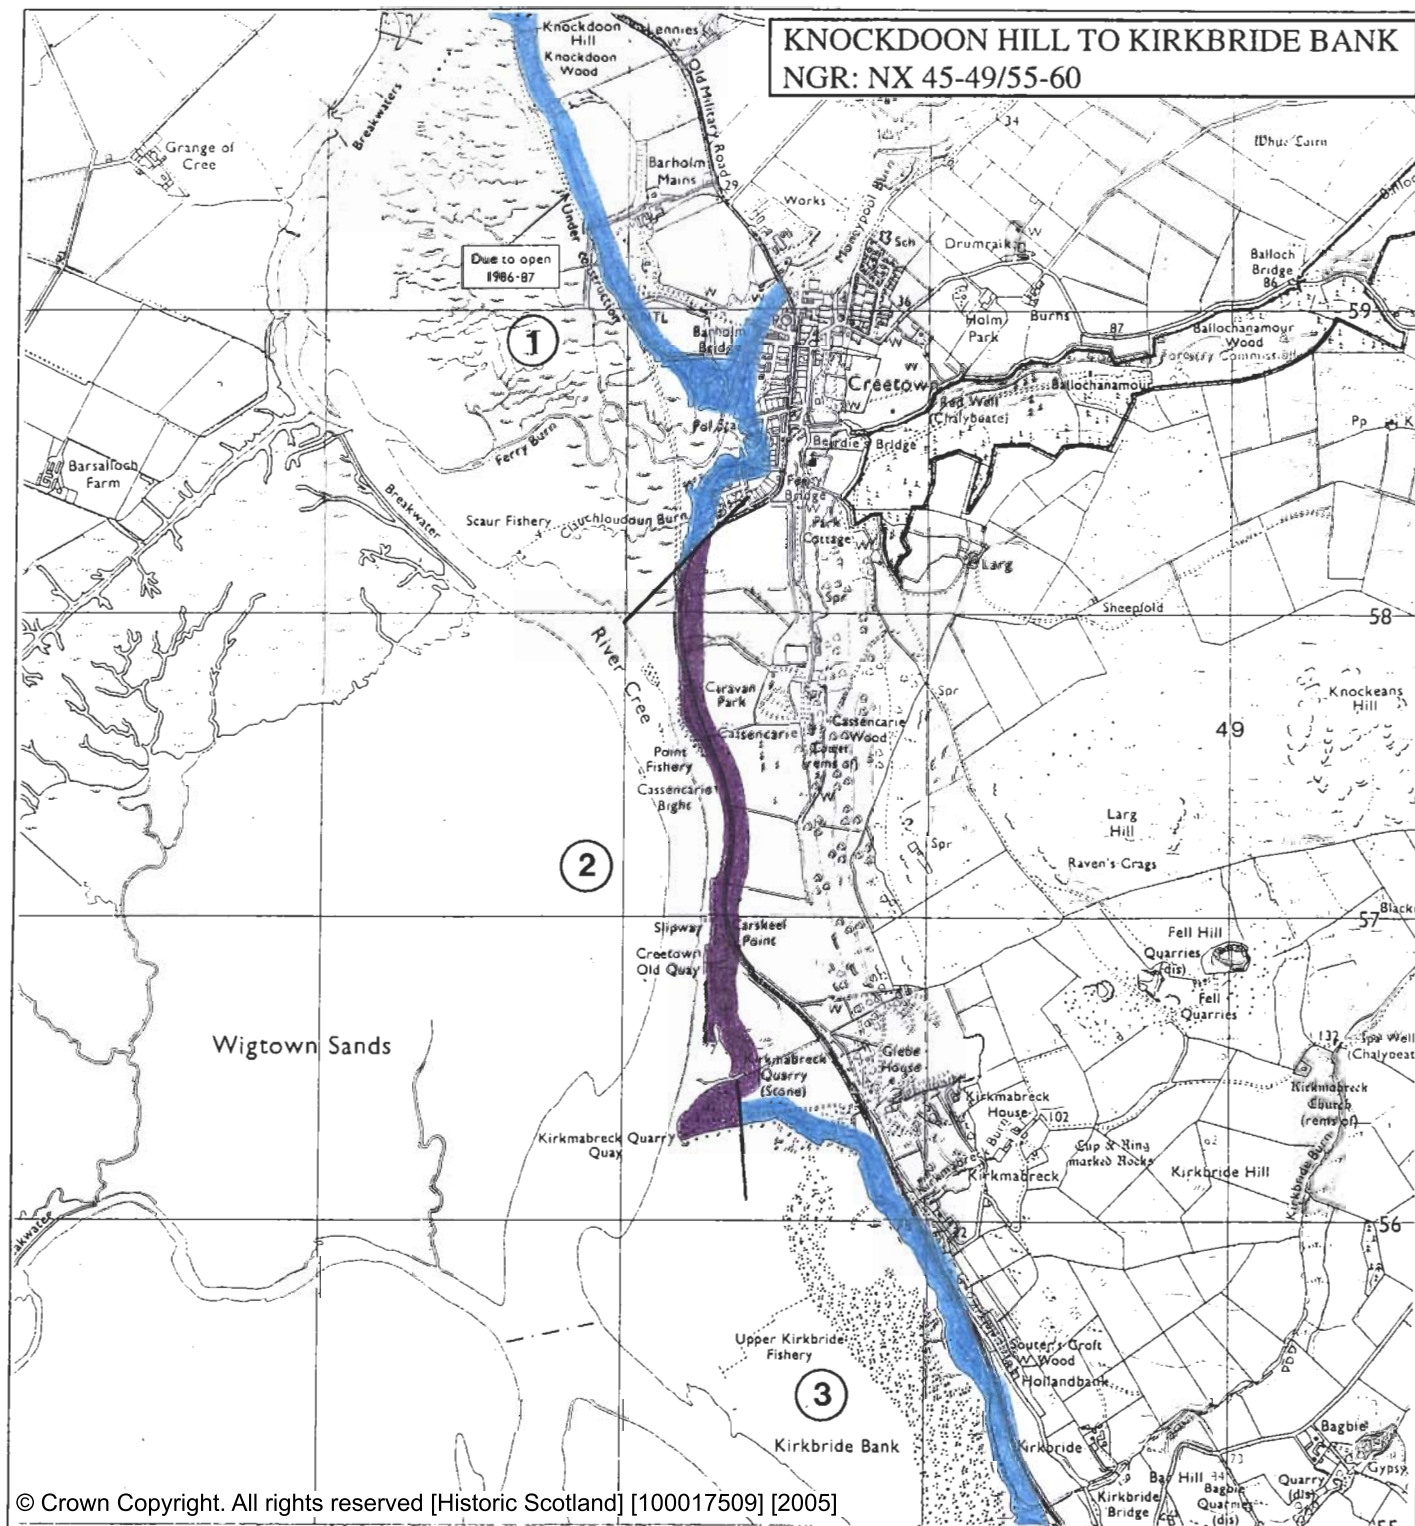
The MHW is consolidated by reed beds. Shingle and mud is accumulating in parts possibly due to long shore drift caused by the large quarry dumps at Kirkmabreck.

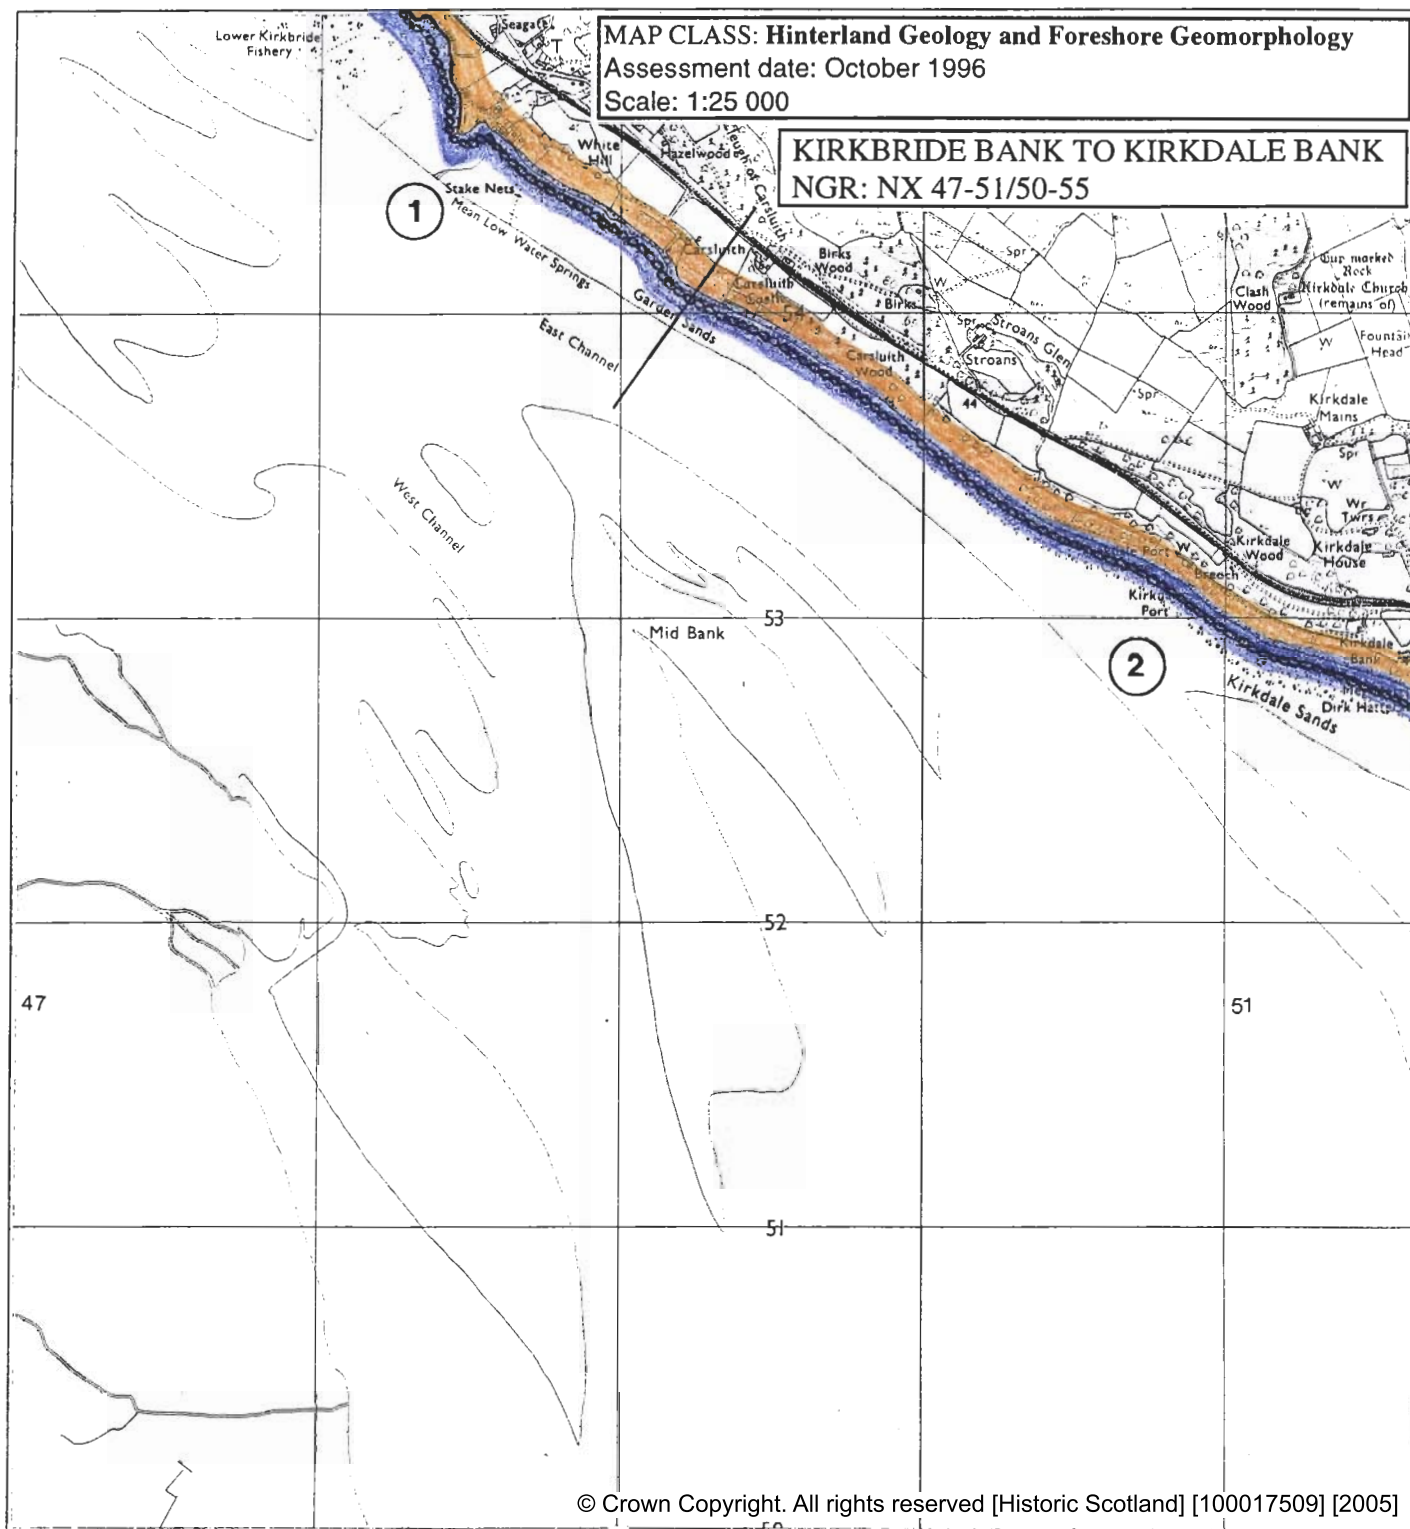
Marine sands and gravel overlie this straight stretch of coastline. The foreshore consists of a sand and shingle beach overlooking wide tidal flats.

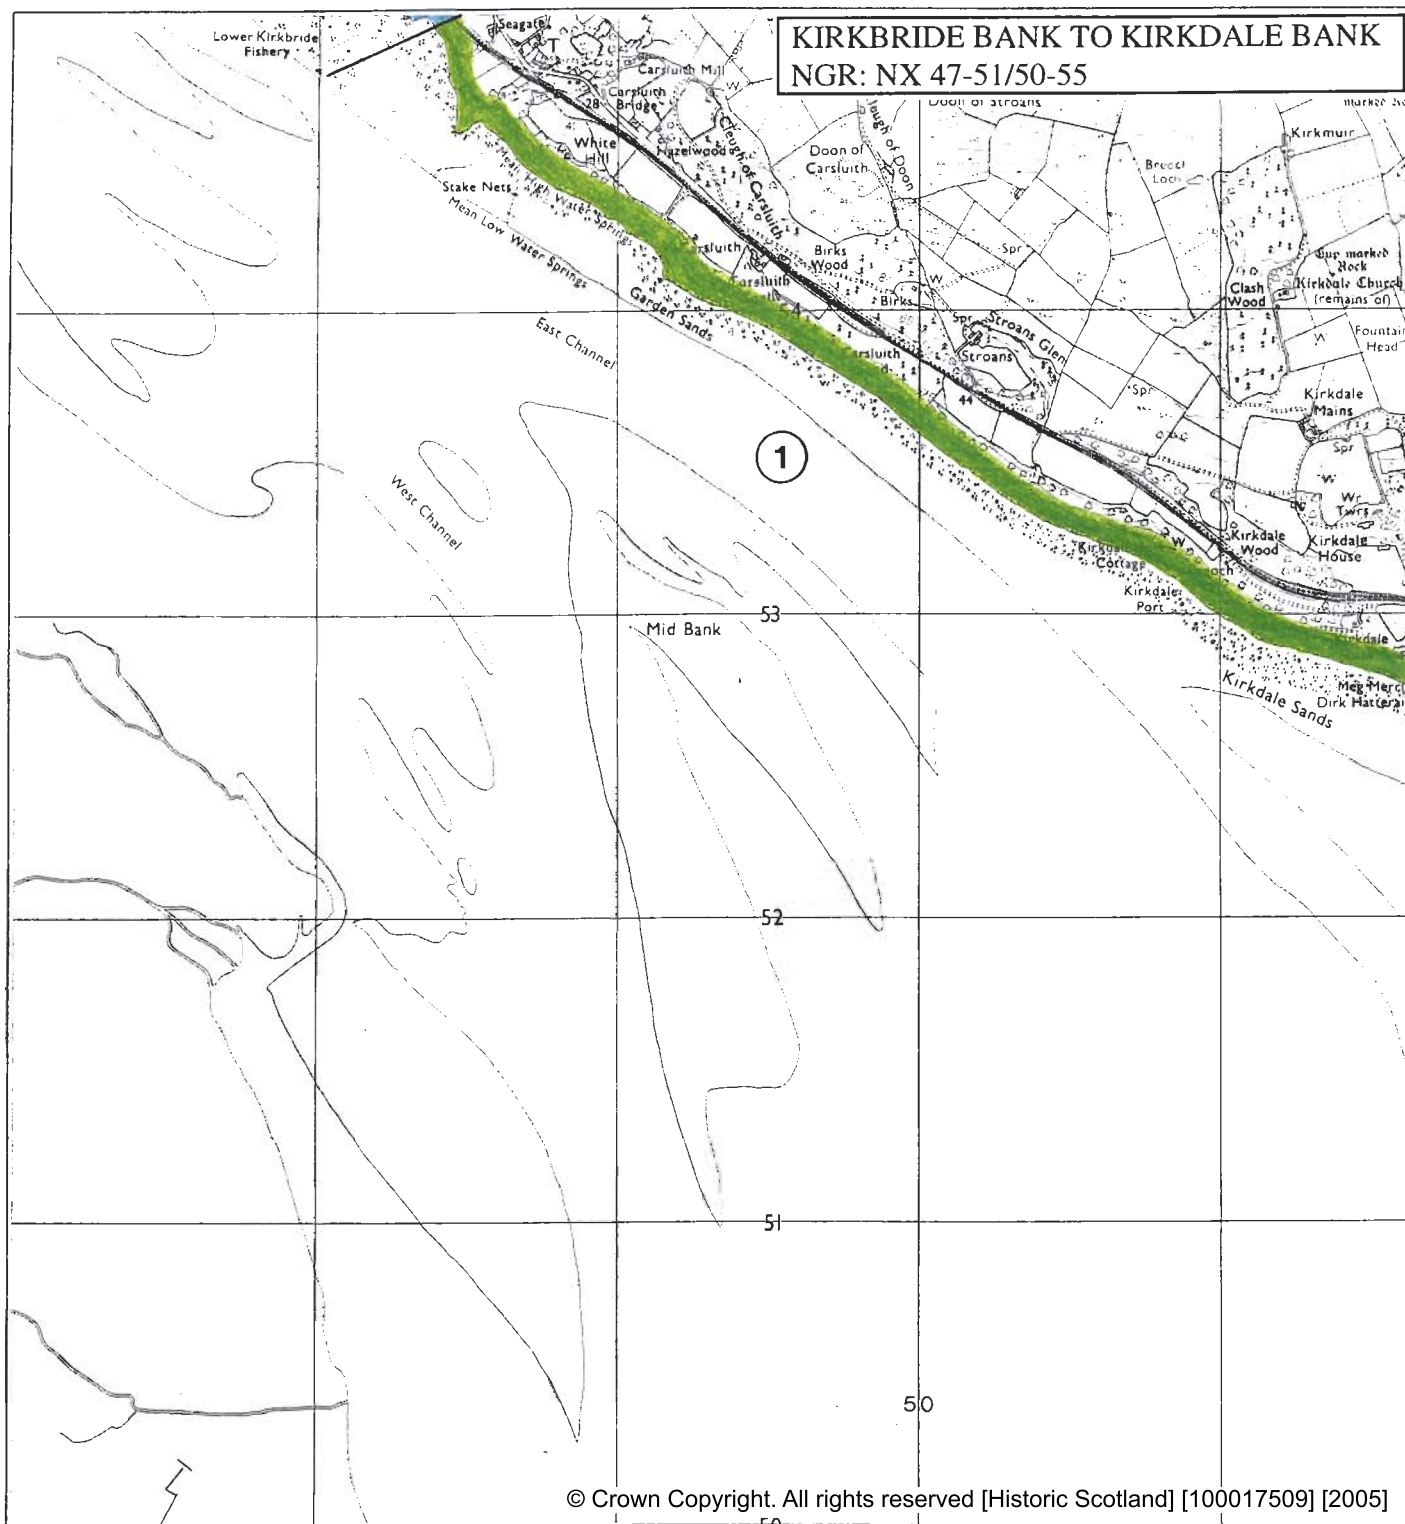
This unit consists of shingle and sandy beaches with a wide intertidal area. The MHW is consolidated with reed beds and salt marsh vegetation.

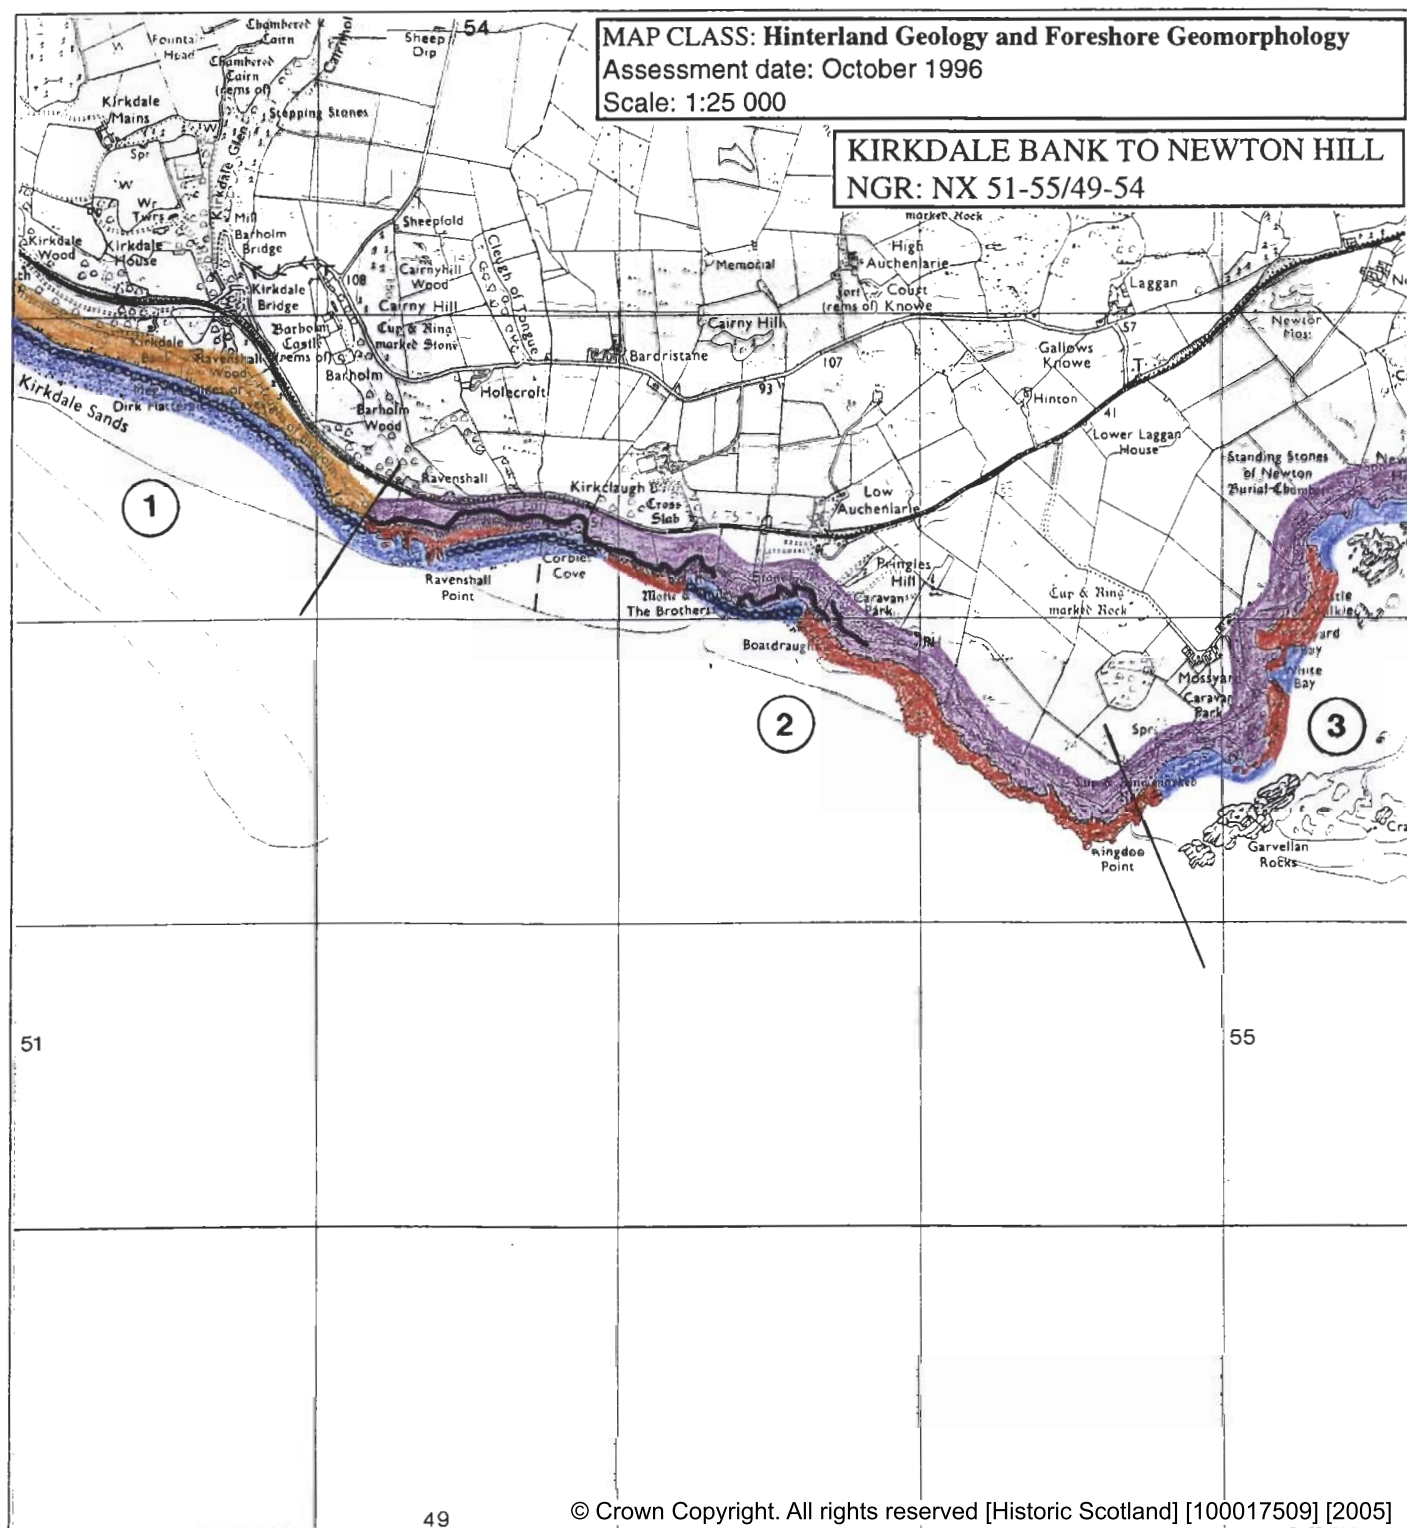
Lower estuary of Fleet Bay. The hinterland consists of till over exposed rock platform. The shoreline is fractured into a series of small rocky bays. Low tidal flats with sand and mud at MHWL.
