Coastal Assessment Survey Solway North Coast

Volume 2 of 3:

Crook of Baldoon to Dalbeattie

A Report for HISTORIC SCOTLAND

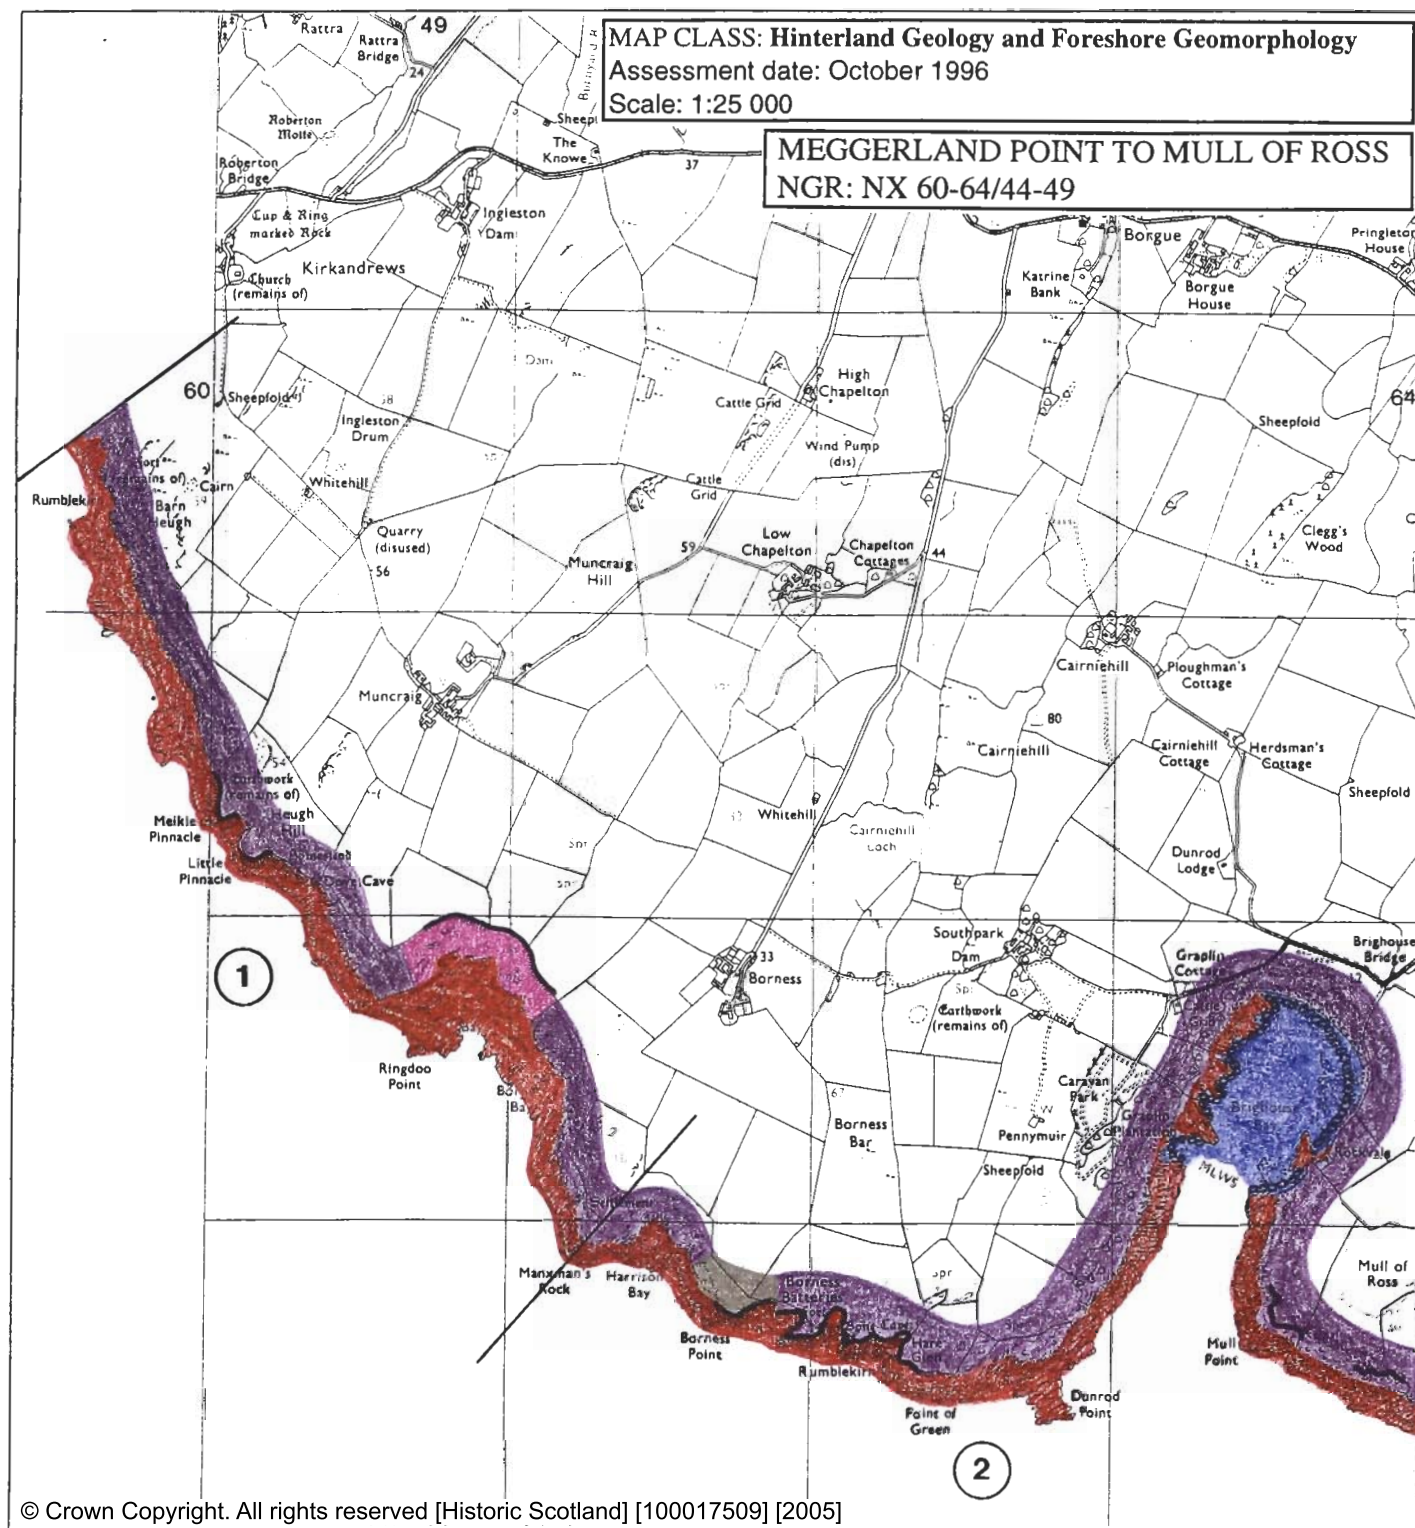
This is an exposed irregular coast including Brighthouse Bay (NX 635455). The cliff-edge is fractured and incised. Greywackee platforms are exposed throughout this unit. Brighthouse bay is exposed at low water and consists of mainly sand and shingle up to the MHWL.

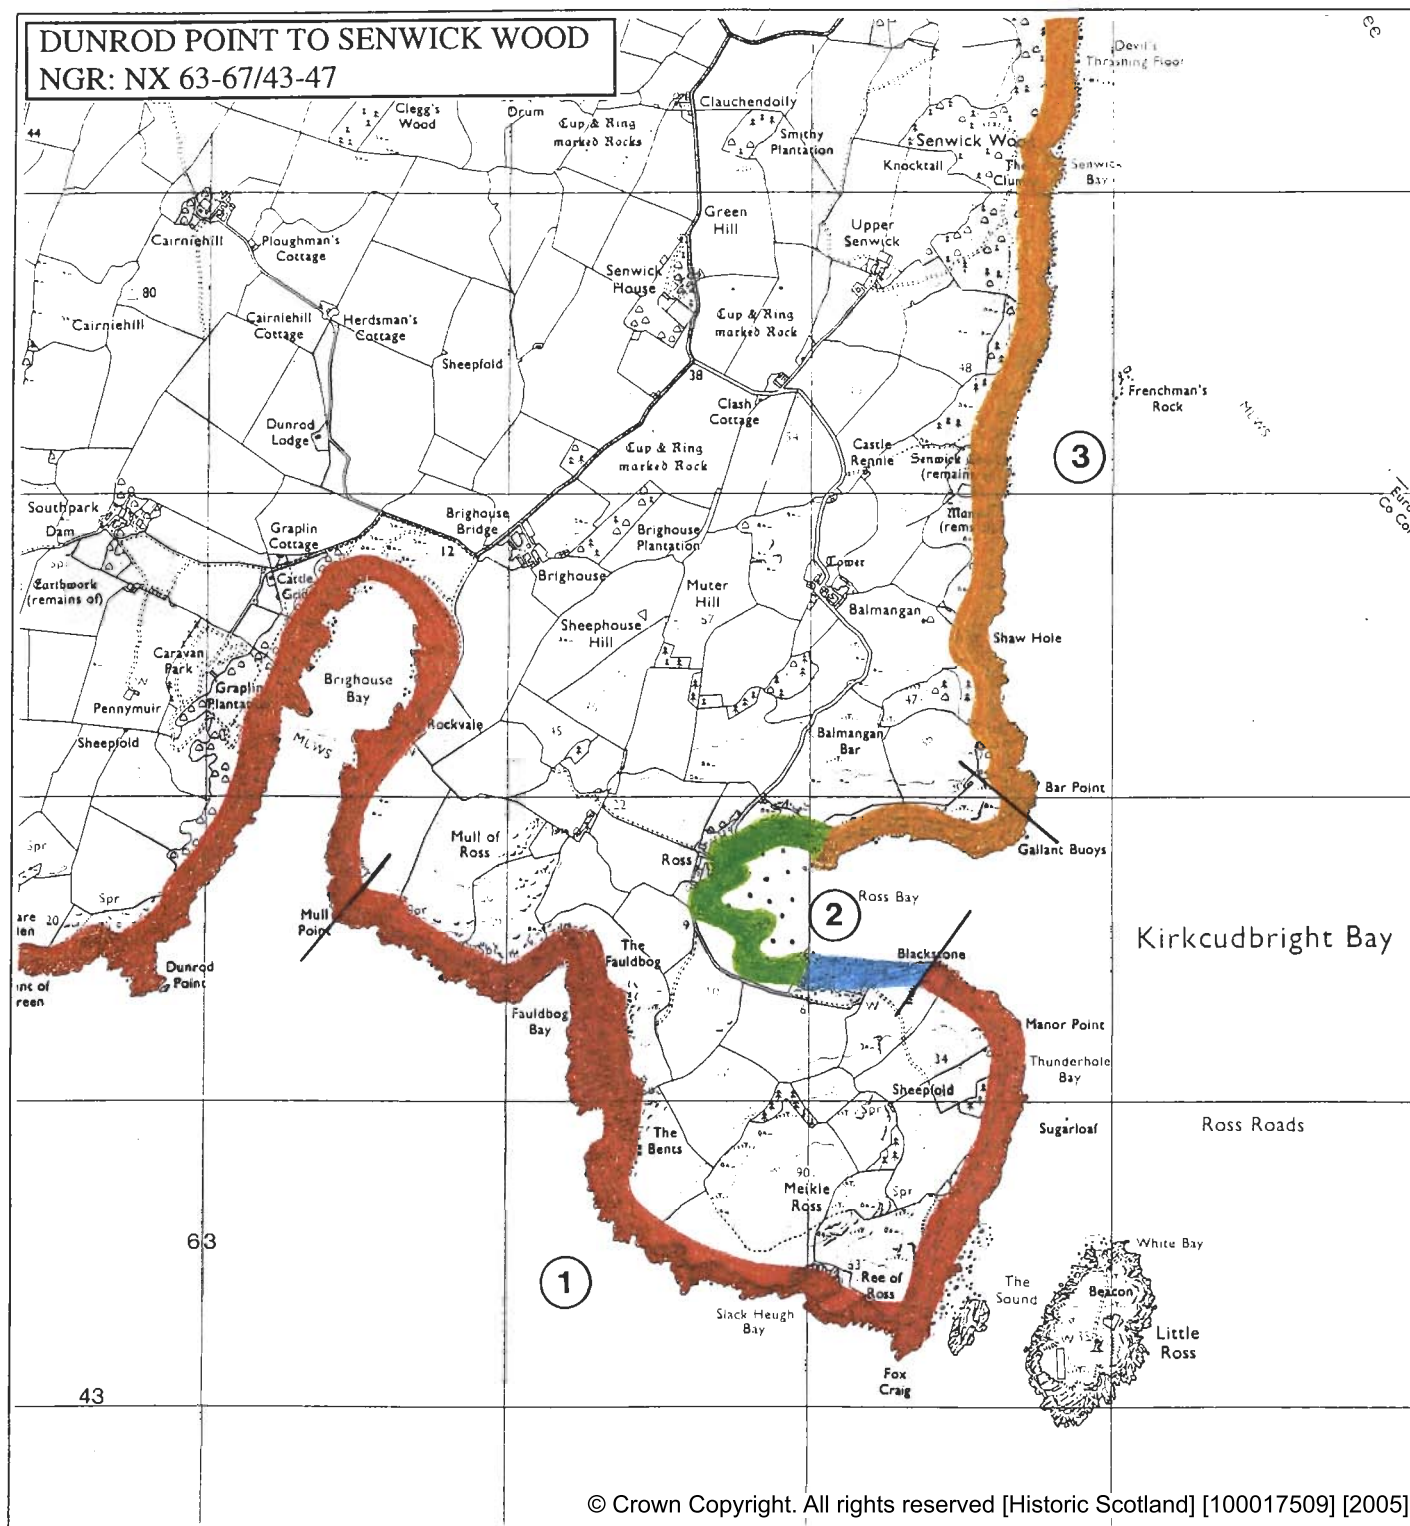
Moderately incised low cliff-edge characterise this unit. At Shaw Hole the cliffs are scoured into narrow gullies. Further north the intertidal zone becomes much wider with mainly sand and poorly sorted boulders. Erosion is considered to be minimal along this stretch of coast due to its sheltered position.

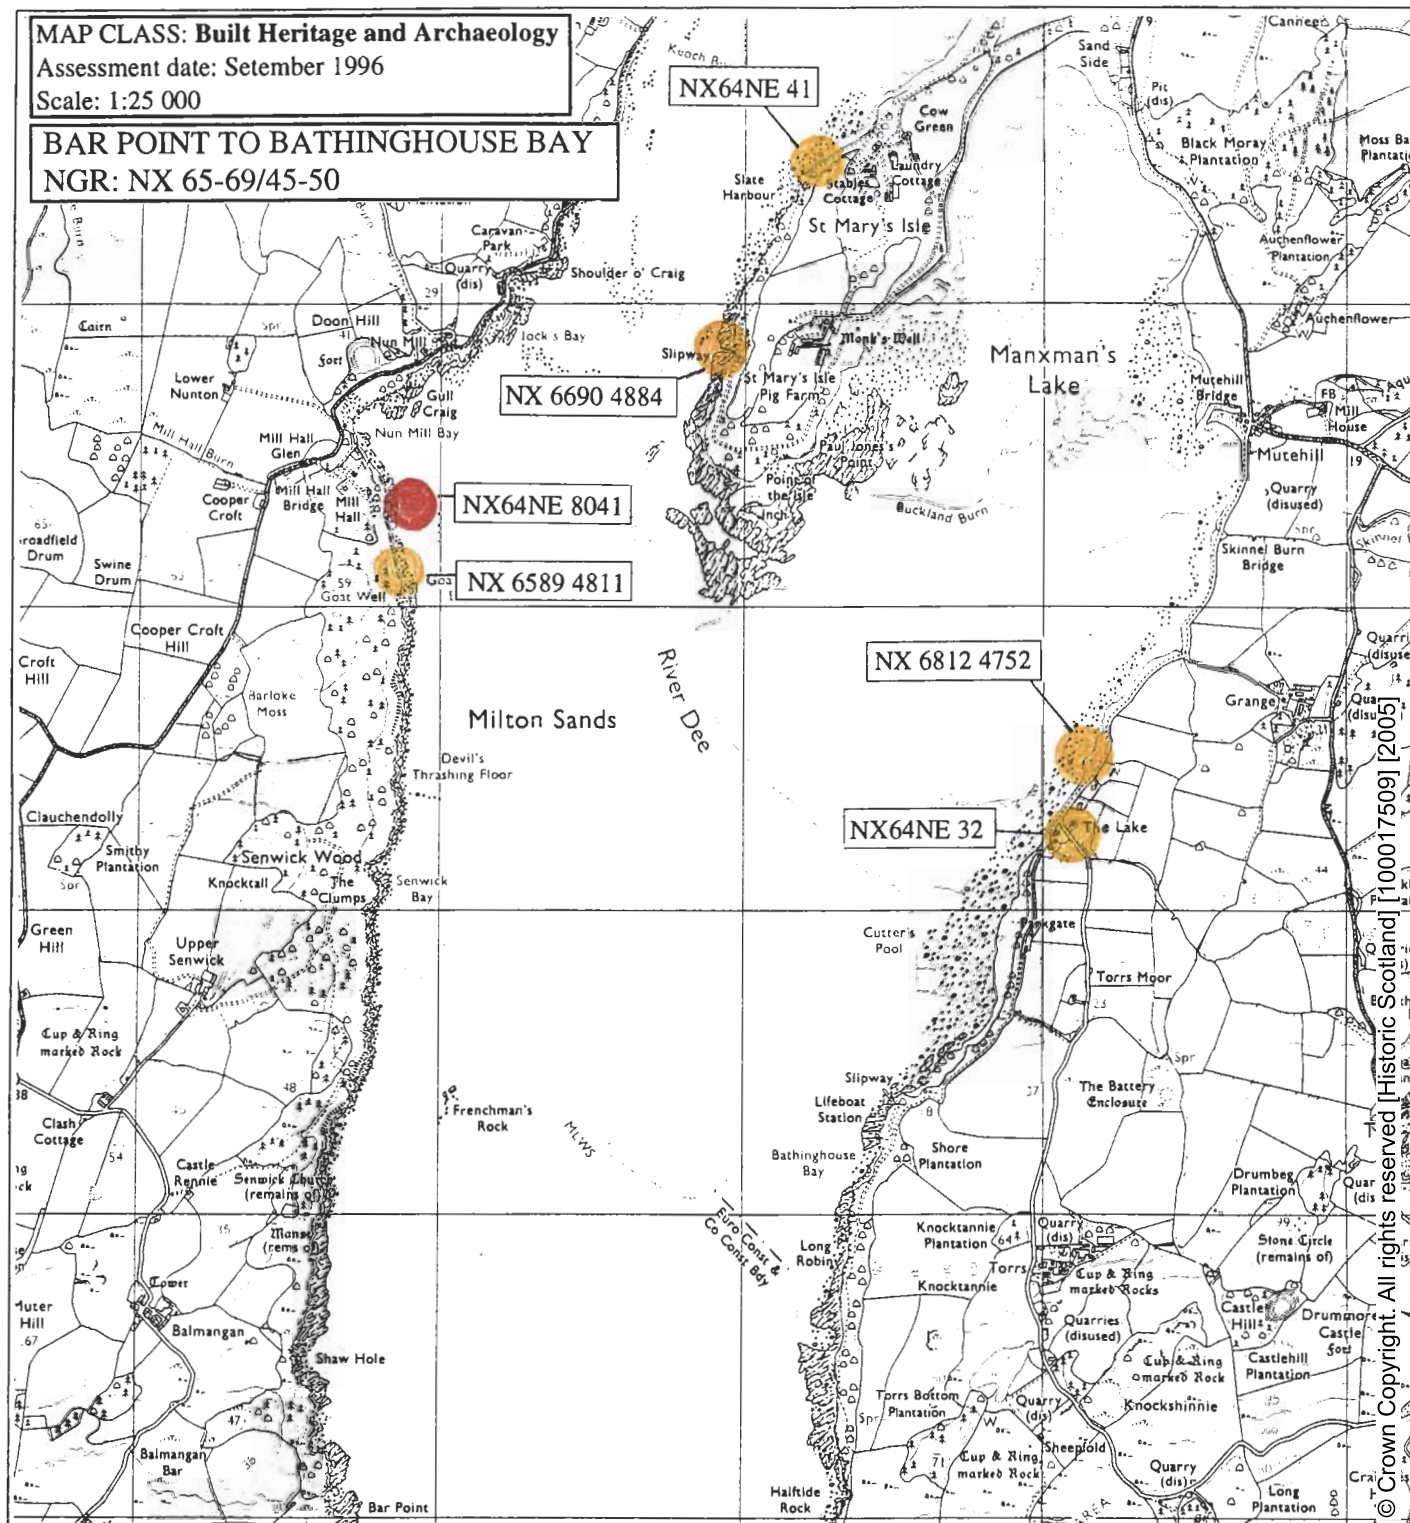
NGR: NX 65-69/45-50

This unit includes Nun Mill Bay and the fractured rocky cliff-edge at Jocks Bay (NX 662 489). At Nun Mill Bay a private sea wall at the MHWL has collapsed and the soft clay behind is eroding out. Wall fabric is strewn about the foreshore.

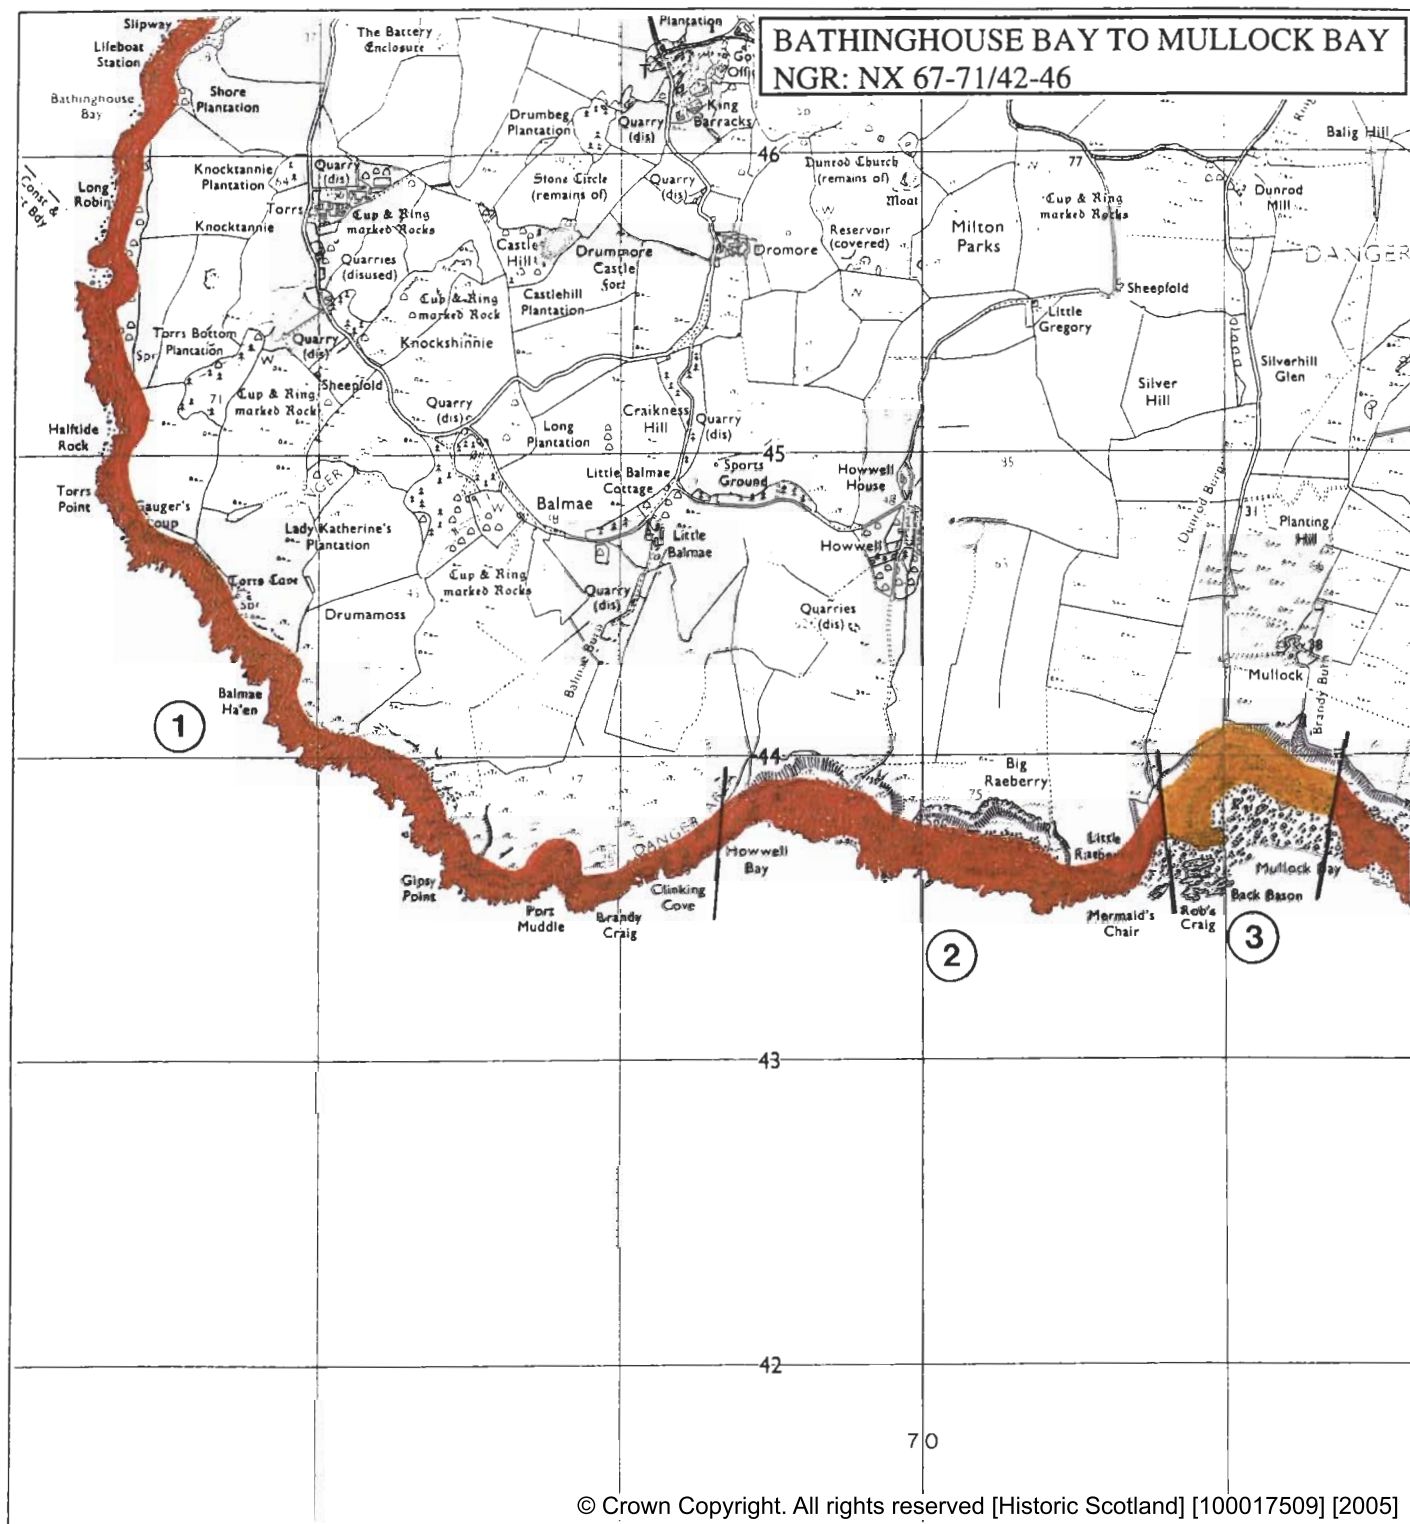
This unit contains Mullock Bay. Large boulders intermixed with shingle occur within the bay. At the MHW cliff material of fluvioglacial origin is slowly eroding out.

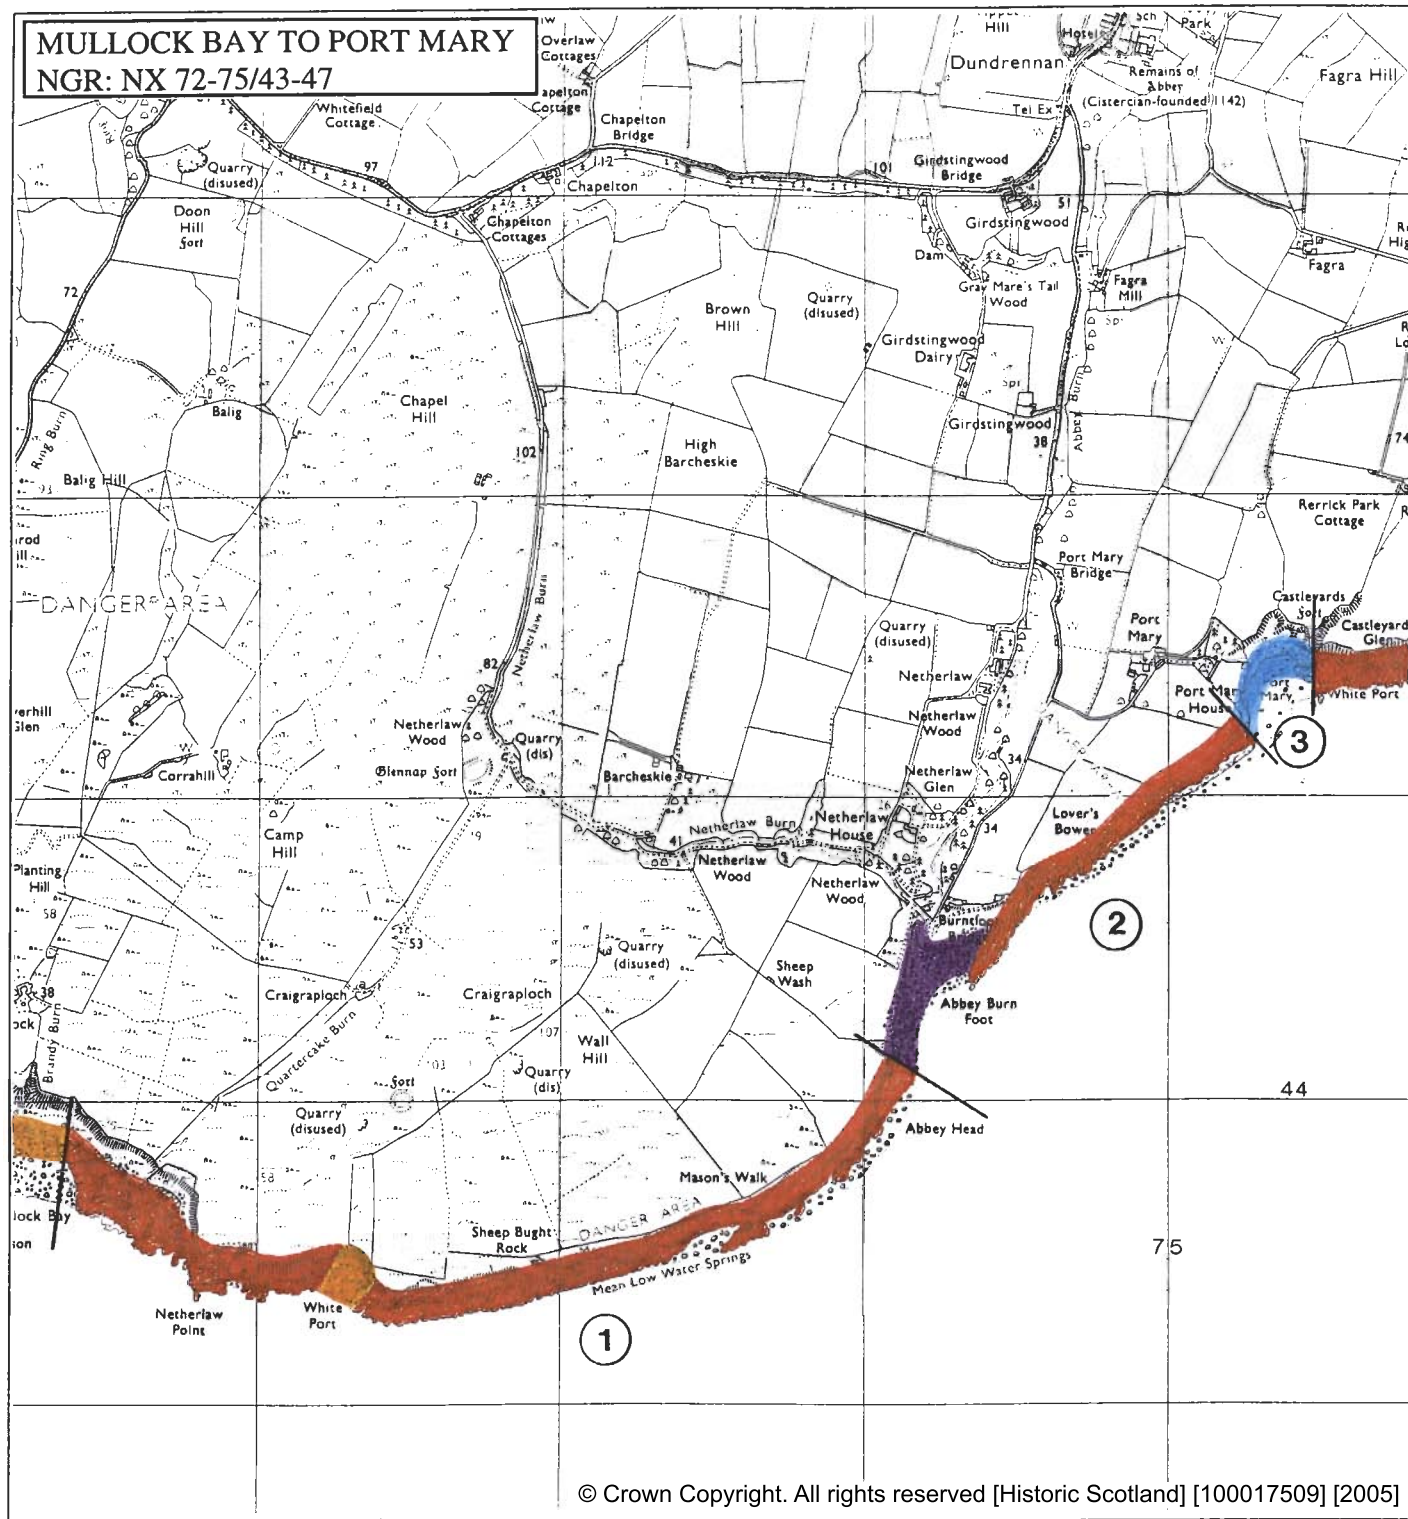
MULLOCK BAY TO PORT MARY NGR: NX 72-75/43-47

This small bay consists of shingle which is banking up at the MHWM. There appears to be no erosion and at the present the beach head is stable.

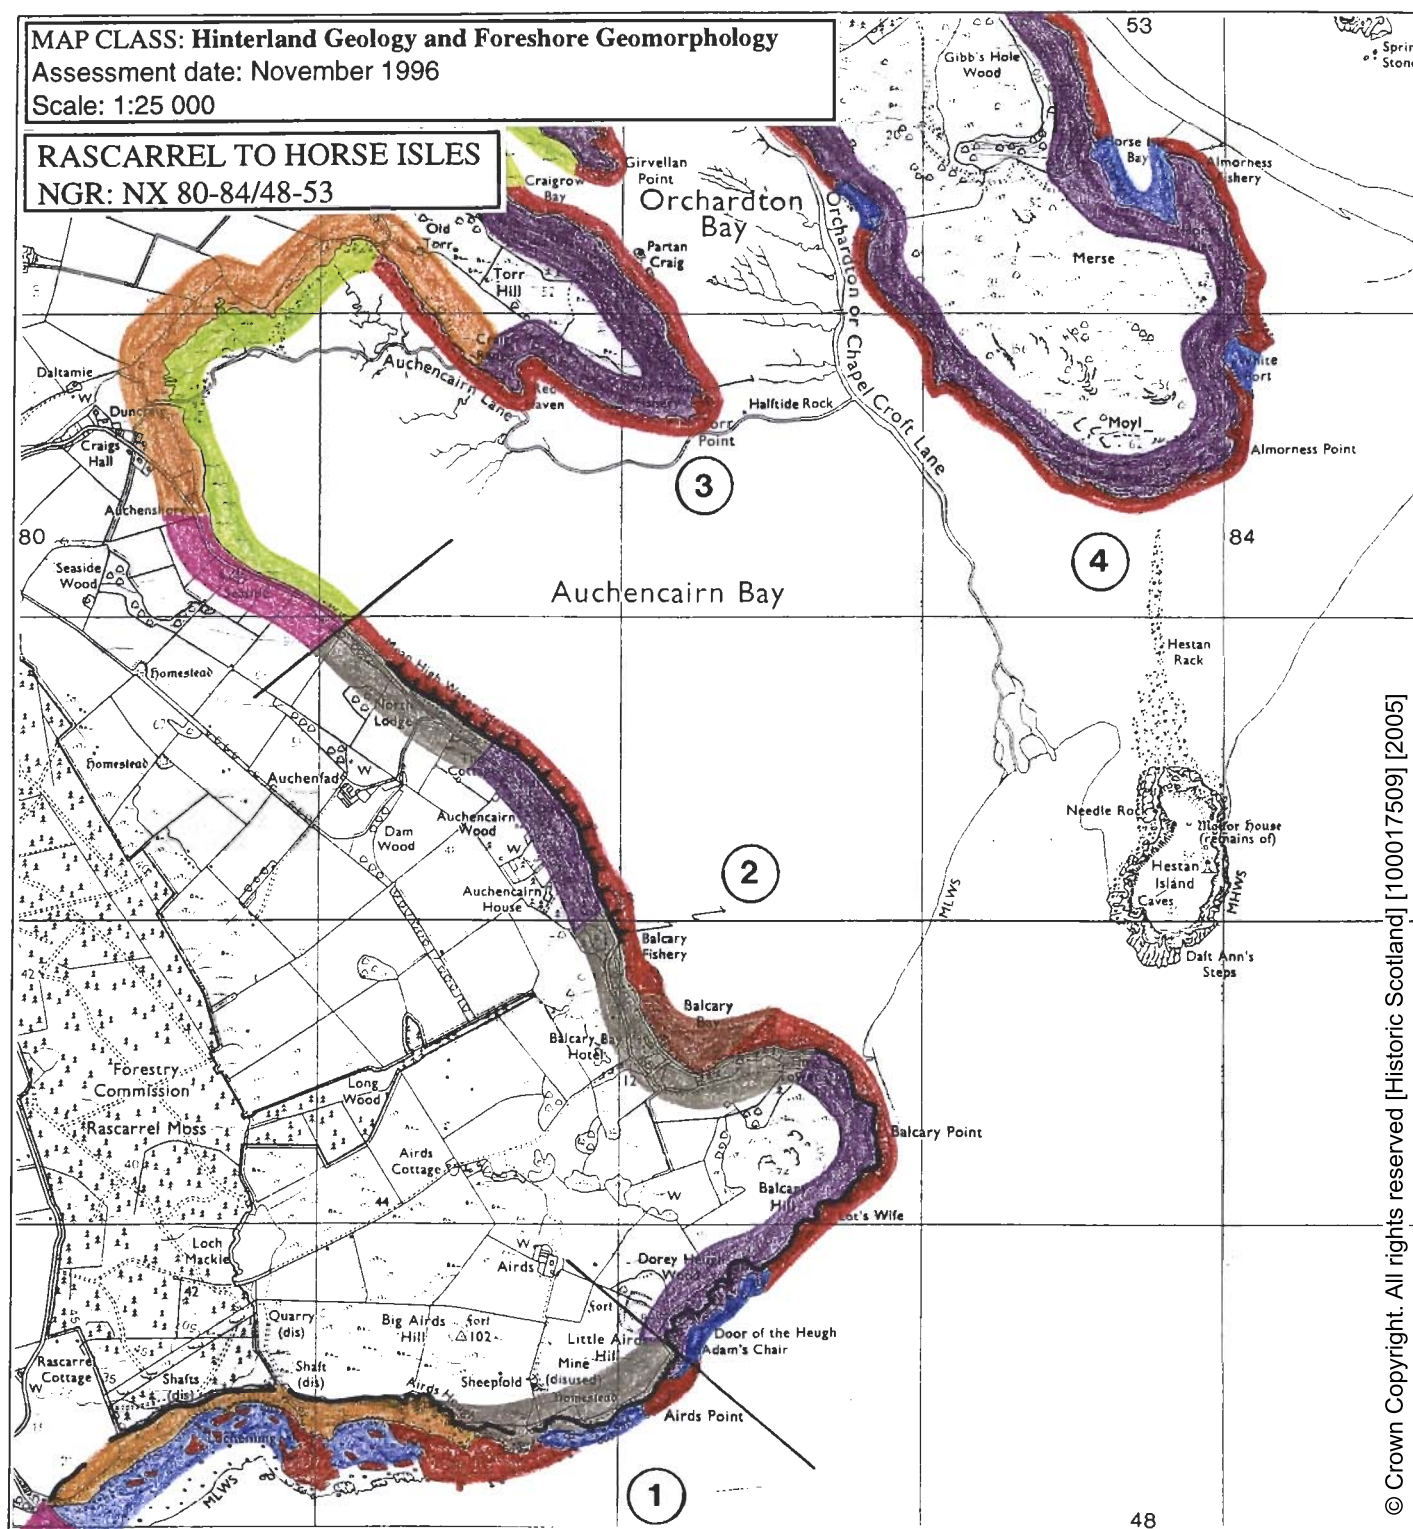
NGR: NX 80-84/48-53

This unit contains a peninsula that forms a division between Orchardton Bay and Rough Firth. Till overlies an irregular cliff-edge. The foreshore on both sides of the peninsula consists of greywacke rock platform which is broken only at White Port (NX 841519) and Horse Isles Bay (NX837524). Here the beaches are sand and shingle.

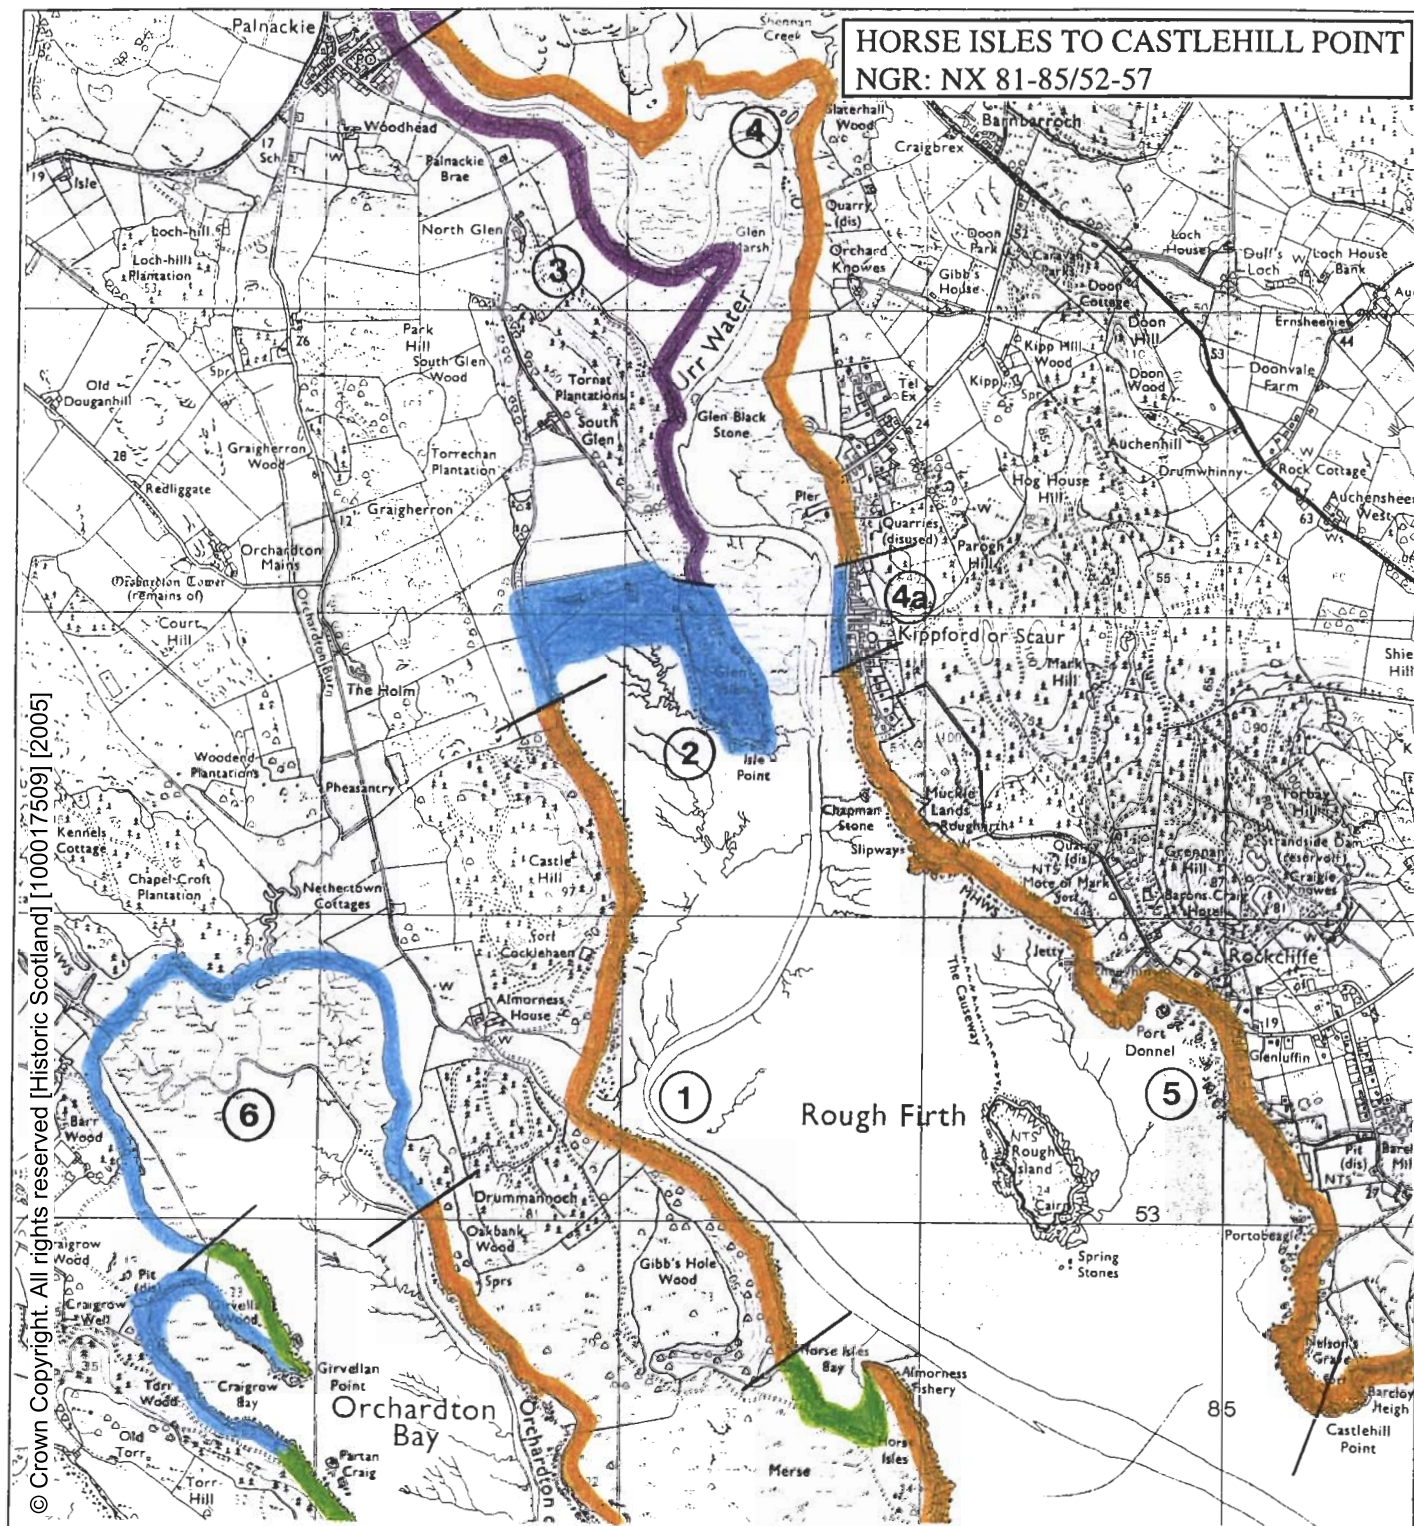
The upper reach of Orchardton Bay which is stabilised by saltmarsh. High sediment loads from the Loch Ling Burn are leading to mud accretion within the bay.
