Coastal Assessment Survey Solway North Coast

Volume 3 of 3: the eastern part of the coast,
case studies, and analysis.

Port Donnel to Gretna

A Report for HISTORIC SCOTLAND

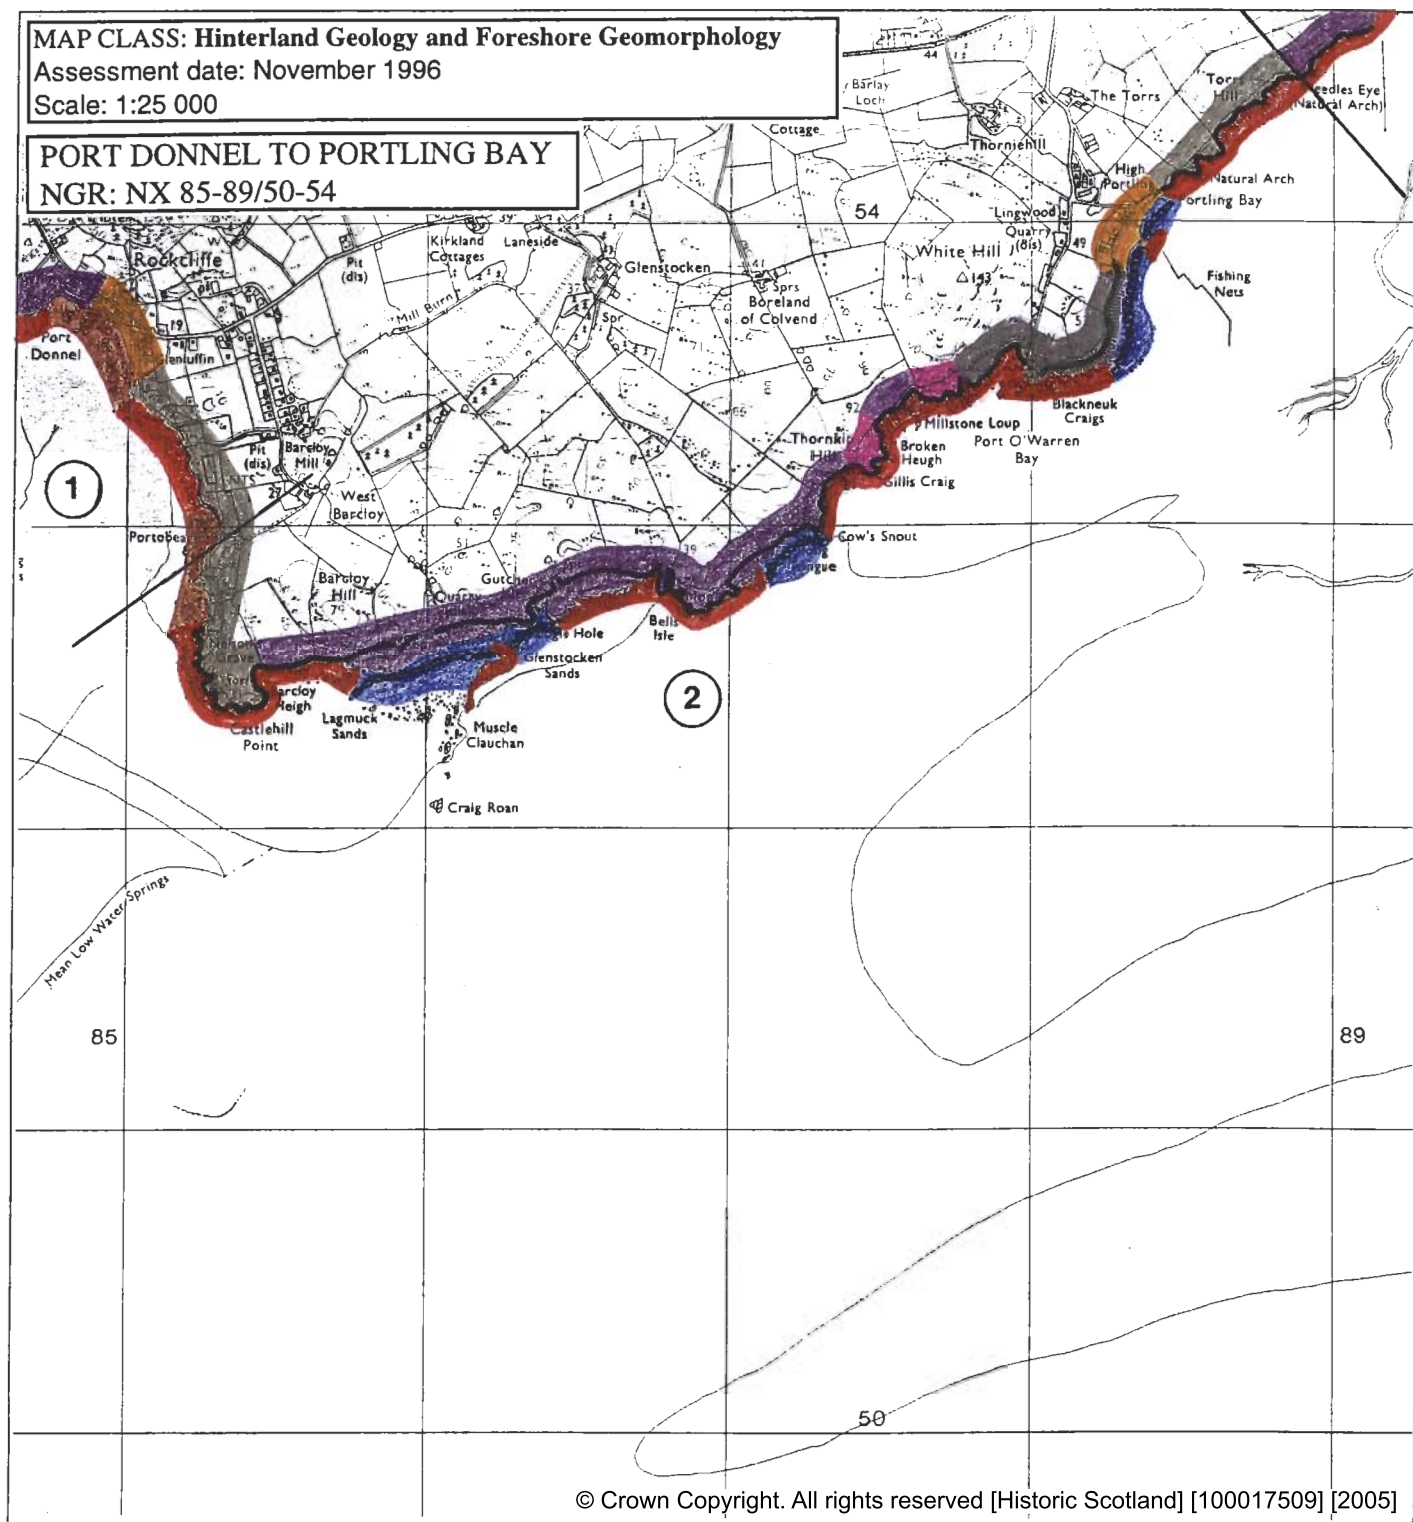
Map 40: Hinterland Geology and Coastal Geomorphology

Till occurs on the hinterland at Kipford on Scaur and at Port Donnel (NX 846537) where it outcrops over visible granite rock. Fluvioglacial drift outcrops to the south. The foreshore consists of a mixture of estuarine sands and mud.

This is an exposed stretch of irregular coastline with a highly incised cliff-edge. Till occurs over visible rock platform with fluvioglacial deposits and marine sands and gravels evident towards to the east of the unit. The shoreline consists of precipitous cliffs with steeply folding Wenlock series greywackee with natural arches.

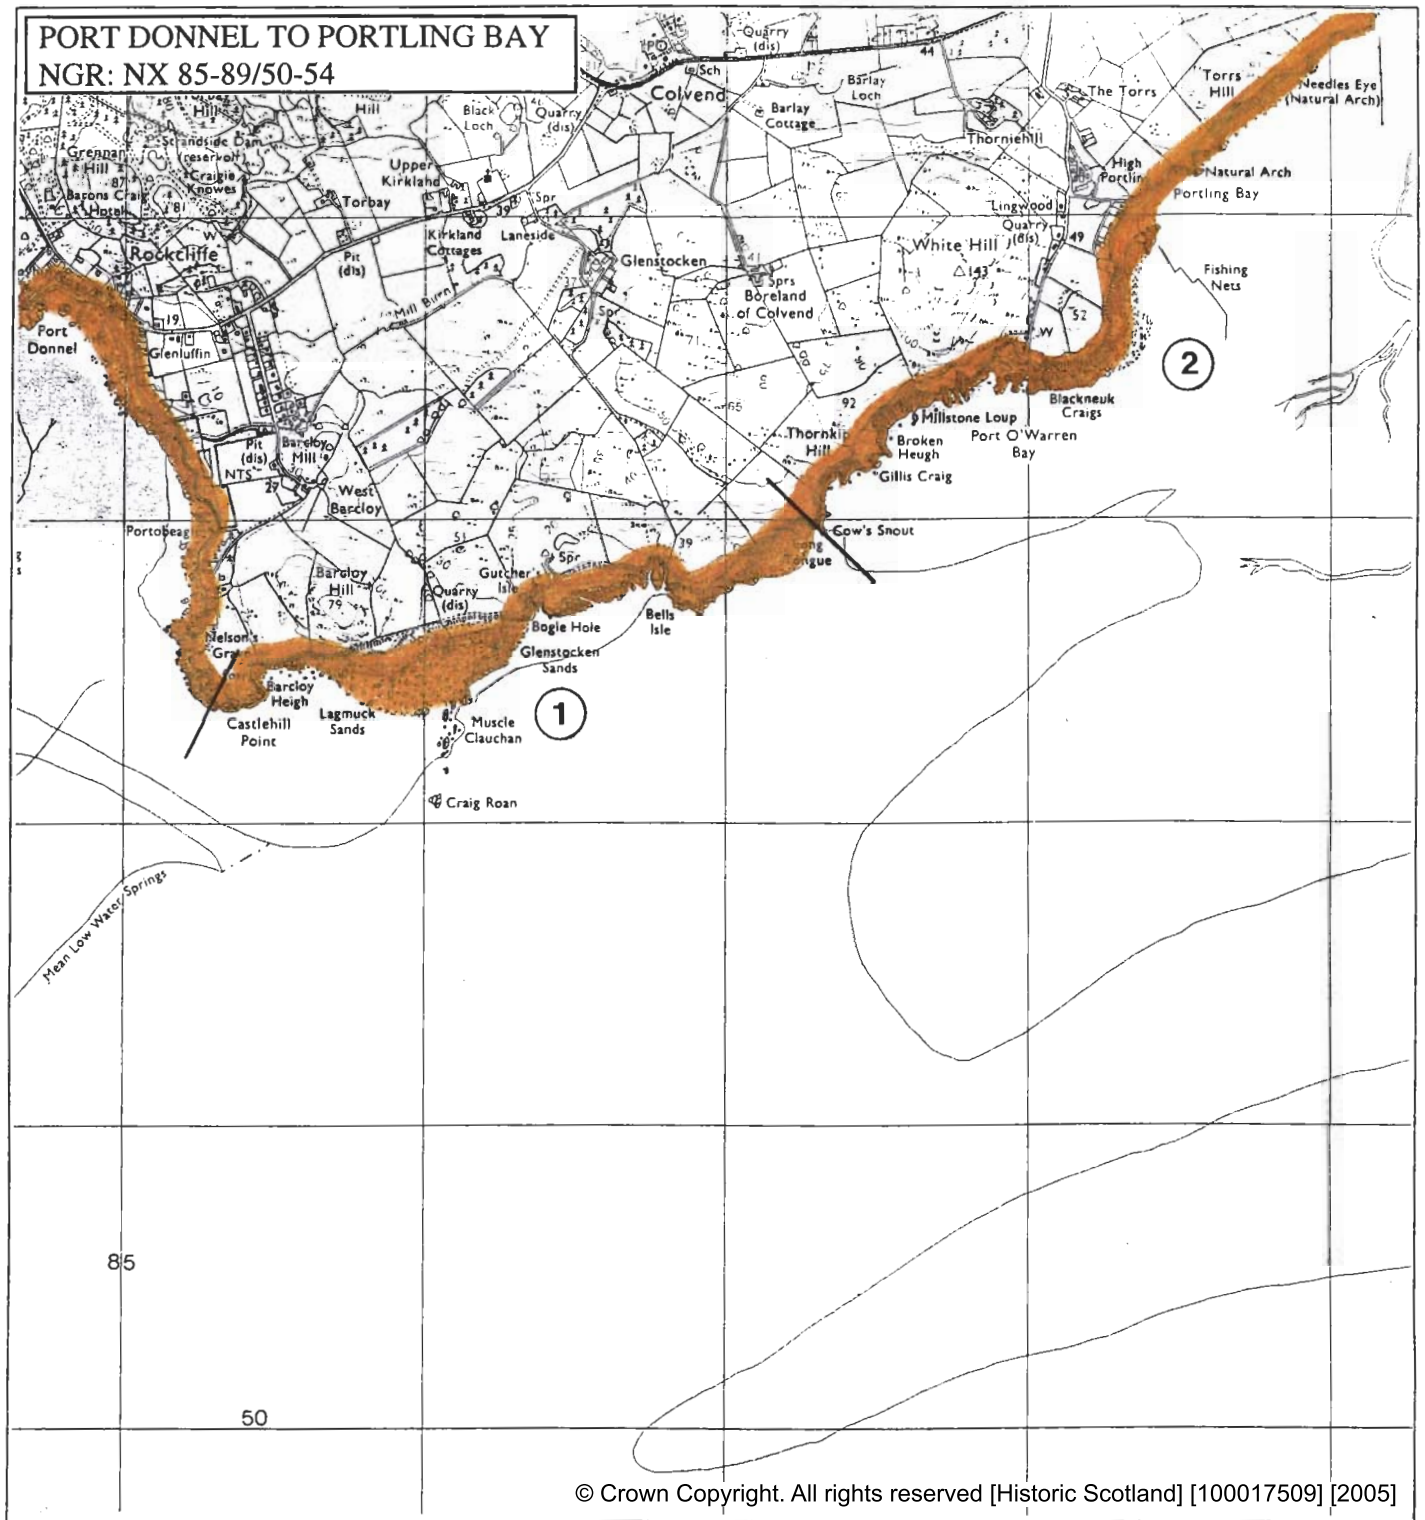
MAP 40: EROSION

Erosion Class: The coastline is exposed but the resilient nature of the underlying geology suggests that erosion is occurring at a slow rate.

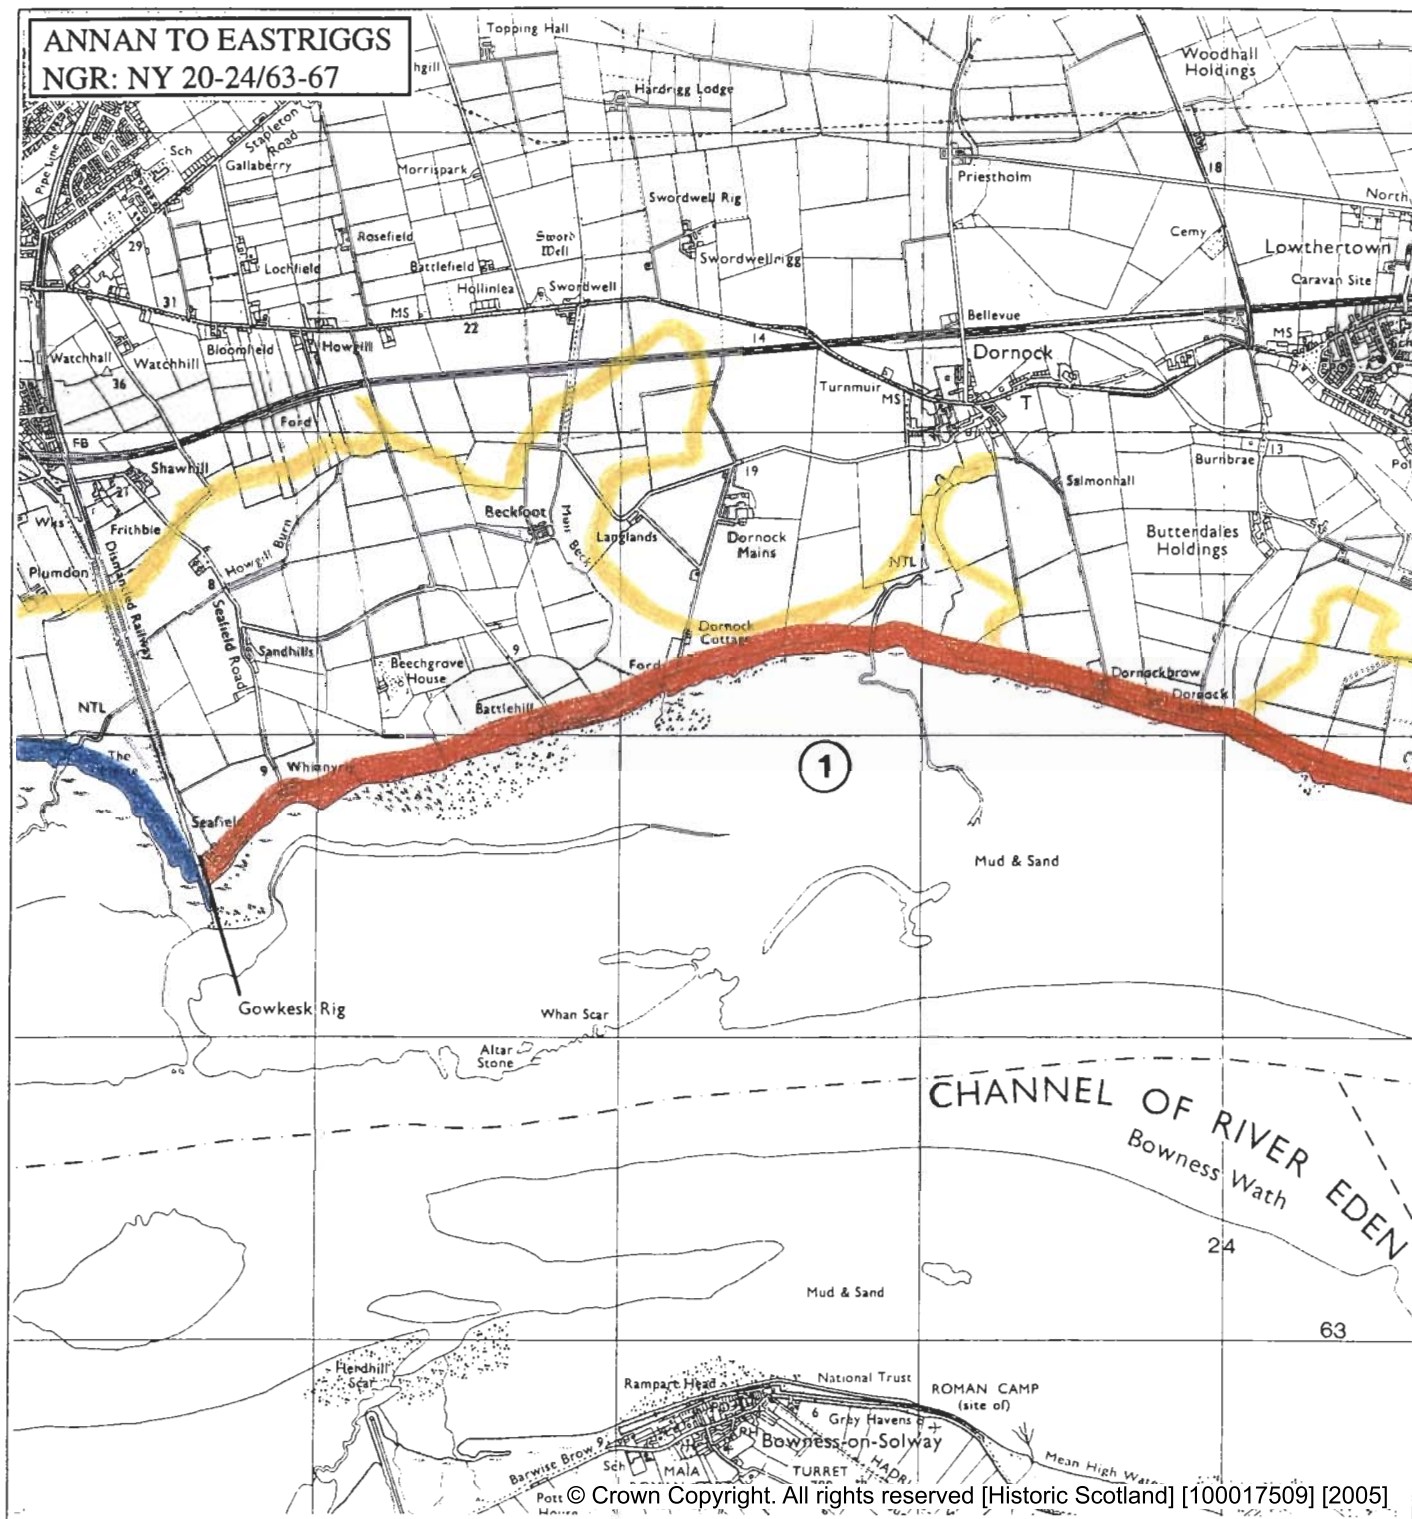
Definitely eroding

This unit shows evidence of erosion at the HWM owing to the soft nature of the drift material (clays). The saltmarsh is failing to protect this region of coastline owing to accelerated mass movement caused by the large spring tides.

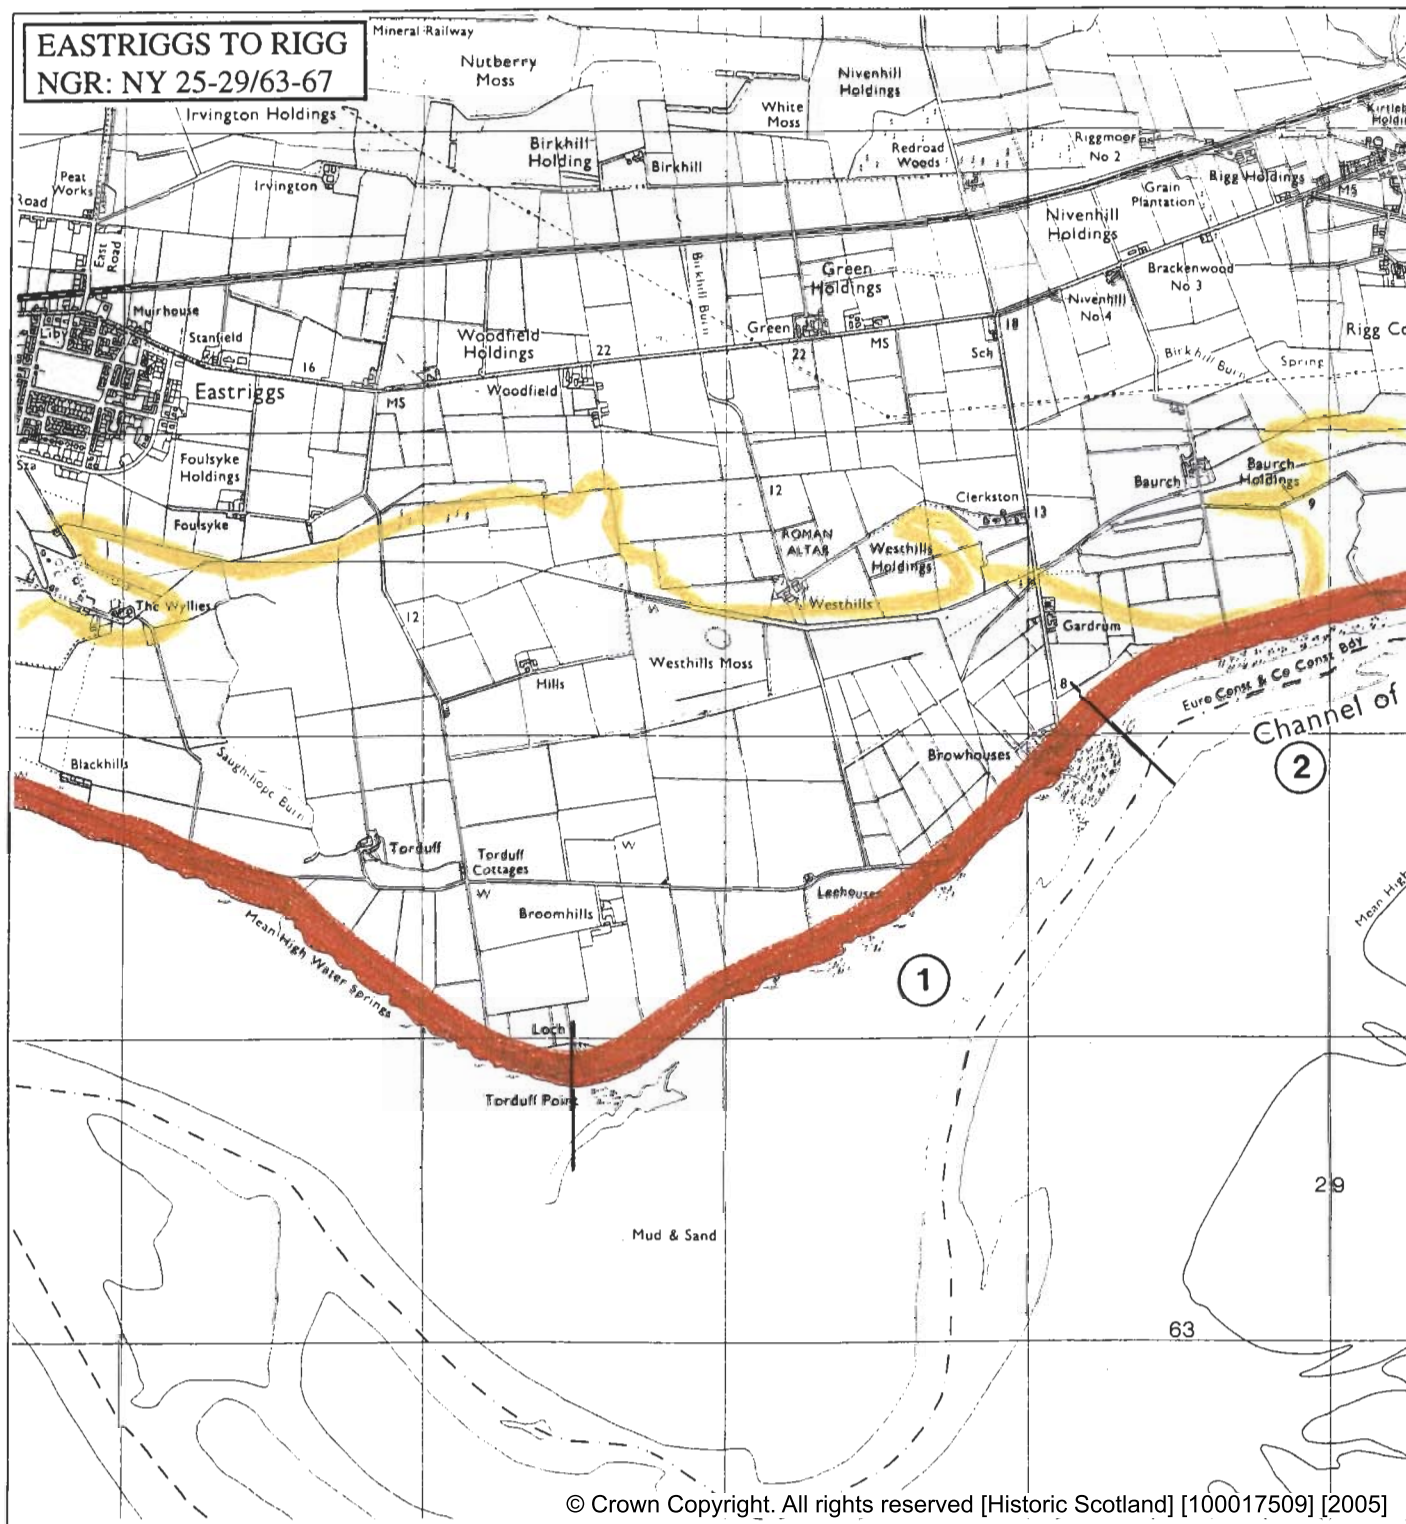
Definitely eroding

Channel of the River Esk with erosion noted towards Redkirk Point. Boulder dump sea defences are offering some protection to the hinterland but the immediate foreshore is severely scoured due to extreme tidal conditions.

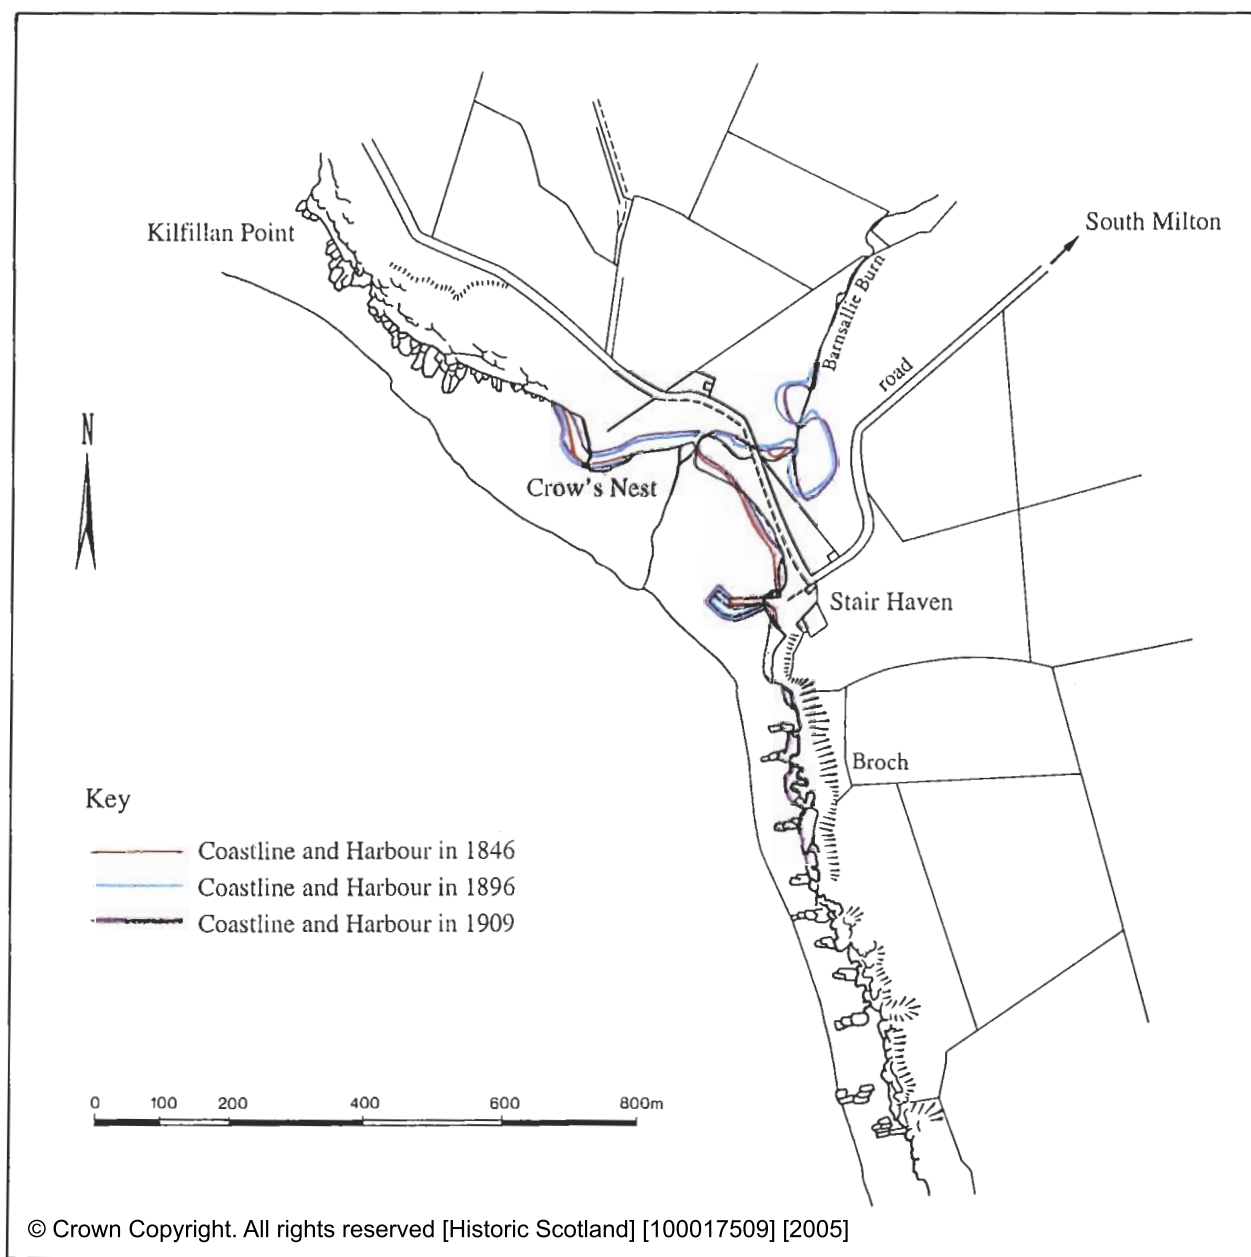
Figure 2 Stair Haven Bay

Stairhaven is a small bay that lies between a headland to the north, known as the Crow's Nest and steep cliffs to the south. A small burn enters the bay from a north-easterly direction. The hinterland geology consists mainly of fluvioglacial sand and gravel which overlie greywacke sandstone that are assigned to Llandoverly Series. The foreshore is very wide with an assortment of beach cover that includes sand, gravel and boulders between bare patches of sand.

Violent wave action has greatly reduced the pier at Stairhaven. It is not an isolated case: similar processes can be seen at Orroland Bay (NX 7746 4623; Map 35) and Knockbrex (NX 5820 4890; Map 28). The suite of decaying stone structures at Stairhaven Bay is significant as an example of a facility related to a former transport system that illustrates both the past economic and transport history of the area. The archaeological importance of the now badly ruined Stairhaven Bay harbour pier, one of many similar sites along the Solway Coast, is reinforced by the survival of contemporary, associated structures in close proximity to it. The function of these buildings was entirely bound up with the existence of the docking facility, and loss of the pier leaves them devoid of a key element that elucidates the choices made in where to site them and in their architectural characteristics. Consideration of these associated structures should be included in future work.

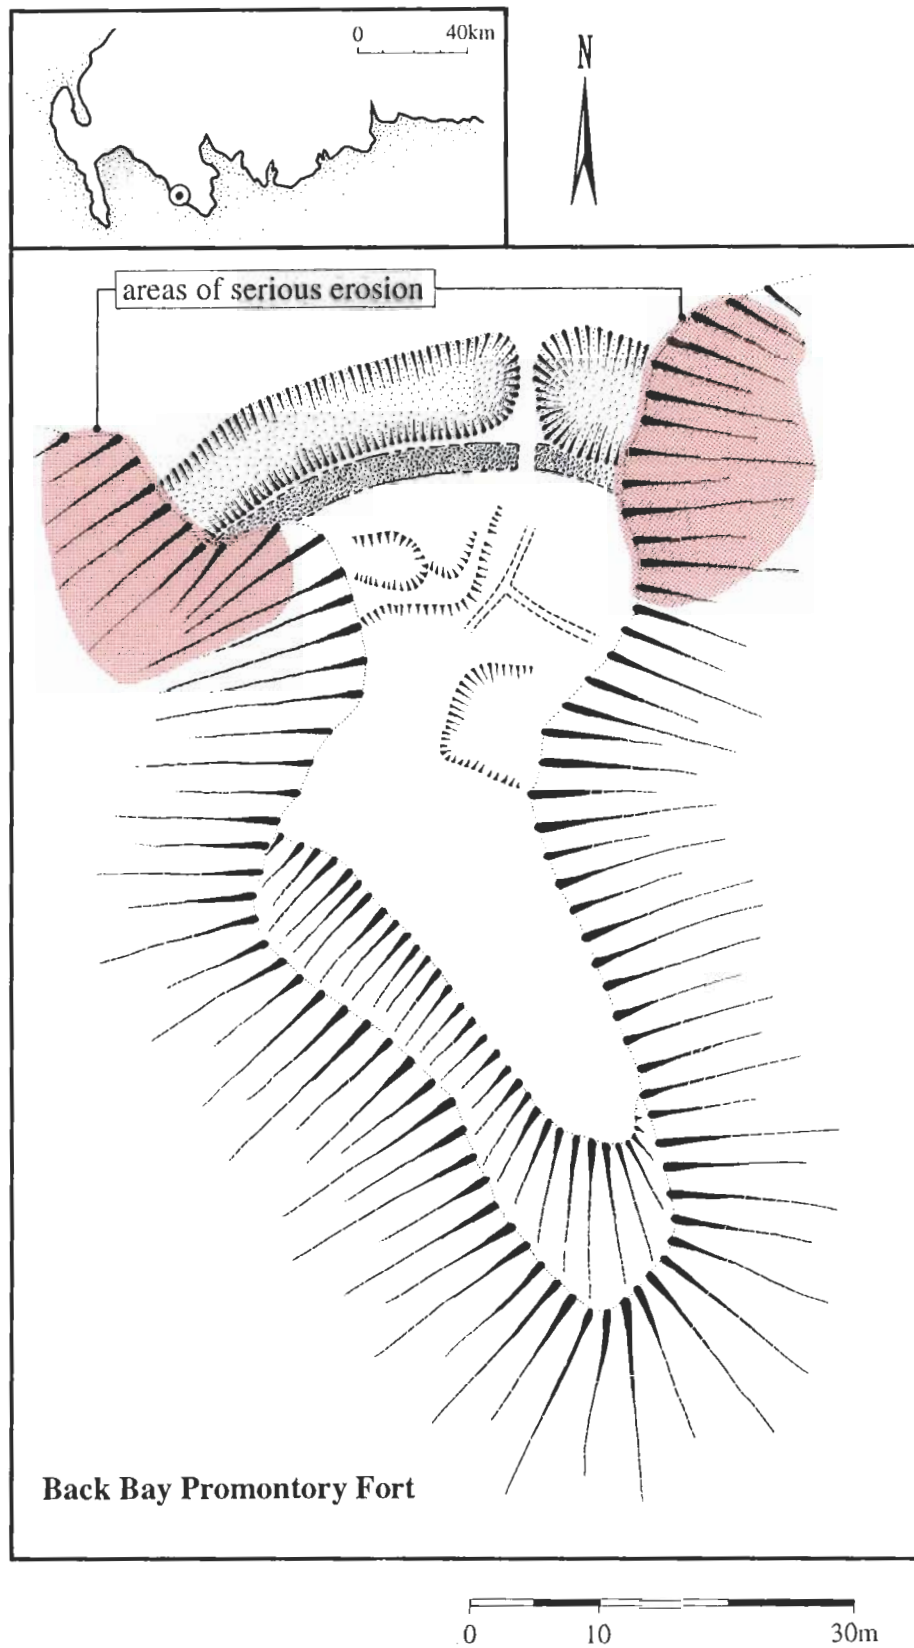
Figure 3 Back Bay Fort

The promontory fort at Back Bay is situated on red-brown clayey glacial drift deposits probably of Devensian age (Figure 3). The underlying bedrock is the more resilient greywacke sandstone. The fort is exposed to the full force of south-westerly gales. During the course of fieldwork, CFA noted that there is serious erosion taking place on the seaward margins of the bank and ditches. The clay-rich earthworks are being lost due to slope failure and constant weathering by the elements.

The impact of coastal erosion affecting Back Bay promontory fort is localised within certain specific areas, particularly at the neck of the promontory where the defensive

structures are located. Animal impact at the site, including cattle and sheep tracks, and rabbit burrowing, is adding to the piecemeal destruction of the rampart, ditch, causeway and counterscarp. Indications of adverse impacts attributable to animals are common on many of the promontory forts on the Solway coast. Human impact, in the form of farming activities, notably dumping and visitor trails, also adversely affects the condition of many sites, despite the scheduled status of the vast majority of these promontory forts, although this does not appear to such a serious problem at Back Bay.

A recurring feature of many promontory forts on the Atlantic seaboard is the location of structures immediately behind the main rampart, even when the actual area enclosed is large (Gilmour, 1996, 4). An important factor, therefore, in gauging the impact of erosion is the consideration of the surviving condition of internal structures within the sites. The presence of internal structures immediately behind the main rampart at Back Bay is evident and should be taken into consideration in future work.

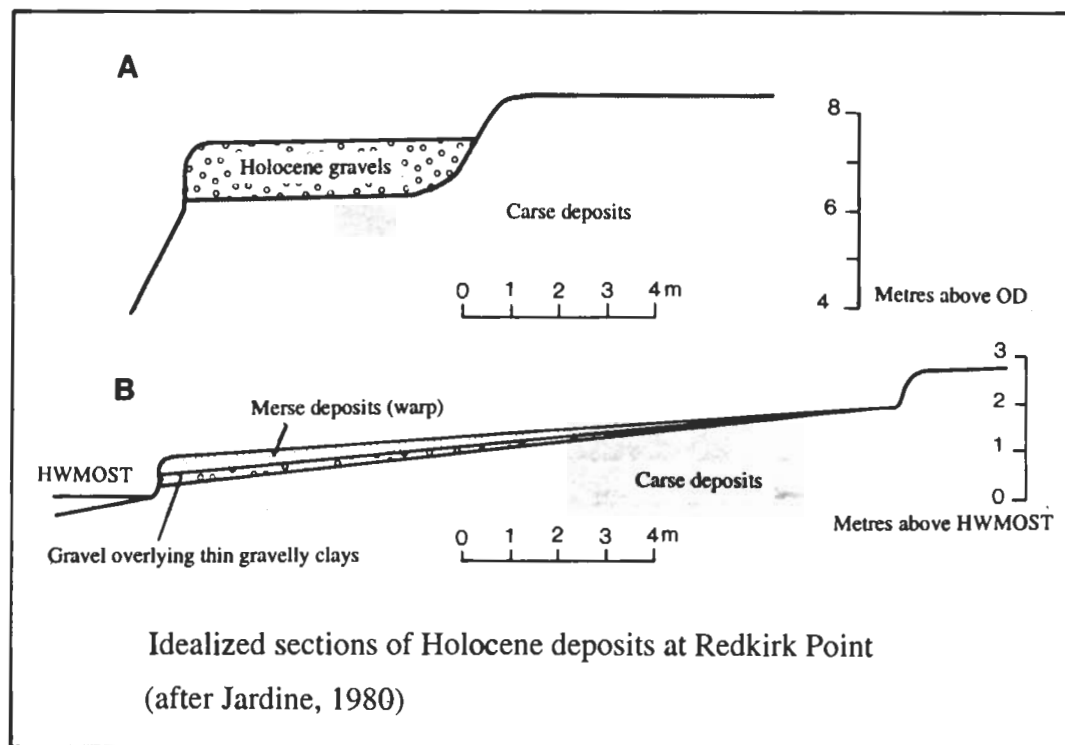
Figure 4 Schematic section of shore at Redkirk Point

Redkirk is one of several sites situated between Redkirk Point and the mouth of the River Esk. This coastline consists of raised coastal sediments which are exposed discontinuously in low cliffs between higher bluffs of red glacial till. The Holocene coastal deposits along this section of coast have been described fully by Bishop and Coope (1977) and Jardine (1964, 6-7 and 1980, 7-10). The highly organic sedimentary sequences stratified between layers of marine sand provide a definite evidence of marine transgression and recession (Table 1). Figure 4 shows a schematic representation of the shore line at Redkirk Point. The principal feature within Section A is the wave cut 'notch' that has been filled with Holocene marine gravels. This is a result of marine transgression that eroded the earlier carse deposits. Twenty metres west of Section A, Section B was recorded as having a wide shelf attributable to marine inundation across the earlier marine carse deposits. This shelf was again overlain by marine gravels which were subsequently overlain by merse deposits attributed to episodes of flooding.

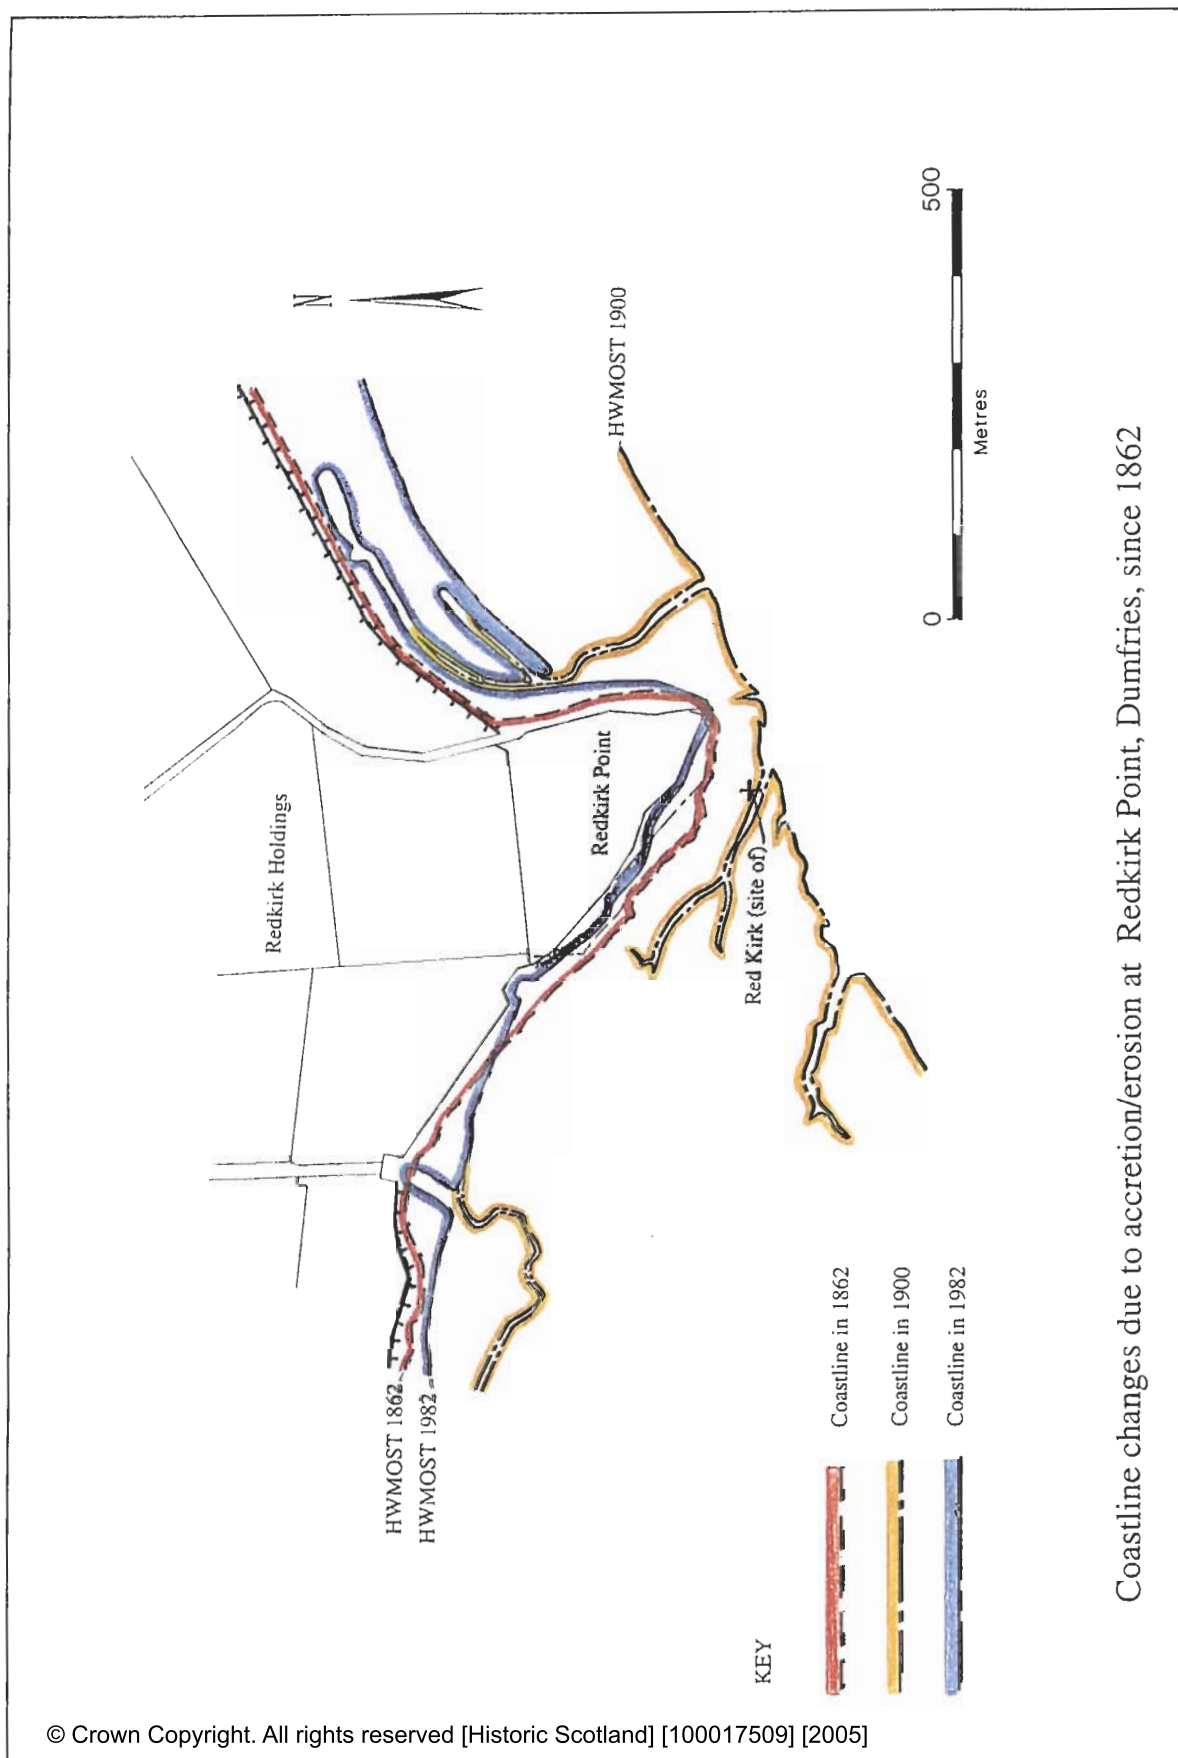
Figure 5 Redkirk Point

The archaeological significance of the exposed Holocene coastal deposits in the region of Redkirk lies is the sheer wealth of palaeoenvironmental data that is stratified within these deposits. These have been demonstrated to contain an environmental record of sea level

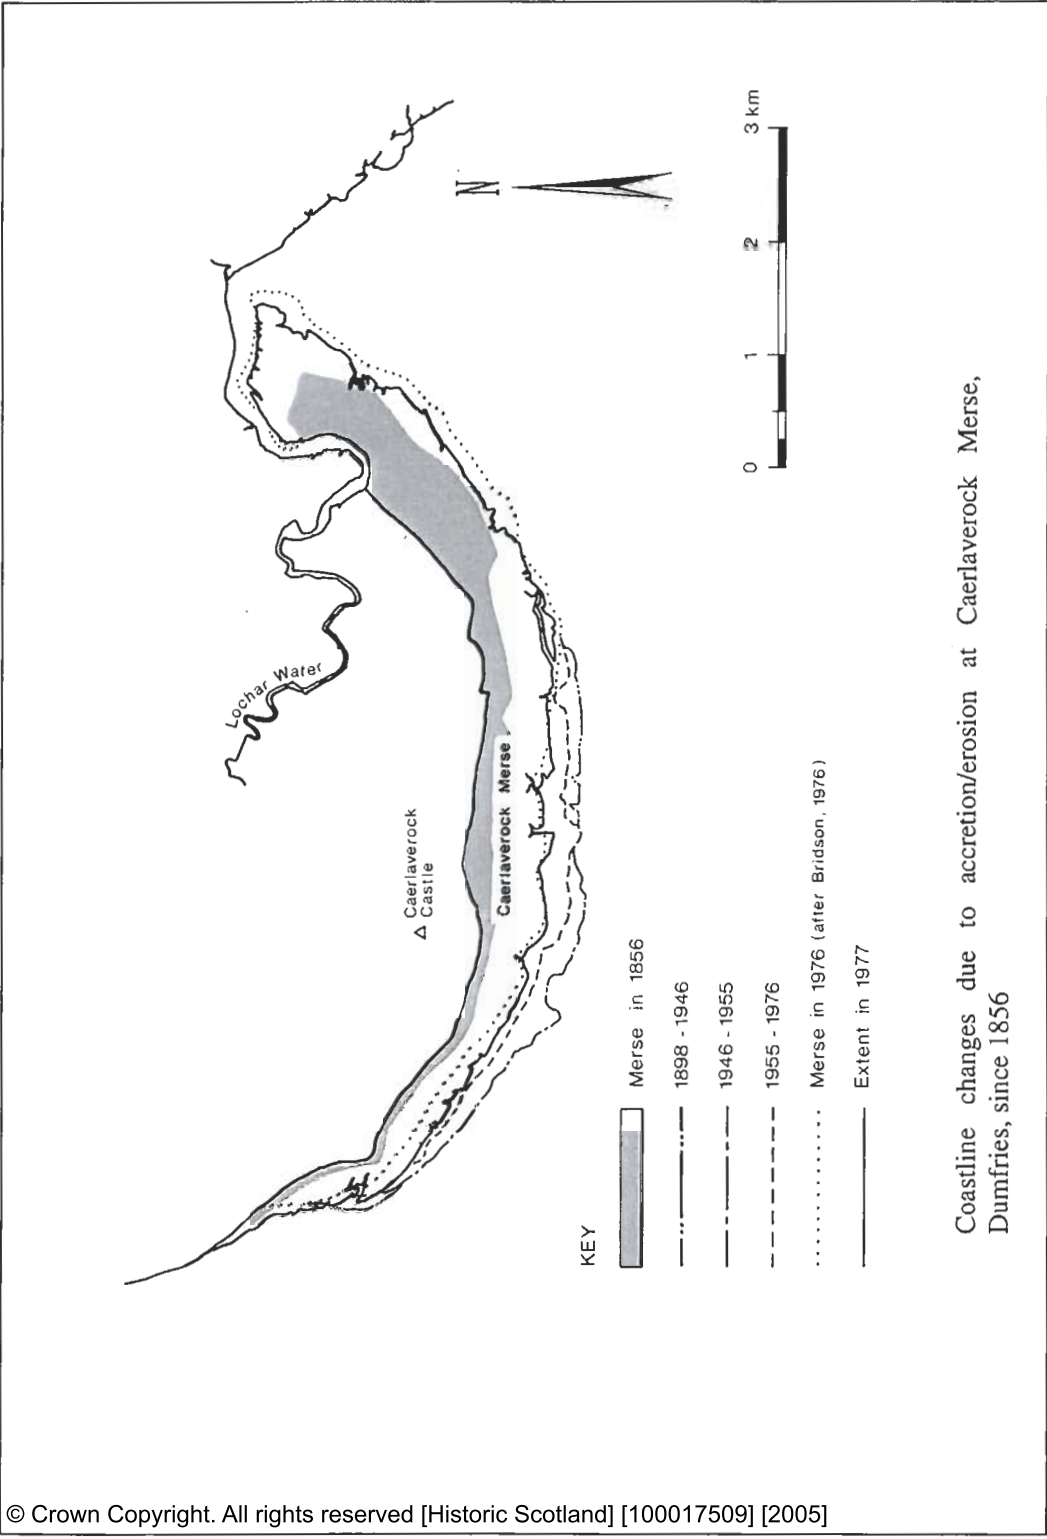
Figure 6 Caerlaverlock Merse

channel at the mouth of the Lochar Water is the main factor in sculpting the shape of the eastern end of the Merse.

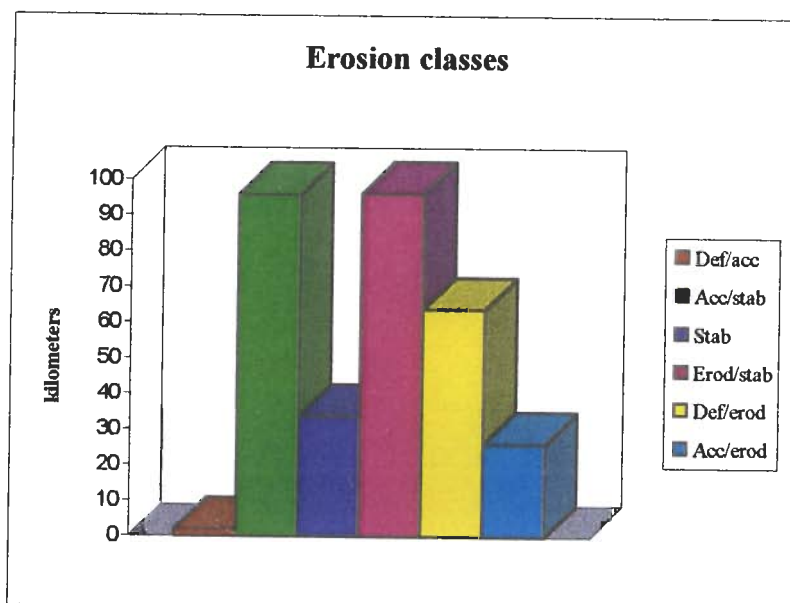
The results from the *Definitely Eroding* class confirm that a substantial portion (20%) of the north Solway coast is being affected by serious erosion. This class includes areas where there is a direct failure of existing sea defences such as is the case at Low Curchie (PLATE 3) (Map 2), Stairhaven Bay (Map 8) and south of Garlieston pier (Map 18) (PLATE 4). The greater majority of units in this class occur on the eastern stretch of the north Solway coast towards Annan, where the coastal edge is generally soft (see below).

Figure 7 Frequency of erosion classes based on their overall distance of the field survey results.

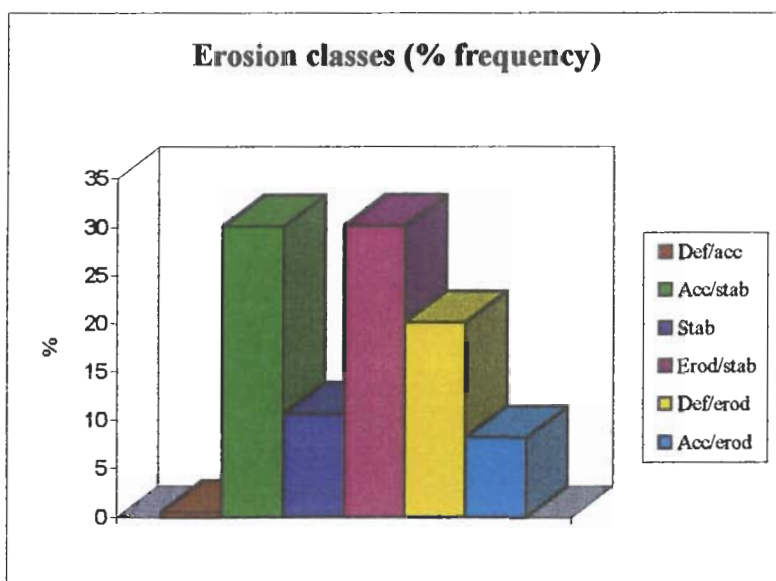
Figure 8 Percentage frequencies of individual erosion classes as a percentage of the total length of field survey (established as 317km based on linear measurement)

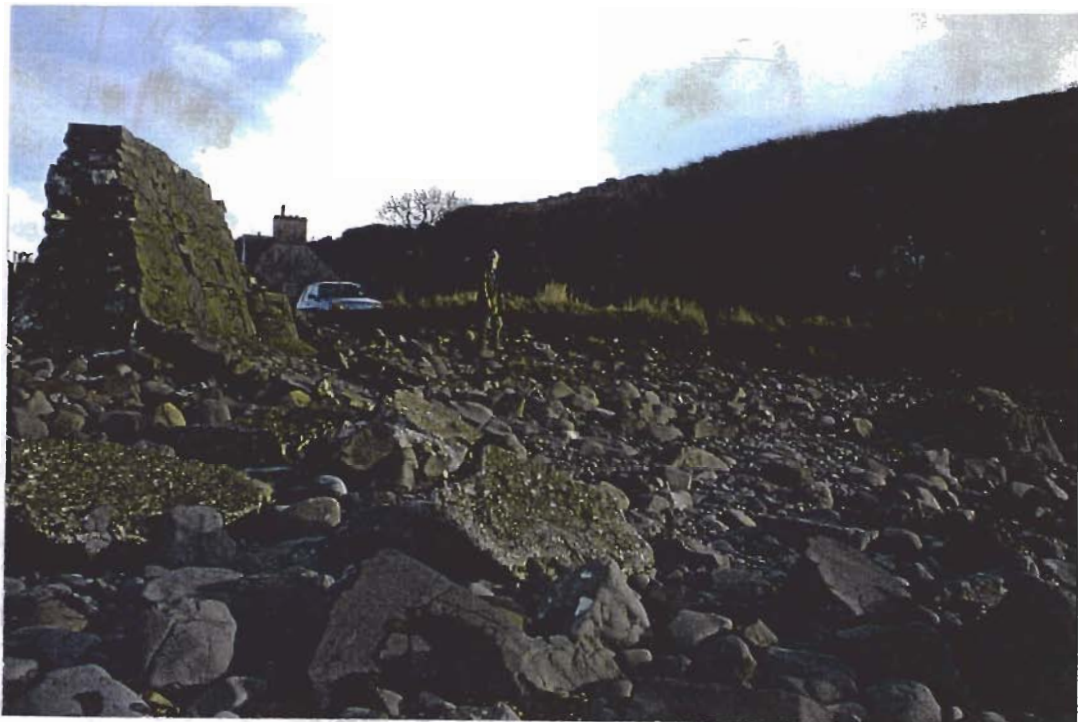
Plate 1. General shot of the ruined Stairhaven pier and eroding section.

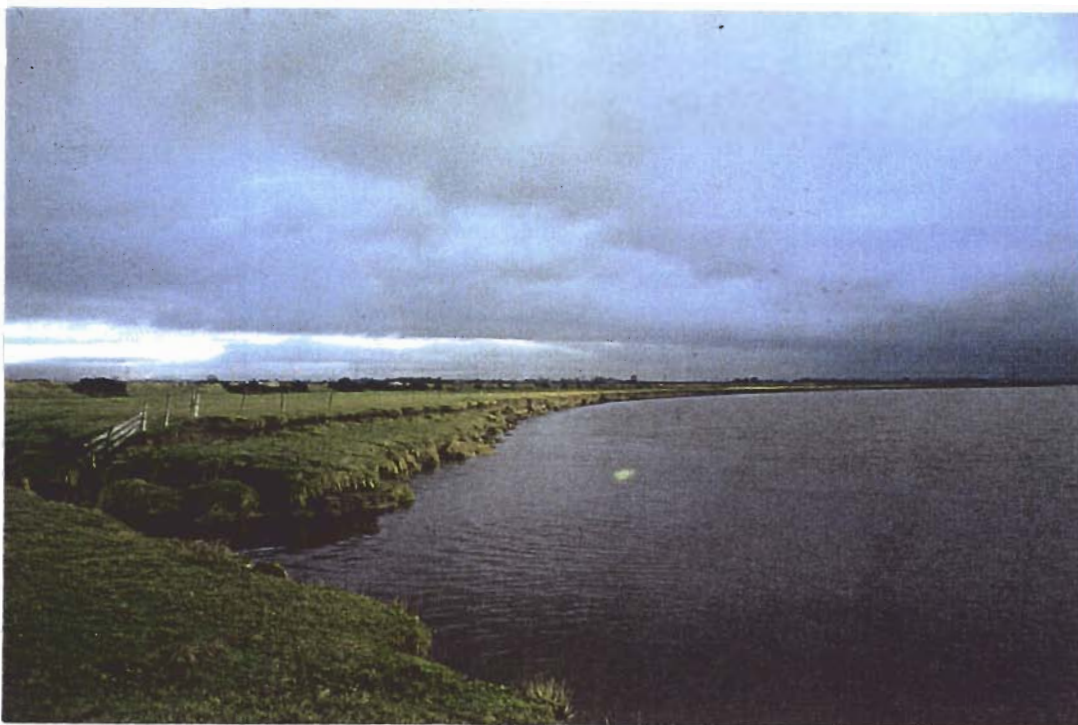
Plate 2. Redkirk Point looking eastwards, note the slope failure on the edge of the field.

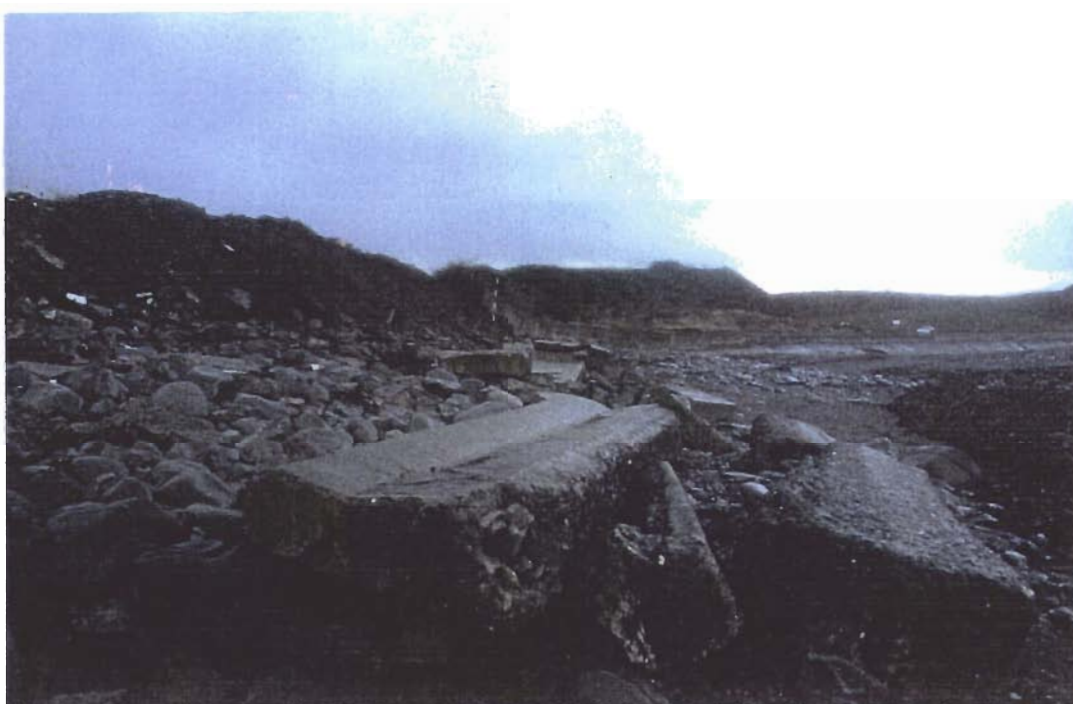
Plate 3. Eroded sea defences at Low Gurchie.
