Coastal Assessment Survey Ullapool to Lochinver

October 1996

Volume 2

A Report Prepared for Historic Scotland

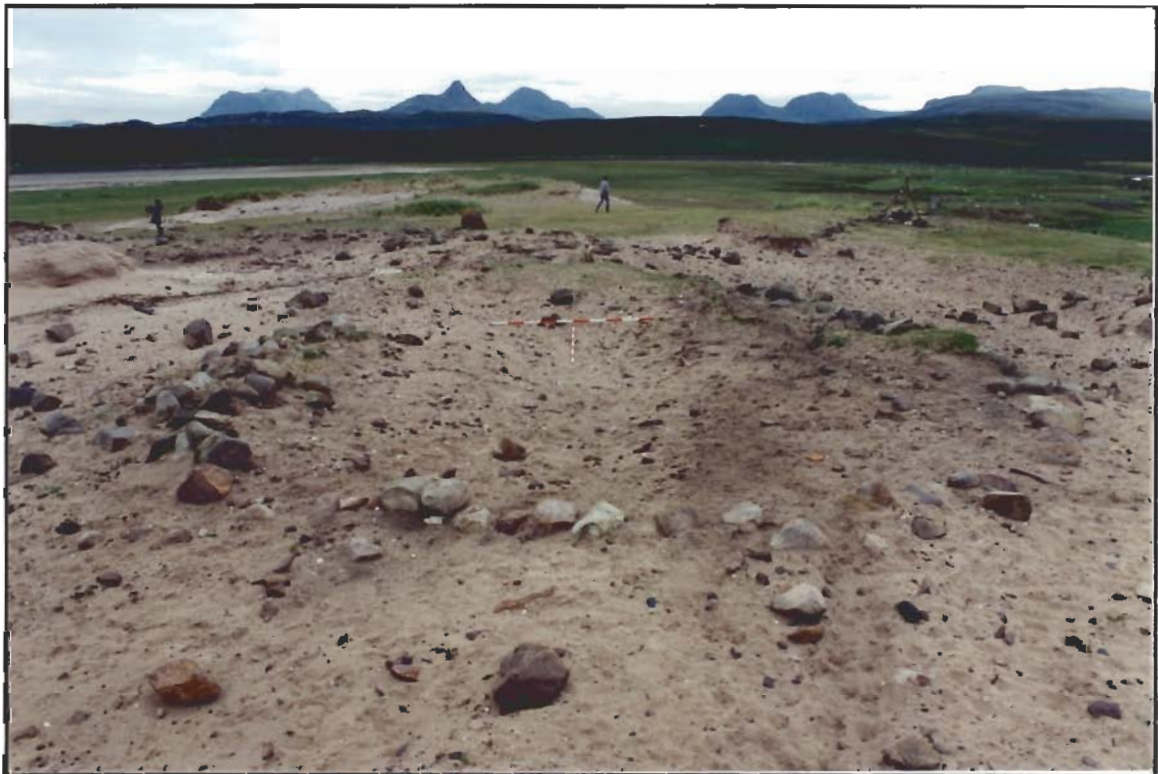
Cover: Achnahaird Sands (NC 01 SW 2). Building 2, facing east south east towards the Coigach mountains. Note stock damage to the walls and interior of the structure.

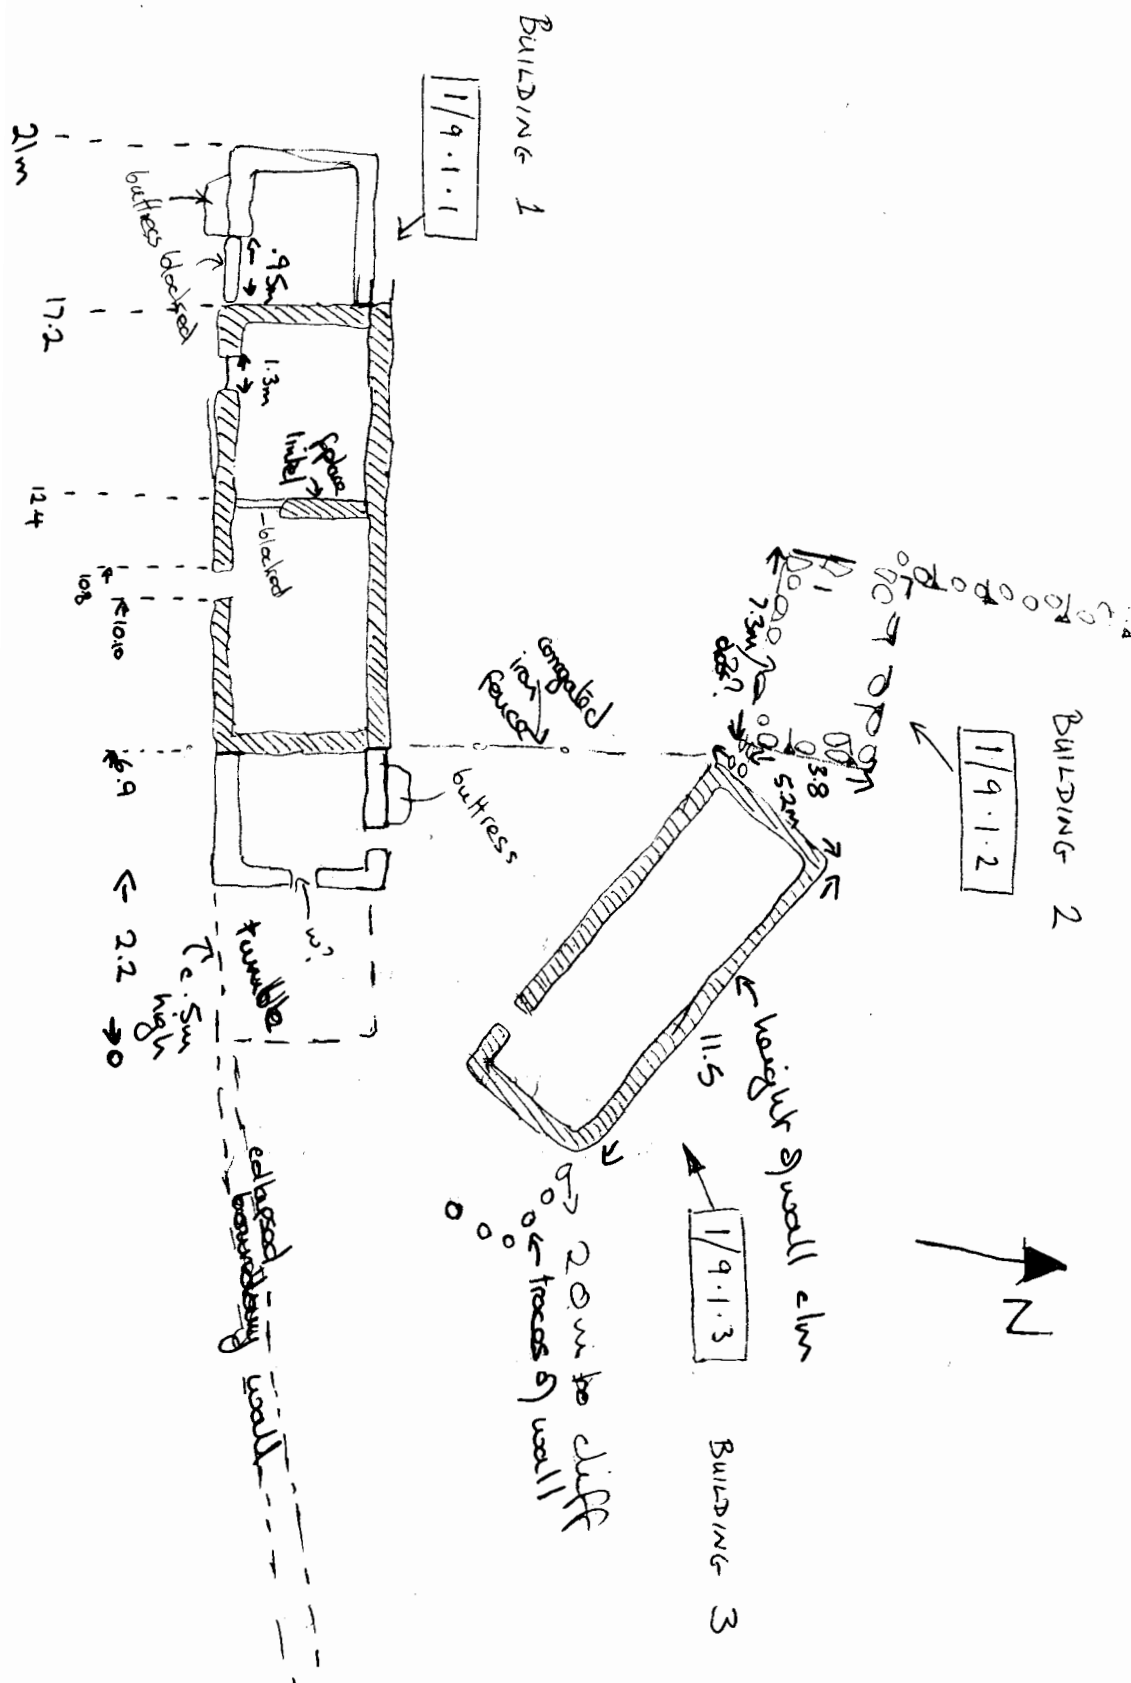
Plan 2: Rhue Township, building complex (1/9.1).

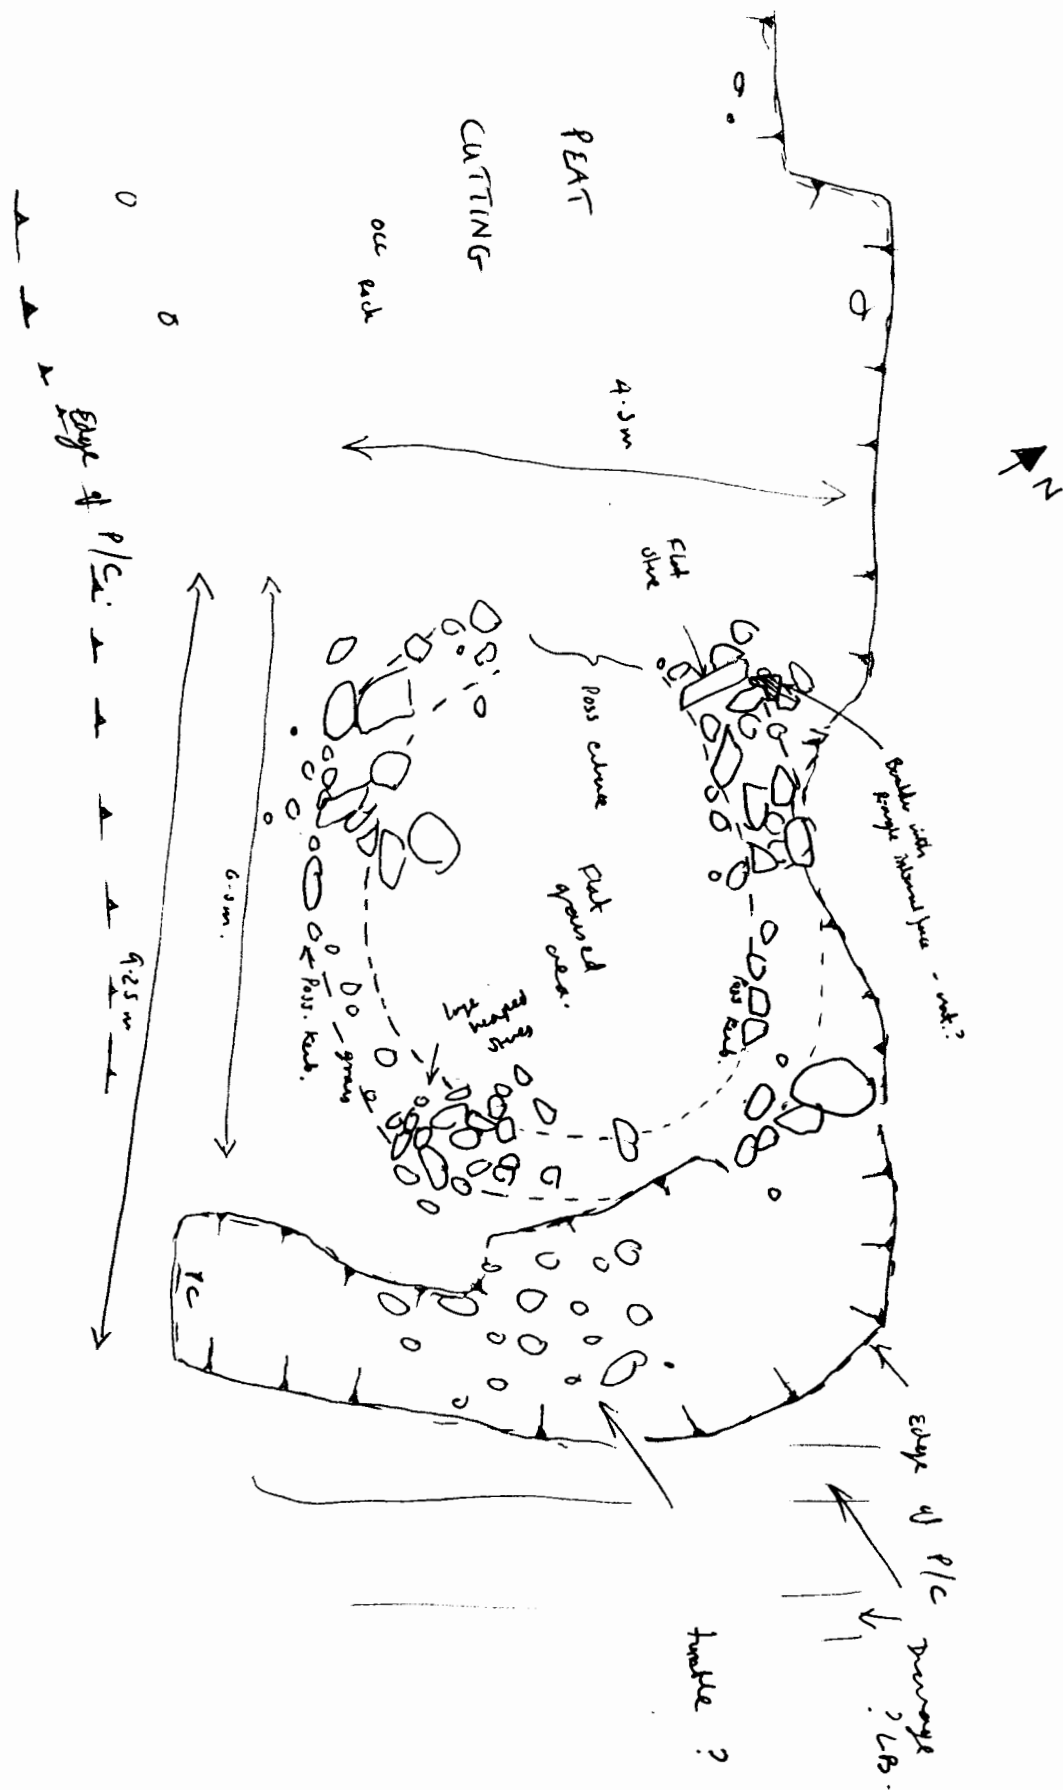
Plan 8: Alltan Dubh, hut circle ? (6/10).

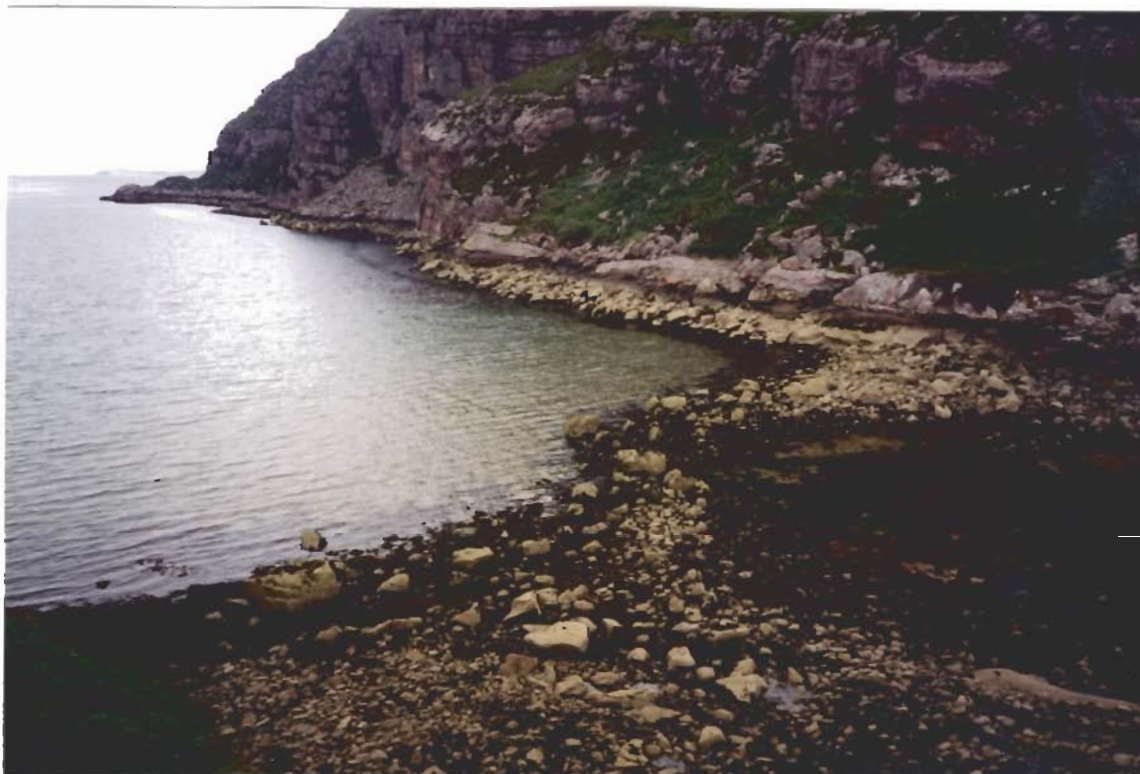
Plate 12: Camas Beag Fish Trap (NC 2111 9009) exposed at low tide, looking north west along an extremely precipitous stretch of coastline towards the Summer Isles.

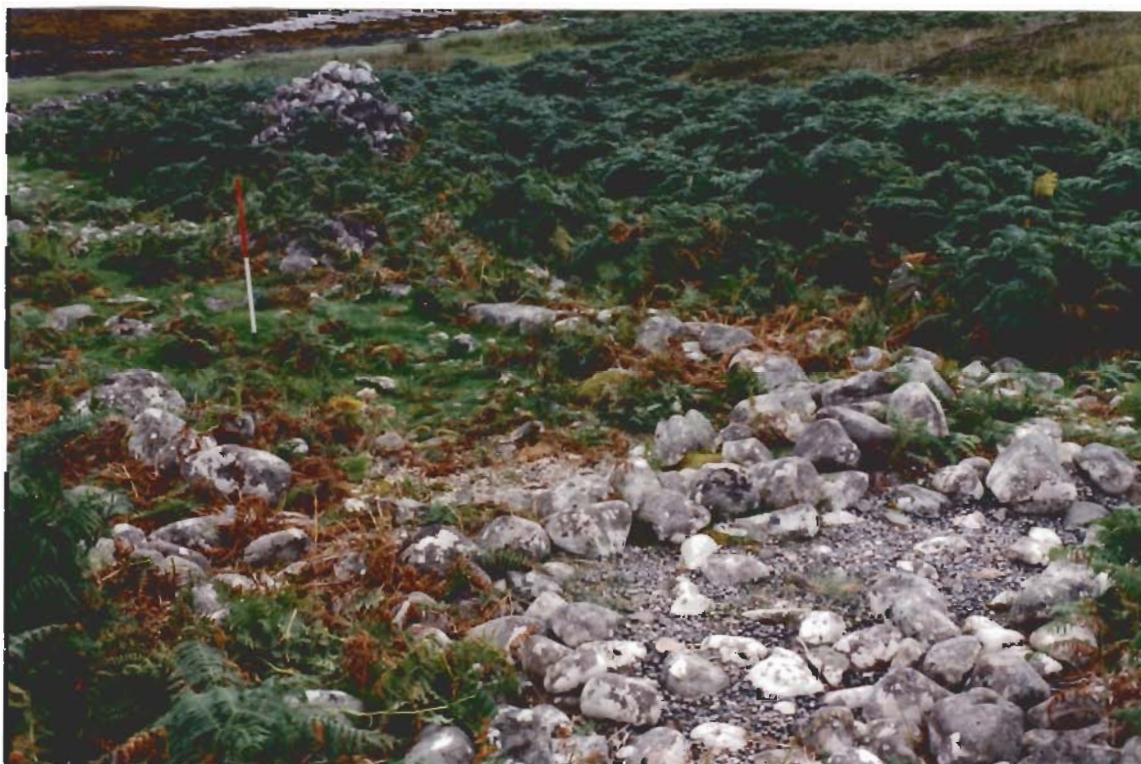
Plate 13: Old Dorney Bay (NB 1984 9115). View of the curved west end of structure 1, shell midden and cairn field. Facing SSE.

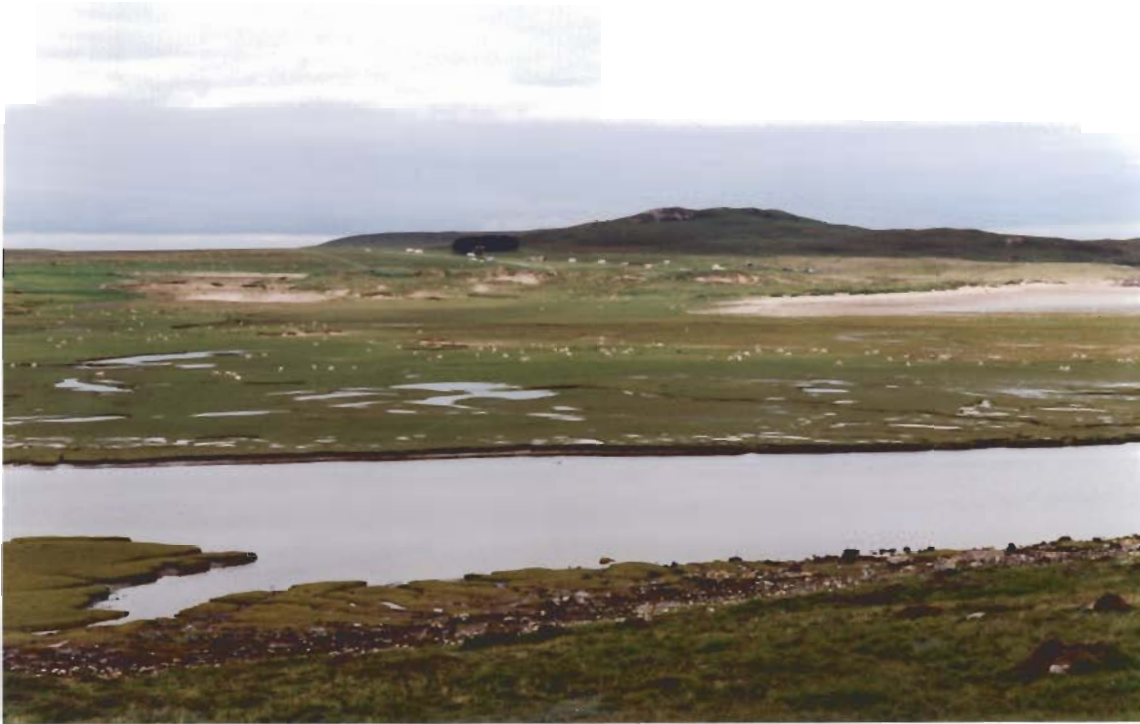
Plate 14: View of Achnahaird Sands (NC 01 SW 2) from the south east. Note an expanse of salt marsh in the mid distance, and the line of a dyke (part of NC 2018 9127) affected by tidal inundation in the foreground. Zones D, E & F are in the eroding area on the left.

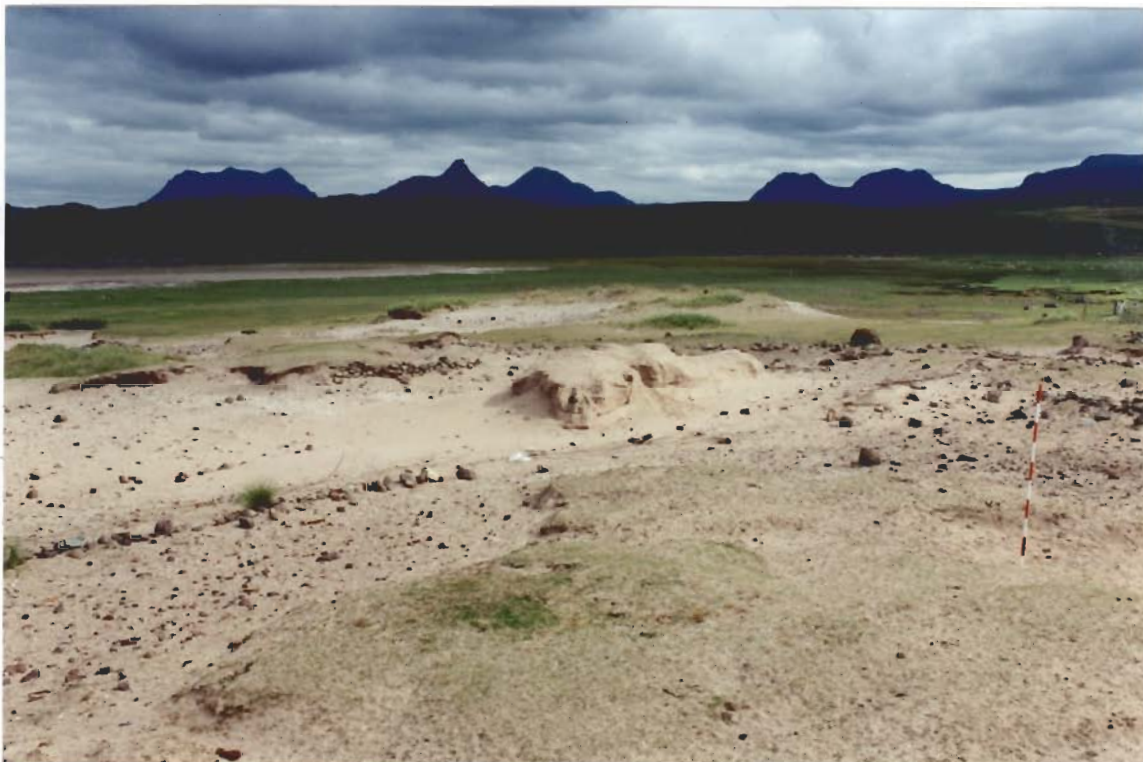
Plate 15: Achnahaird Sands (NC 01 SW 2). General view of Zone D, showing the residual form of an eroding dune mesa which previously protected this area, flanked by buildings 1 (left) and 2 (right). An exposure of shell midden (Zone F) is in the background.

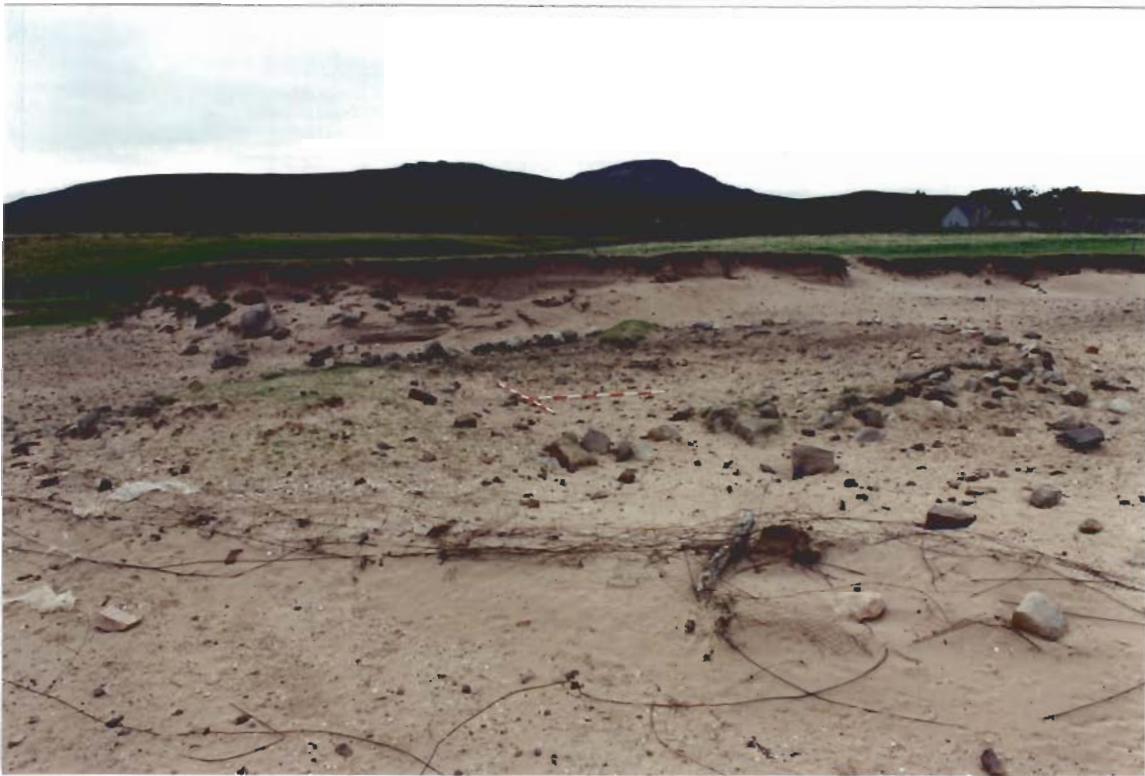
Plate 16: Achnahaird Sands (NC 01 SW 2). Building 2 facing west. Note eroding edge of machair behind the structure. Achnahaird House (NC 01 SW 34) is in the background.

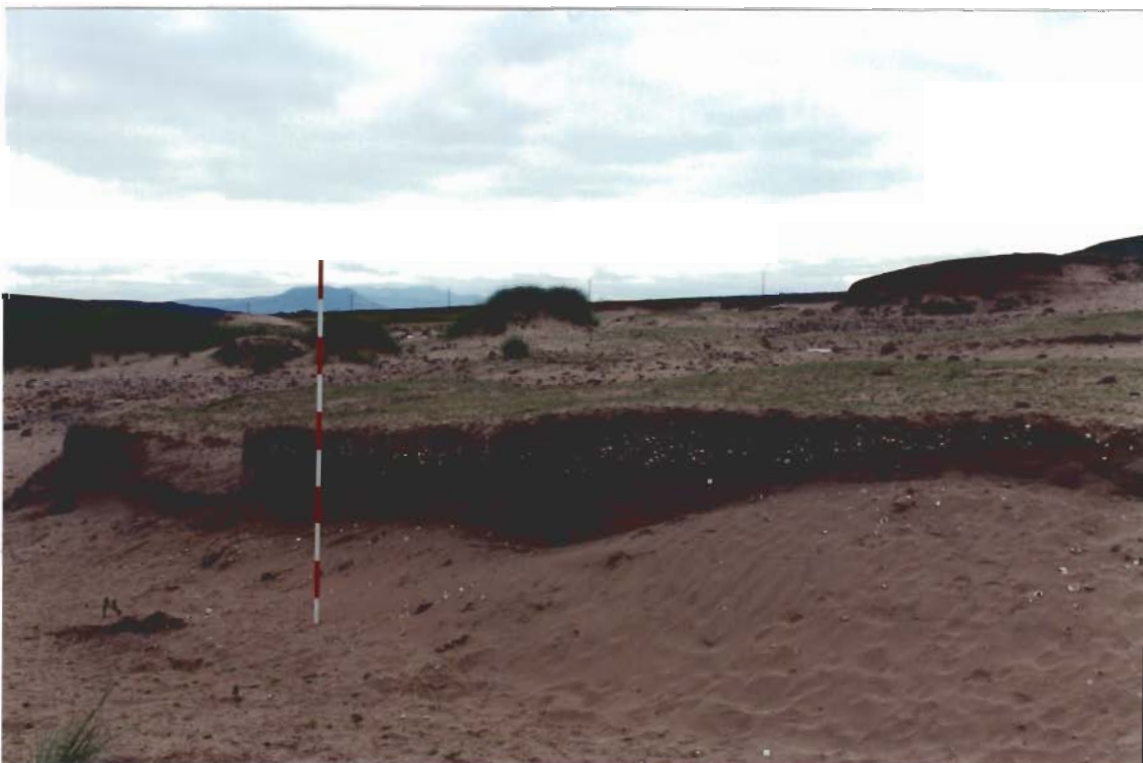
Plate 17: Achnahaird Sands (NC 01 SW 2), Zone E. Eroding section, facing south west, showing *in situ* shell deposit, buried land surface and underlying palaeosol. Note rabbit activity at the base of the section. This land surface has been revealed through the loss of sand dune cover and approximately 1m of machair soil.
