REPORT ON A COASTAL ZONE ASSESSMENT SURVEY OF

WESTSIDE, SHETLAND

EASE ARCHAEOLOGICAL CONSULTANTS
UNIT 8
ABBEYMOUNT TECHBASE
2 EASTER ROAD
EDINBURGH
EH7 5AN

COMMISSIONED BY:

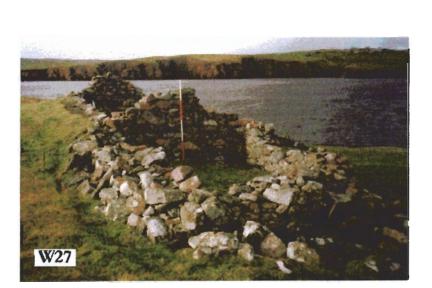
The remains of ruinous field banks and dykes are visible on flat land which forms the base of a U-shaped valley which issues out onto a pebble beach. The area is now waterlogged and peat has begun to develop in places. Most of the remains lay over 100m from the coast edge and appear to be of relatively recent origin.

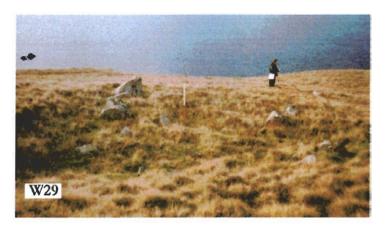
Structure: dwelling 3rd-1st mill BC

Located <20m from coast edge A sub-circular structure, defined by an earthen and stone bank, is located on gently sloping land above a break in slope, leading to low cliffs. Externally, it

measures 7m by 6m; the internal area is approximately 4m by 5m. There is a probable entrance gap to the west side. The rear of the structure appears to have been cut into the slope. Internal divisions are indicated by orthostatic stones and occasional recumbent blocks. An intermittent line of stones and a very ruinous earthen bank, which are located to the west side of the exterior may form a porch-type feature. The site is situated in rough grass land. Fair

Survey

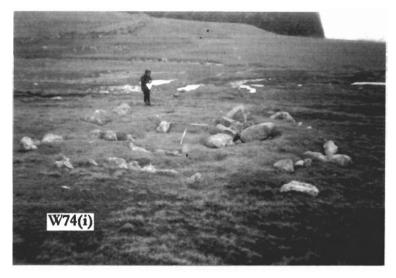
Located <100m from coast edge
(i) An oval structure, measuring
5.5m (N-S) by 5m (E-W)
externally, is situated in rough
grass on a gently sloping hillside.
It is defined by walls which are
2m thick and faced with stone
both internally and externally.

The entrance lies to the west end and has been damaged.

(ii) A second, similar structure is located 15m to the south east. It sits on top of a slight rise and is defined by large earthfast stones. It is sub-circular in plan, measuring 2.5m in diameter. Fair
Survey

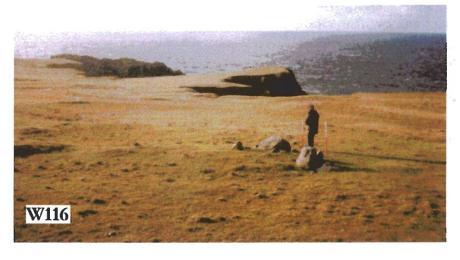
W116

Walls: Map 8
HU 1739 5312
Runkie Head
Field system and
possible structures
3rd-1st mill BC
Located <100m from
coast edge
There are widespread
fragmentary remains in
this area. Segments of

earthen banks and terrace edge can be discerned along with two sub-circular enclosures or structures. One measures 10m by 8m and is defined by earthen and stone banks up to 0.5m in height. The other measures 3m by 4m with banks up to 0.5m high. Several orthostats are visible around the circuit of this bank. They may represent prehistoric houses, surrounded by a field system of contemporary date.

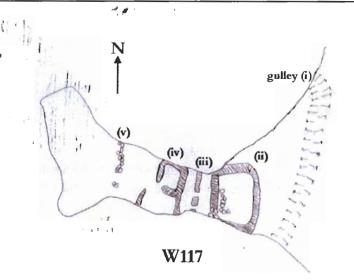
are possible structural remains situated at the seaward end of the promontory. The site is very exposed and the terminals of the banks have already been damaged by erosion. The various elements found at the site are described here, as encountered moving from the landward to the seaward end of the promontory:

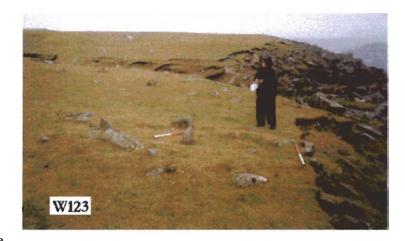
Located on coast edge
An elongated oval structure,
possibly a noost or boat house,
is situated on flat grassland. It
has been partially eroded by the

sea. It is defined by intermittent stones, some of which appear to be orthostats. It measures 3.5m by 2.2m. An examination of the exposed section indicated the presence of several edge-set stones beneath a thin deposit of turf and topsoil.

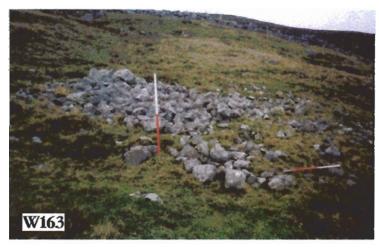
A mound of stone, measuring 3.5m X 5m, may be a burial cairn of prehistoric date. A slight earthen bank is visible beneath the mass of stone on the east side. A kerb or adjoining stone feature is also indicated on the north side. The stones are relatively uniform in size, measuring, on average, 0.3m by 0.2m by 0.1m. The site sits on steeply sloping grassland, some 30m from low cliffs. It is tentatively identified as a burial cairn, since it is unlike other clearance cairns seen in the area and is composed mostly of stones of a similar size. There are several small clearance cairns in this general area, along with the remains of enclosures and dykes.

Fair Survey

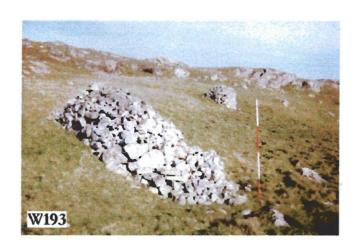
built, with several distinct phases of construction being apparent. The roof has collapsed but the doorway and much of the walls remain intact up to roof height. Part of the walls are clay bonded and some are rendered internally and externally. A large number of drystone dykes and clearance cairns are located in the vicinity. The clearance cairns are rather unusual in that they are very neatly stacked into high upright piles, some reach almost 2m in height. Other features located in this area include enclosed pasture fields, the remains of boat noosts on the adjacent beach and a very well-preserved click mill (HU25NE 38). The walls of the mill survive almost up to roof height and the lower mill stone remains in-situ. The streams and dams are also visible. The site of a second mill lies nearby (HU25NE 39).

Good Survey

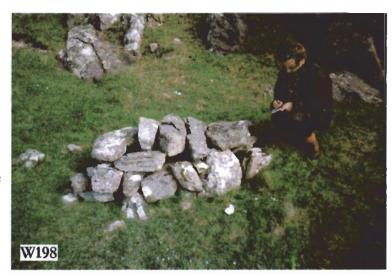
box, set into the ground, with a slab covering. The side walls are lined with up to two courses of flat stone. The base of the box is not lined. The capstones vary in size, but most span the width of the box. They are placed in such a fashion as to leave gaps between. Overall, this feature measures 1.5m in length and 0.75m in width, it stands up to 0.3m high.
