The SCAPE Trust
The University of St Andrews
Queen's University Belfast
March 2010
Commissioned by Historic Scotland

The Eroding Limekilns at Boddin Point, Angus

preservation by
digital record

Historic Scotland Project Number: **53605**
NGR: NO 71340 53347

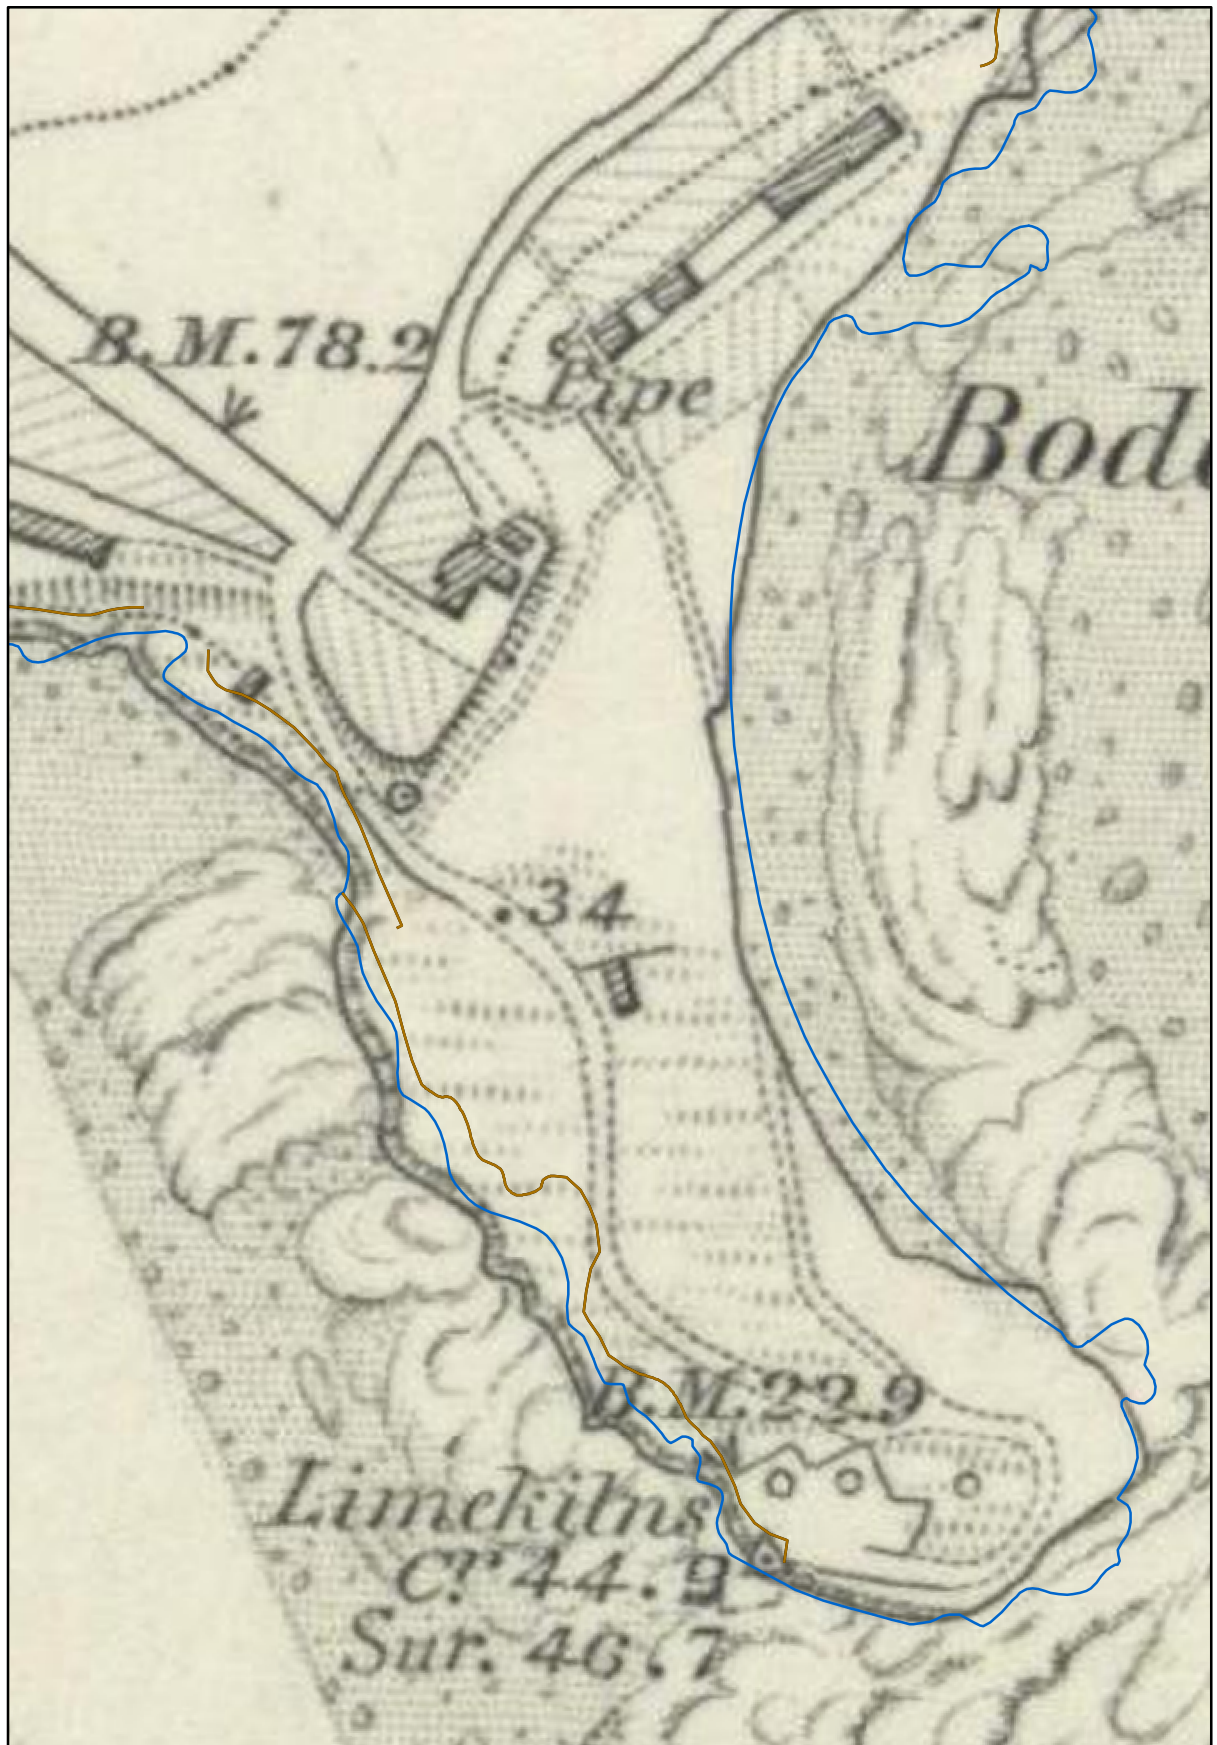
Figure 3. First Ed. OS map showing the limekilns at Boddin, with modern MHWS marked in blue and the cliff top marked in brown. (scale 1:1500)

The quarrying of the limestone, together with coastal processes, has led to a change in the shape of the promontory. The First Edition Ordnance Survey map (1865) was surveyed after the quarry had ceased to operate. Figure 3 shows the present position of the Mean High Water Springs (MHWS) together with the top of the cliff superimposed onto the 1865 map. It appears that the west coast of the headland has suffered heavy erosion, confirmed by the partial collapse of the limekiln; the destruction of a small fishing harbour to the north; and the exposure of the former road leading down to the limekiln in the coastal section. Changes to the position of the MHWS depicted on the two maps are due to coastal processes rather than quarrying.

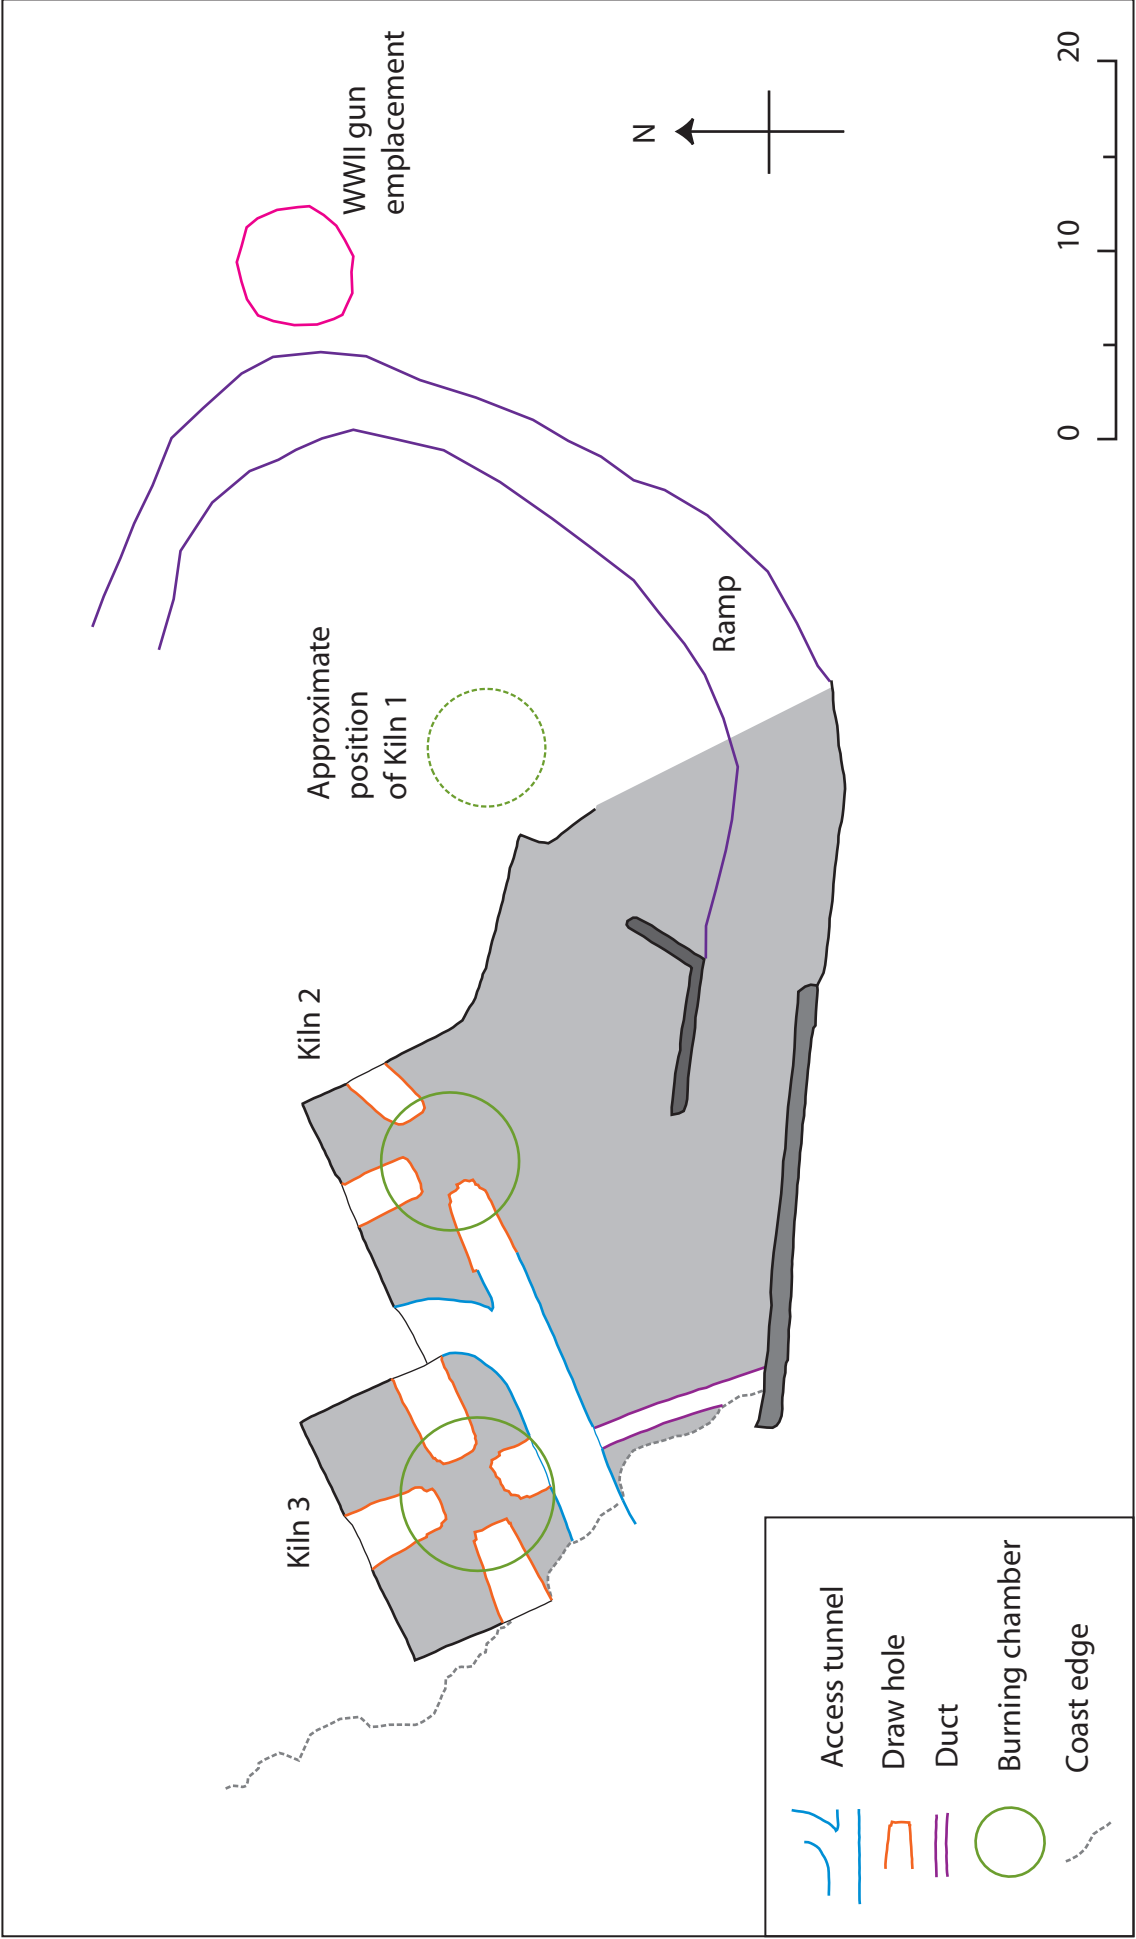
Figure 4. Plan showing principle elements of the limekiln recorded during the survey.

Erosion has led to the collapse of a substantial portion of the southwest quadrant of the structure. At least two thirds of the west wall and the southwest corner of the southern wall of the structure have collapsed exposing the vulnerable rubble and soil core of the monument. Internal structures such as the stone-lined burning chamber of kiln 3; a stone-lined duct (Plate 17); and the brick vaulted interconnecting tunnel are now collapsing. The bedrock platform upon which the whole of the western edge of the monument is constructed comprises a narrow band of sandstone underlain by softer mudstones and siltstones, which are being eroded by wave action leading to significant undercutting of the rock platform. The remainder of the west wall has now been undercut and further collapse of the monument is imminent (Plates 18 and 19).

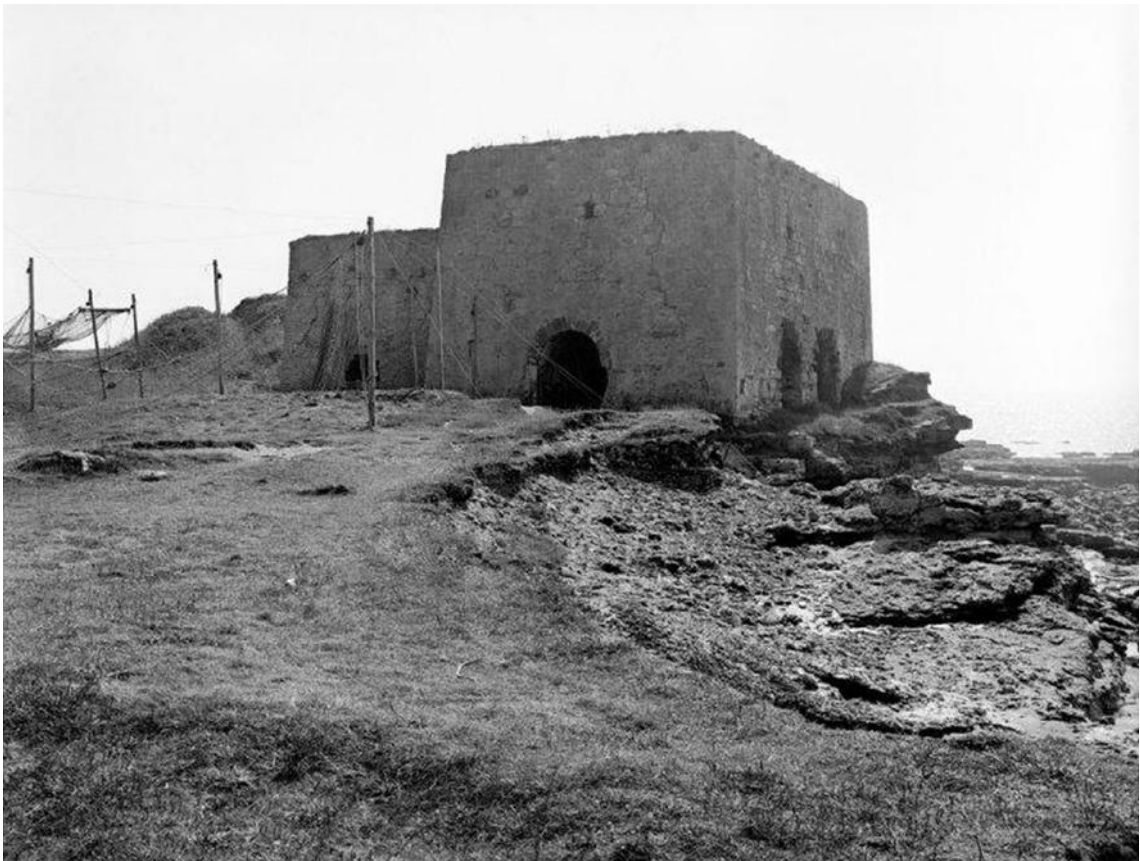
Plate 1. Boddin limekiln photographed by John Hume in 1977 (copyright RCAHMS)

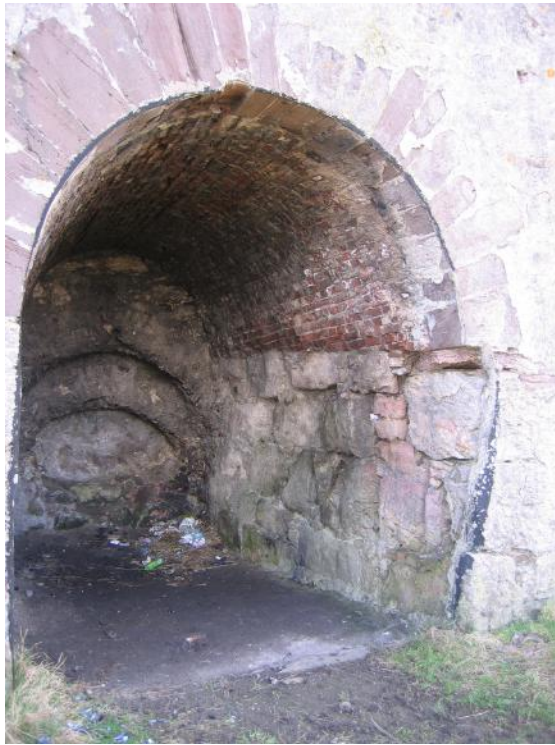
Plate 14. Drawhole recess in the north elevation of kiln 3, showing the brick-vaulted roof and stepped arches of the (blocked) drawhole.

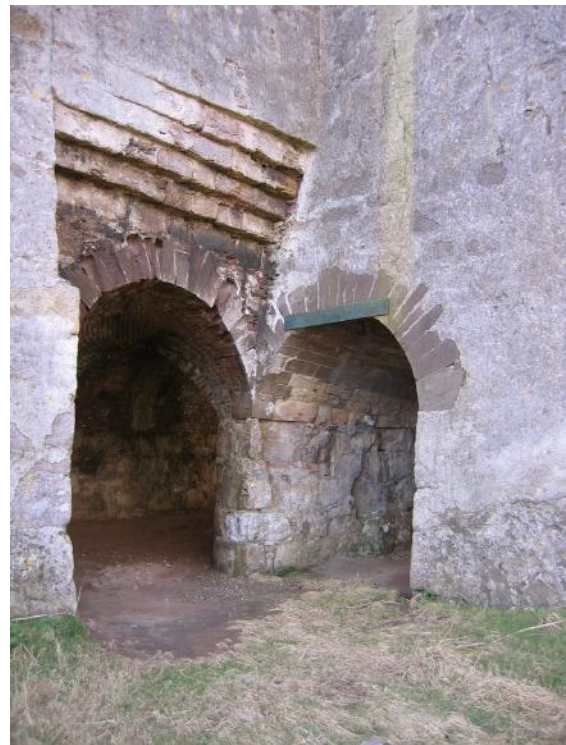
Plate 15. Entrance to the interconnecting passage in the north elevation of the kiln block. The eastern drawhole recess of kiln 3 is to the right.

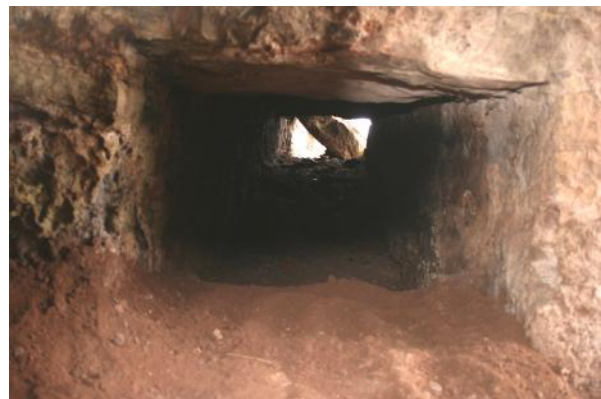
Plate 17. View down the stone-lined duct running between the central interconnecting passage and the base of the south retaining wall. The fallen capstone is in the background. Taken from inside the interconnecting passage looking south.
