Archaeological surveys of *Fauna and Monreith*

Wreck recording, Kirkcudbright Bay
for the Kirkcudbright Bay Views Project
Galloway Glens
October 2019

Recording the remains of *Fauna*, Gibbhill

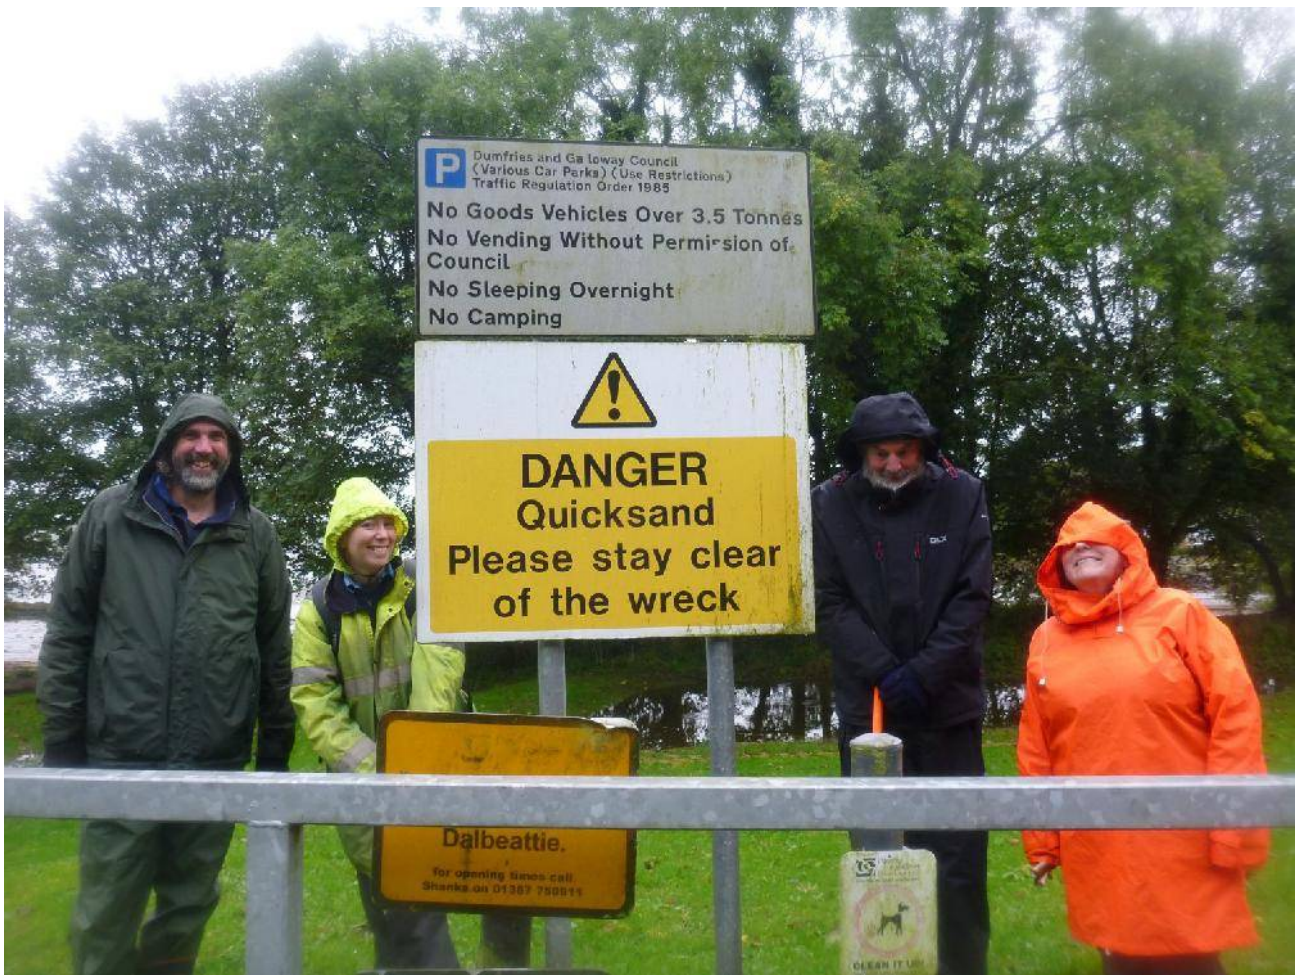
35. Hazards of recording *Monreith*: foreshore conditions around the wreck coupled with inclement weather during the survey with intrepid community volunteers

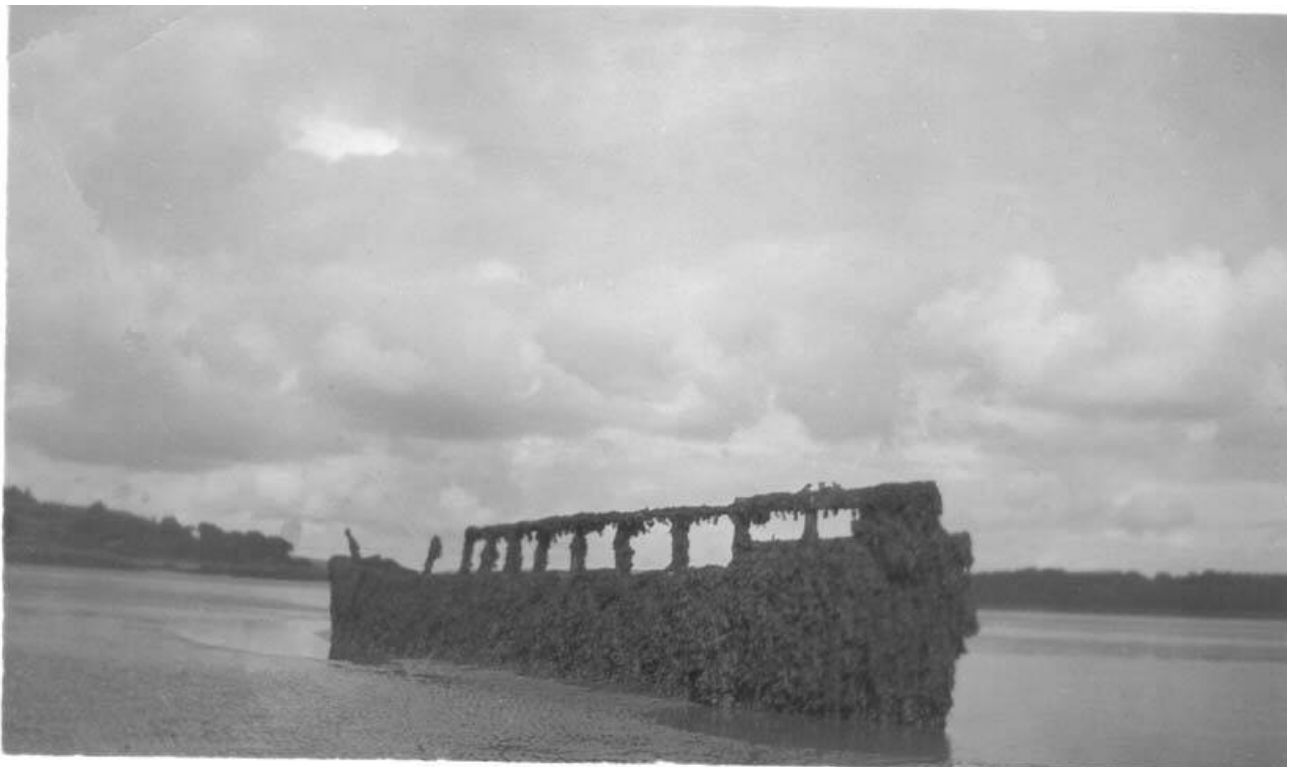
A full description is given in Appendix 2, but in summary, the wreck is currently visible defined by the upstanding ends of frames outlining the shape of the vessel for its entirety from stem to stern, with the stem post at the south end, the stern post at the north end, and up to three strakes visible above the level of the beach. The extent and condition of the remains in 2019 are presented in the wreck recording form (Appendix 2) and in figures 37-40. A historic image dating to c. 1920 (figure 36) shows the hull standing to the height of the gunwhales with some of the top rail intact. Much of the hull has been lost in the intervening 100 years, but comparison between the remains as recorded by this project in 2019 and the visible wreck as shown in previous photographs available on Canmore from 2012 (George Geddes) and 2015 (Project Samphire) (<https://canmore.org.uk/site/125031>) and those taken by Nic Coombey in 2014 (<http://scharp.co.uk/sites-at-risk/3946/>) shows little visible difference, indicating that the process of decay and deterioration is significantly slower than that affecting *Fauna*.

36. The wreck of *Monreith* c. 1920
