EASE ARCHAEOLOGICAL CONSULTANTS

REPORT ON A COASTAL ZONE ASSESSMENT SURVEY OF ORKNEY:

AUGUST 1997

Hazel Moore Graeme Wilson

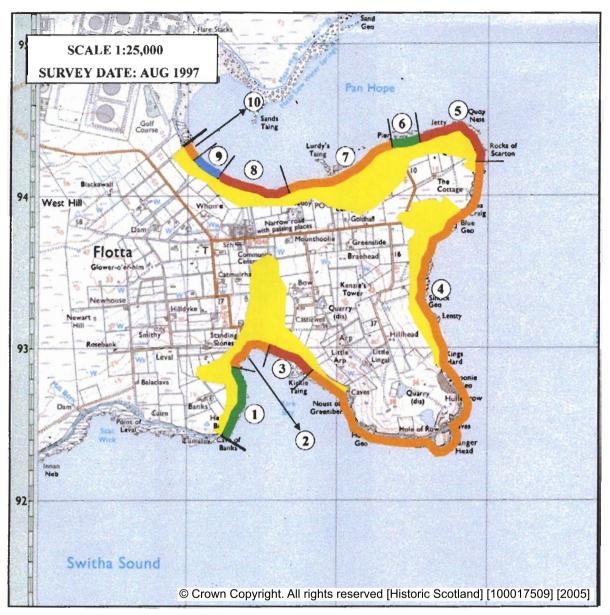
EROSION CLASS FLOTTA
MAP 2

Localised erosion of the coastal edge. An old pier is also eroding.

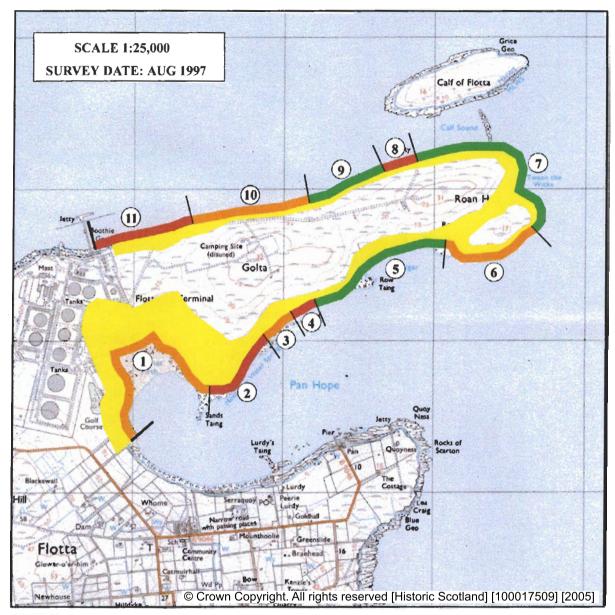
Areas of coastal crosion are common along this section with perhaps a slightly more stable area towards Boothie Geo.

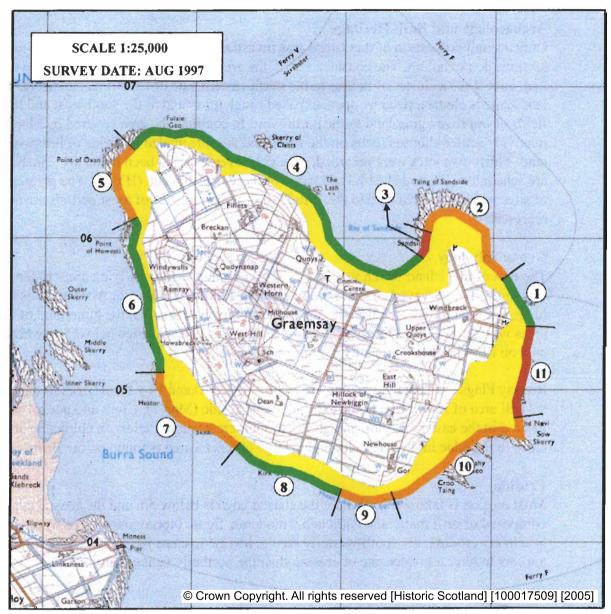
EROSION CLASS GRAEMSAY

Although some areas are stable the overall process is one of crosion. Two small areas of relative stability are north of Clett, a small sea wall helps to protect a small stretch, ~50m, and north of Scarrataing where another short sea wall gives some protection and stability.

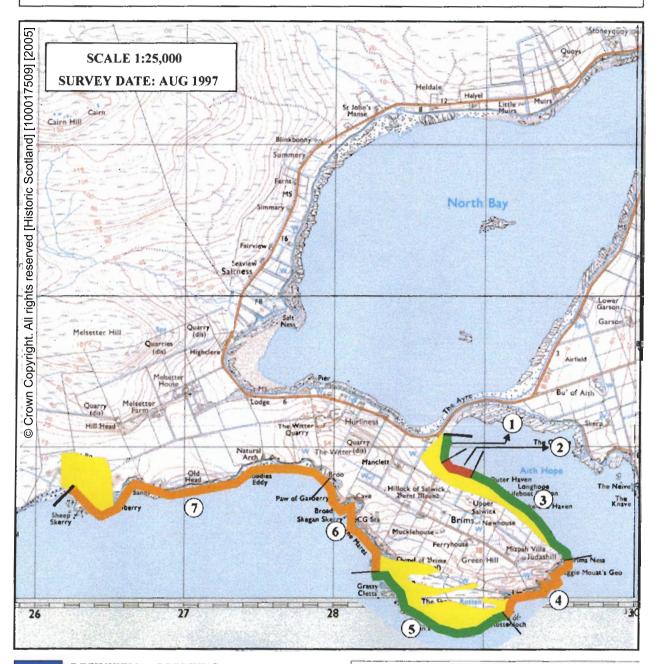
EROSION CLASS
HOY
MAP 1

Local area of erosion dominates this section and most of this erosion is on the sand dunes. Two of the larger erosional areas are on the east side of Sands Geo and on the west facing bay of the Dunes where sand extraction is aggravating the erosion. A huge deflation trough, approximately 20m wide, has cut through the dune system. Most dunes are stable due to vegetation cover although erosion is taking place in localised areas. Along the Old Head there is evidence that the fence line has been moved back 1m from the edge.

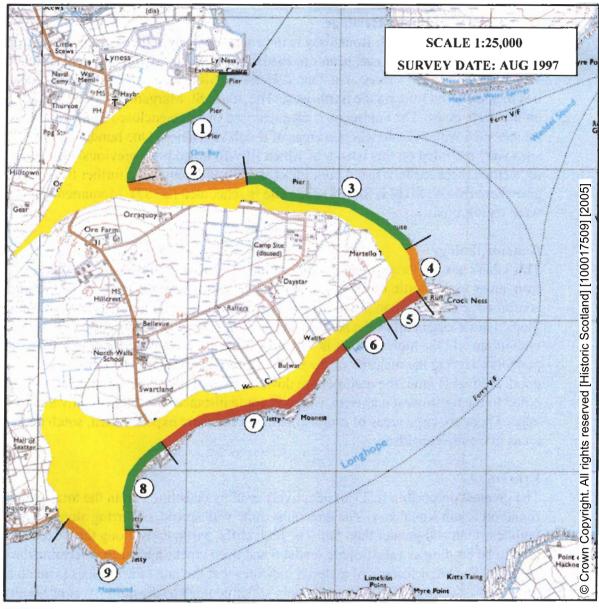
A sea defence wall by the jetty is starting to erode and there are other areas of localised erosion to the west.

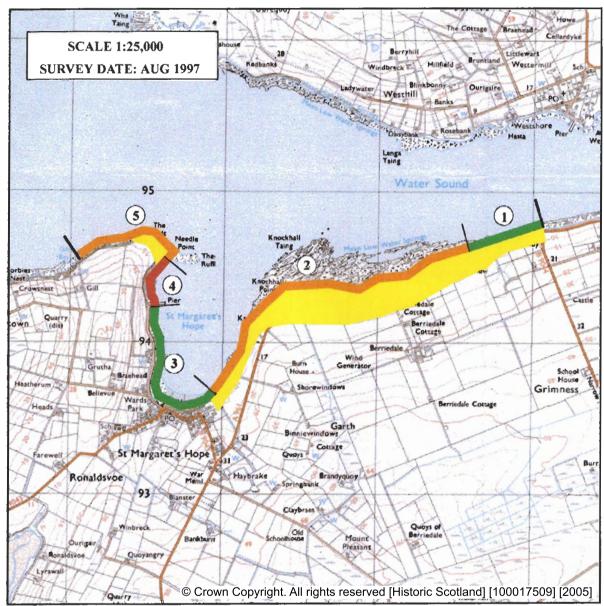
SOUTH RONALDSAY MAP 1

Sea erosion has caused small portions of rock to come away from the face to the west of The Golt. Localised landslip/slump at the cliff top is evident.

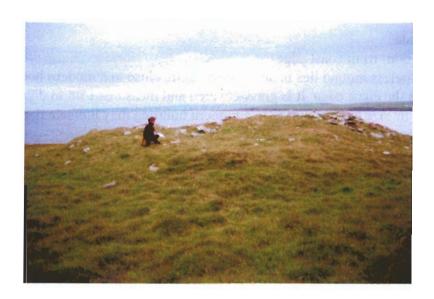
SITE H5

The site is clearly visible, being a large artificial mound built on top of a natural rise at the southern tip of Hunda. It measures some 15m in diameter and stands up to 2m high. A large quantity of loose stone is strewn around the immediate area whilst both in-situ and disturbed structural stone is visible to the hollowed centre. The mound is denuded of vegetation in several places, apparently the result of human and animal disturbance. A loose stone cairn has

been erected to the S side of the mound in recent times. The mound provides fine views across to the north coast of South Ronaldsay and Muckle Howe broch.

Monitor

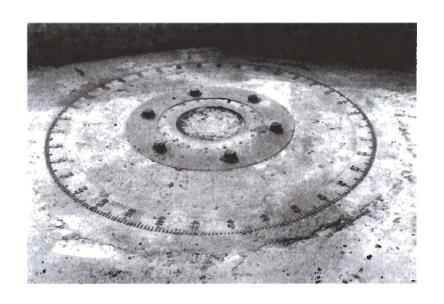
SITE F3:(vi)

- (ix) An open-fronted concrete searchlight emplacement, which served both the Neb and Gate batteries, is set into the cliff edge.
- (x) Two small concrete buildings, probably associated with wartime coastal defence operations, are situated within 5m of the coast edge. Fair

Survey

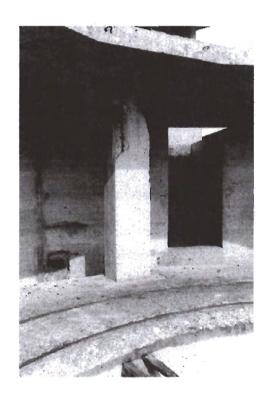
SITE F3: DETAIL OF CRUMBLING CONCRETE
204

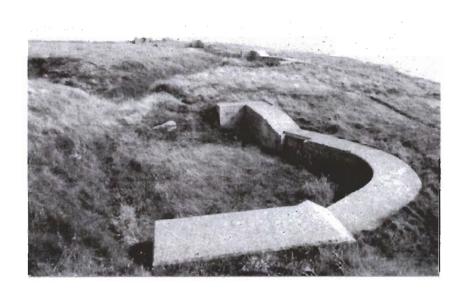
subterranean passage, to a magazine building at the rear. The northernmost gun emplacement has had a modern shipping beacon set upon it.

SITE F27: 1st WORLD WAR GUN EMPLACEMENT

Fair Survey

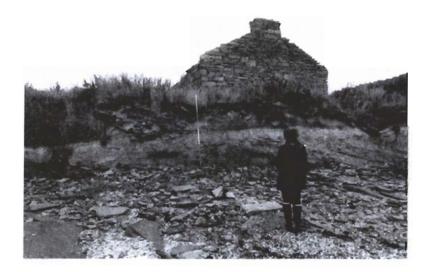
SITE G3

stone-lined drain is also visible in this section. Fair/poor

Monitor

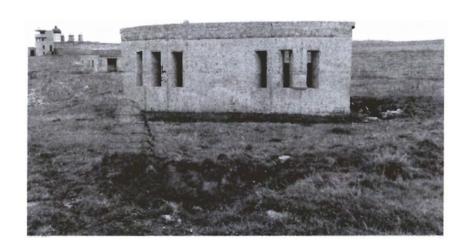
SITE G13

The remains comprise the gun battery, the two searchlight emplacements and a range of buildings built to the rear of the battery against the perimeter wall of Hoy Low lighthouse. The camp buildings for the battery were located inside the perimeter wall.

- (i) The battery is constructed from both mortared stone and concrete and lies 2m from the cliff edge.
- (ii) The searchlight emplacements are located 95m and 160m, respectively, to the S of the battery. They are identical in plan; two bays, each accommodating a searchlight, are located at the N and S corners of the structure. They measure 7.5m long by 6m wide and are entered via a door to the S side.
- (iii) To the rear of the gun battery, backing onto the perimeter wall of the lighthouse, lie the directing tower and the concrete footings of the engine room, shelters and magazine. Good, monitor

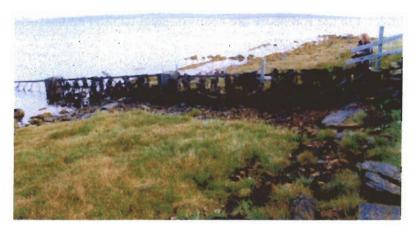
SITE HY17

A length of steel-mesh submarine netting has been re-used as fencing wire at the seaward end of a field boundary.

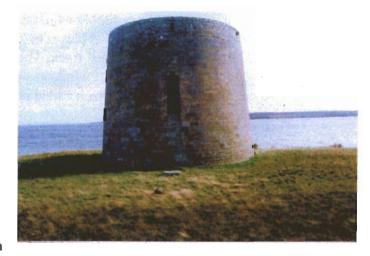
Located <10m from coast edge Crockness martello tower is one of two such structures which served the Hackness battery at Longhope. The battery was built in 1815, during the American War of Independence, to protect the sheltered harbourage at Longhope from American privateers.

The tower is 47m in circumference and 10m high. It appears circular on

the exterior, but due to a thickening of the seaward section of the wall, the interior is elliptical in plan. It was designed to be entered through a doorway on the first floor, via a removable ladder. It is not generally accessible now and thus the interior was not inspected. This site lies 1.5m from the coast edge. The coastline immediately in front of the tower is protected by a gabion wall, 20m long and 1.5m high.

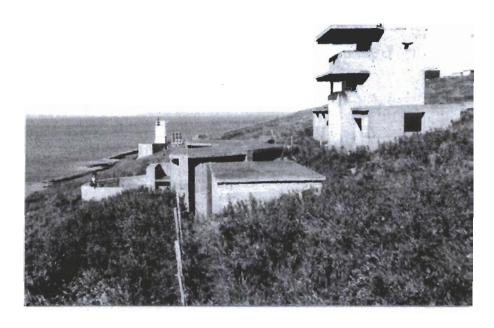
- (xvii) A searchlight emplacement, similar to (xv), is situated to the SW of the gun emplacement (xvii).
- (xviii) An artificial rectangular hollow in the cliff side may have housed storage tanks or a semi-subterranean structure. The cut, which extends into bedrock, measures 20m by 6m and is up to 2m deep in places. A small concrete plinth is located towards the centre of the area. Fair/poor

SITE SR24 NORTH SIDE OF HOXA HEAD

Monitor

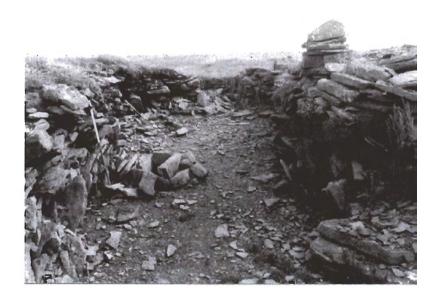
SITE SR82(iv)

- (v) A small grass-covered knoll lies to the NW side of (iv). It is sub-circular in plan, measuring 8m in diameter; it stands to 0.3m high.
- (vi) A sub-circular mound, 8m in diameter, lies to the E end of (iv). It is up to 1m high and has occasional stones protruding from beneath the turf.

Monitor (i)- (iii) (vi) & (vii), rescue excavation required on (iv)

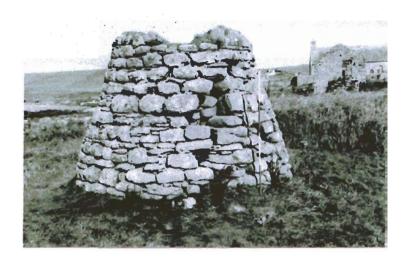
SITE SR98etc., WINDMILL BASE

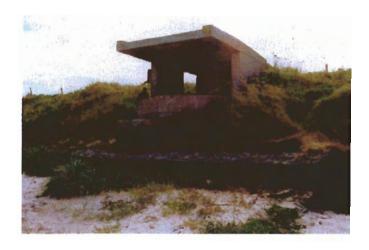
(ii) (ND 4800 9476) A concrete searchlight emplacement lies on the coast edge and has been partly eroded by the sea. It measures 6m long by 3.5m wide. It has a door to the S side and an entirely open front. Raised patterning on the ceiling indicates that it was cast with metal shuttering, the panels probably came from a water tank. The concrete plinth on which the structure is built, has been undermined by the sea and is fragmented. A low gabion wall has been built in front of the coastal section in an attempt to slow down the pace of erosion. (iii) (ND 4777 9484) A concrete searchlight emplacement is located less than 1m from the coast edge. It measures 3.5m by 6m, and appears to be intact. It is currently in use as a garden shed; the front opening has been blocked up and a window has been put in. Fair/poor

SITE SR117: SEARCHLIGHT EMPLACEMENT

Monitor
