Report on Coastal Zone Assessment Survey:

East Lothian & Scottish Borders

**Hazel Moore
Graeme Wilson**

February - March 2006

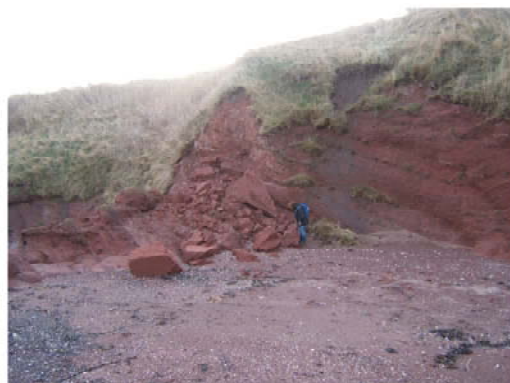
Recent collapse, Seacliff

There is one area in particular, at NT 61466 83904 (pic 95) where localised erosion has recently resulted in collapse of the cliff face together with overlying deposits.

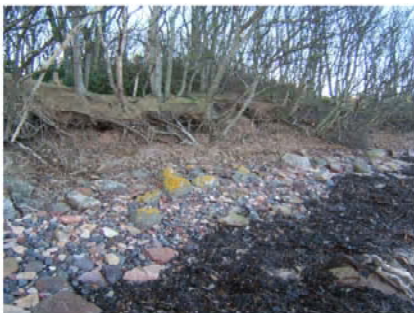
**Erosion, to E side of
St. Baldred's Cradle**

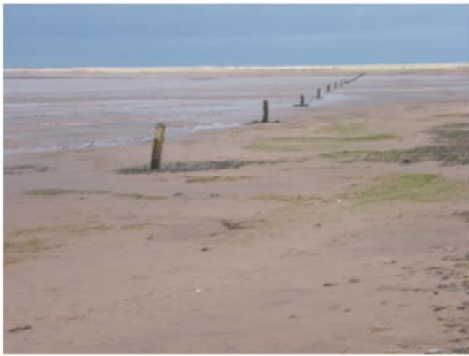
**EL19: Remains of
WWII Glider Trap**

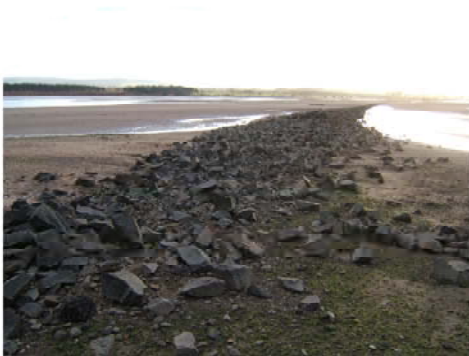
**EL36: Fish trap or
Embankment remains**

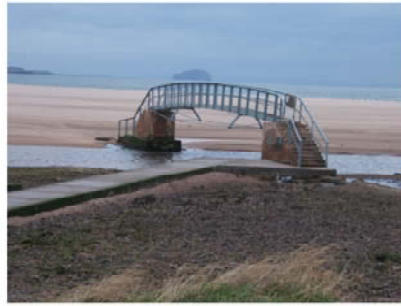
**EL22: Footbridge,
Belhaven Bay**

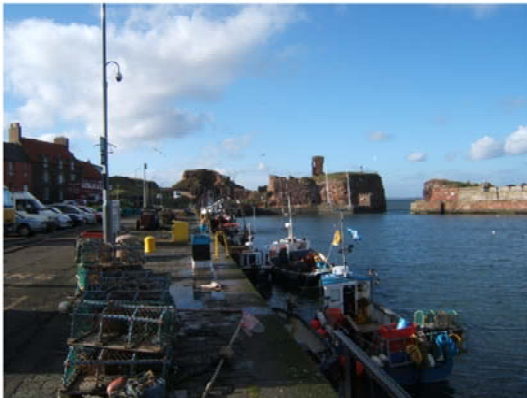
**Dunbar: Castle (EL123) &
Victoria Harbour (EL121)**

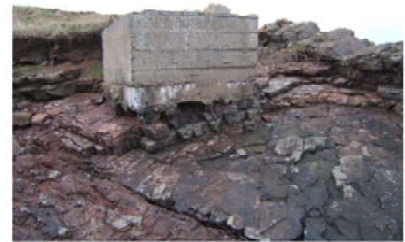
**EL26: Eroding
WWII Structure**

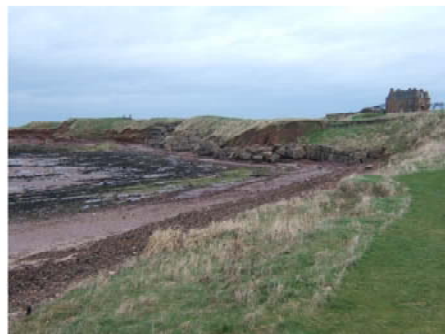
**Erosion & sea wall (EL27)
E side of Belhaven Bay**

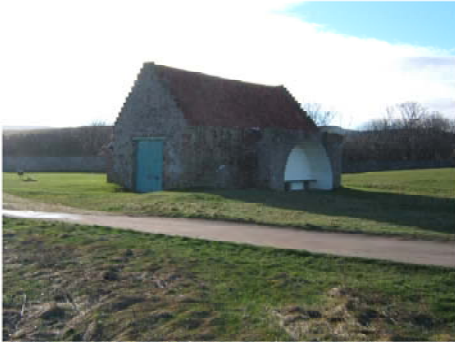
**EL30: The 'Vaults' &
EL31, tie-up post**

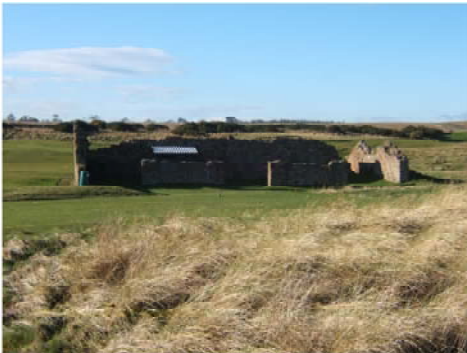
**EL34: Mid Links,
former cottages**

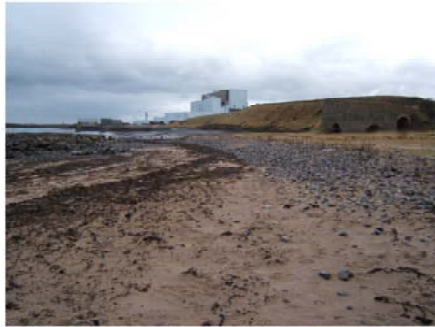
**EL53, Lime kiln
& Torness Power
Station**

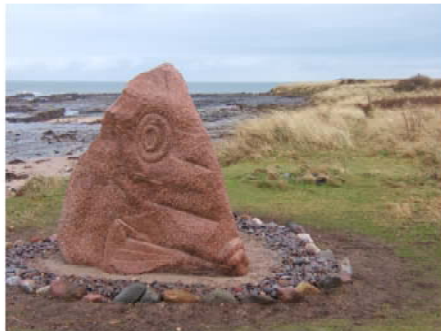
**EL51: Mr. Floaty
Sculpture**

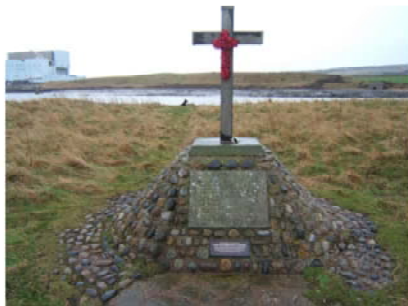
**EL49: Memorial,
Chapel Point**

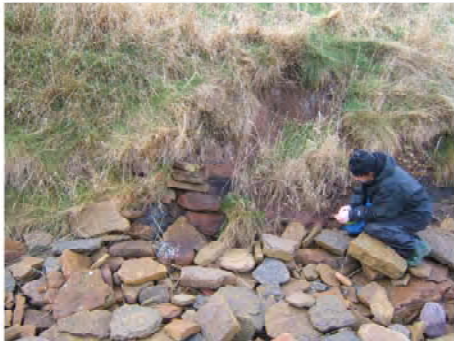
EL56: Eroding deposits at Lawfield

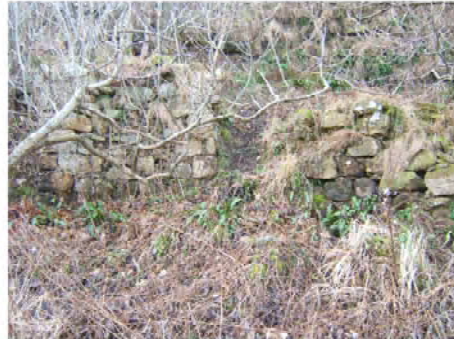
EL57: Designed landscape, Bilsdean

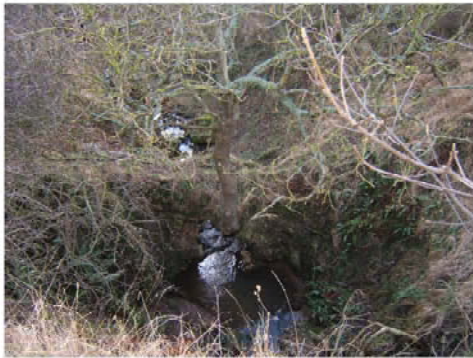
EL57: Bridge, Bilsdean

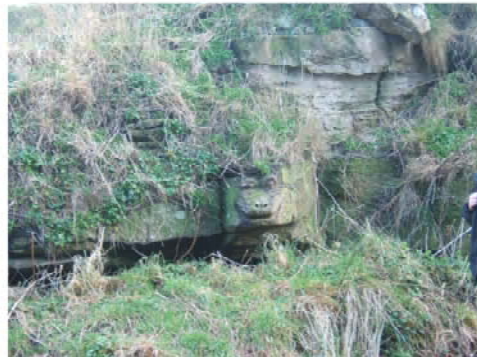
SB1: Carving, Dunglass

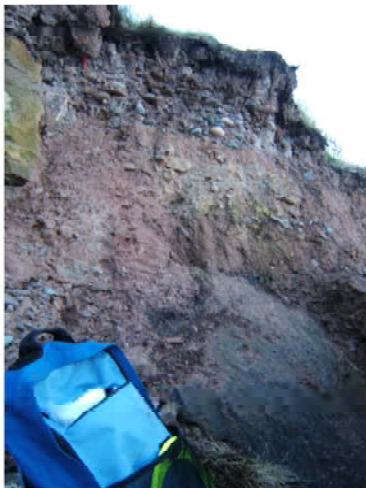
SB2: Eroding deposits, Dunglass

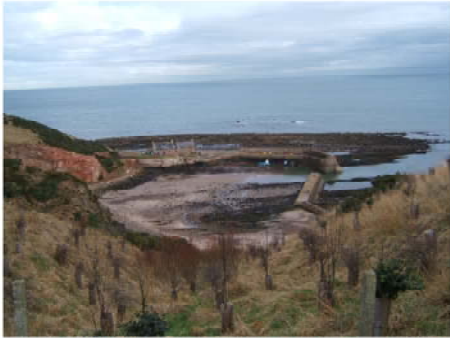
SB3: Cove Harbour

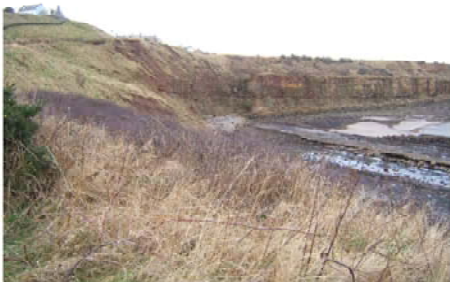
**Erosion at
Cove Bay**

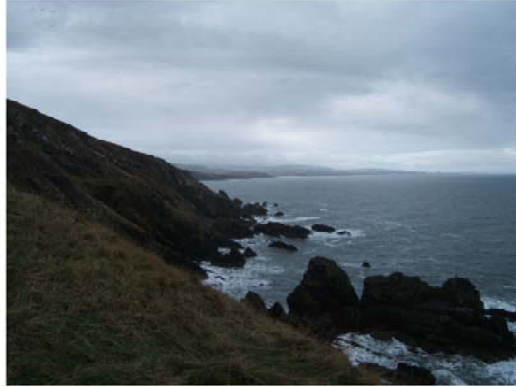
**Cliffs to W of
Telegraph Hill**

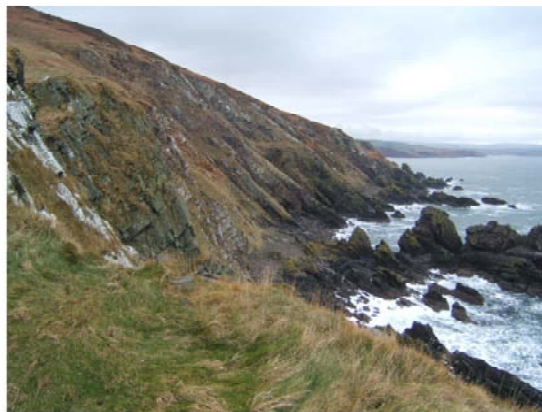
**View of coastline at
The Nick**

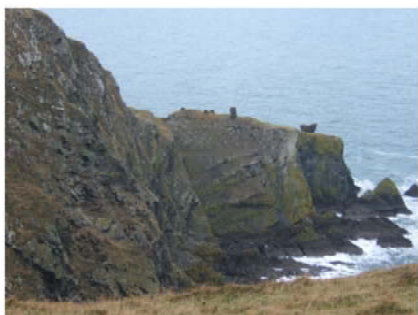
SB9: Fast Castle

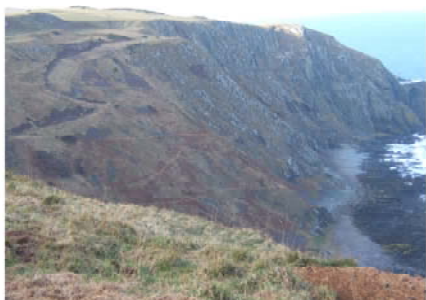
**SB13: Track to
Lumsdaine Shore**

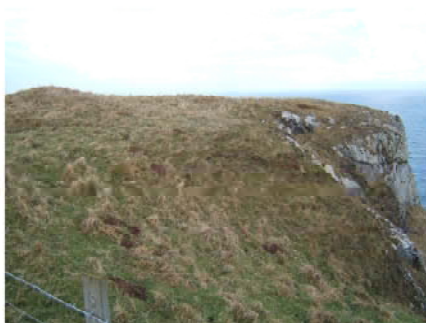
**SB12: Brander Heugh,
Promontory Fort**

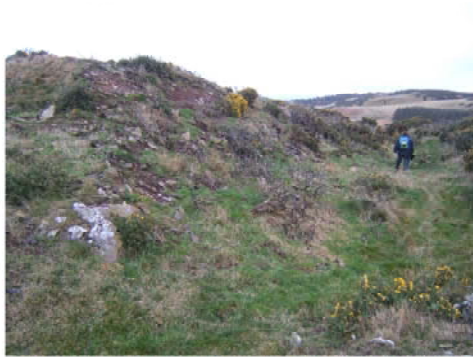
**SB16: Ramparts at
Earn's Heugh**

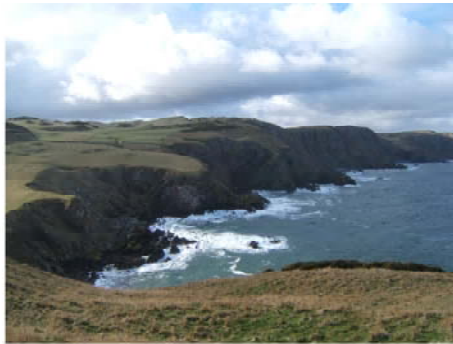
**Coastline to W of
St. Abb's Head**

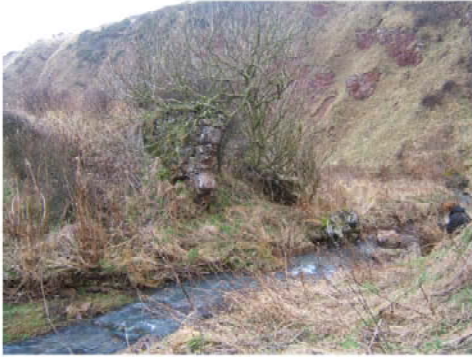
SB23: Possible mill

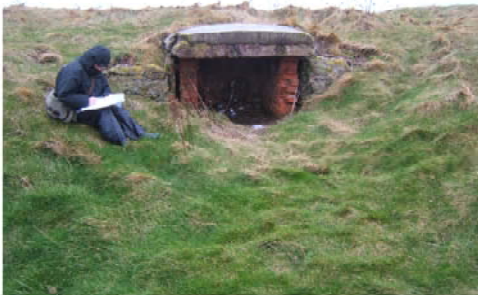
SB22: WWII Structure

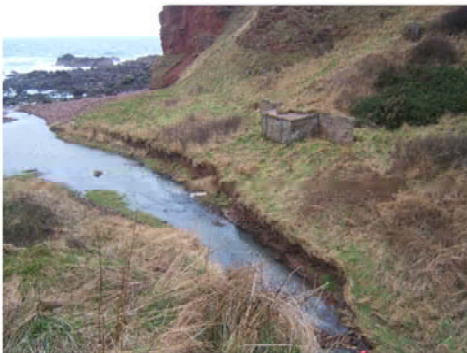
SB24: WWII Structure

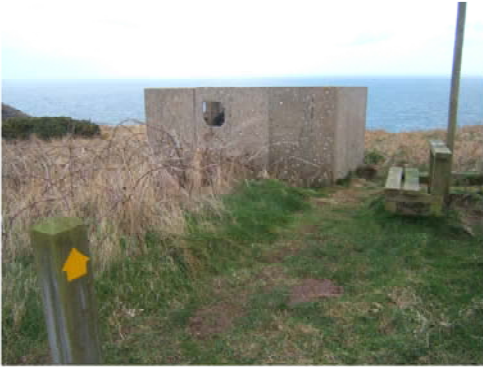
**SB32: WWII
Structure**

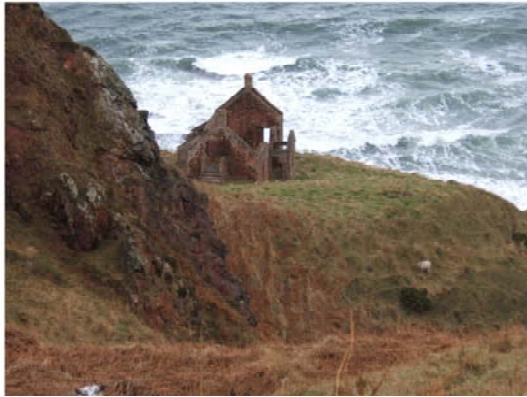
**SB33: Structure at
Lamberton Skerrs**

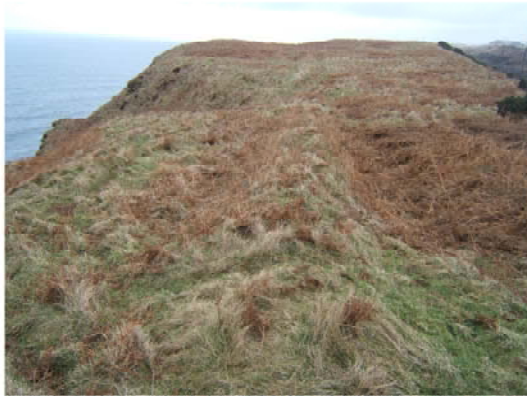
**SB34: Eathwork at
Lamberton Shiel**
